2889 Woodland Glen Lane.
Conroe, Texas 77385
Prepared for: Morgan Lee
Date: 11/11/2021

PROPERTY INSPECTION REPORT FORM

Morgan Lee <i>Name of Client</i>	11/11/2021 <i>Date of Inspection</i>
2889 Woodland Glen Lane., Conroe, Texas 77385 <i>Address of Inspected Property</i>	
Stuart Bradley Fleming <i>Name of Inspector</i>	24786 <i>TREC License #</i>
 <i>Name of Inspector</i>	 <i>TREC License #</i>

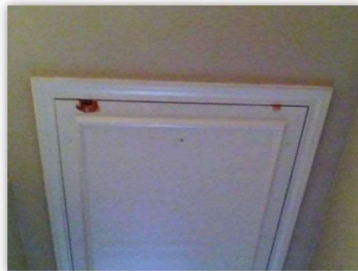
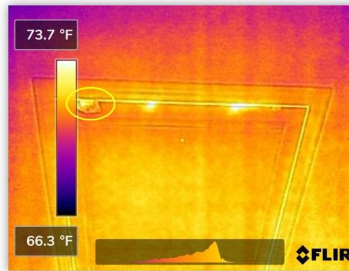
Temperature differences and patterns associated with unconditioned air leakage observed when using the thermal camera on the attic access ladder cover.

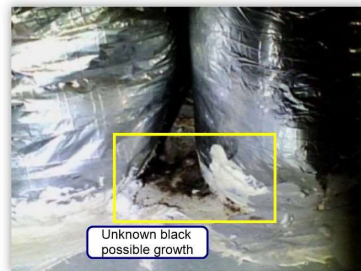
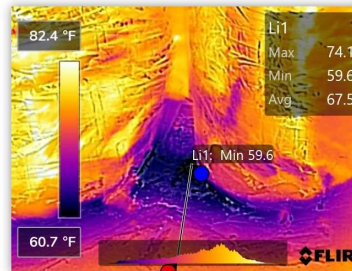
Temperature differences and patterns associated with conditioned air leakage observed when using the thermal camera on the plenum.

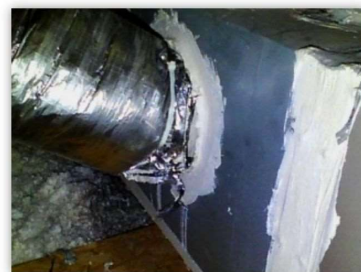
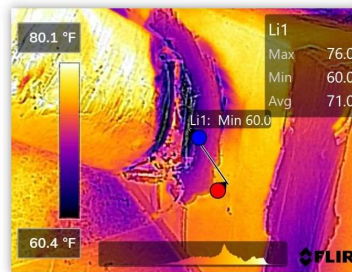
Temperature differences and patterns associated with conditioned air leakage observed when using the thermal camera on the plenum.
