Property Inspection Report #6/27/20239122 Golden Sunshine Drive
8616 Daffodil St. Houston, TX 77063

PROPERTY INSPECTION REPORT FORM

9122 Golden Sunshine Drive, Houston, TX 77064

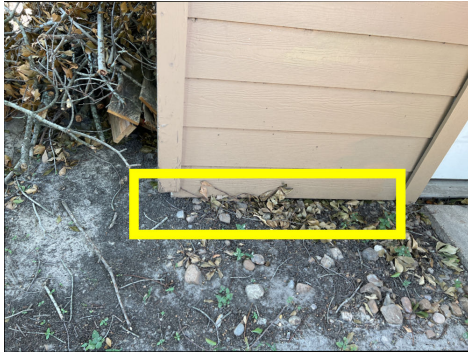
Soil level too high around areas including, but not limited to, multiple areas house . Common industry practice requires a clearance of at least 4 inches from the bottom of the siding to the soil. High soil level near the siding promotes wood rot and is considered a conducive condition to termite activity and water penetration.

High soil

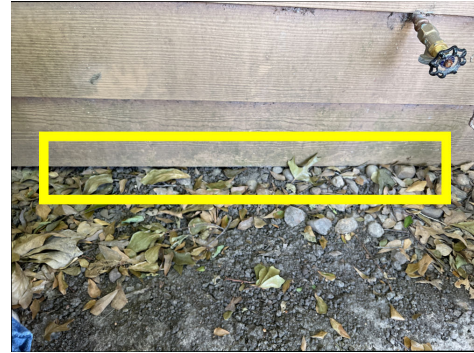
High soil

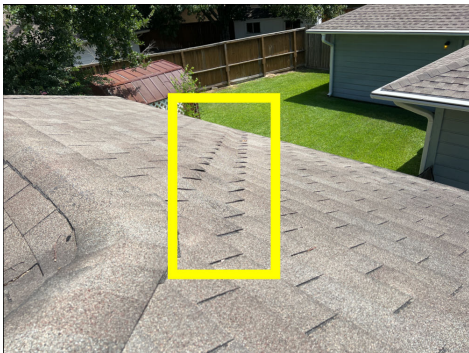
Ridge(s) on planes of roof surface observed. This is an indication that the addition was not perfectly tied into the existing structure.

Ridges on roof plane

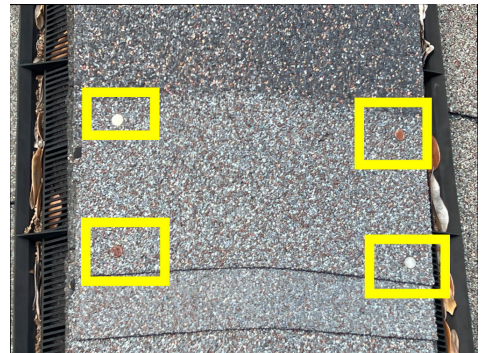
Exposed staples/nail-heads/fasteners observed on the roof are not properly sealed. Water entry possible.

Exposed nail heads

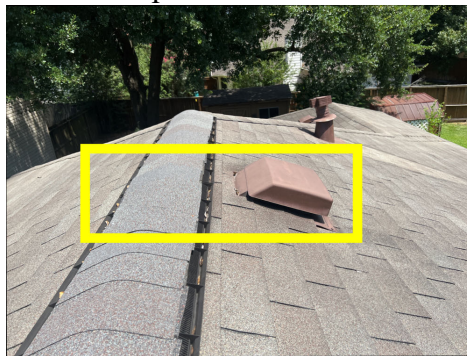
Two types of roof vent used

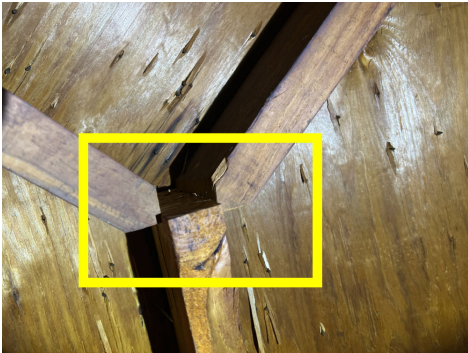
One or more ends of rafters were observed to be not cut flush with corresponding components - some degree of misfit was observed, average/mediocre framing. No repairs recommended.

Poor framing cuts to one or more rafters

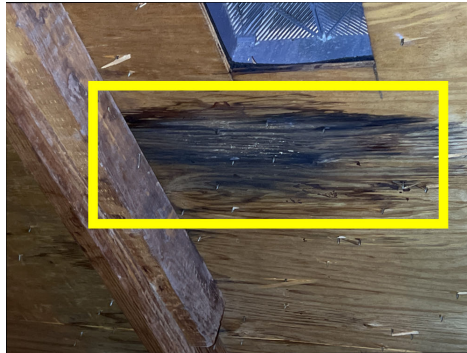
Area(s) of water-stained and/or rotted roof decking observed in the attic.

Water stains/wood rot on roof decking

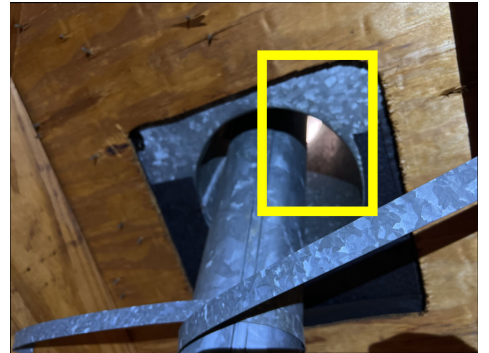
Daylight is visible from interior of attic at one or more locations. Recommend sealing these areas to prevent potential pest / rodent / water entry.
 Furnace exhaust

Daylight observed in attic

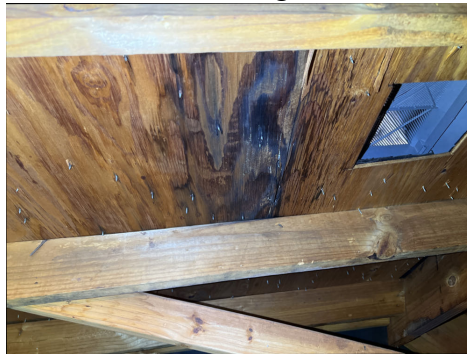
Water, stains/wood rot on roof decking

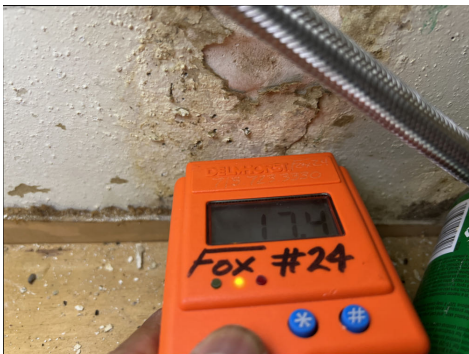
Moisture meter registers water stains as active; below kitchen sink

Elevated moisture observed at/below kitchen sink

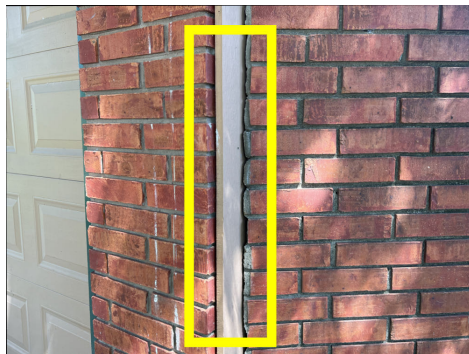
Caulking missing and/or deficient around windows / doors / vertical trim / joints in siding. May allow wind driven rain entry.

Caulk and seal vertical trim

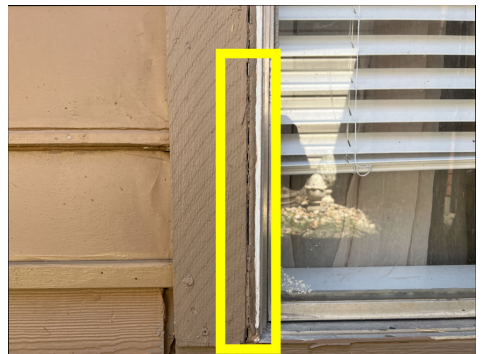
Caulk and seal windows

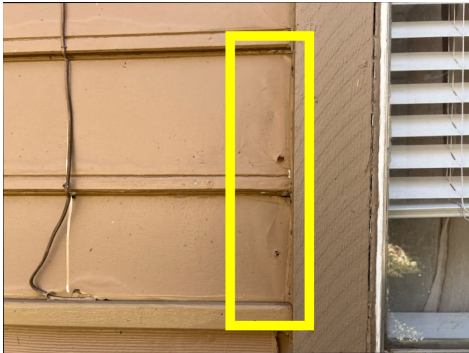
Wood rot

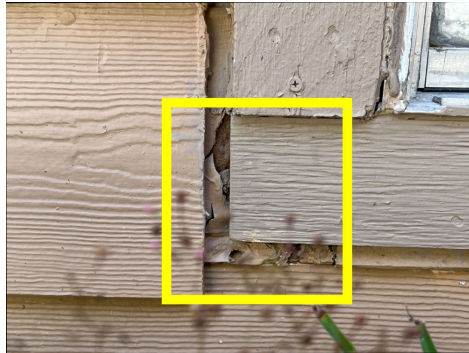
Caulk and seal exterior penetrations

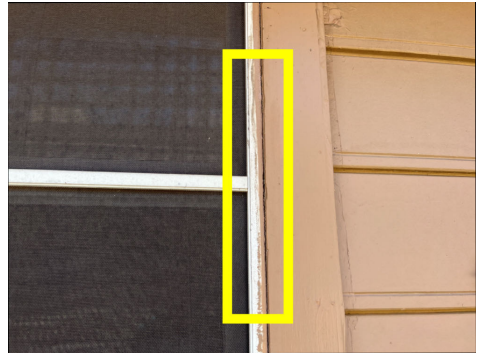
Caulk and seal windows

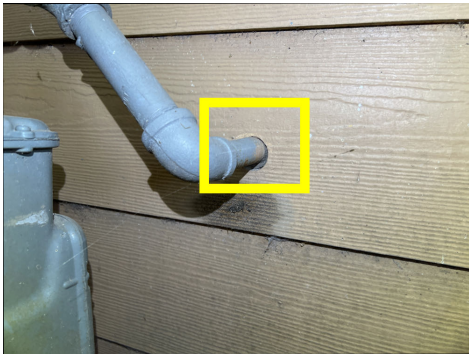
Caulk and seal exterior penetrations

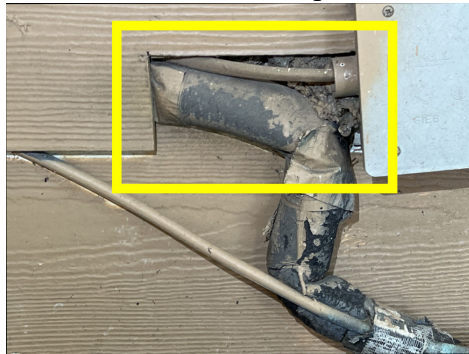
Caulk and seal exterior penetrations

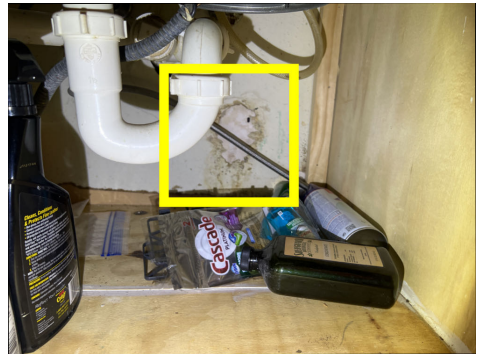
Water stains under kitchen sink
Active leak

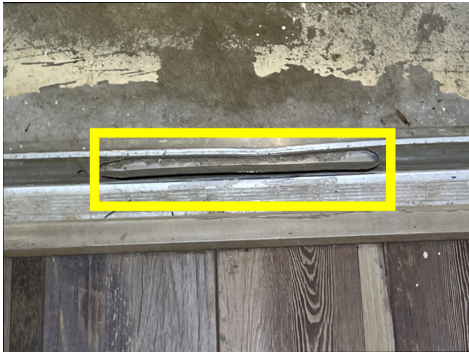
Threshold for garage pedestrian door observed to be loose / missing / damaged.

Garage pedestrian door threshold is damaged

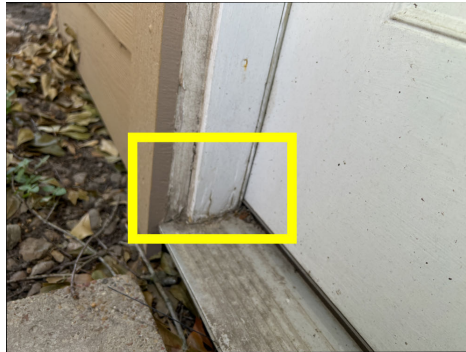
Wood rot of lower door and/or jamb;

Wood rot on door/door frame

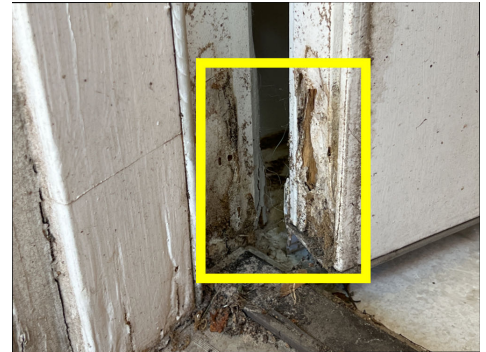
Wood rot on door/door frame

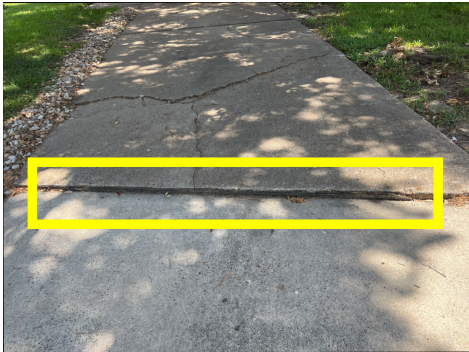
Tripping hazard(s) - walks and/or driveways are uneven.

Tripping hazard

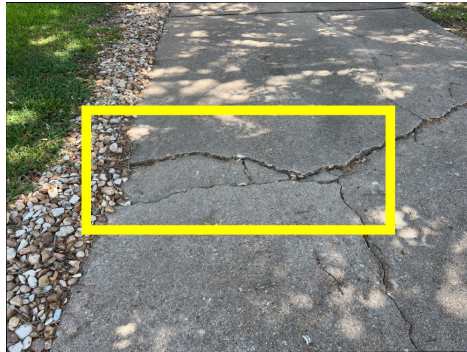
Tripping hazard

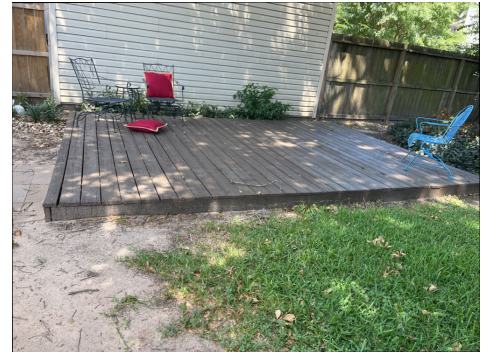
Earth wood contact in some areas - conducive condition to termite activity and wood rot.

Earth to wood contact at back deck

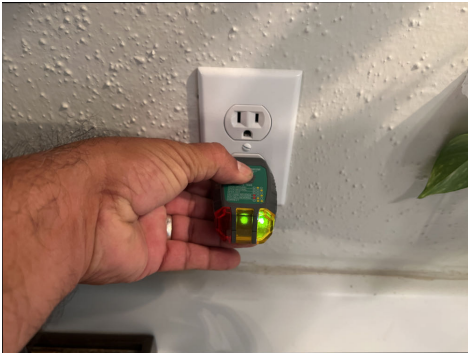
There was no GFCI protection observed at all required locations, including but not limited to; all bathrooms, kitchen countertop outlets, exterior outlets, in the garage, etc. This condition is a recognized hazard and should be corrected by a licensed electrician.

Kitchen outlet not properly GFCI protected

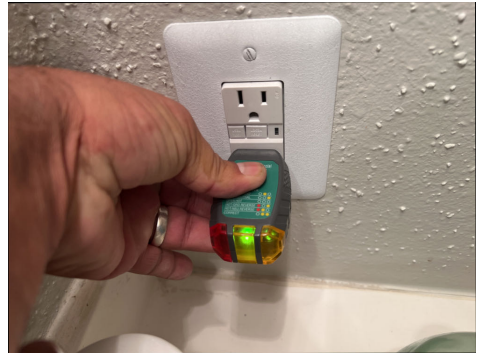
Bath GFCI outlet not working properly

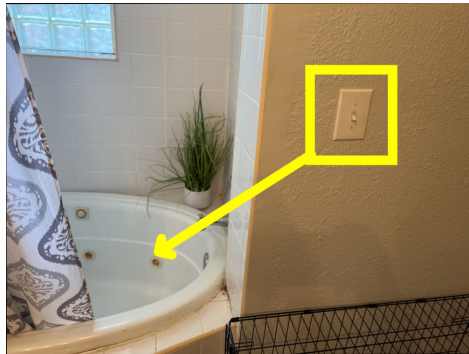
Switch/outlet can be operated while standing in tub/shower, shock hazard.
Primary bath

Switch can be operated from bathtub

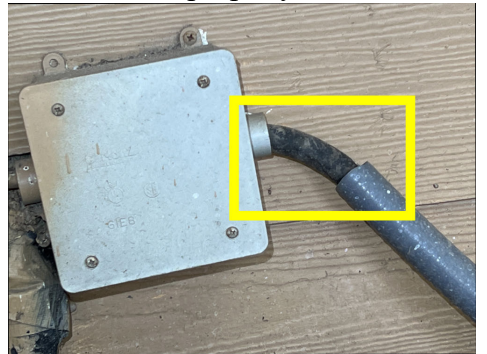
Wire not properly enclosed in conduit

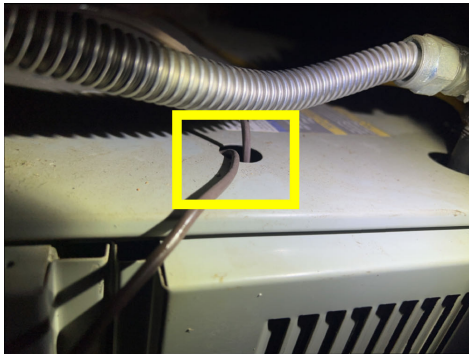
Thermostat wiring not secured to attic unit(s), missing small fitting that secures wiring to the cabinet to prevent pulling loose by service personnel or homeowner.

Thermostat wire not properly secured

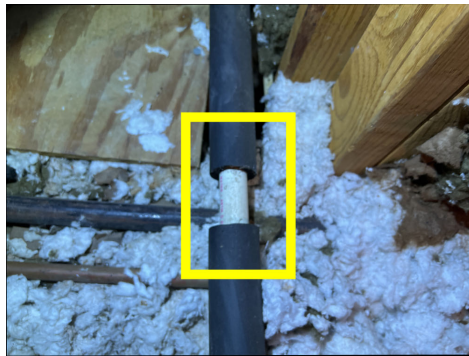
Primary drain line missing insulation

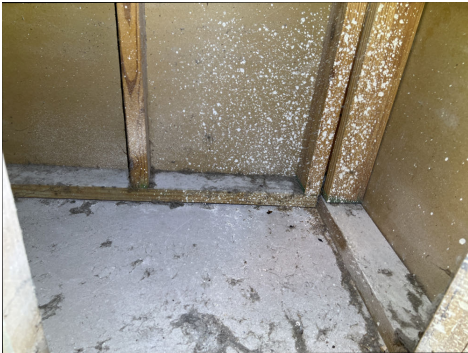
The return air chase is not properly sealed. This condition results in a very significant reduction in cooling capacity and substantially increased operating costs.

Return air chase not properly sealed

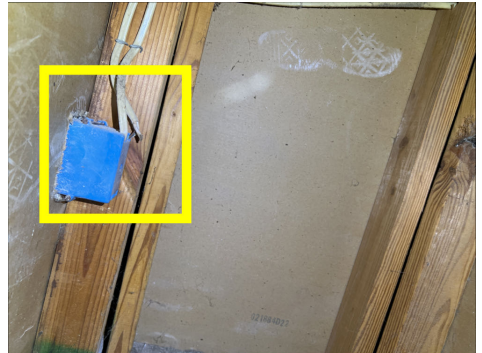
120 volt electrical wiring improperly located in return air chase. This does not comply with the current industry standard/code. Ref. NEC 300-22(c).

120 V wire located in return air chase

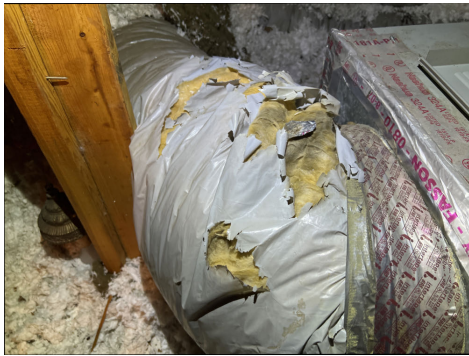
Some gray duct wrapping damaged on ducts in the attic needs to be repaired. This product appears to be a type that was recalled many years ago due to deterioration of the exterior vapor barrier when exposed to light, recommend replacement.

Damaged gray duct

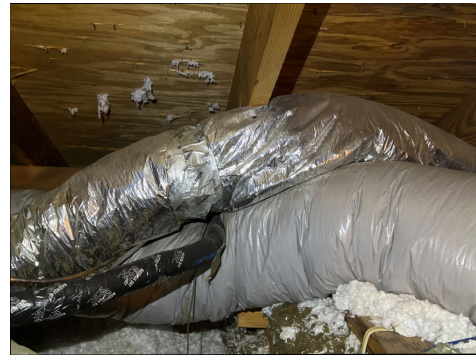
AC flex duct touching

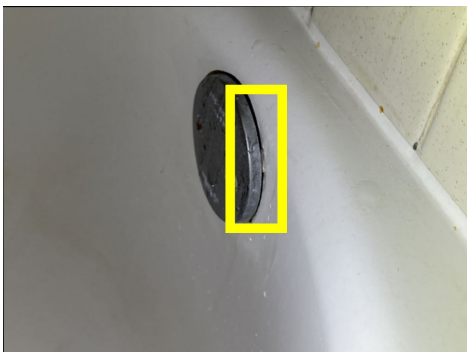
Tub overflow cover is loose

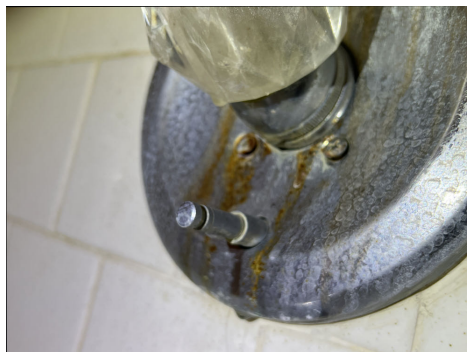
Bath faucet leaks at base

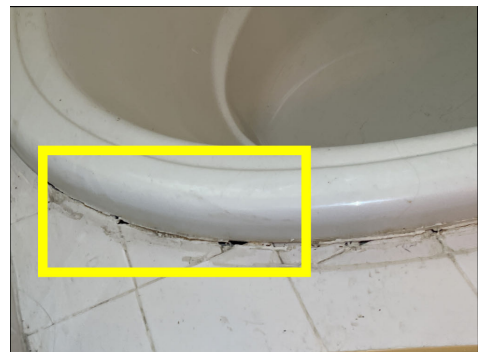
Caulk and seal bathtub

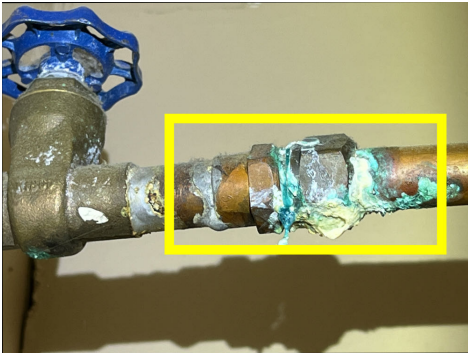
Missing dielectric coupler

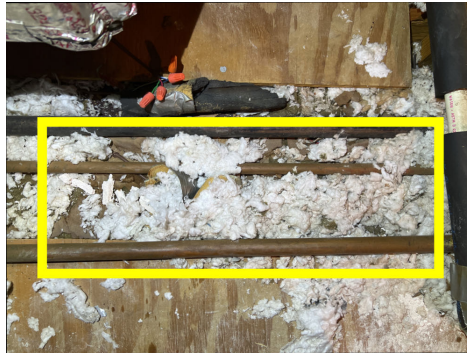
Missing insulation of exposed water lines in the attic.

Insulate attic waterlines

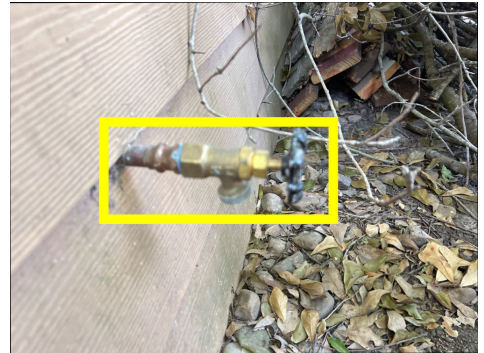
Missing insulation on exterior water line(s) and/or sprinkler anit-backflow system to prevent freeze damage.

Insulate exterior waterlines

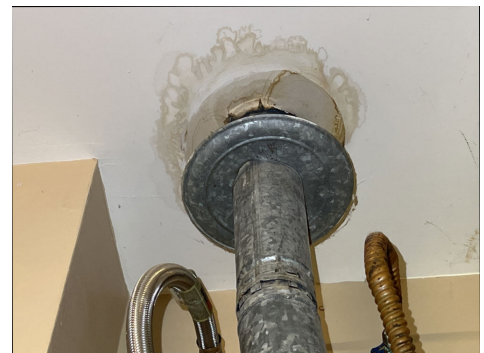
Vent collar not properly secured to ceiling

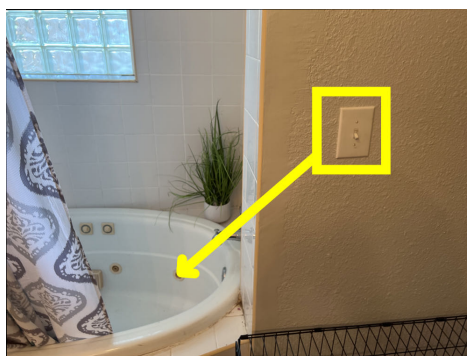
Switch can be operated from bathtub

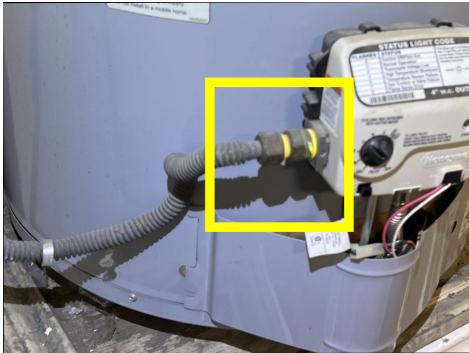
Missing drip leg

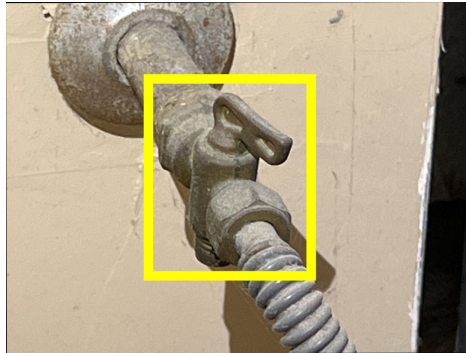
Observed older spring valve

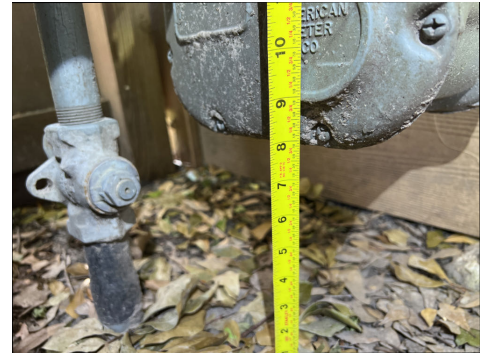
Gas meter lower than 10" from ground

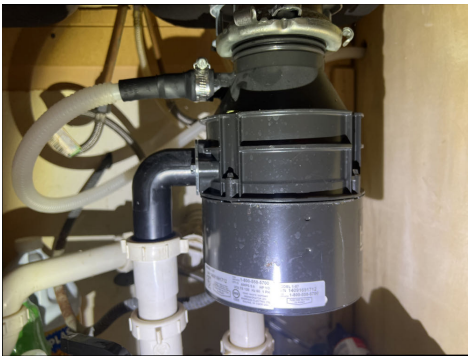
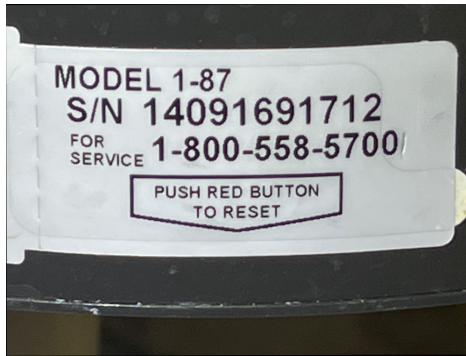
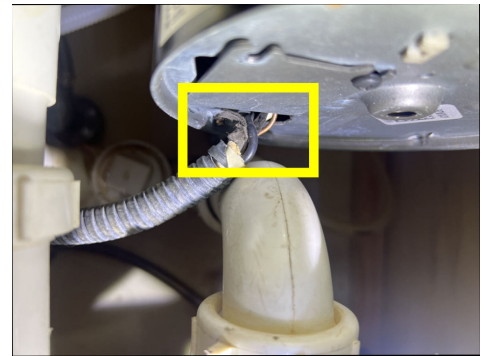
Electrical wiring is not in protective conduit and not secured to the base of disposal unit.

Wires exposed at Base/conduit not secure

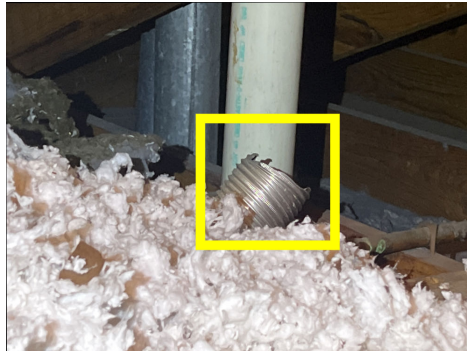
Bath fan exhaust into attic
