### MOLD ASSESSMENT

590 Evan Gann Road Lufkin, Texas

ES#23-536

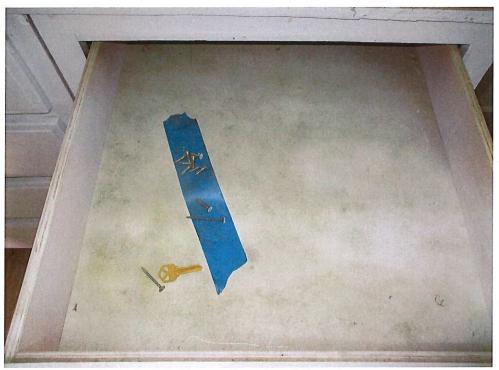
- Mold growth and moisture damage on cabinets and in drawers throughout kitchen. Photos 2 6
- Mold growth on vanity in master bathroom.
- Mold growth on vanity in guest bathroom. Photo 7
- Mold growth on underside of shelving in laundry room. Photo 8
- Mold growth on wood subfloor decking under carpet in bedroom 1. Photo 9

Photo 2 - Mold growth and moisture damage on cabinets and in drawers throughout kitchen.

All building materials affected by moisture/mold growth should be cleaned or removed. All efforts should be made to repair all potential moisture sources.

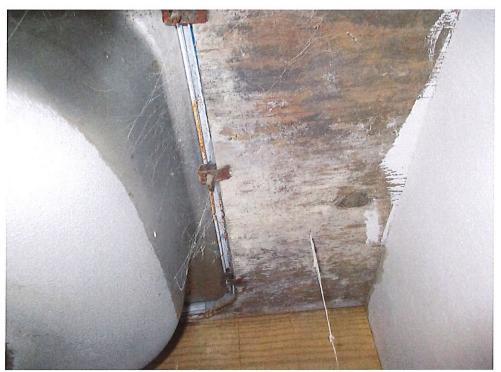
Photo 3 - Mold growth and moisture damage on cabinets and in drawers throughout kitchen.

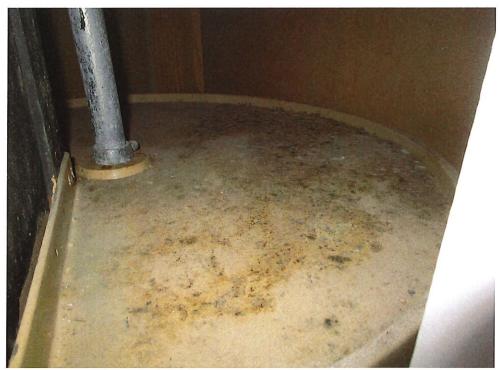
Photo 4 - Mold growth and moisture damage on cabinets and in drawers throughout kitchen.

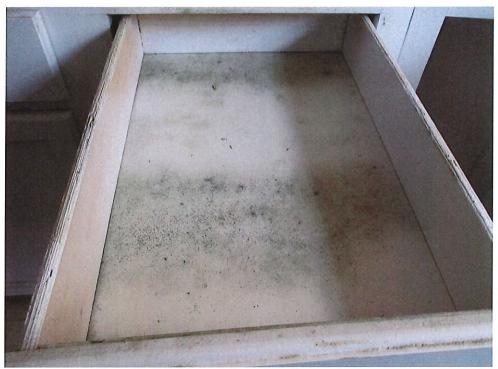
Photo 5 - Mold growth and moisture damage on cabinets and in drawers throughout kitchen.

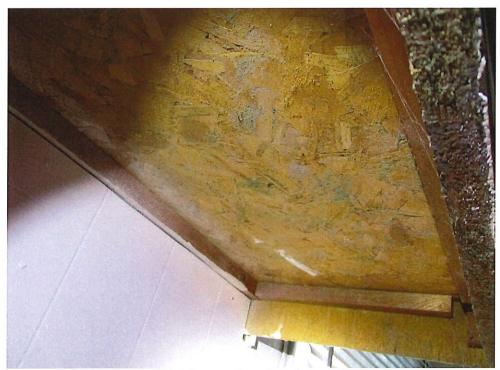
Photo 6 - Mold growth and moisture damage on cabinets and in drawers throughout kitchen.

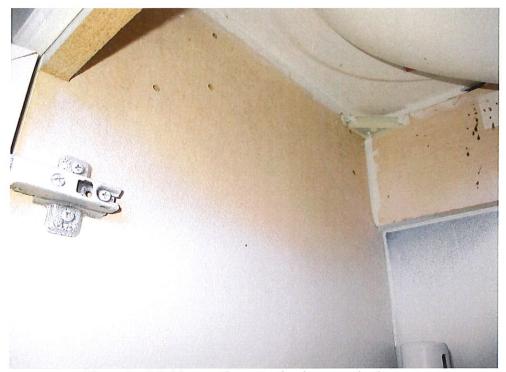
Photo 7 - Mold growth on vanity in guest bathroom.

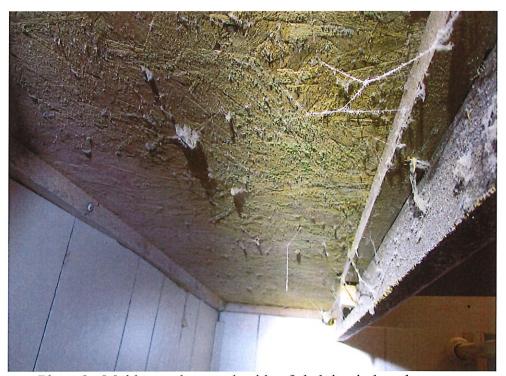
Photo 8 - Mold growth on underside of shelving in laundry room.

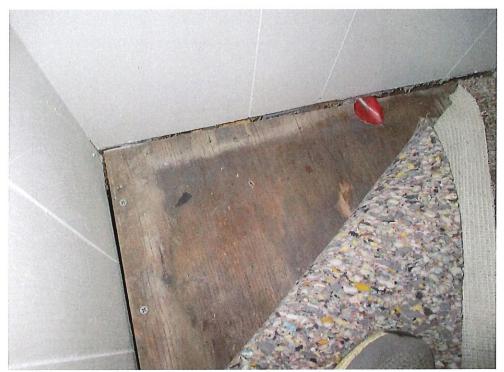
Photo 9 - Mold growth on wood decking under carpet in bedroom 1.

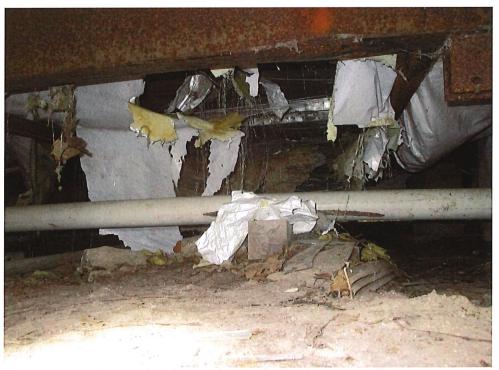
A look at the crawlspace revealed signs of moisture damage to the subfloor and insulation (photos 10 - 12). Mold growth was also observed throughout the crawlspace on various surfaces (photos 13, 14). This damage is believed to be due to plumbing leaks and/or the lack of insulation. A licensed plumber should be consulted to ensure all leaks are fixed to prevent further damage. Results from swab samples collected from the crawlspace determined the mold growth to be *Aspergillus/Penicillium* (See Section III for mold type descriptions).

Photo 10 - Excessive moisture damage to the subfloor and insulation in crawlspace.

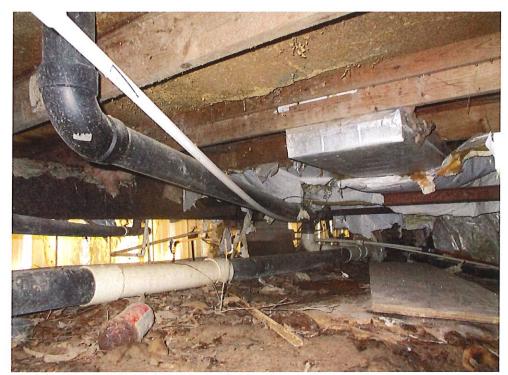
Photo 11 - Excessive moisture damage to the subfloor and insulation in crawlspace.

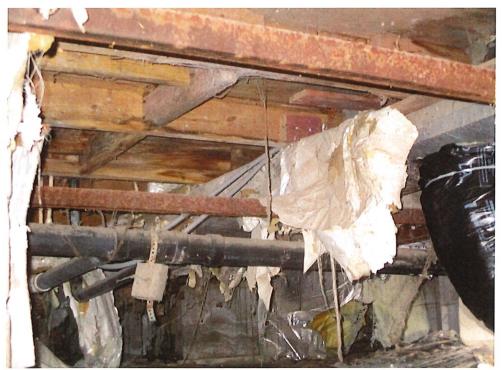
Photo 12 - Excessive moisture damage to the subfloor and insulation in crawlspace.

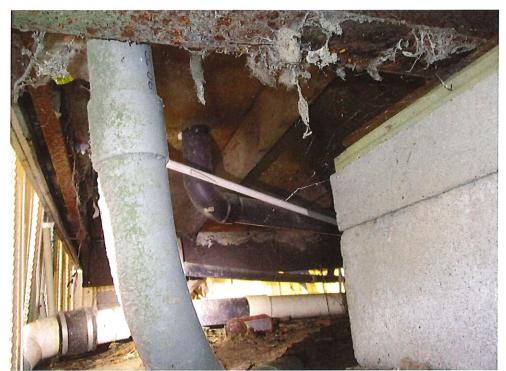
Photo 13 - Mold growth observed throughout the crawlspace on various surfaces.

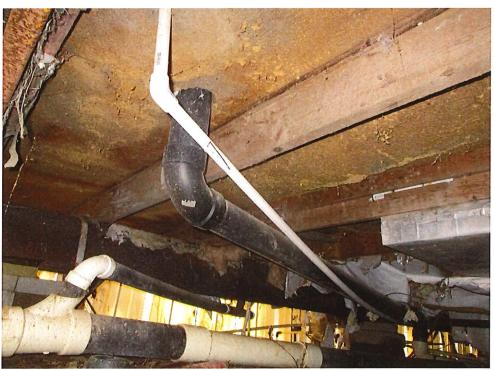
Photo 14 - Mold growth observed throughout the crawlspace on various surfaces.
