PROPERTY INSPECTION REPORT

4843 Hidden Chestnut Ln. , Houston , TX 77084
Inspection prepared for: Matt Messer
Real Estate Agent: Open House - Open House

Date of Inspection: 6/29/2023
Age of Home: 2004 Size: 2,080
Structure Type: Structure is a wood framed structure
on a concrete slab foundation.

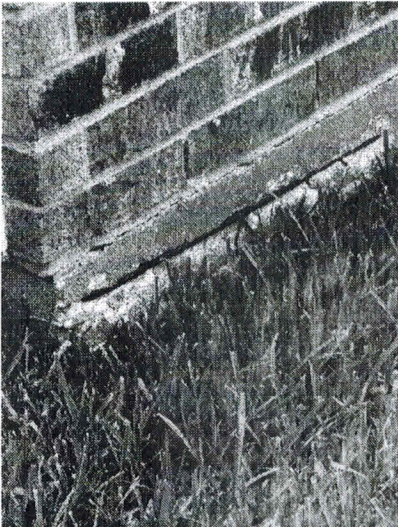
• Rebar is steel rods that provide strength to concrete foundations. Rebar that is exposed to atmosphere needs to be cleaned, sealed, and covered with grout to stop corrosion and spalling.

- Exposed steel rebar noted on exterior foundation between soil and brick / stone / siding.

Exposed steel rebar noted on exterior foundation between soil and brick / stone / siding.

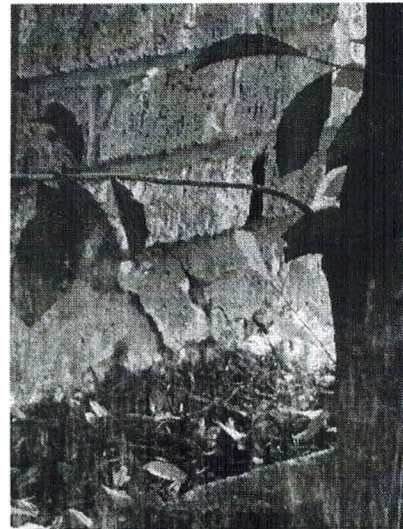
• One or more corner wedge cracks noted on foundation corner(s). These do not normally present a structural support problem but can be location(s) of undetected insect entry. The reason for damaged foundation corners typically is from thermal expansion of masonry walls. Walls heat up and expand while foundation remain cool. The stress placed on concrete foundation from wall movement results in a broken corner of slab. This is a very common issue seen every day by home inspectors. Unless noted elsewhere, corner wedge cracks are more of a cosmetic issue than a structural problem.

Corner pop, front right corner.

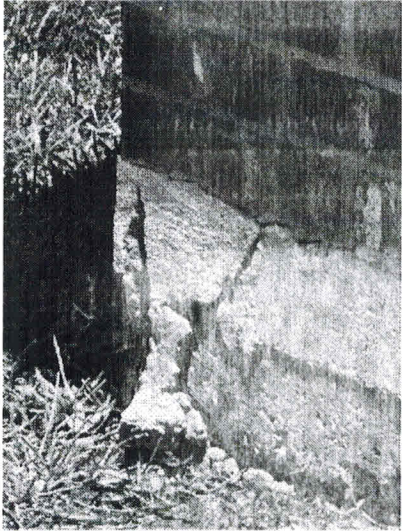
Corner pop, front left corner.

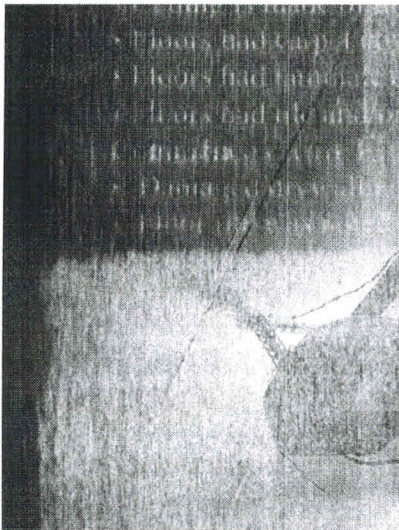
- Damaged drywall noted on ceiling in one or more locations.
- Floor tile was noted to be damaged in one or more locations.

Damaged garage ceiling.

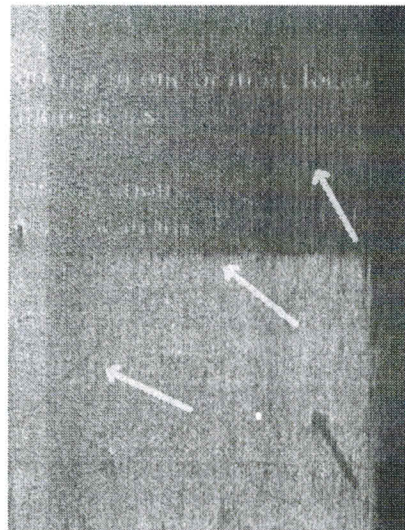
Damaged ceiling.

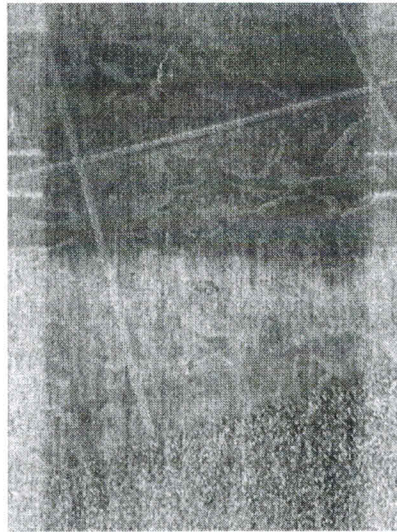
Damaged floor tile.

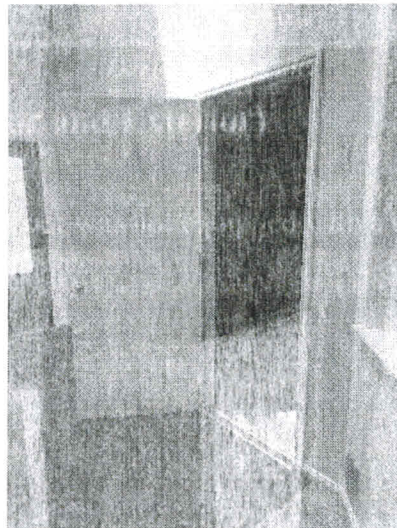
The garage entry door was not equipped with a self closing device.

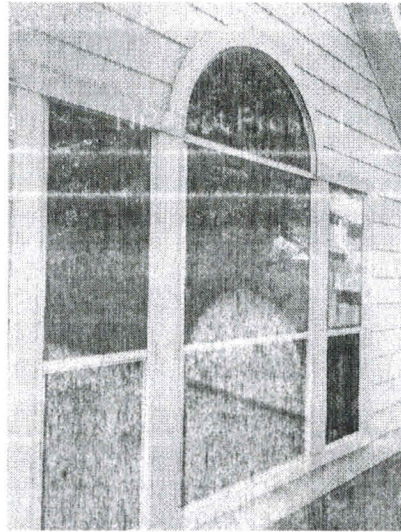
- One or more of the thermal pane windows were observed to have lost their seals. This has resulted in condensation or a fog like film to develop between the panes of glass. The thermal pane windows are no longer functional as designed when the seal is lost and replacement may be necessary. I recommend consulting with a qualified contractor for further evaluation and repair where necessary. Areas include, but are not limited to:

Several windows noted with lost seal

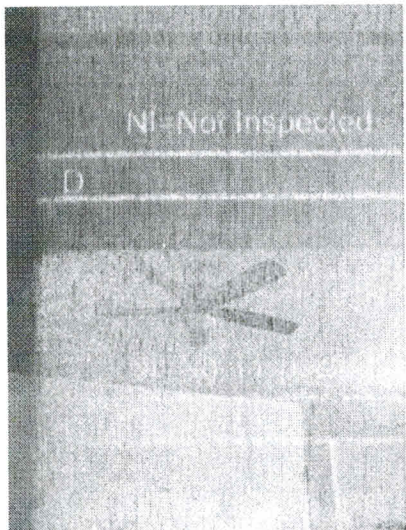
Living room ceiling fan did not appear to be working

- One or more ceiling fans were not working at time of inspection.
- One or more electrical receptacles appear to be overheating

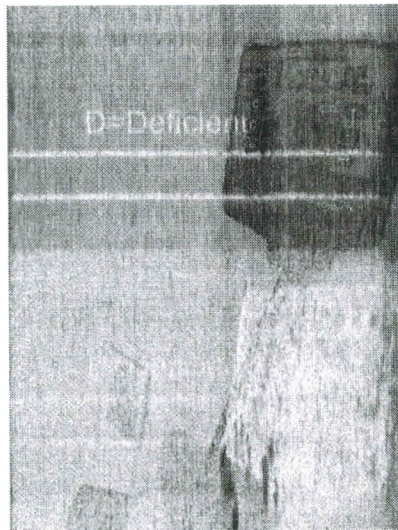
Garage electrical receptacle appears to be overheating at sprinkler system control.

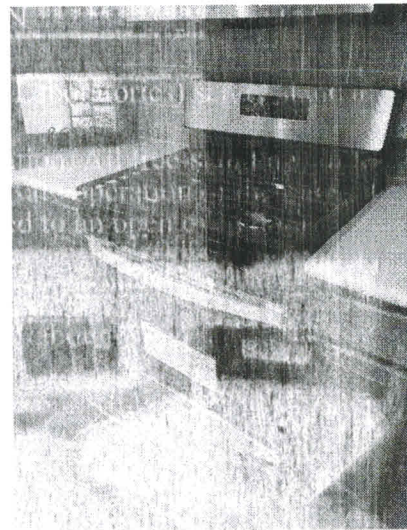
- Oven: Natural gas
- Anti-Tip devices became a UL (Underwriters Laboratories) safety standard requirement in 1991.
- Anti-tip bracket is missing from range installation. All free-standing, slide-in ranges include an anti-tip device and is essential in the safe operation of the range. It provides protection when excess force or weight is applied to an open oven door

Anti-tip bracket is missing from range installation. All free-standing, slide-in ranges include an anti-tip device and is essential in the safe operation of the range. It provides protection when excess force or weight is applied to an open oven door

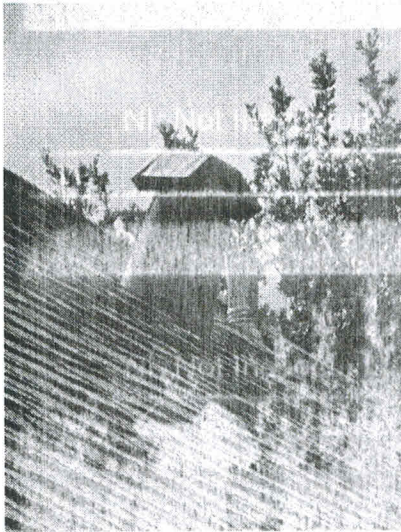
- The dryer vent pipe has been terminated through roof with an unapproved roof jack. Dryers terminated at roof requires a roof jack that is designed for this purpose. It is required to have a back draft damper to keep birds and rodents from building nests in the dryer exhaust pipe.

Unapproved roof材 used for dryer vent pipe.

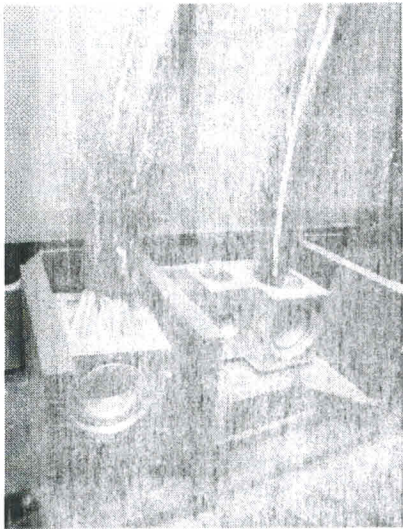
- Service entrance wiring is underground
- The aluminum service conductors in electrical panel missing anti-oxidant grease.

Aluminum service conductors missing anti-oxident grease.

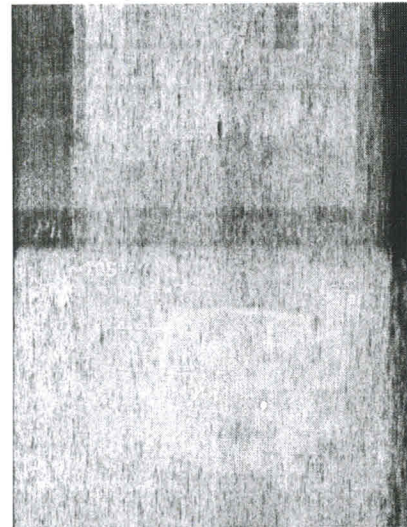
Thermal imaging camera used to detect over heating electrical components. No issues.
