STUCCOSPEC
SAFE AIRE TECHNOLOGY
STUCCO & MOLD INSPECTIONS

Moisture Assessment Report

4534 Park Court
Bellaire, TX 77401
04/24/2023

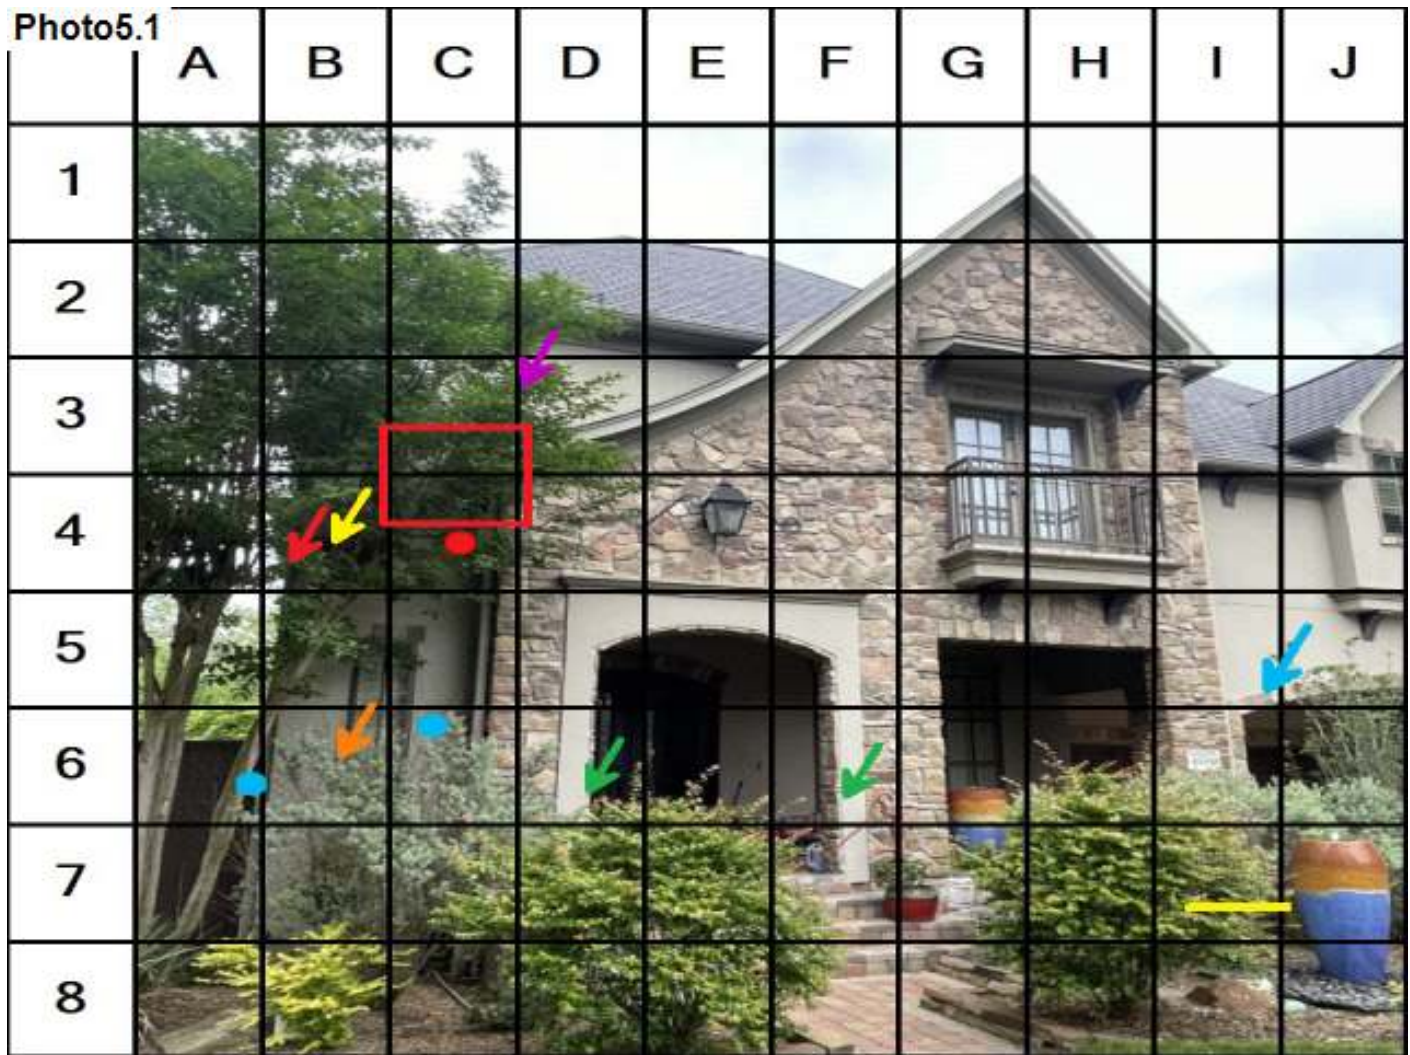
Photo 5.1

Grid Location	Item Description	Moisture Readings	Substrate Condition	Observations-Photo #5.1	Chapter Reference
				Assess all windows, doors, penetrations and terminations and reseal as needed.	Ch 3.1,3.2
A6	Outside Corner	10%	Firm	Moisture reading was made at the outside corner.	
C4	Below Missing Kickout Flashing		NONE	Moisture reading was made below the missing kickout flashing. No resistance and evidence of substrate damage is noted. Repair all substrate damage as needed. See detail #6.1.	
C6	Wall Below Missing Kickout Flashing	22%	Firm	Slightly elevated moisture reading was made below the missing kickout flashing, down the wall.	
Yellow Arrow	Control Joint Cracking			Cracking is present at the control joints. Seal all cracks at the control joints with the proper polyurethane caulking as needed. See detail #6.2.	
Red Arrow	Outside Corner Cracking			Cracking is present at the outside corners. Seal all cracks at the outside corners with the proper polyurethane caulking as needed. See detail #6.3.	Ch 3.6

Purple Arrow	Vegetation			Vegetation is in close proximity with the stucco walls. It is suggested to cut back the vegetation to prevent future moisture intrusion and mildew staining from occurring as needed. See detail #6.4.	
Red Box	Missing Kickout Flashing			Missing kickout flashing is noted at the roof termination. Cracking and staining is present below the missing kickout flashing. It is suggested to install proper kickout flashing and repair all possible substrate damage as needed. See details #6.5 and #6.6.	Ch 3.4
Orange Arrow	Window Sealants			Aged sealants with separation is noted around the window frames. It is suggested to reseal all window frames with the proper polyurethane caulking as needed. See detail #6.7.	Ch 3.2
Yellow Line	Bottom of Wall			Stone at the bottom of the wall is in contact with the flat work / rocks. This area is functioning properly at the time of the inspection. See detail #6.8.	Ch 3.3

Blue Arrow	Stone Accents			Tops of stone accents lack adequate sealants. Reseal all with the proper polyurethane caulking as needed. See detail #6.9.	Ch 3.7
Green Arrows	Fastener Holes			Fastener holes lack sealants. Seal all with the proper polyurethane caulking as needed. See details #6.10 and #6.11.	Ch 3.1

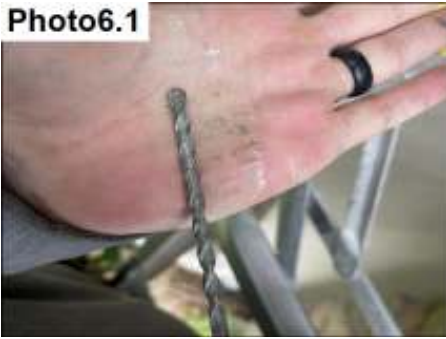
Photo6.1

Evidence of substrate damage is noted.

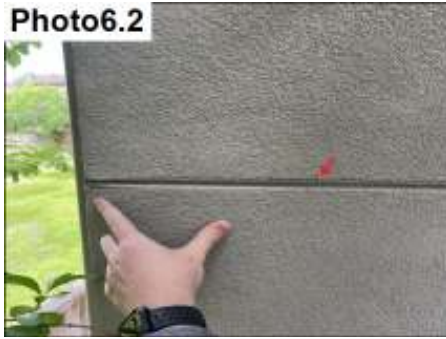
Photo6.2

- Assess all windows, doors, penetrations and terminations and seal / reseal as needed. Always maintain sealants.
- Cracking is present at the control joints. Seal all cracks at the control joints with the proper polyurethane caulking as needed. See details #6.2, #10.2, and #15.5.

Control joint cracking is present.

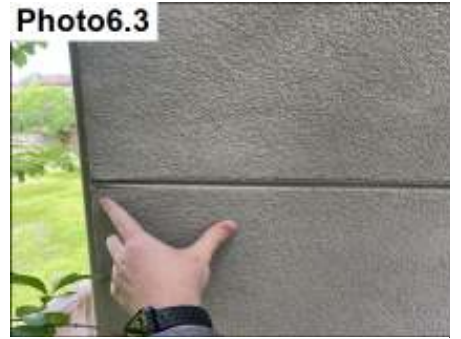
Photo6.3

- Cracking is present at the outside corners. Seal all cracks at the outside corners with the proper polyurethane caulking as needed. See details #6.3 and #8.8.

Outside corner cracking is present.

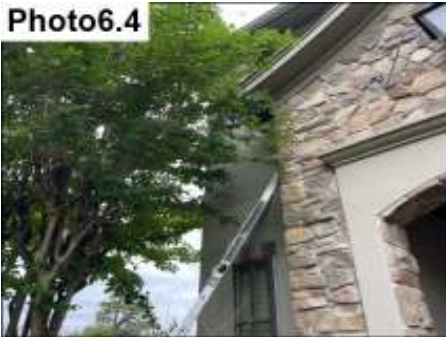
Photo6.4

- Vegetation is in close proximity with the stucco walls. It is suggested to cut back the vegetation to prevent future moisture intrusion and mildew staining from occurring as needed. See detail #6.4.

It is suggested to cut back the vegetation.

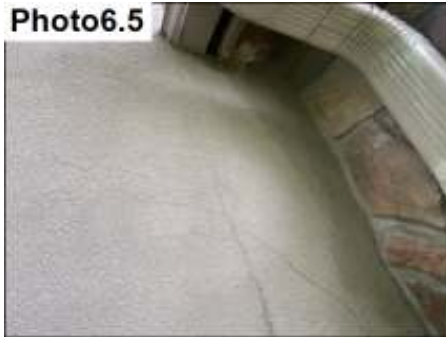
Photo6.5

- Missing kickout flashing is noted at the roof termination. Cracking and staining is present below the missing kickout flashing. It is suggested to install proper kickout flashing and repair all possible substrate damage as needed. See details #6.5 and #6.6.

Cracking and staining is present below missing kickout flashing.

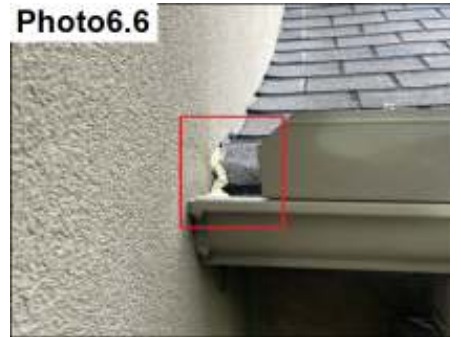
Photo6.6

Missing kickout flashing at roof termination.

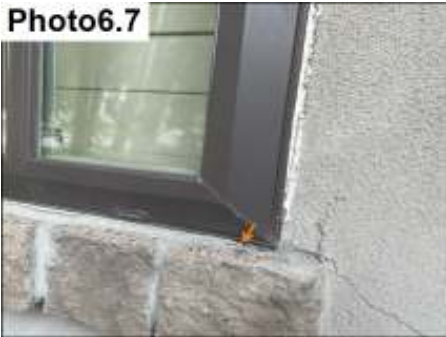
Photo6.7

- Aged sealants with separation is noted around the window frames. It is suggested to reseal all window frames with the proper polyurethane caulking as needed. See details #6.7, #11.2, #13.2, and #16.2.

Sealant separation is noted around the window frames.

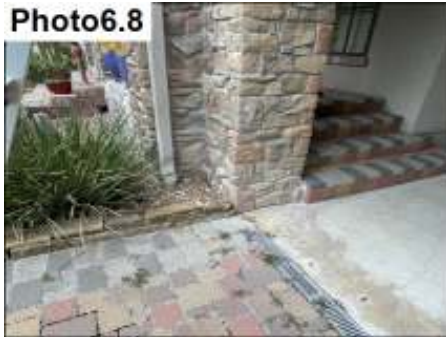
Photo6.8

- Stone at the bottom of the wall is in contact with the flat work / rocks. This area is functioning properly at the time of the inspection. See detail #6.8.

Bottom of wall is in contact with the rocks / flat work.

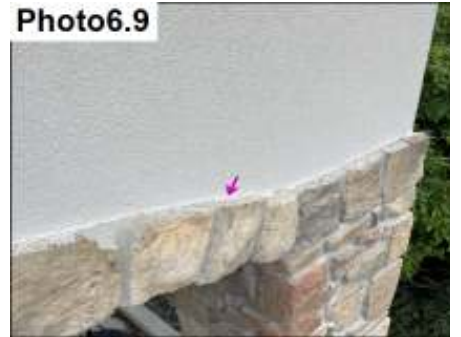
Photo6.9

Tops of stone accents lack adequate sealants.

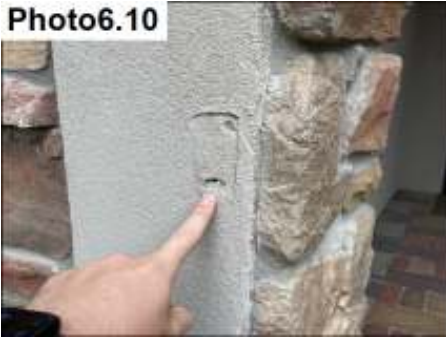
Photo6.10

Fastener holes lack sealants.

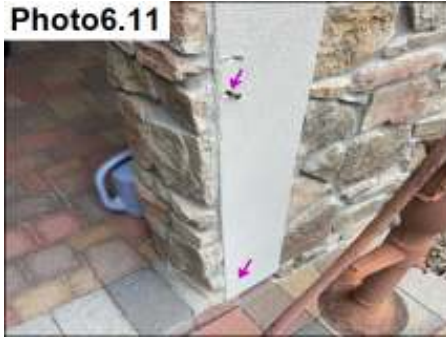
Photo6.11

Fastener holes lack sealants.

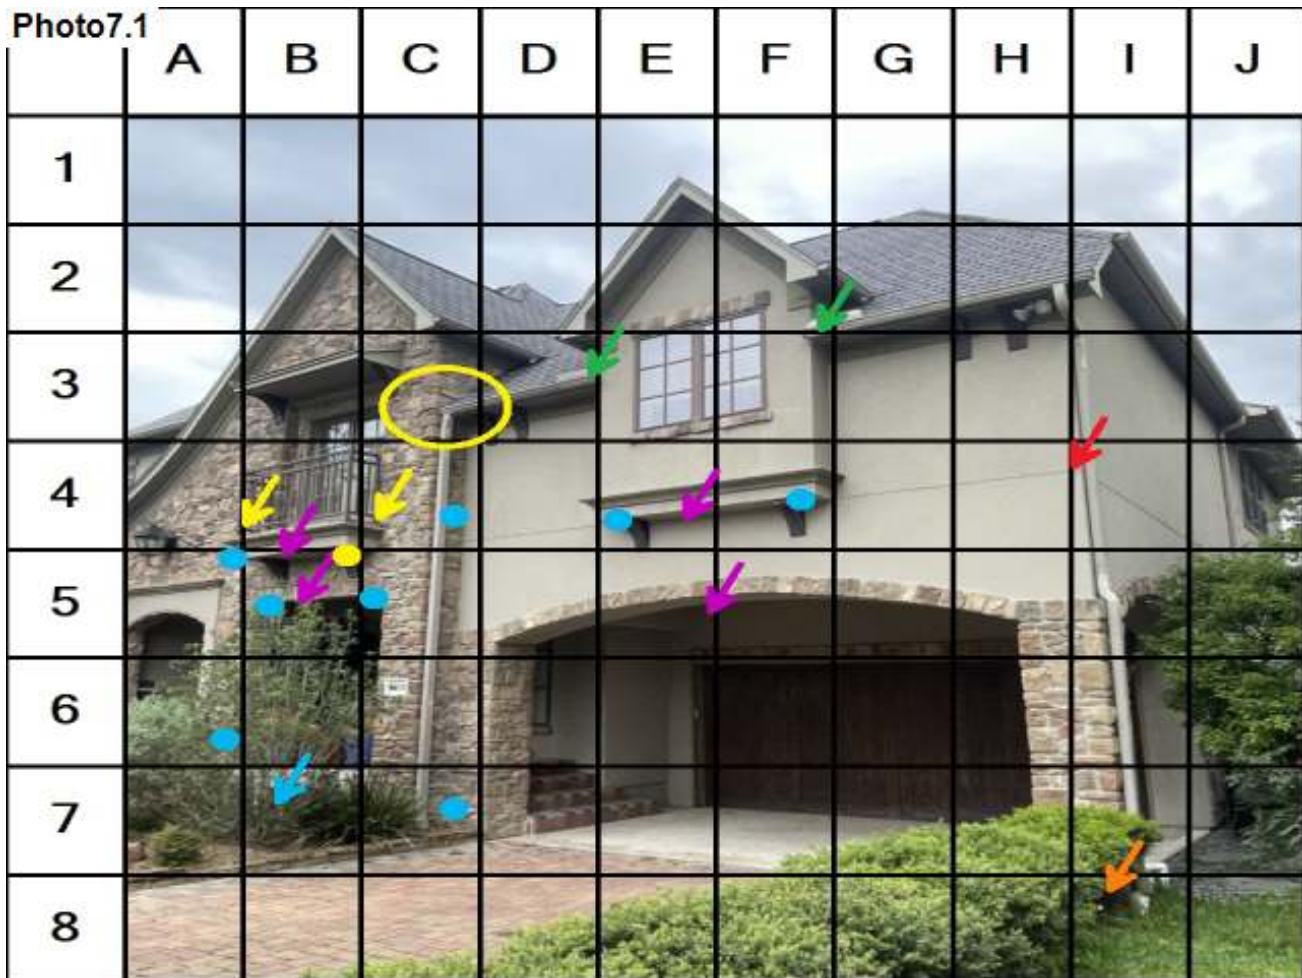
Photo 7.1

Grid Location	Item Description	Moisture Readings	Substrate Condition	Observations-Photo #7.1	Chapter Reference
				Assess all windows, doors, penetrations and terminations and reseal as needed.	Ch 3.1,3.2
A5	Bottom of Balcony	18%	Firm	Moisture reading was made at the bottom of the balcony, below the flashings.	
A6	Base of Column	10%	Firm	Moisture reading was made at the base of the column.	
B5 (Yellow dot)	Bottom of Balcony	11%	Firm	Moisture reading was made at the bottom of the balcony, below the flashings.	
B5 (Blue dot)	Bottom of Wall	15%	Firm	Moisture reading was made at the bottom of the stone wall, below the balcony flashings above.	
C4	Below Kickout Flashing	13%	Firm	Moisture reading was made below the kickout flashing.	
C5	Bottom of Wall	14%	Firm	Moisture reading was made at the bottom of the stone wall, below the balcony flashings above.	
C7	Base of Column	18%	Firm	Moisture reading was made at the base of the column.

E4	Bottom of Wall	14%	Firm	Moisture reading was made at the bottom of the wall, below windows and kickout flashings above.	
F4	Bottom of Wall	10%	Firm		
Yellow Arrows	Balcony Flashings			Balcony flashings are present and performing properly. It is suggested to reseal all balcony flashing terminations with the proper caulking as needed. See details #8.1 and #8.2.	Ch 3.5
Blue Arrow	Concrete Porch			The bottom of the entry way porch is believed to be solid concrete construction. This is a favorable detail. See detail #8.3.	Ch 3.3
Orange Arrow	Column Base			Column base is elevated and sitting on an elevated concrete footing. This is a favorable detail. See detail #8.4.	
Green Arrows	Roof Flashing / Fascia Board Terminations			Sealant separation is noted at the roof flashing and fascia board terminations. Reseal all with the proper polyurethane caulking as needed. See details #8.5 and #8.6.	Ch 3.4
Yellow Circle	Kickout Flashings			Kickout flashing is present and performing properly at the roof termination. It is suggested to reseal all with the proper polyurethane caulking as needed. See detail #8.7.	Ch 3.4

Red Arrow	Outside Corner Cracking			Cracking is present at the outside corners. Seal all cracks at the outside corners with the proper polyurethane caulking as needed. See detail #8.8.	Ch 3.6
Purple Arrows	Weep Relief			No weep relief is present at the bottom of the walls. Weep relief is a favorable detail that allows for proper moisture drainage of the wall(s). Due to low moisture content, no further stucco repairs are recommended at this time. See details #8.9 and #8.10.

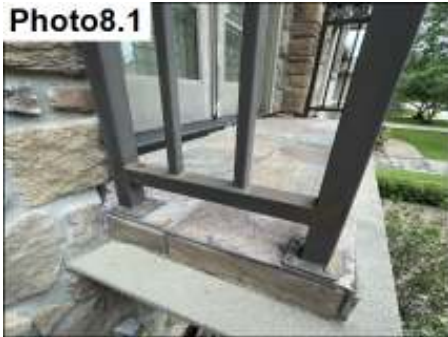
- Balcony flashings are present and performing properly. It is suggested to reseal all balcony flashing terminations with the proper caulking as needed. See details #8.1 and #8.2.

It is suggested to reseal balcony flashings.

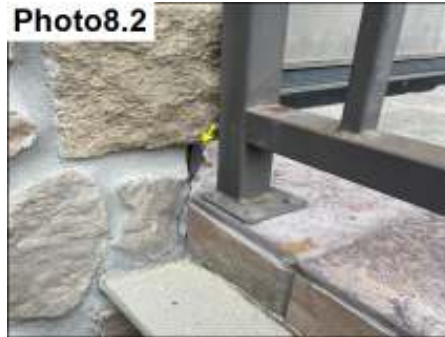
It is suggested to reseal balcony flashings.

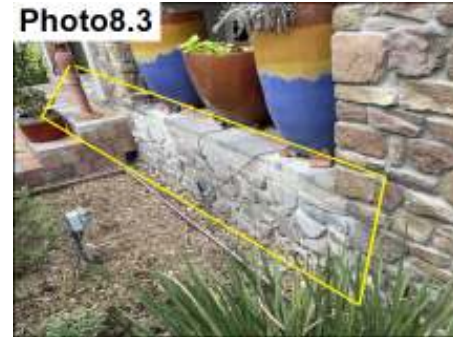
- The bottom of the entry way porch is believed to be solid concrete construction. This is a favorable detail. See detail #8.3.
- Column base is elevated and sitting on an elevated concrete footing. This is a favorable detail. See detail #8.4.

Solid concrete construction is noted at base of entry porch.

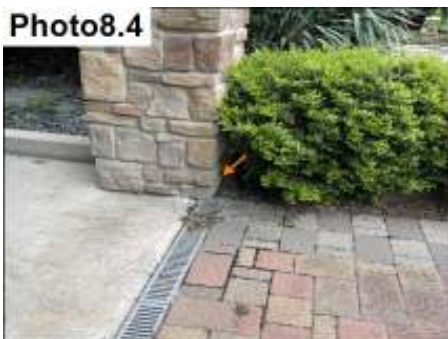
Column base is concrete construction.

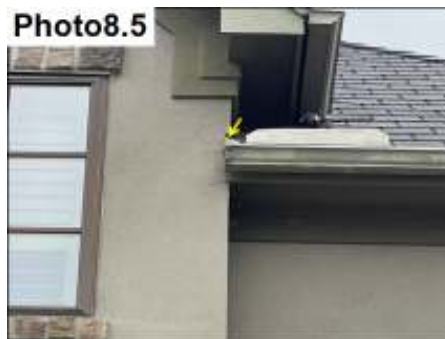
- Sealant separation is noted at the roof flashing and fascia board terminations. Reseal all with the proper polyurethane caulking as needed. See details #8.5 and #8.6.

It is suggested to reseal roof flashing & fascia board terminations.

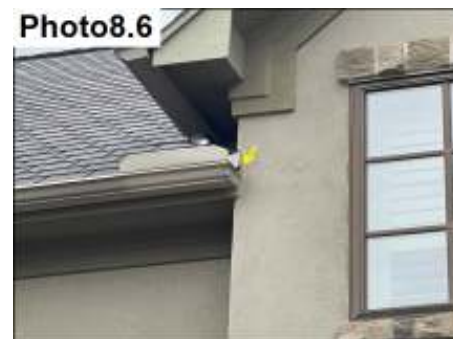
It is suggested to reseal roof flashing & fascia board terminations.

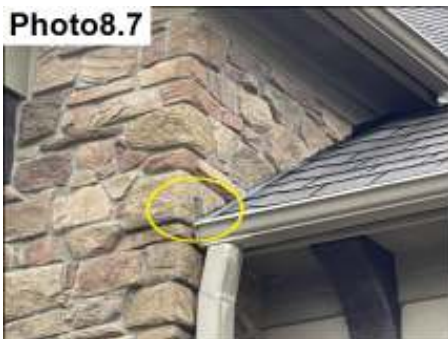
- Kickout flashings are present and performing properly at the roof terminations. It is suggested to reseal all with the proper polyurethane caulking as needed. See details #8.7 and #15.3.

It is suggested to reseal kickout flashing.

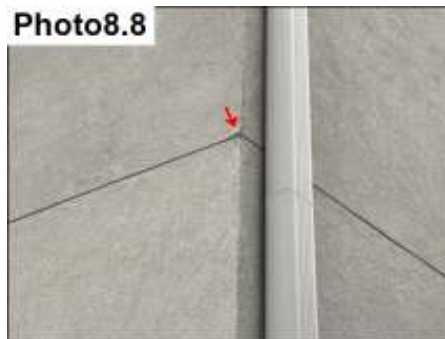
Cracking is present at the outside corners.

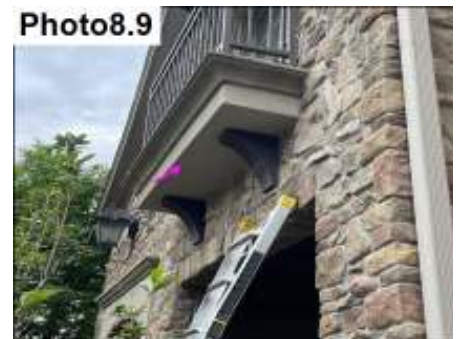
- No weep relief is present at the bottom of the walls. Weep relief is a favorable detail that allows for proper moisture drainage of the wall(s). Due to low moisture content, no further stucco repairs are recommended at this time. See details #8.9, #8.10, and #13.3.

No weep relief is present at the bottom of the walls.

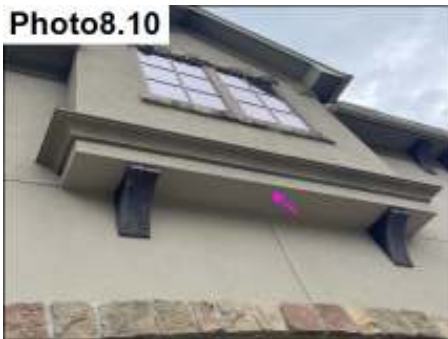
No weep relief is present at the bottom of the walls.

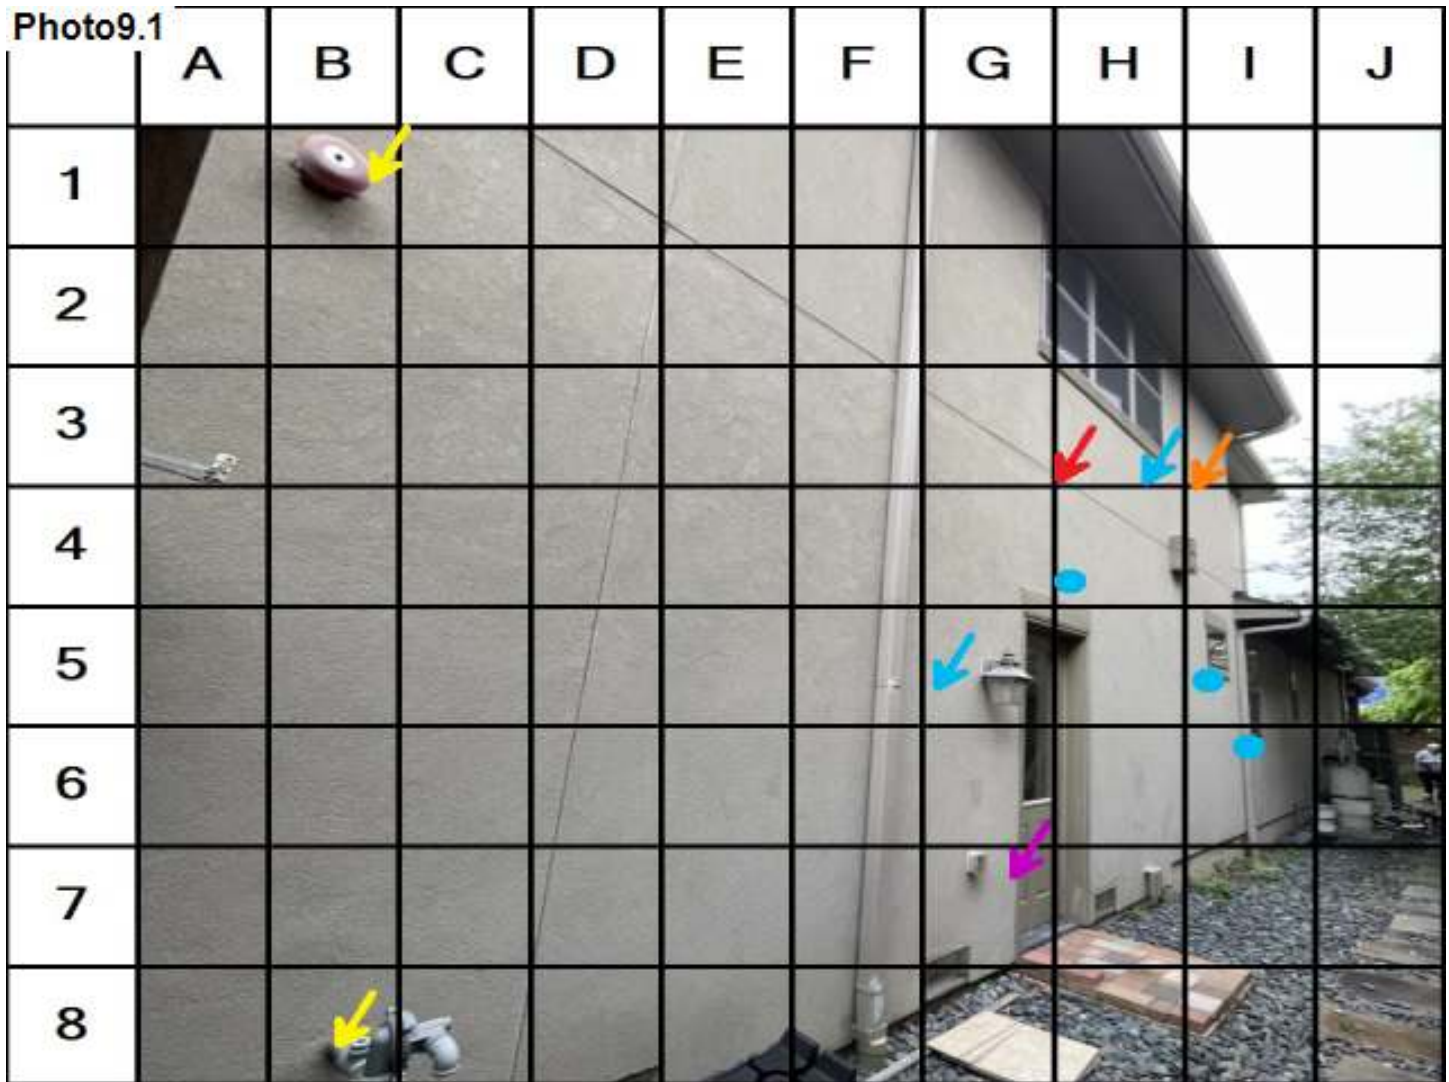
Photo9.1

Grid Location	Item Description	Moisture Readings	Substrate Condition	Observations-Photo #9.1	Chapter Reference
				Assess all windows, doors, penetrations and terminations and reseal as needed.	Ch 3.1,3.2
H4	Door Header	16%	Firm	Moisture reading was made at door header, below windows above.	
I5	Window Lower Left	15%	Firm	Moisture reading was made at window lower left.	
I6	Window Lower Left	15%	Firm		
Purple Arrow	Door Frames			Sealant separation is noted around door frames. Reseal all with the proper polyurethane caulking as needed. See detail #10.1.	Ch 3.2
Red Arrow	Control Joint Cracking			Cracking is present at the control joints. Seal all cracks at the control joints with the proper polyurethane caulking as needed. See detail #10.2.	Ch 3.6
Yellow Arrows	Penetrations			Penetrations lack adequate sealants. It is suggested to seal all penetrations with the proper polyurethane caulking as needed. See details #10.3 and #10.4.	Ch 3.1

Orange Arrow	Hairline Cracking			Hairline cracks are present. To temporarily cover cracks, it is suggested in the future to re-paint the entirety of the home with an elastomeric paint. Hairline cracks are a cosmetic concern. Elastomeric paint will help protect the cracks and prevent future cracking.	Ch 3.6
Blue Arrows	Rust Aggregates			Rust aggregates / spots are present. These spots are frequently the result of iron deposits found among the marble aggregates used in the finish coat. Consult with your stucco manufacturer for proper removal of these spots. See details #10.5 and #10.6.	Ch 3.6

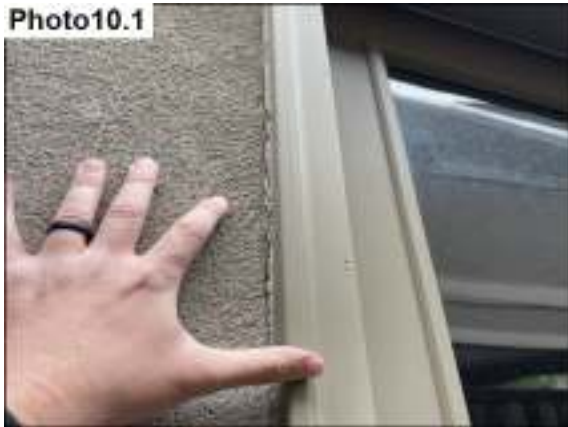
Photo10.1

- Sealant separation is noted around door frames. Reseal all with the proper polyurethane caulking as needed. See detail #10.1.

Sealant separation is noted around door frames.

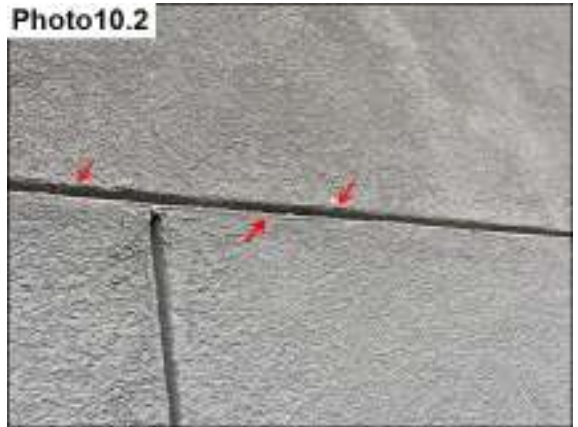
Photo10.2

Control joint cracks are present.

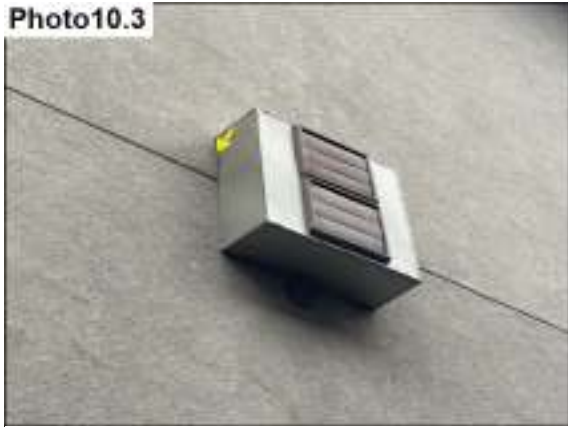
Photo10.3

- Penetrations lack adequate sealants. It is suggested to seal all penetrations with the proper polyurethane caulking as needed. See details #10.3, #10.4, and #18.11.

Penetrations lack sealants.

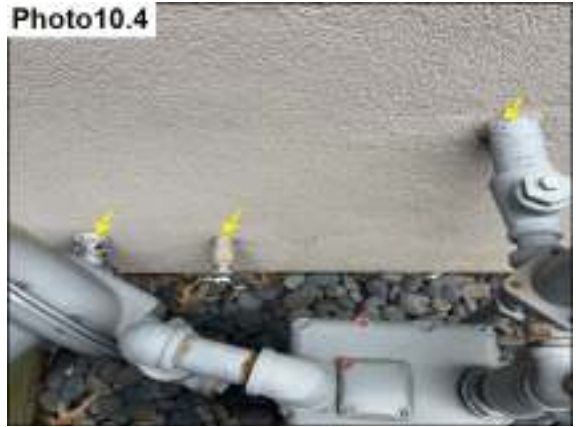
Photo10.4

Penetrations lack sealants.

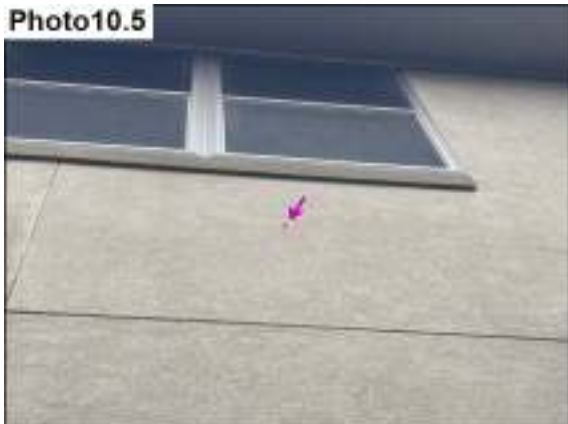
Photo10.5

- Rust aggregates / spots are present. These spots are frequently the result of iron deposits found among the marble aggregates used in the finish coat. Consult with your stucco manufacturer for proper removal of these spots. See details #10.5, #10.6, #18.1, #18.2, and #18.3.

Rust aggregates are present.

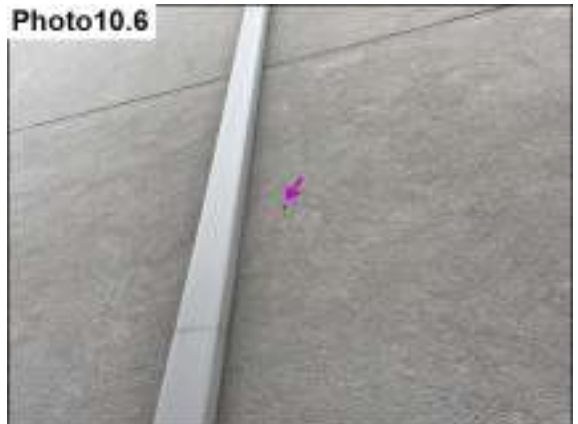
Photo10.6

Rust aggregates are present.

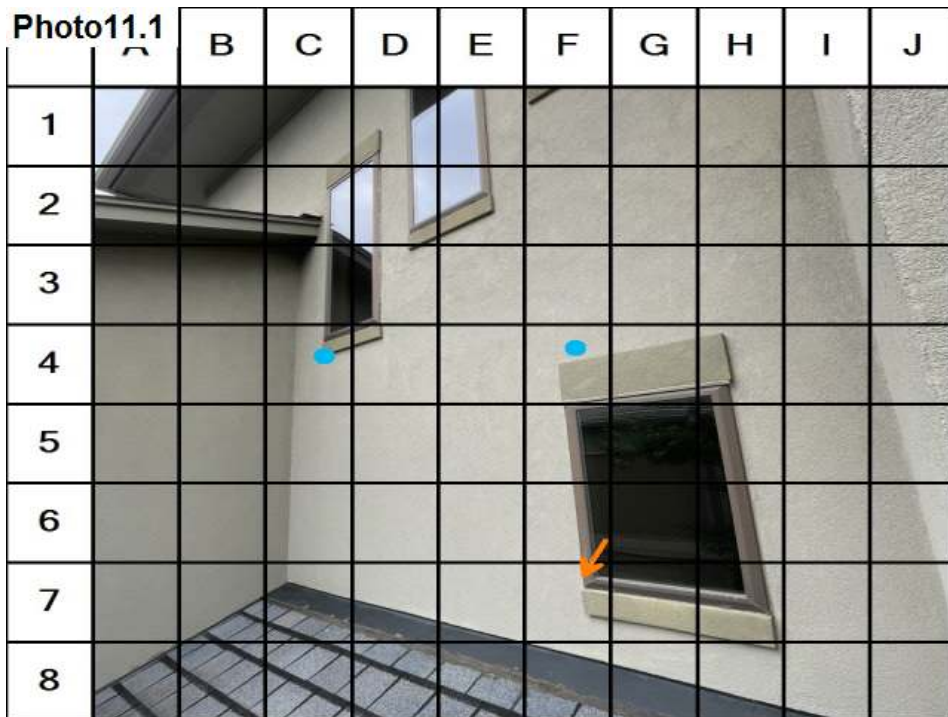
Grid Location	Item Description	Moisture Readings	Substrate Condition	Observations-Photo #11.1	Chapter Reference
				Assess all windows, doors, penetrations and terminations and reseal as needed.	Ch 3.1,3.2
C4	Window Lower Left	21%	Firm	Slightly elevated moisture reading was made at window lower left, below roof flashing termination above.	
F4	Window Header	11%	Firm	Moisture reading was made at window header, below windows above.	
Orange Arrow	Window Sealants			Aged sealants with separation is noted around the window frames. It is suggested to reseal all window frames with the proper polyurethane caulking as needed. See detail #11.2.	Ch 3.2

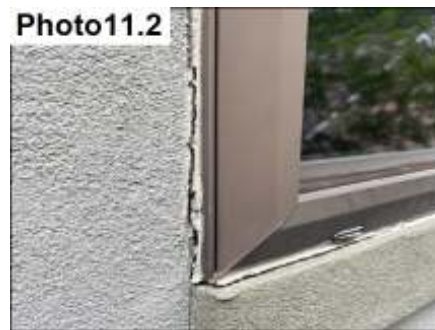
Sealant separation is noted around window frames.

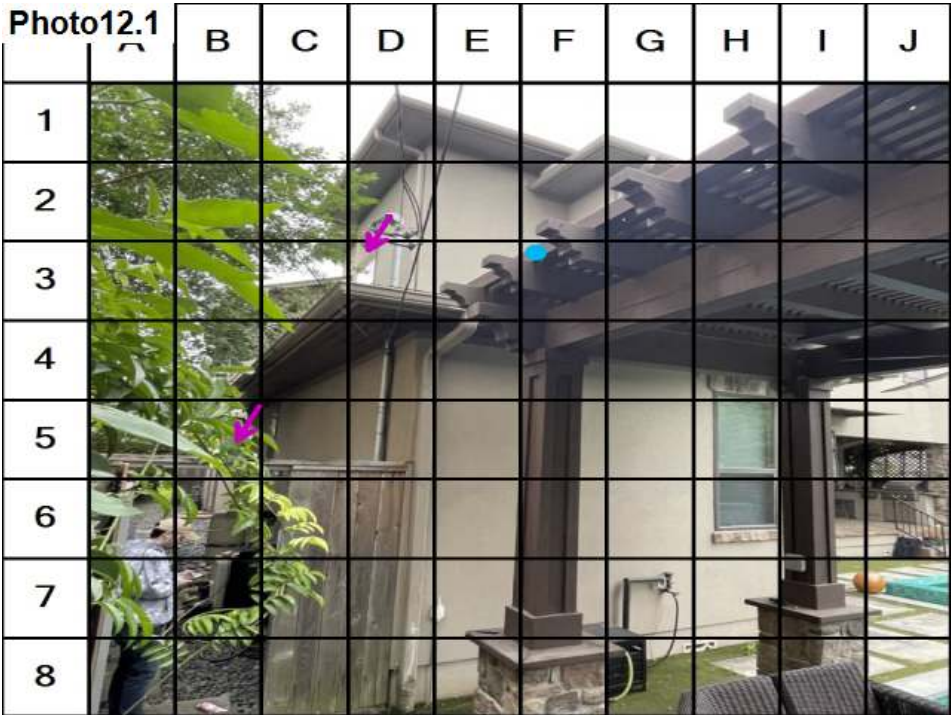
Grid Location	Item Description	Moisture Readings	Substrate Condition	Observations-Photo #12.1	Chapter Reference
				Assess all windows, doors, penetrations and terminations and reseal as needed.	Ch 3.1,3.2
F3	Below Kickout Flashing	10%	Firm	Moisture reading was made below the kickout flashing.	
Purple Arrows	Accent Bands			Sealant separation is noted at the tops of the accent bands. Reseal all with the proper polyurethane caulking as needed. See detail #12.2.	Ch 3.7

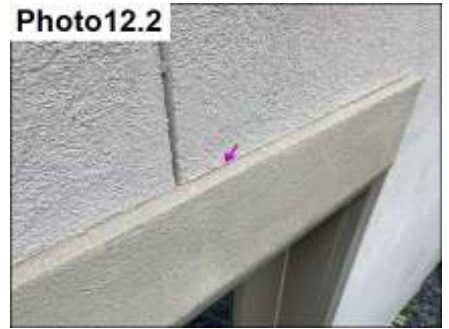
- Sealant separation is noted at the tops of the accent bands. Reseal all with the proper polyurethane caulking as needed. See detail #12.2.
- Noticeable cosmetic paint differences are present. Touch these cosmetic areas up with the proper paint as needed. See detail #13.4.

Tops of accent bands lack adequate sealants.

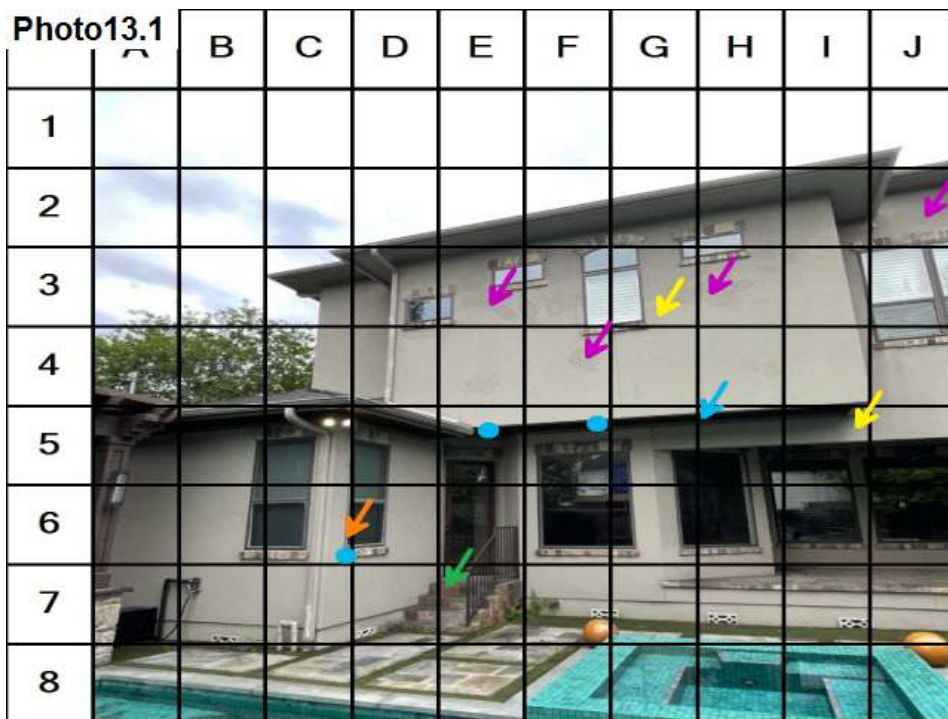
Grid Location	Item Description	Moisture Readings	Substrate Condition	Observations-Photo #13.1	Chapter Reference
				Assess all windows, doors, penetrations and terminations and reseal as needed.	Ch 3.1,3.2
E5	Bottom of Wall	15%	Firm	Moisture reading was made at the bottom of the wall, below windows above.	
F5	Bottom of Wall	16%	Firm		
Orange Arrow	Window Sealants			Aged sealants with separation noted is around the window frames. It is suggested to reseal all window frames with polyurethane caulking as needed. See detail #13.2.	Ch 3.2
Blue Arrow	Weep Relief			No weep relief is present at the bottom of the wall. Weep relief is a favorable detail that allows for proper moisture drainage of the wall(s). Due to low moisture content, no further stucco repairs recommended at this time. See detail #13.3.	
Yellow Arrows	Hairline Cracking			Hairline cracks are present. To temporarily cover cracks, it is suggested in the future to re-paint the entirety of the home with an elastomeric paint. Hairline cracks are a cosmetic concern. Elastomeric paint will help protect the cracks and prevent future cracking.	Ch 3.6

Purple Arrows	Paint Differences			Noticeable cosmetic paint differences are present. Touch these cosmetic areas up with the proper paint as needed. See detail #13.4.	
Green Arrow	Solid Concrete Construction			Rear stairs are CMU construction. This is a favorable detail. Seal all stair terminations. See detail #13.5.	Ch 3.3

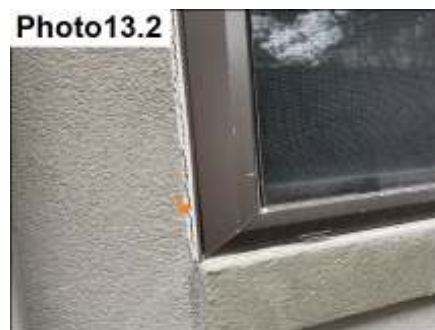
Sealant separation is noted around the window frames.

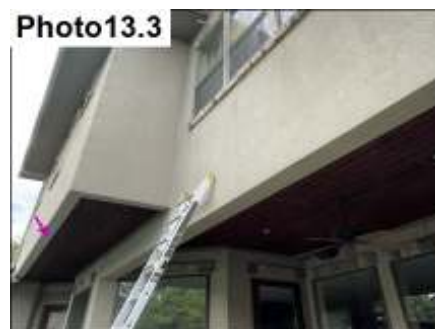
No weep relief is present at the bottom of the walls.

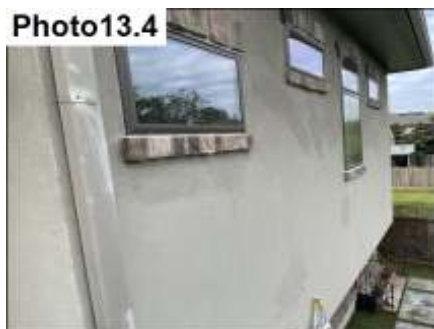
Paint differences are present.

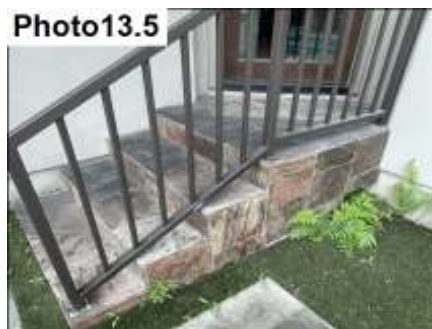
- Rear stairs are CMU construction. This is a favorable detail. Seal all stair terminations. See detail #13.5.
- Porch flashing terminations lack adequate sealants. Seal / reseal all with the proper polyurethane caulking as needed. See detail #15.1.

Stair construction is CMU. Seal all terminations.

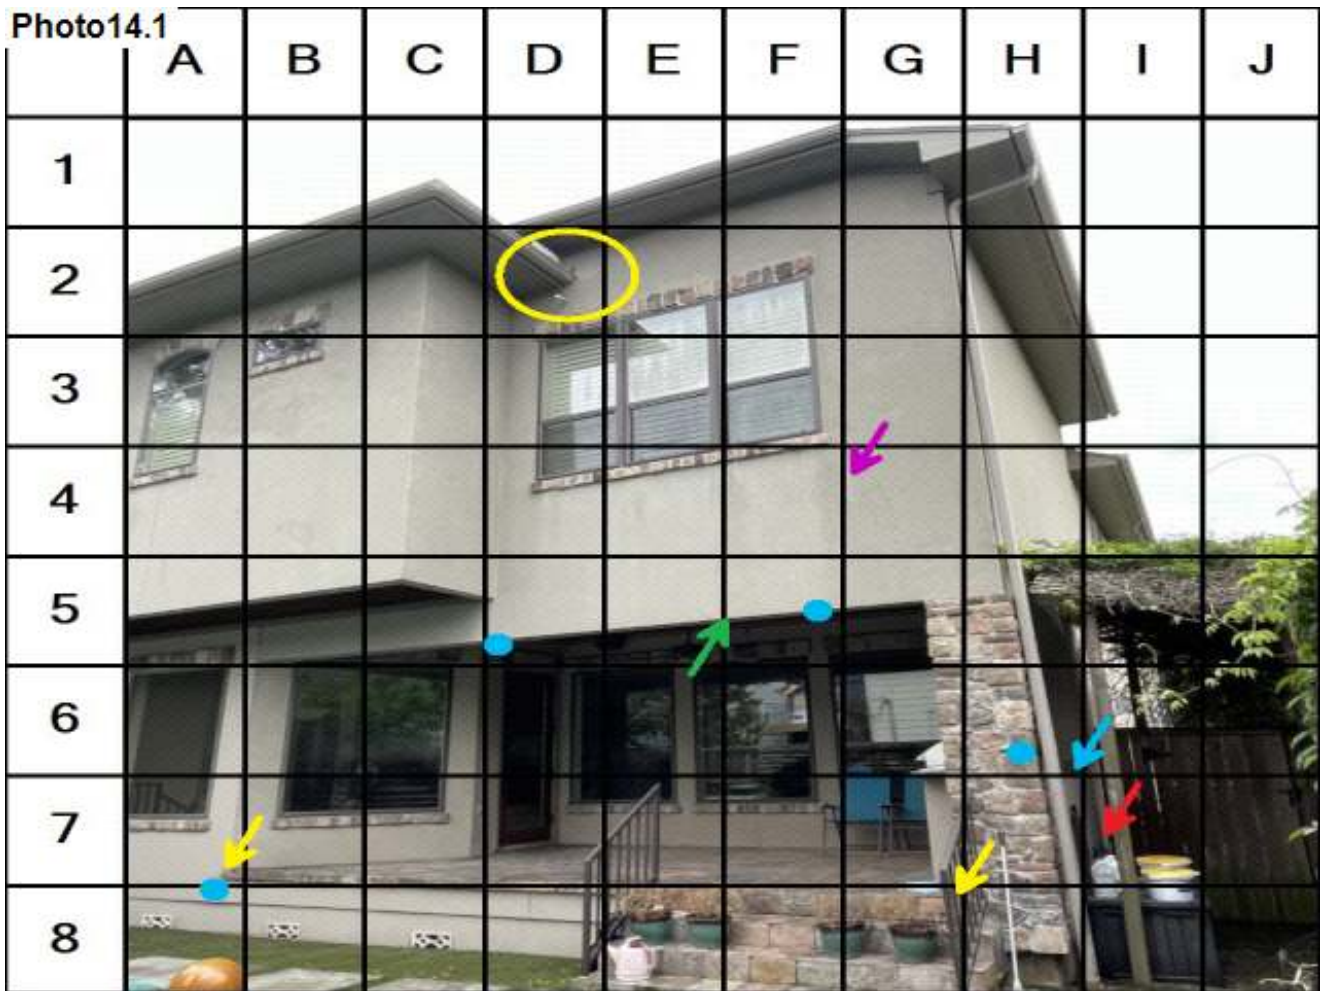
Photo 14.1

Grid Location	Item Description	Moisture Readings	Substrate Condition	Observations-Photo #14.1	Chapter Reference
				Assess all windows, doors, penetrations and terminations and reseal as needed.	Ch 3.1,3.2
A8	Below Porch Flashing Termination	14%	Firm	Moisture reading was made below the porch flashing termination.	
D5	Bottom of Wall	24%	Firm	Elevated moisture reading was made at the bottom of the wall, below windows and kickout flashing above.	
F5	Bottom of Wall	25%	Firm	Elevated moisture reading was made at the bottom of the wall, below windows above.	
H6	Outside Comer	17%	Firm	Moisture reading was made at the outside corner.	
Yellow Arrows	Porch Flashing Terminations			Porch flashing terminations lack adequate sealants. Seal / reseal all with the proper polyurethane caulking as needed. See detail #15.1.	Ch 3.5
Purple Arrow	Vines			Evidence of past vine growth is noted on the stucco. It is suggested to keep the vines off of the stucco to prevent future damage to the stucco finish coat as needed. See detail #15.2.	Ch 3.6

Yellow Circle	Kickout Flashing			Kickout flashing is present and performing properly at the roof termination. It is suggested to reseal all with the proper polyurethane caulking as needed. See detail #15.3.	Ch 3.4
Green Arrow	Weep Relief			No weep relief is present at the bottom of the wall. Weep relief is a favorable detail that allows for proper moisture drainage of the wall(s). Due to elevated moisture content, it is suggested to install a weep relief at the bottom of the wall as needed. See detail #15.4.	
Red Arrow	Control Joint Cracking			Cracking is present at the control joints. Seal all cracks at the control joints with the proper polyurethane caulking as needed. See detail #15.5.	Ch 3.6
Blue Arrow	Outdoor Kitchen Terminations			Outdoor kitchen terminations lack adequate sealants. Seal all terminations with the proper polyurethane caulking as needed. See detail #15.6.	Ch 3.10

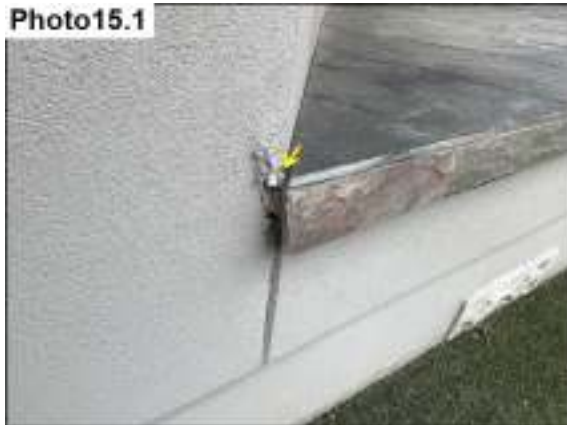
It is suggested to reseal porch flashing terminations.

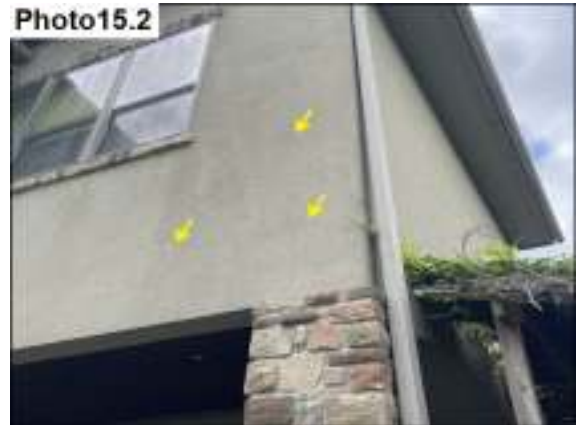
- Evidence of past vine growth is noted on the stucco. It is suggested to keep the vines off of the stucco to prevent future damage to the stucco finish coat as needed. See detail #15.2.

Evidence of past vine growth is noted.

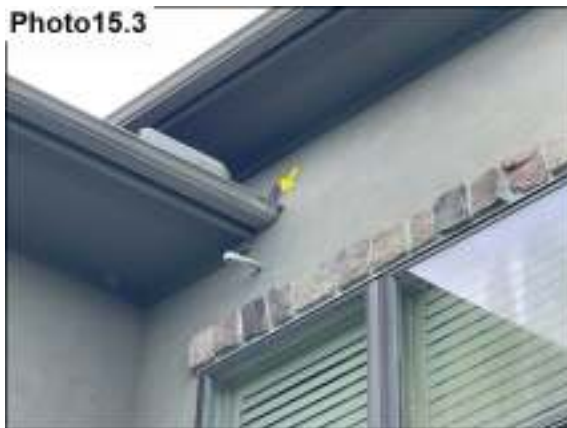
It is suggested to reseal kickout flashing.

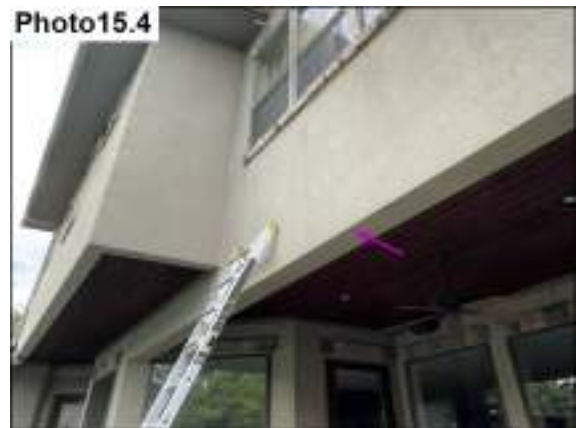
It is suggested to install weep relief at the bottom of the wall.

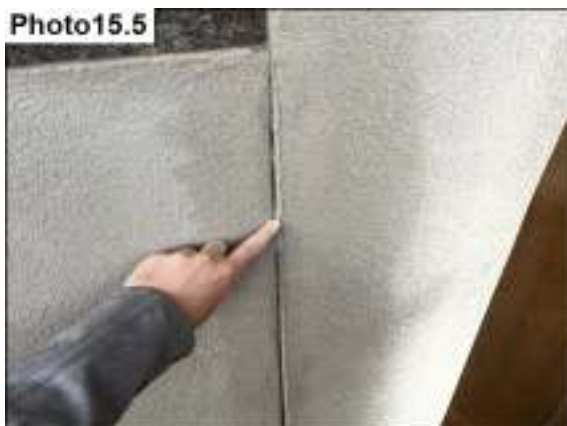
Control joint cracking is present.

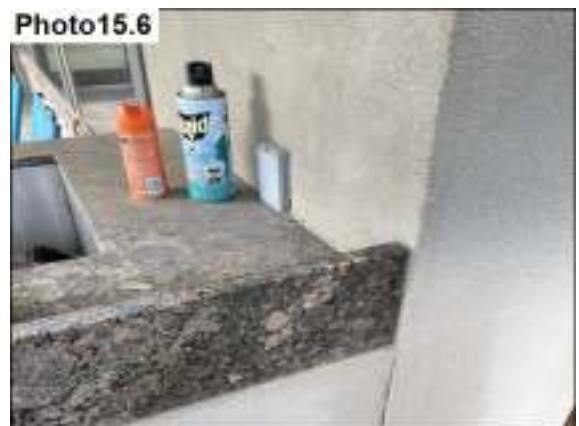
- Outdoor kitchen terminations lack adequate sealants. Seal all terminations with the proper polyurethane caulking as needed. See detail #15.6.
- Large cracks are present at the control joints in this elevation. It is suggested to repair all large cracks at the control joints as needed. See details #18.4, #18.5, #18.6, #18.7, #18.8, #18.9, and #18.10.

Outdoor kitchen terminations lack sealants.

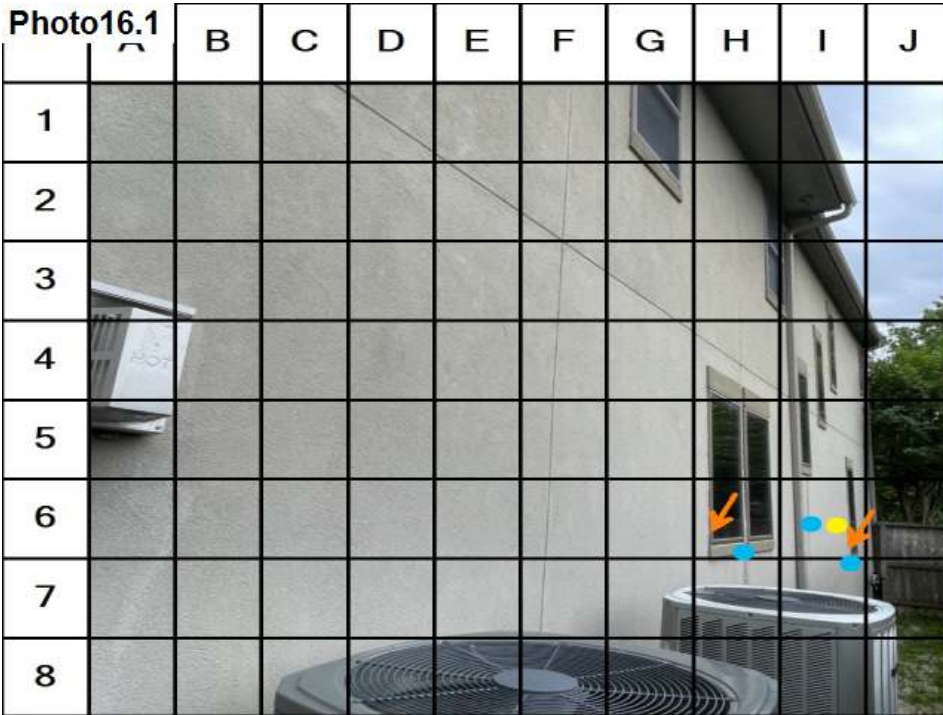
Grid Location	Item Description	Moisture Readings	Substrate Condition	Observations-Photo #16.1	Chapter Reference
				Assess all windows, doors, penetrations and terminations and reseal as needed.	Ch 3.1,3.2
H6	Window Lower Right	18%	Firm	Moisture reading was made at window lower right	
I6 (Blue dot)	Window Lower Left	19%	Firm	Slightly elevated moisture reading was made at window lower left.	
I6 (Yellow dot)	Wall Below Windows	17%	Firm	Moisture reading was made below windows, down the wall.	
I7	Window Lower Left	16%	Firm	Moisture reading was made at window lower left.	
Orange Arrows	Window Sealants			Aged sealants with separation is noted around the window frames. It is suggested to reseal all window frames with the proper polyurethane caulking as needed. See detail #16.2.	Ch 3.2

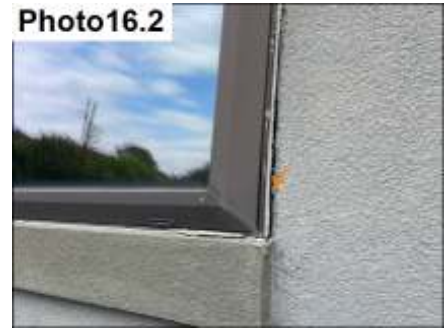
Sealant separation is noted around the window frames.

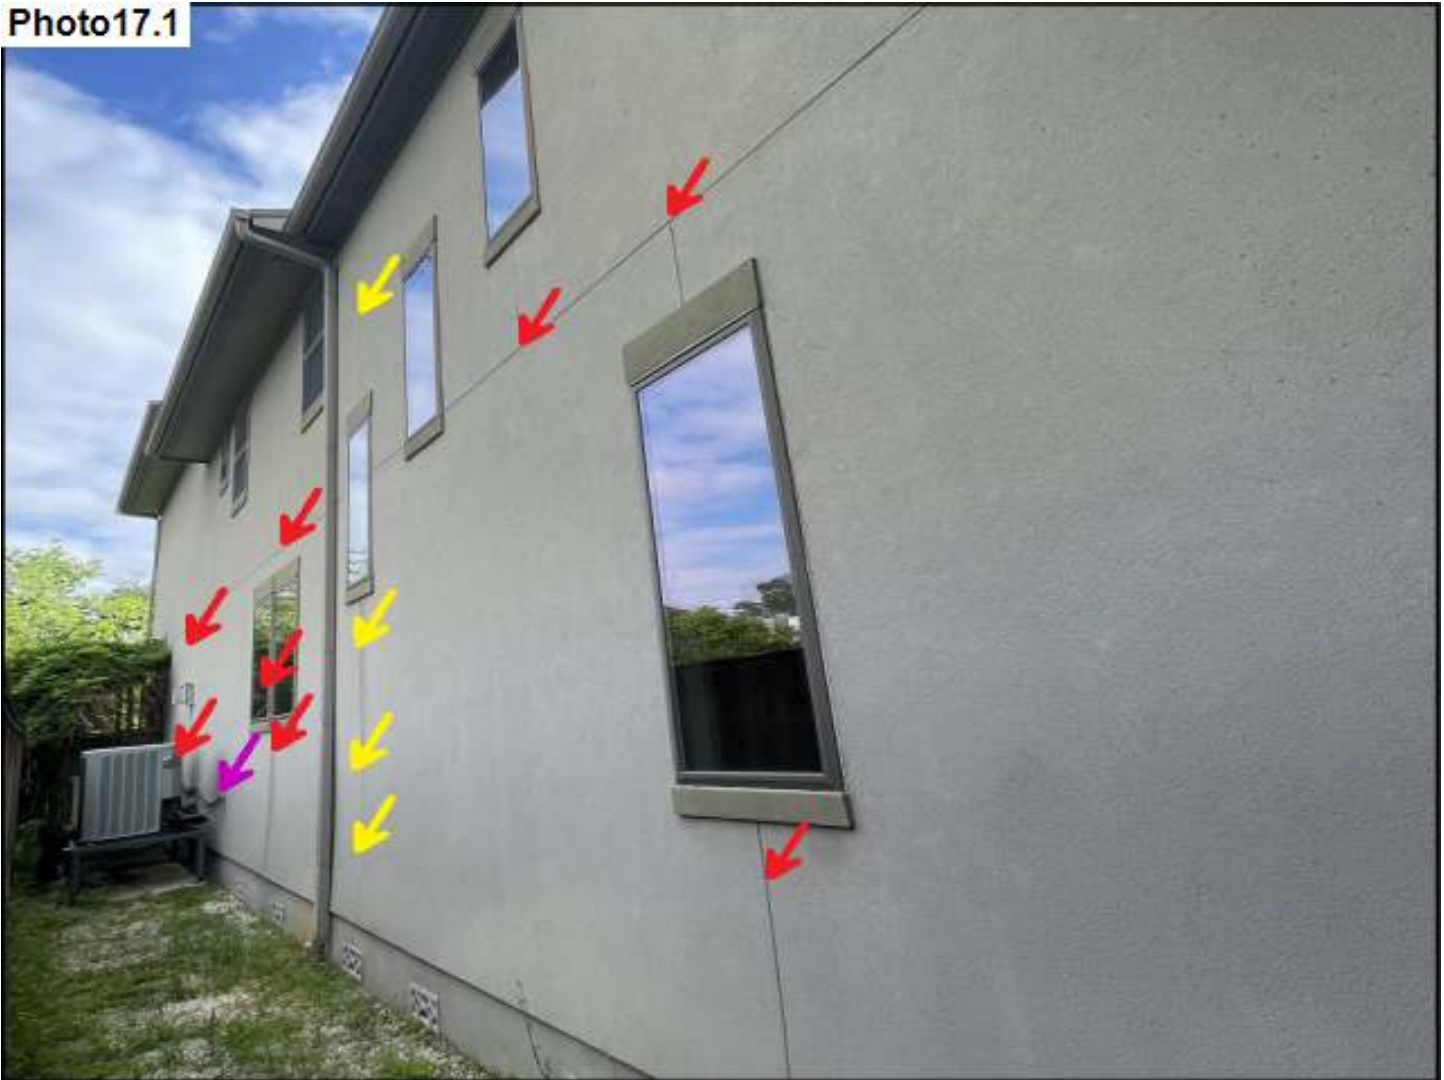
Photo17.1

<u>Grid Location</u>	<u>Item Description</u>	<u>Moisture Readings</u>	<u>Substrate Condition</u>	<u>Observations-Photo #17.1</u>	<u>Chapter Reference</u>
				Assess all windows, doors, penetrations and terminations and reseal as needed.	Ch 3.1,3.2
Yellow Arrows	Rust Aggregates			Rust aggregates / spots are present. These spots are frequently the result of iron deposits found among the marble aggregates used in the finish coat. Consult with your stucco manufacturer for proper removal of these spots. See details #18.1, #18.2, and #18.3.	
Red Arrows	Control Joint Cracking			Large cracks are present at the control joints in this elevation. It is suggested to repair all large cracks at the control joints as needed. See details #18.4, #18.5, #18.6, #18.7, #18.8, #18.9, and #18.10.	Ch 3.6
Purple Arrow	Penetrations			Penetrations lack adequate sealants. It is suggested to seal all penetrations with the proper polyurethane caulking as needed. See detail #18.11.	Ch 3.1

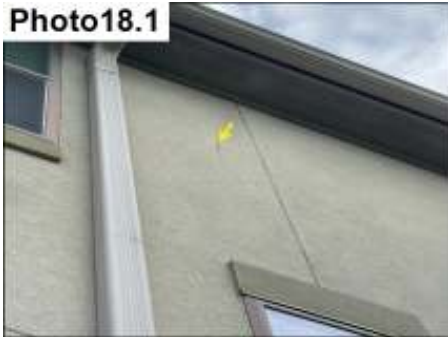
Photo18.1

Rust aggregates are present.

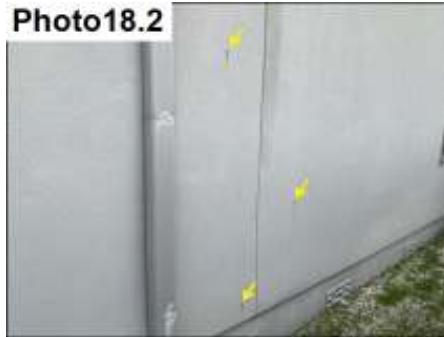
Photo18.2

Rust aggregates are present.

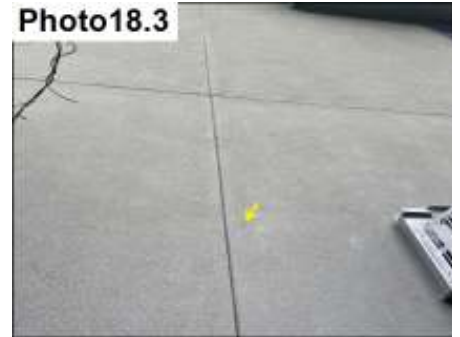
Photo18.3

Rust aggregates are present.
