STUCCOSPEC
SAFE AIRE TECHNOLOGY
STUCCO & MOLD INSPECTIONS

Moisture Assessment Report

4534 Park Court
Bellaire, TX 77401
04/24/2023

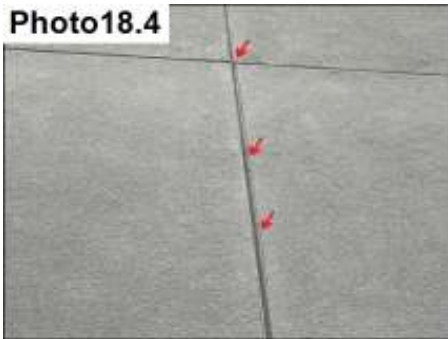
Photo18.4

Large cracks are present at the control joints.

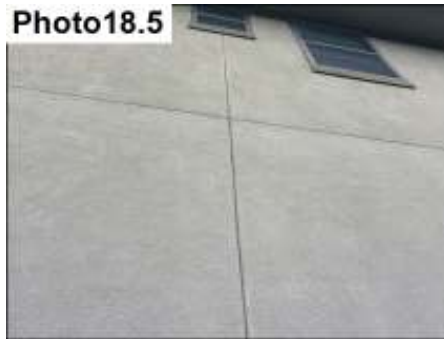
Photo18.5

Large cracks are present at the control joints.

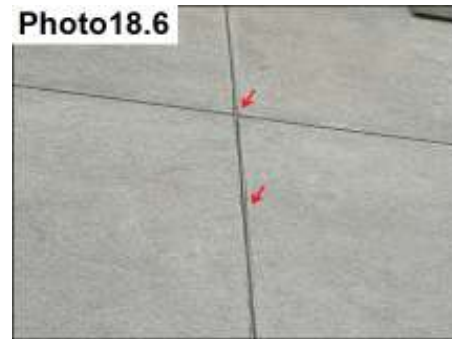
Photo18.6

Large cracks are present at the control joints.

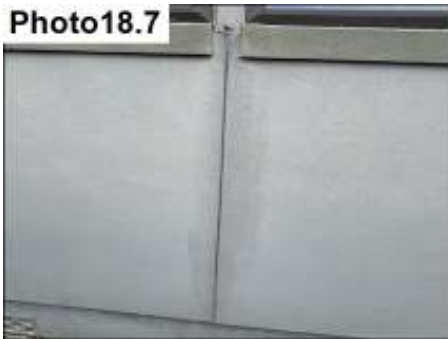
Photo18.7

Large cracks are present at the control joints.

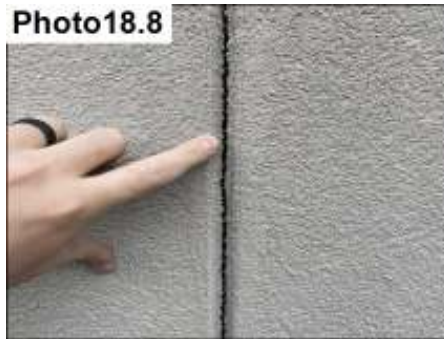
Photo18.8

Large cracks are present at the control joints.

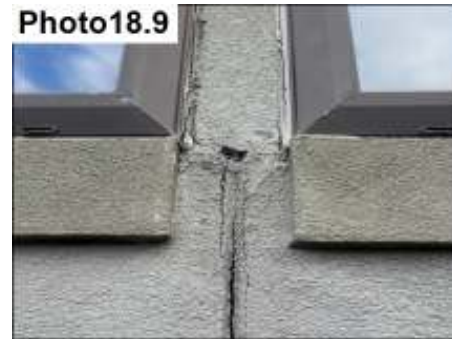
Photo18.9

Large cracks are present at the control joints.

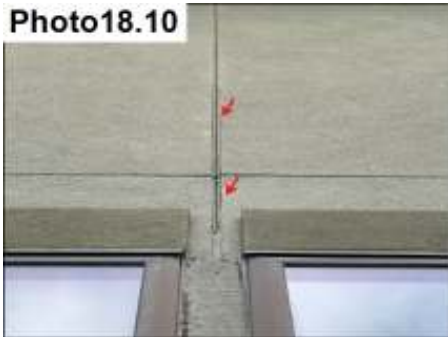
Photo18.10

Large cracks are present at the control joints.

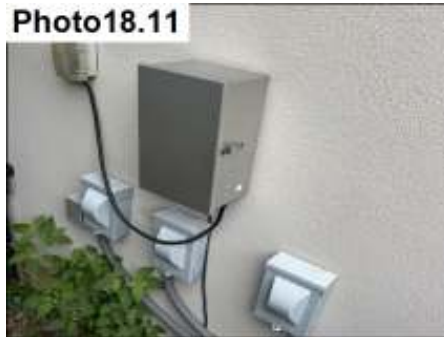
Photo18.11

Penetrations lack sealants.
