Inspection Report

Property Address:
367 Knollwood Creek
Onalaska Texas 77331

PROPERTY INSPECTION REPORT

By: Joe Bradley 7310 TREC #7310 / Bradley Real Estate Inspection 5/5/2022

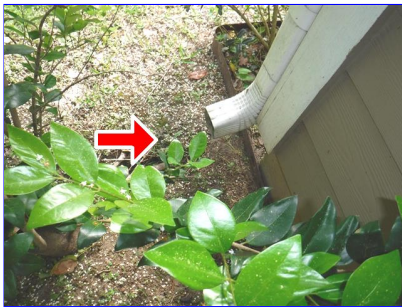
Missing gutter downspout splash blocks

B. Item 1 (Picture) Missing splash blocks B. Item 2 (Picture) Example blocks

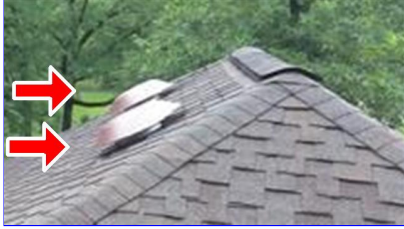
Noted 2 old power vents. Recommend blocking off power vents to allow air to flow from soffit vents.

D. Item 1 (Picture) Recommend blocking old power vents

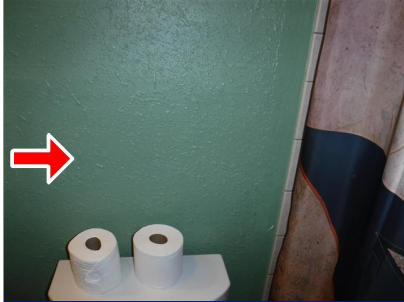
Signs of repair downstairs bathroom wall

E. Item 1 (Picture) Signs of repair downstairs bathroom

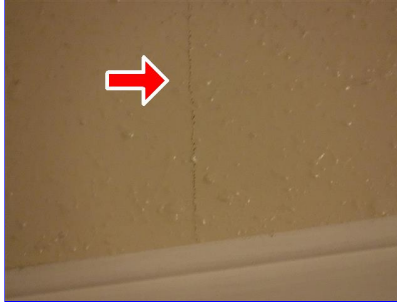
Sheetrock tape joint crack over upstairs bedroom closet

E. Item 2 (Picture) Sheetrock tape joint crack upstairs bedroom

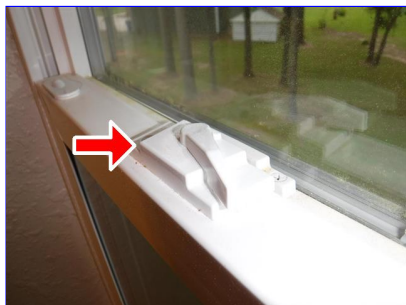
Adjust locks 2 windows dining room

Adjust locks upstairs bedroom

H. Item 1 (Picture) Adjust locks

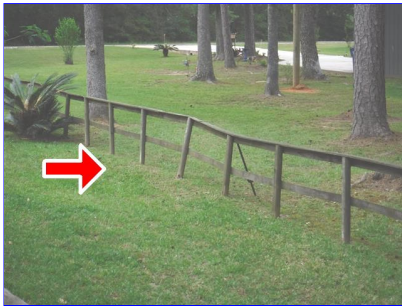
Fence down left side in disrepair and leaning.

L. Item 1 (Picture) Fence in disrepair

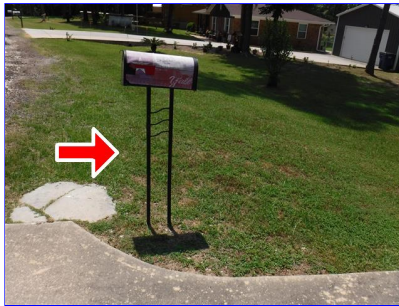
Mailbox leaning.

L. Item 2 (Picture) leaning mailbox

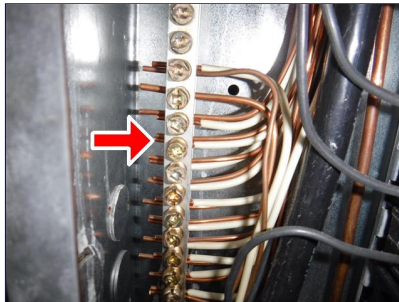
Grounds and neutrals under same lugs

A. Item 4 (Picture) Neutrals and grounds under same lugs

Recommend having a licensed electrician evaluate and recommend repairs

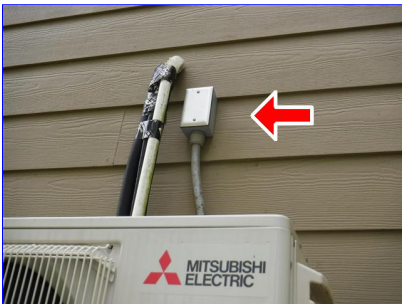
No electric disconnect.

B. Item 1 (Picture) No electric disconnect

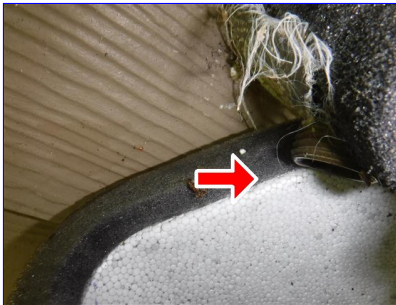
Missing anti siphon devices on outside hose bibs.

A. Item 2 (Picture) Missing anti siphon device

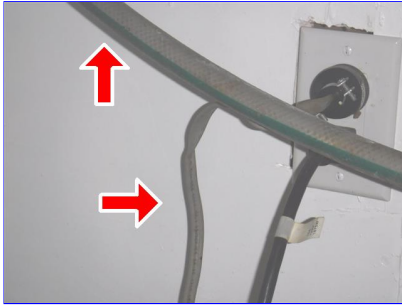
Romex wiring used for power cord

A. Item 1 (Picture) Romex wiring

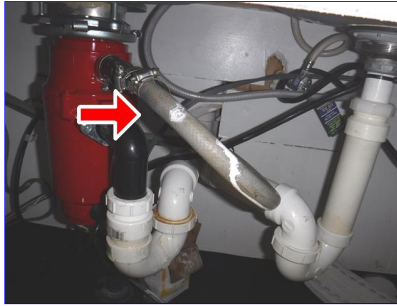
Water hose used for drain line.

A. Item 2 (Picture) Water hose used for drain line

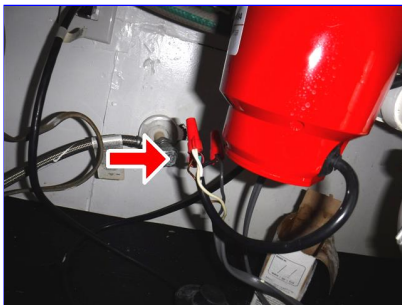
Romex wiring is not allowed for power cord, power cord should be a UL Listed power cord installed with a bushing / clamp.

Improper wire connection

Romex used for power cord.

B. Item 1 (Picture) Improper wire connection / romex used for power cord

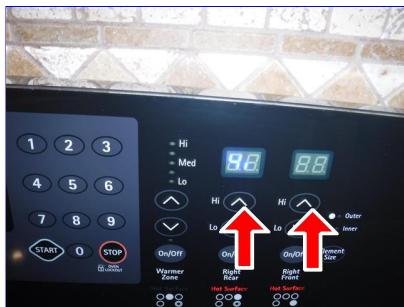
Burner display starting to go out.

D. Item 1 (Picture) Burner display starting to go out.

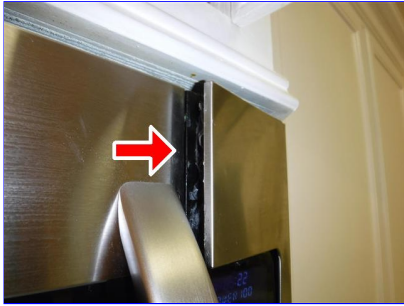
Damaged front housing.

E. Item 1 (Picture) Damaged front housing

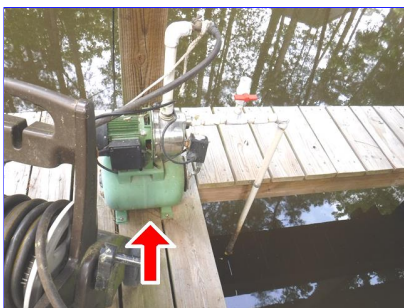
Pump had lost its prime.

A. Item 1 (Picture) Lake pump

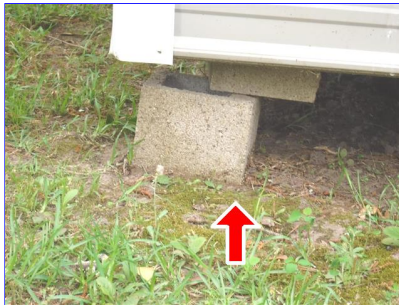
Noted several improper block stacks

C. Item 2 (Picture) Improperly stacked blocks

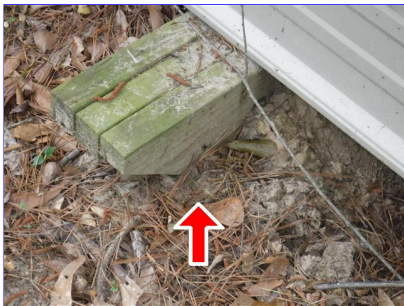
C. Item 3 (Picture) Wooden runners in contact with ground

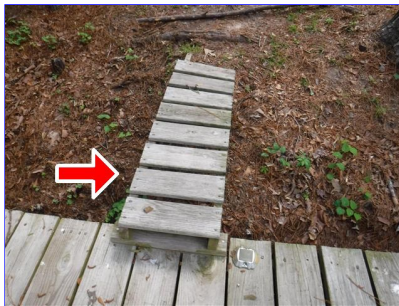
Improper board walk should be removed.

C. Item 4 (Picture) Improper walk boards boat house.
