## **Inspection Report**

**Property Address:**  
7710 Round Bank Dr.  
Houston Tx. 77064

# PROPERTY INSPECTION REPORT FORM

Mr. Shawn Tillman	7/2/2023
<i>Name of Client</i>	<i>Date of Inspection</i>
7710 Round Bank Dr., Houston, Tx. 77064	
<i>Address of Inspected Property</i>	
Van A Johnson	TREC#10463
<i>Name of Inspector</i>	<i>TREC License #</i>
<i>Name of Sponsor (if applicable)</i>	<i>TREC License #</i>

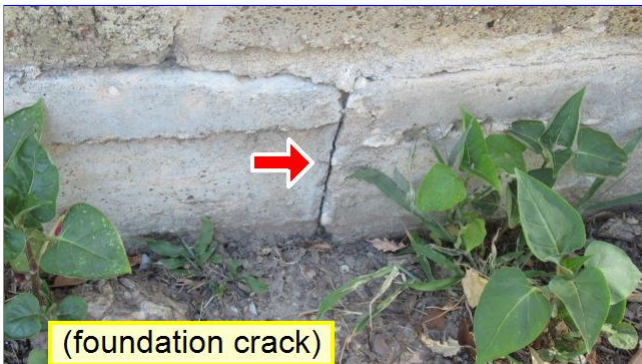
A. Item 1(Picture)

This home is more than 40 years old and the foundation is not performing as intended. There is a foundation crack on the east side of the garage door. There are other indicators throughout the report that will support foundation movement. A structural engineer should be consulted.

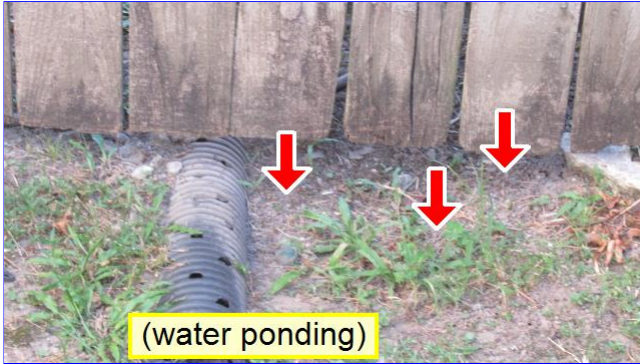
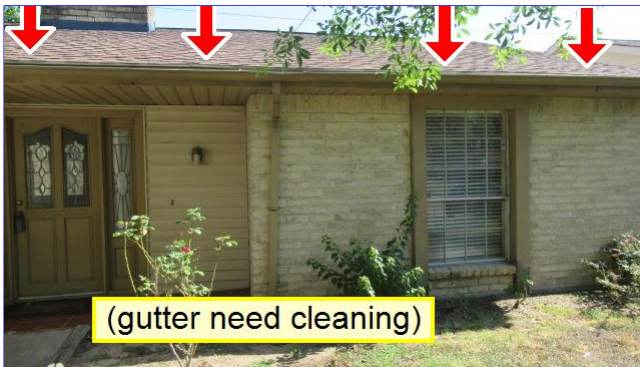
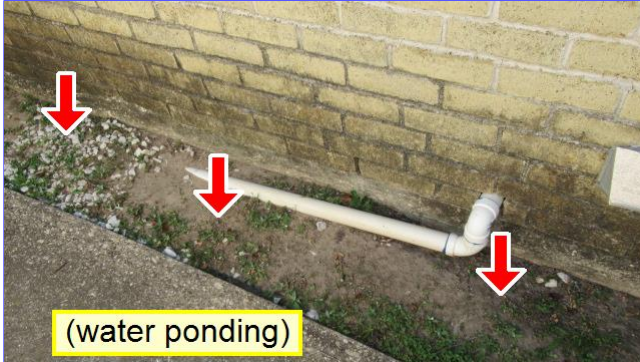
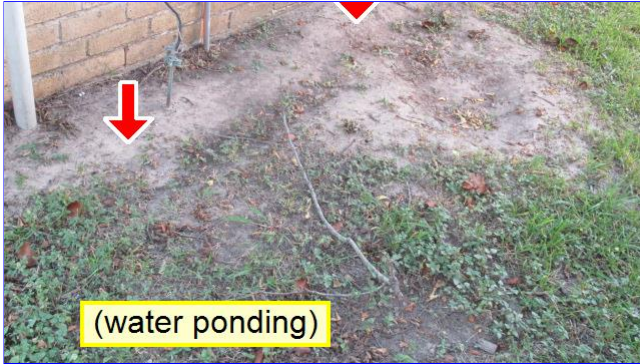
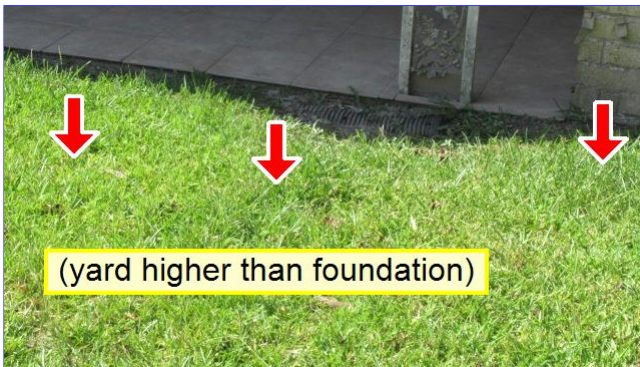
Water is ponding in some areas around the foundation due to poor drainage or the lack of gutters. The front gutter need cleaning and securing. At the back of the home, the yard is higher than the home foundation. A qualified person should be consulted.

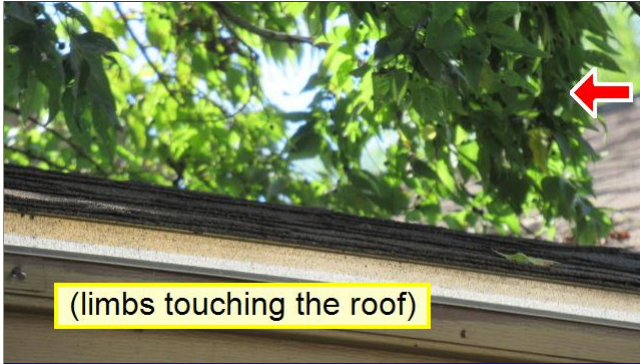
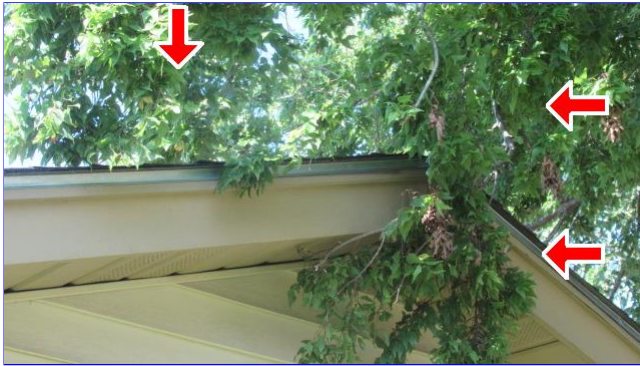
There are some tree limbs touching the roof covering at the rear of the home. The limbs need trimming.

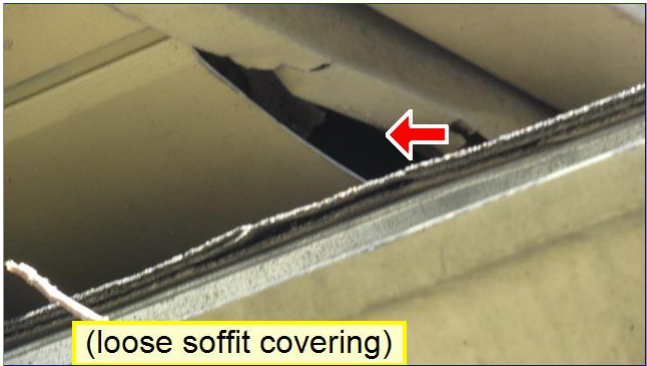
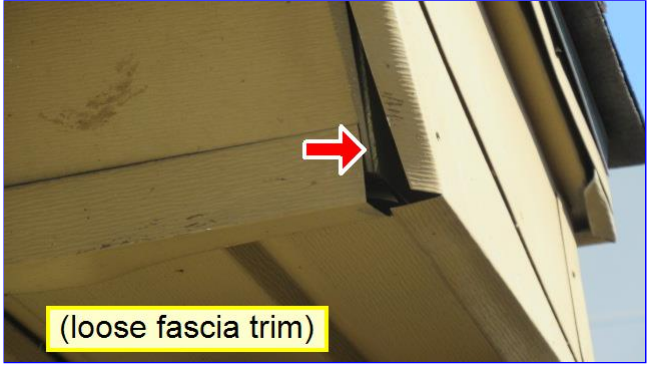
There is some loose soffit covering and fascia trim. Repairs are needed.

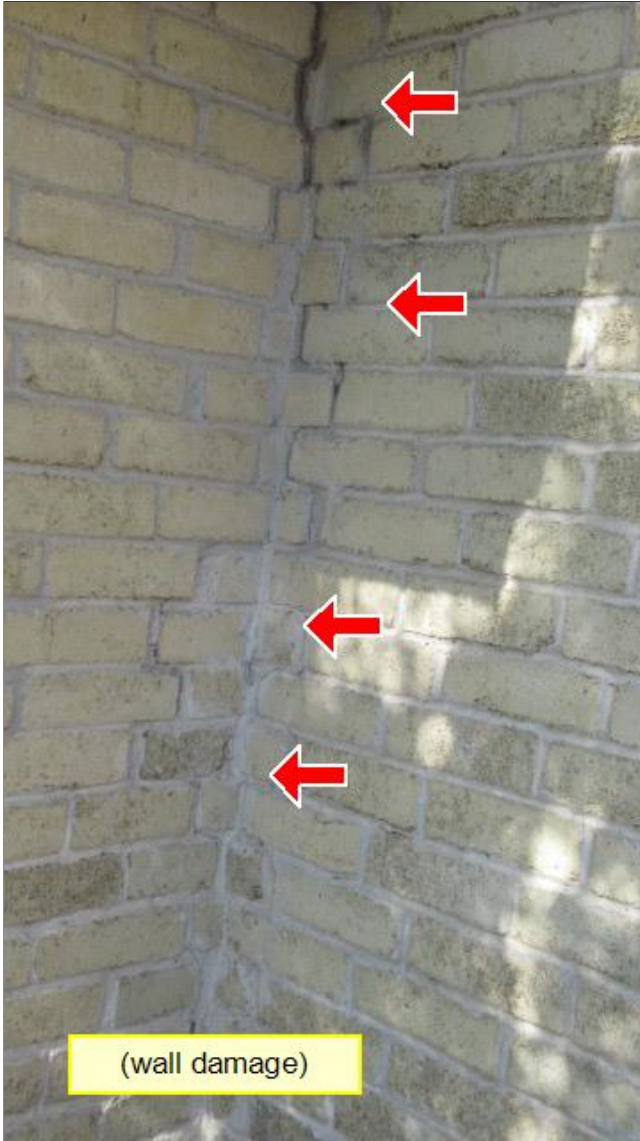
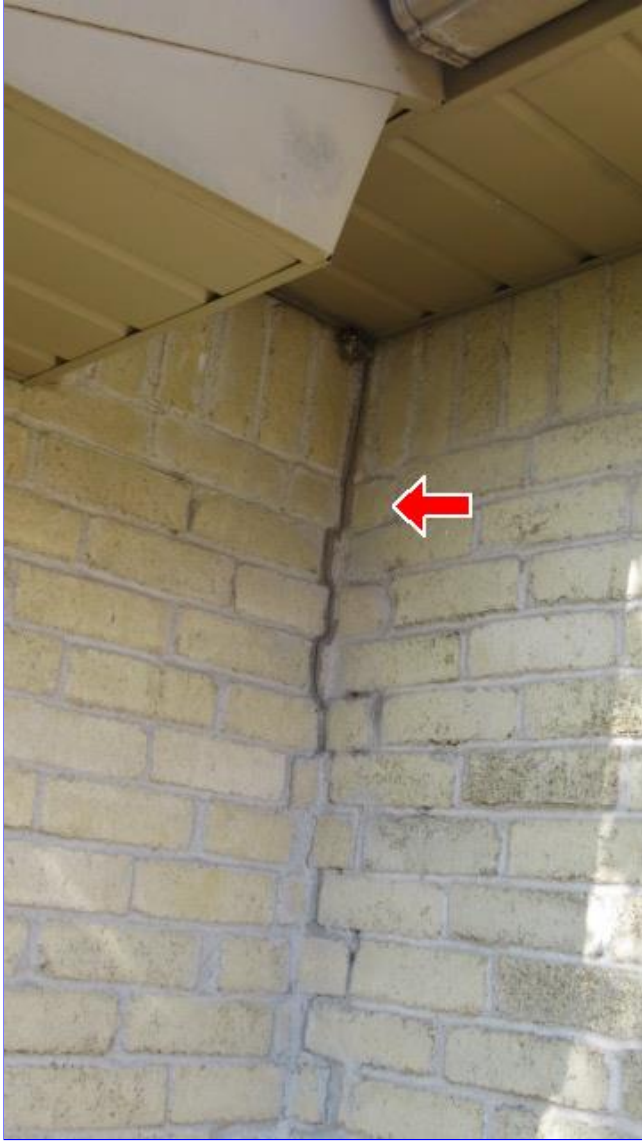
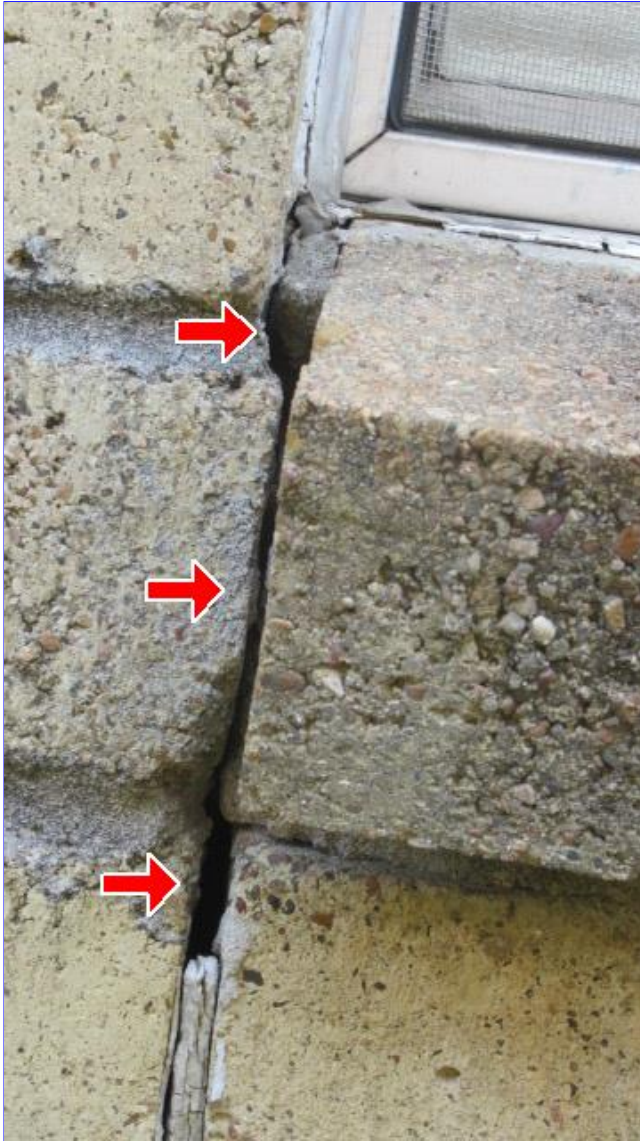
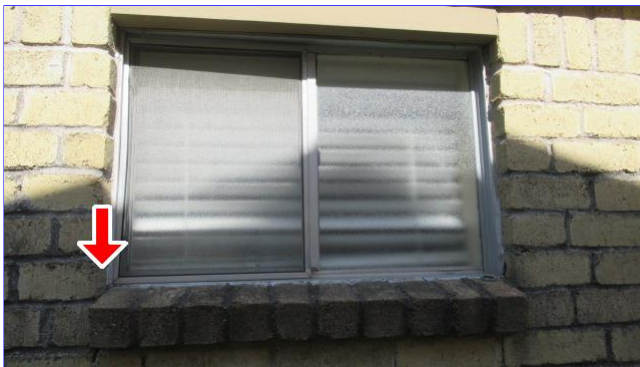
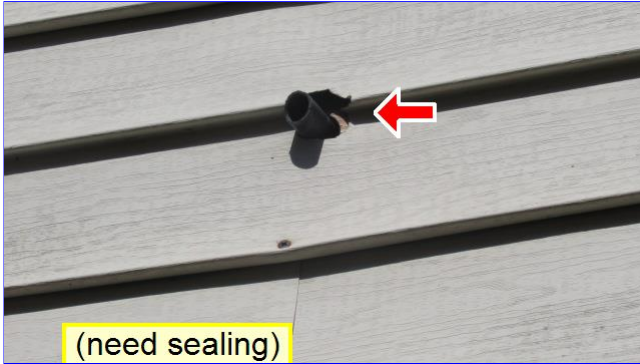
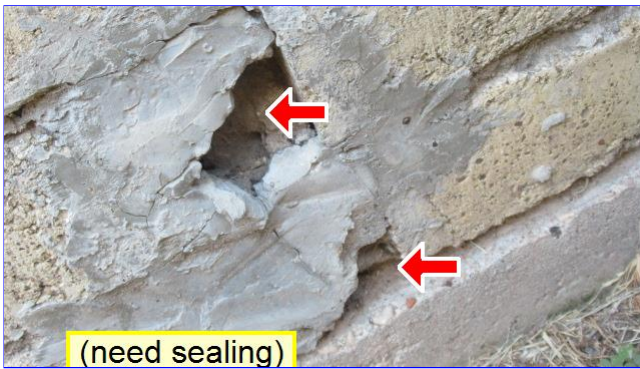
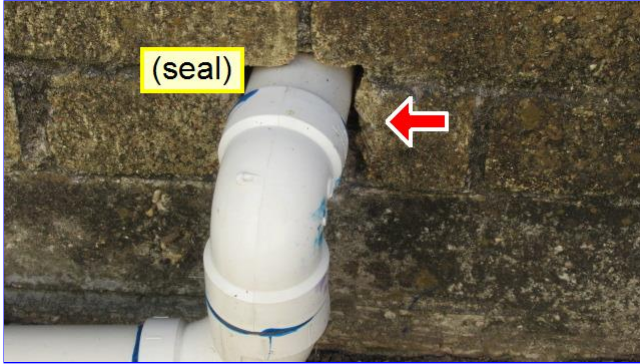
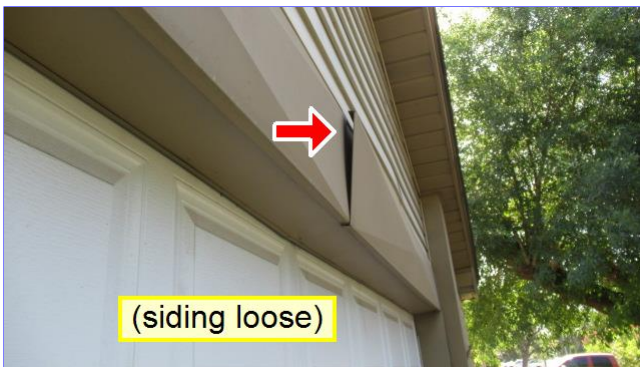
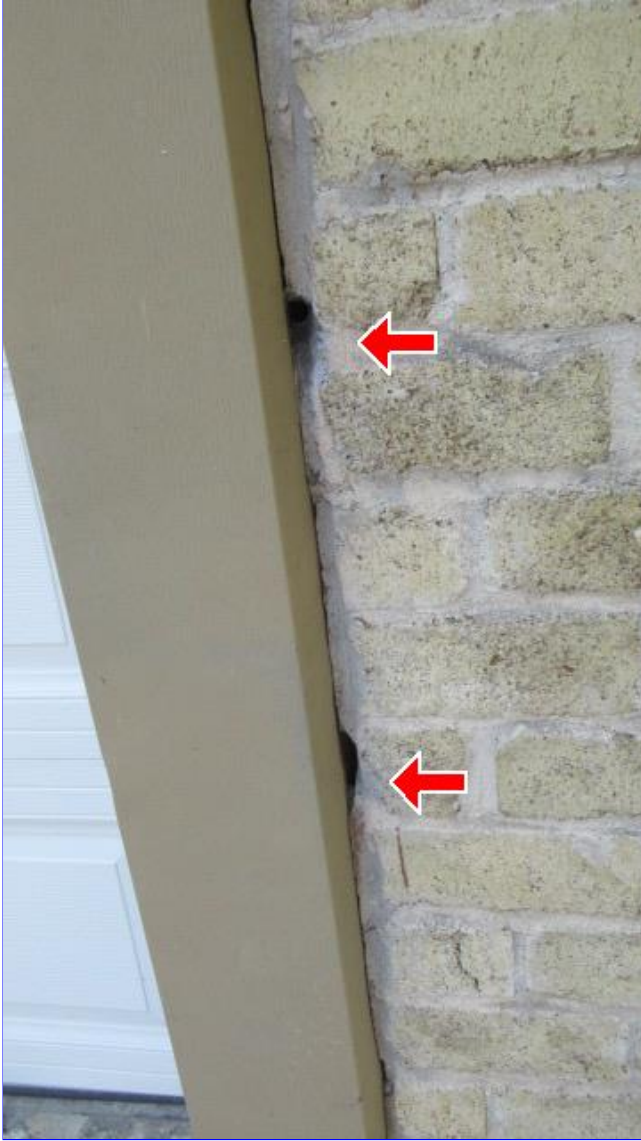
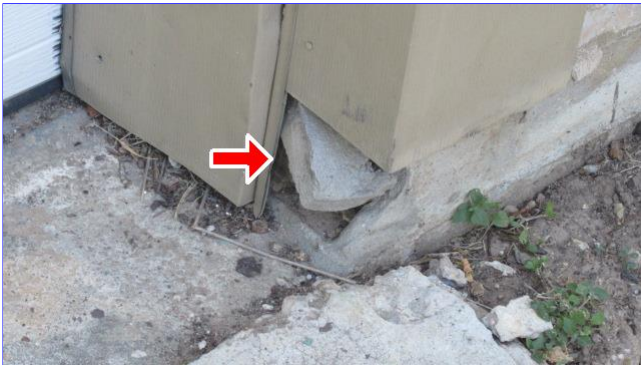
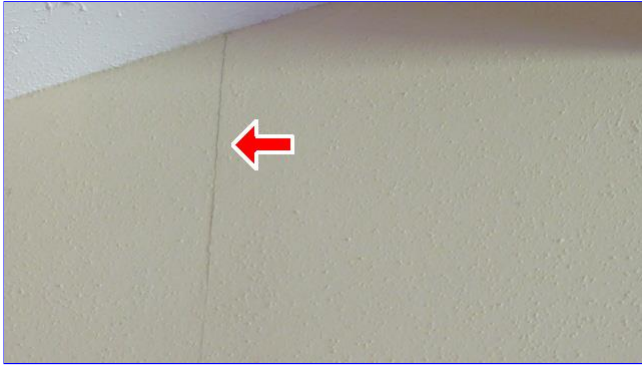
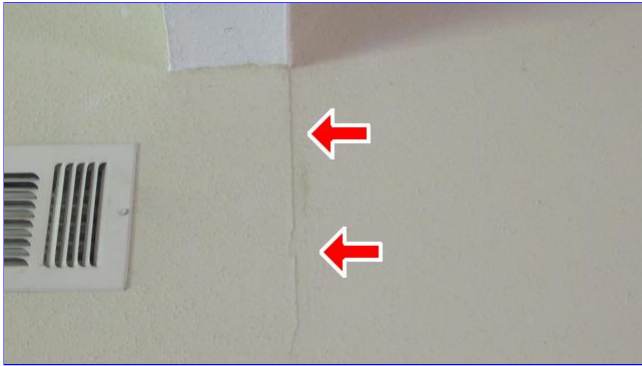
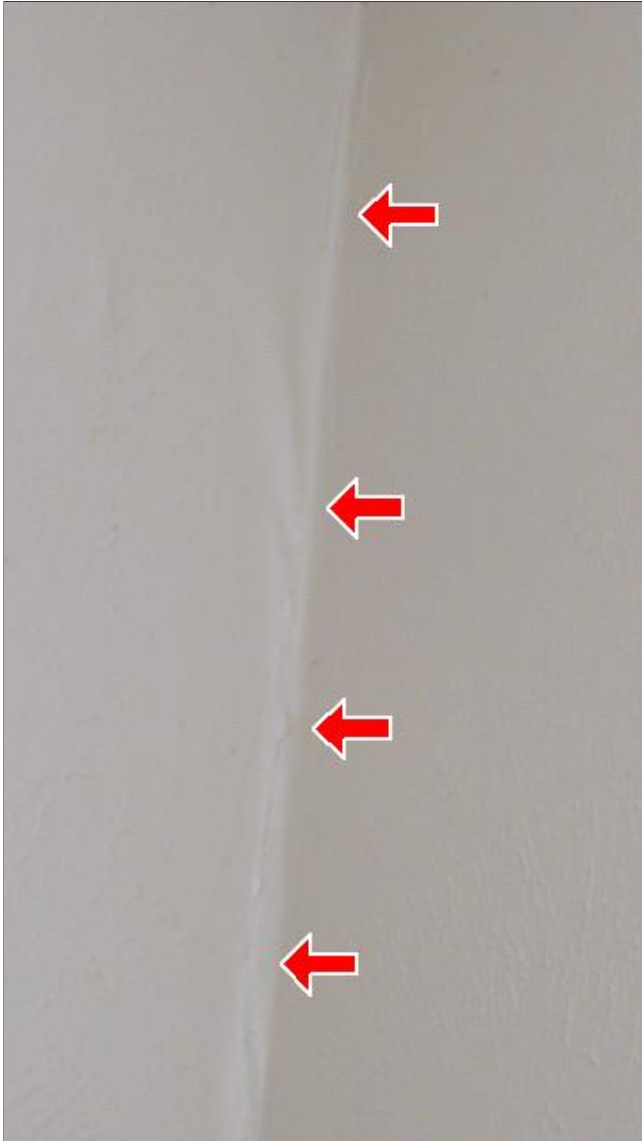
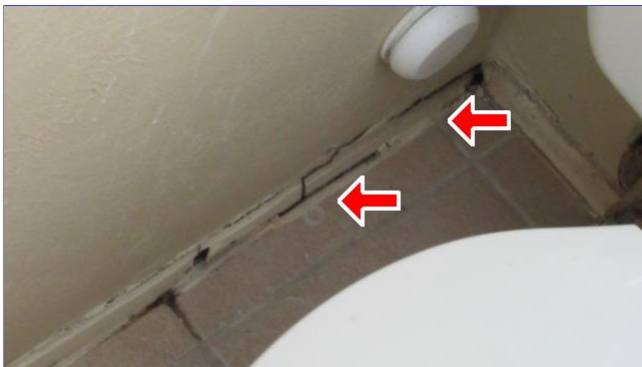
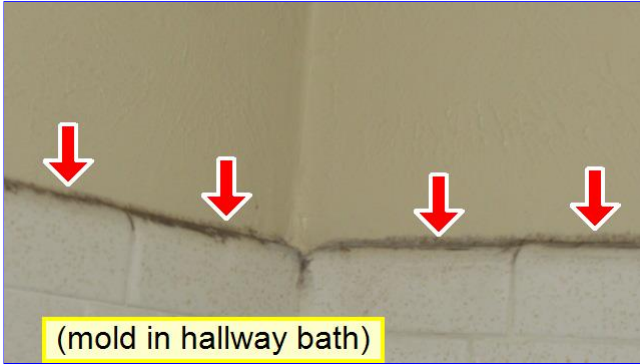
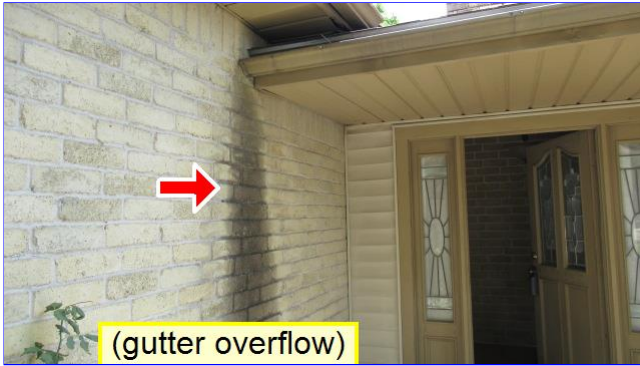
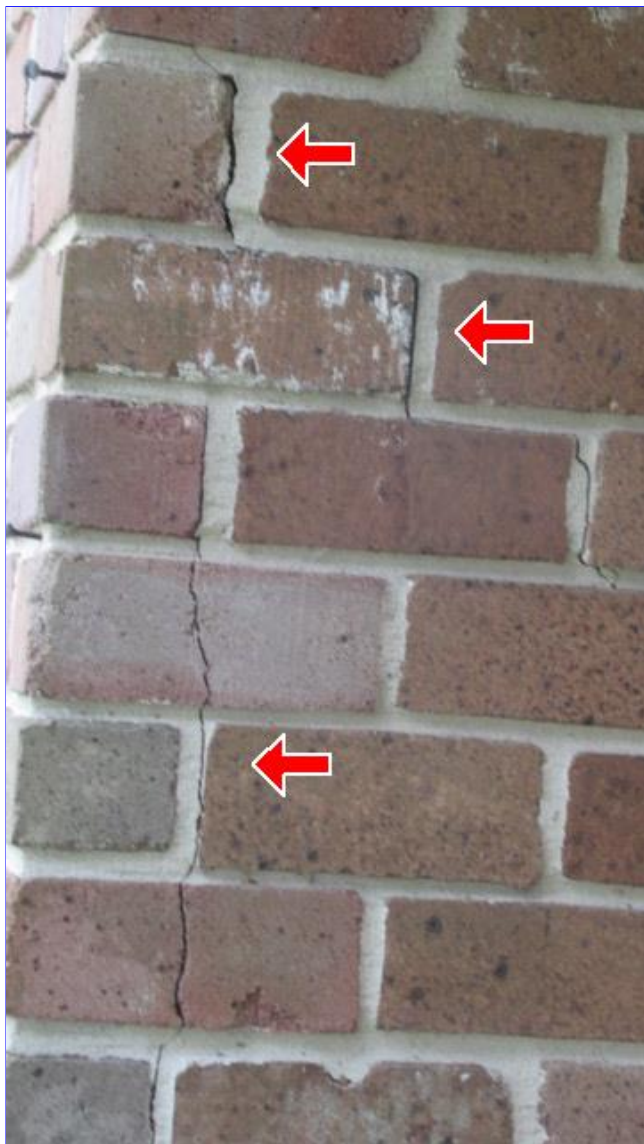
There are several interior and exterior wall blemishes that need repairs.

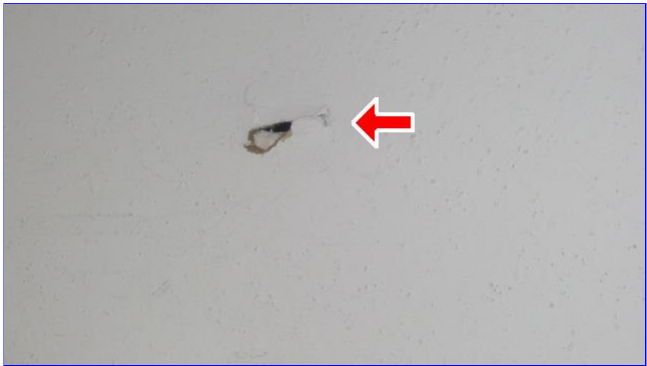
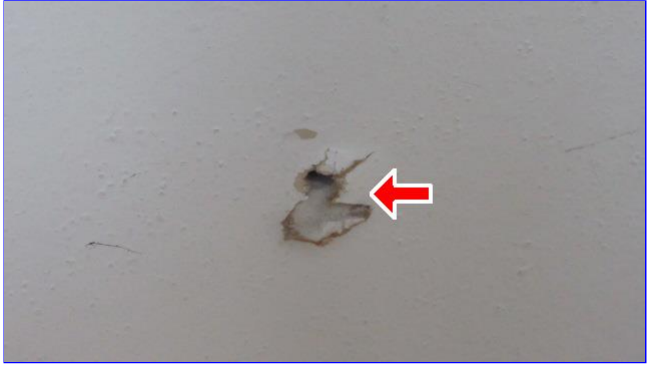
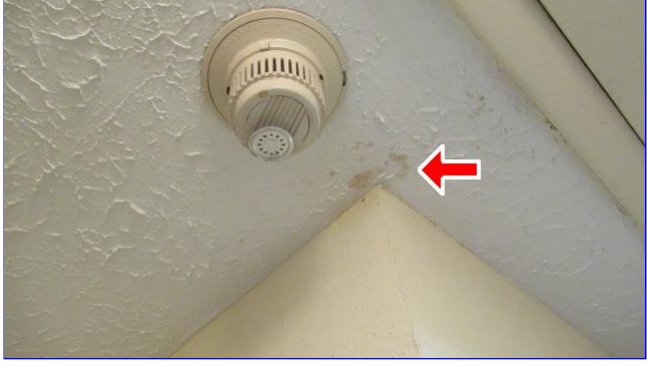
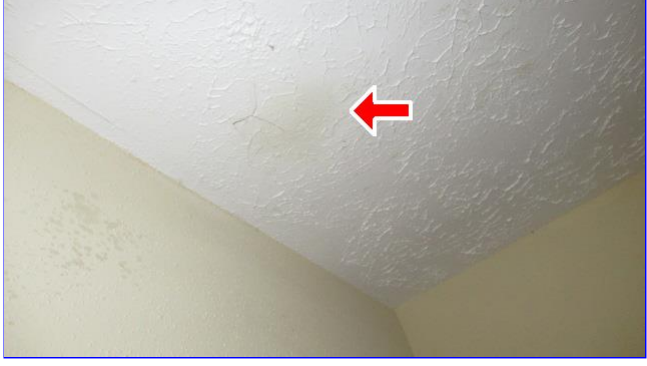
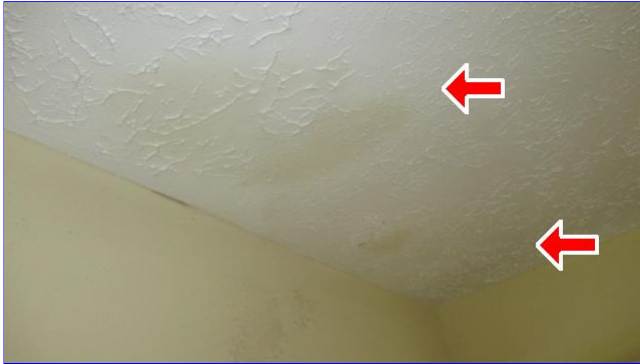
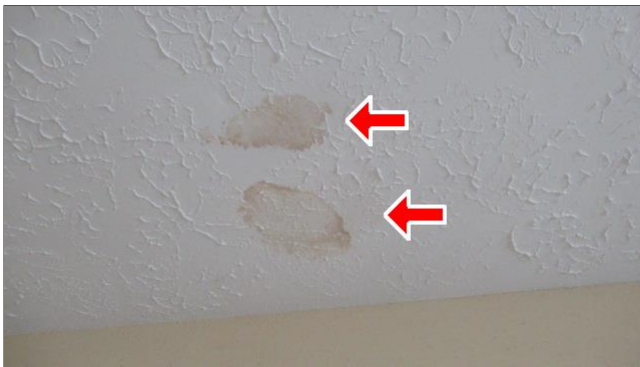
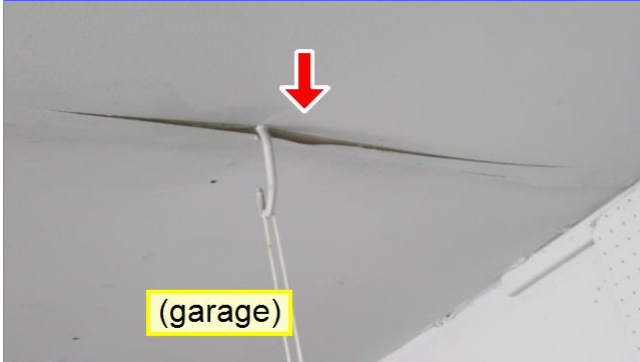
There are some interior ceiling blemishes and some of the floors are not level. Repairs and further investigation is needed.

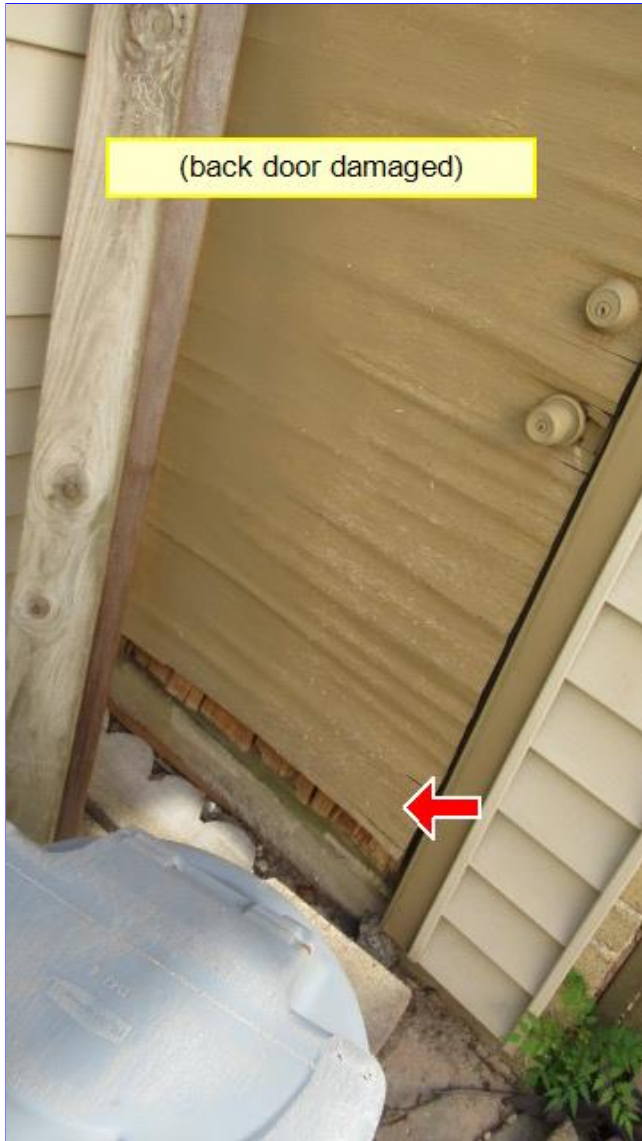
G. Item 1(Picture)

The back garage door is damaged. The patio storm door need adjustment. The garage area storm door does not have a closer. The door from the home to the garage area is not self closing. Repairs are needed.

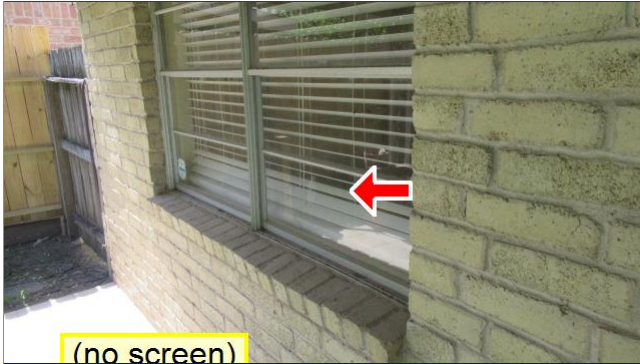
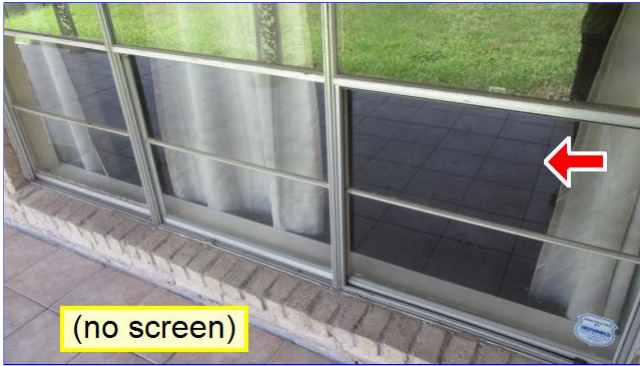
The windows do not have screens.

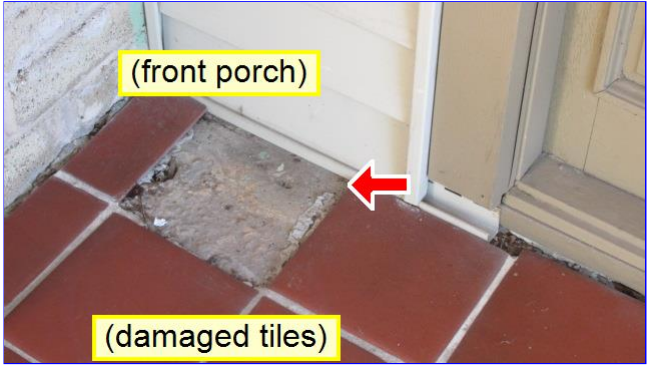
K. Item 1(Picture)

The front porch has some damaged tiles. Repairs are needed.

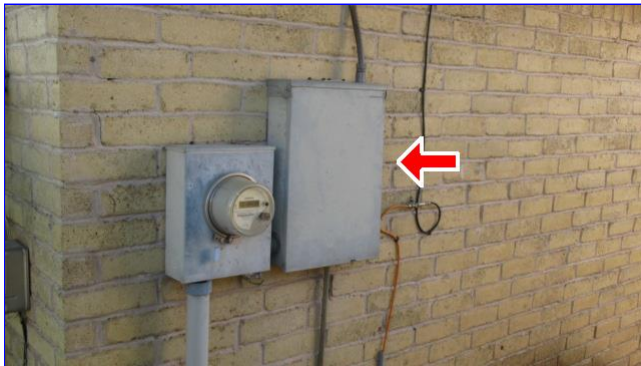
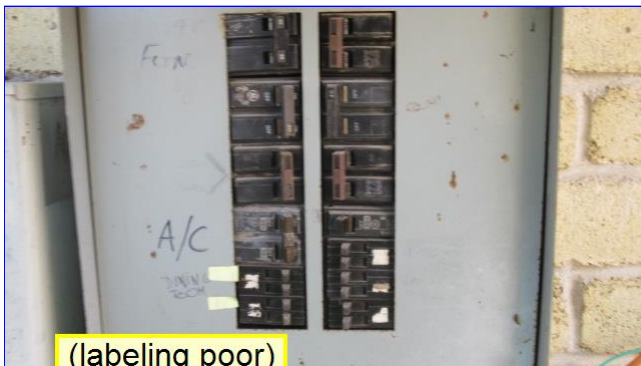
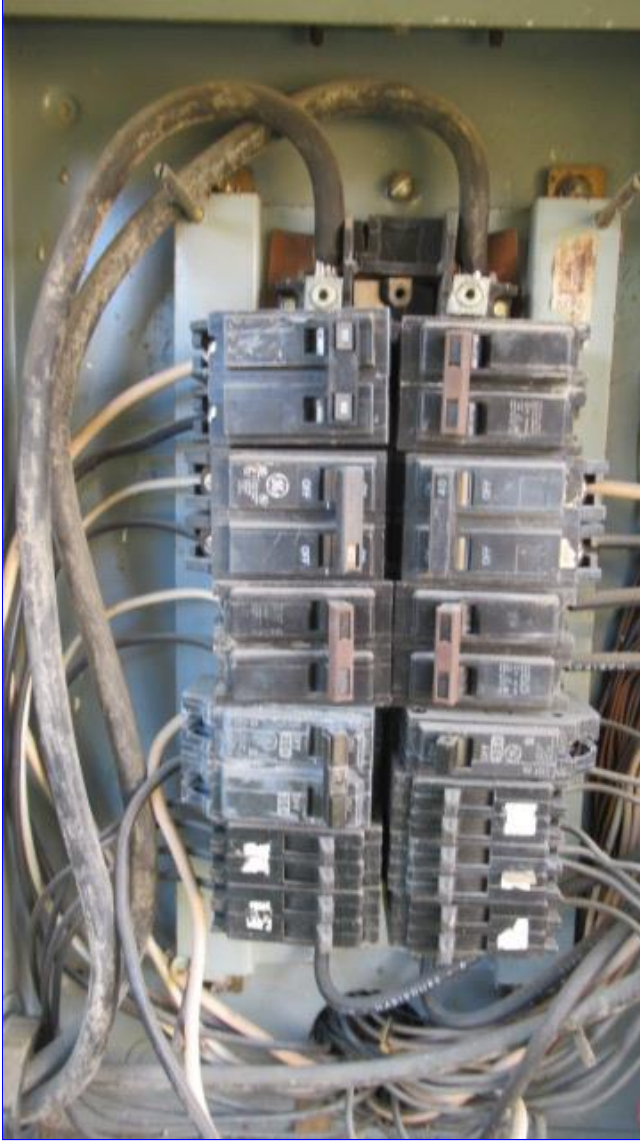
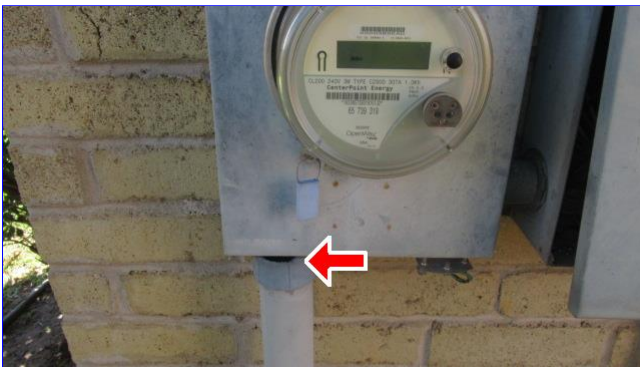
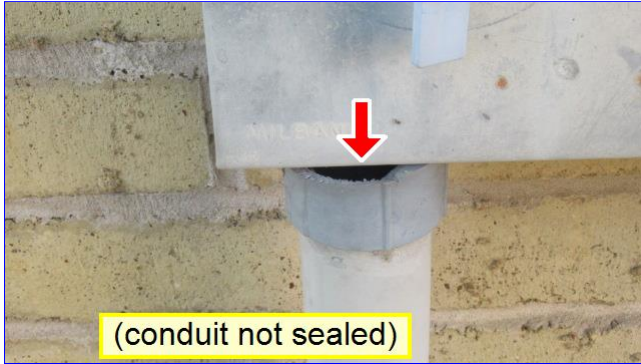
The main service panel does not have a main service disconnect breaker. The panel has more than 6 circuits breakers to terminate all power to the home. This is an electric code violation. Some of these circuits are not labeled. The main electric cable conduit is no longer sealed. A licensed electrician should be consulted.

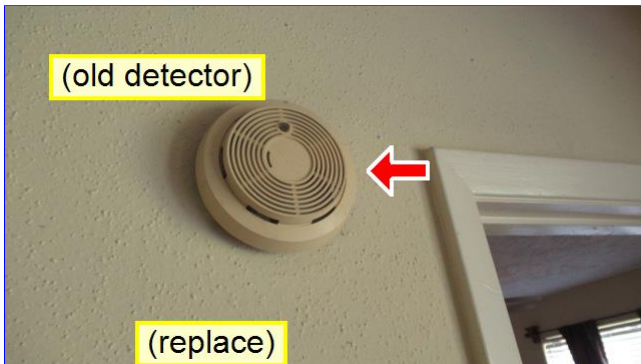
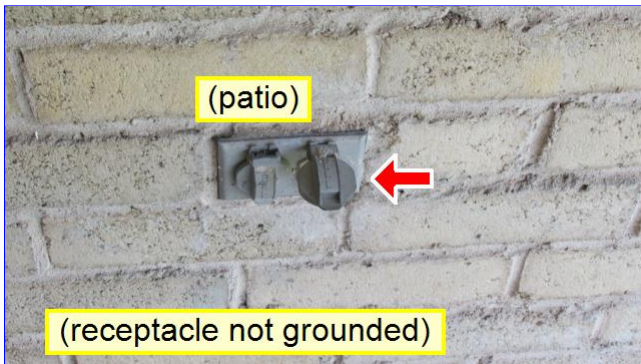
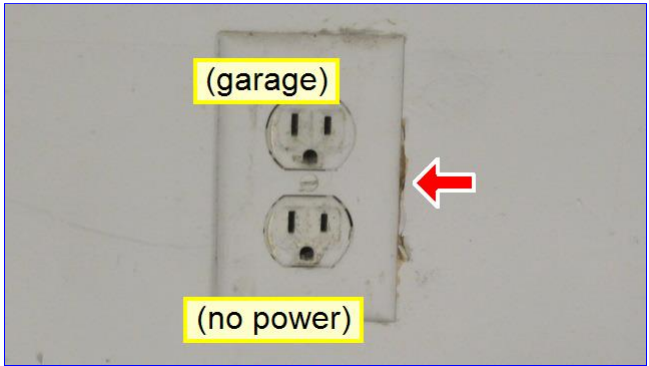
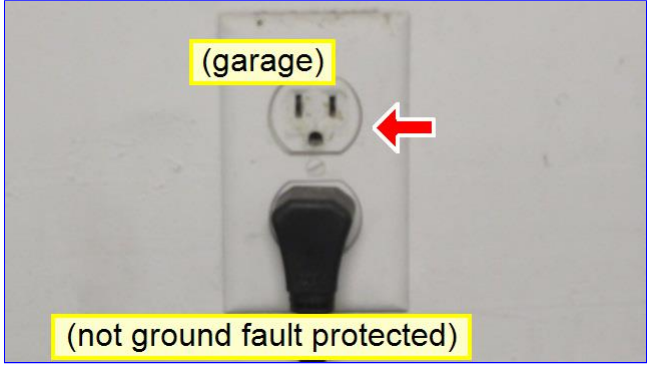
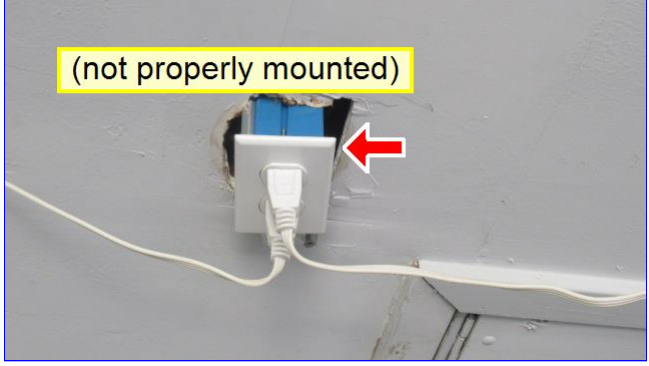
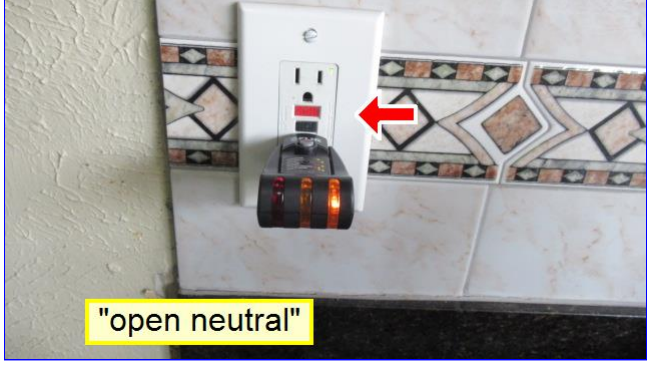
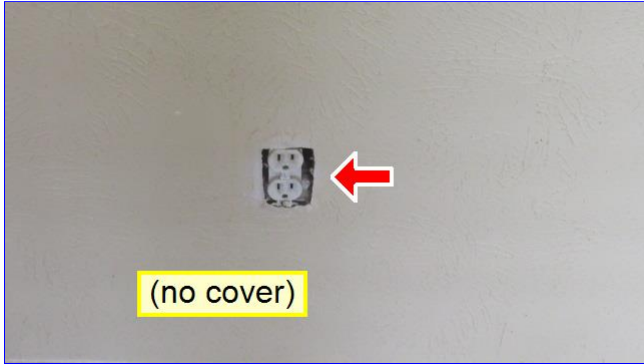
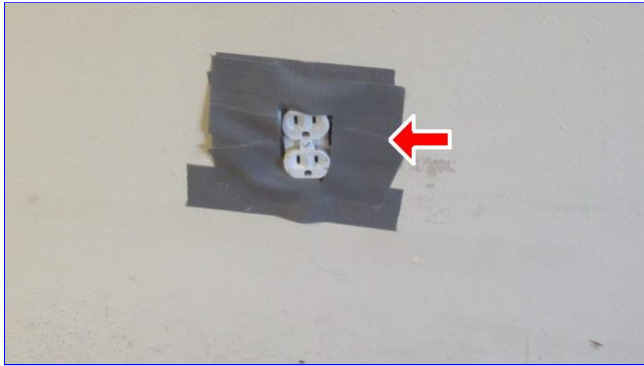
This home does not have code required smoke detectors installed inside each bedroom. The existing hallway detectors are old and should be replaced for **safety reasons**. On the exterior, the patio receptacle is not grounded. In the garage, a receptacle is without power, another one is not ground fault protected, and another one is not properly mounted. In the kitchen, the south countertop ground fault device has an "open neutral wire". There are some interior receptacles without covers. A licensed electrician should be consulted.

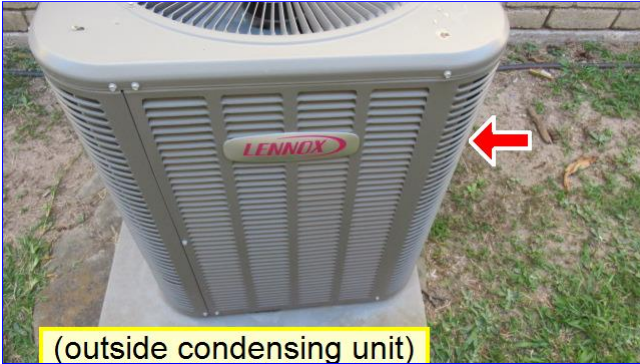
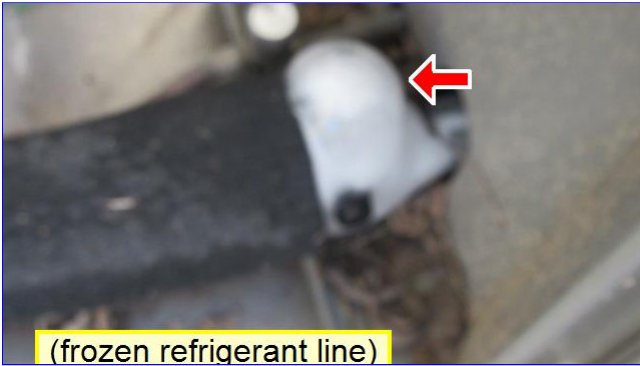
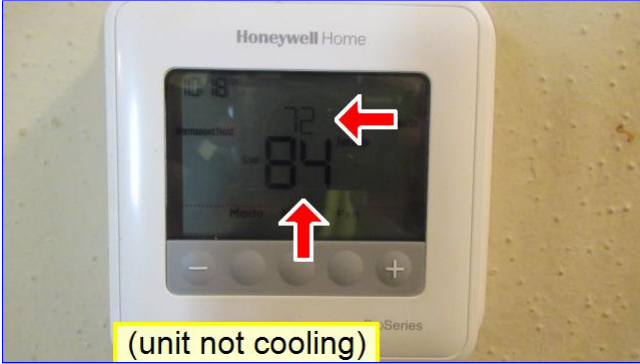
The cooling system is not cooling at all. The low pressure refrigerant line is frozen at the outside condensing unit. A licensed air conditioning specialist should be consulted.

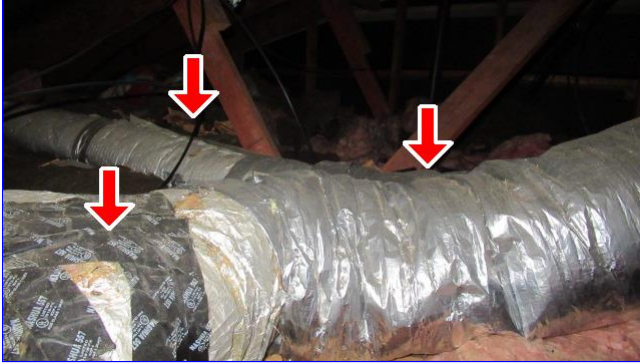
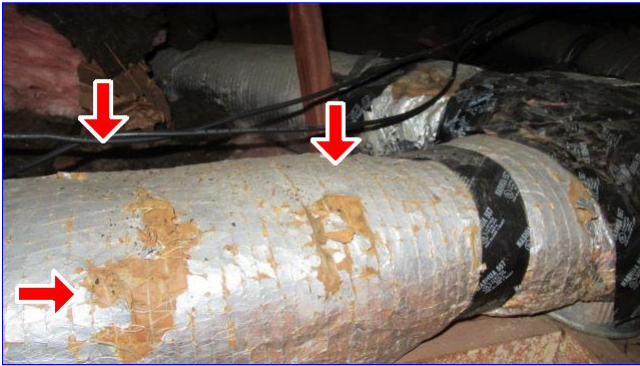
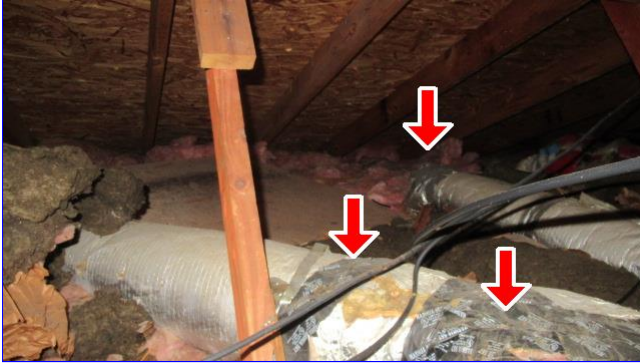
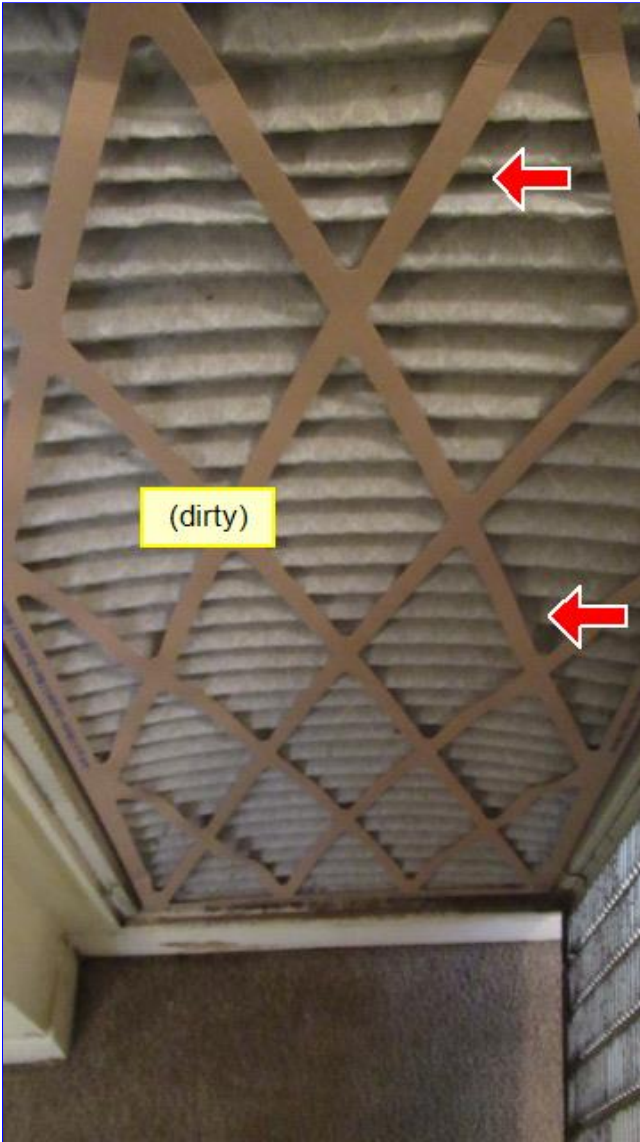
Most of the duct system was not visible in the attic. The visible ducts are old and damaged. Repairs and replacement is needed. The return air filter is dirty and need to be replaced.

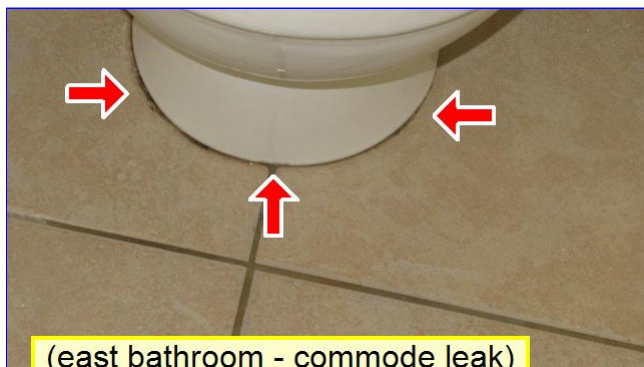
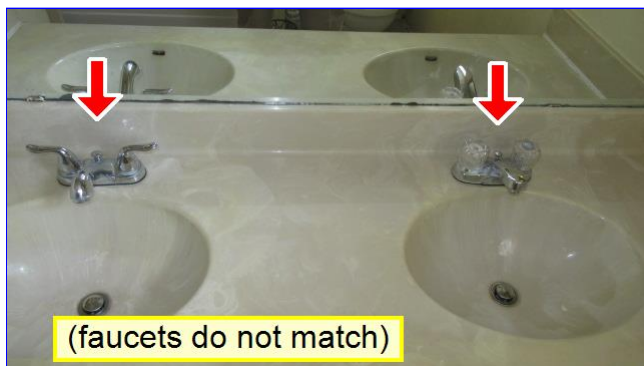
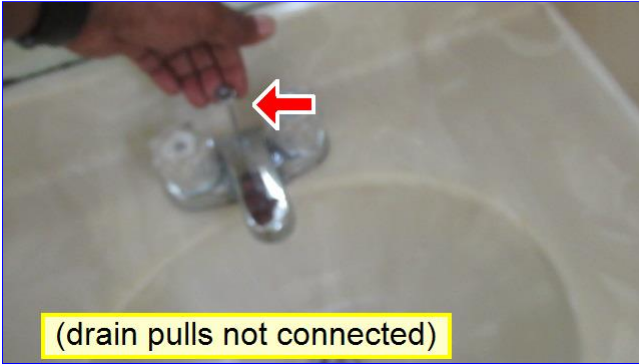
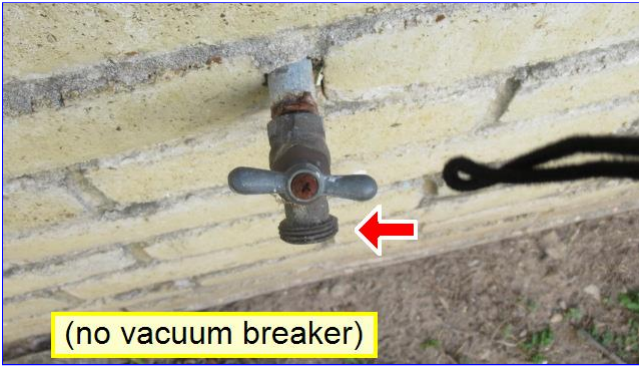
In the master bath, the water pipes vibrate when the commode is filling. The water flows to the vanities decrease during this time. Further investigation is needed. In the east side hallway bath, the commode is leaking at the base(wax ring defective). The vanity faucets do not match and the drain pulls are not connected. The exterior hose bibs do not have vacuum breakers attached. A licensed plumber should be consulted.

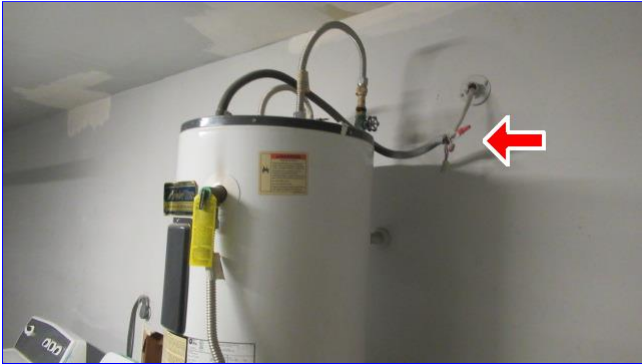
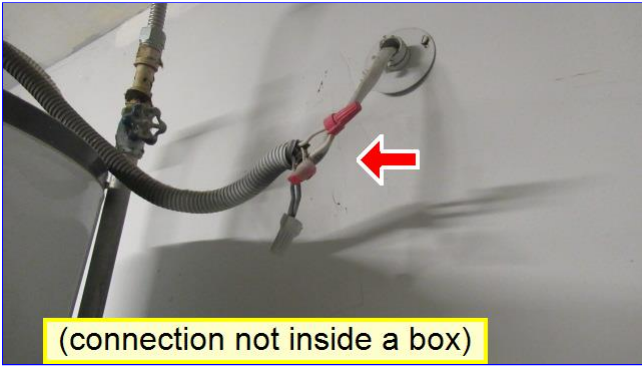
The wiring connections are not inside an electrical box. A licensed electrician should be consulted.

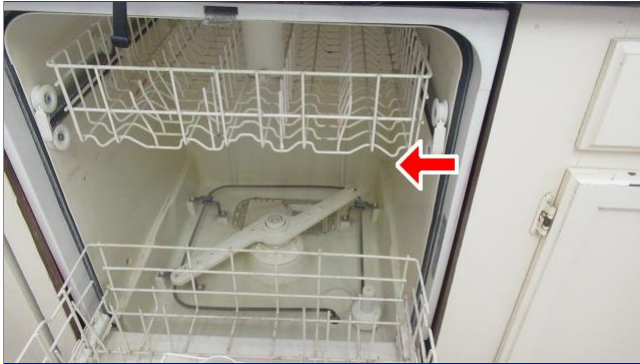
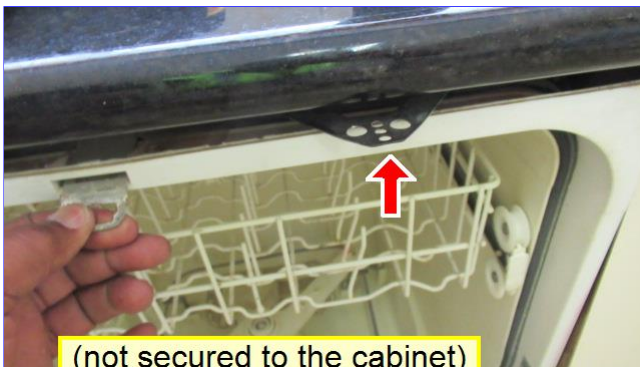
The dishwasher is not secured to the cabinet and there is no water flow to it. Repairs are needed.

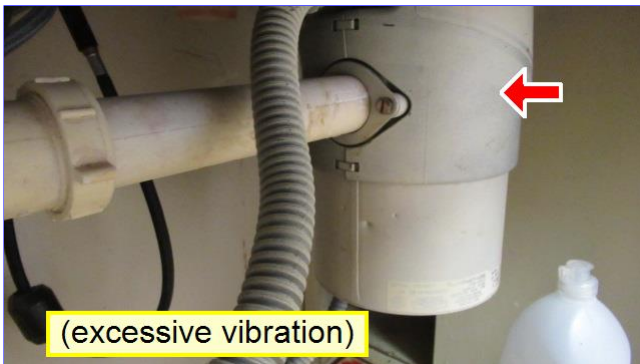
B. Item 1(Picture)

The disposer works but has excessive vibration.

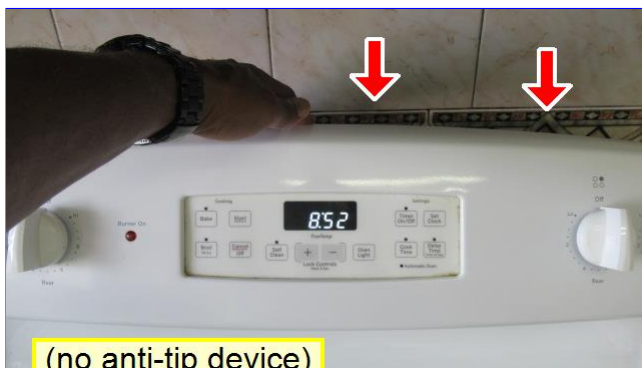
D. Item 1(Picture)

D. Ranges, Cooktops and Ovens  
**Range/Oven:** GENERAL ELECTRIC  
**Comments:**  
The range does not have an anti-tip device attached. This is a potential safety hazard.

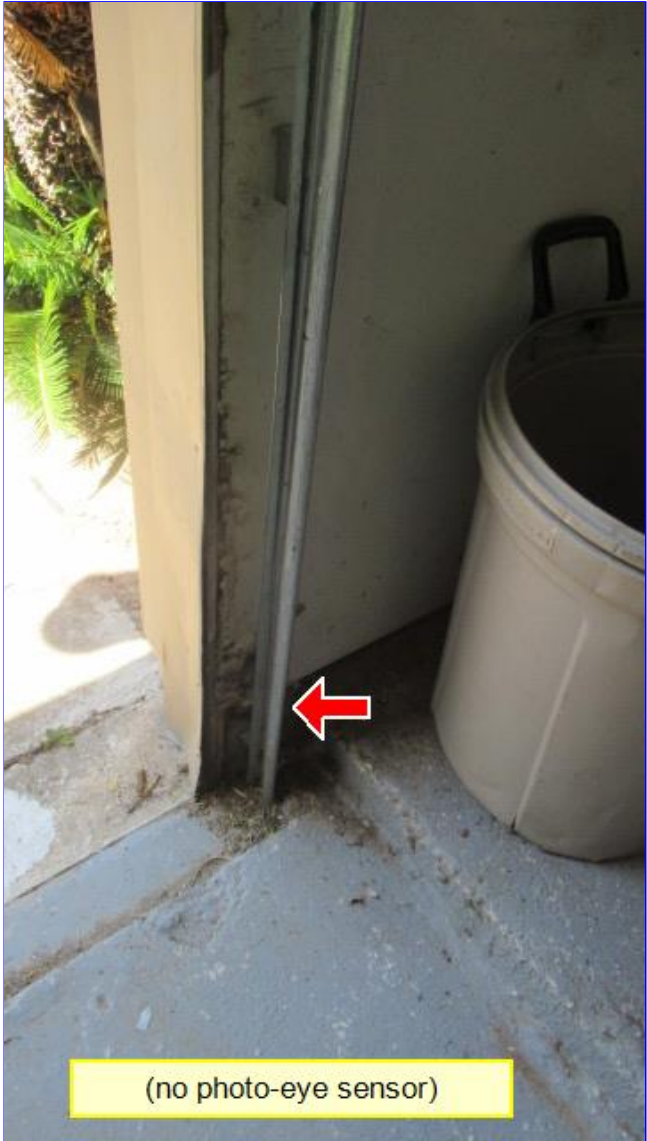
G. Item 1(Picture)

G. Garage Door Operator(s)  
**Auto-opener Manufacturer:** GENIE  
**Garage Door Type:** One automatic  
**Garage Door Material:** Metal  
**Comments:**  
The garage door opener does not have safety photo-eye sensors installed. This condition is a potential safety hazard. Repairs are needed.
