FIG Services LLC d/b/a FOX INSPECTION GROUP Property Inspection Report #220120CS-2819 Meandering Elm Trail 8616 Daffodil St. Houston, TX 77063

PROPERTY INSPECTION REPORT

Prepared For:	Robert & Armi Harper (Name of Client)	
Concerning:	2819 Meandering Elm Trail, Houston, TX 77045 (Address of Inspected Property)	
By:	Cory Simpson, TREC: PI #25086 (Name and License Number of Inspector)	01/20/2022 (Date)

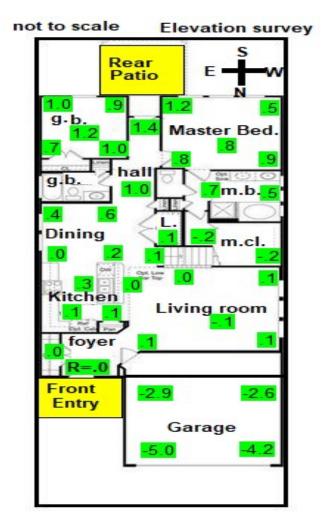
A foundation elevation survey was conducted during the inspection. The floor plan below represents data gathered using a Zip Level and adjusting for floor covering height differences. i.e. differences between tile, carpet and wood flooring (except step down to the garage). Measurements are listed to the nearest 1/10th of an inch. The greatest variance was -.2 to 1.4 inches.

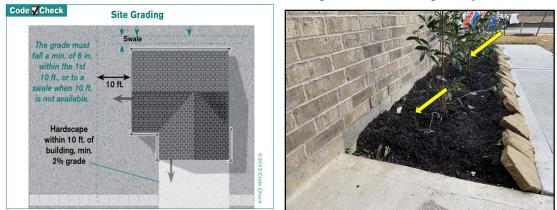
Soil grade and drainage patterns around some areas of the house do not appear to properly direct water away from the foundation to aid in controlling runoff water and could cause differential movement of the foundation or water penetration during heavy rains.

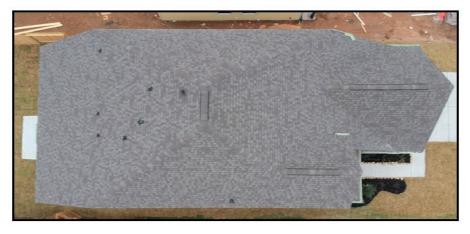
ROOF SURFACE:

No significant deficiencies or anomalies observed at the time of inspection.

Note: Observed staining to shingles at north exterior.

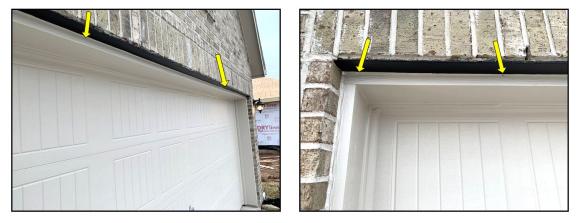
Did not observe head flashing over some windows/doors. Head flashing helps prevent water penetration. Without head flashing, window sealant must be maintained as it is the only defense against water penetration; above garage car door.

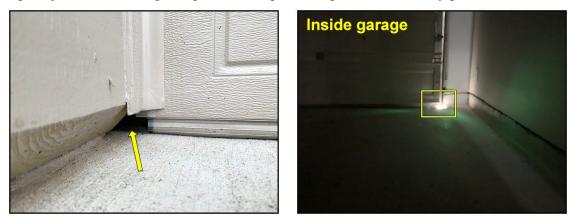
Gaps at joints in building components are potential pest / rodent entry points.

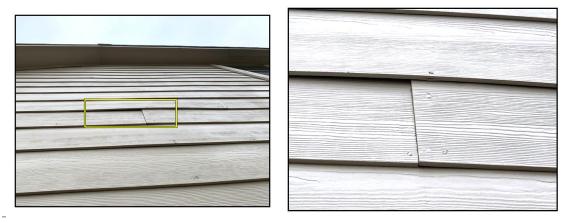
Trim / siding observed to be not secured down at one or more areas of house/garage.

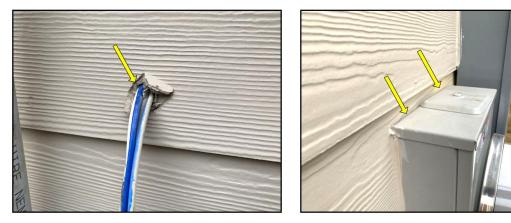
Need sealing/caulking around all holes and exterior siding penetrations on top and both sides, (*leave the bottom open*) to prevent water entry. Including but not limited to dryer, bath and range top vents, light fixtures, etc.

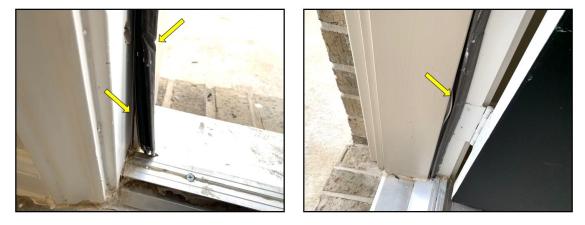
Weather-stripping torn/damaged and/or missing on one or more exterior door(s).

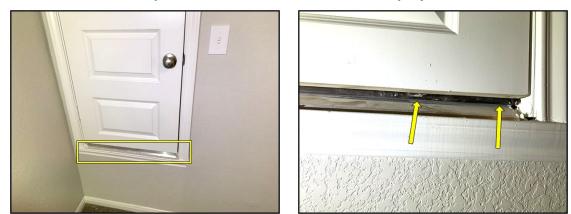
Note: Observed the 2nd floor attic access door to be cut short for jamb/ seal.

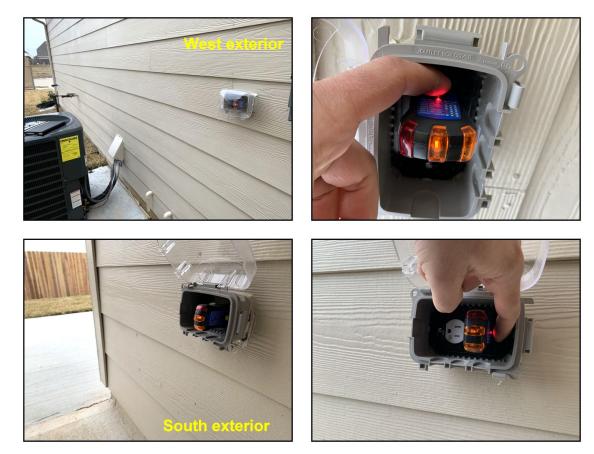
Did not observe GFCI protection of all outlets in required locations, including but not limited to the locations marked below. This condition is a recognized safety hazard and needs repair.

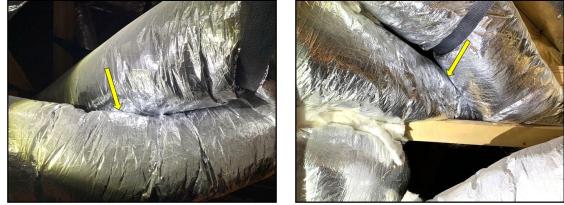
Observed several/multiple areas in the attic where flex duct touch and are missing required 1" clearance from other ducts to prevent condensation between ducts that touch. Recommend general maintenance to flex ducts in the attic, Re-support where needed, seal/tape minor air leaks, repair torn/damaged vapor seal, etc.

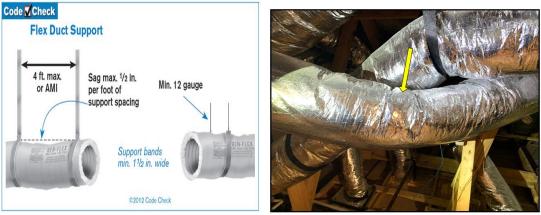
Some flex duct observed to be routed improperly, not to manufacturer's installation instructions. Recommend additional support and/or routing ducts to eliminate "snaking" drooping or crimping of flex duct more than 1" per foot which adds unnecessary additional resistance.

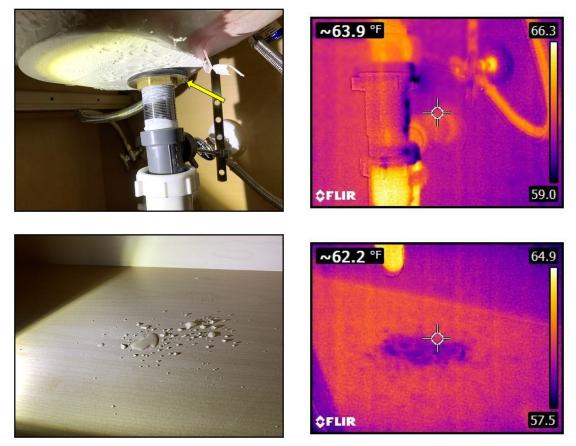
Small leak below the sink; master bathroom right sink.

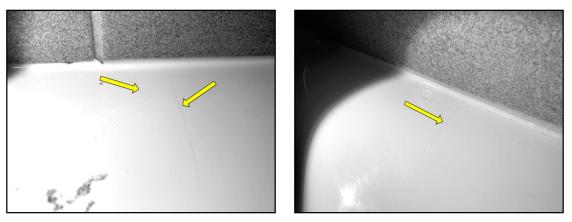
Note: Small scratches observed to master tub.

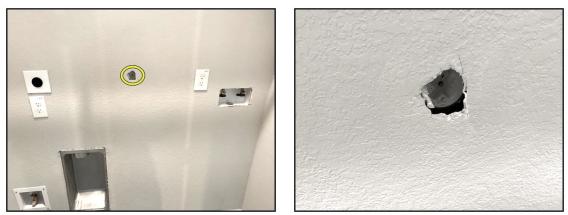
Note: Observed laundry clean-out recessed in wall, recommend consulting with builder on proper access/ plate for clean-out.

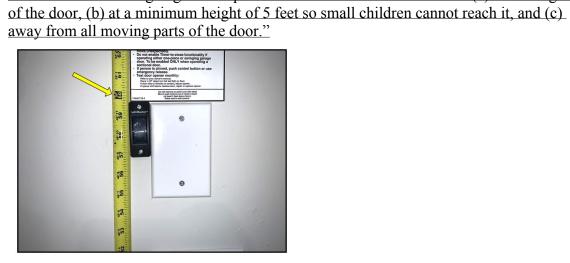
-	-		-	
I=Inspected	NI=Not Inspected	NP=Not Present	D=Deficient	
I NI NP D				
	GAS OVEN:			
	Oven is not installed on	to recommended ant	i-tip bracket on the back side of the u	<u>nit.</u>
	Unit inspected visually Timer and cleaning cyc		ed. No gas to property at time of insp	ection.
	0		erved at the time of inspection. ed. No gas to property at time of insp	ection.
	E. Microwave Ovens Comments: No significant deficience	ies or anomalies obse	erved at the time of inspection.	
	F. Mechanical Exhaust Vents Comments: No significant deficienc		erved at the time of inspection.	
	Did not confirm/verify p	proper venting of all ı	inits to the exterior.	
	G. Garage Door Operators Comments:			
	0 1	-	perly located. Federal safety standard ttes "Locate control button: (a) within
