Property Inspection Report

5326 Lantana Creek Court, Katy, TX 77494

Date of Inspection: 3/29/2023 Time: 9:00 AM

Inspector: Brent Turnage

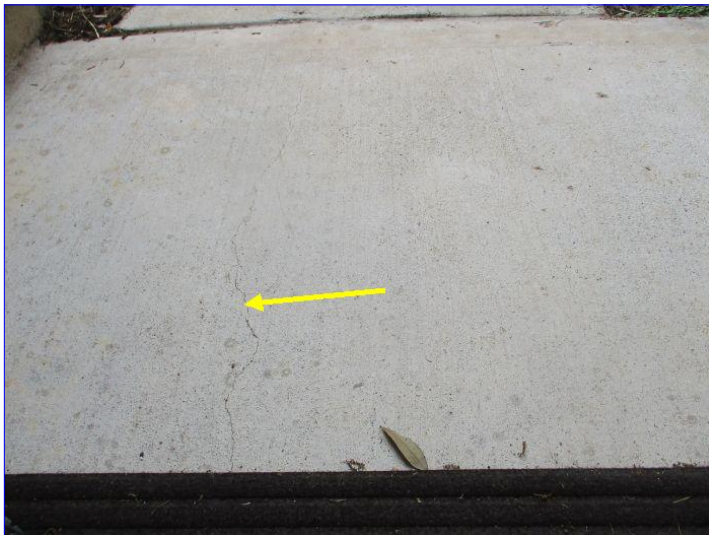
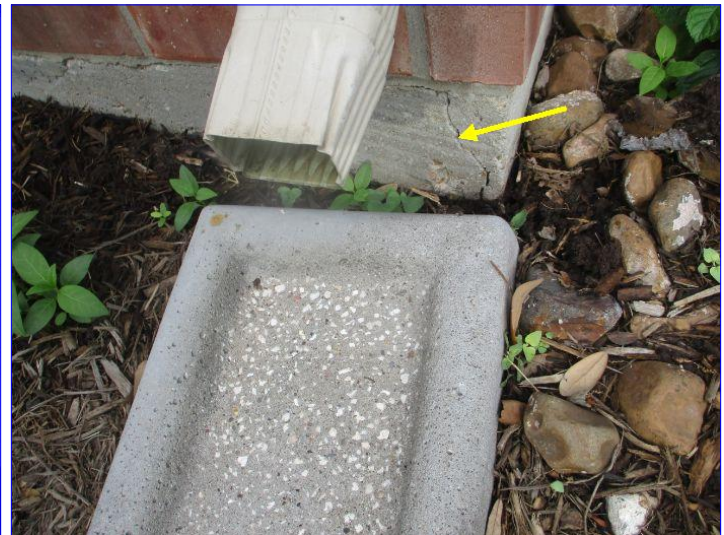
- In my opinion the foundation is performing as intended. No significant problems were observed.
- Minor vertical cracking was observed in the foundation at the front porch. This type of cracking is usually the result of shrinkage of the concrete as it cures. Shrinkage cracks are very common and should not be cause for alarm.
- Surface deterioration (known as spalling) was observed on the exterior corners of the exposed foundation walls at the front right of the garage and front left of the guest bedroom. This condition is common in many homes and does not usually represent a structural concern. In an effort to prevent long term deterioration, it would be wise to consider patching deteriorated areas.

STRUCTURAL SYSTEMS		
Page 8 Item: 1	Foundations	<ul style="list-style-type: none"> • Surface deterioration (known as spalling) was observed on the exterior corners of the exposed foundation walls at the front right of the garage and front left of the guest bedroom. This condition is common in many homes and does not usually represent a structural concern. In an effort to prevent long term deterioration, it would be wise to consider patching deteriorated areas.
Page 8 Item: 2	Grading & Drainage	<ul style="list-style-type: none"> • Observed gutter downspouts discharging directly onto grading. Recommend adding splash blocks to prevent soil erosion in the future.
Page 9 Item: 3	Roof Covering Materials	<ul style="list-style-type: none"> • Cupped shingles were observed at the left side of the dining room, recommend repairing.
Page 10 Item: 5	Walls (Interior and Exterior)	<ul style="list-style-type: none"> • Today's standards require fire blocking to be installed at the rear of the Pex manifold at the rear wall of the garage. • Damage trim was observed at the bottom of the rear patio left column, recommend repairing. • Damaged siding boards were observed at the rear of the master bedroom, left side of the dining room and left side of the family room, recommend repairing. • Cracking was observed at the front of the garage. This implies that some structural movement of the building has occurred, the rate of movement can not be predicted in a one time inspection. Recommend monitoring for further movement.

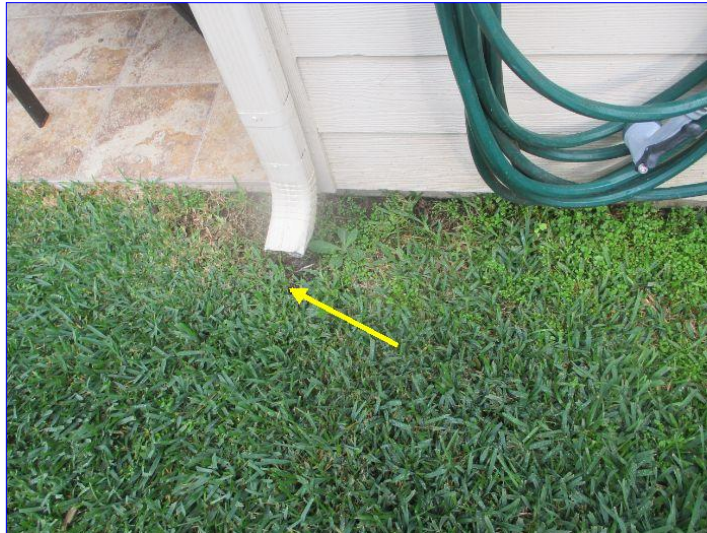
- French drains were observed at the left side of the home noted.
- Observed gutter downspouts discharging directly onto grading. Recommend adding splash blocks to prevent soil erosion in the future.

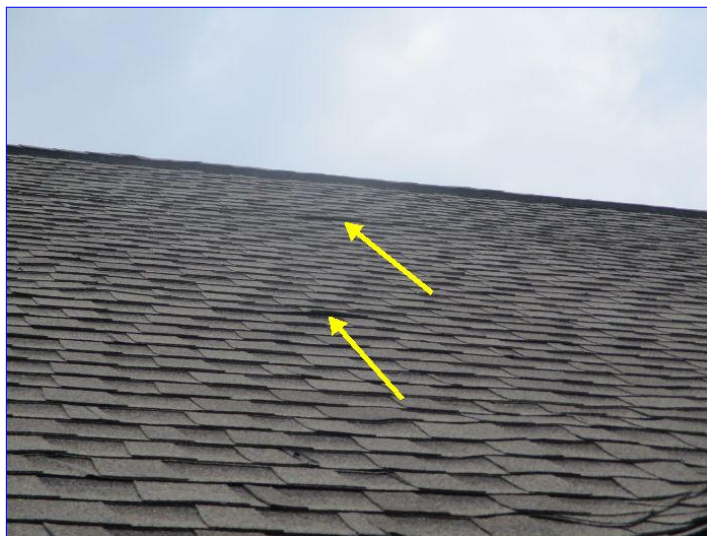
- Note: Shingles and flashing are not lifted to observe nail pattern or determine condition of material installed below due to the potential to cause damage or leakage. Some issues and or defects are not visible as they are covered by roofing materials, flashing etc. Not all portions of the roof covering may be visible. Unforeseen issues could be revealed in the event repairs or replacement are undertaken.
- Cupped shingles were observed at the left side of the dining room, recommend repairing.

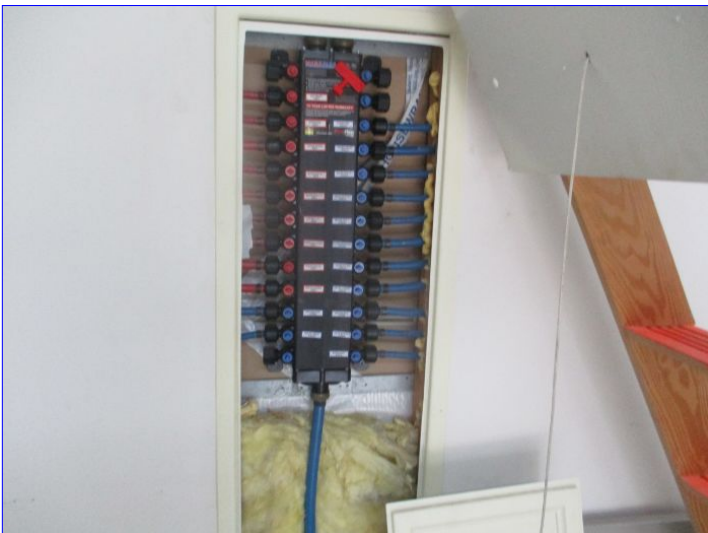
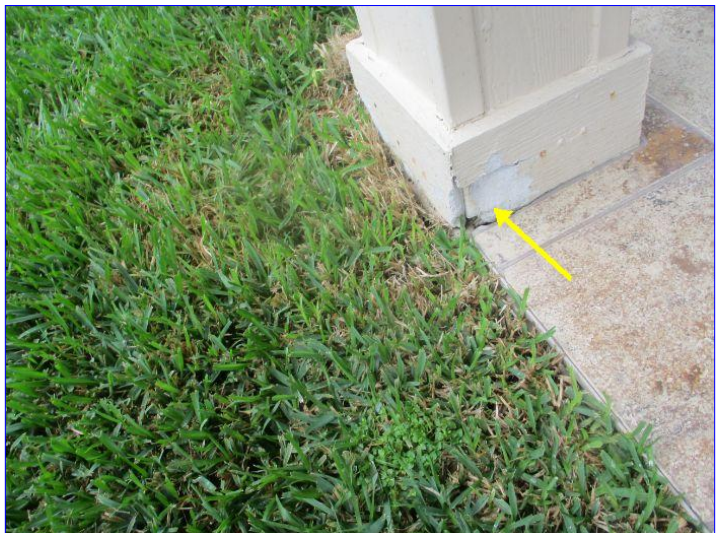
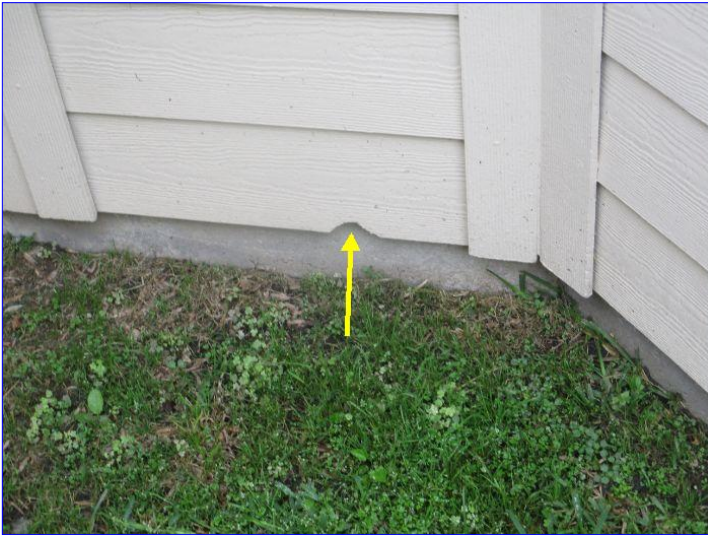
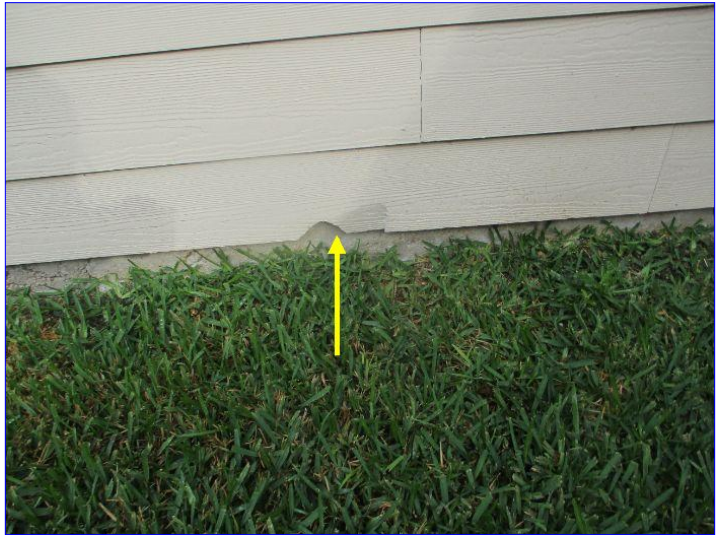
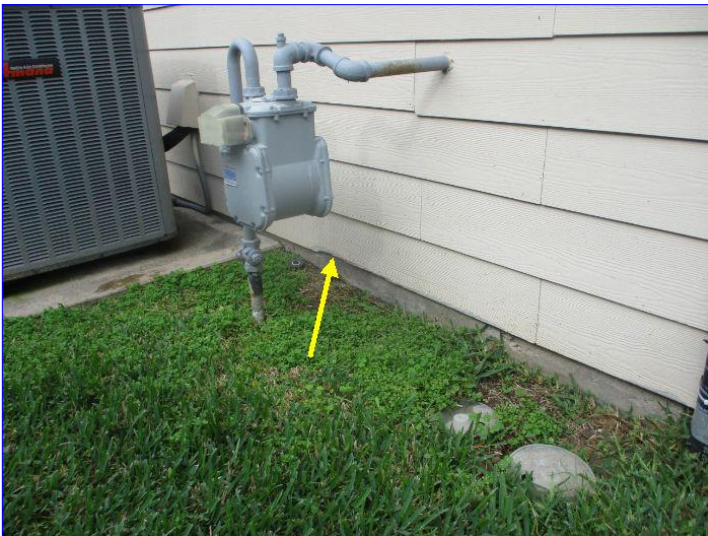
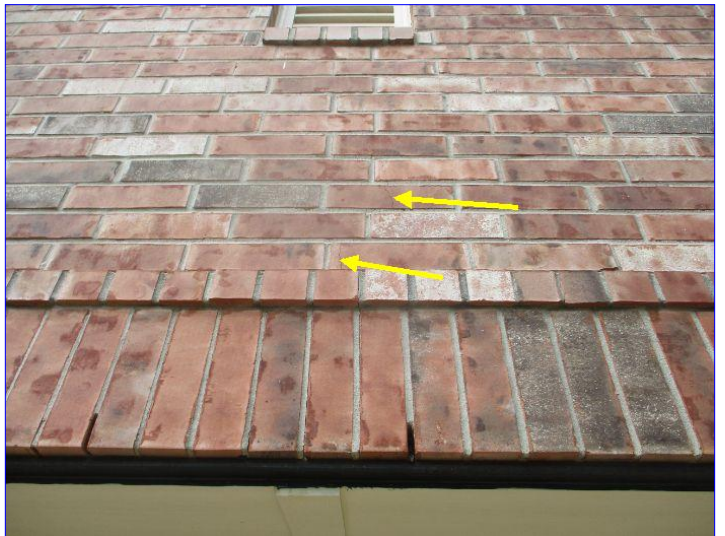
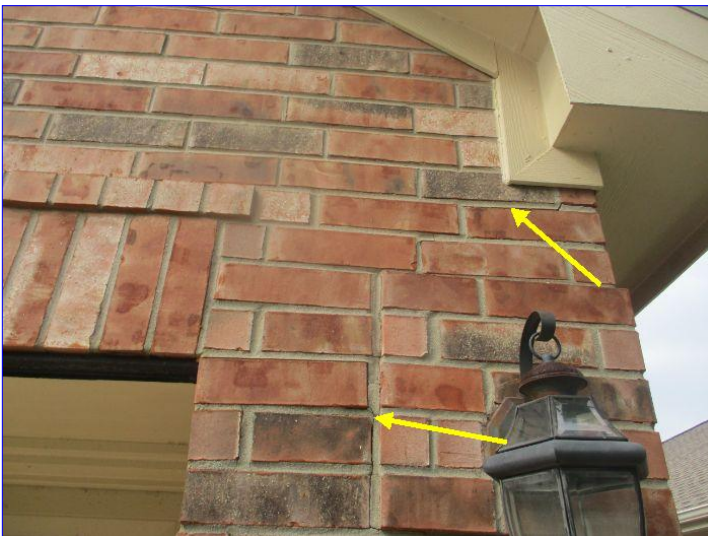
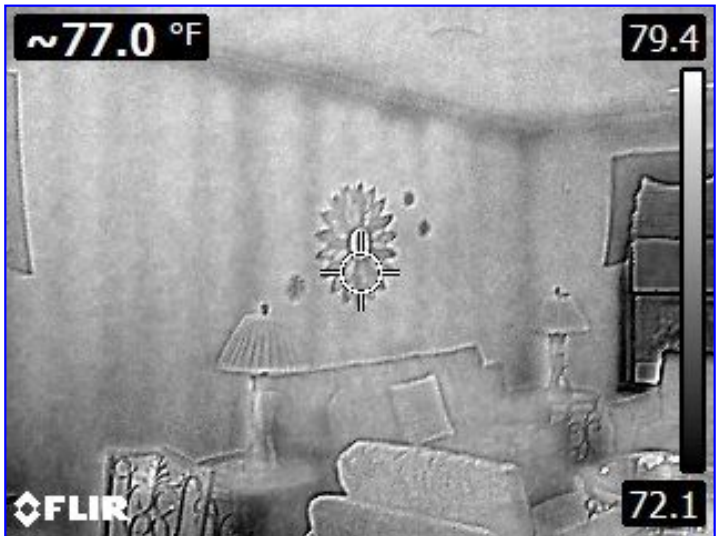
- Note: Not all interior walls are visible or accessible in occupied homes as they are obstructed by wallpaper, paneling or furnishings. Certain exclusions may apply.
- An infrared scan was performed during inspection. No deficiencies were observed at this time.
- Today's standards require fire blocking to be installed at the rear of the Pex manifold at the rear wall of the garage.
- Damage trim was observed at the bottom of the rear patio left column, recommend repairing.
- Damaged siding boards were observed at the rear of the master bedroom, left side of the dining room and left side of the family room, recommend repairing.
- Cracking was observed at the front of the garage. This implies that some structural movement of the building has occurred, the rate of movement can not be predicted in a one time inspection. Recommend monitoring for further movement.

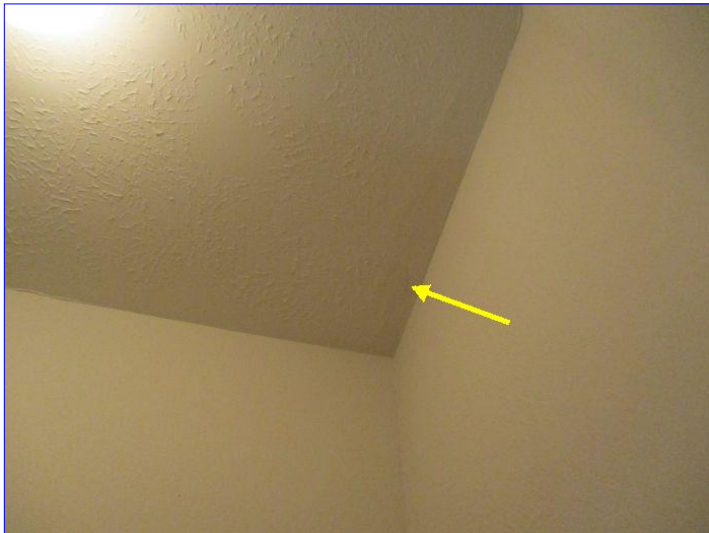
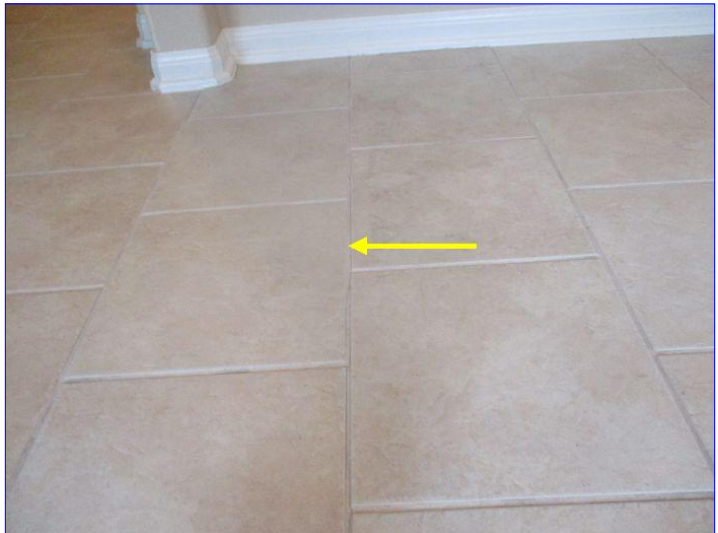
- Note: Not all ceilings/floors are visible or accessible as they may be obstructed by wallpaper, paneling, furnishings, etc. Certain exclusions may apply.
- An infrared scan was performed during inspection. No deficiencies were observed at this time.
- Minor cracks were observed on interior of the home. This condition is mainly cosmetic in nature and should be patched.
- Staining was observed at the right side of the pantry with no moisture present at the time of the inspection; the cause for the staining should be determined and repair as necessary.
- Cracked floor tile grout was observed at the foyer, recommend repairing.

Page 12 Item: 6	Ceilings and Floors	<ul style="list-style-type: none"> • Minor cracks were observed on interior of the home. This condition is mainly cosmetic in nature and should be patched. • Staining was observed at the right side of the pantry with no moisture present at the time of the inspection; the cause for the staining should be determined and repair as necessary. • Cracked floor tile grout was observed at the foyer, recommend repairing.
Page 12 Item: 7	Doors (Interior and Exterior)	<ul style="list-style-type: none"> • Observed exterior doors (front door) that are key operated from the inside. Recommend improvements for proper safety / egress. • Garage access door does not appear to be served by self closing hinges. Recommend improvements for proper safety.
Page 13 Item: 8	Windows	<ul style="list-style-type: none"> • The window tension spring rods are in need of lubrication. • A window tension spring has become disengaged for the master bedroom rear right window, recommend repairing.

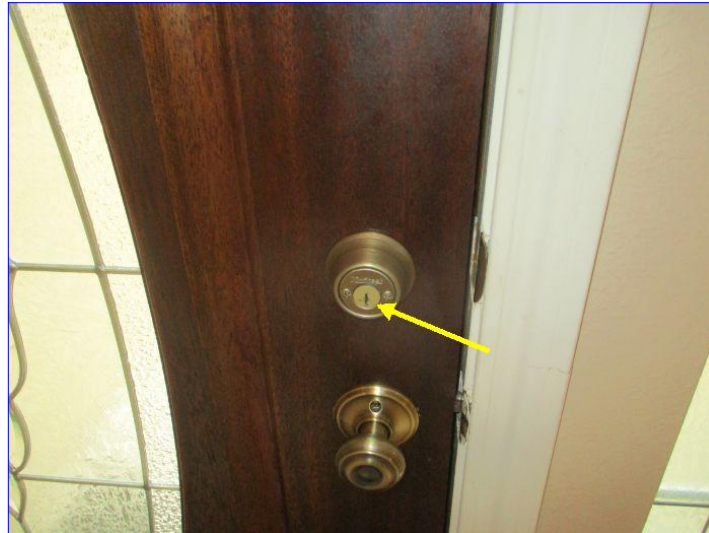
- Observed exterior doors (front door) that are key operated from the inside. Recommend improvements for proper safety / egress.
- Garage access door does not appear to be served by self closing hinges. Recommend improvements for proper safety.

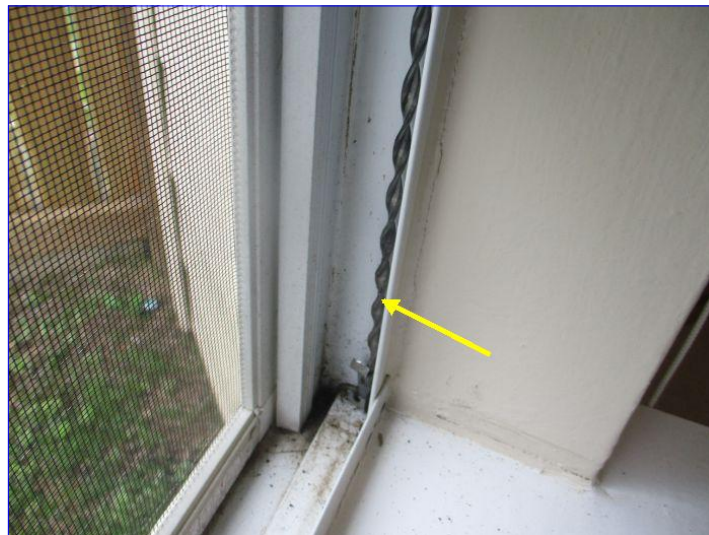
- The window tension spring rods are in need of lubrication.
- A window tension spring has become disengaged for the master bedroom rear right window, recommend repairing.

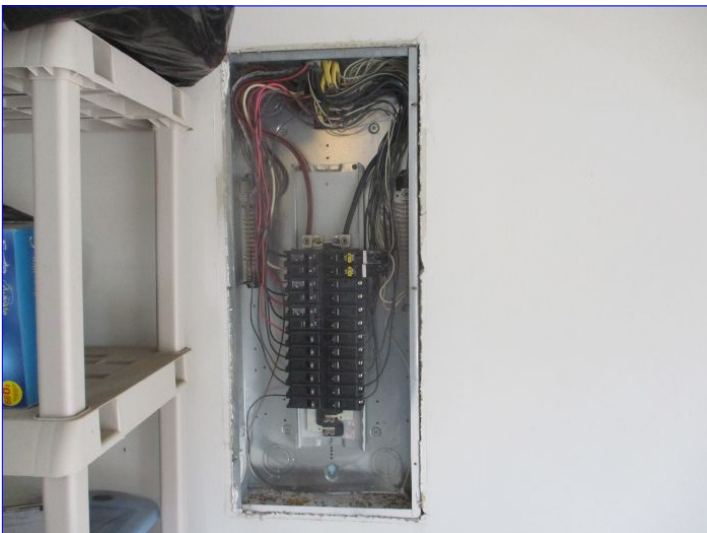
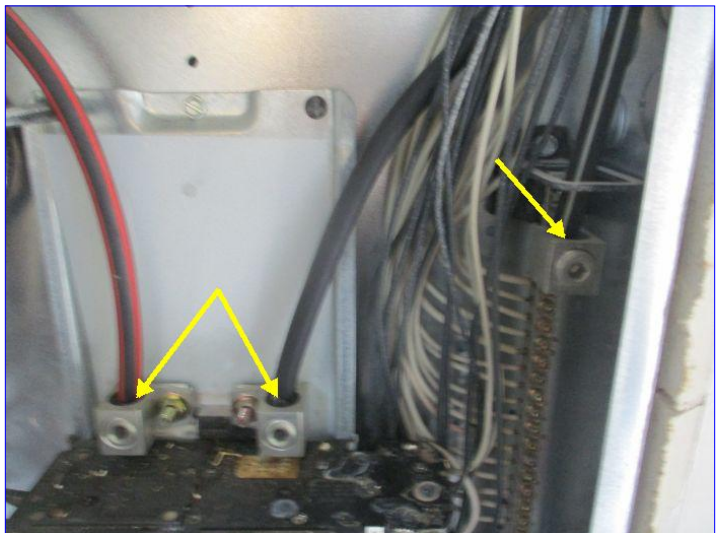
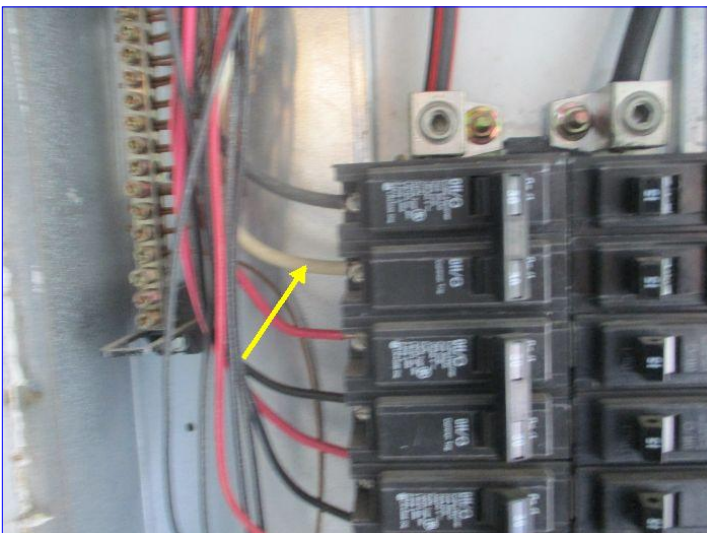
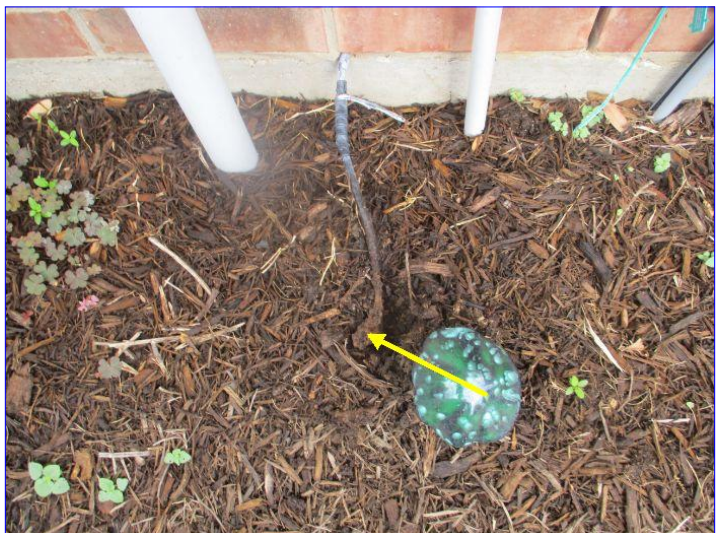
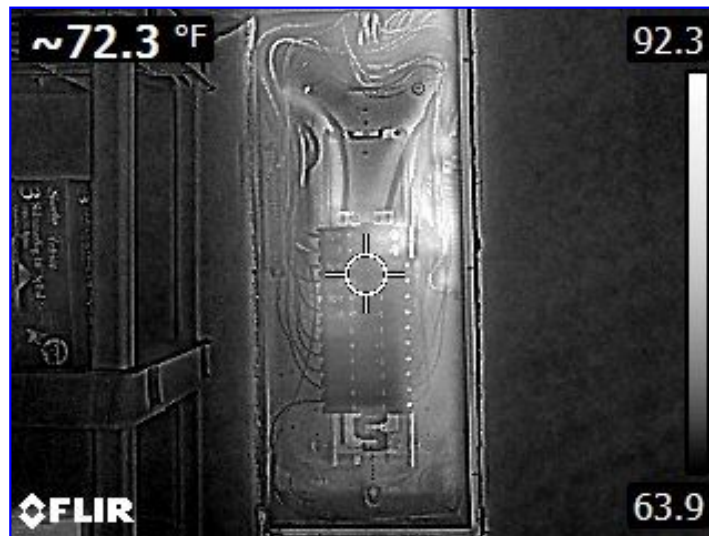
- Antioxidant should be installed on the aluminum service lines to prevent oxidation in the future.
- All neutral wires (white wire) used as a hot wire should be identified as a hot wire.
- The ground wire is not connected to the ground rod clamp; this condition should be improved.

ELECTRICAL SYSTEMS		
Page 15 Item: 1	Service Entrance and Panels	<ul style="list-style-type: none"> • Antioxidant should be installed on the aluminum service lines to prevent oxidation in the future. • All neutral wires (white wire) used as a hot wire should be identified as a hot wire. • The ground wire is not connected to the ground rod clamp; this condition should be improved.

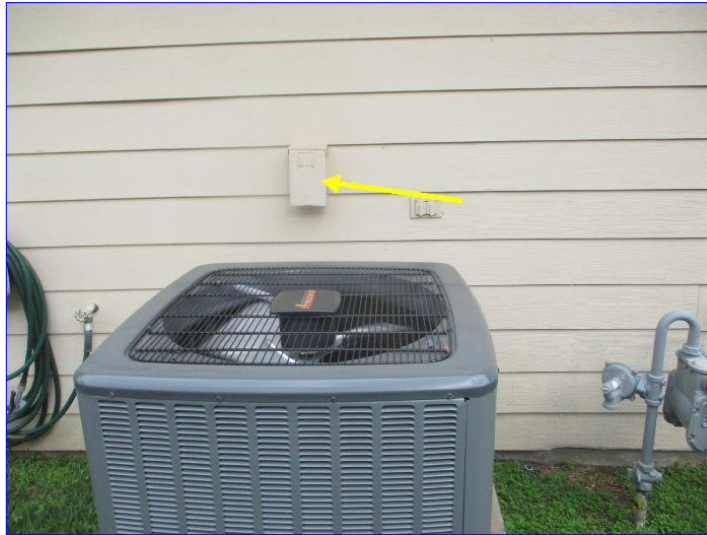
- The installation of a ground fault circuit interrupter (GFCI) is required for all bathroom outlets (master bathroom left side of the left sink). A ground fault circuit interrupter (GFCI) offers protection from shock or electrocution.

- The installation of a ground fault circuit interrupter (GFCI) is recommended for all utility room outlets and all garage outlets to today's standards. A ground fault circuit interrupter (GFCI) offers protection from shock or electrocution.

- Observed no Arch Fault Circuit Interrupter Breaker (AFCI) for the living areas light fixtures and outlets, today's standards require all bedrooms and living areas are required to be protected by an (AFCI) breaker, recommend repairing.

- Inoperative florescent light bulbs were observed at the utility room, master bathroom closet and garage x2, recommend repairing.
- Observed the A/C disconnect to be located behind the A/C unit, today's standards require all disconnects to be installed at the side of the A/C unit to allow for proper access.

Page 16 Item: 2	Branch Circuits, Connected Devices, and Fixtures	<ul style="list-style-type: none"> • The installation of a ground fault circuit interrupter (GFCI) is required for all bathroom outlets (master bathroom left side of the left sink). A ground fault circuit interrupter (GFCI) offers protection from shock or electrocution. • The installation of a ground fault circuit interrupter (GFCI) is recommended for all utility room outlets and all garage outlets to today's standards. A ground fault circuit interrupter (GFCI) offers protection from shock or electrocution. • Observed no Arch Fault Circuit Interrupter Breaker (AFCI) for the living areas light fixtures and outlets, today's standards require all bedrooms and living areas are required to be protected by an (AFCI) breaker, recommend repairing. • Inoperative florescent light bulbs were observed at the utility room, master bathroom closet and garage x2, recommend repairing. • Observed the A/C disconnect to be located behind the A/C unit, today's standards require all disconnects to be installed at the side of the A/C unit to allow for proper access. • Today's standards require all exposed exterior outlets to have a weather proof cover installed.

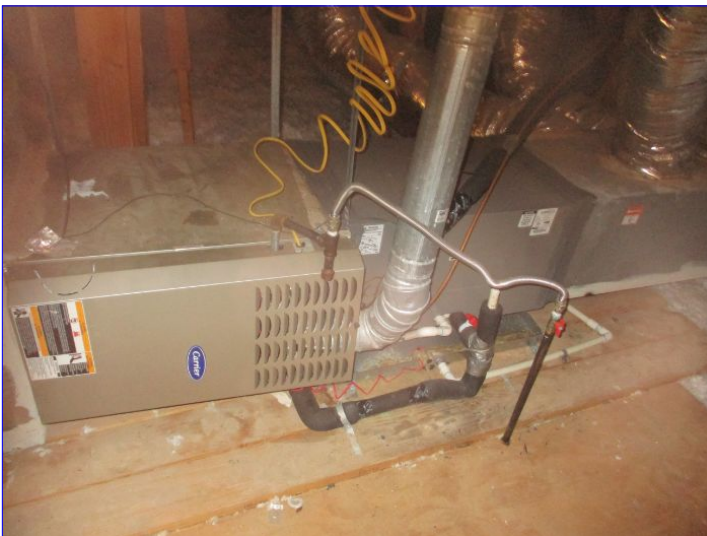
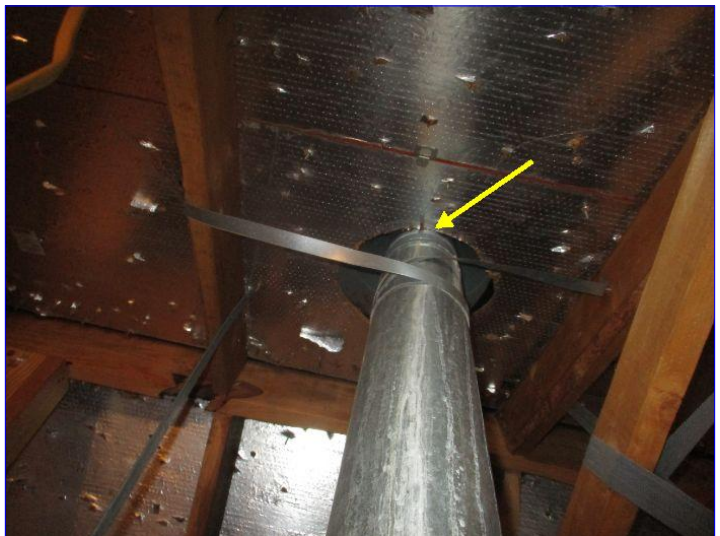
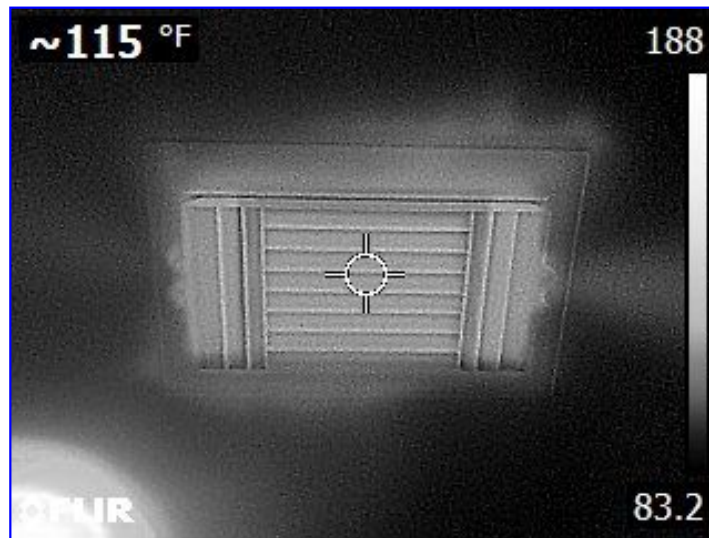
- Note: We recommend that the heating system be completely serviced before each heating season. Filters should be changed as needed. Checking humidifiers, electric air filters and proper airflow is not within the scope of this inspection. Heat pumps are not operated when the outside temperature is above 70 degrees.
- The system is older. It may require a slightly higher level of maintenance, and may be more prone to major component breakdown. Predicting the frequency or time frame for repairs on any mechanical device is virtually impossible. Recommend monitoring / repairs as necessary.
- The furnace flue pipe does not have the proper 1" clearance to combustibles; this condition should be improved.

Page 18 Item: 1	Heating Equipment	<ul style="list-style-type: none"> • The furnace flue pipe does not have the proper 1" clearance to combustibles; this condition should be improved.
Page 19 Item: 2	Cooling Equipment	<ul style="list-style-type: none"> • Air leaks were observed at the evaporator coil; these areas should be properly sealed.

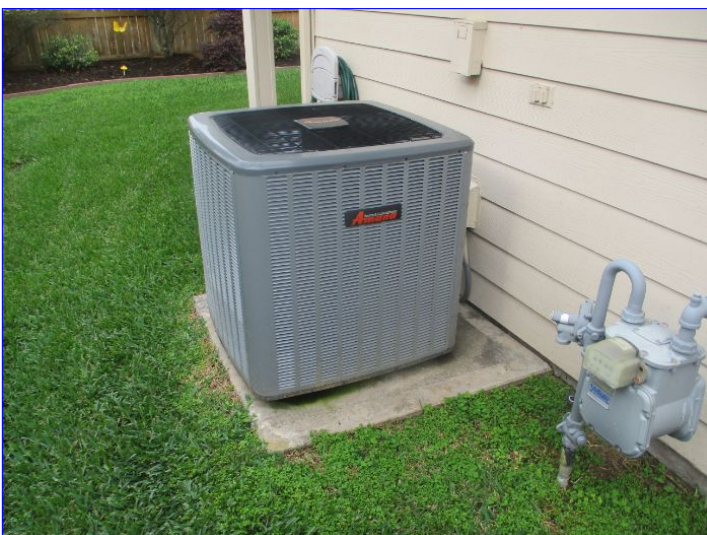
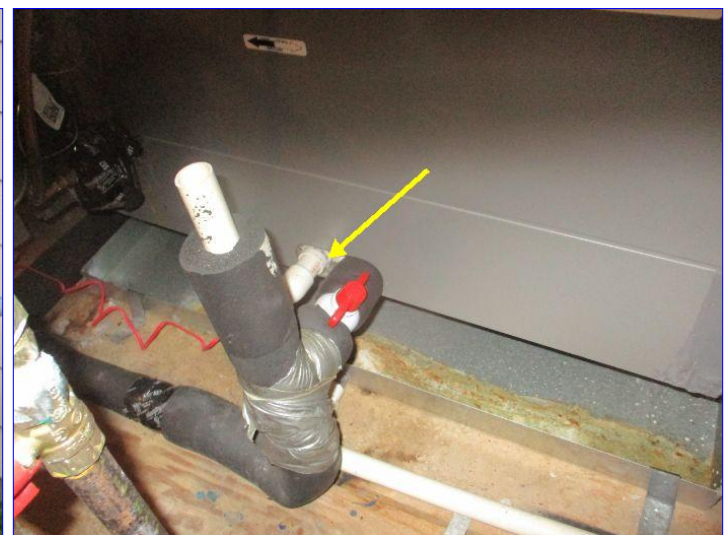
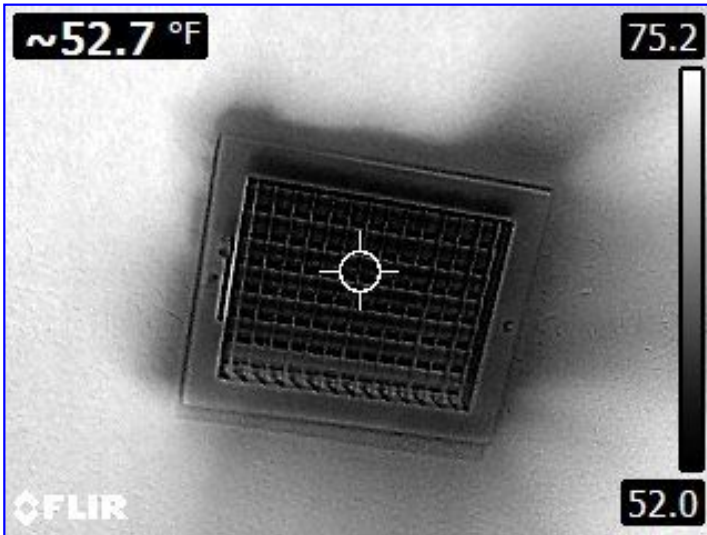
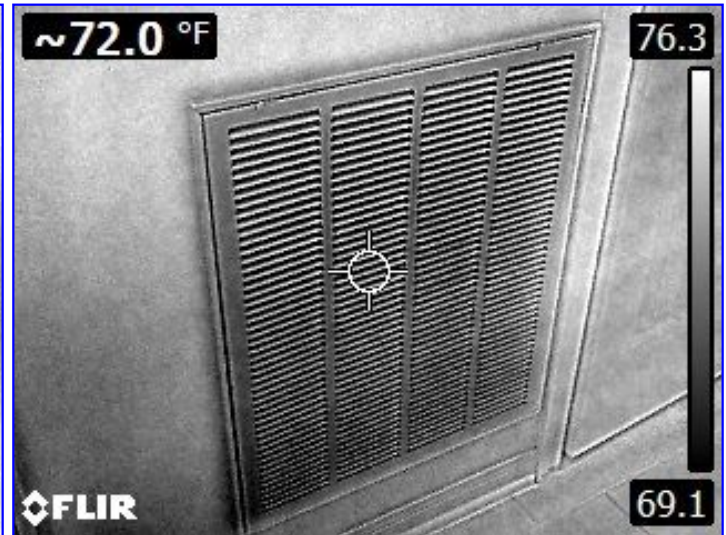
- Note: We recommend the AC system be completely serviced before each cooling season and the condensate drain flushed with chlorine bleach every 2 months during the cooling season to prevent clogging. Air conditioning units are not checked when the outside temperature is below 60 degrees because of possible damage to the compressor unit.
- The a/c unit operated to control and produced a temperature differential of 19 degrees. This is within test limits of 15 to 20 degrees.
- Air leaks were observed at the evaporator coil; these areas should be properly sealed.

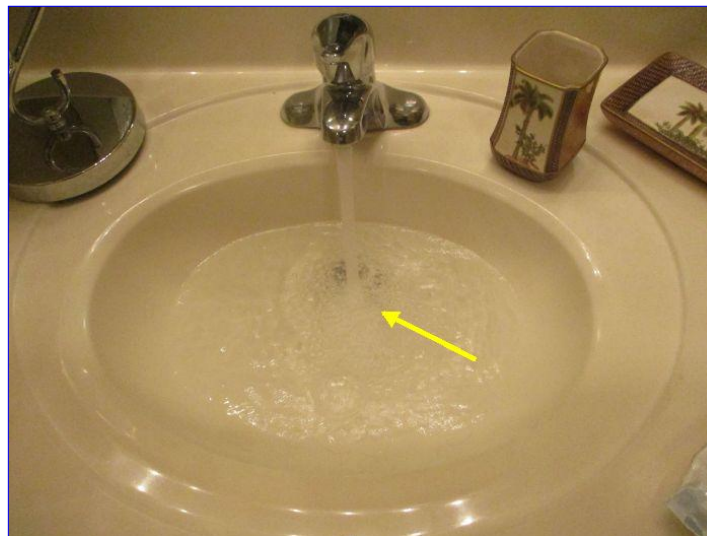
- Note: Supply lines, equipment and reservoirs concealed or in enclosures, underground, between ceilings and floors or within walls are not visible to be inspected for leaks or defects.
- Type of Supply Piping Material:
 - PEX
 - The guest bathroom sink was observed to drain slowly, suggesting that an obstruction may exist. Further evaluation is recommended and repairs as needed.
 - Observed the guest bathroom toilet to be loose at the floor, recommend properly securing.

Page 21 Item: 1	Plumbing Supply, Distribution Systems and Fixtures	<ul style="list-style-type: none"> • The guest bathroom sink was observed to drain slowly, suggesting that an obstruction may exist. Further evaluation is recommended and repairs as needed. • Observed the guest bathroom toilet to be loose at the floor, recommend properly securing.
Page 22 Item: 3	Water Heating Equipment	<ul style="list-style-type: none"> • Discolored hot water was observed when tested, recommend further investigation and repair as necessary.
Page 22 Item: 4	Hydro-Massage Therapy Equipment	<ul style="list-style-type: none"> • The jets are dirty and should be cleaned.

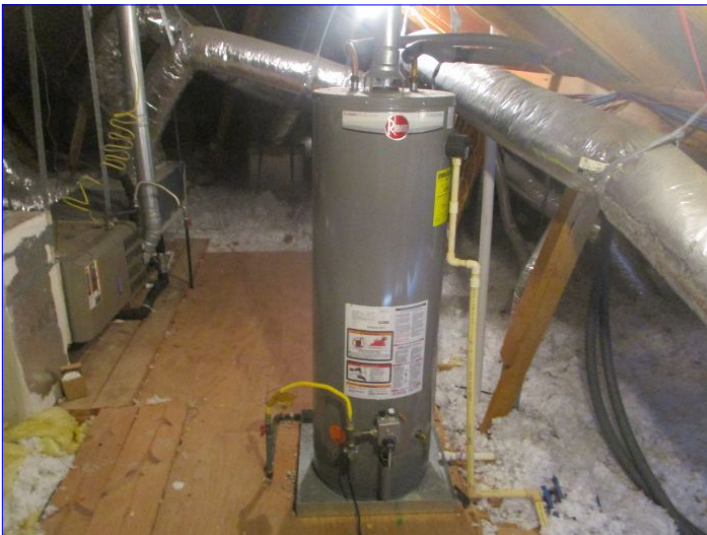
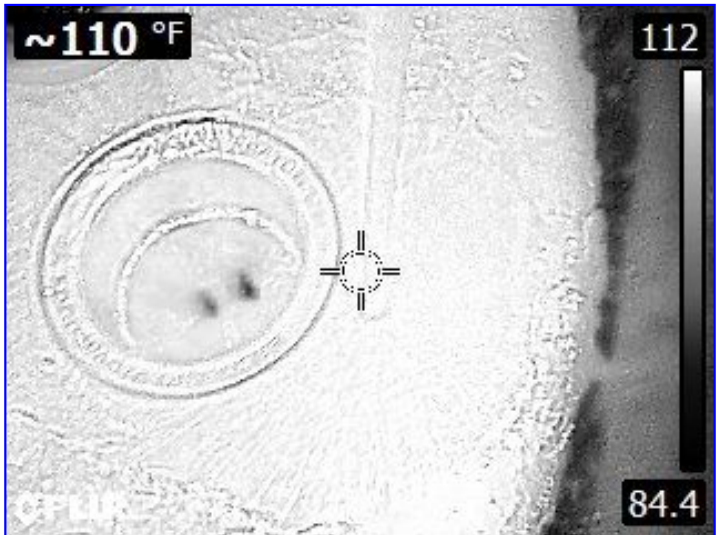
- The water temperature was measured at 110 degrees which is within acceptable limits for safety.
- Discolored hot water was observed when tested, recommend further investigation and repair as necessary.

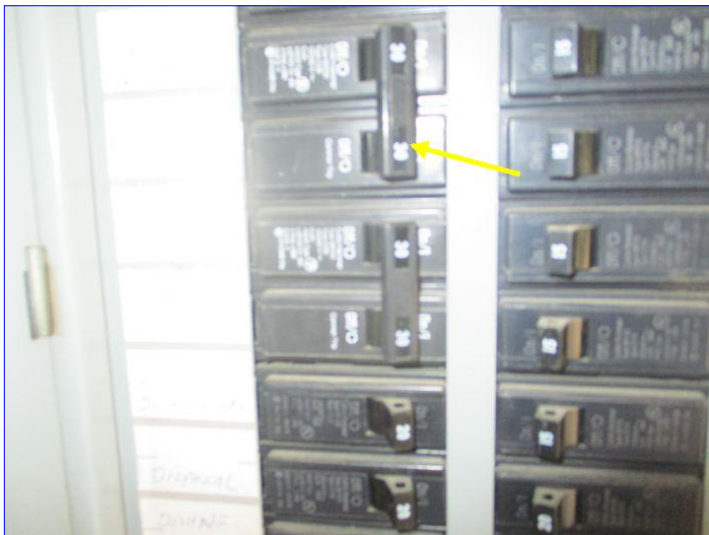
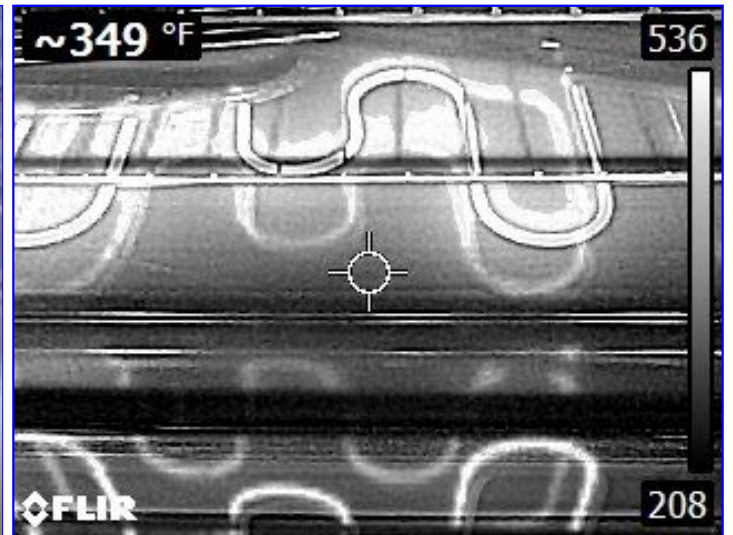
- GE Brand electric range serial # LH250577Q
- The burners operated properly at the time of the inspection.
- The oven temperature was measured within tolerance when set at 350. Unit appears to be properly calibrated.
- The breaker for the oven is undersized, the unit calls for a 50 amp breaker (30 amp breaker in the panel), recommend repairing.

Page 24 Item: 4	Ranges, Cooktops, and Ovens	<ul style="list-style-type: none"> • The breaker for the oven is undersized, the unit calls for a 50 amp breaker (30 amp breaker in the panel), recommend repairing.
-----------------	-----------------------------	---

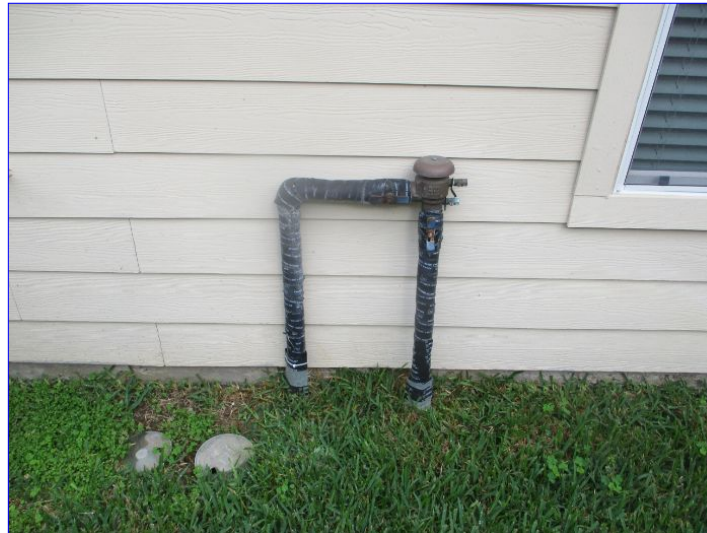
- Rain Bird Brand 4 zone system
- The sprinkler back flow device should be secured at the wall.
- A rain sensor was not observed at the time of this inspection. Rain sensors stop the system from turning on in the rain. Recommend installing.
- The water spray from the sprinkler system should be re-directed away from the structure and/or any fencing, decks, etc., to decrease the possibility of damage.
- Some of the heads are tilted to one side. Recommend adjustments to the heads as necessary.

Page 26 Item: 1	Landscape Irrigation (Sprinkler) Systems	<ul style="list-style-type: none"> • The sprinkler back flow device should be secured at the wall. • A rain sensor was not observed at the time of this inspection. Rain sensors stop the system from turning on in the rain. Recommend installing. • The water spray from the sprinkler system should be re-directed away from the structure and/or any fencing, decks, etc., to decrease the possibility of damage. • Some of the heads are tilted to one side. Recommend adjustments to the heads as necessary.
-----------------	--	--
