Property Inspection Report

3618 Goodhope St, Houston, TX 77021
Inspection prepared for: Alexis Vargas

Date of Inspection: 07/22/2023 Time: 2:30PM
Age of Home: 2006 Size: 3072 sqft

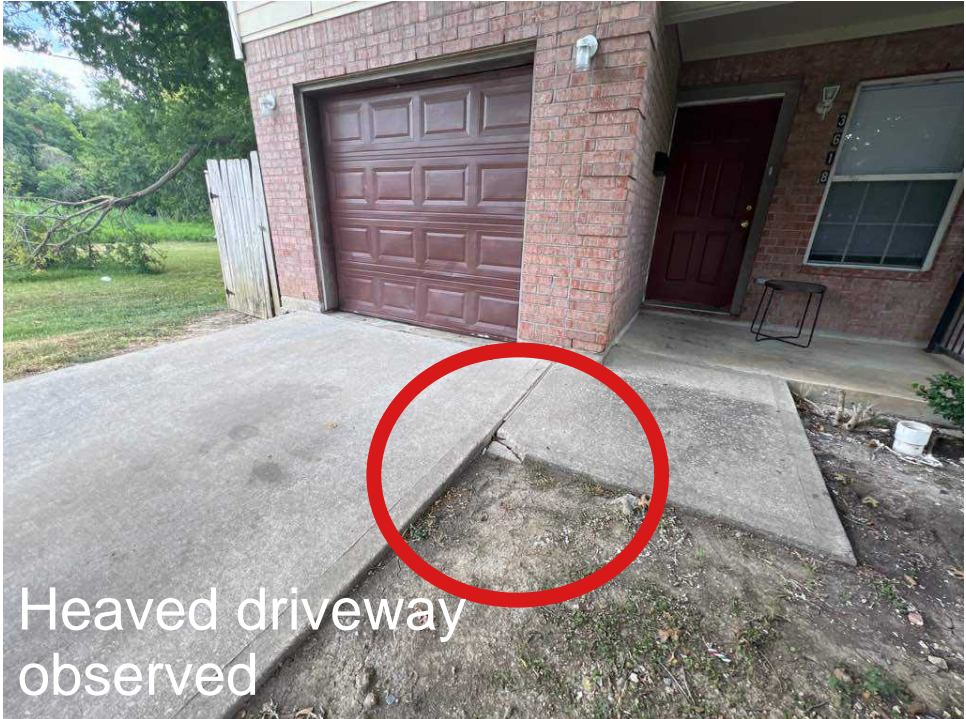
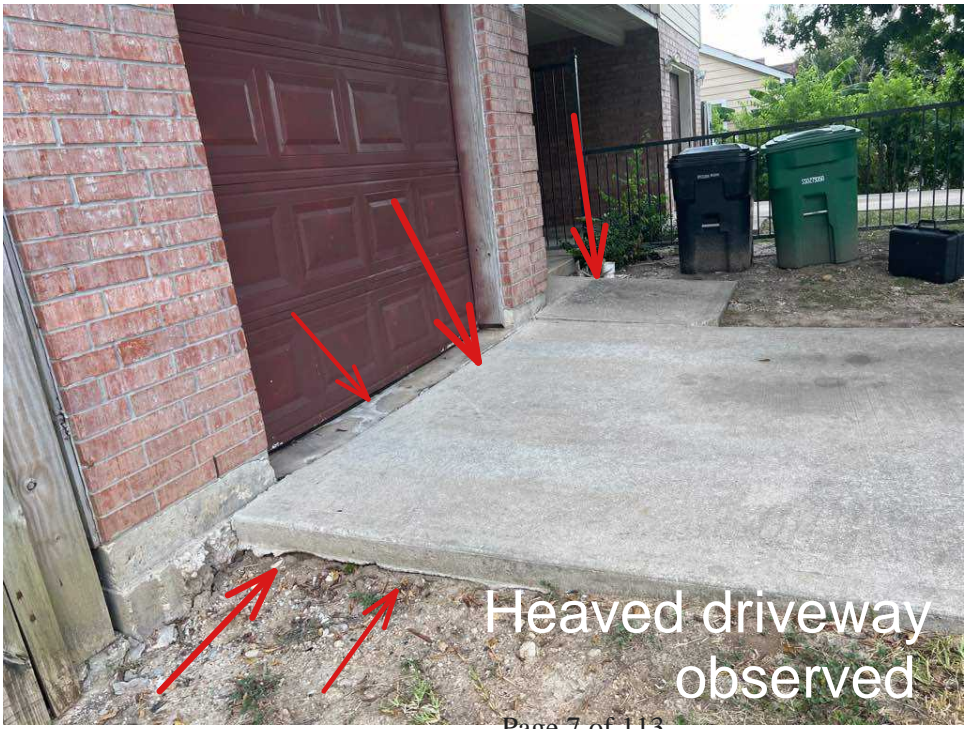
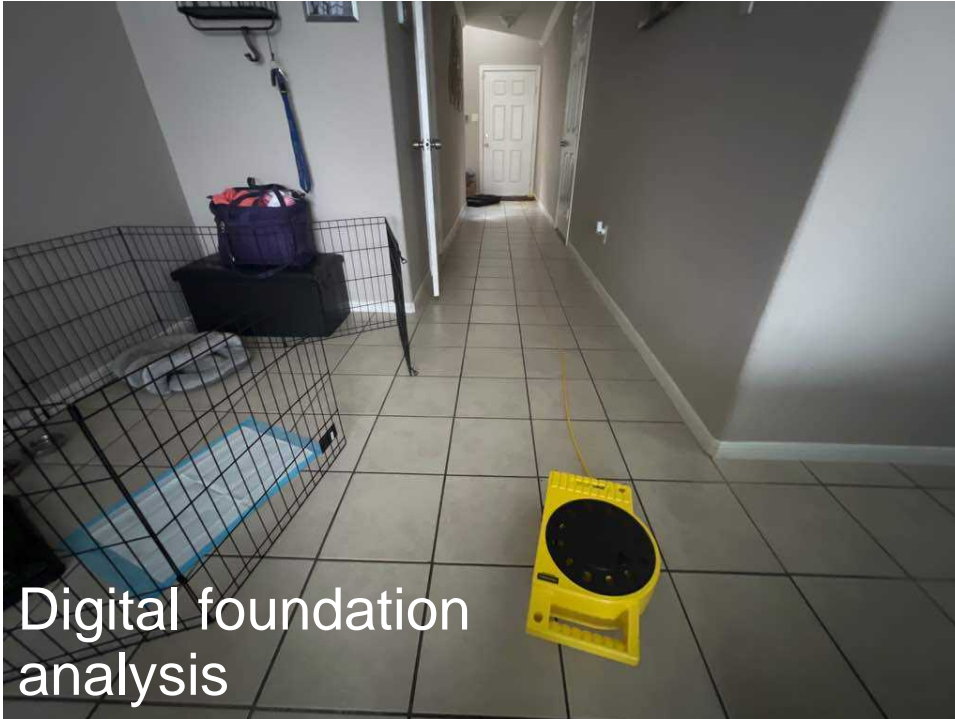
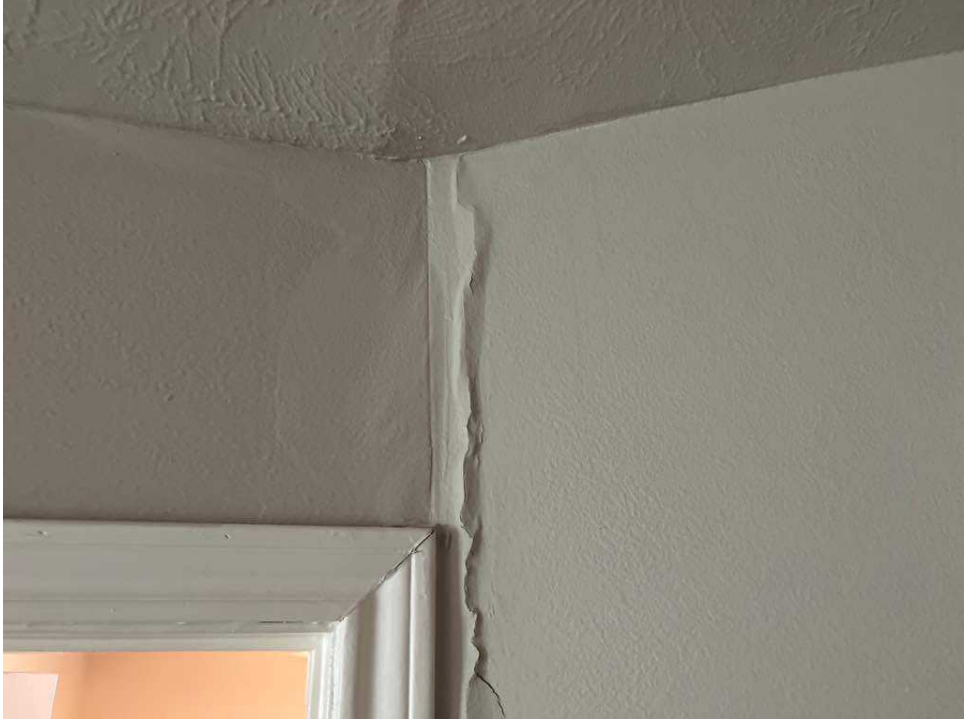
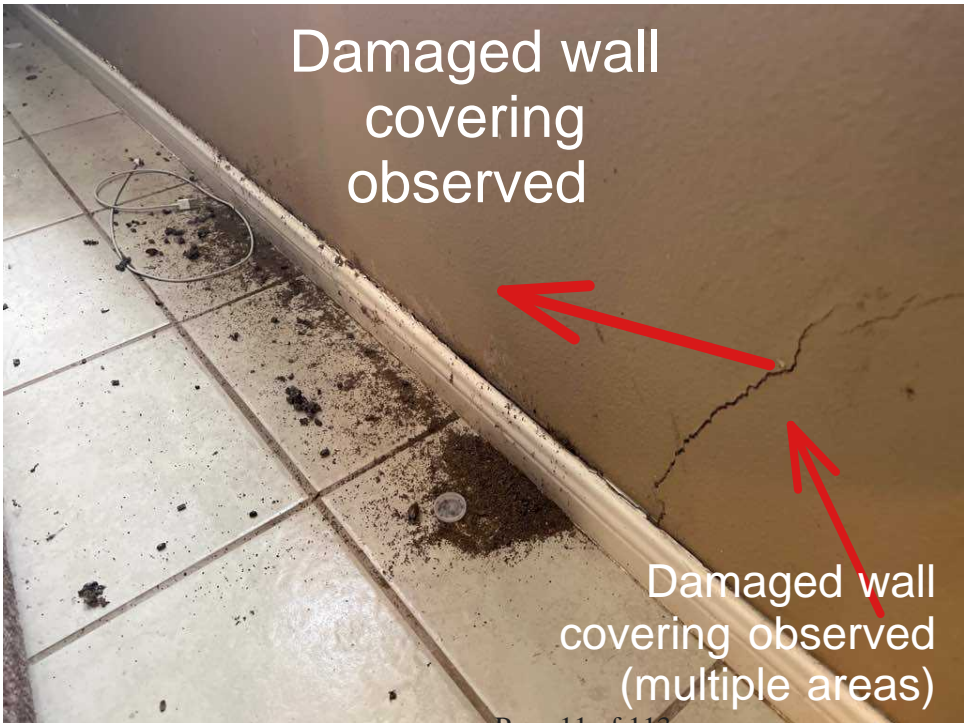
Observed foundation measurements that exceeded normal settlement tolerances.

Foundation Opinion: In my professional opinion - The foundation is not performing as intended.

Further evaluation recommended by Structural Engineer.

Further evaluation recommended by structural engineer or qualified foundation specialist.

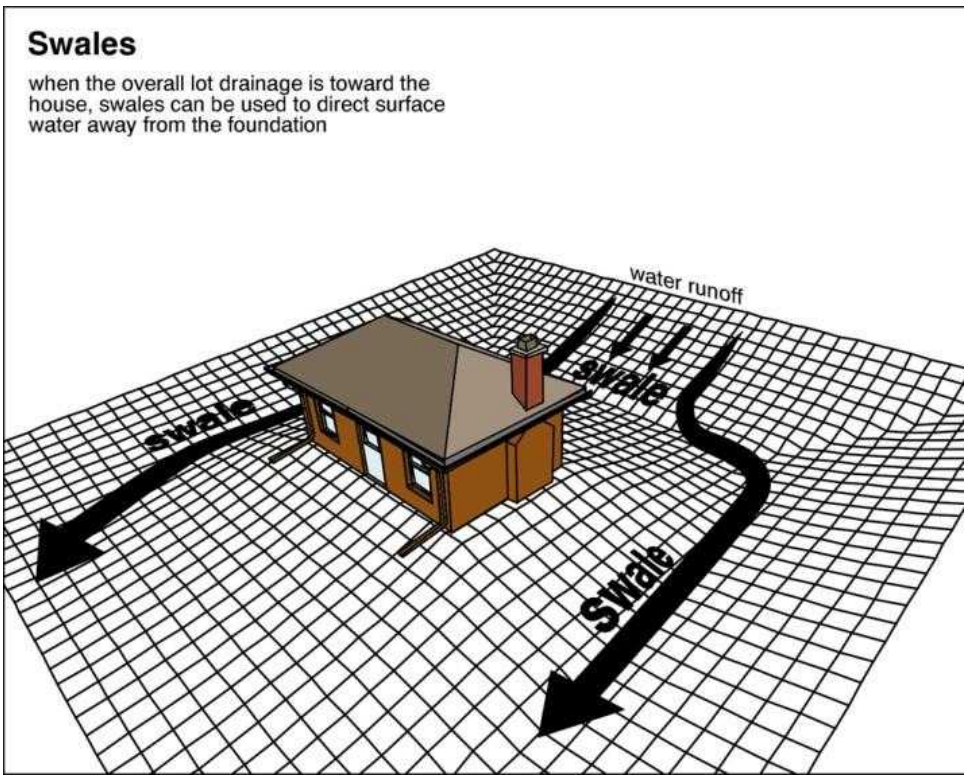
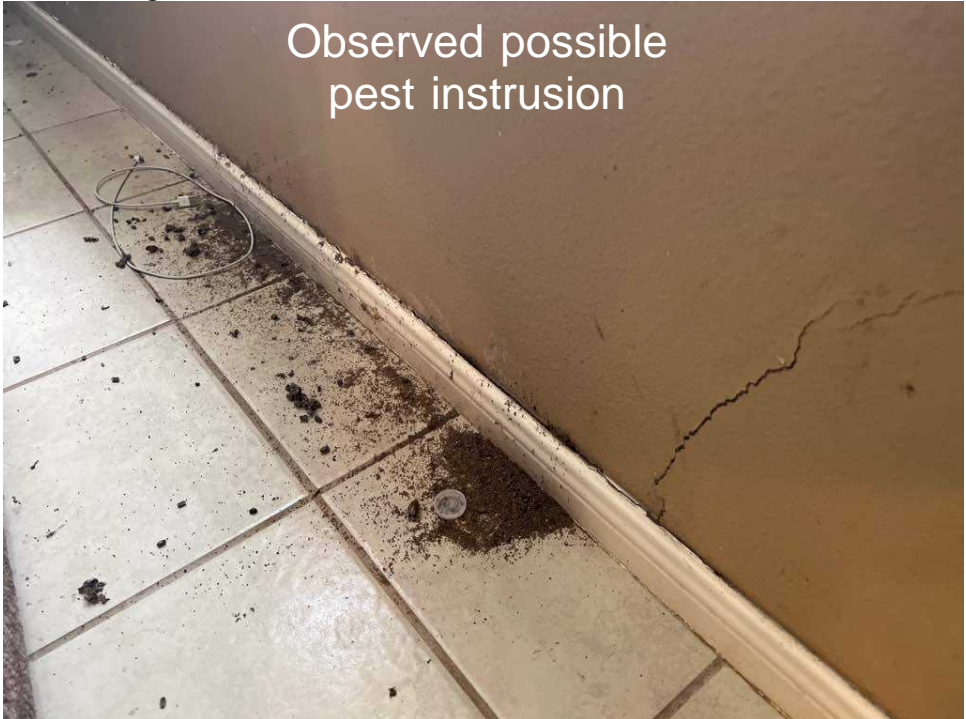
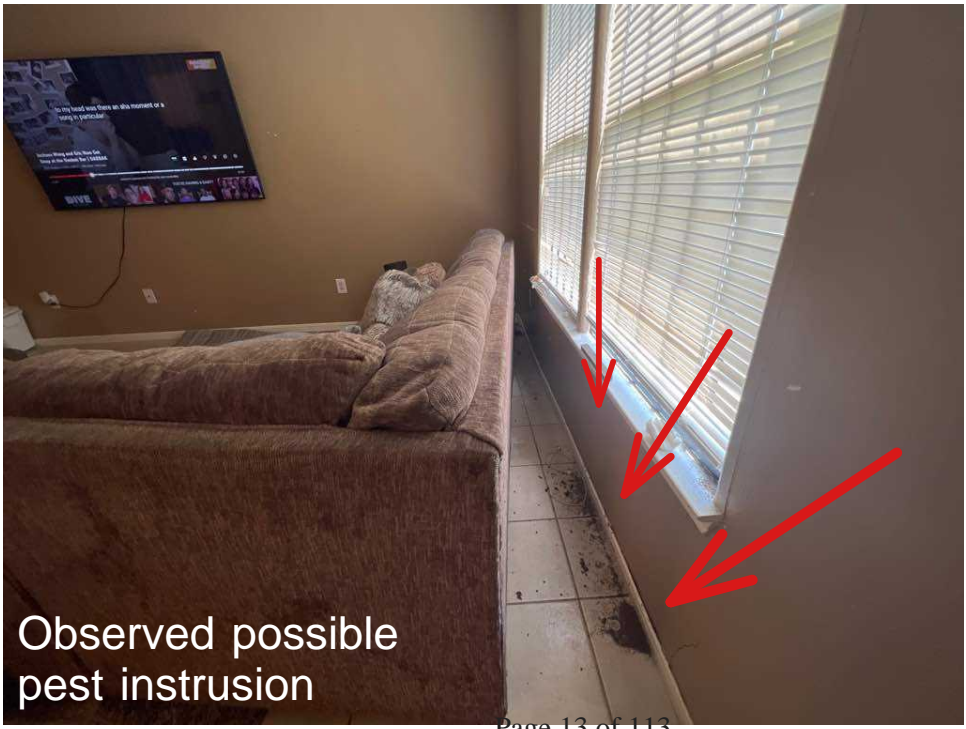
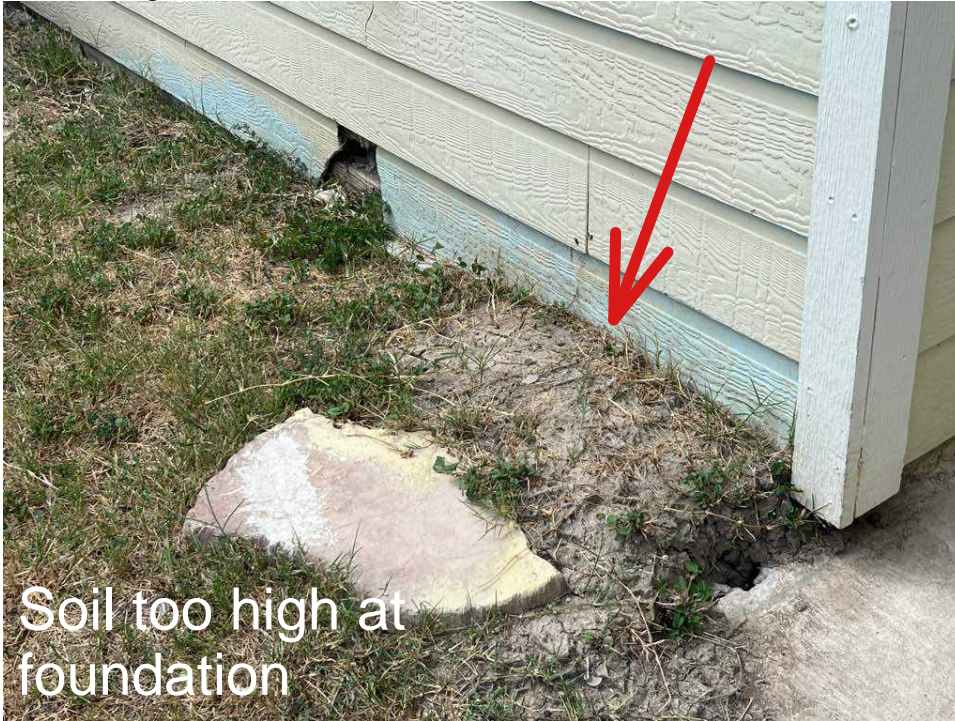
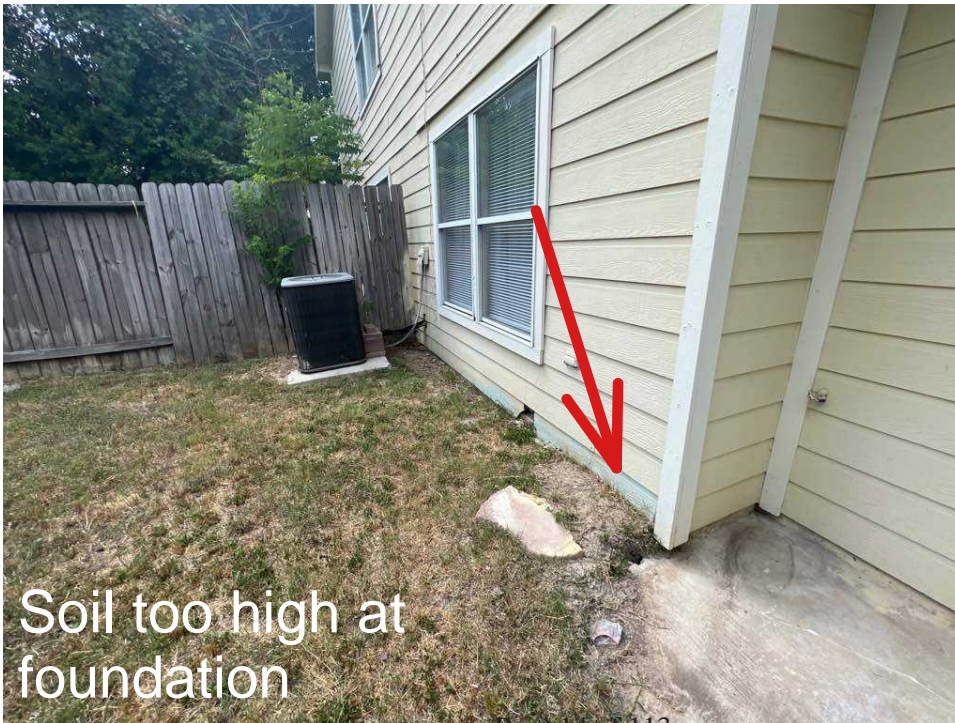
Comments: Moderate slope,
Observed possible pest intrusion

Soil too high at foundation (Unit B)

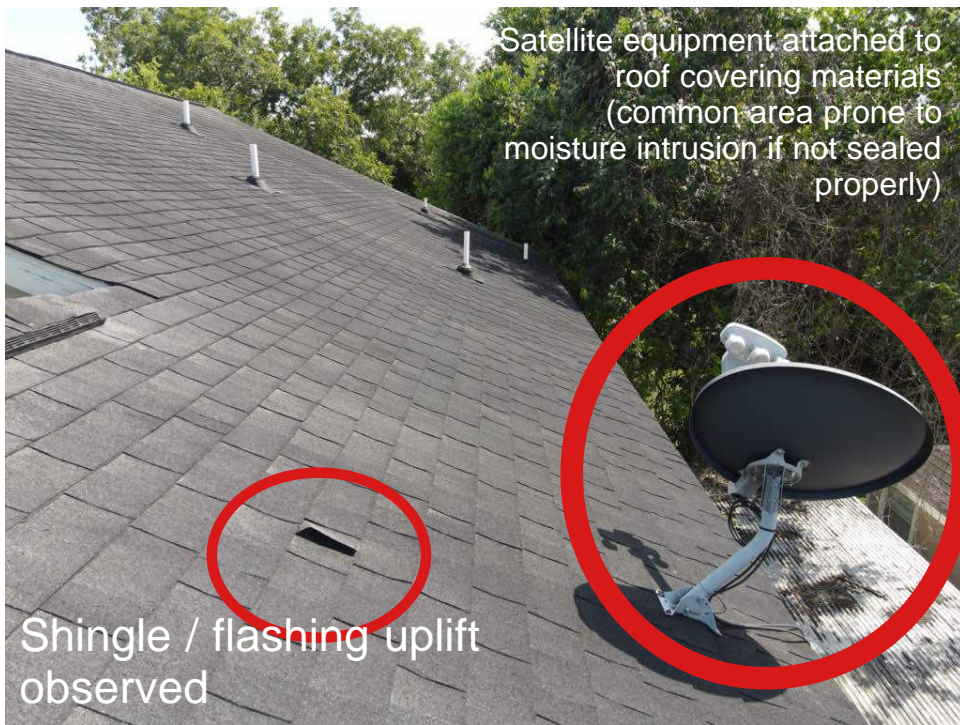
4. Satellite equipment attached to roof covering materials (common area prone to moisture intrusion if not sealed properly)

Further evaluation recommended

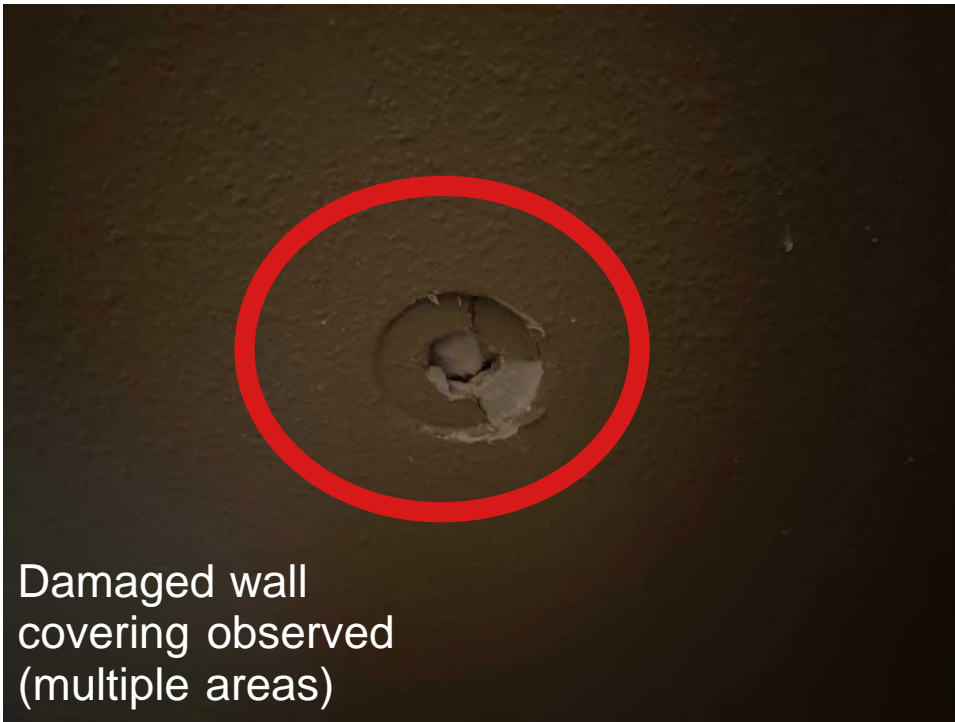
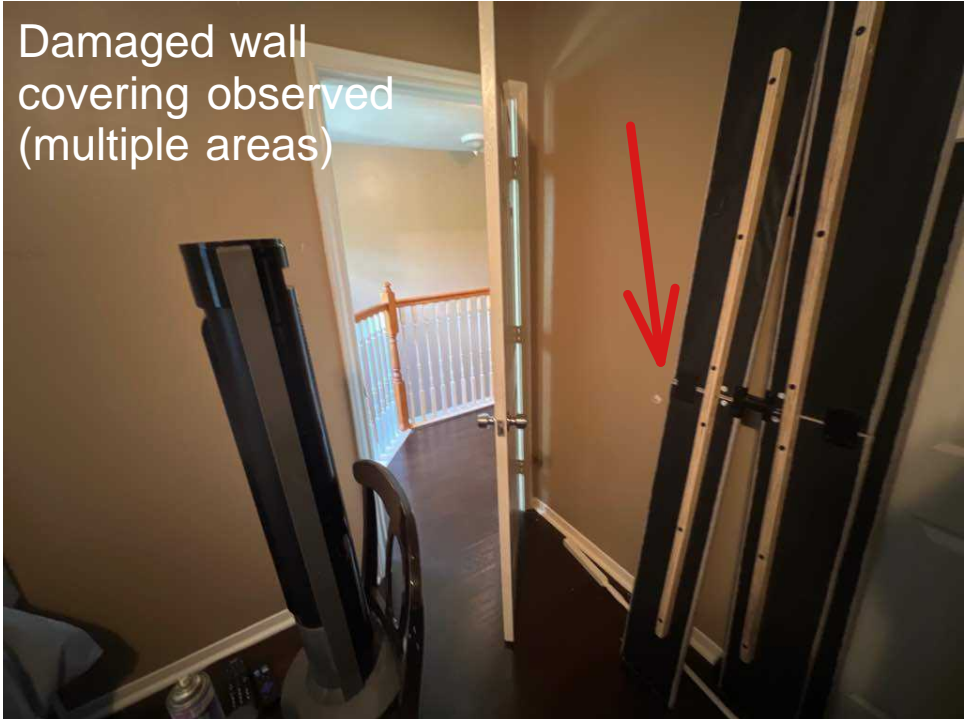
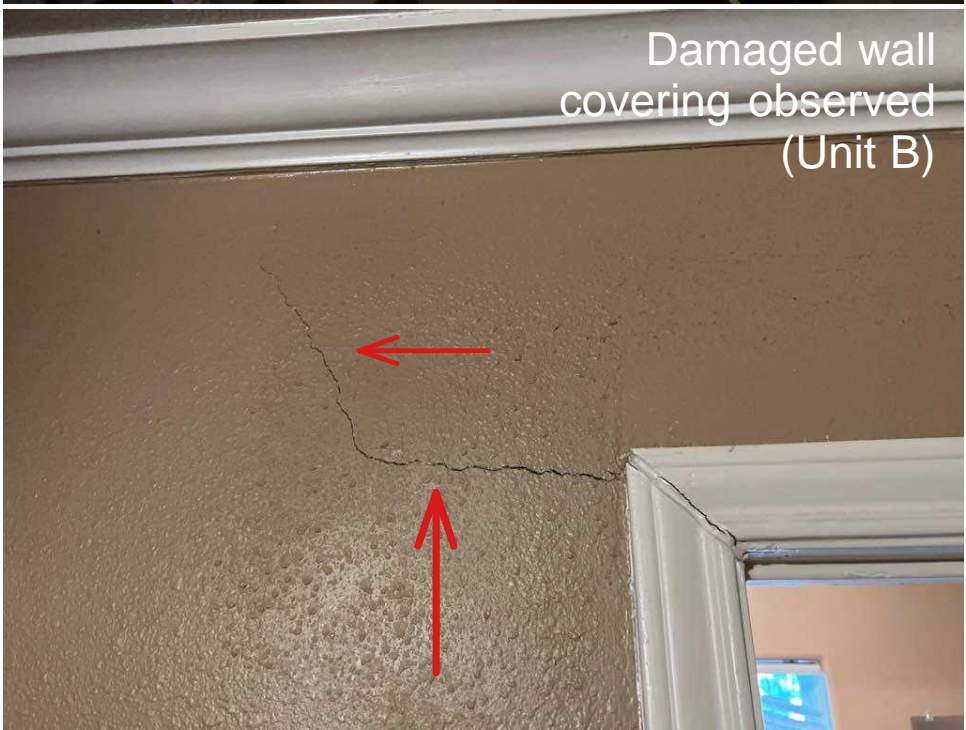
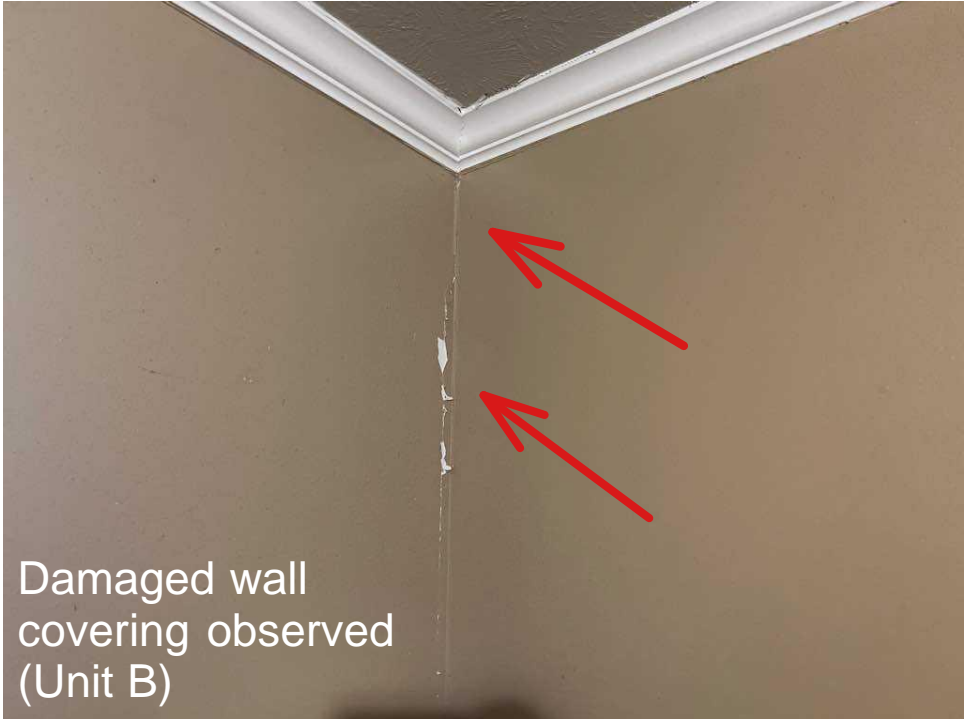
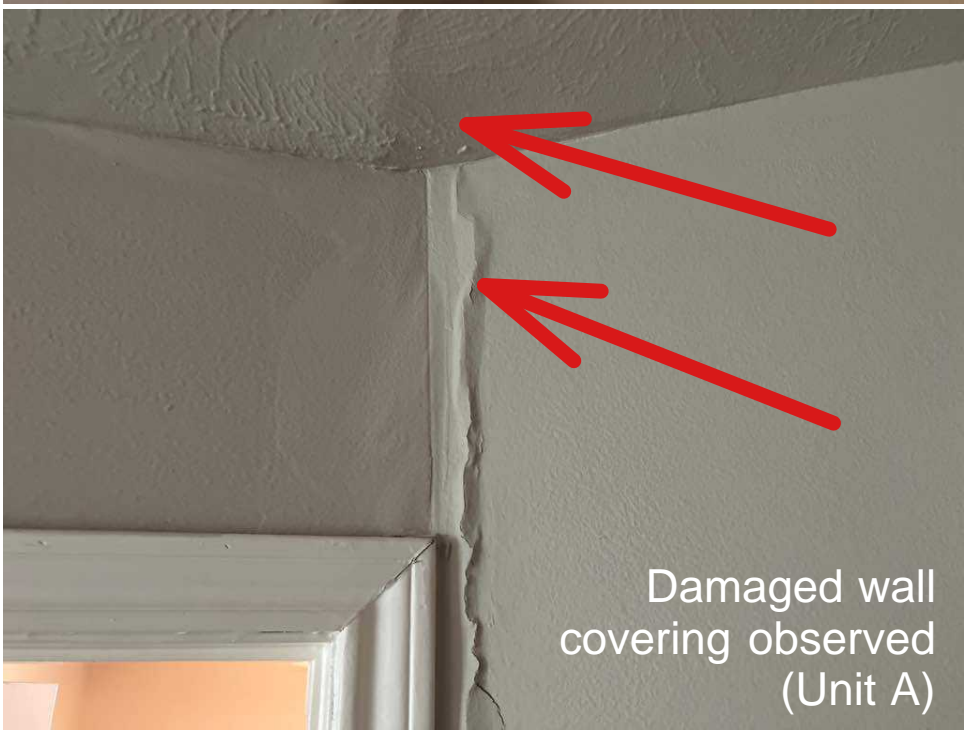
1. Damaged wall covering (exterior) observed.

2. Damaged wall covering (interior) observed.

Correction recommended to minimize possibility of moisture / pest intrusion.,

Correction recommended to avoid further deterioration of wall coverings.

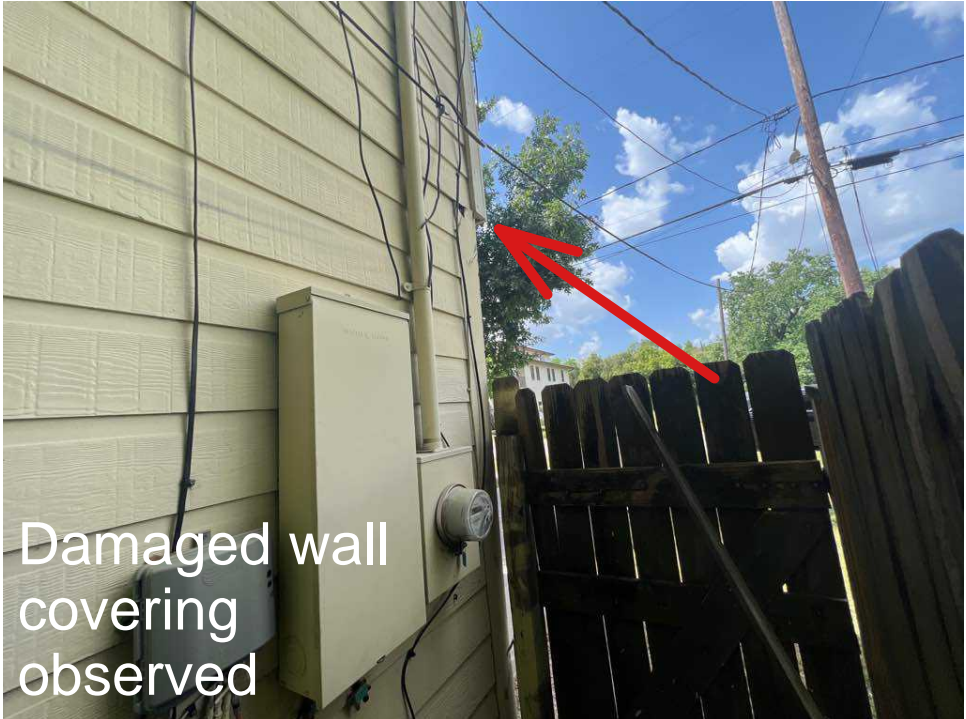
Damaged wall covering observed

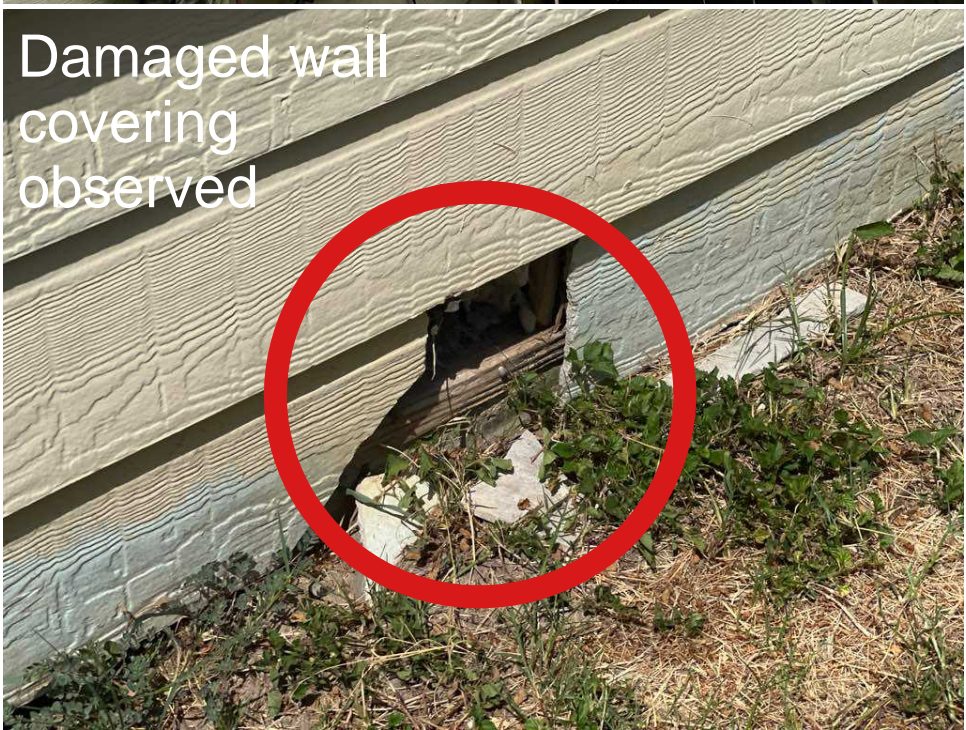
Damaged wall covering observed

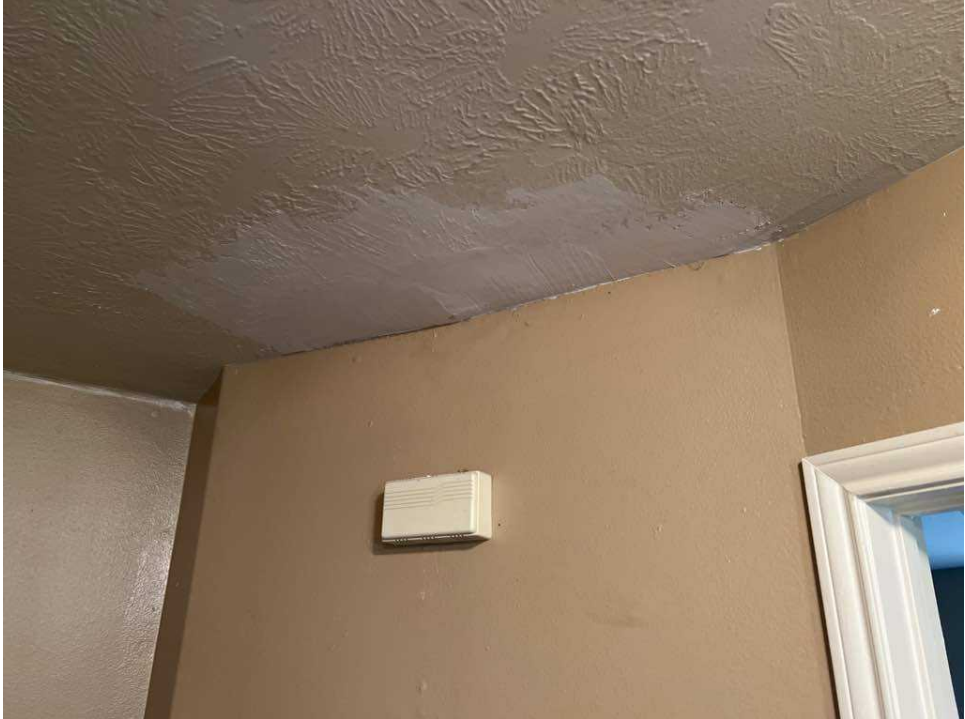
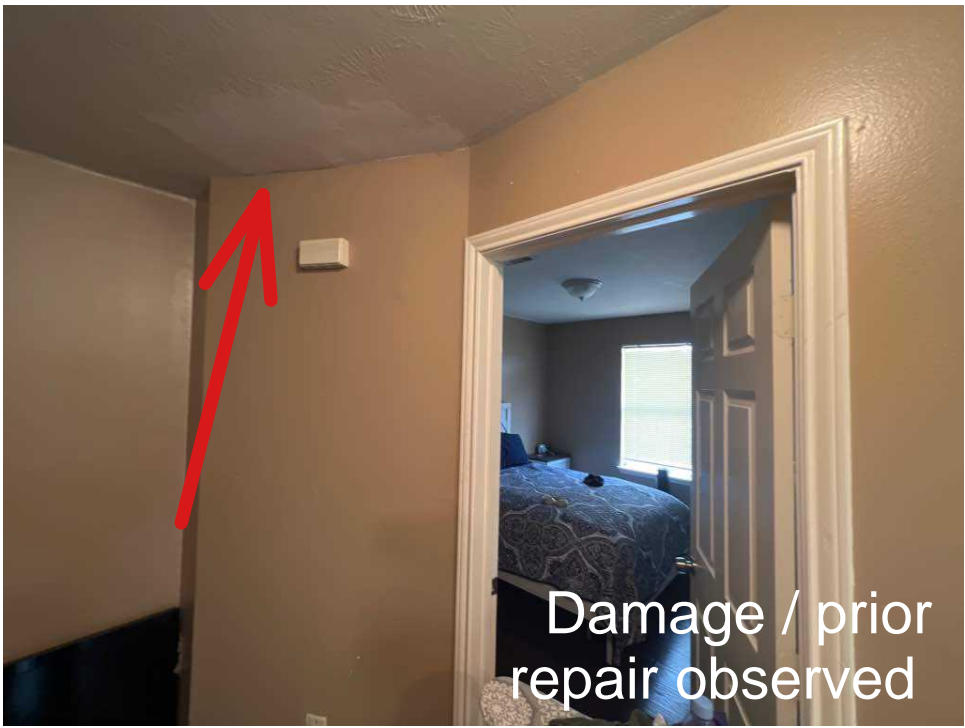
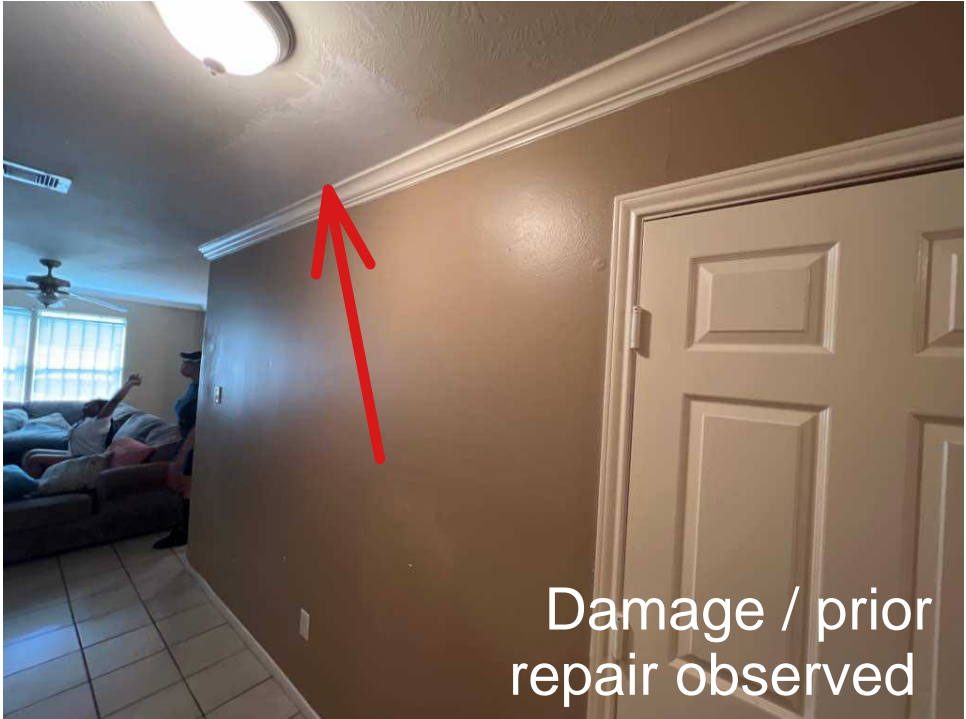
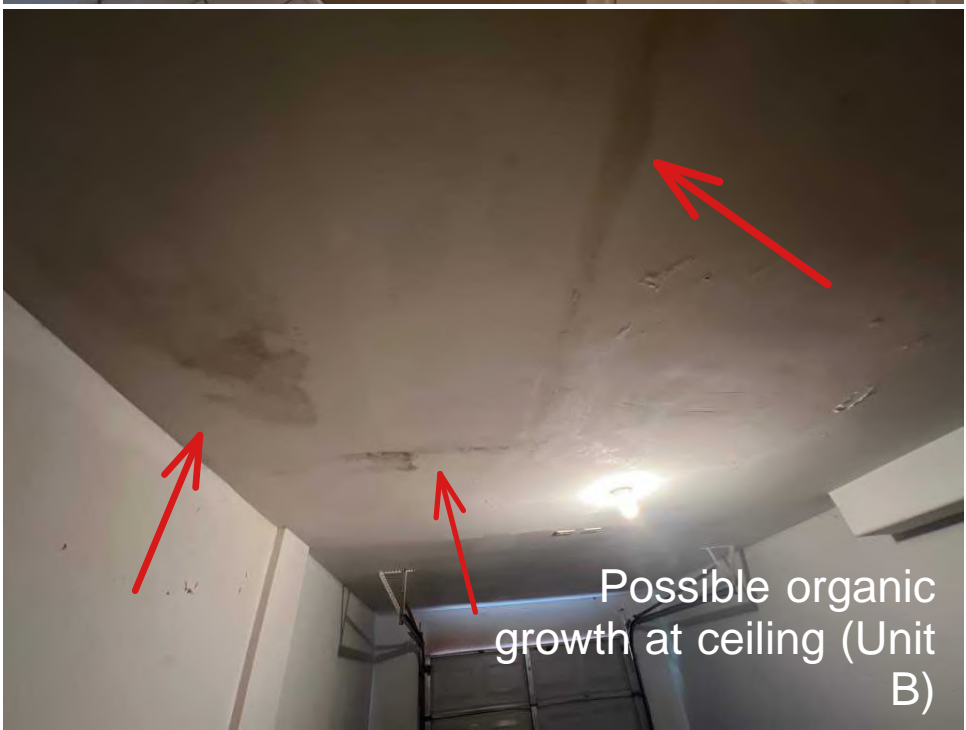
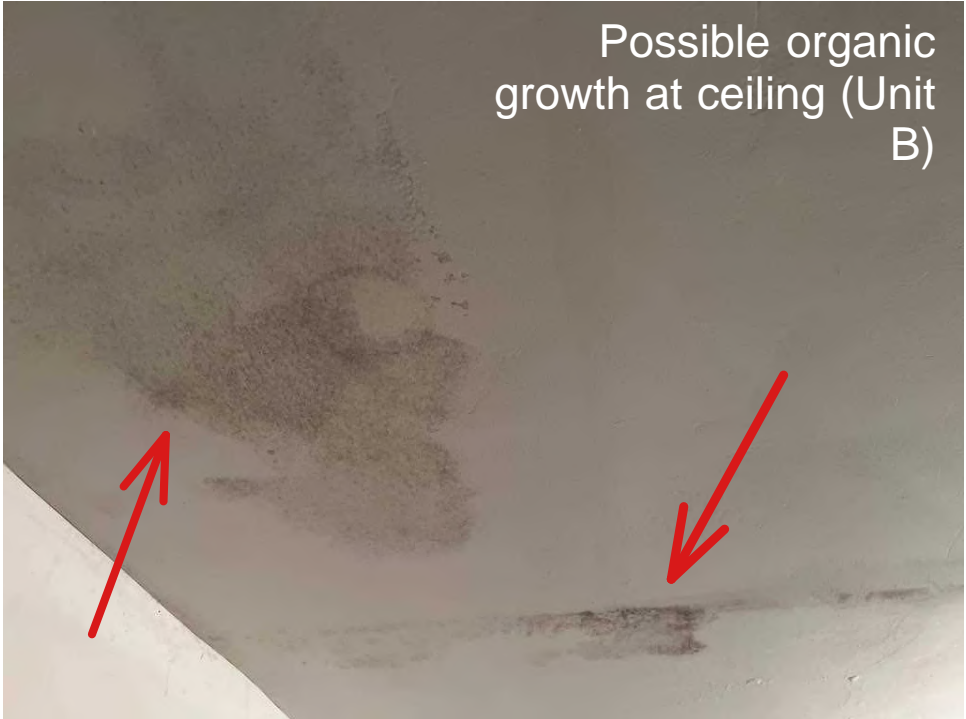
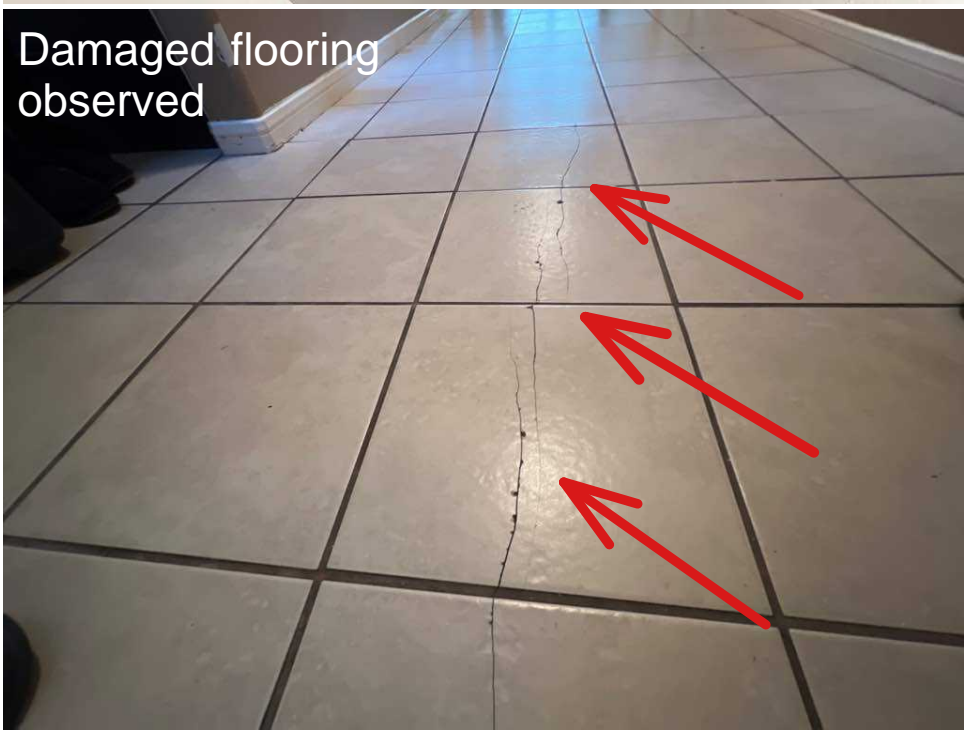
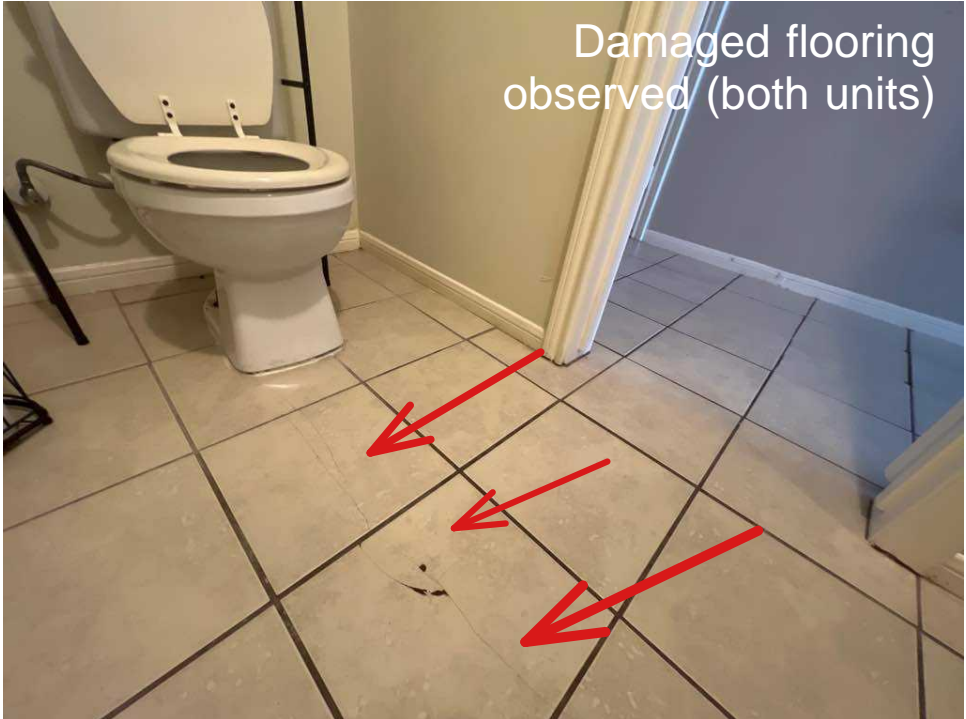
Comments: Drywall,
Damage at ceiling observed (multiple locations).

All damage should be corrected / repaired to prevent further deterioration.

Correction recommended by qualified contractor.

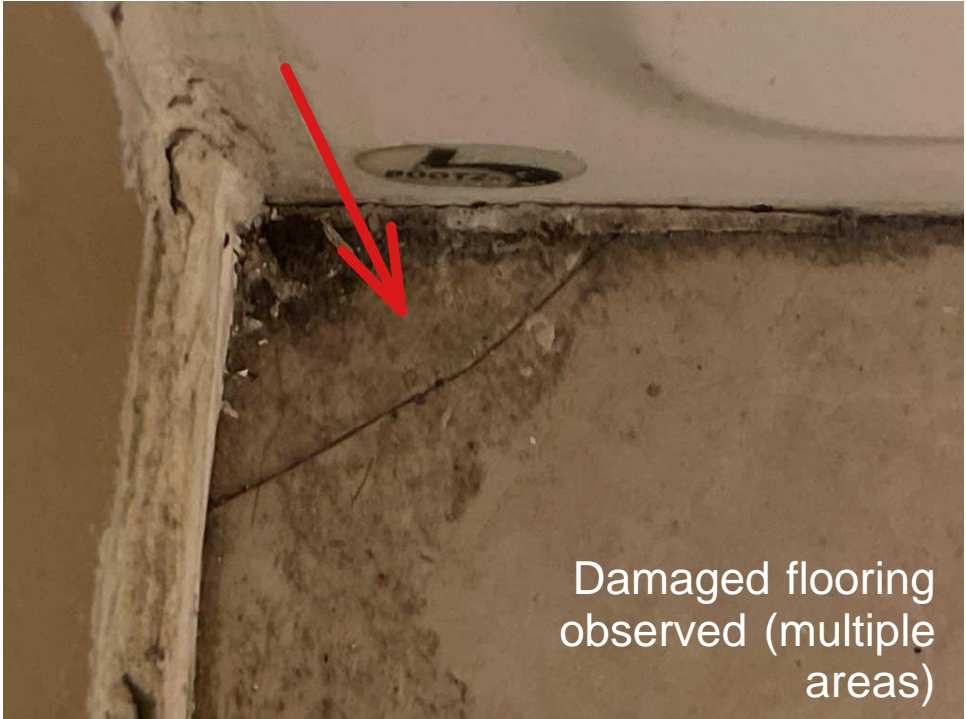
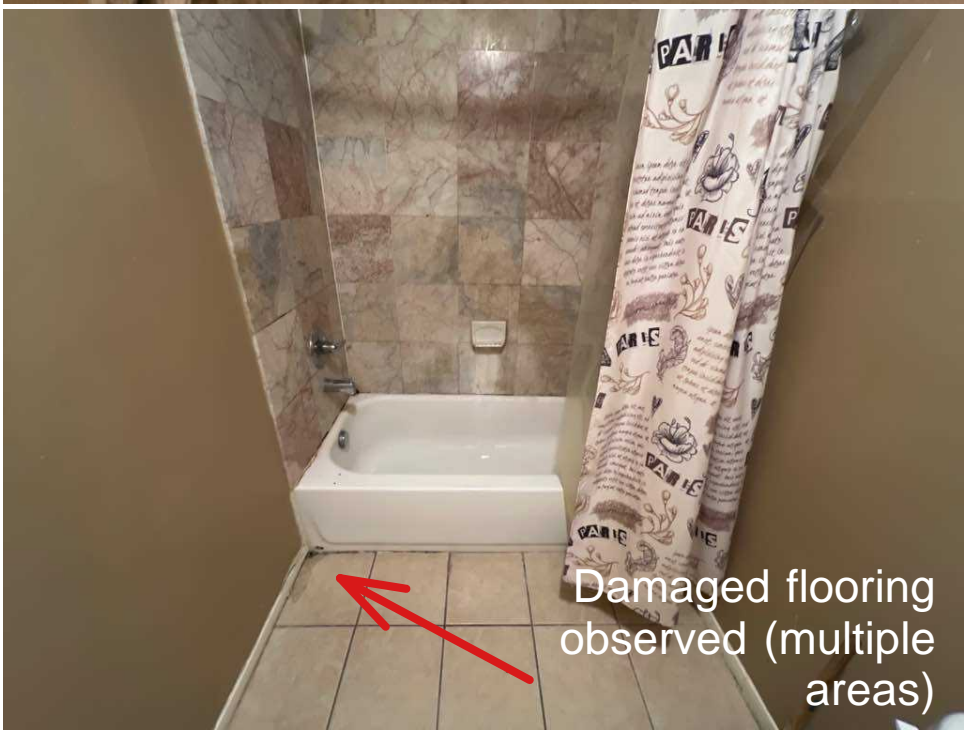
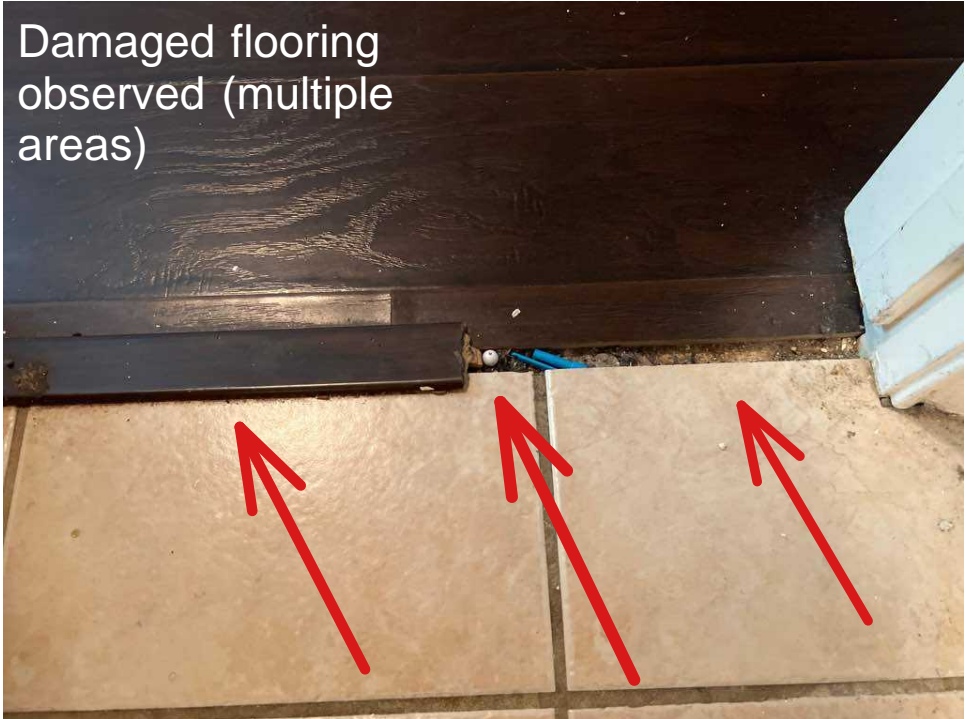
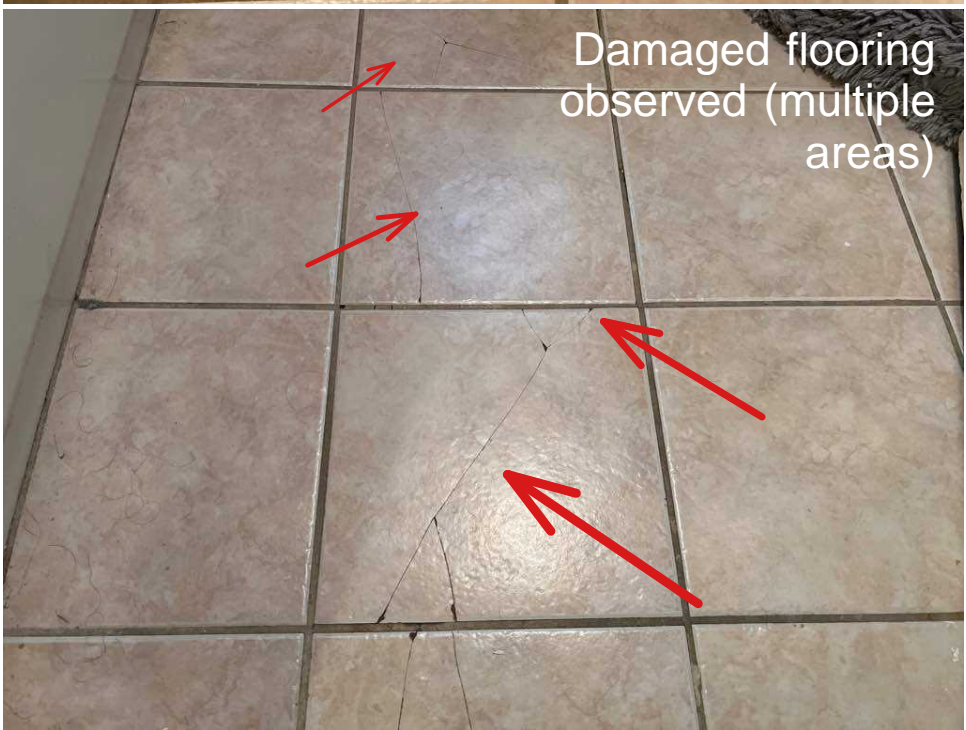
Comments: Tile, Laminate,
Observed damaged flooring.

Further evaluation & correction recommended by qualified contractor.

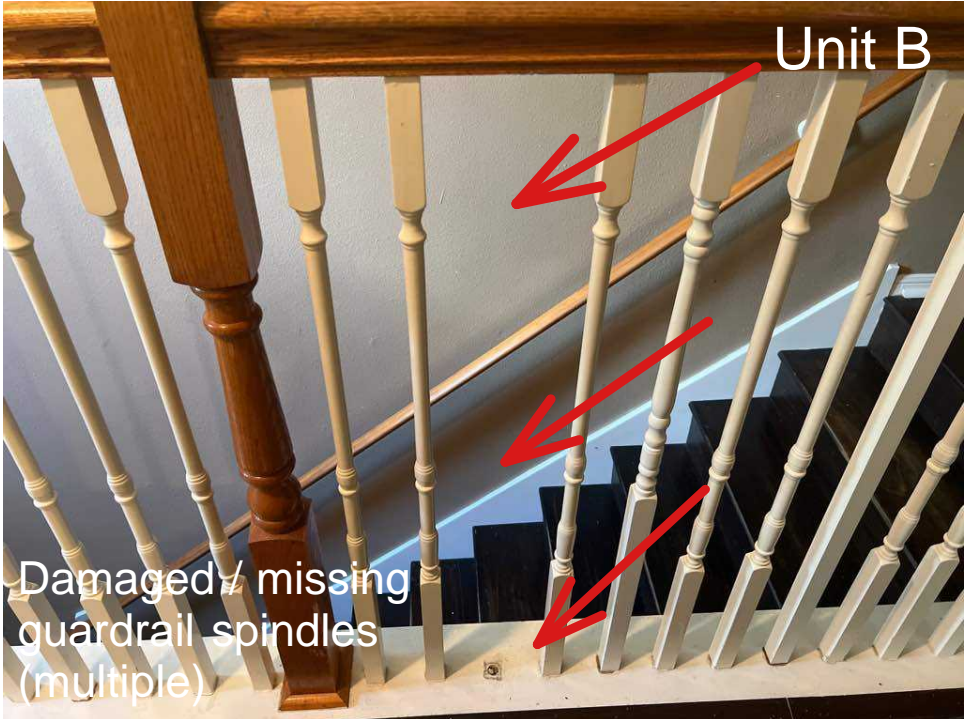
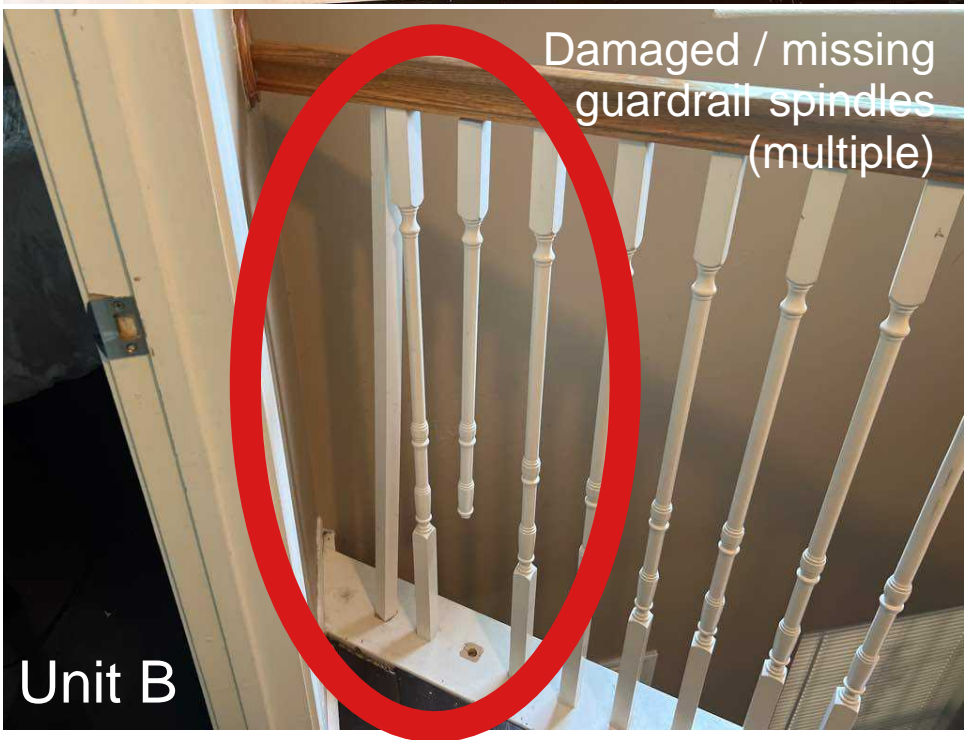
Comments: Wood stairs with wood handrails,
Observed stairway spindle spacing too wide.

Four inches is the recommended maximum spacing for stair spindles (safety).

Further evaluation recommended by qualified contractor.
