Property Inspection Report

3618 Goodhope St, Houston, TX 77021
Inspection prepared for: Alexis Vargas

Date of Inspection: 07/22/2023 Time: 2:30PM
Age of Home: 2006 Size: 3072 sqft

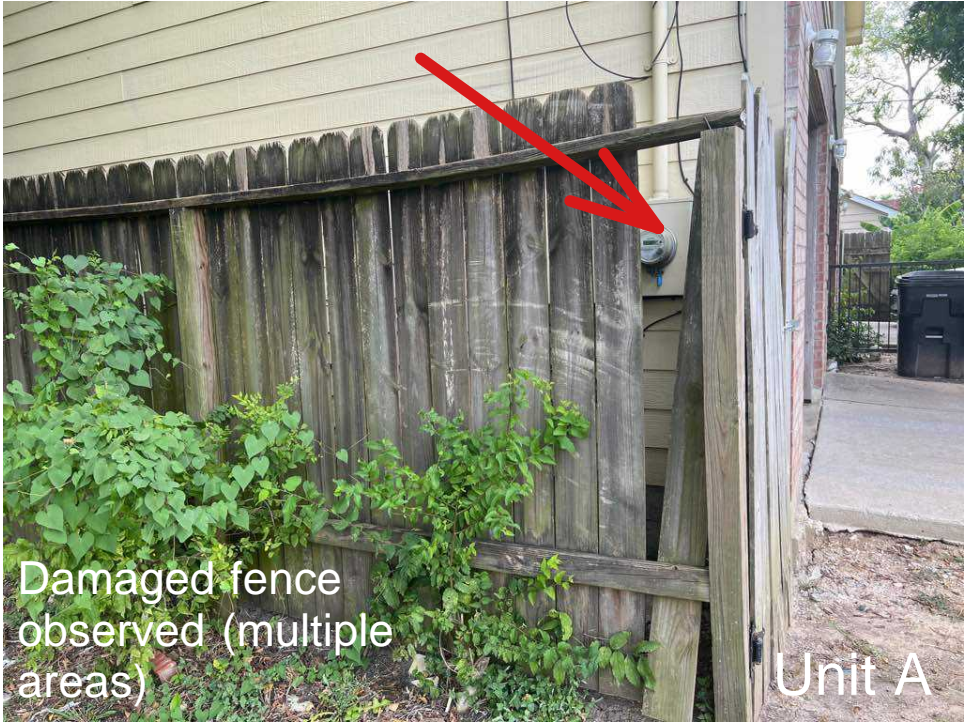
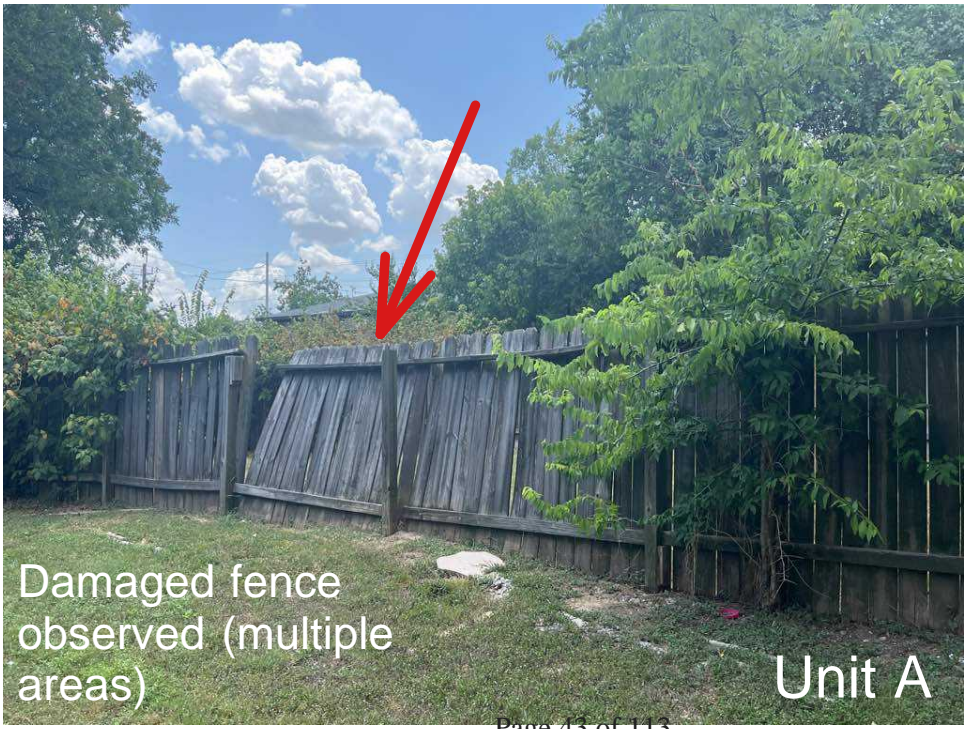
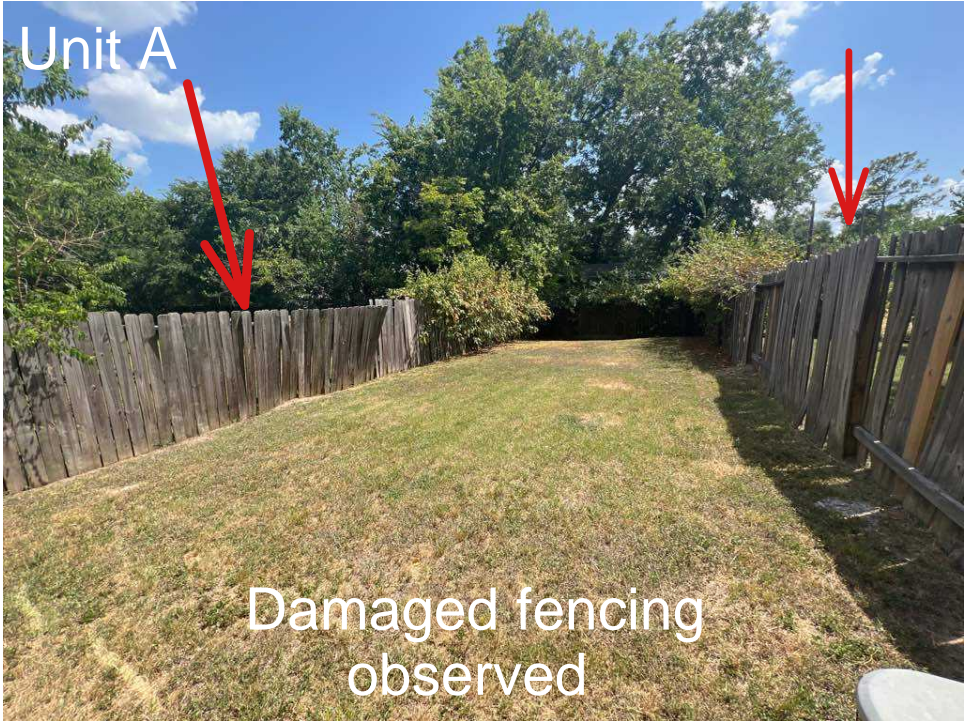
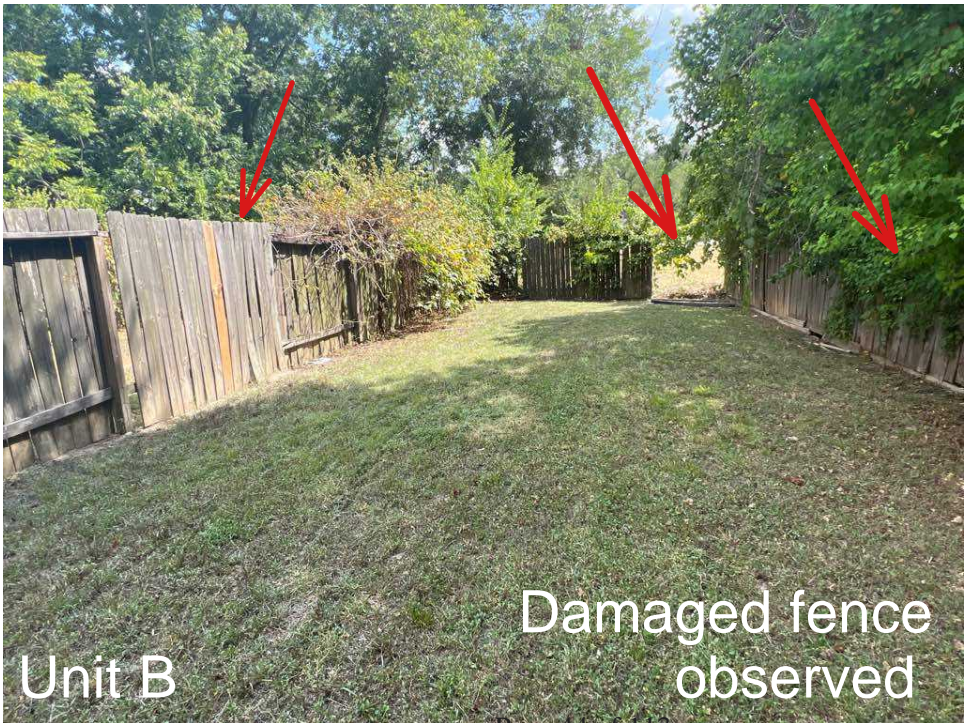
Comments: Wood Fence,
Damaged fence observed

Correction recommended by qualified contractor

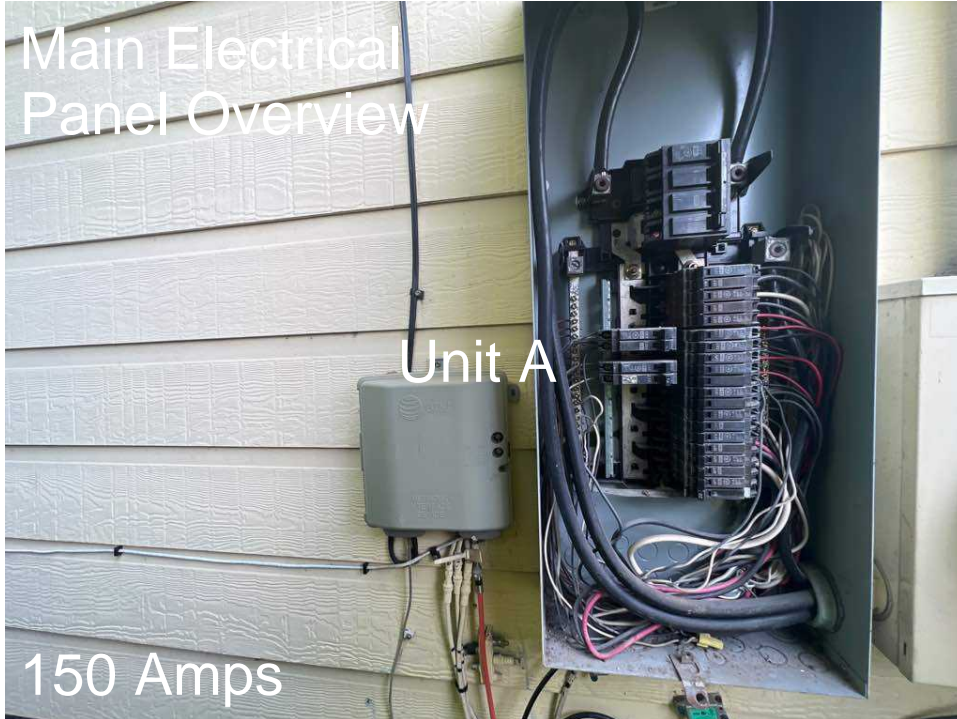
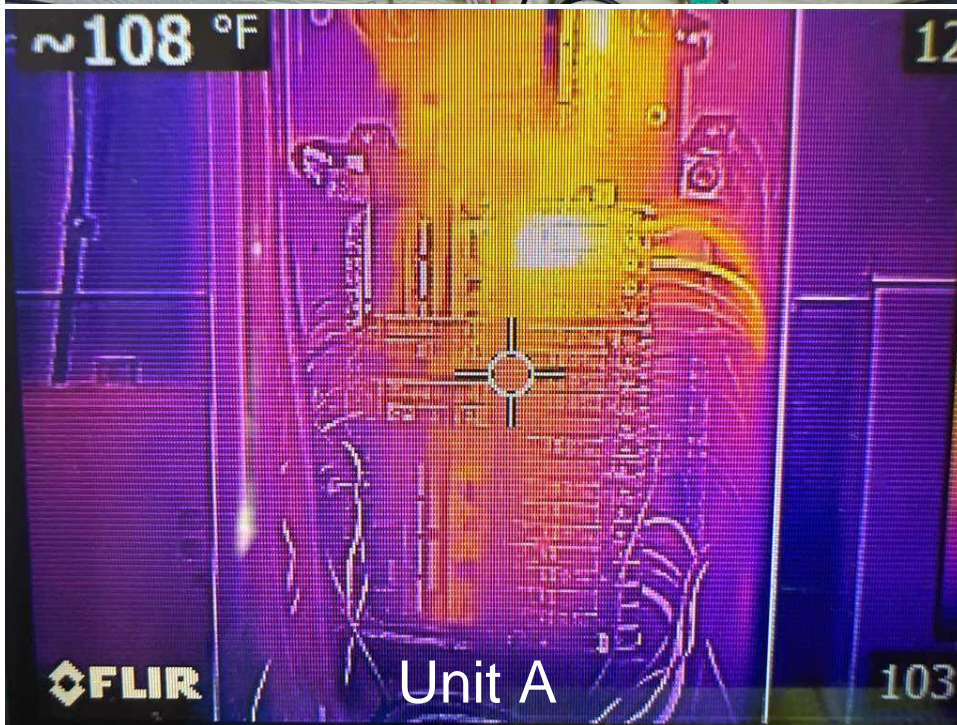
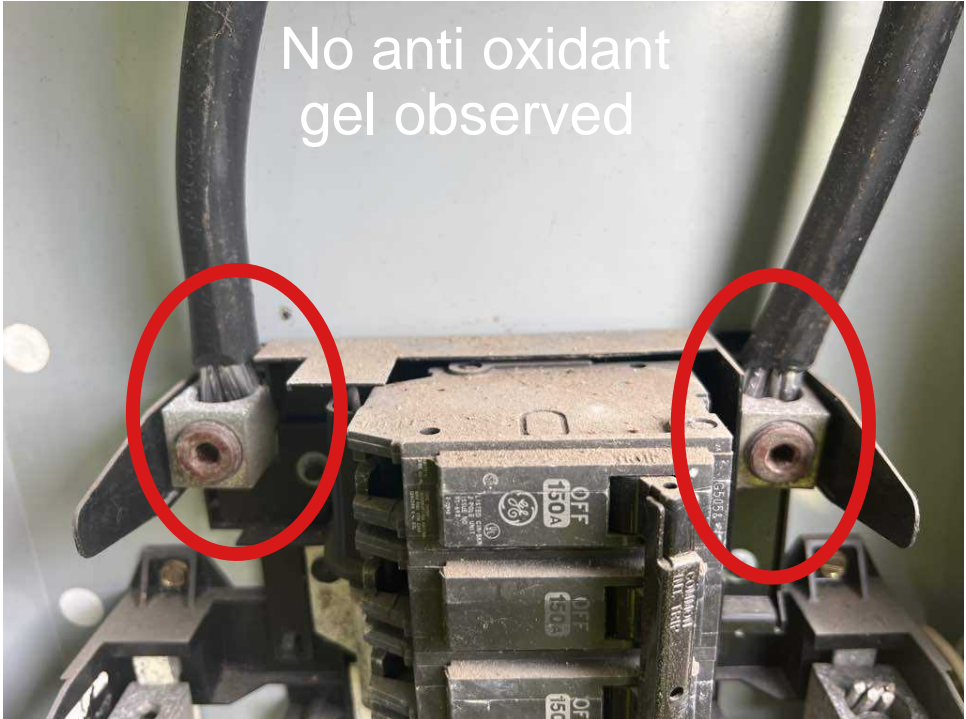
1. No anti-oxidant paste observed at main electrical aluminum cables in panel.

Anti oxidant paste is recommended for aluminum cables because (without the paste) aluminum can overheat & become fire hazard.

Further evaluation & correction recommended by qualified contractor.,

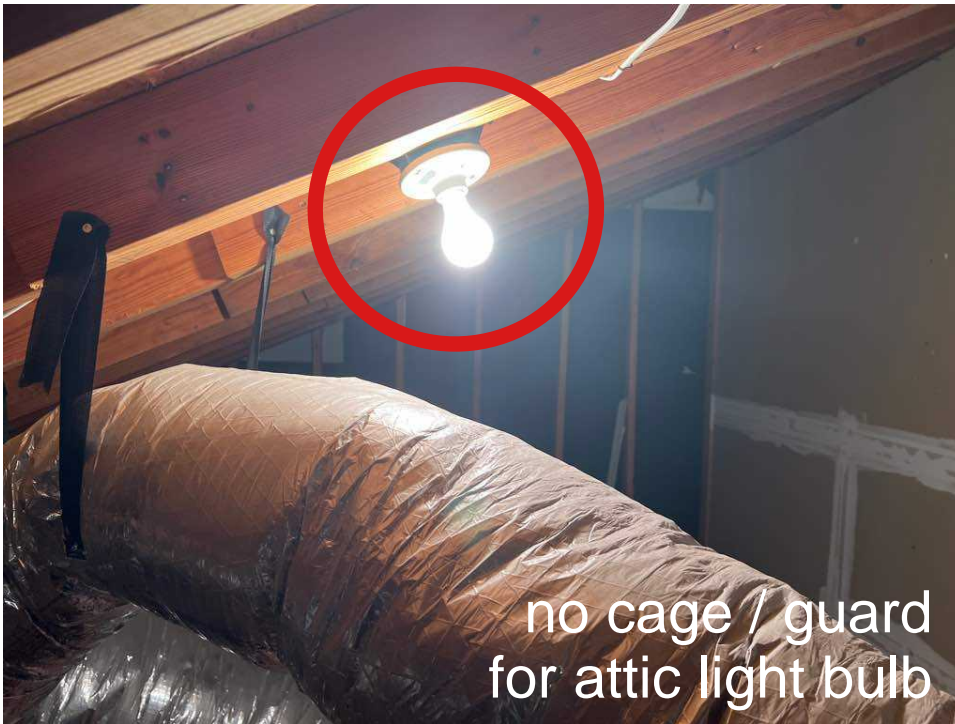
Comments: Interior / Exterior,
Observed no cage / guard for attic light bulb - safety item.

Correction recommended by qualified contractor

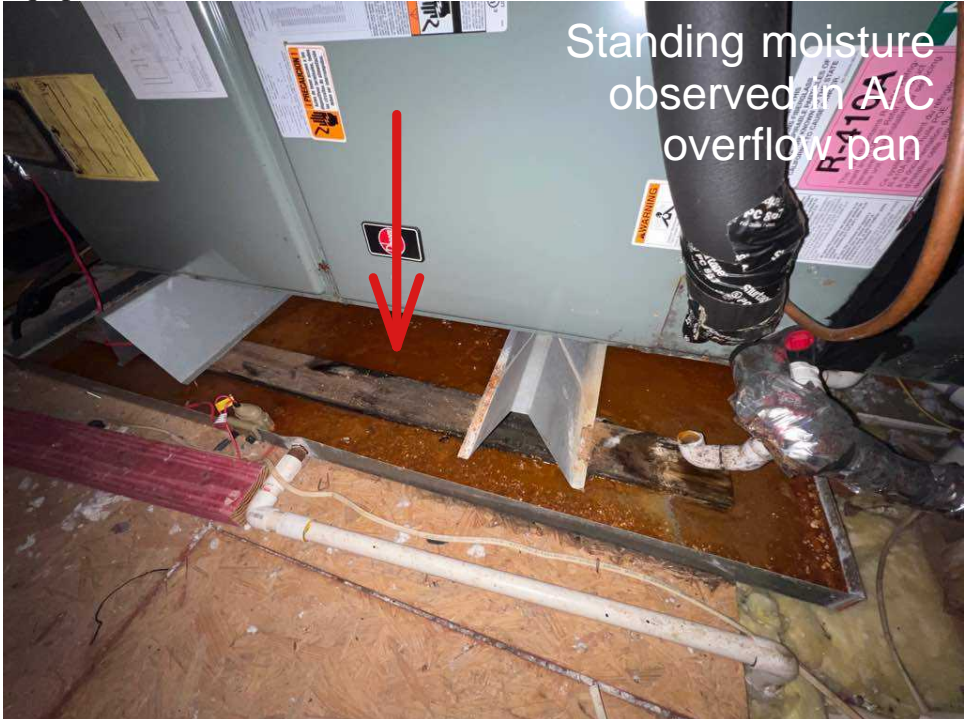
1. Moisture observed in A/C overflow pan.

Moisture in A/C overflow pan often indicates blockage of primary condensation drain line.

Standing moisture
observed in A/C
overflow pan

Further evaluation and correction recommended by qualified contractor.

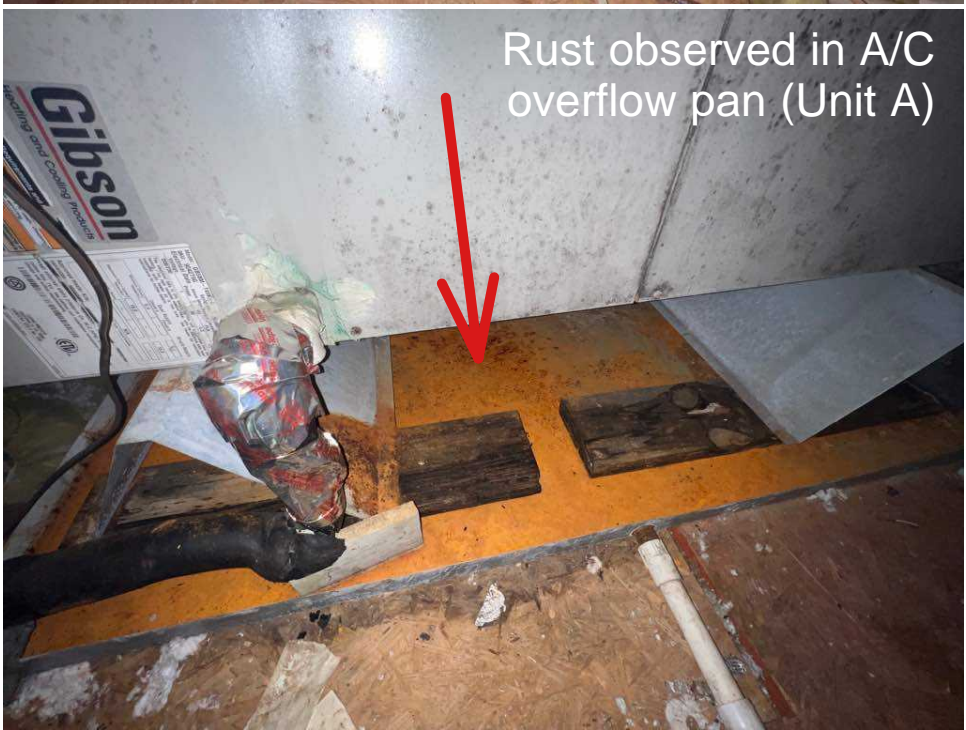
Rust observed in A/C
overflow pan (Unit A)

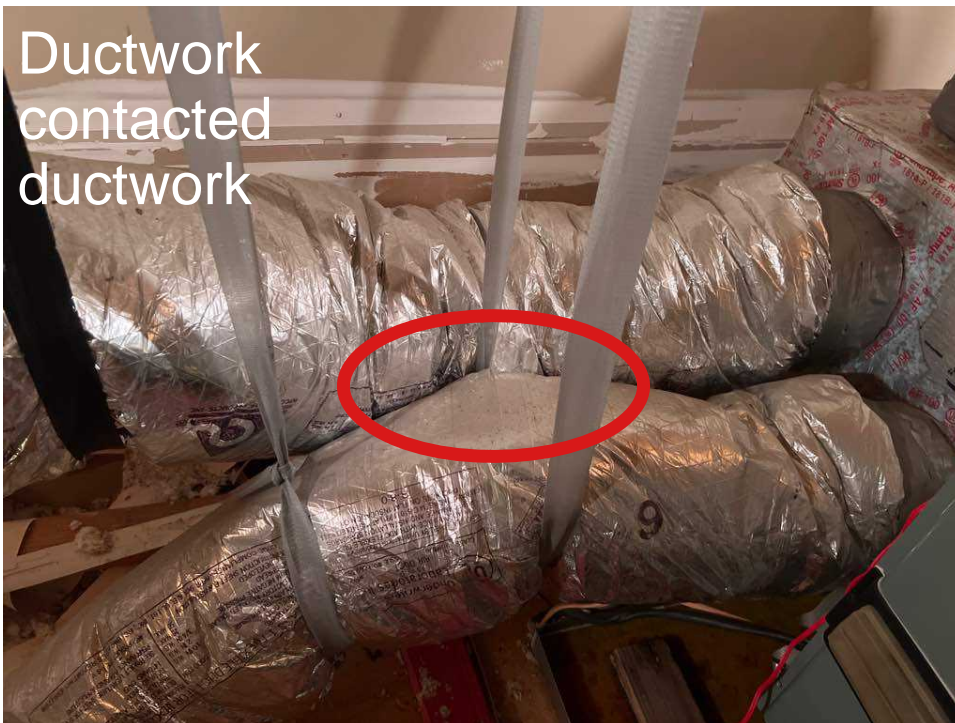
The intent of the one inch clearance is to prevent condensation between ducts.

Further evaluation & correction recommended by qualified contractor.

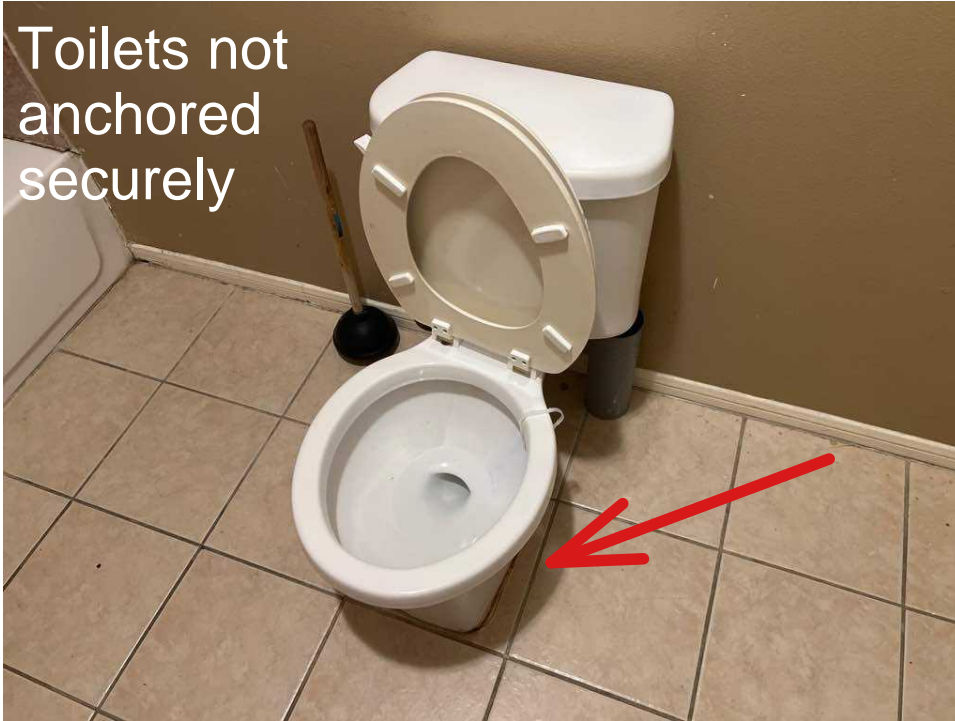
Comments: Flushing (Two-Piece) Toilet,
Observed toilet loose at floor mounting.

Correction recommended by qualified contractor.

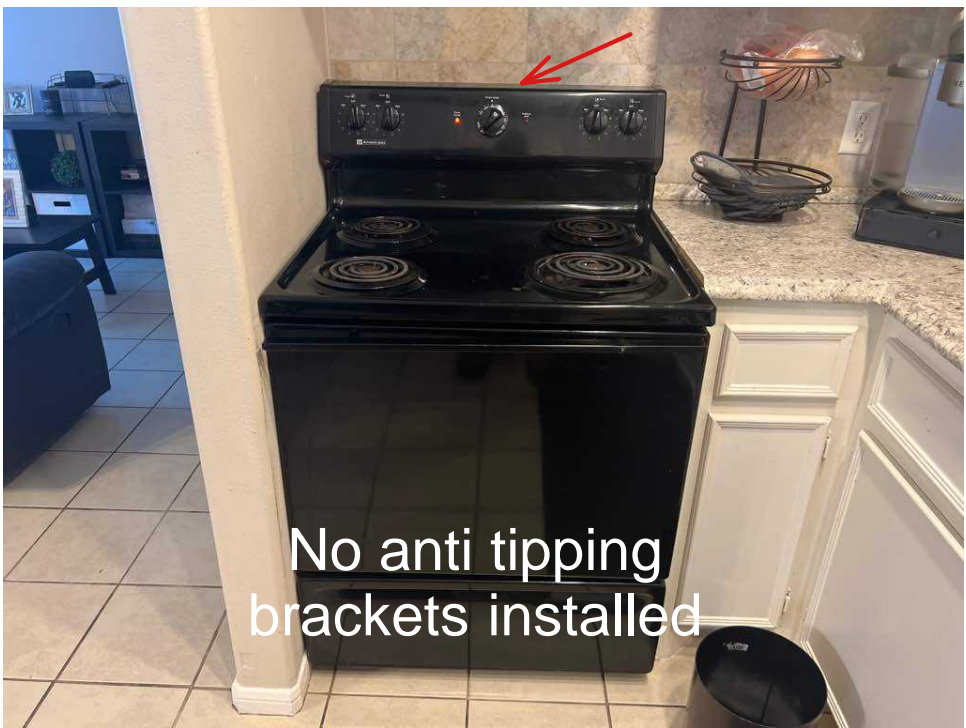
without anti-tip bracket secured
