## **RESIDENTIAL INSPECTION REPORT**

79 Bradford Cir Sugar Land, TX 77479

# **PROPERTY INSPECTION REPORT FORM**

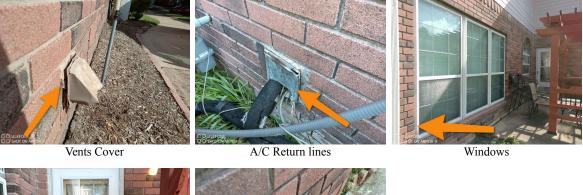
Trim Boards

All Exterior Wall Penetrations, Doors/Windows, Vent Cover(s), Trim Boards, A/C Return Lines, Outlets -One or more areas were not properly sealed/caulked. Most exterior sealants have a lifespan of 5 to 8 years and should be regularly maintained with that lifespan in mind. Evaluation and remediation is recommended.

Recommendation: Contact a qualified professional.

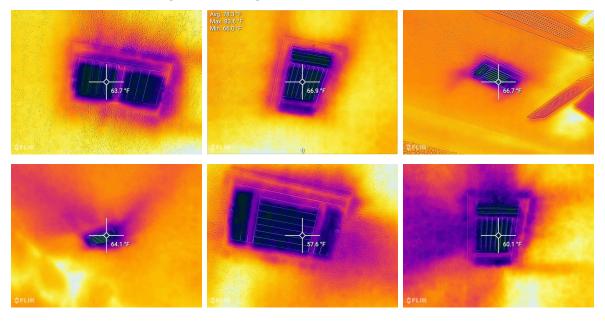
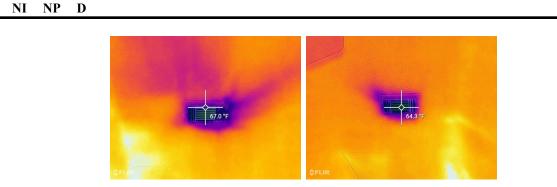
The air conditioner was functional but did not adequately produce cold air. Evaluation and remediation by a licensed HVAC contractor is recommended.

Recommendation: Contact a qualified HVAC professional.
