PROFESSIONAL HOME INSPECTION, LLC

925 S. 6th Street  
La Porte, TX 77571

Report Identification: 20230906-01, 925 S. 6th Street, La Porte, TX

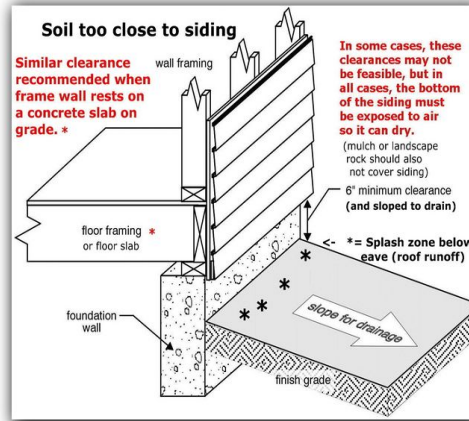
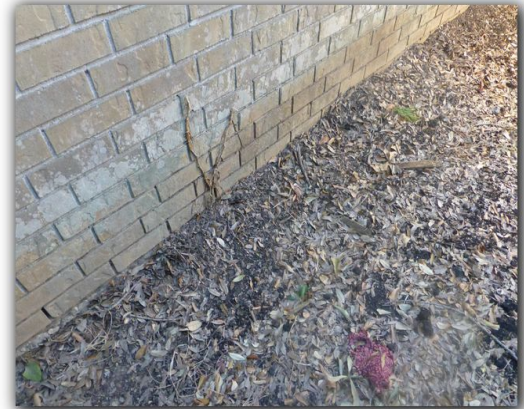
The soil level is too high around some of foundation perimeter. Common industry practice requires at least 4 inches from the bottom of the brick veneer to the soil and 6 inches with wood or other materials. High soil levels around brick or wood siding promotes wood rot and is considered a conducive condition to termite activity and water penetration. (Ref IRC R404.1.6)

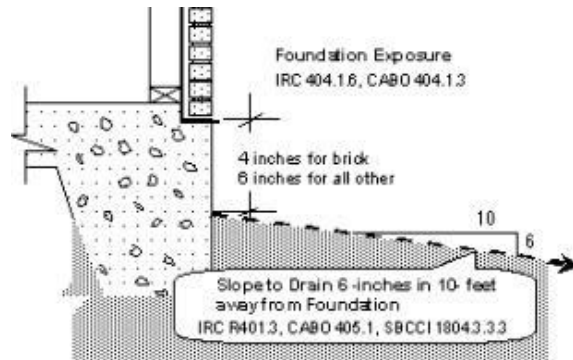
Soil grade and drainage patterns around certain areas of the house do not appear to properly direct water away from the foundation to aid in controlling runoff water and could cause differential movement of the foundation or water penetration during heavy rains.

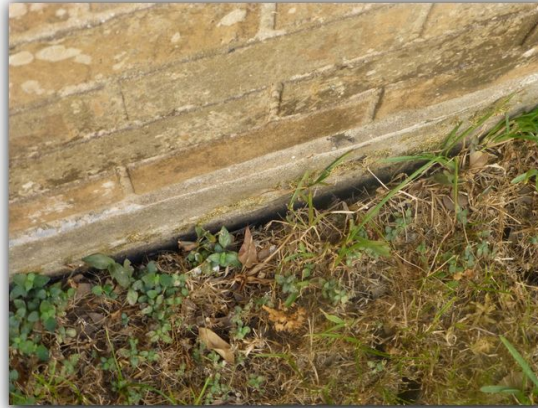
The soil is cracked and pulled away from the foundation, which can adversely affect the condition of the home after it rains and the soil expands. Homes in the Houston area are on an expansive clay soil, which is very common in this area. Proper watering of this type of soil in the area of the foundation is important to the integrity of the structure. Recommend consulting a qualified contractor in starting a slow, proper foundation watering system.

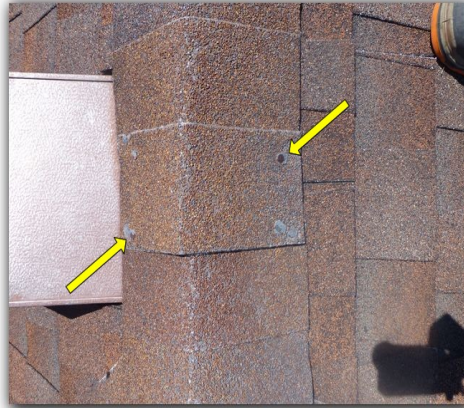
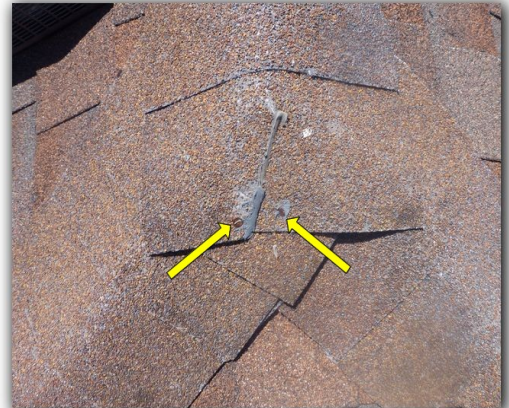
Exposed staples, nail heads, and/or fasteners observed on the roof. All exposed fasteners should be sealed to prevent water entry.

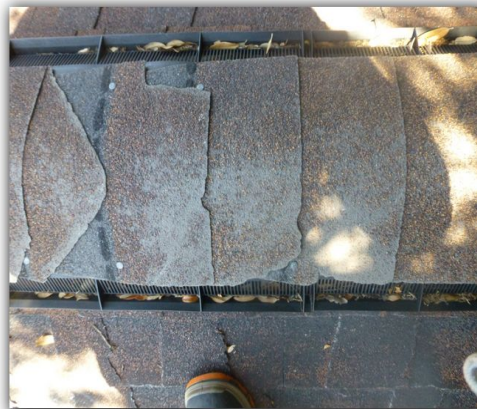
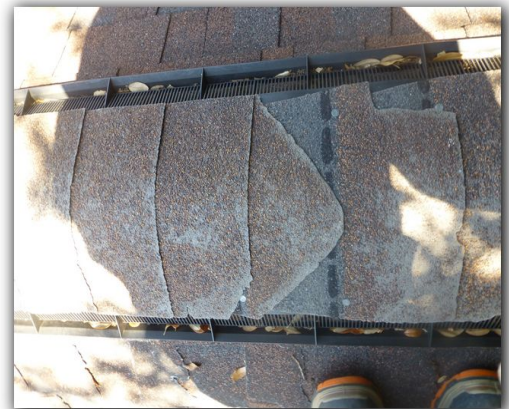
Areas that need immediate attention are the areas that have torn, damaged, and/or missing shingles.

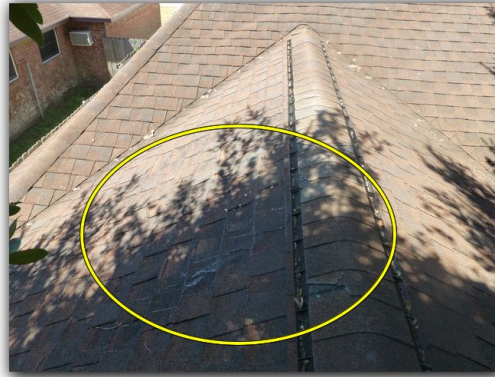
There is excessive debris on the roof. Excessive debris on the roof can hinder drainage and cause multiple issues in that area. I recommend clearing all excessive debris from the roof area.

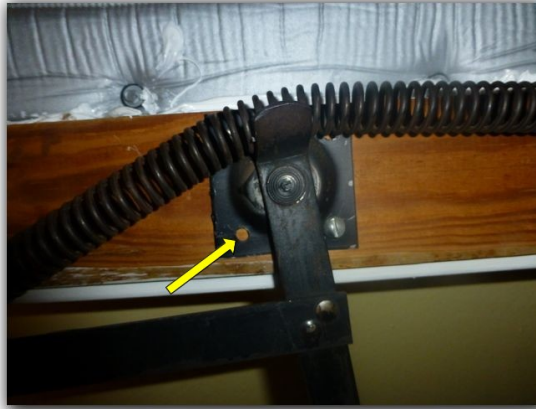
The landing platform was deficient or missing at the top of the attic stairway. Decking should be installed at the top of the stairs to prevent damage and injuries from stepping onto and falling through the ceiling. (Ref. IRC R311.7.6)

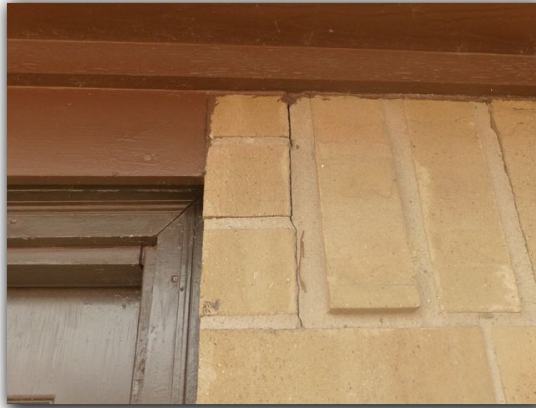
Cracks in brick veneer observed at several locations. Recommend the buyer take photographs of the cracks, their locations, and widths, with a high resolution camera that has a date stamp for future reference.

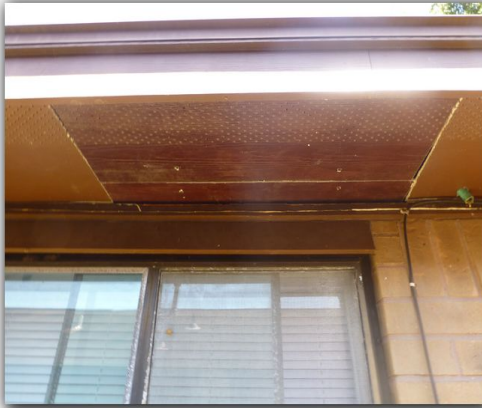
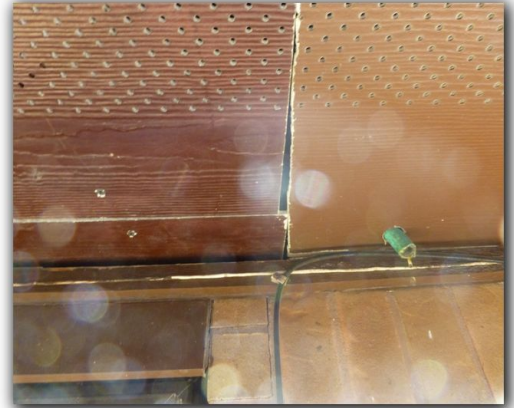
Soffit repairs needed on the right side of the residence.

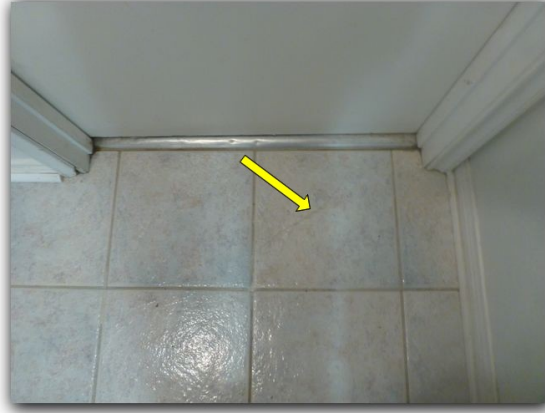
There were one or more cracked/unbonded tiles throughout the residence.

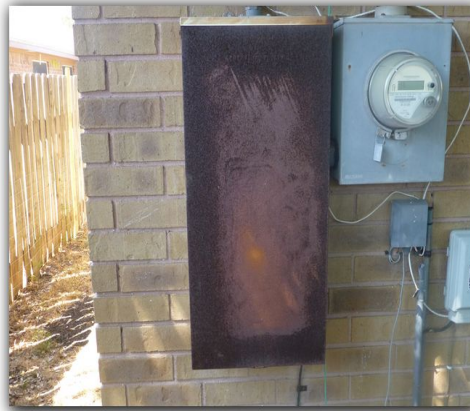
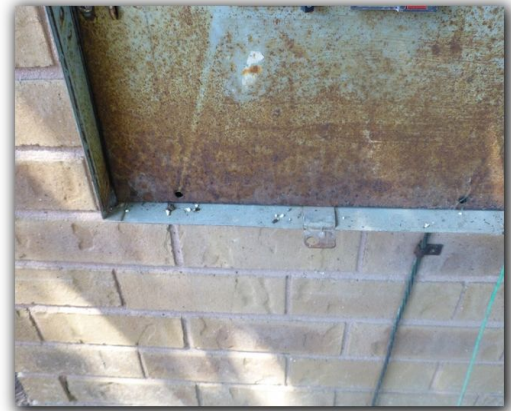
Observed rust on the outer cover and dead front cover of the electrical panel.

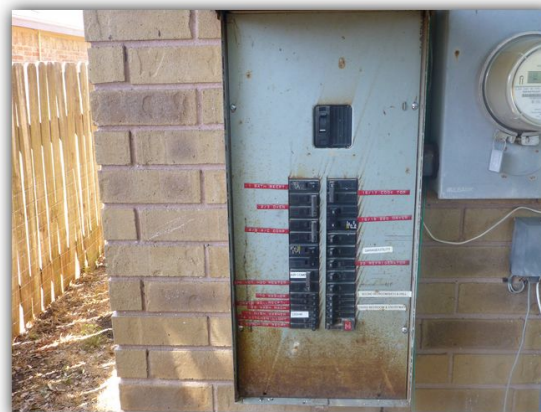
Not all breakers are properly identified. Each disconnecting means shall be legibly marked to indicate its purpose. (Ref. IRC E3404.13)

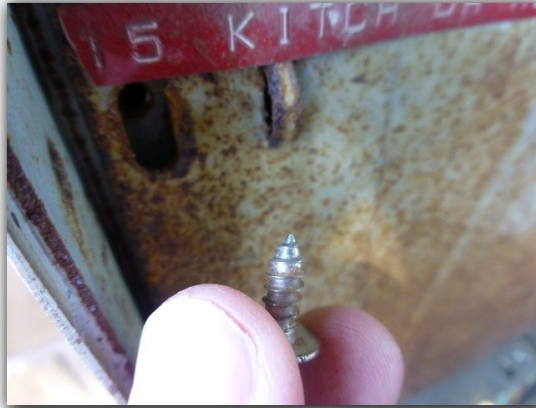
The dead front cover was secured with sharp screws. Blunt tip screws should be used to secure the panel. Sharp tip screws can pierce live electrical wiring. This is a safety hazard. Recommend repairs.

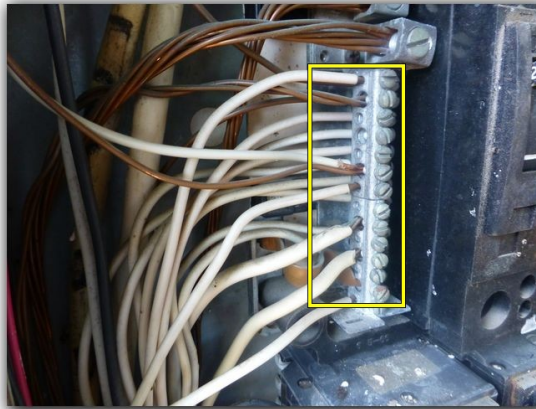
Double lugging of the neutral wiring observed, does not meet current electrical standards.

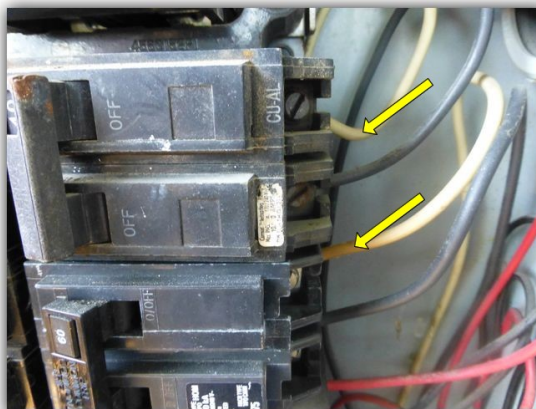
White wire used for power distribution, connected to breaker with no colored tap for identification. This is a safety hazard. Recommend repair

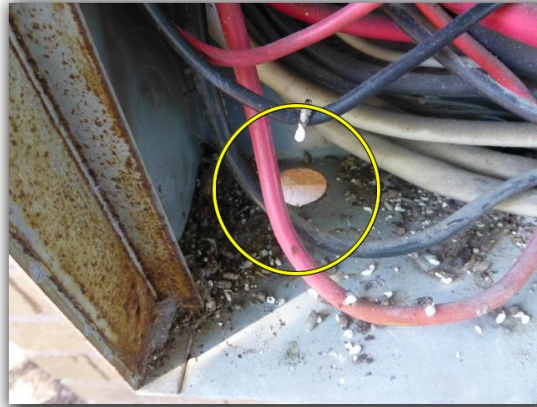
Open knockouts observed on the electrical panel. Unused openings, other than those intended for the operation of the equipment, those intended for mounting purposes, and

those permitted as part of the design for listed equipment, shall be closed to afford protection substantially equivalent to the wall of the equipment (Ref. IRC E3404.6)

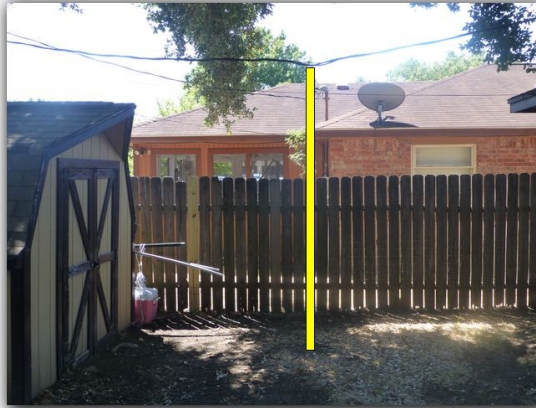
The overhead service conductors are too low, this is an safety hazard and should be corrected by a licensed electrician. The vertical clearance shall be 10 feet at the lowest point of the drip loop (Ref. IRC E3604.2.2)

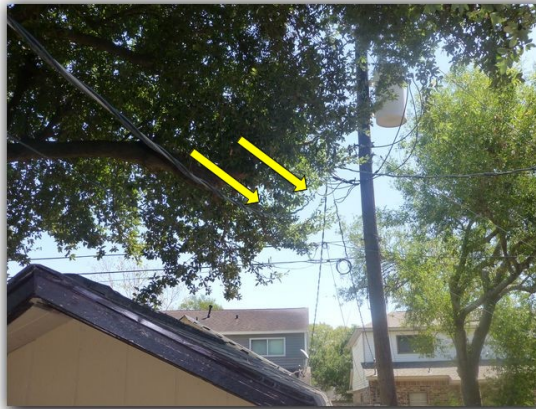
Electrical service wire obstructed by or contacting trees or vines.

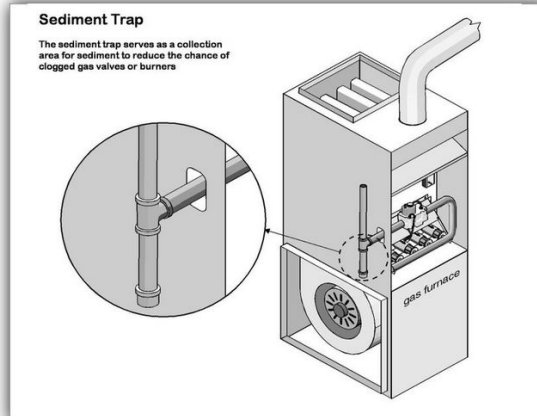
There was no sediment trap installed in the furnace gas line. A sediment trap consists of a tee in the gas line before the inlet of the control valve. The tee provides a place where the gas will have to make a sharp turn and it provides a place for moisture and particles to collect. Preventing debris and moisture from entering the pilot or burner assembly will prolong the life of the unit.

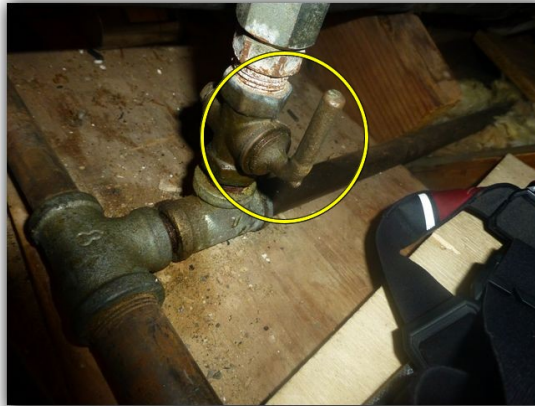
The spring loaded gas shut off valve is no longer compliant with current industry standards. Recommend replacing the shut off valve.

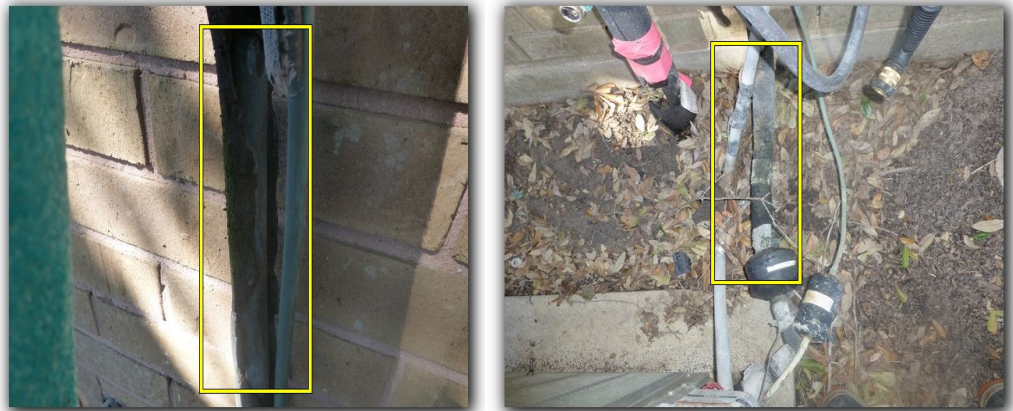
Section of suction line insulation was missing or deteriorated near the condenser. The purpose of the insulation is to prevent the suction line from attracting heat on its way to the condensing coil. System performance may be adversely affected when the outdoor insulation is missing or deficient.

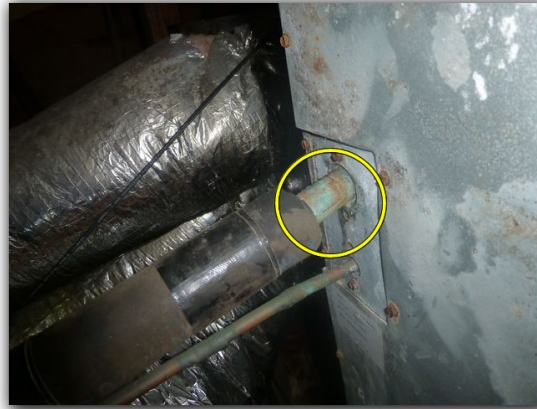
Section(s) of the suction line insulation was missing or deficient in the attic near the coil. Warm attic air will condense on the cold suction line, creating condensation and will reduce the efficiency of the unit.

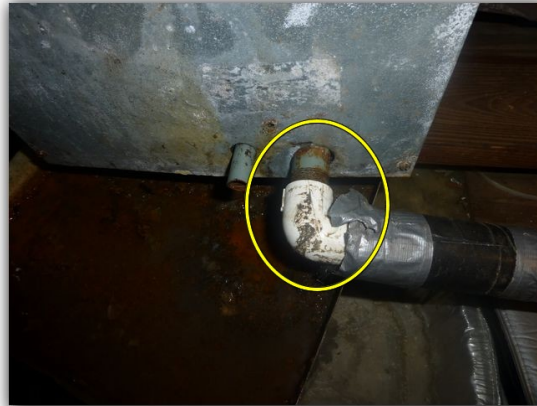
The insulation on the primary condensate drain line was missing and/or deteriorated at the time of inspection. Insulating the drain line will prevent moisture from condensing on the exterior of the drain line and dripping onto the attic floor and/or ceiling or other adjacent structures.

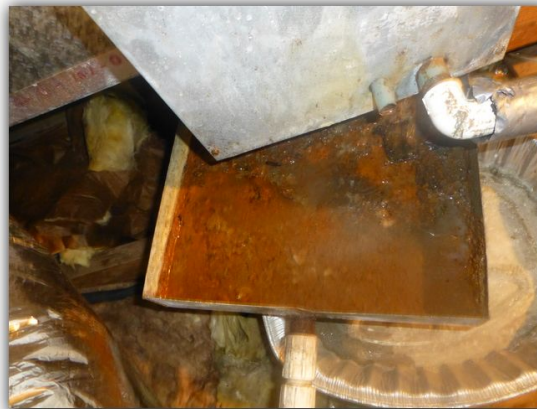
Observed rust in the emergency drain pan. This indicates that the primary condensate discharge line was clogged at some point and water was discharging through the emergency drain, leaving standing water in the emergency drain pan. Should the emergency drain pan rust through, damage could occur to the ceiling if the primary drain line becomes clogged.

The emergency condensate drain pan was full of water at the time of inspection. This indicates that there is a blockage in the primary condensate drain line. It also indicates that the drain pan is not properly sloped. If the emergency drain becomes clogged, condensate will overflow out of the pan and onto the ceiling, causing damage to the sheetrock. I recommend having a licensed HVAC technician further evaluate the system and make the necessary corrections and/or repairs.

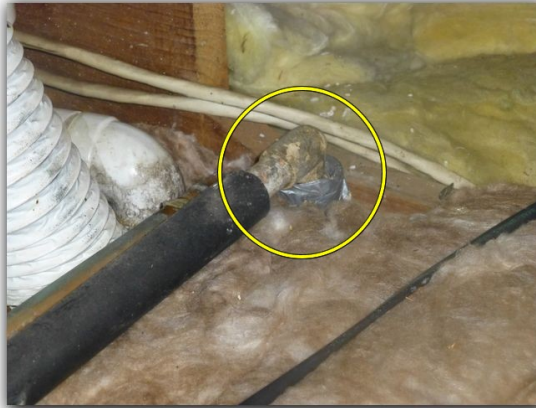
Primary drain line is improperly tied into drain waste vent. Drain line does not drain into a "wet" plumbing trap per today's industry standards, resulting in possible sewer gas and bacteria backing into HVAC equipment / ducts and into house.

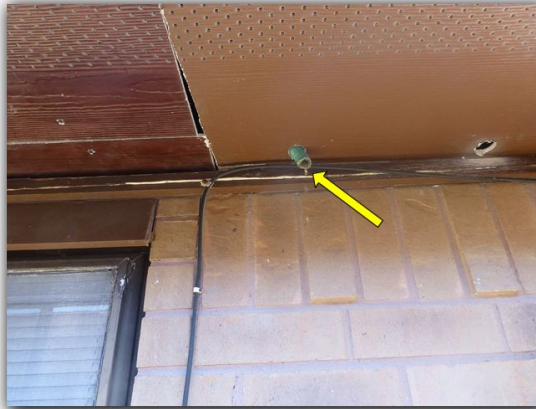
The emergency drain was discharging condensate at the time of inspection.

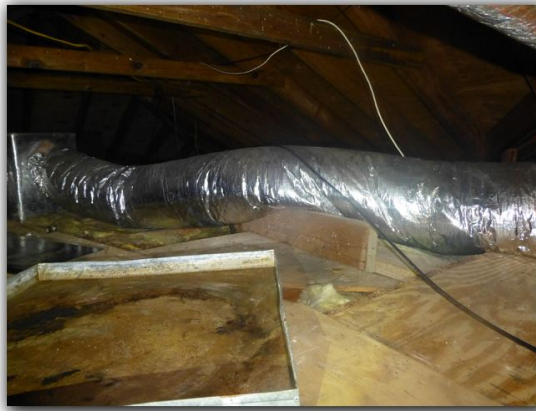
Some of the flex duct was observed to be improperly routed with sharp bends and/or excessive material. Improper routing increases friction loss in the duct and reduces heating and cooling efficiency. The radius at the centerline of the bend should be no less than one duct diameter.

Portions of supply ducts within the attic space were not supported as required. The supply ducts should be supported every 4 feet with 1 1/2" straps to hold it relatively level to ensure adequate airflow.

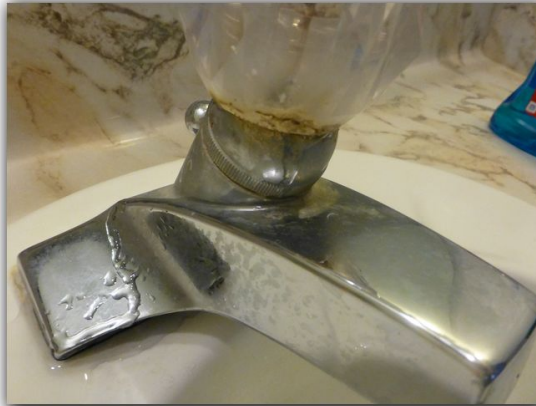
The faucet in the primary bathroom was leaking at the time of inspection. Recommend repairs.

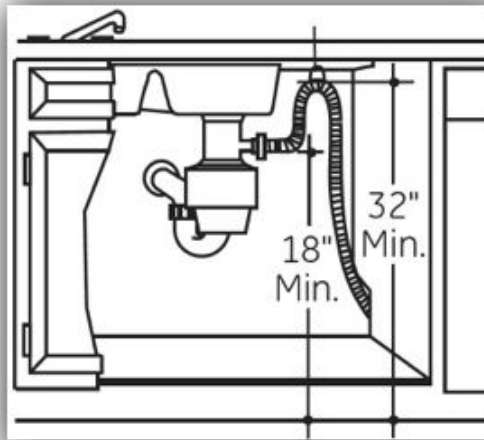
Drain line needs to be elevated above side inlet of disposal to underside of countertop to prevent debris and gray water from draining down line from disposal and back into dishwasher.

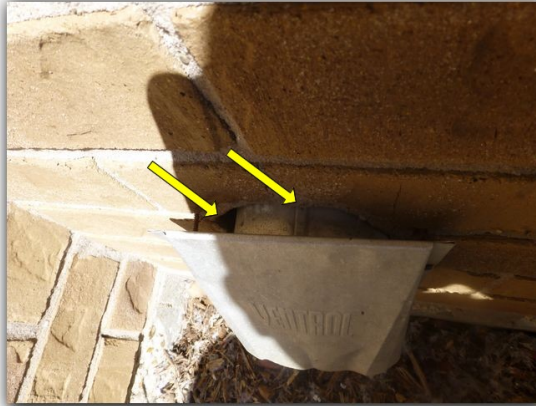
The dryer vent piping termination was not properly sealed. Recommend repairs.
