Glenco Inspections

PROPERTY INSPECTION REPORT

Concerning: 8810 WILLOW SPUR DR.

Inspector Jason Smith

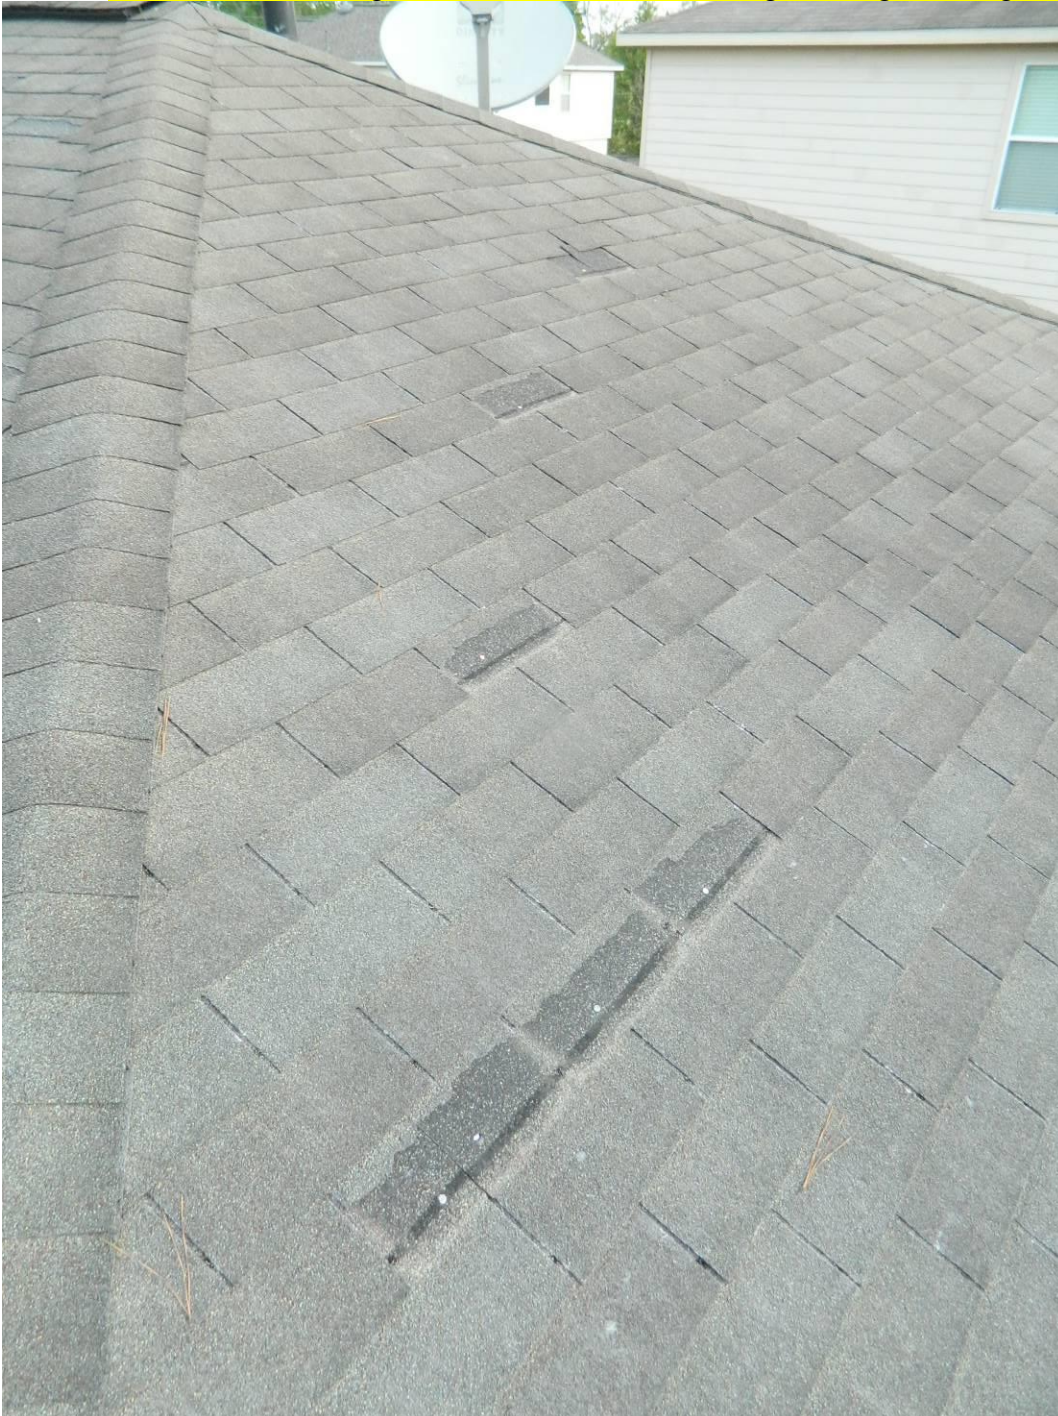
- In my opinion, the roof covering is in need of replacement.
 1. At least 18 shingles tabs are missing.
 2. The roof covering shows evidence of hail damage and significant granular wear in areas.

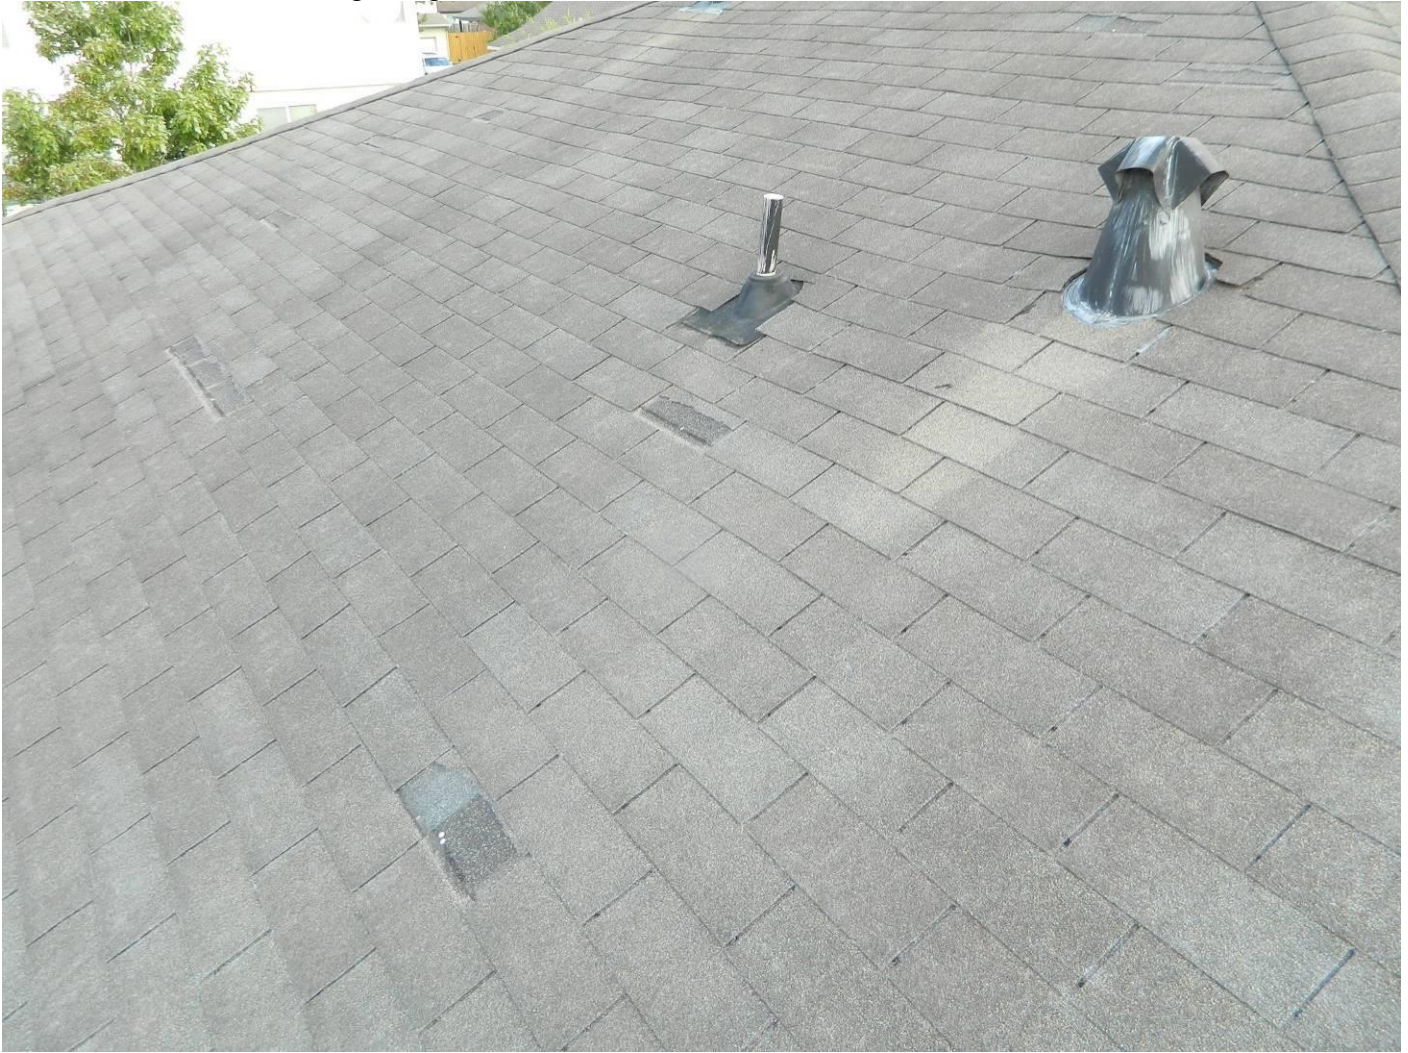
- Locations of missing shingle tabs.

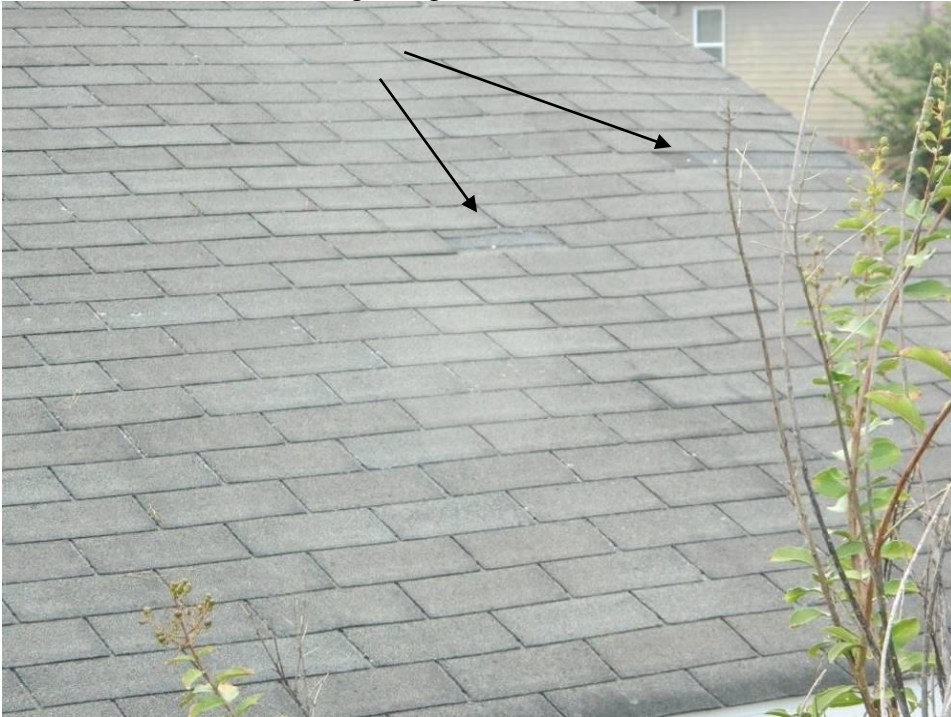
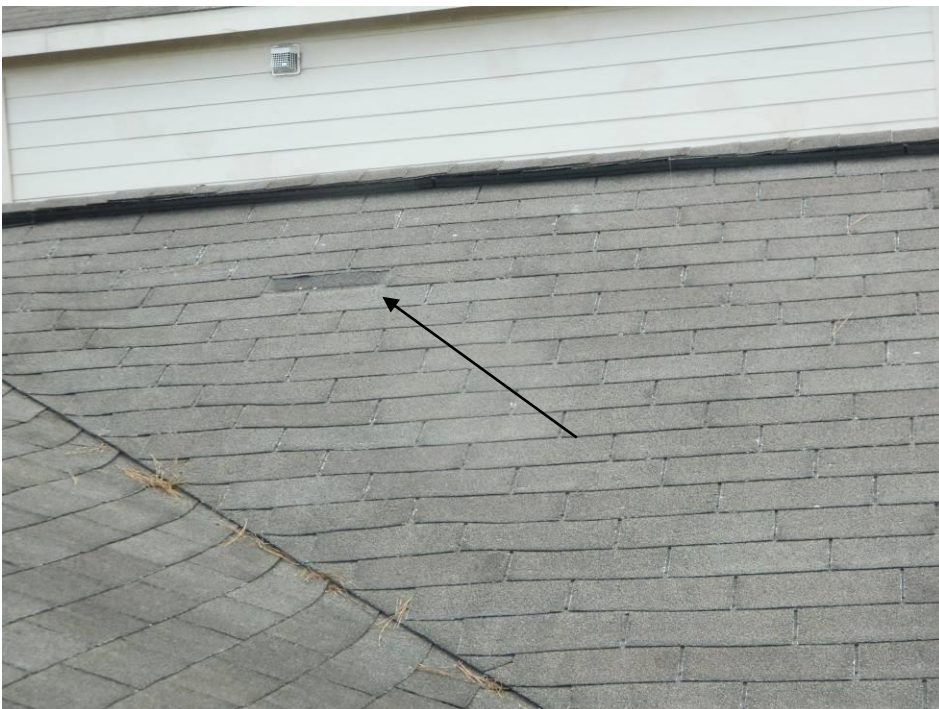
- Locations of missing shingle tabs.

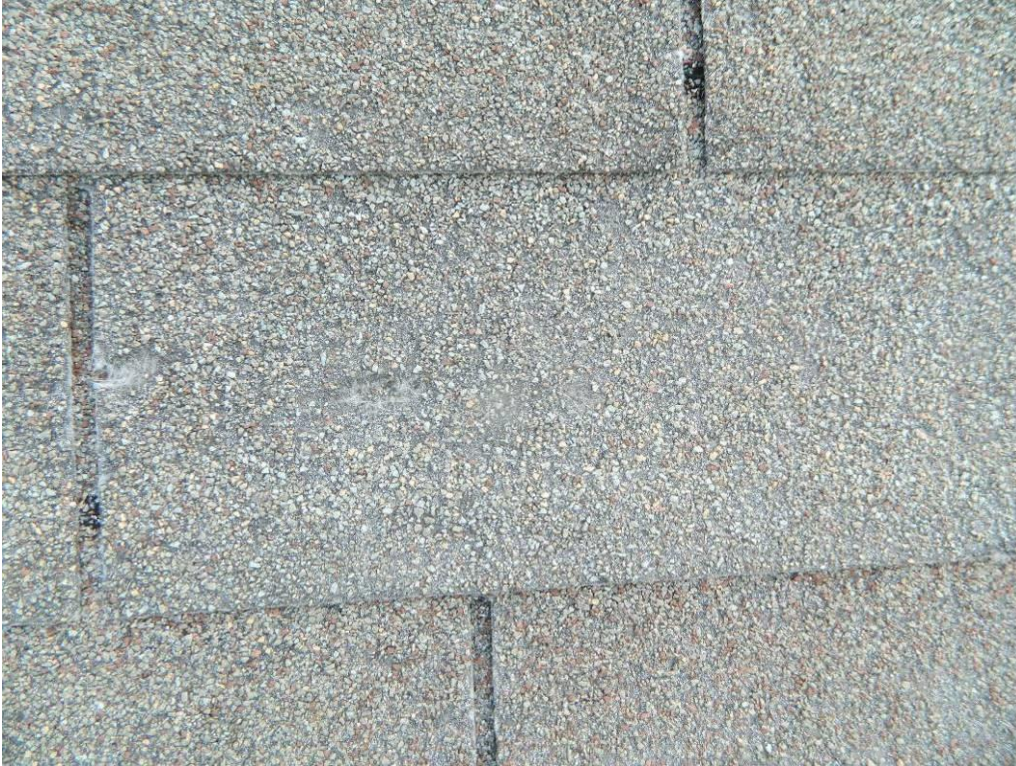
- Locations of granular wear and hail damage.

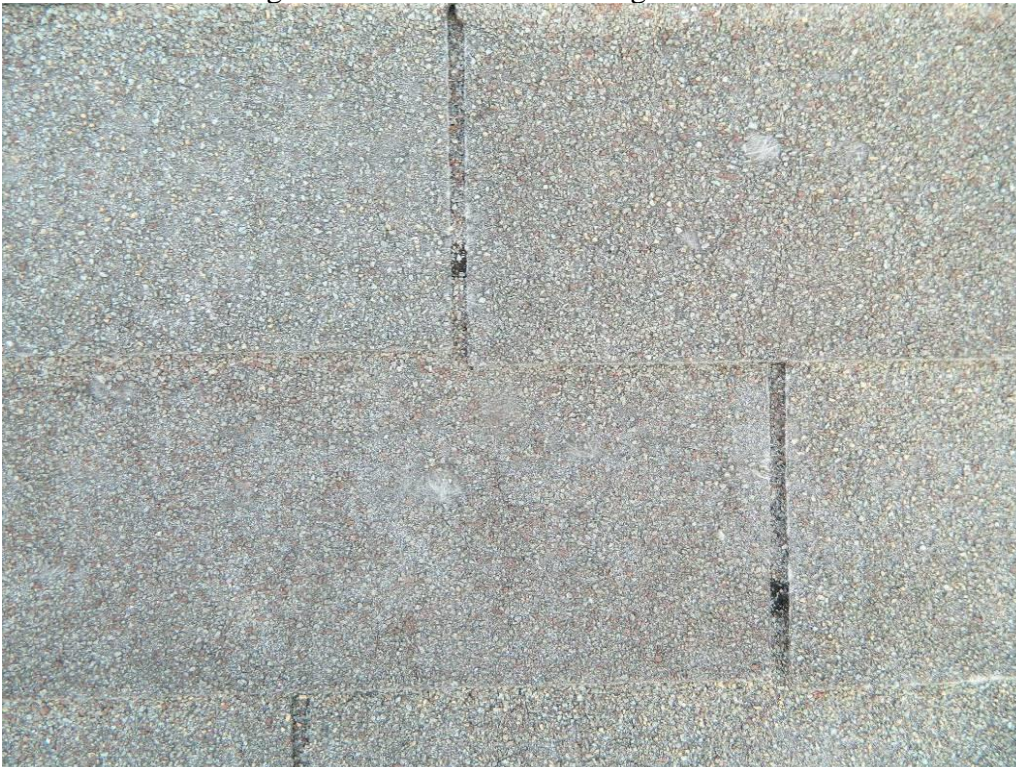
- Locations of granular wear and hail damage.

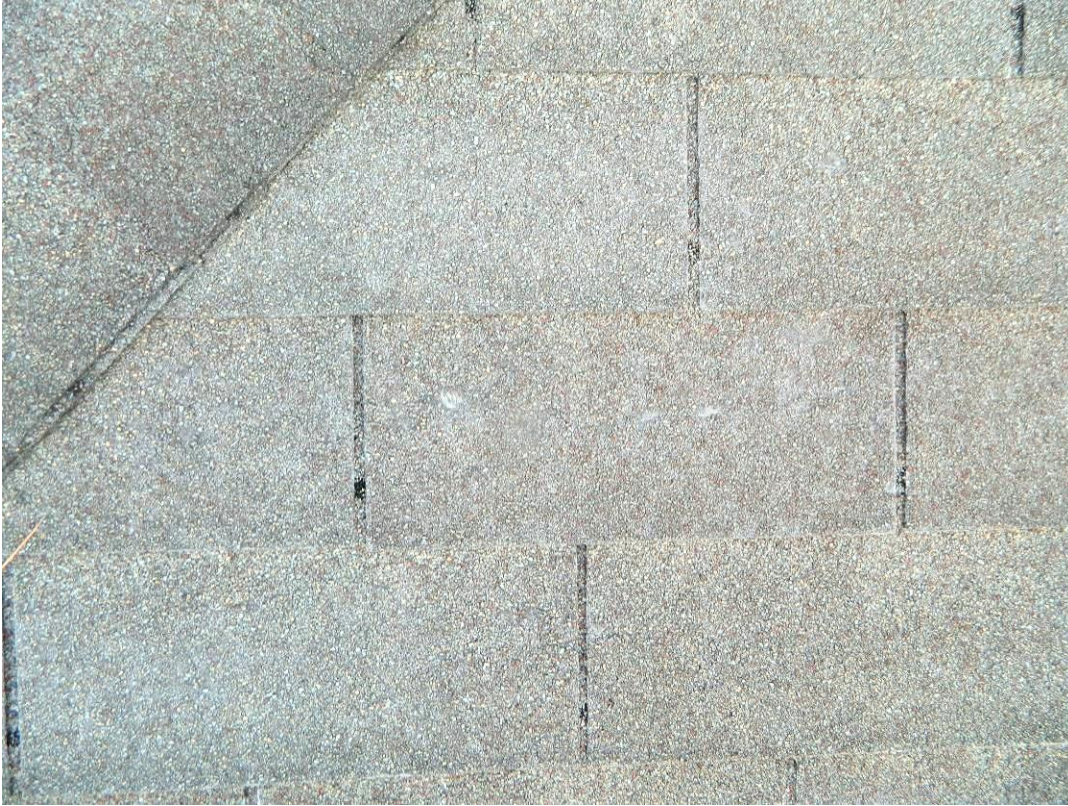
- Locations of granular wear and hail damage.

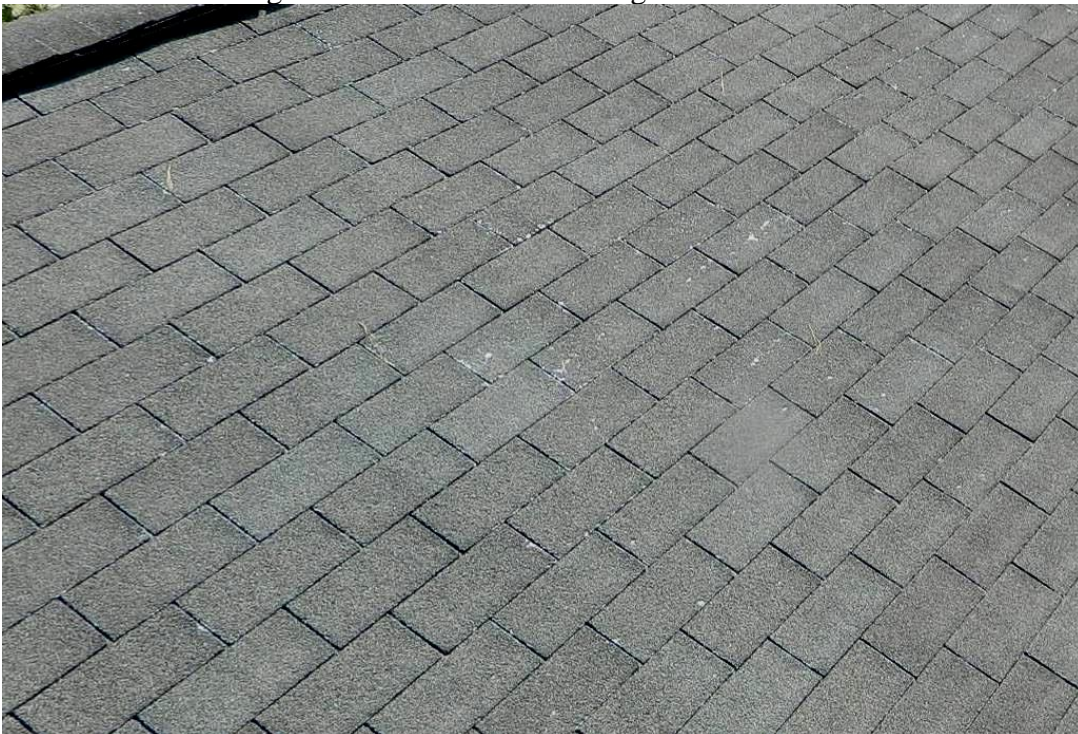
- Locations of granular wear and hail damage.

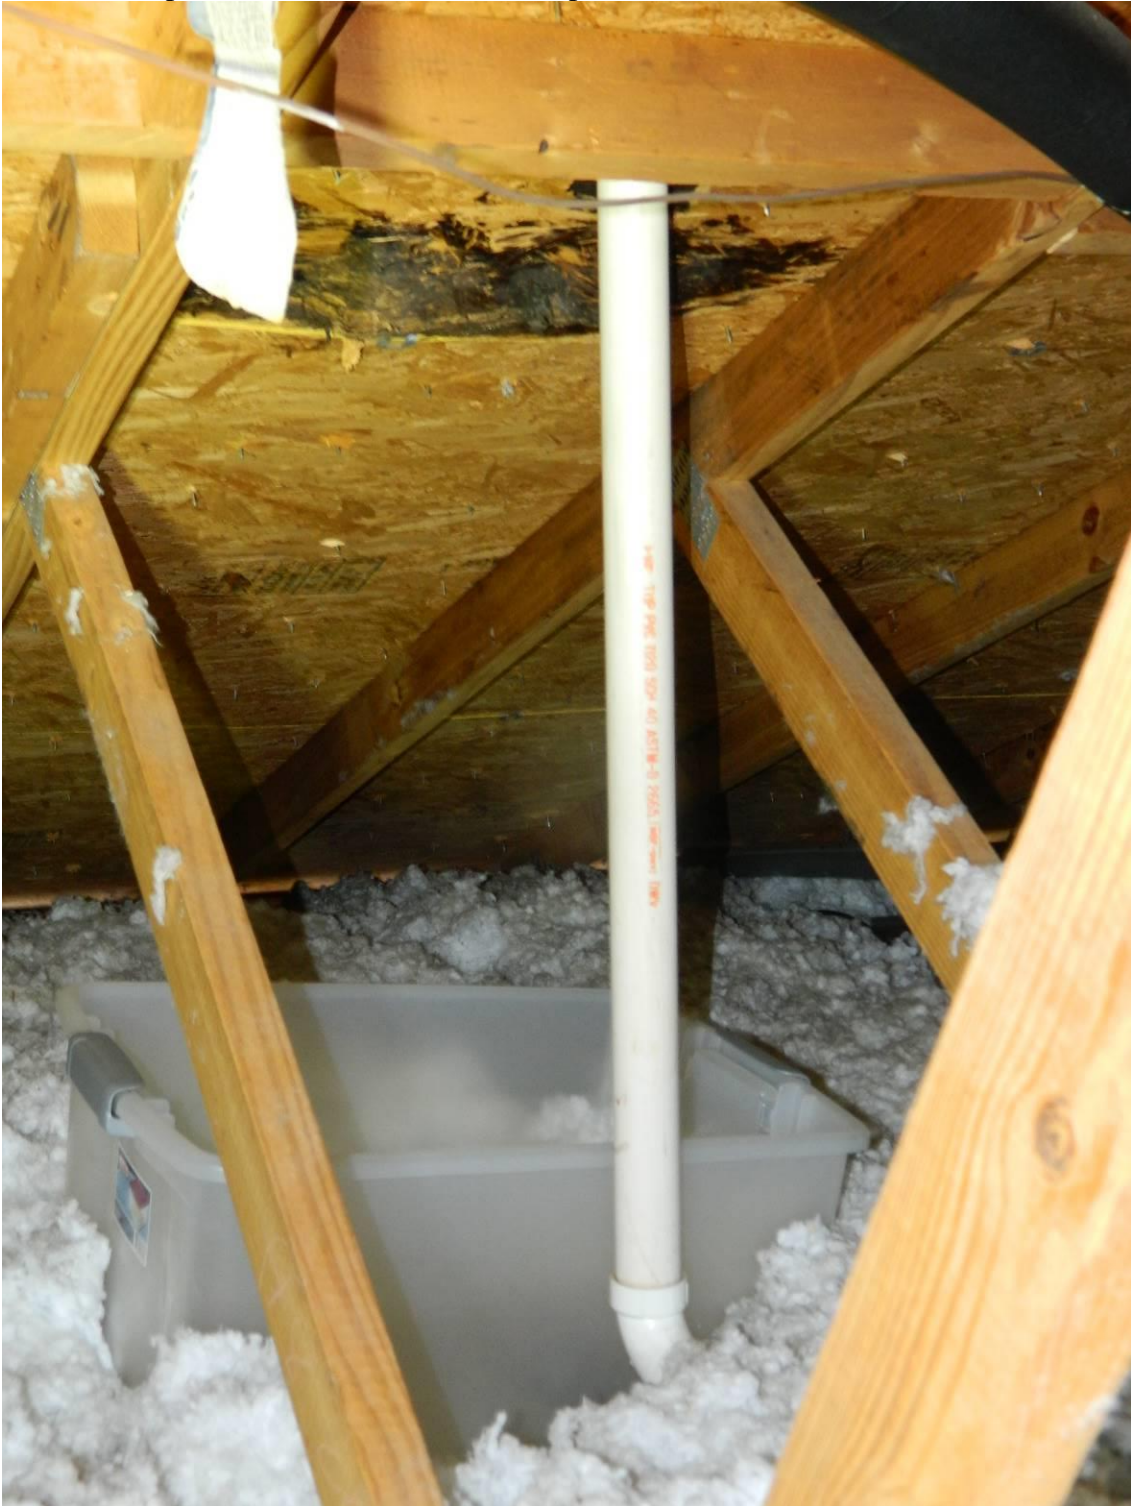
- Water damage to the decking is observed at the right side slope and due to a roof leak. -A bucket has been placed under the roof leak to capture the water.

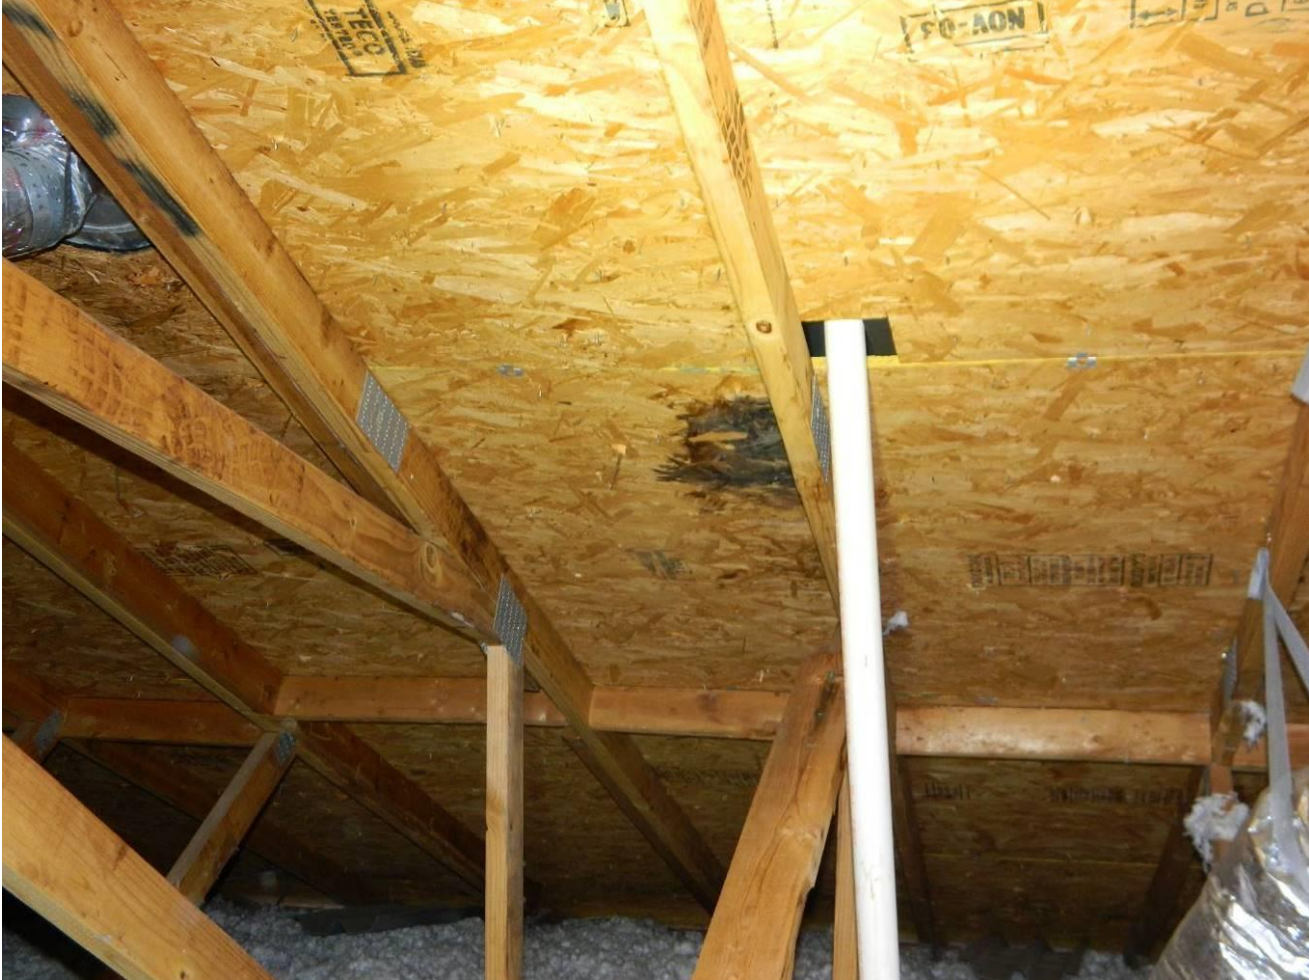
- A roof leak is observed at the left side slope as evident by water damaged decking.

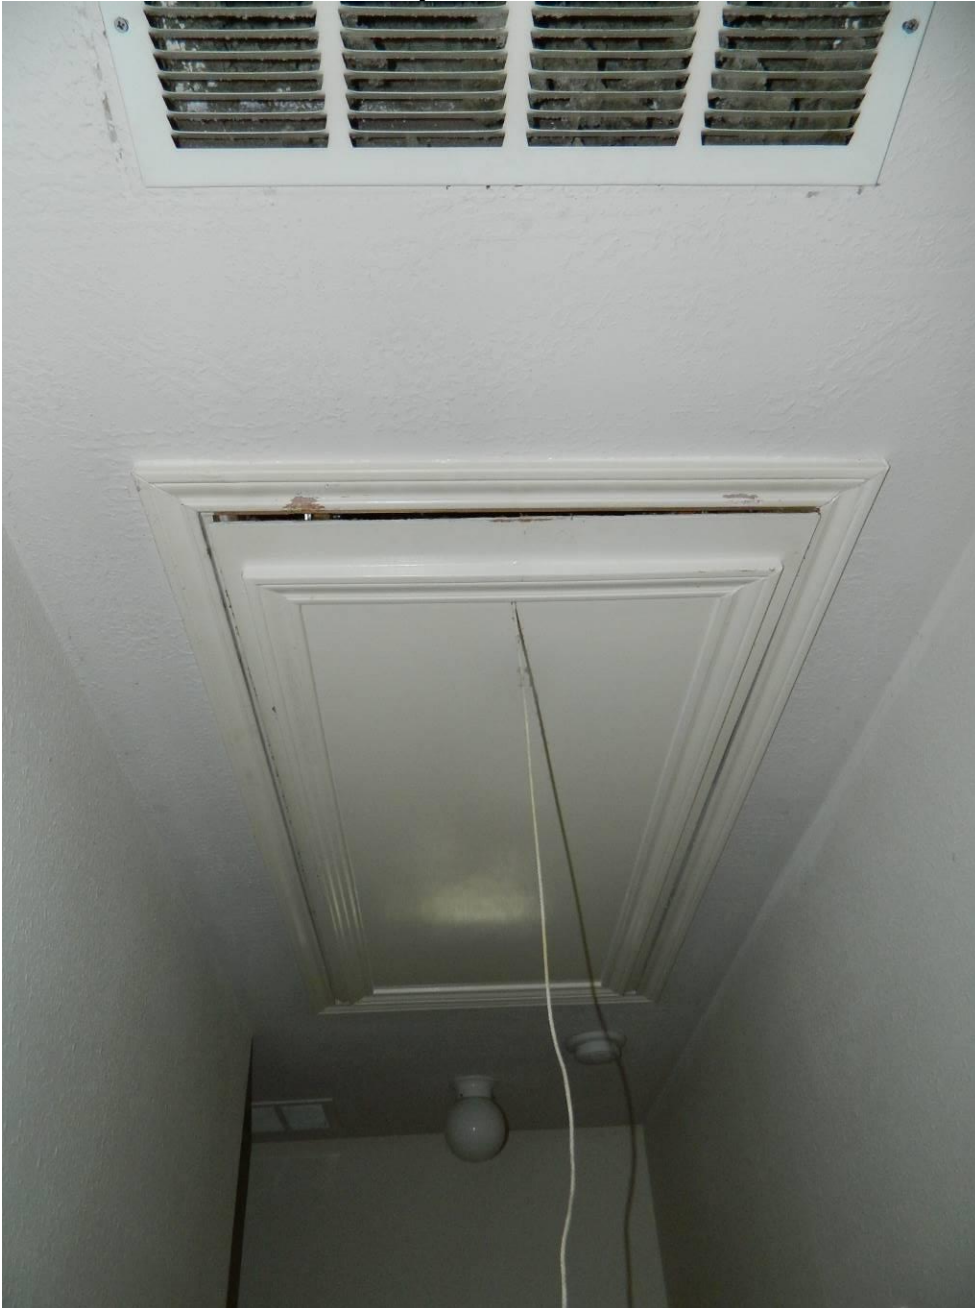
- The attic ladder does not fully close.

- The attic ladder needs to be insulated to reduce energy cost.

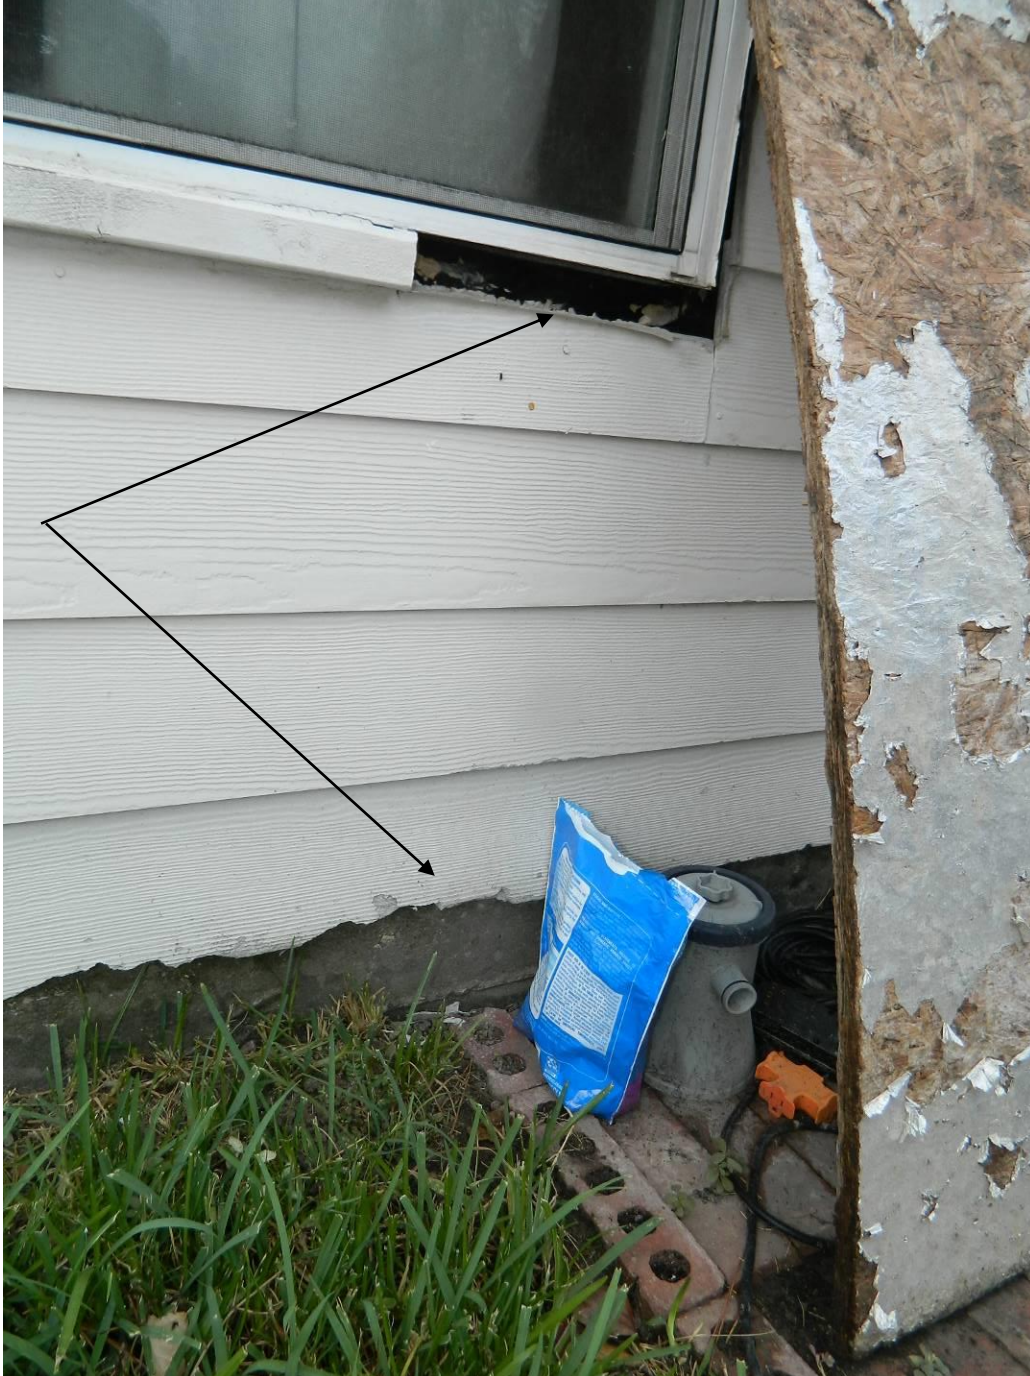
- Damage to the kitchen window trim and Siding is observed at the back of the house.

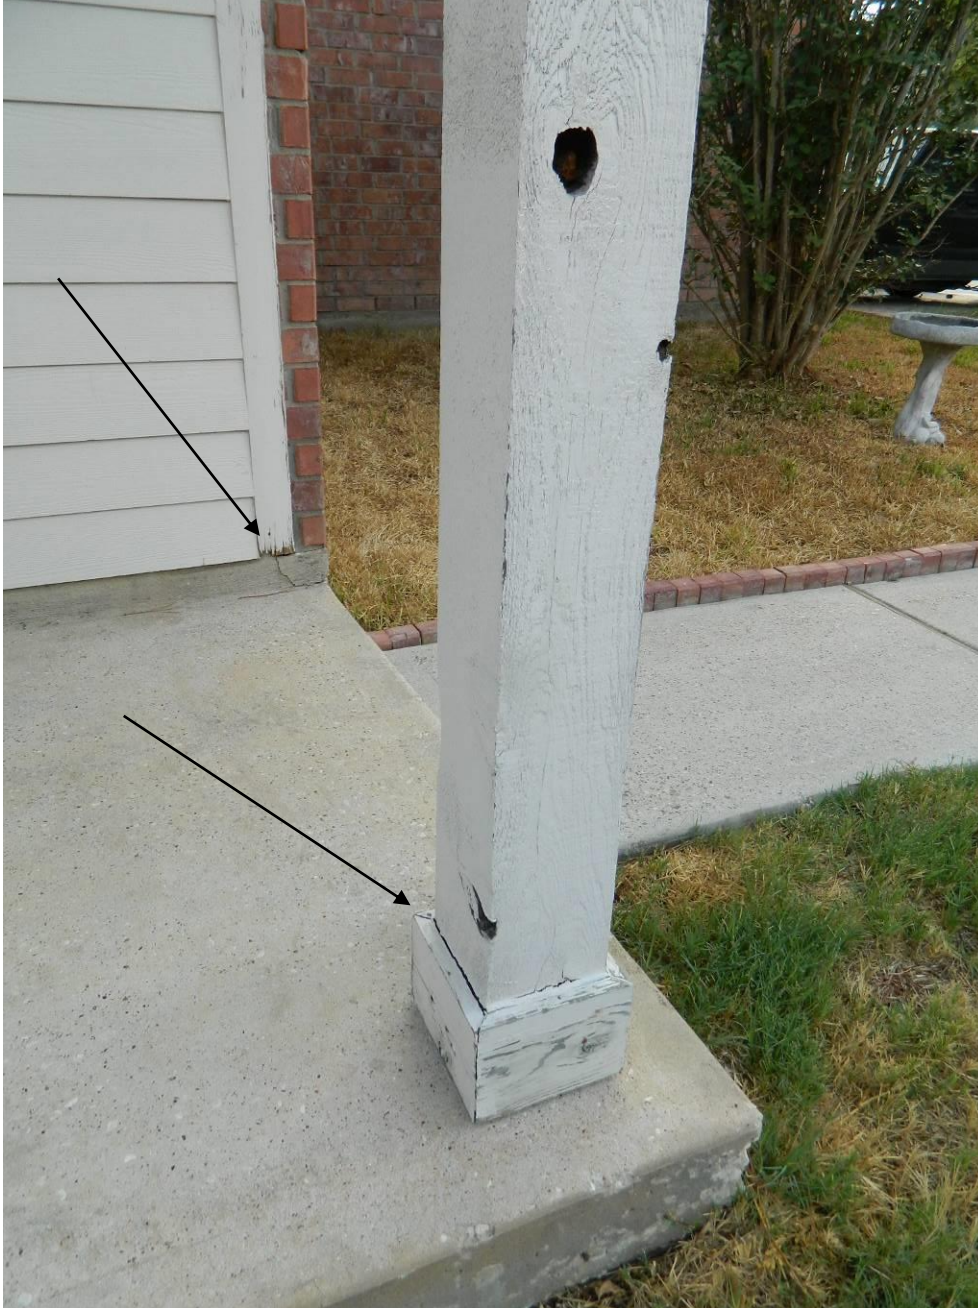
- Minor wood rot is observed to the front lower column's trim.
- Minor wood rot is observed to the siding trim to the right of the front entry.

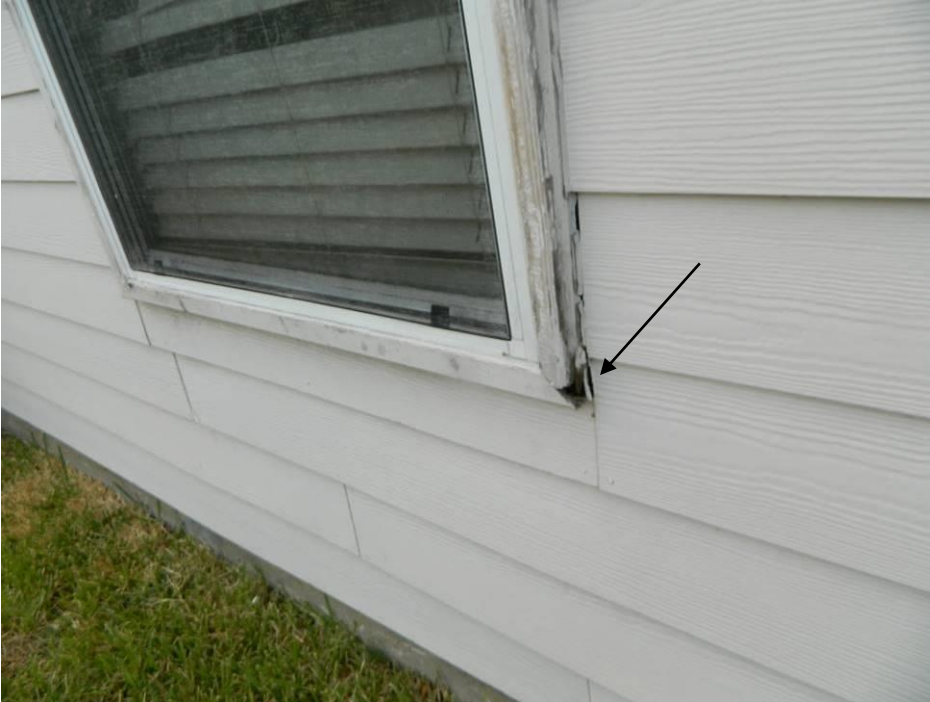
- Wood rot to the master bedroom window trim is observed.

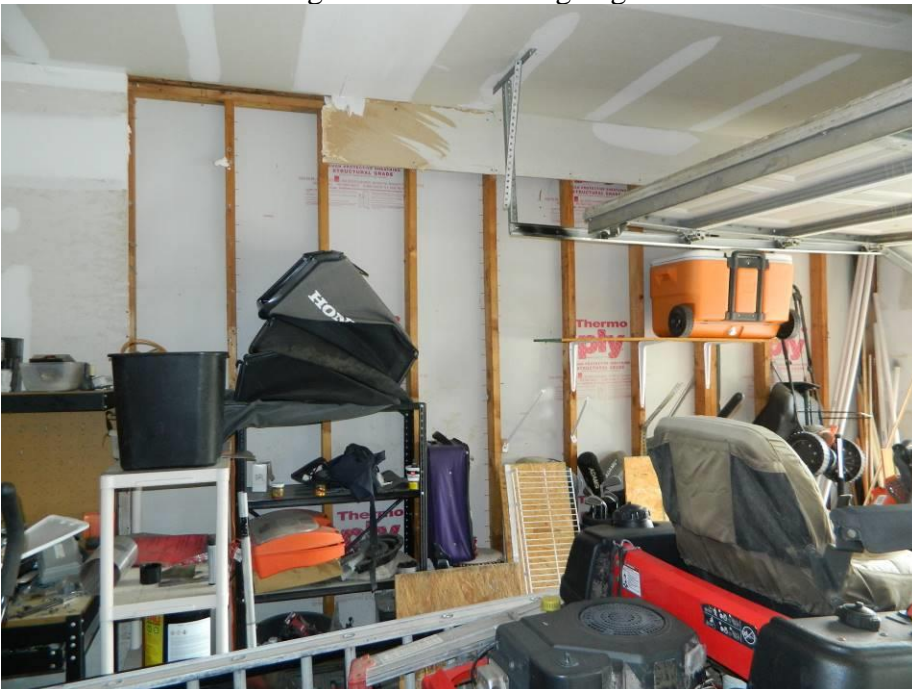
- Minor patched sheetrock cracks are observed at several locations.
- Sheetrock is missing to the wall of the garage.

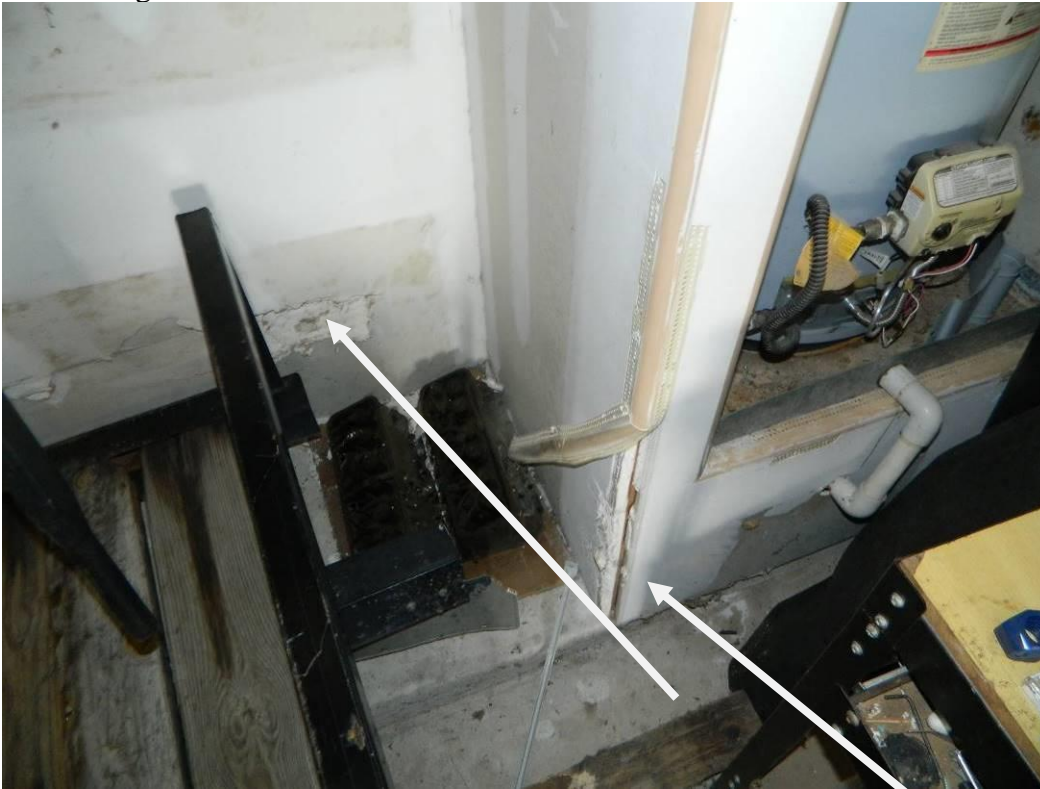
- Damage to the wall due to the trailer.

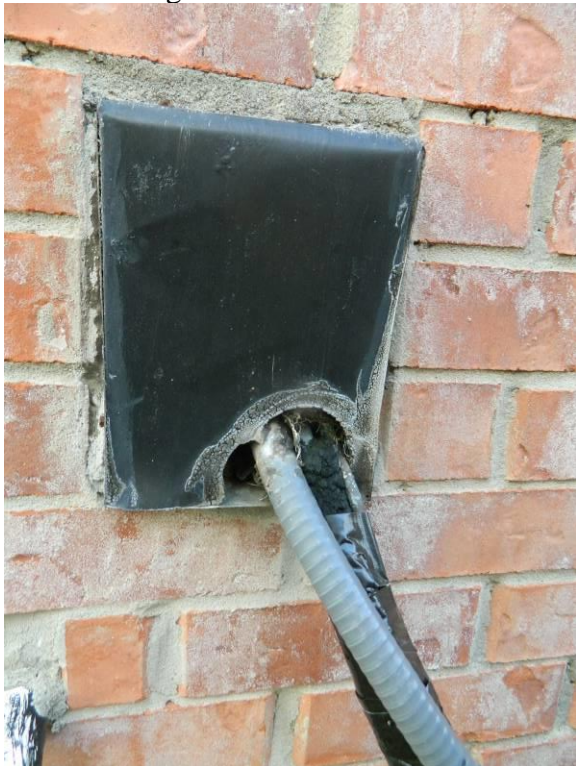
- The refrigerant line entrance needs to be sealed.

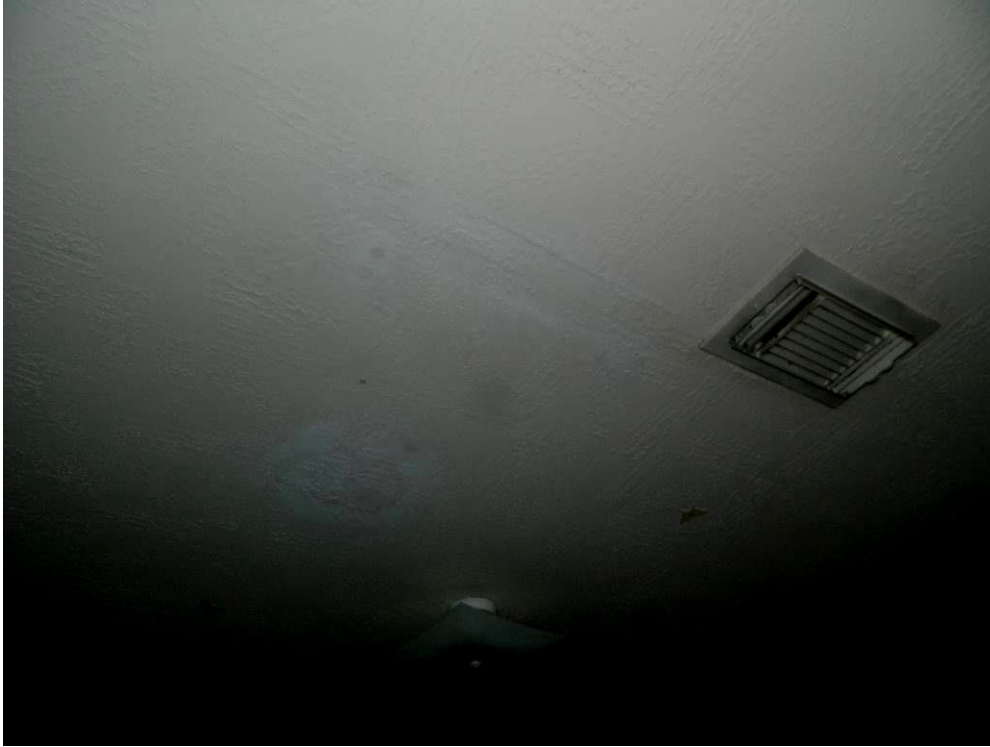
- Water damage (due to a roof leak) and patch is observed to the ceiling of the guest bedroom.

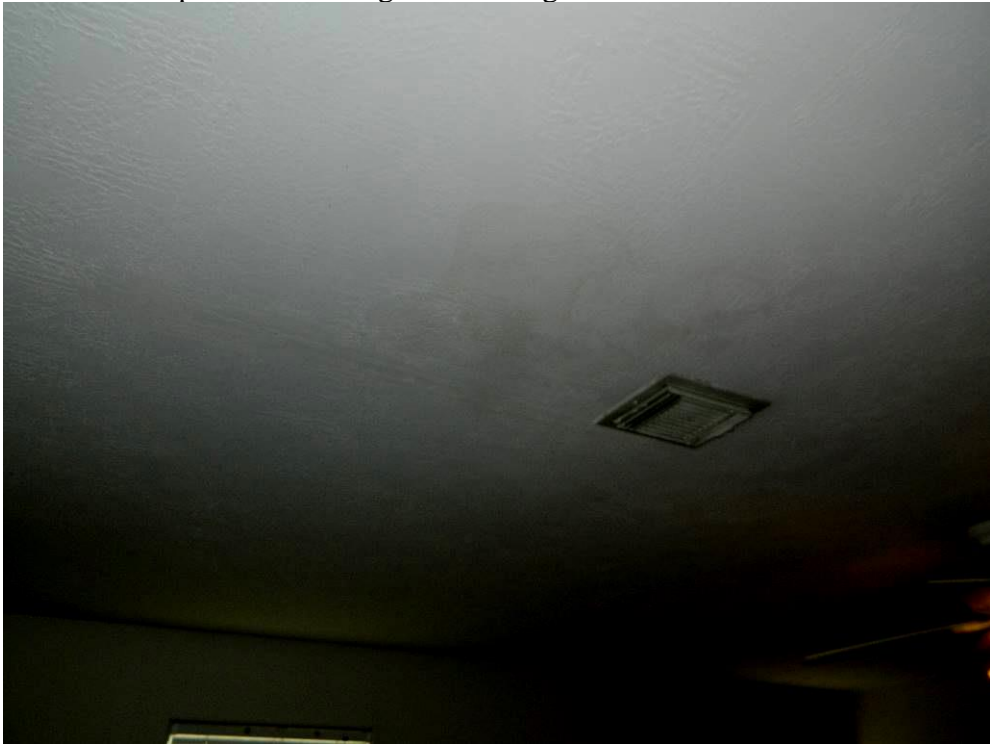
- A water spot in the ceiling of the living room is observed and due to a roof leak.

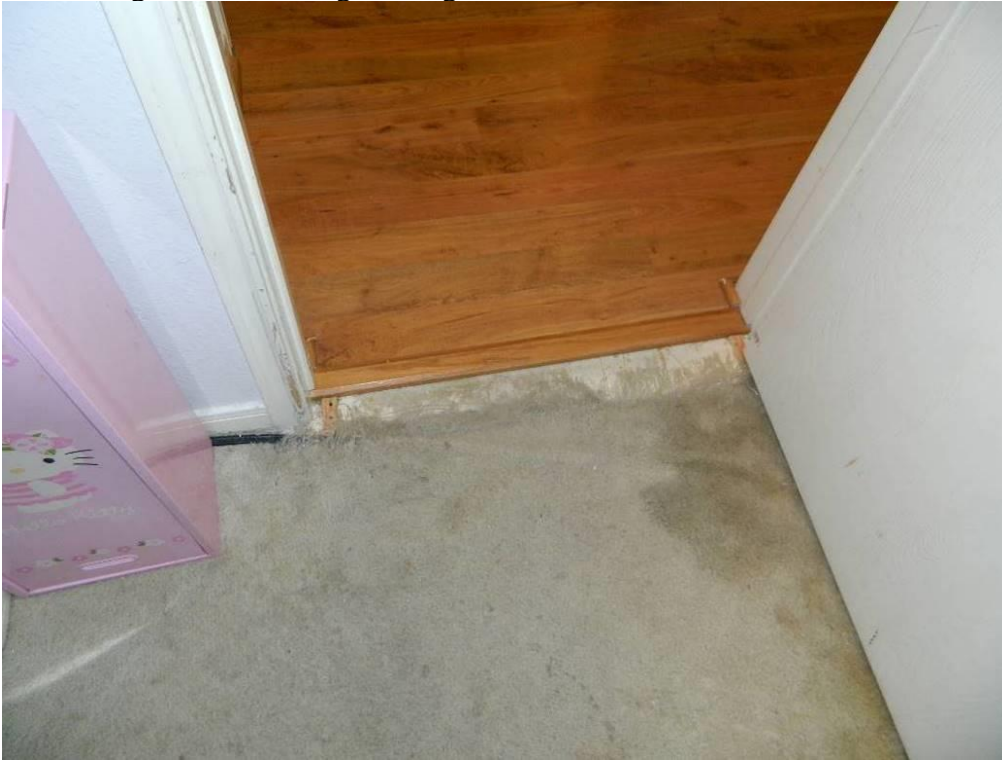
- Damage to the flooring of the guest bedroom and master bedroom.

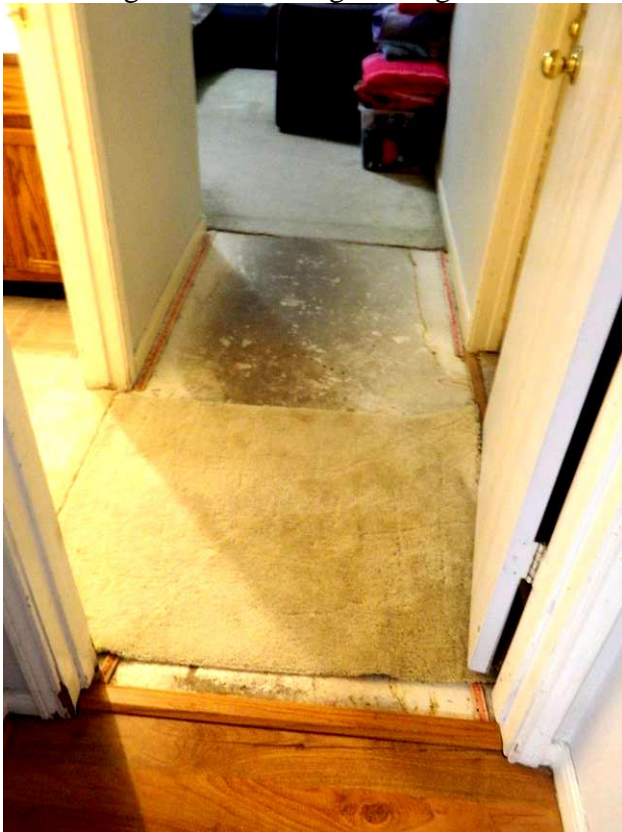
- Damage to the flooring of the guest bedroom and master bedroom.

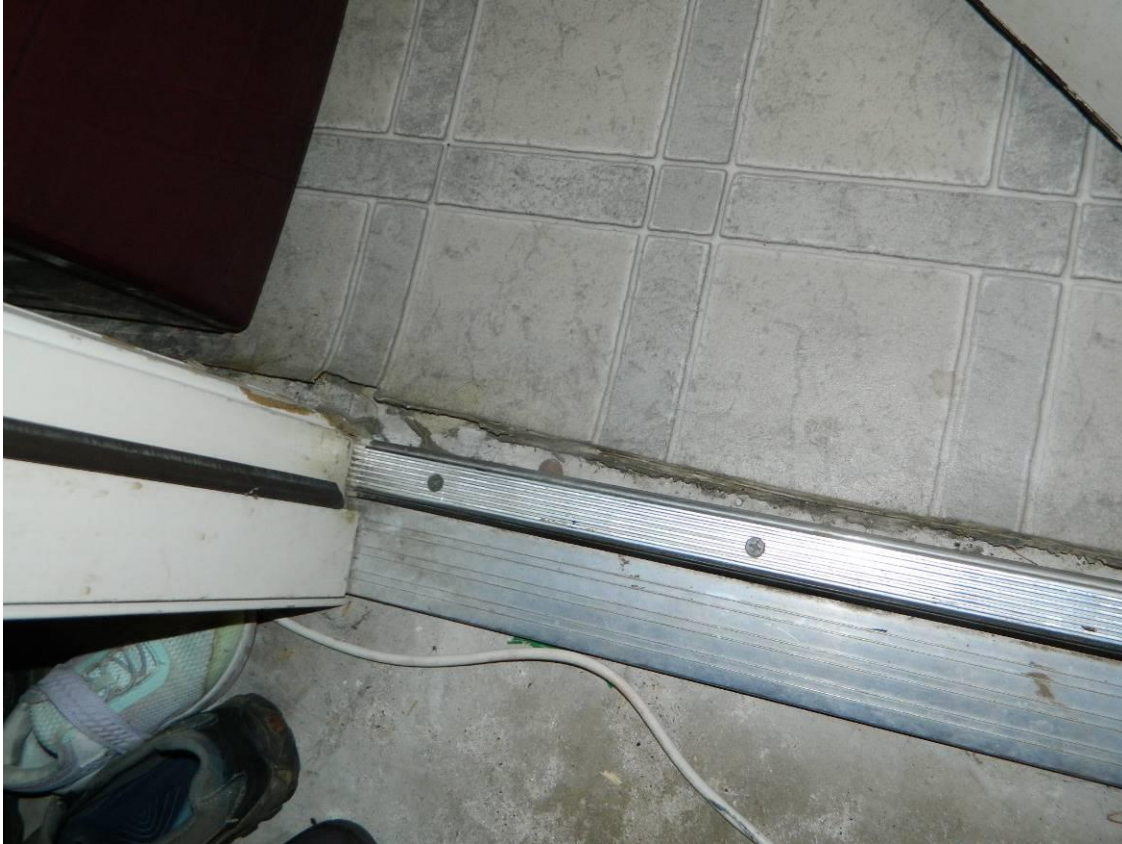
- Minor cracks in the sheetrock are observed at various locations.
- The floors are slightly unlevel in areas.
- The baseboard is loose in the study.
- The quarter round is missing in areas.
- Wood flooring is improperly cut and missing saddle trim at the entry to the kitchen.
- The vinyl flooring is coming up at the garage.

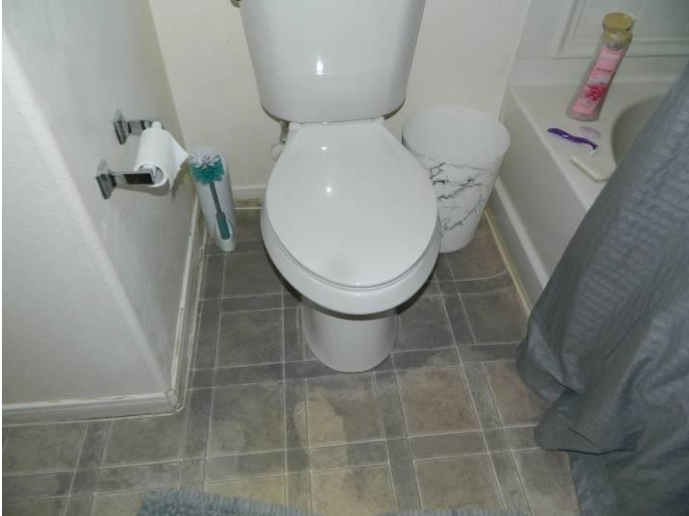
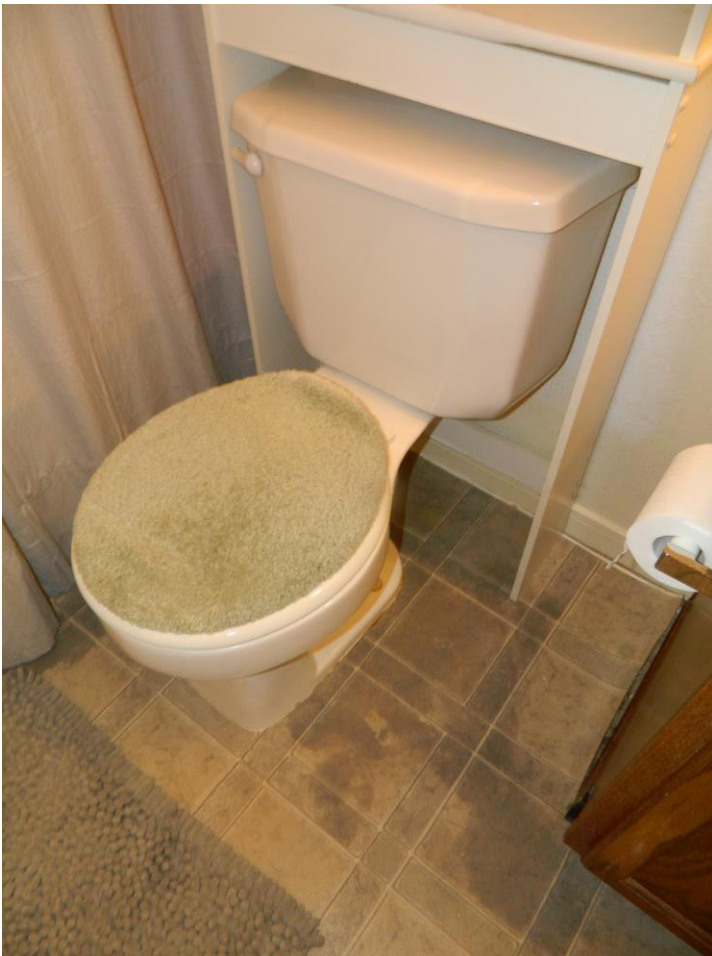
- Vinyl flooring is water damaged around the guest toilet, master toilet and near the back door. The flooring is coming up in areas.

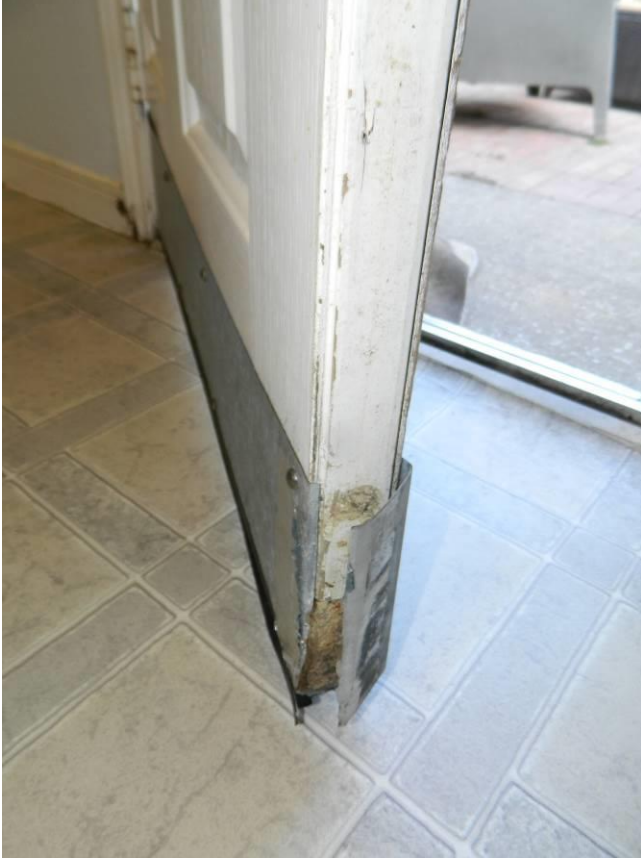
- The rear door has wood rot at the bottom and metal flashing in an attempt to repair.

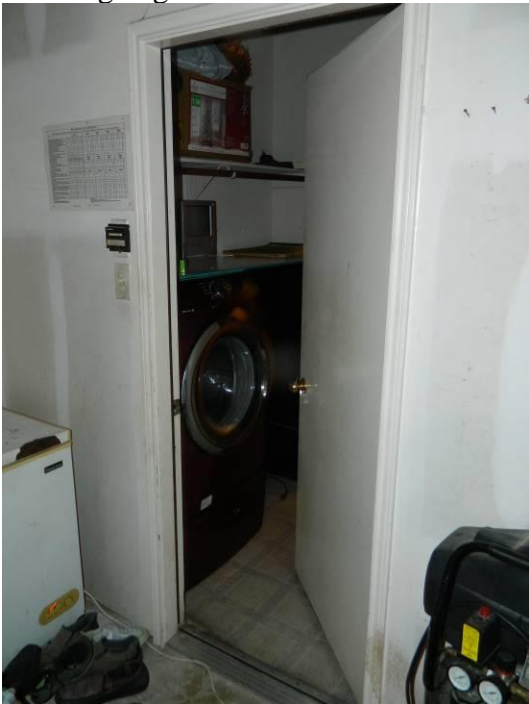
- The garage door should be a self-closing 20-minute fire door.
