Glenco Inspections

PROPERTY INSPECTION REPORT

Concerning: 8810 WILLOW SPUR DR.

Inspector Jason Smith

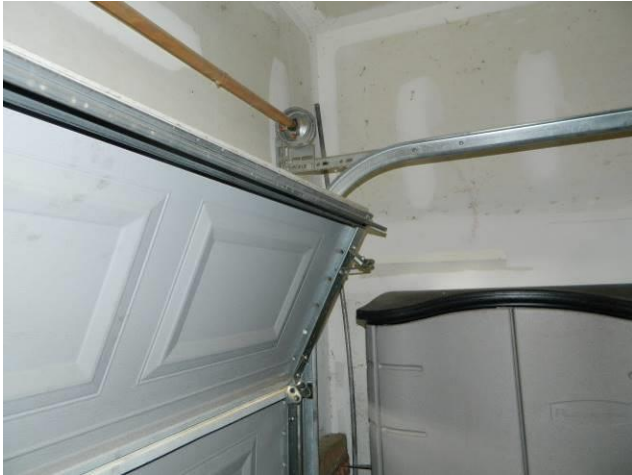
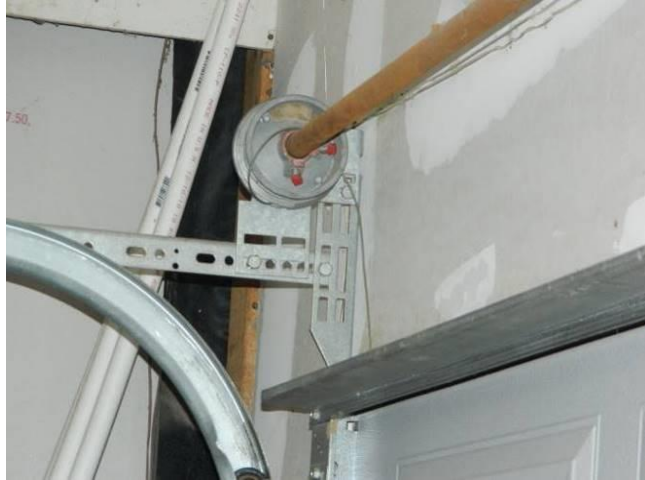
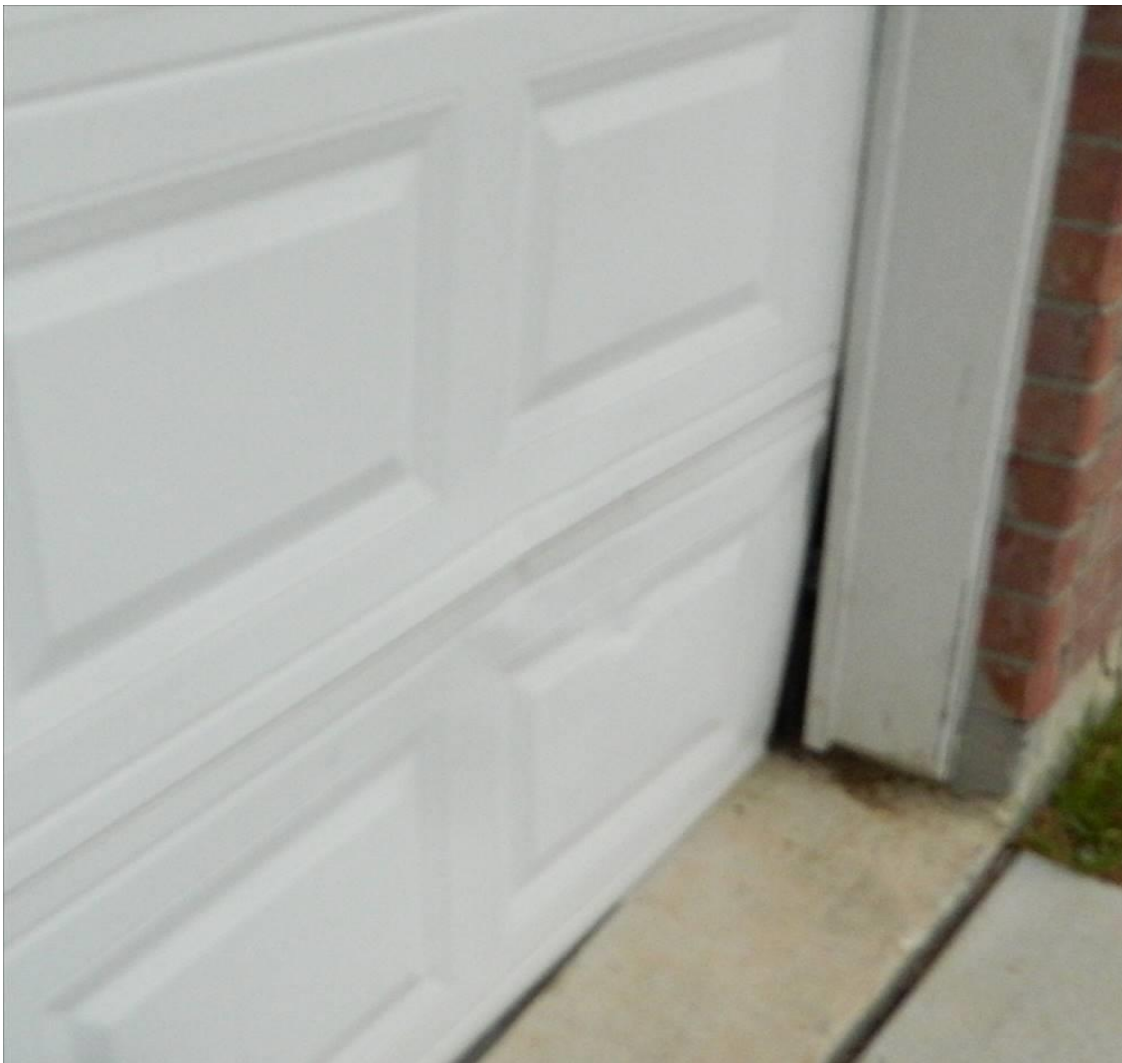
- The garage door is damaged, dented at the bottom right corner, missing rollers, damage torsion bar wire and off the tracks.

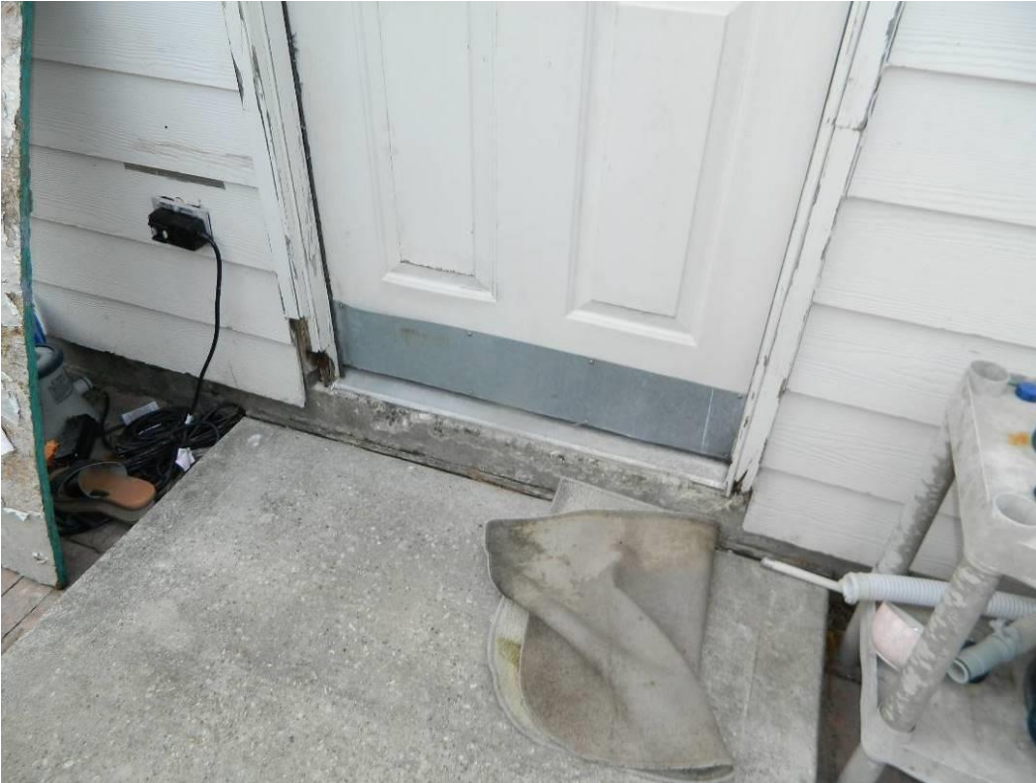
- Wood rot to the rear door, door trim and frame is observed.

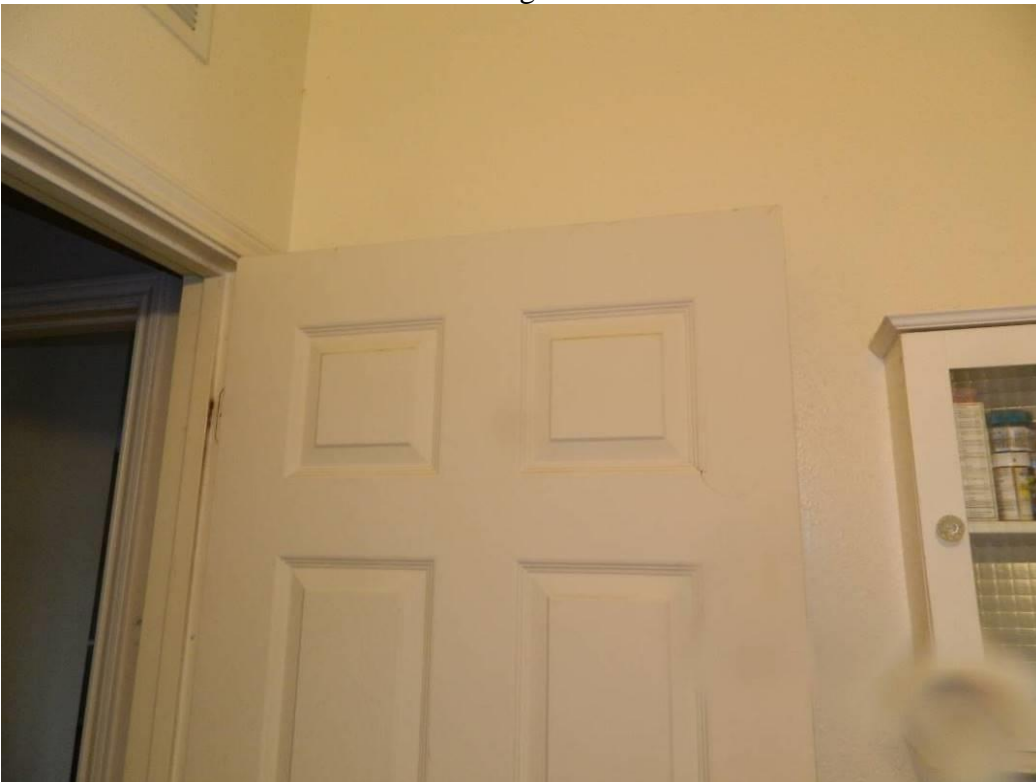
- The master bathroom door is damaged/ cracked.

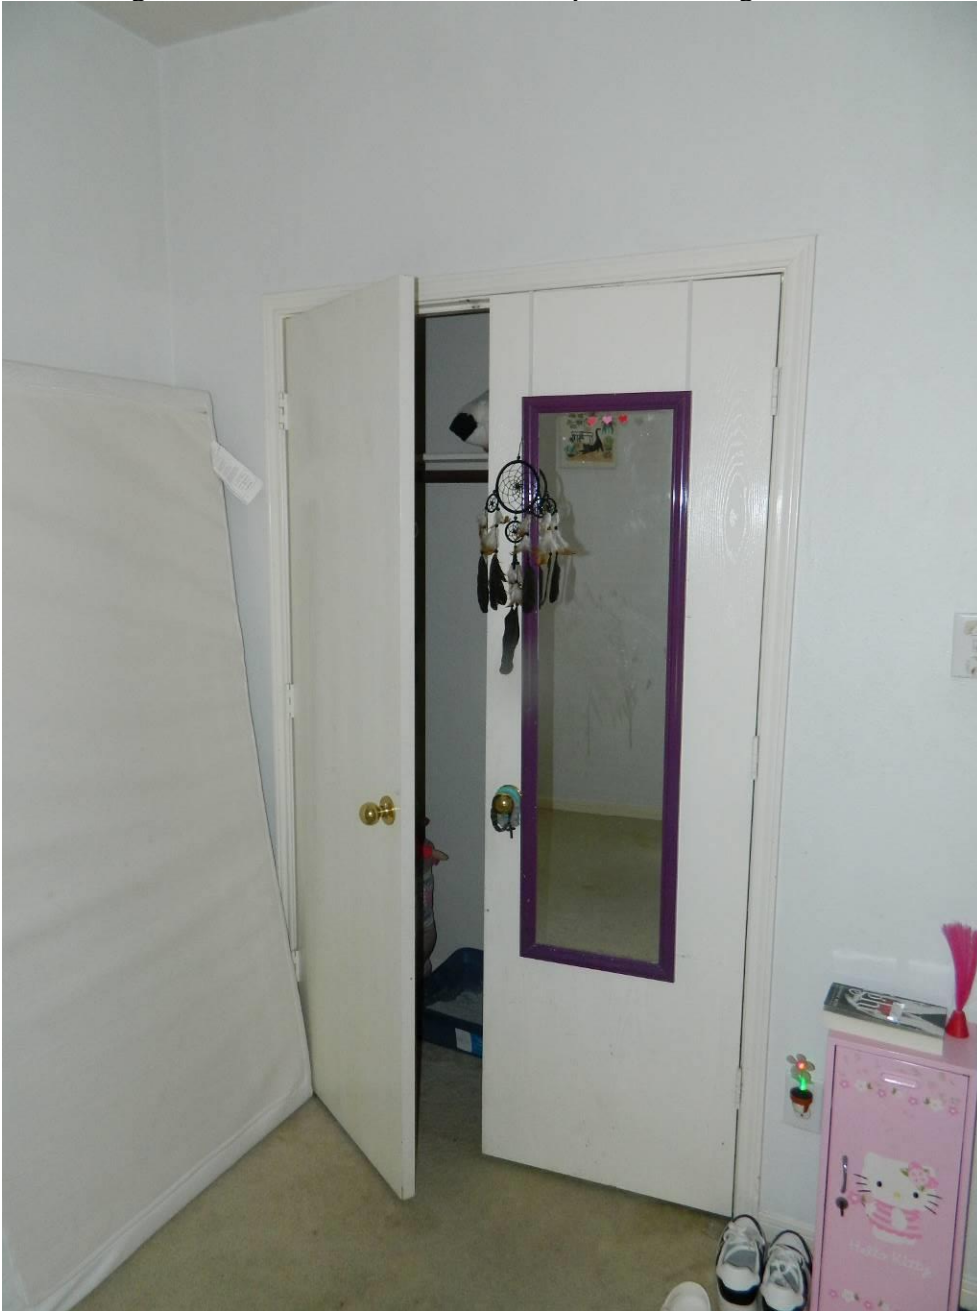
- The guest bedroom closet door ball stops are missing. -The doors do not stay closed.

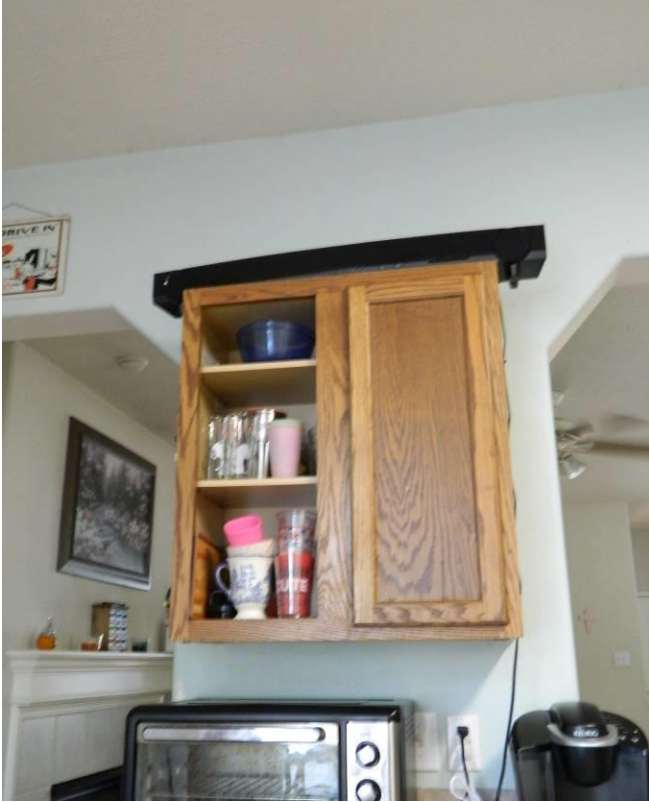
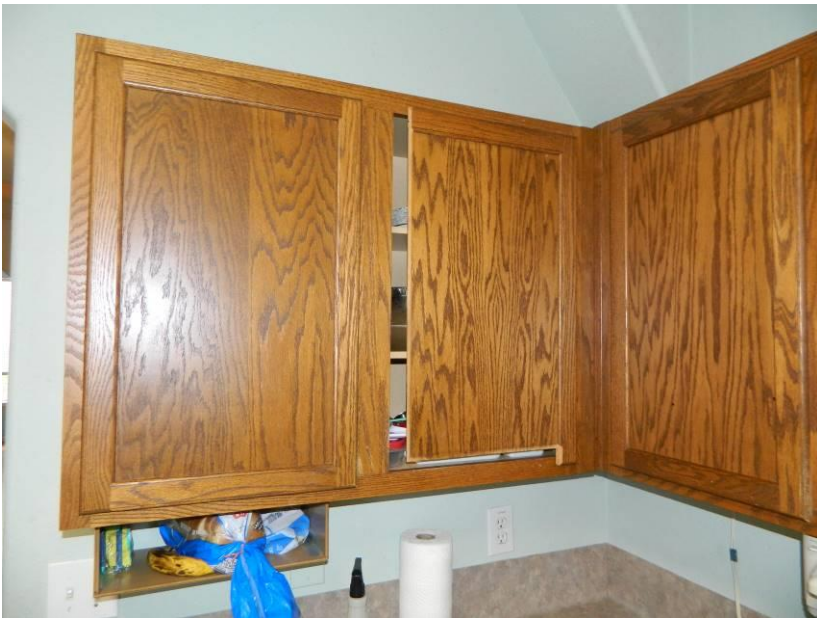
- A kitchen cabinet door is missing, and one is damaged.

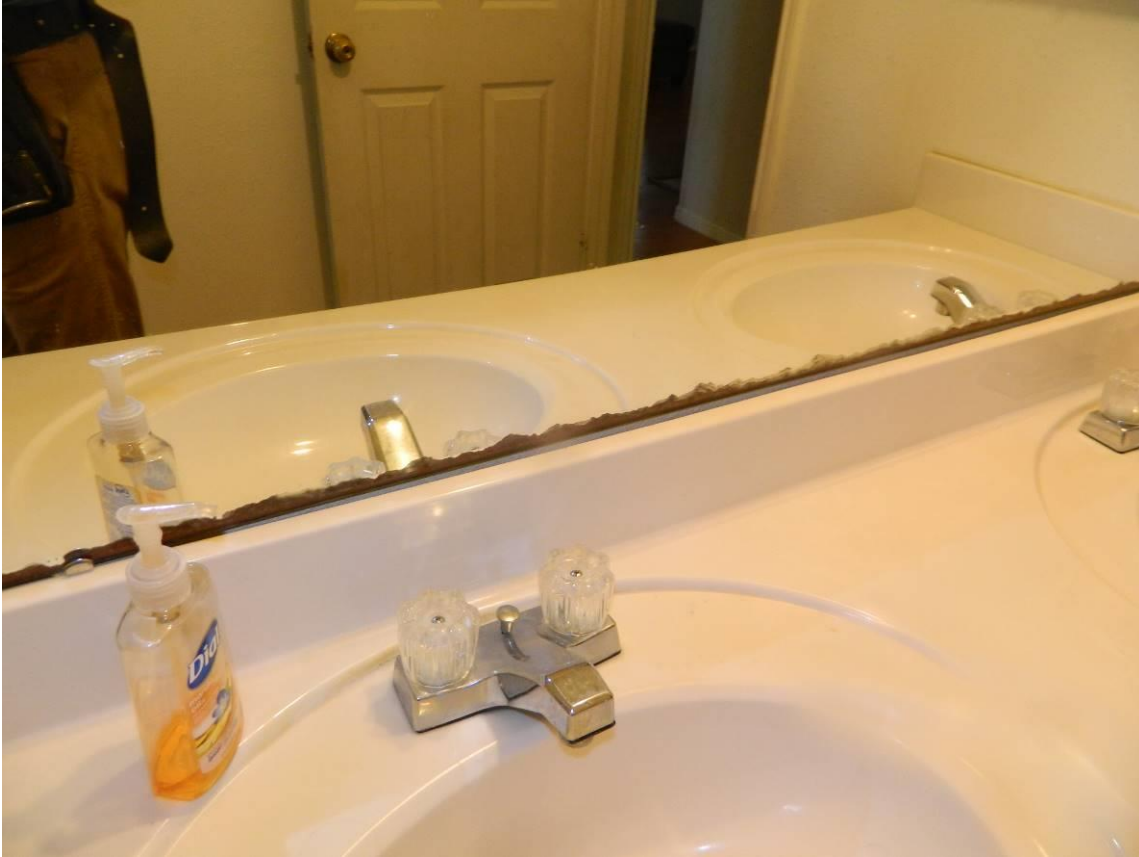
- Mirror rot is observed to the master and guest bathroom mirrors.

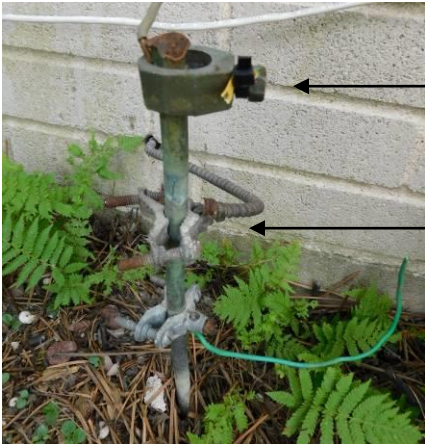
- The electrical system should be equipped with 2 ground rods/devices installed in an approved manner, connected to the ground bus bar through a single wire or parallel wires. In the event 2 ground rods are installed, the ground rods should be spaced a minimum of 6ft apart. (if 25 ohms of resistance or less can be verified, the second ground rod is not required) Only one ground rod was observed.
- The service equipment-grounding electrode (rod) is an incorrect type clamp. An acorn clamp approved for direct contact with soil should be installed.

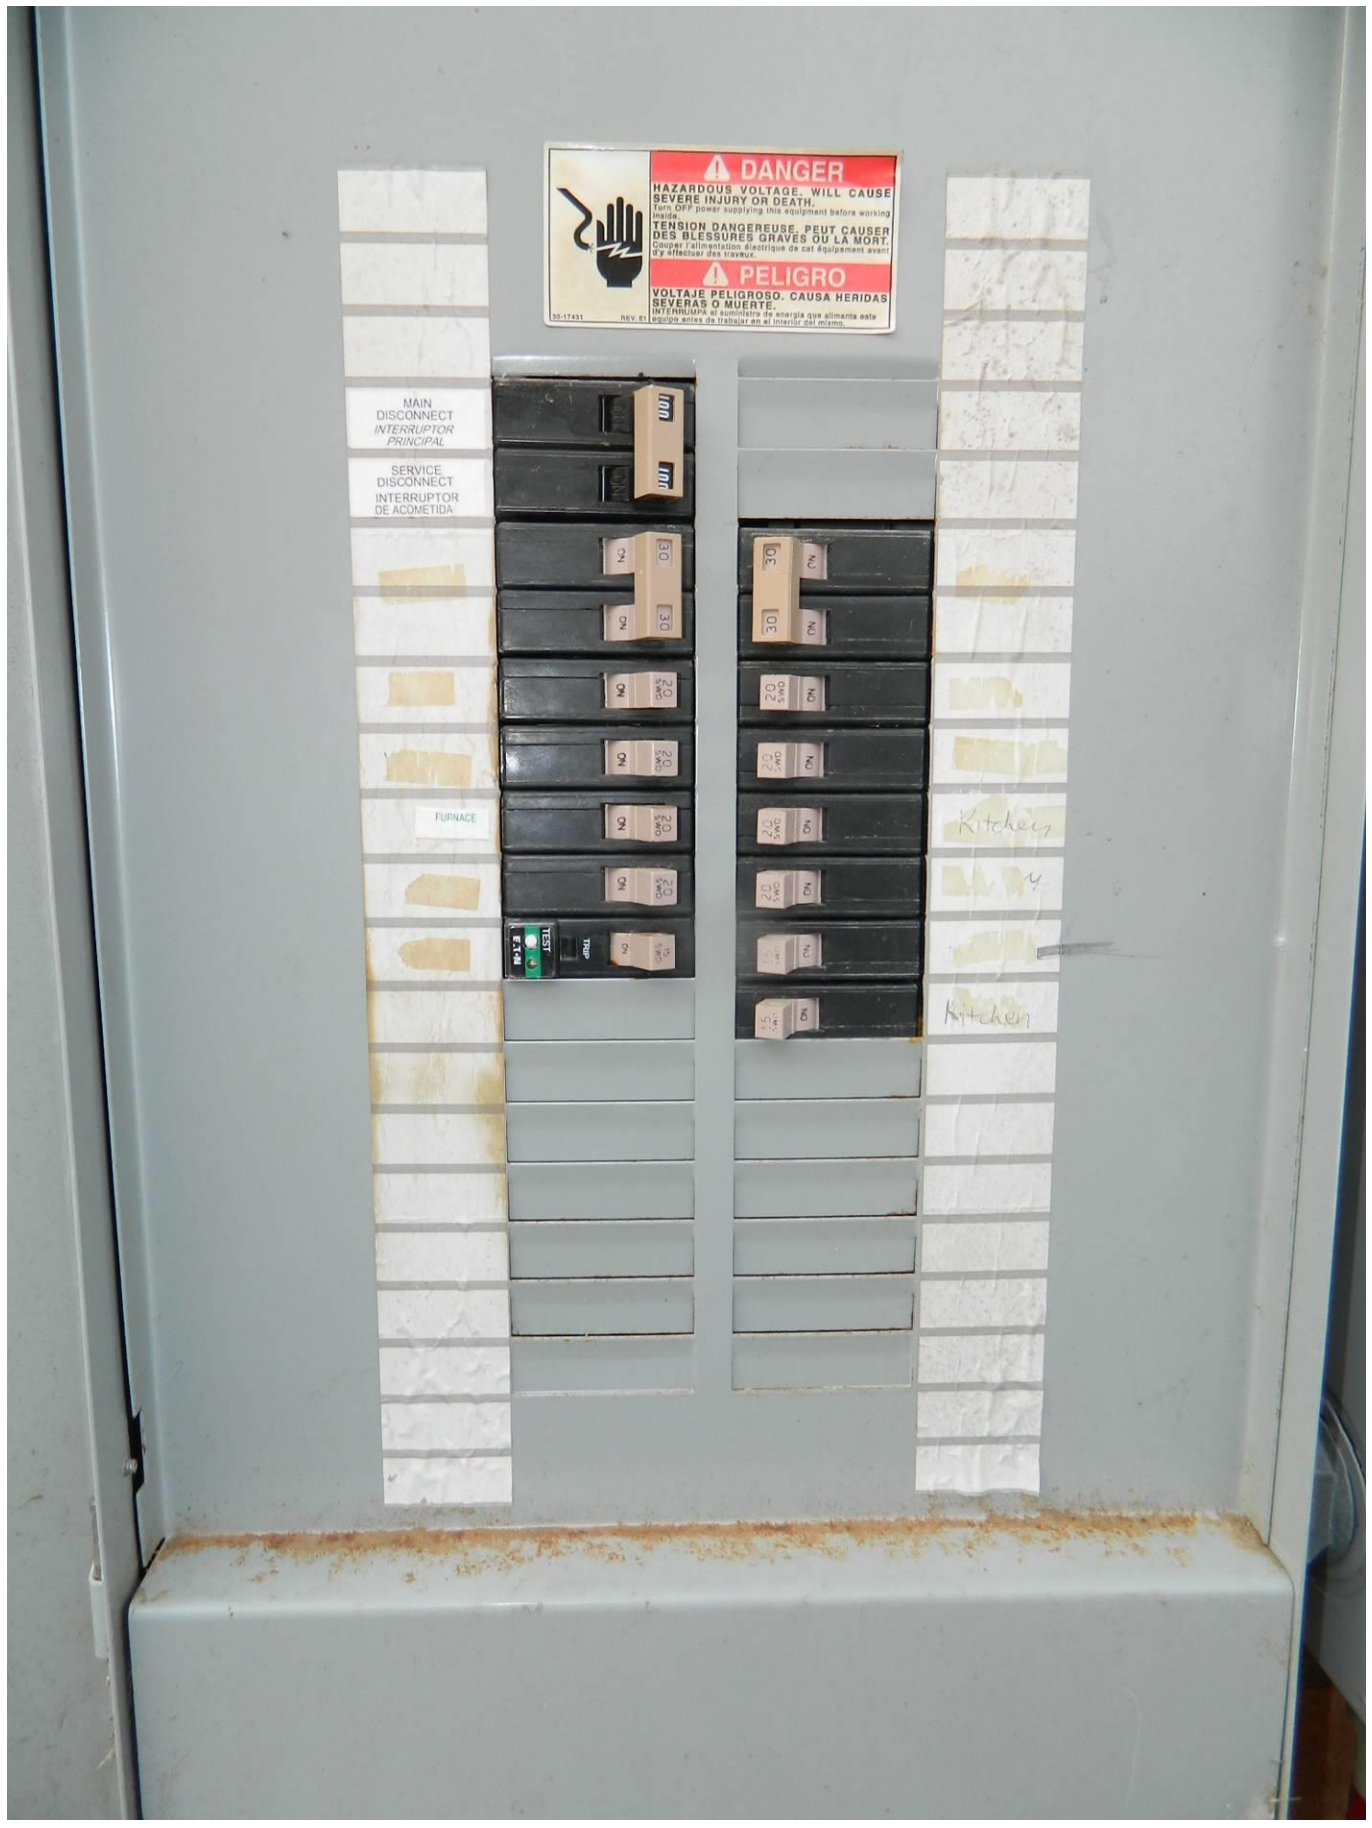
- The service wires should have anti oxidation grease installed to prevent heating and electricity loss.
- All circuits/ breakers should be clearly labeled to identify the outlets or appliances served by that breaker.
- White insulated wires used as hot wiring should be labeled at both end with black tape.
- Arc fault breakers are needed. Arc fault breakers should be installed in all outlet locations including the family rooms, dining rooms, living rooms, parlors, libraries, dens, bedrooms, sunroom, recreations rooms, closets, hallways, laundry room or similar rooms, area or areas.

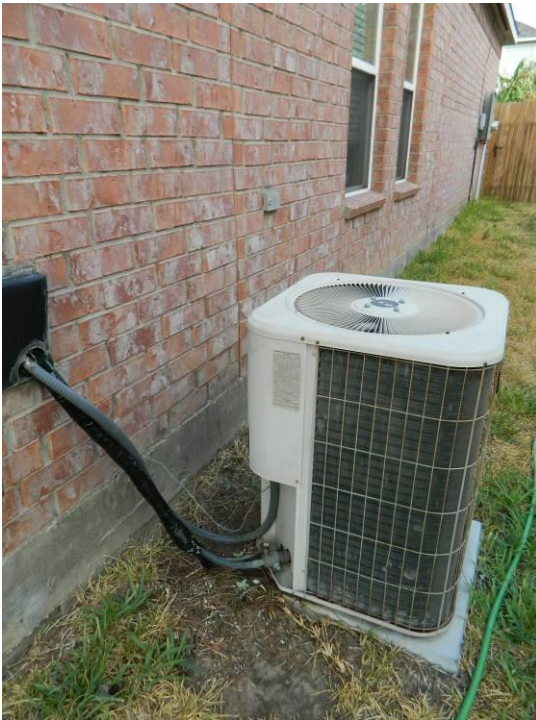
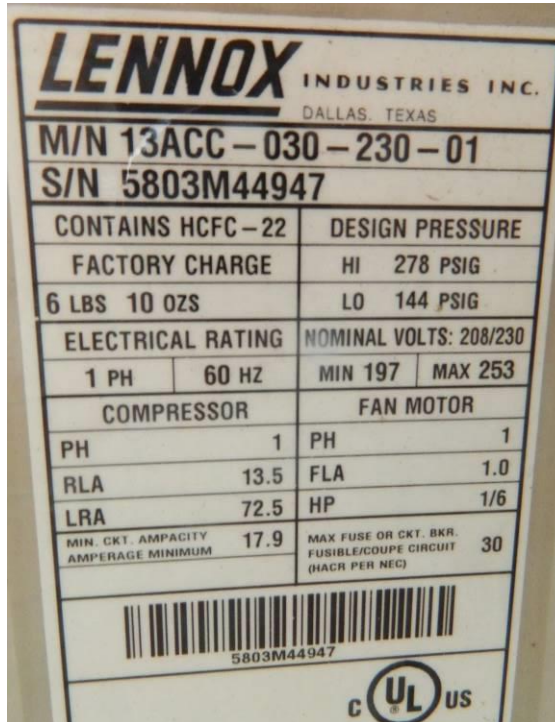
- The A/C system was manufactured in 2003 and considered to be past its normal life expectancy.
- The evaporative coil has rust at the sides of the coil which will cause refrigerant leaks. Also, the coil is dirty and needs to be cleaned.
- The primary drain from the evaporative coil should be fully insulated.
- The refrigerant line/ suction line needs to be fully insulated at the condenser to prevent condensation.

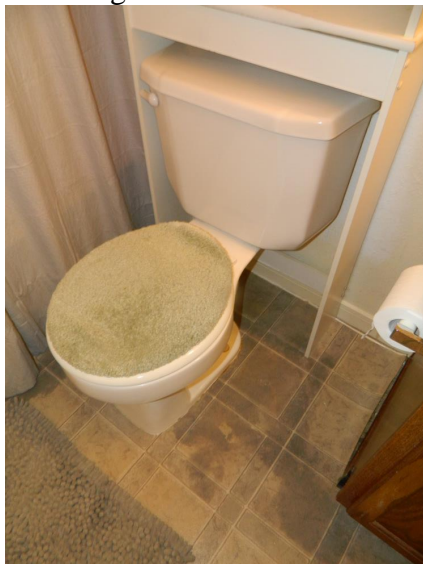
- The guest toilet leaks at the base as evident by water damage to the surrounding flooring.

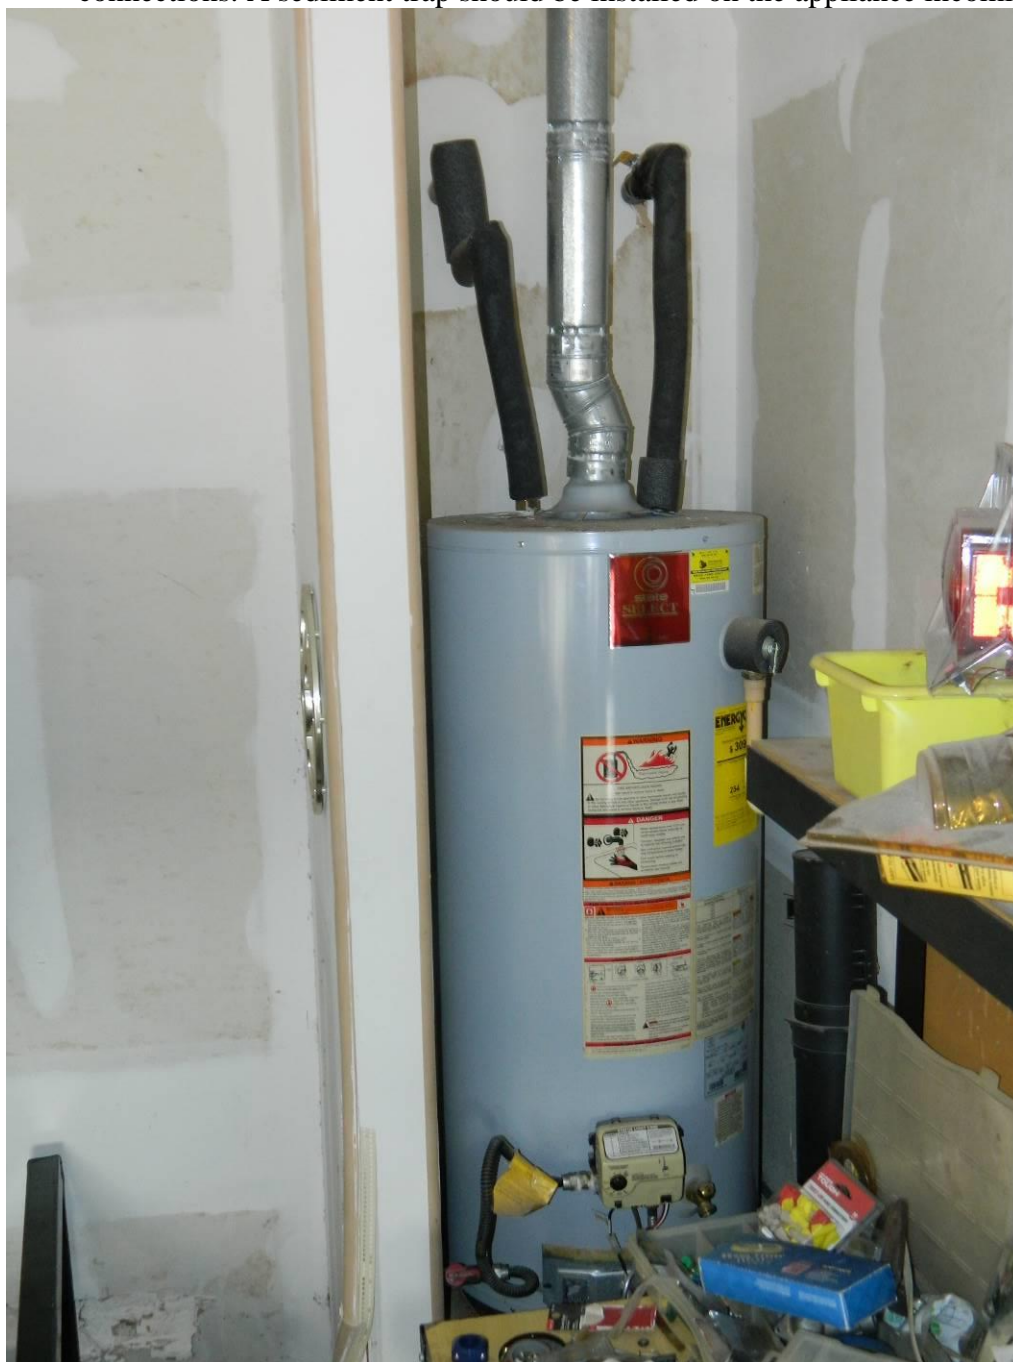
- No drip leg was noted. A “drip leg” or “sediment-trap” is normally required for gas appliance connections. A sediment trap should be installed on the appliance incoming gas line.

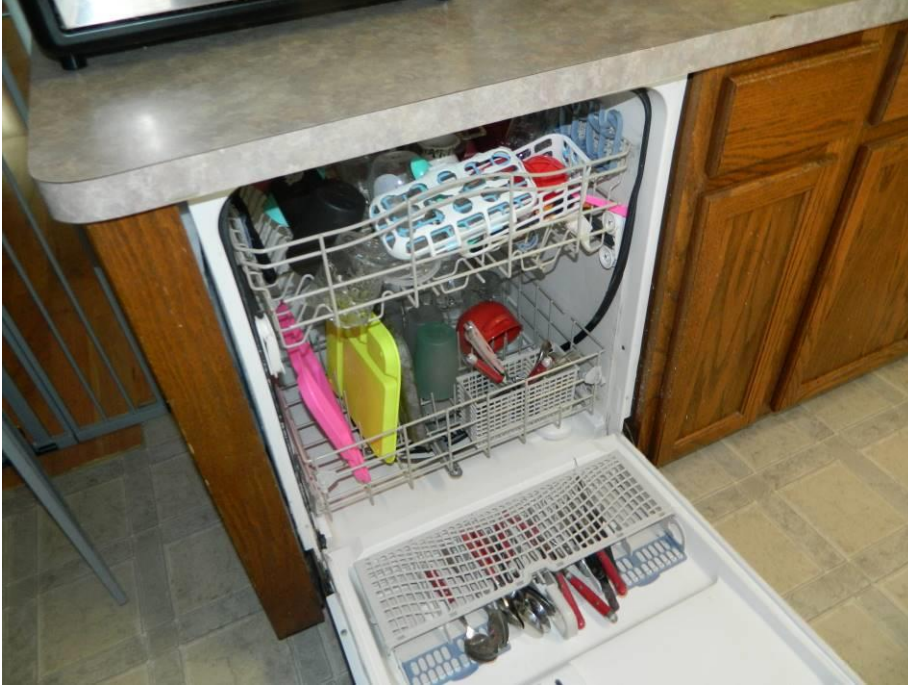
- The unit door gasket is damaged, the unit will leak.
- The button covers are damaged.
- No air gap valve in discharge line off the dishwasher to prevent backflow from the disposer.

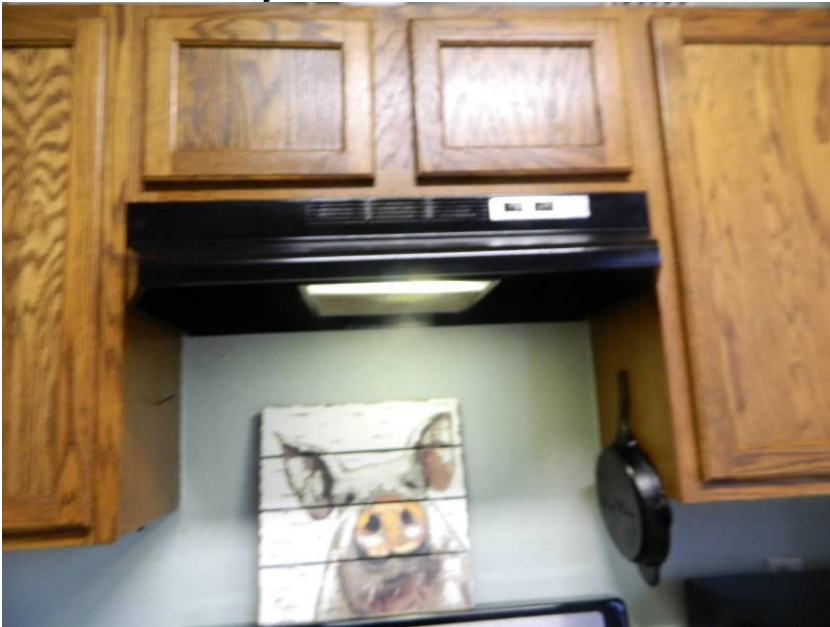
- The unit is noisy.

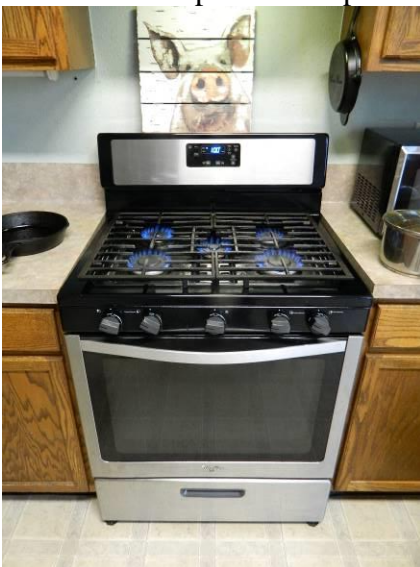
- The oven is inoperable.
- The gas valve is located behind the unit and is not readily accessible.
- No anti tip device to prevent the oven from tipping over if excessive weight is applied to the door.

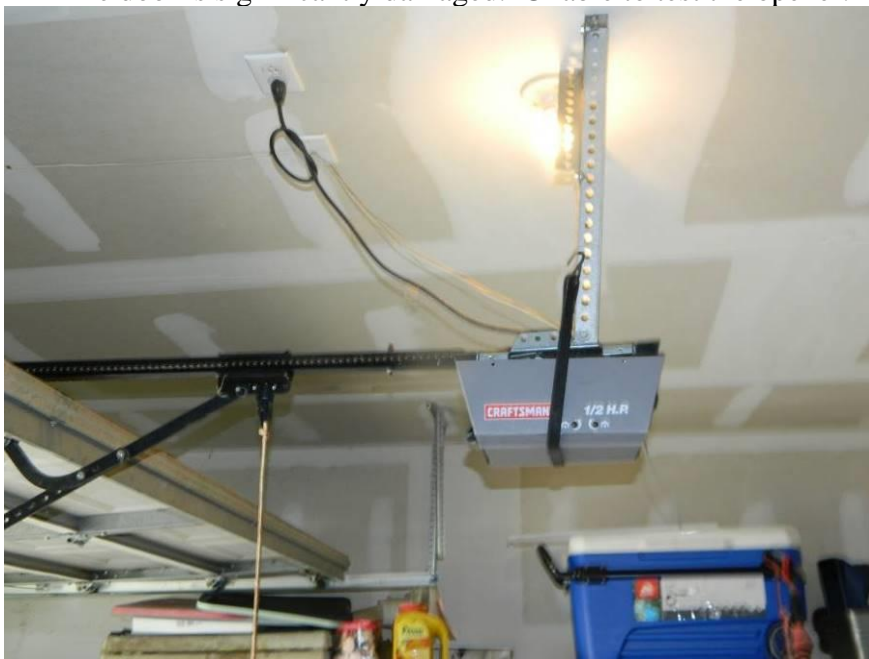
- Missing required safety sticker / decal next to operator button.
- The door is significantly damaged. Unable to test the opener.
