Residence is a one-story wood frame structure.
For the purpose of this report, residence faces north.
Residence was vacant at the time of the inspection.

PROPERTY INSPECTION REPORT

Concerning: 22135 Kerryblue Dr, Katy, TX 77450
(Address or Other Identification of Inspected Property)

By: David Terry, Lic #10562 06/03/2021
(Name and License Number of Inspector) (Date)

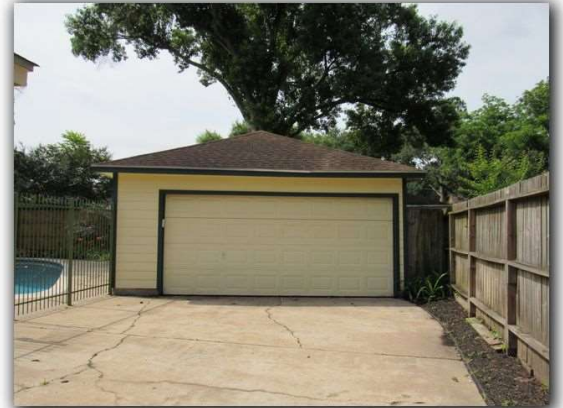
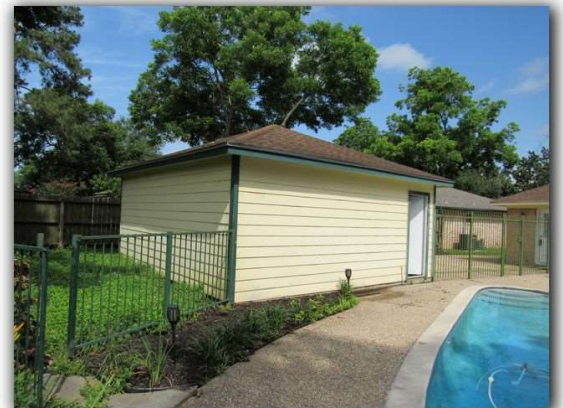
The residence was observed as having a conventional concrete slab on grade foundation. The foundation appears to be functioning as designed and intended at this time. The structure did not exhibit visible indications of excessive shifting or settlement damage typically associated with foundation problems. Minor brick veneer cracks were observed on the west and east sides of the master bedroom area. The structural members and load bearing walls appeared unremarkable at this time. The foundation appears to be reasonably level.

Evidence of minor shifting was observed along the southeast portion of the foundation. While it is this inspector's opinion that the foundation has only experienced minor shifting, if concerned, further evaluation by a Registered Professional Engineer or a qualified foundation repair contractor would be recommended.

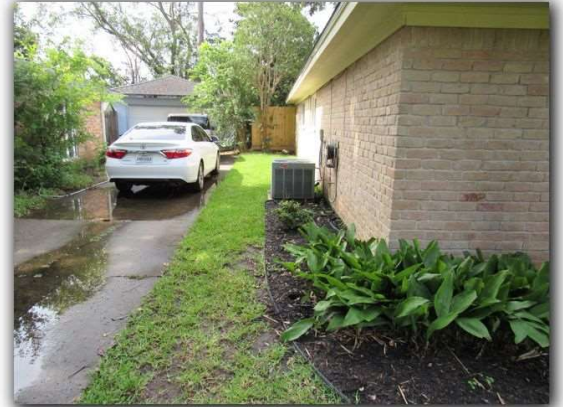
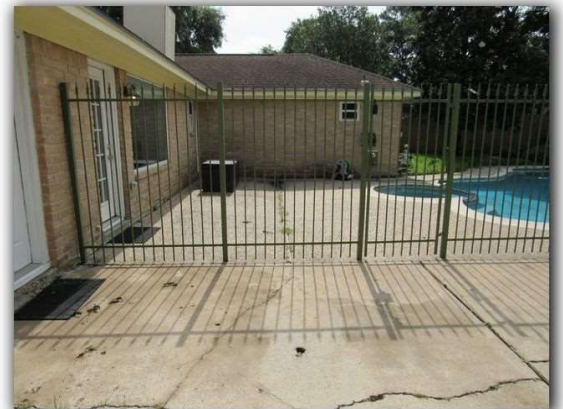
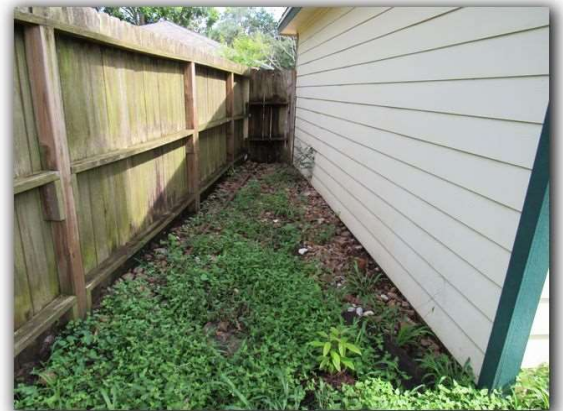
The grading on the property appears satisfactory at this time. The slope and drainage was considered typical and normal. It is recommended that 3-5" of foundation exposure be kept around the perimeter of the foundation and that a consistent moisture content be maintained. Improper grading and moisture control can lead to possible foundation problems.

It is recommended to lower the soil level of the flower beds along the perimeter of the foundation, as needed, to expose 3-5" of the foundation wall and provide proper drainage away from the foundation.

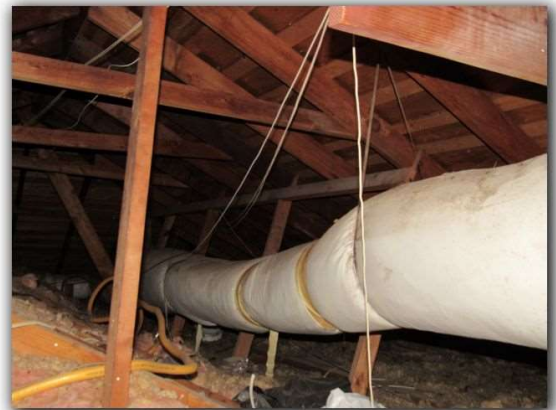
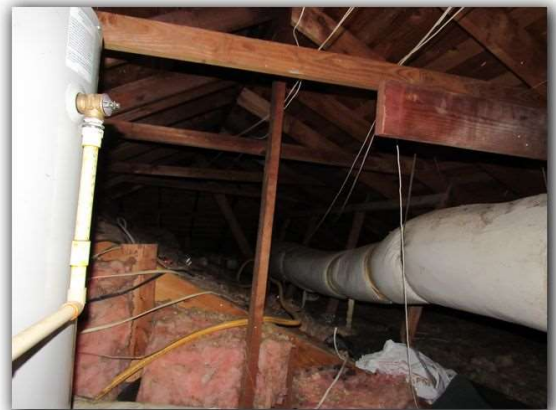
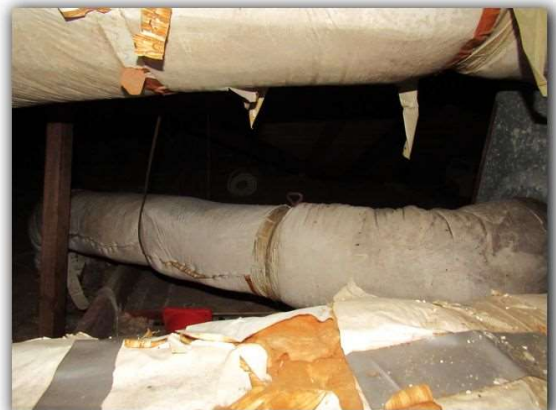
The accessible portions of the attic area of the residence was visually inspected. The overall condition of the visible interior rafters, framing, supports and radiant barrier lined decking appear sound at this time. Insulation in the attic area was observed at a depth of approx. 6-8". Attic ventilation was observed to be continuous soffit vents at the eaves with ridge vents at the ridge. Attic ventilation appears to be adequate at this time.

Recommend securing the vertical insulation in the attic as needed.

- Purlins in the west and east attic areas were observed to have inadequate strut supports. Recommend adding struts to the purlins at a maximum spacing of 4' on center and at an angle not greater than 45 degrees from vertical (IRC - R802.5.1).
- Recommend installing a cricket at the roof structure and chimney to provide adequate discharge of storm water and eliminate the accumulation of debris from behind the chimney.

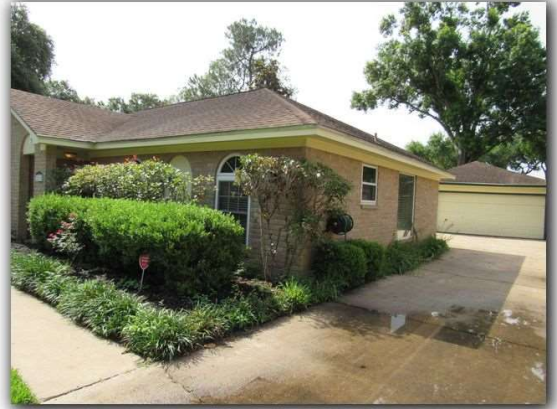
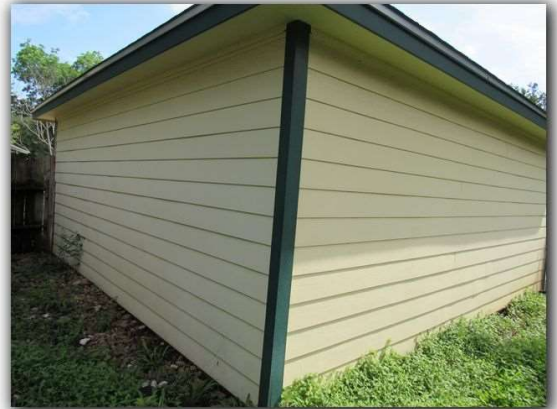
The masonry wall areas and fiber cement sided walls on frame construction were observed to be in overall good condition at this time. Interior and exterior walls showed no indication of excessive shifting at this time.

Minor brick veneer cracks were observed on the west and east sides of the master bedroom area.

Minor taped seam cracks observed in the master bedroom closet.

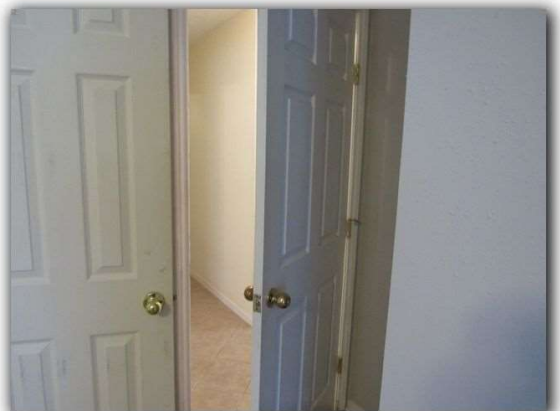
Closure/fit adjustments are needed at the northeast bedroom entry door.

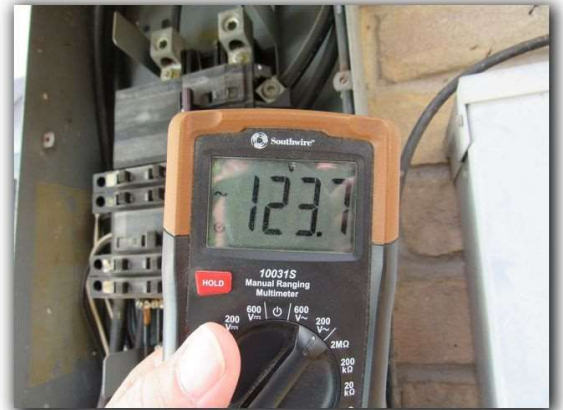
100amp service panel- 110/220v copper wired breaker service. Breaker wiring, buss bar shields and breakers showed no indications of over heating or arcing and were observed to be in good condition at this time.

Double lugging was observed at the neutral bus bar. Double lugging is not permitted and the neutral wires should be terminated separately in the bus bar.

Recommend legible labeling be provided for the circuit breakers to allow identification to isolate circuits as needed for repairs (IRC-E3606.2).

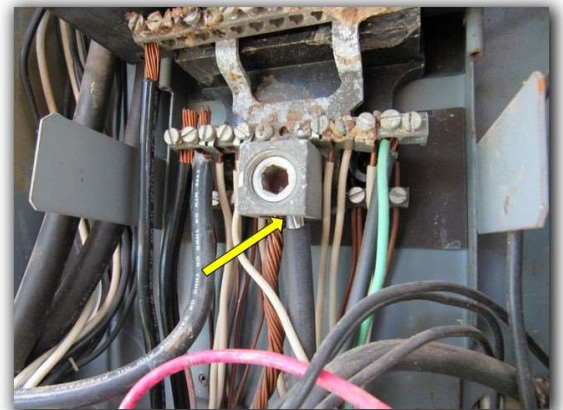
- The service panel cabinet does not appear to be bonded. Recommend necessary repairs be made to bond the service panel cabinet to the neutral bus bar. Metal components that can become energized from a lightning strike should be bonded/grounded.
- The aluminum main leads and ground wire in the service panel are required to be protected with an anti-oxidant inhibitor per the electrical code. The electrical grease is not present and should be installed on the leads connected to the main breaker and bus bar.

- Recommend replacing the pointed fasteners in the service panel dead front with blunt nose fasteners suitable for use with service panels.

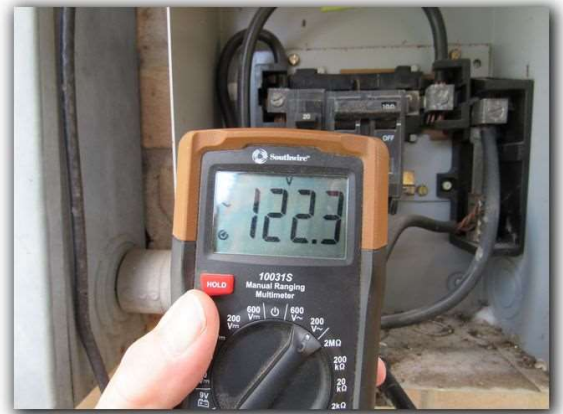
50amp sub-panel-50amp main- 110/220v copper wired breaker service. Breaker wiring, buss bar shields and breakers showed no indications of over heating or arcing and were observed to be in good condition at this time.

Recommend legible labeling be provided for the circuit breakers to allow identification to isolate circuits as needed for repairs (IRC-E3606.2).

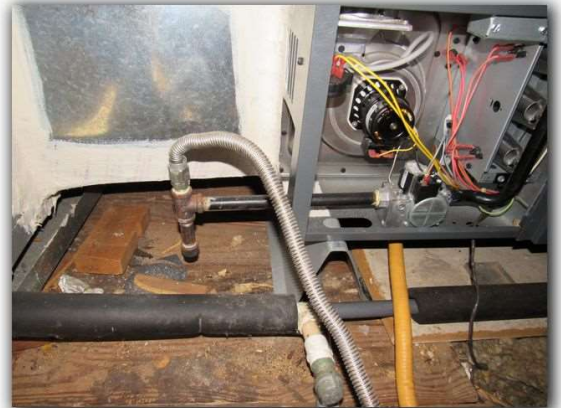
2015 GOODMAN gas fired forced air 60,000 BTU furnace MOD. #GMS80603ANBC. Furnace was operated using the standard manual controls. Furnace operations appeared satisfactory at this time. Burner compartments were relatively free of rust or scale deposits and the flame color was consistent. Furnace installation was also considered satisfactory at this time.

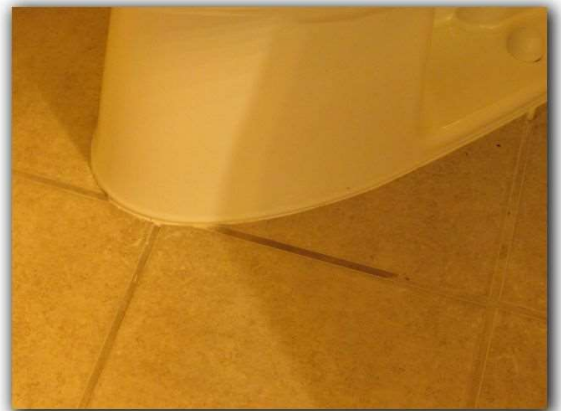
Repairs are needed to remedy the leak at the base of the toilet in the hall bath. The toilet should be removed, the closet flange and toilet base cleaned and a new wax ring and closet bolts installed when mounting the toilet.

Repairs are needed to secure the loose toilet in the master bath. The toilet should be removed, the closet flange and toilet base cleaned and a new wax ring and closet bolts installed when mounting the toilet.

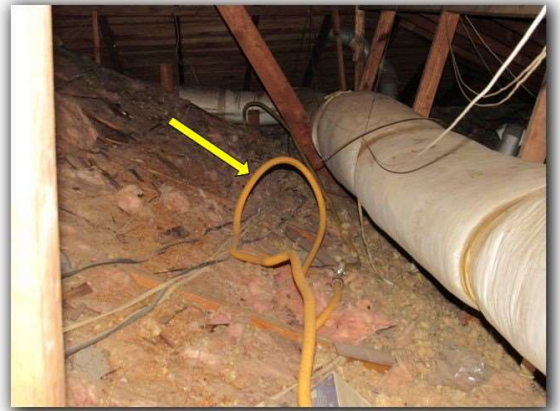
CSST observed to supply gas service to the kitchen area from the east side of the residence.

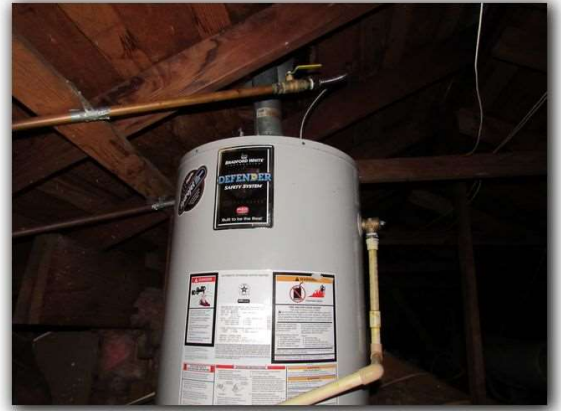
2020 BRADFORD-WHITE 40 gallon gas fired water heater MOD. #RG240S6N, unit was observed to be functional and properly installed at this time. Water temperature was measured at 121 degrees, temperature controls on the water heater can be adjusted for comfort levels.

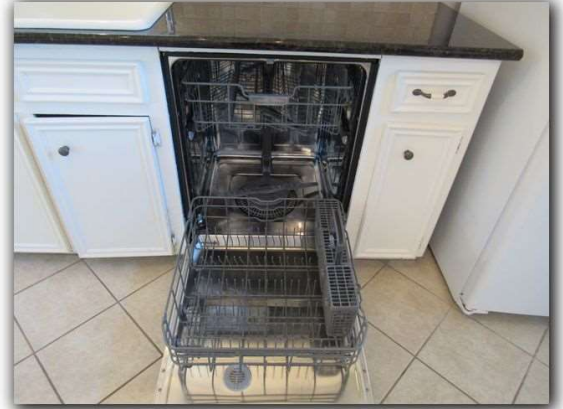
The LG dishwashing unit was found to be operational. No leakage or cycling problems were observed at this time.

Drain loop in the discharge line not present at the time of the inspection. Recommend the dishwasher discharge line extend higher than the termination point to create a loop and provide anti-siphon protection.

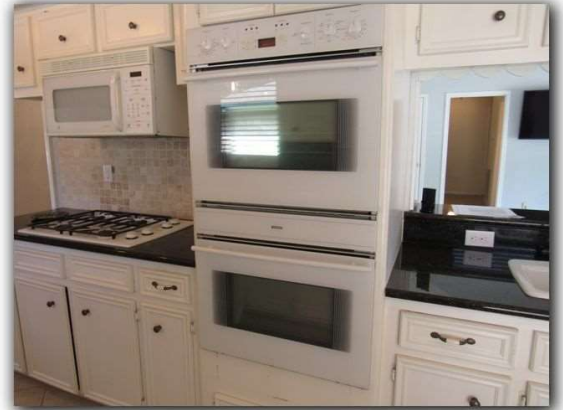
The BOSCH gas cooktop was observed to be operational. The BOSCH electric double oven was also observed to be operational. Oven temperatures were consistent with oven settings.

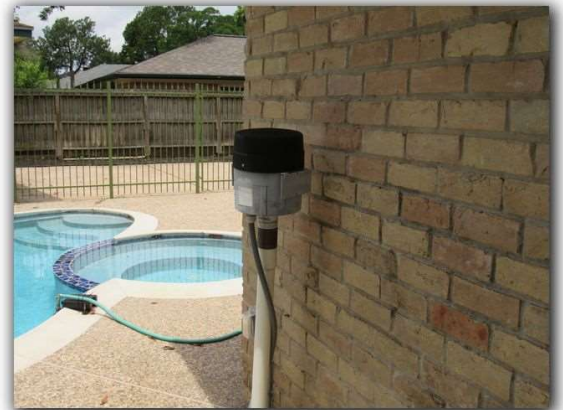
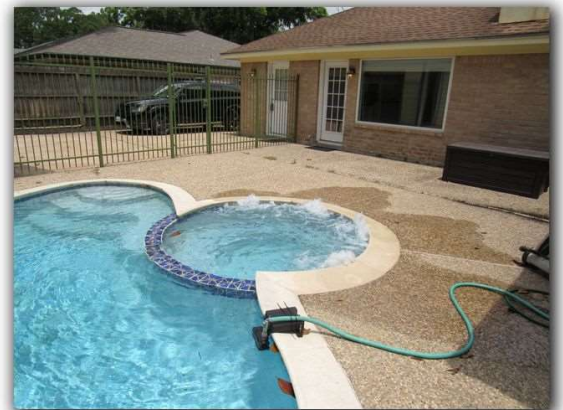
In-ground gunite constructed pool/spa was observed to be structurally sound, no visible cracks in the surfacing or tiling was present at this time. The pool equipment was operated using the timer controller at the equipment area. The 1.5hp-pool pump, 3/4hp booster cleaner pump, cartridge filter system, POLARIS cleaner, returns, skimmers, and spa jets were observed to be operational at the time of the inspection.

Recommend replacing the inoperable pool and spa lights. Light failed to illuminate using the local switches.

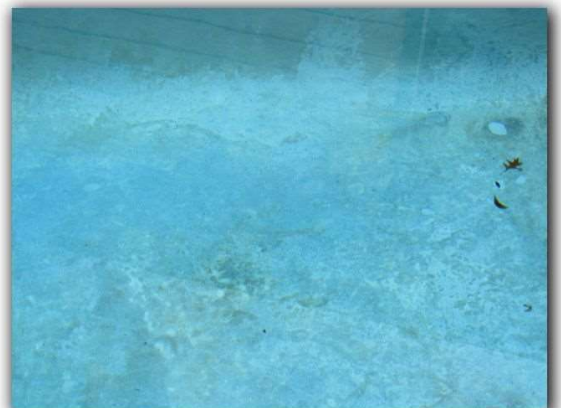
It appears the pool and spa may need re-plastering. Recommend further evaluation by a qualified pool contractor.

Repairs are called for to bond the pool equipment.
