Inspection Report

Property Address: 22135 Kerryblue Dr. Katy TX 77450

PROPERTY INSPECTION REPORT FORM

Brian Ahearn	8/15/2023	
Name of Client	Date of Inspection	
22135 Kerryblue Dr., Katy, TX 77450		
Address of Inspected Property		
Albert DeBolt	#21289	
Name of Inspector	TREC License #	
Name of Sponsor (if applicable)	TREC License #

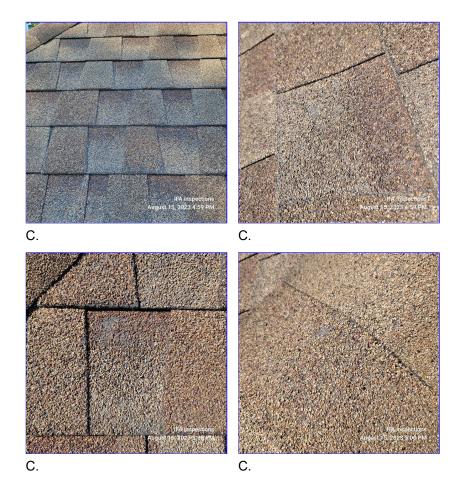
(2) The shingles are exhibiting extreme granular loss in multiple areas.

Recommend having a licensed roofing contractor evaluate all noted items and other roof components further prior to the end of your option period. Recommend repair as necessary.

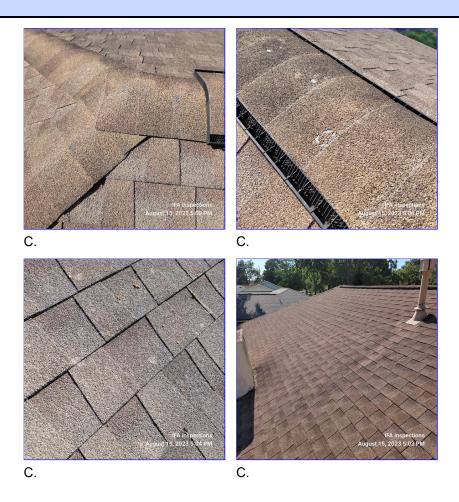
(3) The flashing is lifting at the back of the chimney. There are multiple unsealed nails.
