PROPERTY INSPECTION REPORT

Concerning: 5019 Preserve Park Dr, Spring, TX 77389
(Address or Other Identification of Inspected Property)

By: Scott Osborne, Lic #20555 04/07/2020
(Name and License Number of Inspector) (Date)

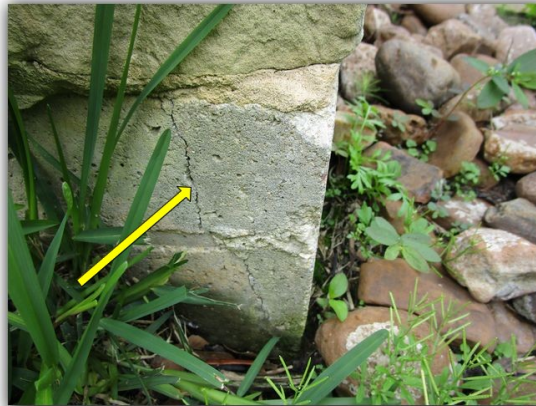
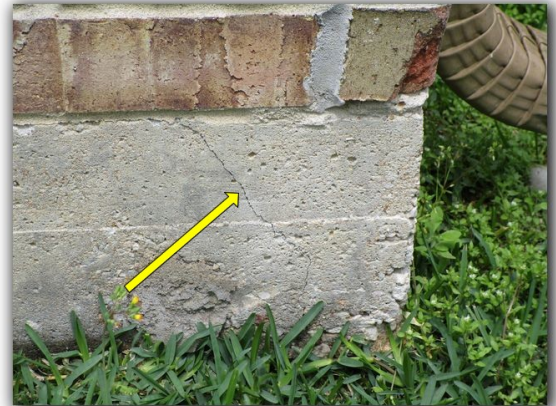
There are cracks at the corners of the foundation. Corner cracks are commonly found on slab foundations. They are generally cosmetic in nature. However, they may require minor repair to prevent water and pest penetration.

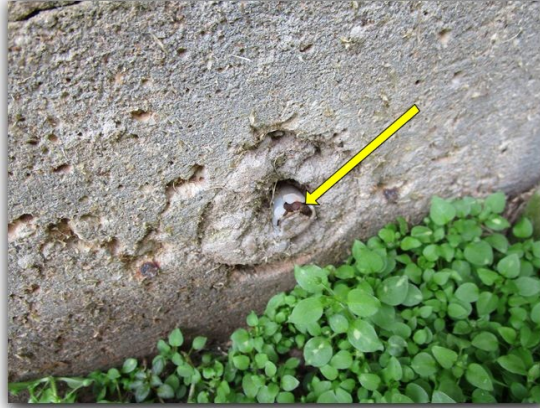
There are exposed cable ends on the right side of the home. These cable ends should be sealed to help prevent oxidation/rusting of the cable into the foundation.

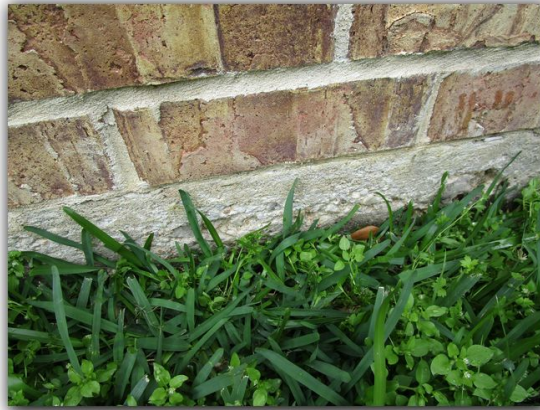
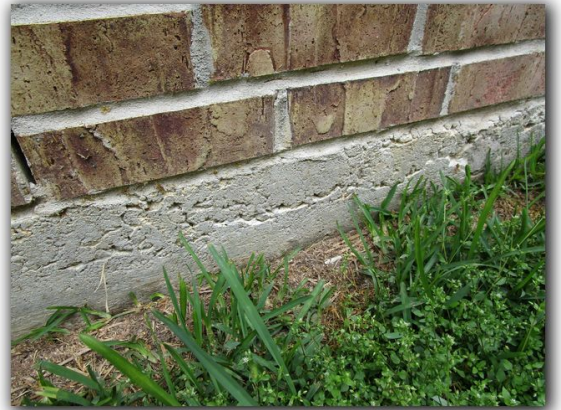
There is exposed aggregate on the right side of the foundation near the front and middle of the right side of the home.

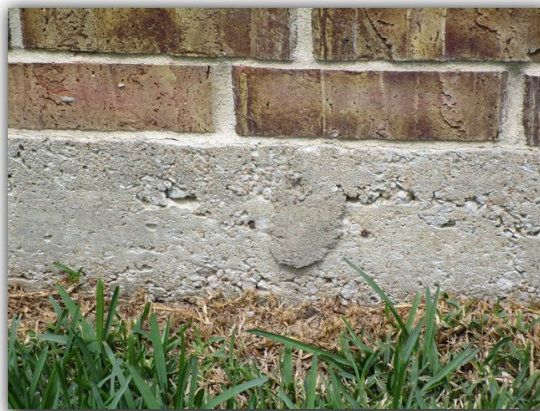
There is exposed aggregate below the rear left windows (living room).

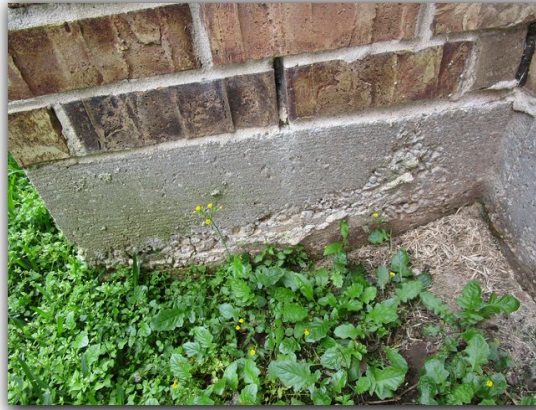
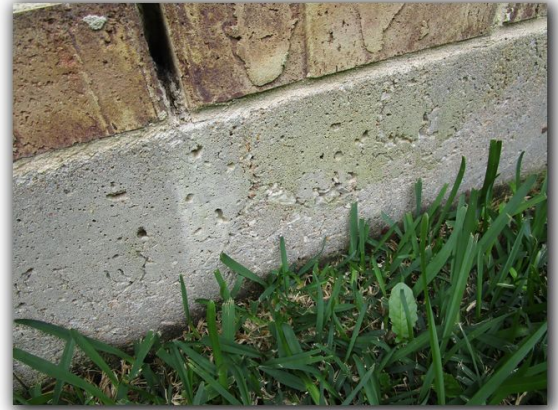
There is exposed aggregate on the left side of the home below the breakfast and living room windows.

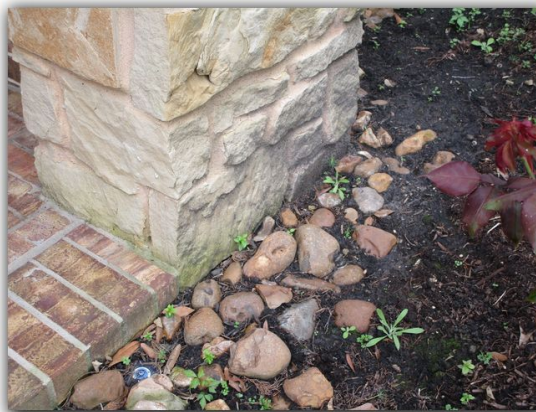
There is high soil at the front of the home to the right of the front entry area covering the base of the wall. This is conducive to water and pest penetration into the home.

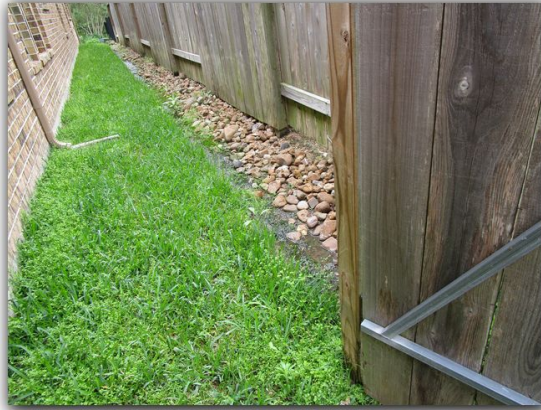
There are low spots along the right property and fence lines that currently hold water. The soil is heavily saturated along these areas.

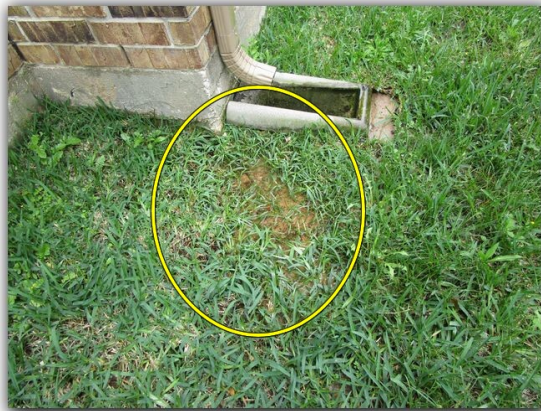
There are low spots along the left property and fence lines that currently hold water. The soil is heavily saturated along these areas. There is a low spot at the left side of the home at the corner near the dining room window that currently holds water. This is conducive to wood destroying insects and slab movement.

NOTE: I recommend monitoring the drainage after rain to determine if there is an additional need for drains.

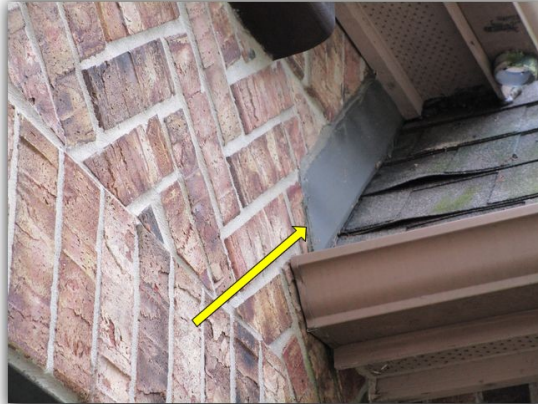
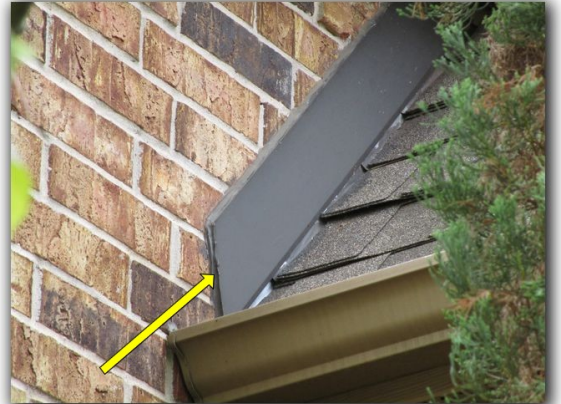
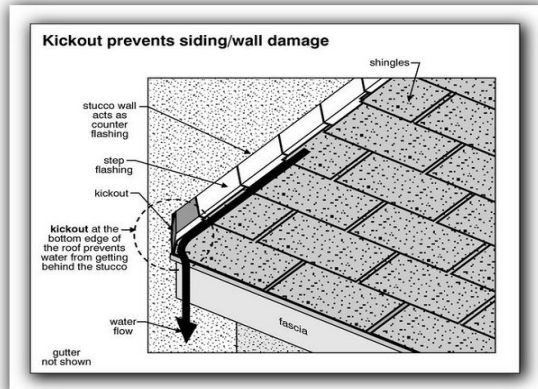
There is missing kick out flashing at the vertical wall intersections at multiple locations around the home, including at the front of the home above the front spare bedroom (right and left sides). Kick out flashing is used to help divert water away from the vertical wall intersection to help reduce the chance of moisture penetration into a wall cavity.

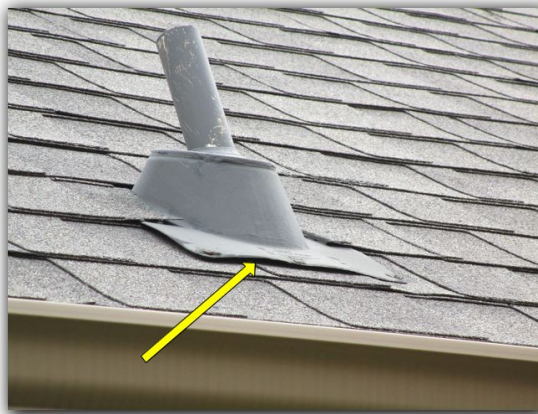
The roof jacks are lifted at the lower edge at more than one location.

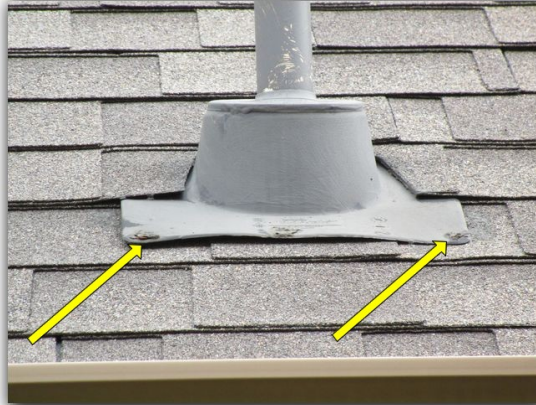
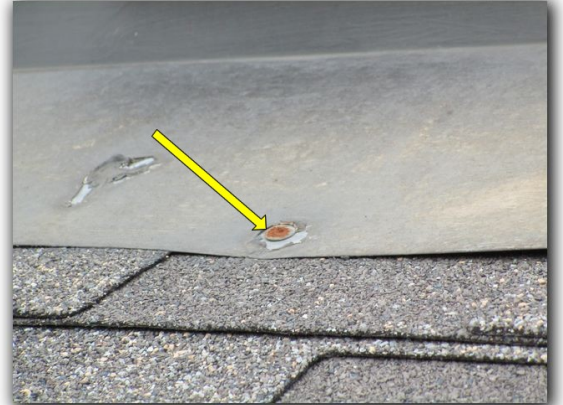
There are exposed nail heads on the roof. Nail heads should be sealed with roof caulking material. Over time, water may penetrate the roof around a rusted nail if they are not properly sealed.

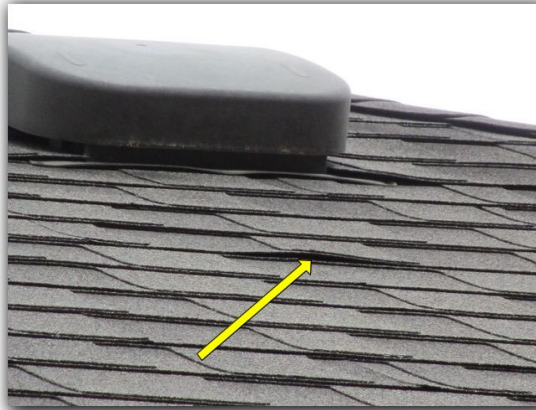
There is a lifted shingle at the right side of the roof near the ridge close to the front corner.

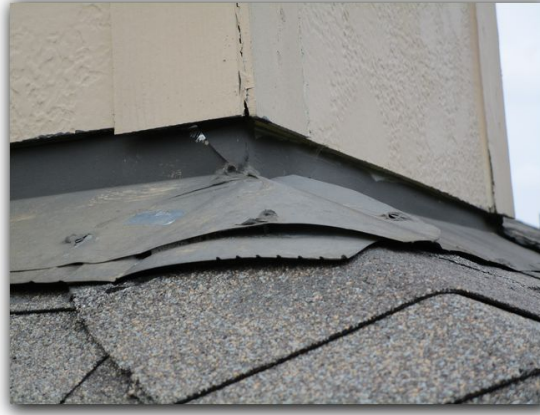
The flashing is lifted at the chimney area.

There is granular material from the shingles in the gutters.
I recommend the roof be evaluated by a qualified roofing contractor. Any exposed openings are potential moisture or pest penetration points and should be sealed.

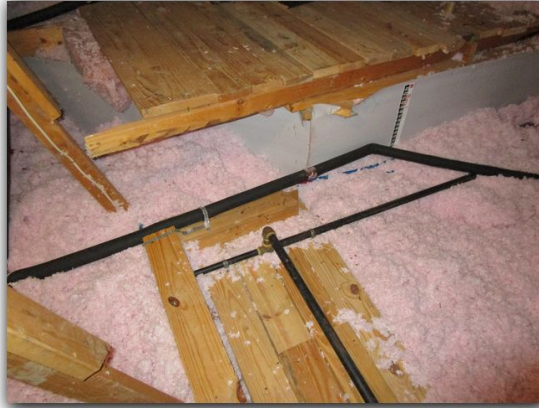
There is no step installed at the furnace platform in the attic. This poses a potential trip hazard.

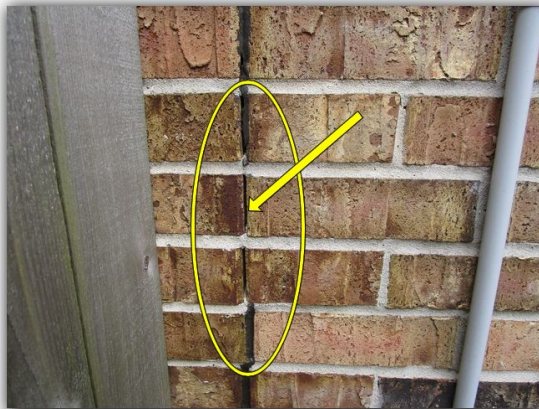
There is missing caulking material in the expansion joint on the left wall by the fence.

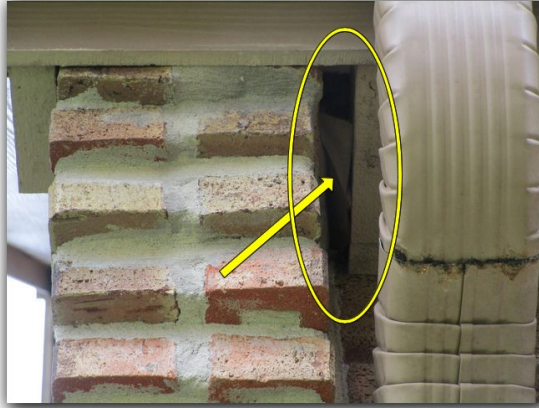
There is a gap at the fascia / frieze trim at the front right corner, creating an exposed opening.

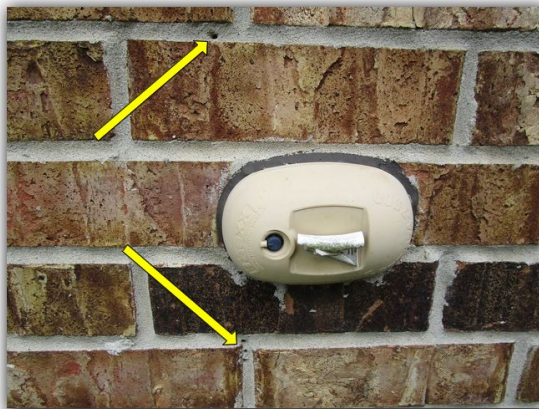
There are small holes in the brick at the right wall near the front corner.

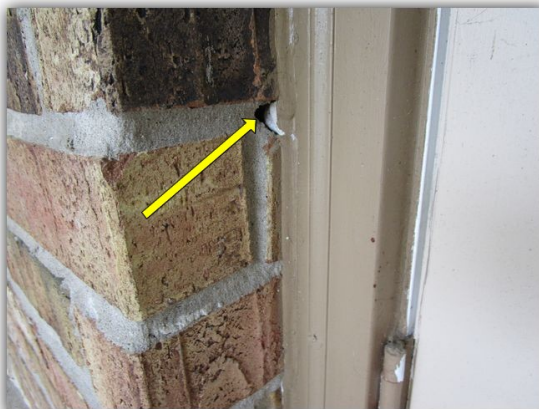
There is an exposed opening at the rear master bedroom exterior entry doors at the door frame.

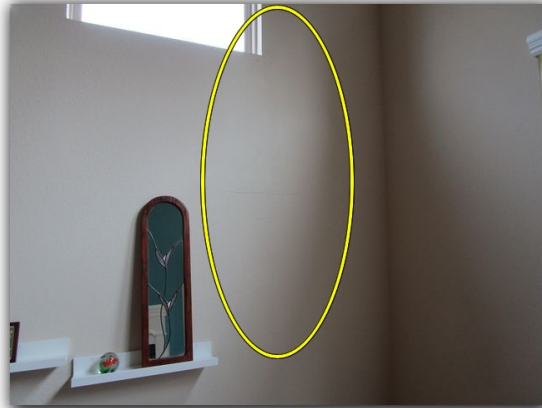
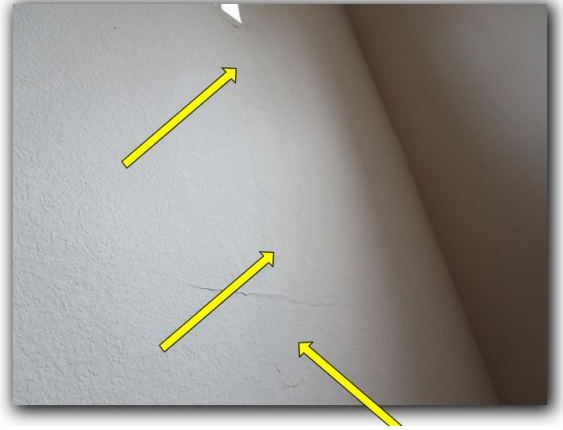
There is evidence of moisture stains on the wall in the living room at the rear left window (left wall at the rear corner). The wall is soft in this area. I recommend further review, including what may be inside the walls, and where the source of the moisture is originating, by a qualified contractor.

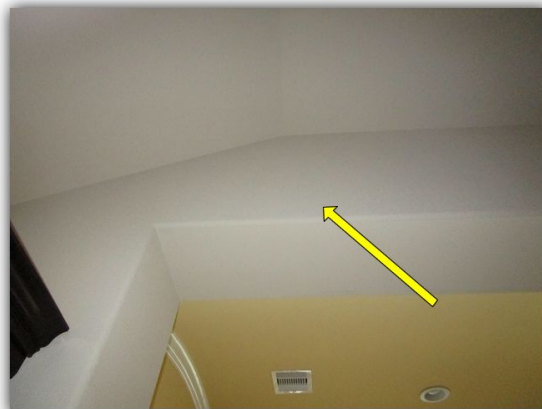
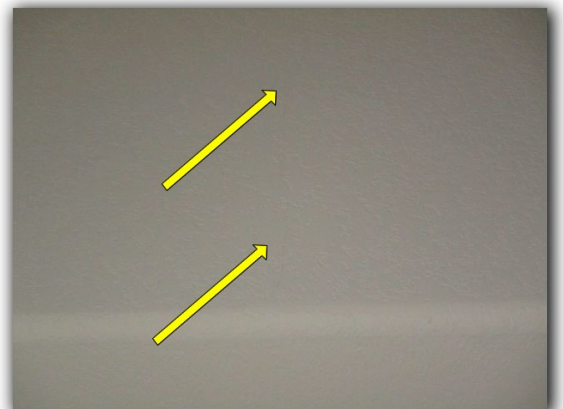
There is a hairline crack on the wall in the kitchen at the top left corner of the framed opening to the dining room / area.

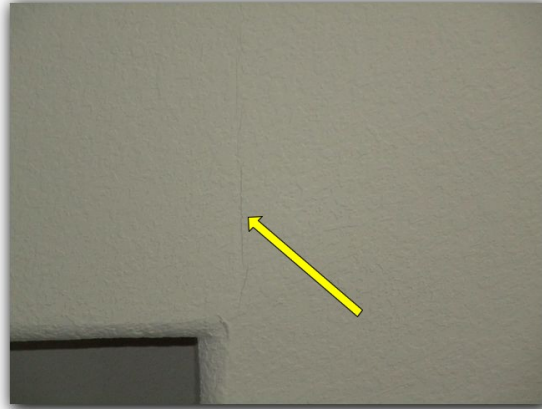
There are cracks at the corners of the tray ceiling in the office.

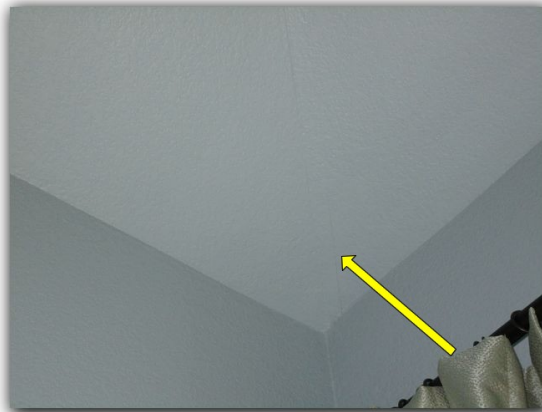
There are cracks at the angled ceiling intersections in the master bedroom (rear right corner).

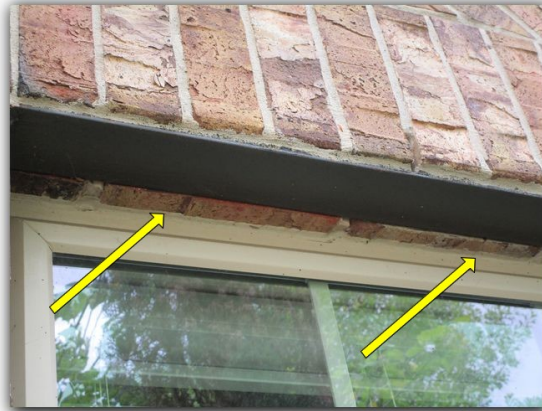
The Z flashing is not visible above the windows. I cannot determine how the windows are sealed against water penetration. The caulking / seal around the window frame must be maintained to help prevent moisture penetration.

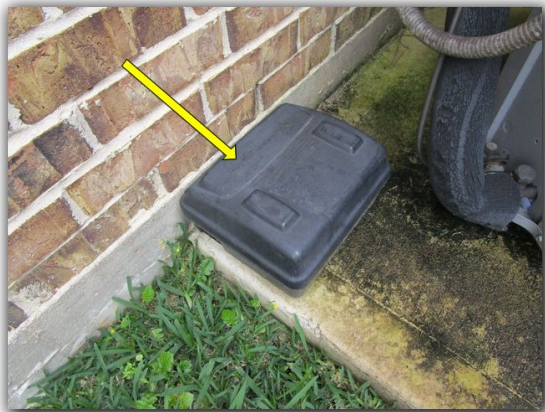
Notes: If the home is occupied, owner's belongings inside cabinets can conceal hidden damages.
There are signs of vermin activity in the garage and at the exterior of the home.

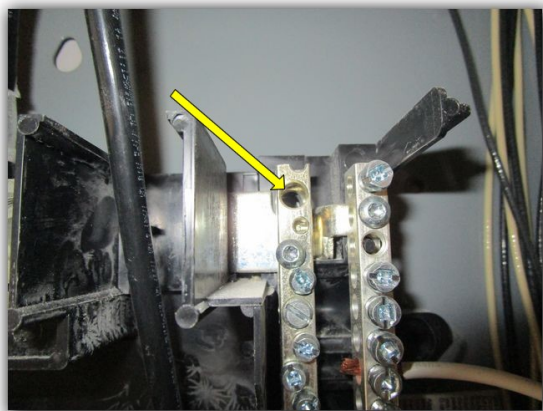
There is no bonding bar / screw in the sub panel in the garage.

I recommend a complete review by a licensed electrician to review and repair any and all deficiencies.

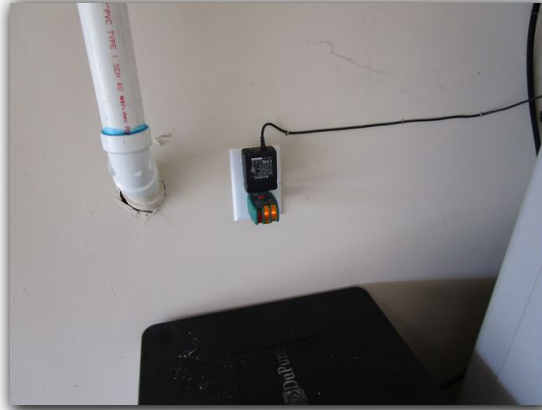
There are outlets that are not GFCI protected, as is currently required, including in the garage at the water softener, and in the master bathroom linen closet.

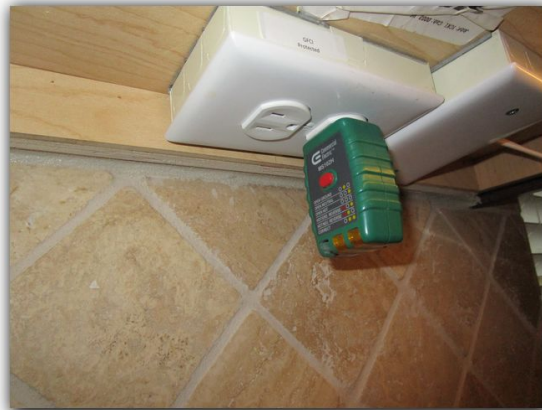
There are loose outlets in the office.
There is no electrical power to the outlet in the kitchen to the right of the refrigerator.

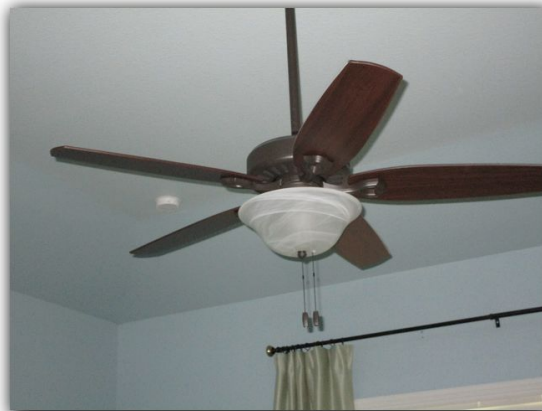
NOTE: The control switch for the ceiling fan in the master bedroom is "upside down".
The glass globe is loose on the master bedroom ceiling fan / light fixture.

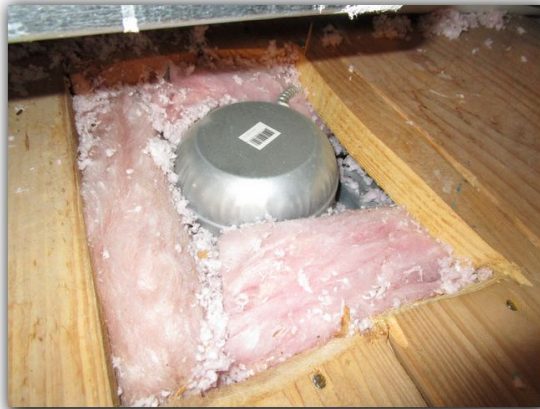
There are ceiling fans that are not properly balanced in the rear right spare bedroom. There are recessed light fixtures observed in the attic that do not have proper clearance from combustible materials including insulation.

I recommend a complete review by a licensed electrician to review and repair any and all deficiencies.

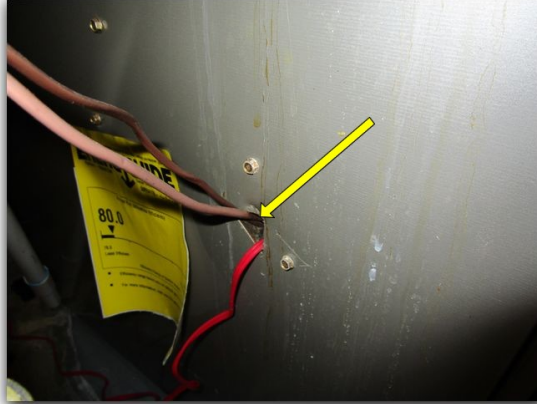
There is no protective grommet where the thermostat and other wires penetrate the casing.

I recommend a complete review of the entire HVAC system by a qualified HVAC technician.

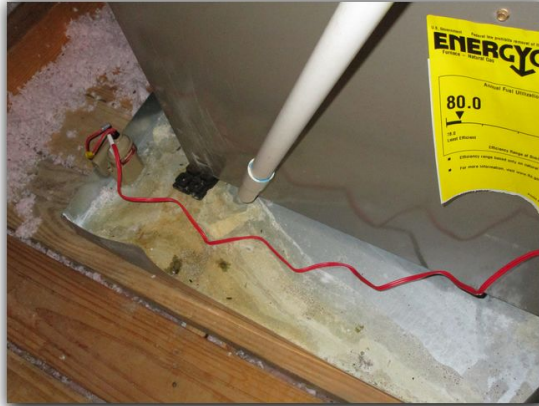
I recommend the heating and cooling systems be serviced by a licensed HVAC technician prior to each heating and cooling season. It cannot be verified that the previous occupants performed regular or routine maintenance. There is evidence of prior moisture in the overflow pan in the attic.

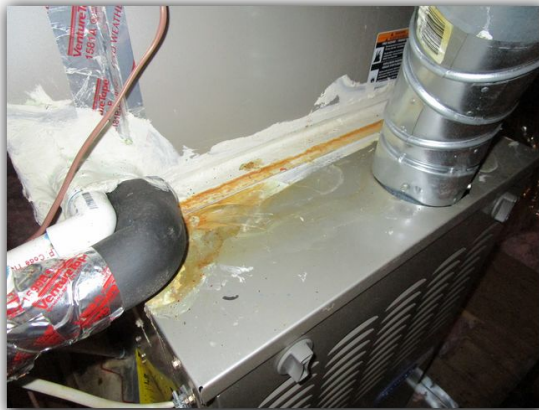
There is evidence of rust on the HVAC casing in the attic.

I recommend a complete review of the entire HVAC system by a qualified HVAC technician prior to closing.

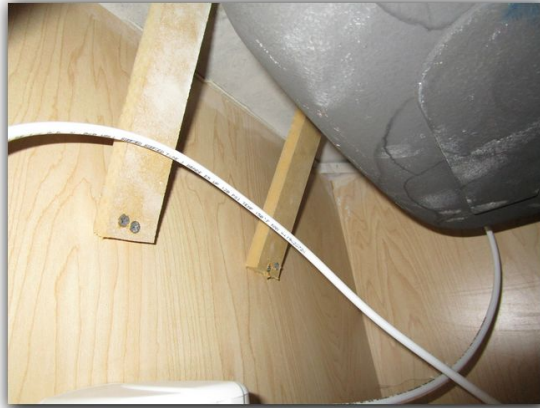
The sink has not been supported using the manufacturer supplied clips for the kitchen sink. Instead the under-mount sink is being supported using scrap lumber.

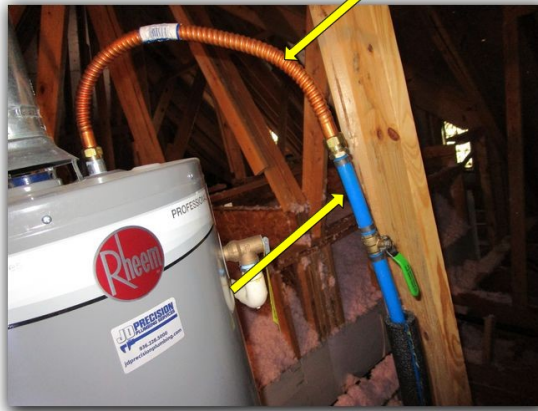
The water supply lines are not fully insulated in the attic.

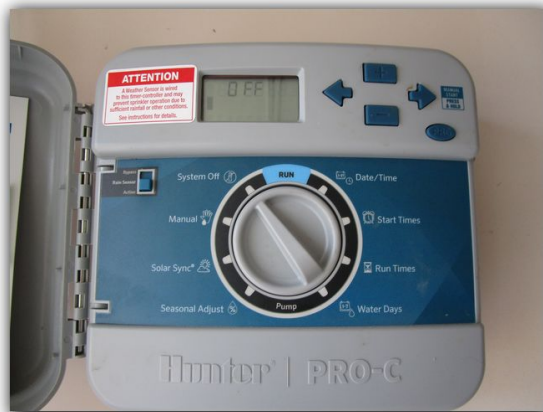
There are sprinkler heads that spray the fence and home at more than one location. The sprinkler heads may require adjustment. Spraying directly onto the home can lead to moisture penetration. I recommend having the system reviewed by a qualified irrigation specialist.
