Inspection Report

Property Address: 20607 Providence Point Dr Katy TX 77449

PROPERTY INSPECTION REPORT

| Prepared For: | Judena Pierre | | |
|---|---|---|--|
| By: | Antonio Wilson 9936 / Cliff-Bell Real Estate Inspectors | 7/18/2023 | |

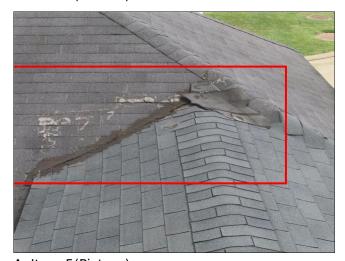
A. Item 4(Picture)

Inspector observed a visible dip, sag, or sunken area on the roof at the time of inspection. When a heavy object drops on the roof, it will cause a depression in the area and likely some structural damage to sheathing and roof trusses or rafters underneath. This condition can also be a indicator that water is seeping through the sheeting.

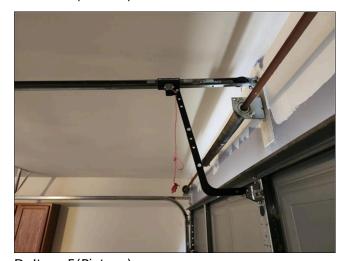
D. Item 4(Picture)

Garage door operator did not respond to control buttons at the time of inspection. The inspector could not determine the cause. Recommend consulting with a reputable Overhead Company to determine any corrective action.

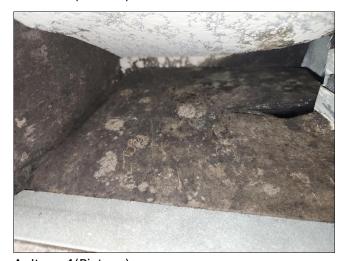
A. Item 3(Picture)

Inspector observed suspect microbial growth or a mold-like substance on air supply registers, the air supply diffuser, or inside air supply duct at the time of inspection.

The inspector did not inspect, test, or determine if this growth is or is not a health hazard. Surface sample analysis can confirm the presence of mold and determine what types of mold spores are growing on the material. Recommend consulting with a licensed mold assessment consultant to determine the presence, extent, amount, or identity of mold or suspected mold in a building.

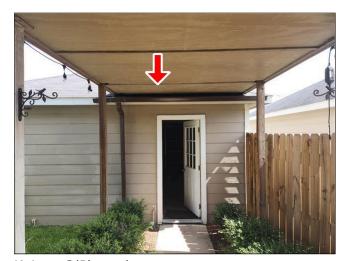
K. Item 3(Picture)

Inspector observed evidence of peeling, cracking, or bubbling paint at the time of inspection.

Water, high humidity, and excessive condensation are the most likely in a residential structure. When water penetrates through the coats of paint, it causes the layers to separate and detach from the surface. This results in bulging, cracking, and finally, peeling.
