PROPERTY INSPECTION REPORT

Concerning: 1214 Pioneer Richmond, Texas 77406
(Address or Other Identification of Inspected Property)

By: Fred Willcox Professional Inspector #160 August 2, 2019
(Name and License Number of Inspector) (Date)

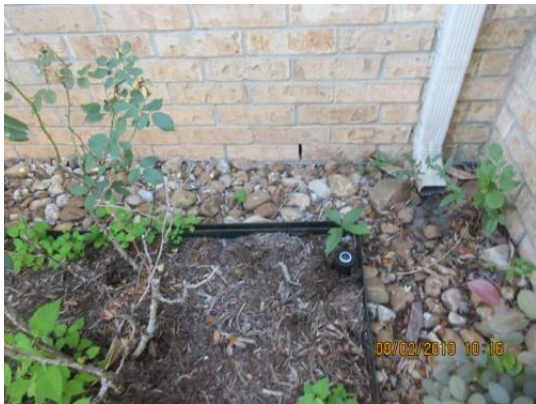
Deficiency: The soils surrounding the foundation were in contact with or were too close to the exterior veneers in some areas.

Information: The minimum standard of clearance from the surface of the ground level to the bottom of masonry veneer is 4 inches. The minimum standard of clearance from the surface of the ground to the bottom of wood veneer is 6 inches. The minimum allowable slope for drainage requires that the soils and flower beds around the house slope and minimum of 6 inches in the first ten feet away from the house. The grading of the lot should be corrected to insure proper drainage.

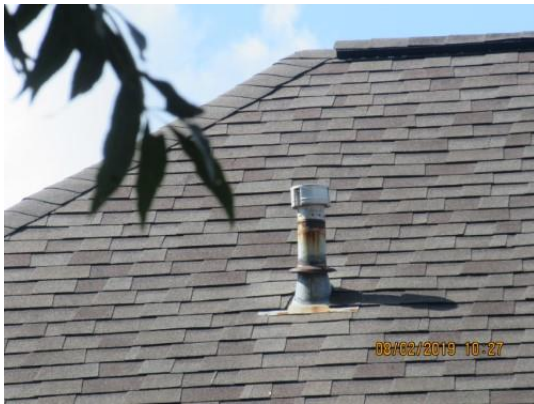
Deficiency: One of the type B vent terminations appeared to have inadequate clearance above the roof deck.

Information: The current requirement is that the termination is at least two feet above any part of the roof deck within ten feet of the vent pipe termination. The requirement is made ensure proper drafting of the vents. The termination of the vent pipes should be raised for safety. See Table in Figure G2427.5.3 from the International Building Code below.

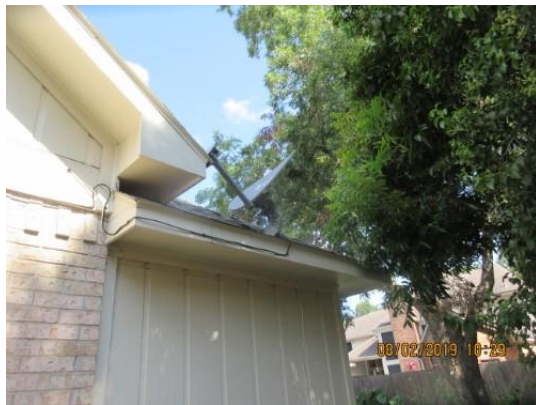
Deficiency: The dish assembly bracket for the satellite antenna system had been bolted to the roof deck through the shingles.

Information: There was no attempt to make the junction of the bracket with the shingles or the penetrations of the bolts through the shingles waterproof. The bracket junction and the bolt penetrations should be made waterproof or the dish should be removed from the surface of the roof. If the dish is removed, the damaged shingles should be replaced.

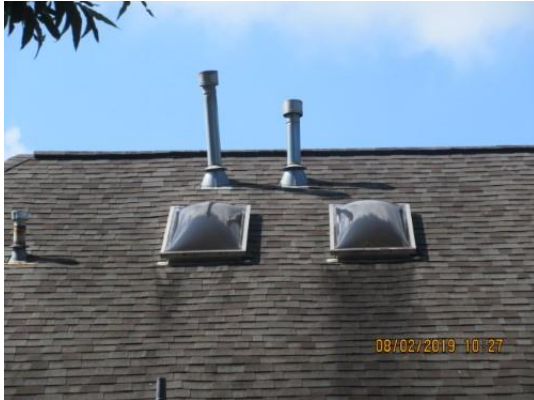
Information: Skylights will ultimately leak. Skylights do not have adequate clearance above the surface of the roof to allow water to be diverted away from the skylight. As water collects against the skylight, the water will ultimately reach a depth that it will overcome any flashing system. It is only a question of the amount of rain that falls in a given period of time that determines when a skylight will leak.

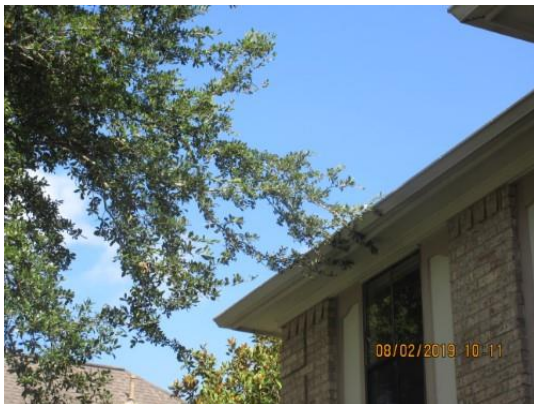
Deficiency: Tree limbs were in contact with the roof's surface.

Information: Tree limbs scraping across the roof covering materials can cause damage. The limbs should be trimmed to avoid damage to the roof covering materials.

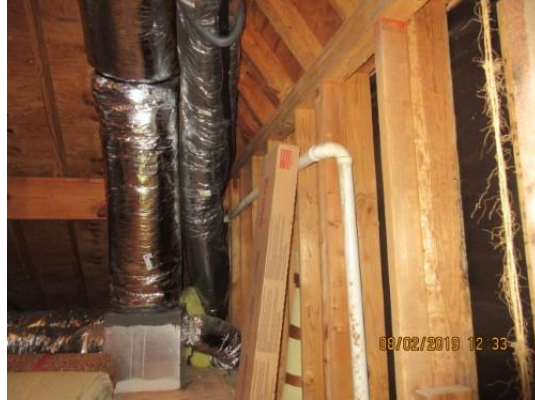
Deficiency: The pony walls in the attic were not tied back to the ceiling joists and framing to prevent the pony walls from rotating.

Information: Pony walls are walls that are not full height that extend above the ceiling joists. The top of the pony wall must be tied back to the framing to overcome the turning moment produced by the horizontal component of the loads produced by the rafters.

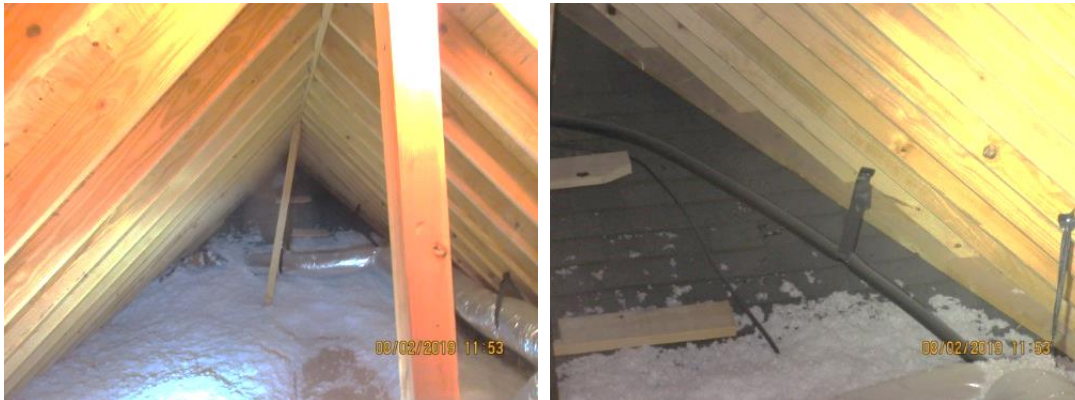
Deficiency: Some of the addition valleys of the roof were improperly created. These valley rafters rested on the original garage roof deck.

Information: The jack rafters of the additions were supported on the roof decking. Common rafters can only support the weight of the roof covering materials and are not allowed to support other structural members. Valleys are required to be created by attaching the jack rafters to a single board. In addition, the type of construction used on this house makes it impossible to determine the load carrying capabilities of the structural frame. As there were no visible deflections or indications of stress at the improperly created valleys there is no need for immediate repair of the valleys.

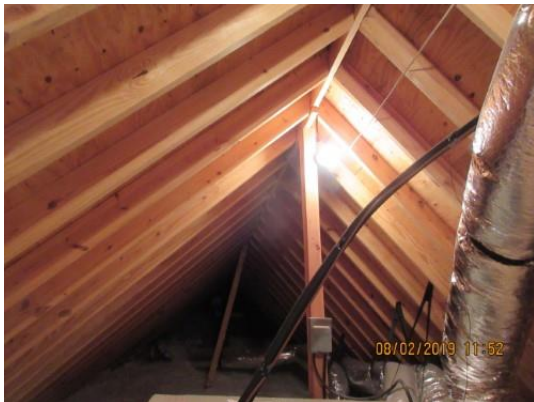
Deficiency: There were an inadequate number of collar ties attached to the rafters of the addition.

Information: Collar ties are horizontal pieces of lumber used to attach rafters to each other under the ridge board, forming an “A”, if you will. Collar ties are high wind load members. When wind passes over the ridge of a roof, it becomes turbulent and can form a vacuum. This vacuum will attempt to pull the roof framing apart at the ridge. Collar ties are used to prevent this separation. Collar ties should be installed on approximately four-foot centers.

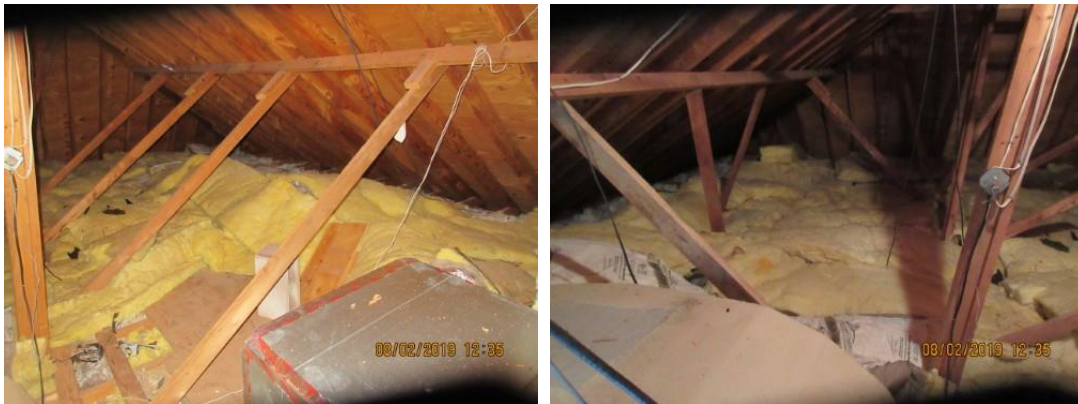
Deficiency: Insulation depths varied from a couple of inches to mounds of insulating materials.

Information: The depth of the insulating materials should be uniform for proper performance. The depth of the insulating materials determines their resistance to heat transfer. Varying depths of insulating materials means uneven resistance to heat transfer.

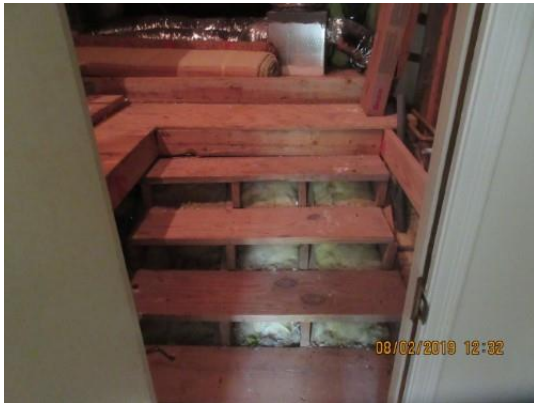
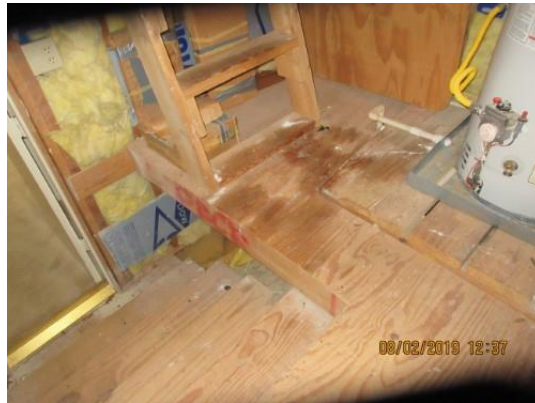
Deficiency: There was no continuous handrail on the attic staircase.

Information: A continuous handrail is required for safety on any stairs more than 4 risers in height.

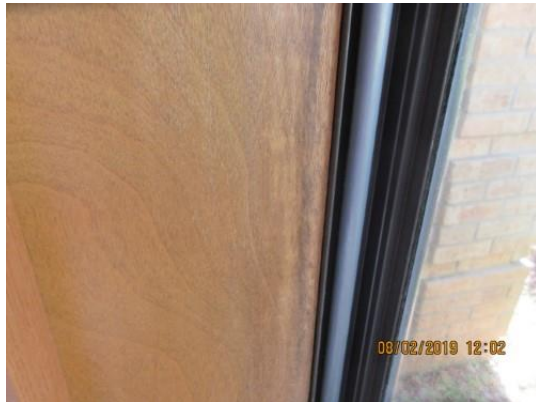
Deficiency: Water penetration was noted on the interior of the window frames and sills in the living room and dining room, etc.

Information: The sources of the water penetration should be determined and repaired. The presence of water penetration may indicate the growth of microbial organic organisms that may be toxic. Indoor air quality tests are not a part of this inspection. Should you desire an indoor air quality test, the test should be arranged prior to closing. Once the sources of the water penetration have been determined and repaired, all decayed, deteriorated or damaged materials, including walls covering materials, trim, moldings, insulating materials and framing members should be removed and replaced and finished to match the existing structure.

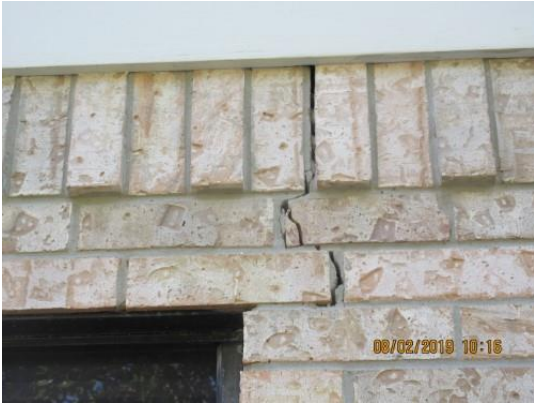
Deficiency: There were minor cracks in the brick veneer.

Information: The cracks should be repointed by a skilled mason to match the existing structure.

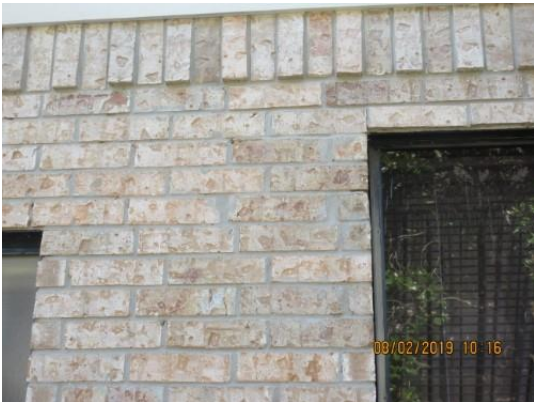
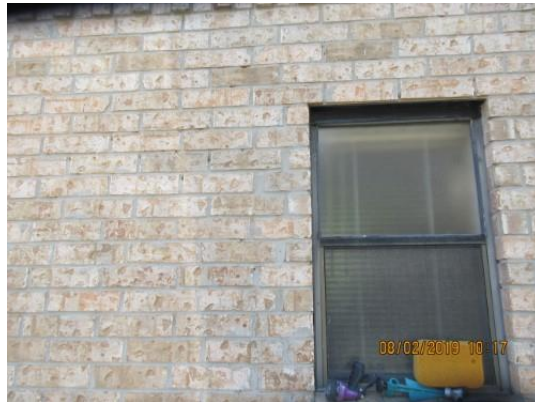
NOTICE: The brick veneer had been repointed on the east and west sides of the house. The reason(s) for the repointing of the bricks should be obtained from the current owners.

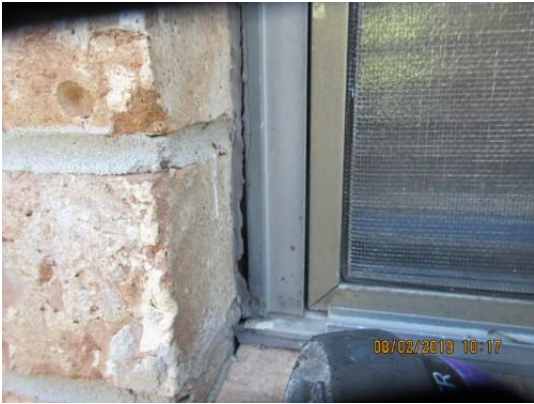
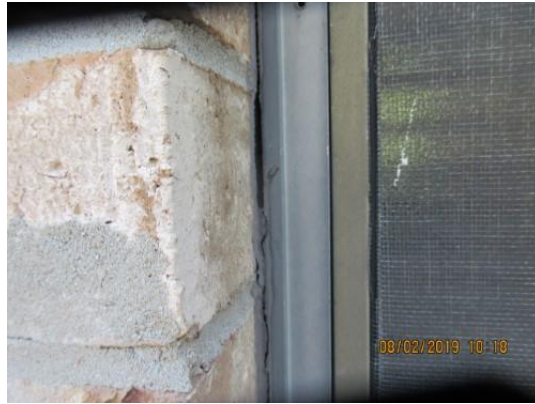
Deficiency: The junctions of the window frames and door frames with the brick veneer were not properly sealed (caulked).

Information: The lack of a proper seal can allow water into the wall cavity and can allow a more ready transfer of air from the exterior of the house to the interior of the house. All of the wall openings should be properly sealed with an approved adhesive to reduce the possibility of water penetration, to restrict the access of pests and insects to the interior of the house and to limit the transference of air from the interior of the house to the exterior atmosphere.

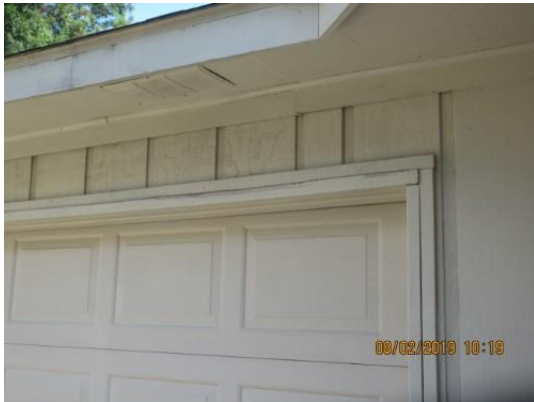
Deficiency: The garage door header sagged.

Information: This indicates that the header was not adequate to properly transfer the structural loads to the columns of the garage door frame. The header should be replaced with a header adequate to properly transfer the structural loads.

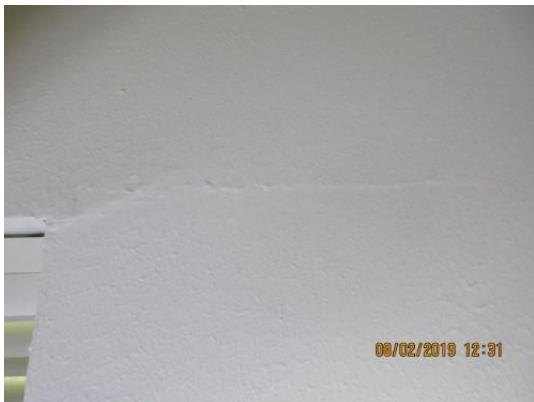
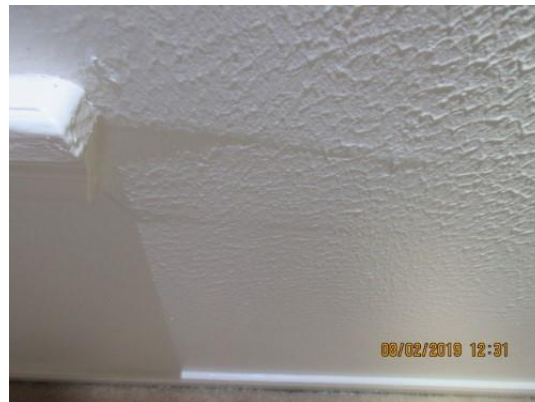
Deficiency: There appeared to be patches in the drywall coverings of the walls and ceilings throughout the structure.

Information: The causes of the patches could not be determined. Information on the patches should be obtained from the current owner.

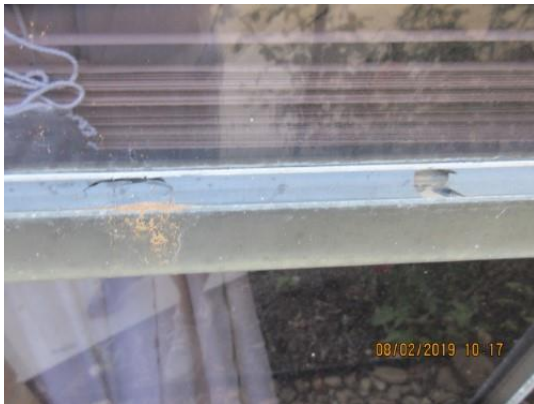
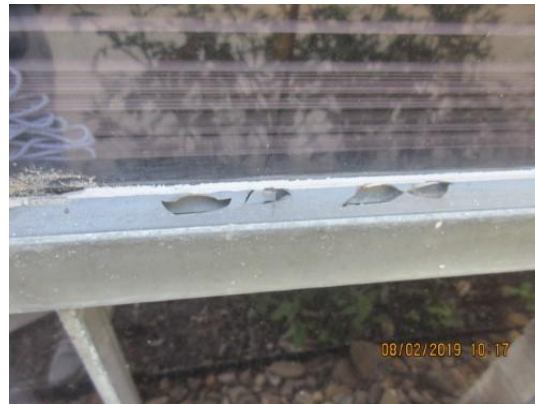
Deficiency: There were damaged glazing strips on some of the windows.

Information: The cracked and damaged glazing strips should be replaced were necessary.

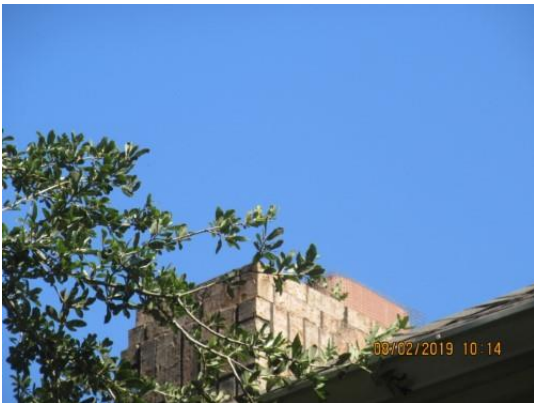
Deficiency: There was no spark arrestor cap on the chimney termination.

Information: A spark arrestor is primarily used for safety, but they also reduce or prevent rain water from entering the flue. Spark arrestors also prevent animal life, excluding insects, from entering the flue.

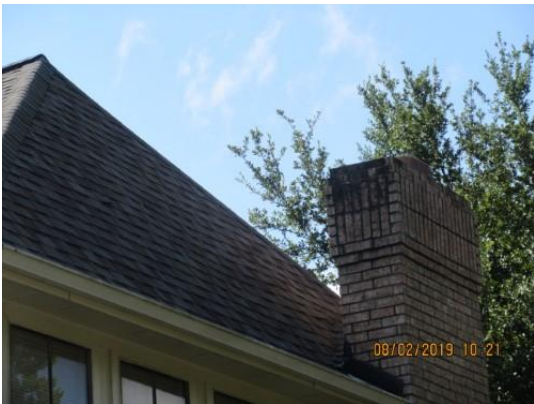
Deficiency: The chimney termination appeared to have inadequate clearance above the roof deck.

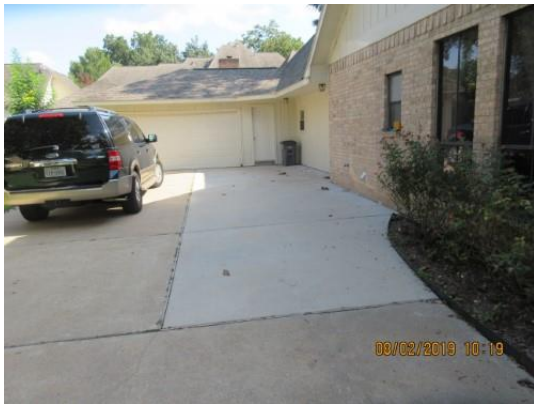
NOTICE: Sections of the driveway had been replaced. The reason(s) for the replacement of the driveway should be obtained from the current owners.

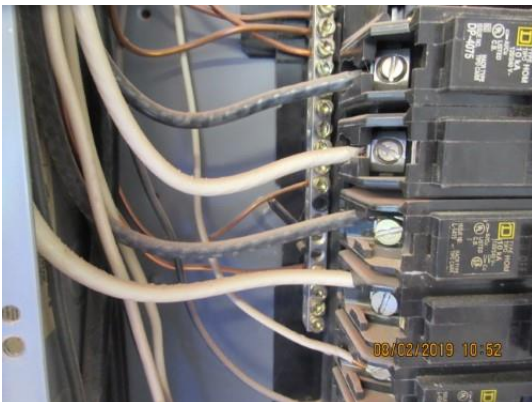
Deficiency: The conductors in the panel were not properly color coded.

Information: Neutral (white insulated) conductors were used as hot conductors and were not identified as hot, or ungrounded, conductors. All hot (ungrounded) conductors are required to be identified by the use of any color other than white, gray or green or bare copper. The conductors should be properly identified for safety.

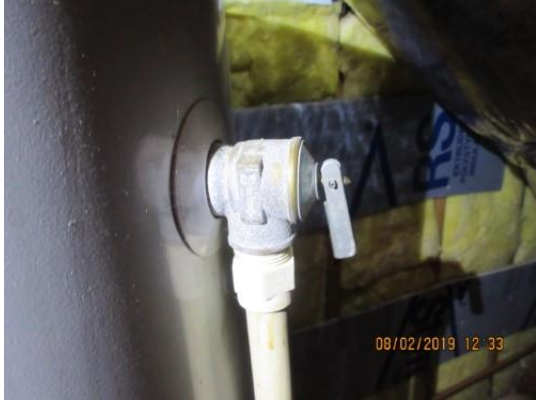
Information: An attempt was made to operate the device and the valve would not open under moderate pressure. The temperature and pressure relief valve is a safety device. Should the burner valve remain open, the temperature of the water in the system would continue to increase however; the water could not boil as there would be no room to allow the water to turn to steam. When a water valve is opened, the water would turn instantly into steam if the temperature of the water is above 212 degrees Fahrenheit. This action would cause the tank to explode. The temperature and pressure relief valve is required to be operated periodically to keep the valve from corroding. As the valve was not operable, the valve should be replaced for safety.
