Advantage Inspections Plus

12219 Rocky Knoll
Houston, TX 77077
Prepared for:
Dalton & Jolie Schafer
Monday, December 21, 2020

PROPERTY INSPECTION REPORT

Concerning: 12219 Rocky Knoll, Houston, TX 77077
(Address or Other Identification of Inspected Property)

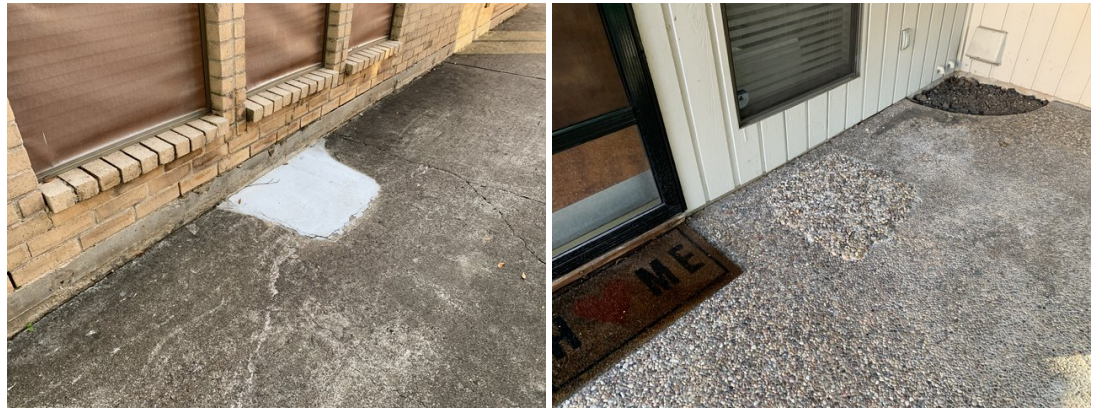
2. There are various signs of damage that are typical of a foundation problem that can be the result of the forces used to lift the house and repair the foundation. These can include cracks in the bricks as well as separation of trim.

- Review the foundation repair documents and consult with the engineer that did the assessment. Determine if another evaluation is needed.

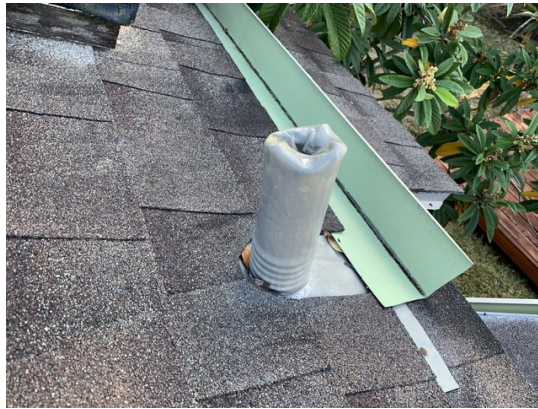
2. The tree limbs need to be trimmed. They are rubbing the roof and will damage the shingles.
 - This is noted above the primary bedroom.

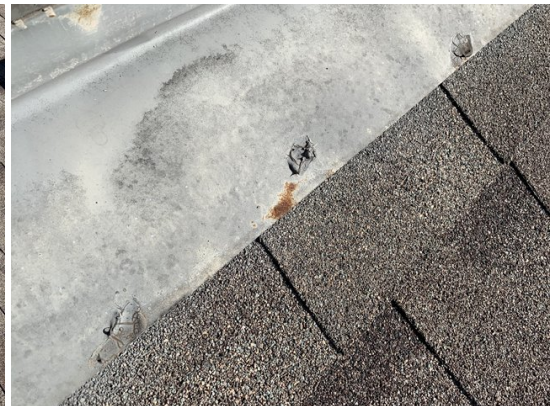
4. The dark spots are actually a form of algae that grows on the roofs. The south section of the roof receives enough sunlight to get hot enough to kill this algae. This is why it is never visible on the south side of the house.

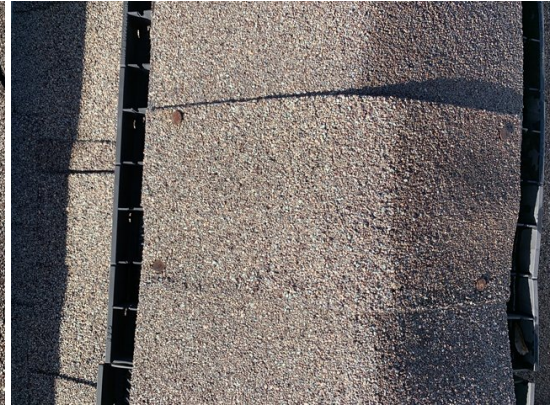
6. There are a few shingles that are damaged. The granules appear to have been knocked off, but damage does not appear to have gone through into the asphalt layer. This is typical of excessive foot traffic or walking on hot shingles (softer asphalt).

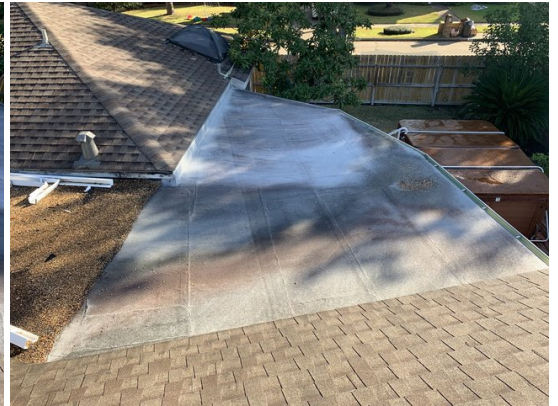
8. There is one section of the roof that does not drain well. The covered patio and enclosure is not well pitched. Monitor this area for future leaks.

- Clear the debris and trash from this area. It is also a bottle neck that will receive rain water from the top part of the roof.

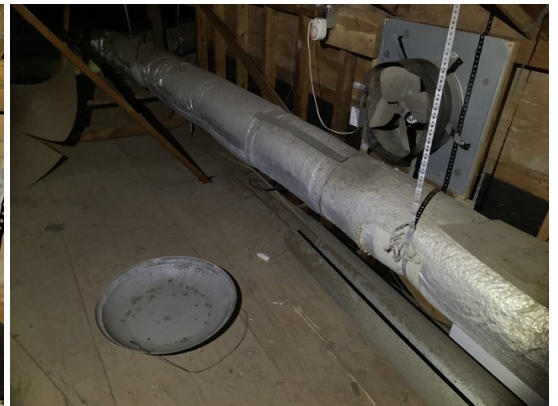
- The fan shroud/protector needs to be installed (or a safe alternative is needed).

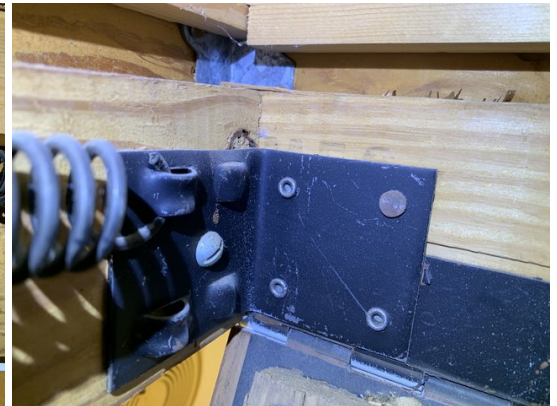
5. Attic access stairway is not installed properly. Manufacturers recommend shims be installed between the wooden frame and the ceiling joists. There should be 16 lag screws or 16d nails, and these fasteners should go through the holes in the metal brackets by the hinge and pivot point.

- Some nails are missing from the brackets.

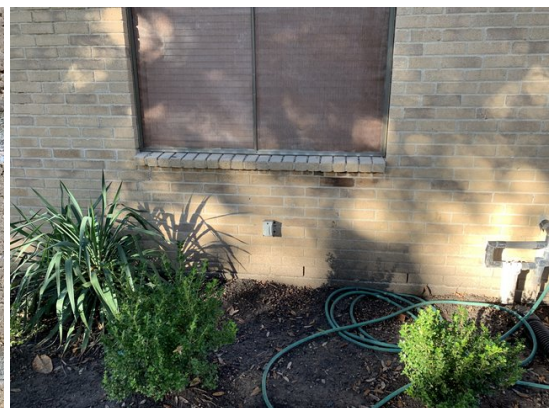
2. There are a few areas that have cracked bricks. This is not uncommon and is generally considered a cosmetic issue. With the foundation repair noted, this may be a symptom of a problem or a result of the repair.

- Some of the bricks are out of plane.

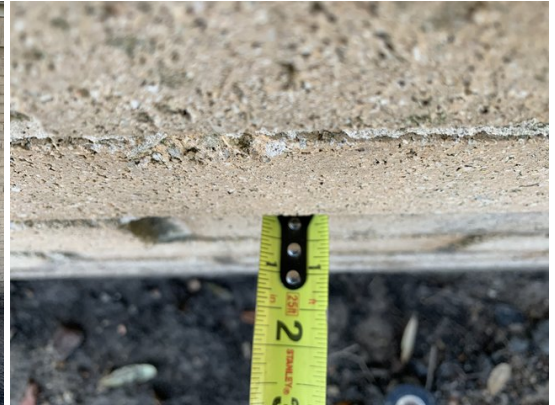
- While not uncommon, cracked bricks may indicate problems with the foundation. Check to see if this was addressed in the engineer's foundation report.

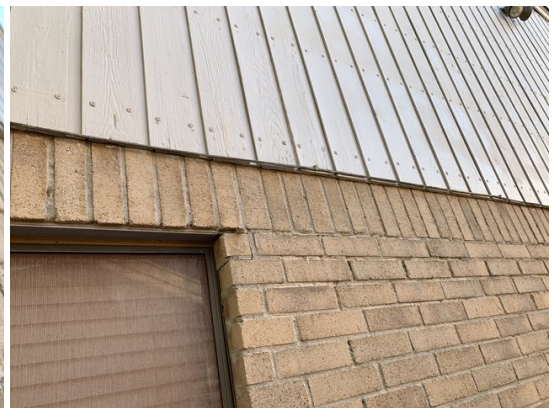
4. There are a few pieces of siding or trim that are rotten or starting to rot. Consider replacing it with a more durable, modern product that requires less maintenance.

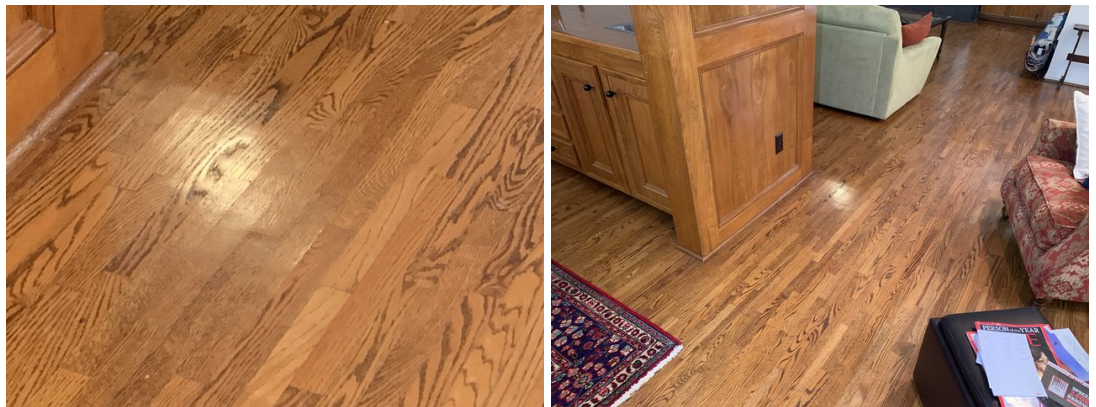
- It appears some water damage may be present.

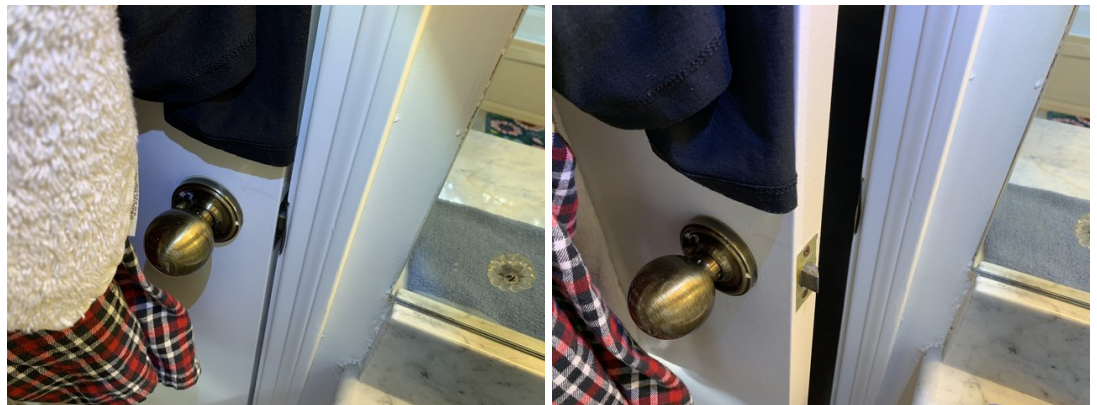
3. The primary bathroom door will not latch.

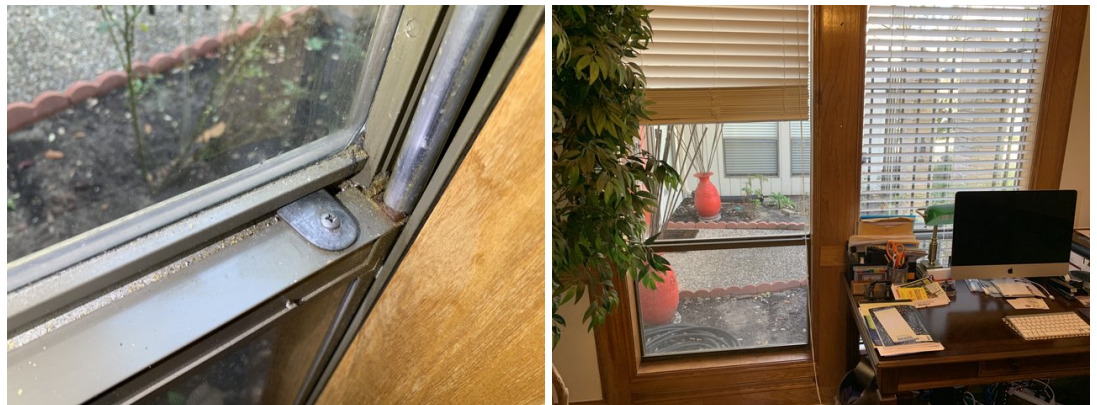
6. The windows in the study have been locked with a metal tab. These windows cannot be operated. If this is a bedroom, then the window must open for a secondary egress in the event of an emergency.

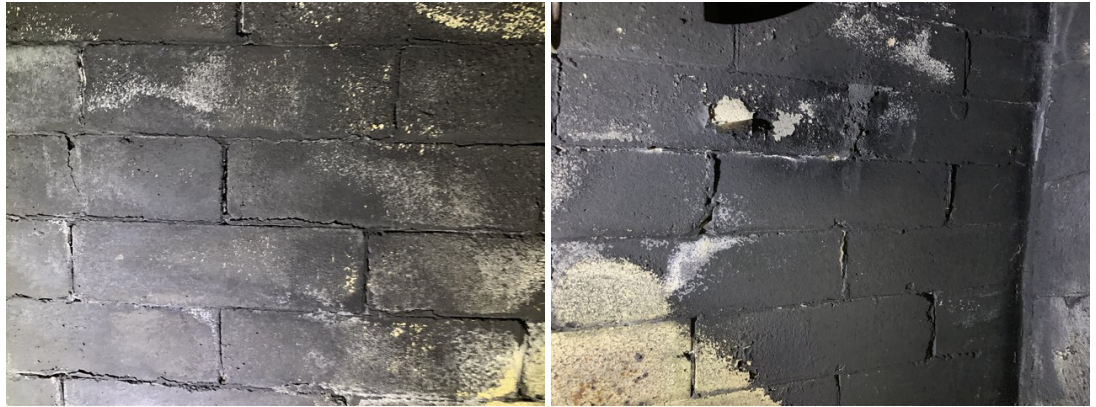
- The mortar for the firebricks is cracked. After cleaning, check the condition of the firebricks. Some of these areas can be repaired with a fireproof mortar or sealant. A mason or chimney sweep may be needed to evaluate the bricks when they are cleaned to determine to what extent there is damage.

- Clean up trash located inside the firebox.

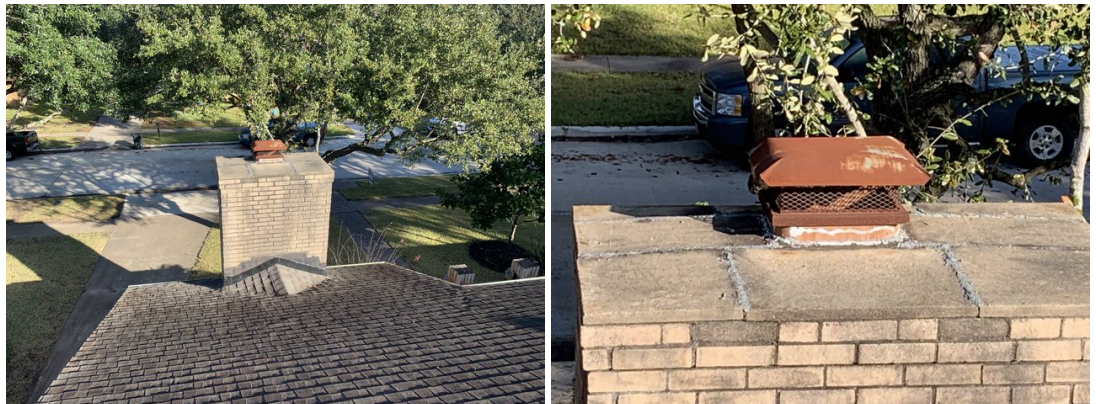
- The chimney cap mortar has voids/cracks. It needs to be pointed up.

- The chimney cap is rusting. It should be properly prepared, primed and painted with a rust-inhibiting paint.
- There is some rust noted at the top of the firebox as well.

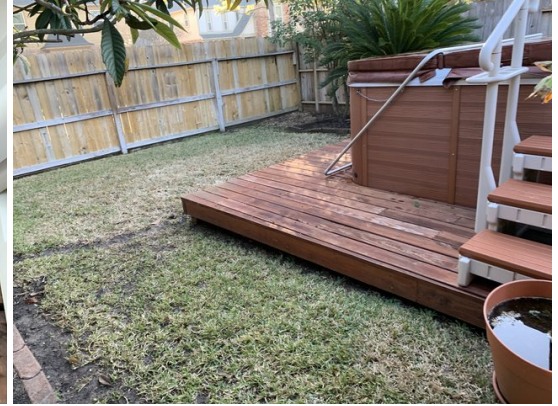
1. The decking needs to be refinished in some areas before there is damage from exposure to the elements.

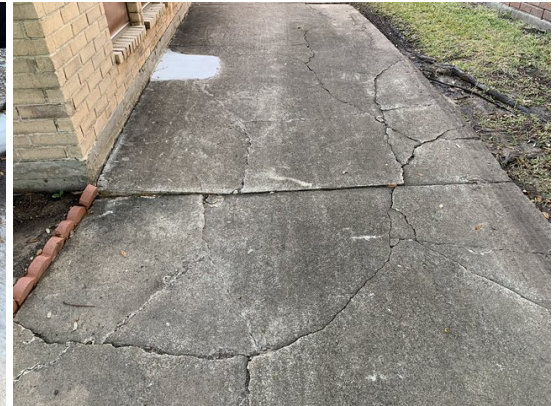
5. The concrete driveway/sidewalks are not level or are heaving in some areas. This can be due to dry soil condition, previously dry soil conditions or tree roots. Monitor this as it may be a trip hazard. There are some companies that specialize in the raising concrete and leveling walk ways.

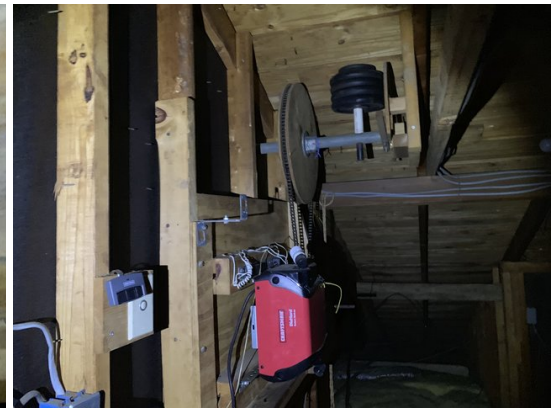
- Use caution as this is site built utilizing parts/machines in a way they are not designed to be used. It could not be operated/inspected for that reason.

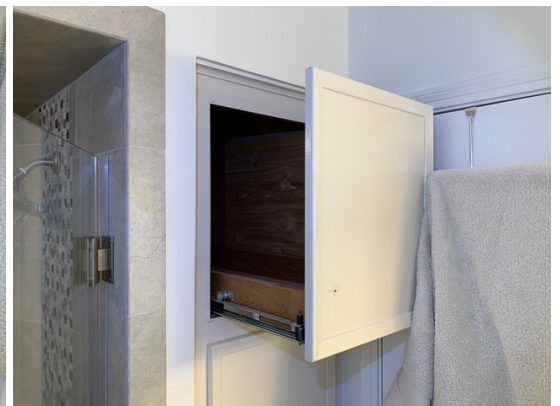
9. The primary bathroom has drawer that cannot be opened completely. It is a higher drawer than typical and is missing the drawer pull found on adjacent cabinets.

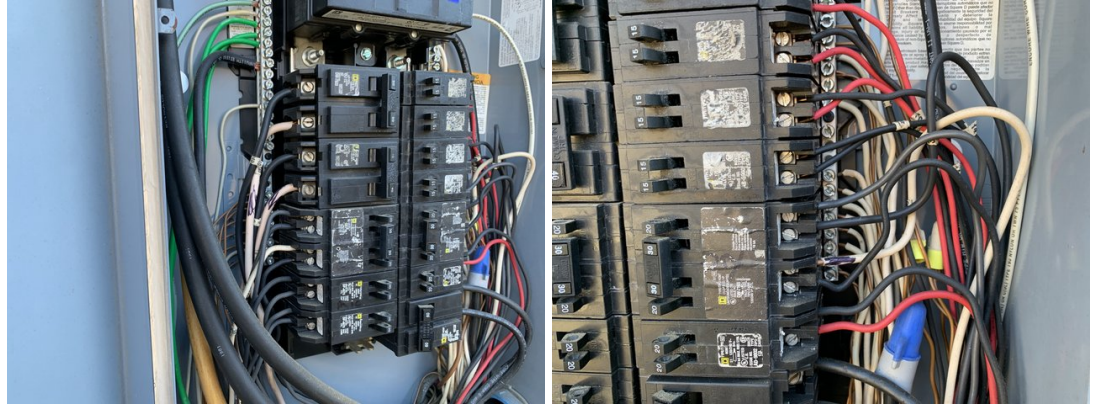
4. Trip ties are missing on some breakers that share a 220 Volt circuit. Since the house runs on 220 Volt wiring, the power comes in on two 110 Volt power lines. Any circuit that shares both power lines (AC, stove, dryers, etc.) should have trip ties to turn off both lines.

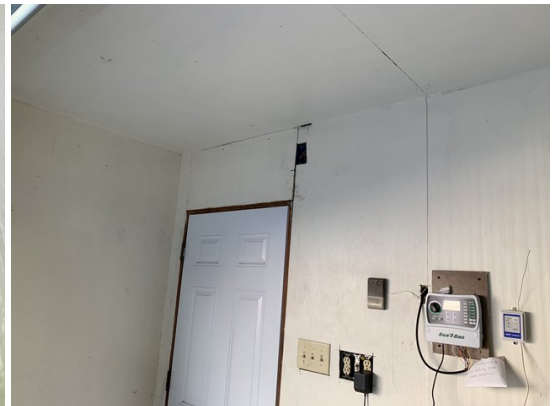
5. Some junction boxes are missing cover plates. These protect the electrical wiring connections and are required.

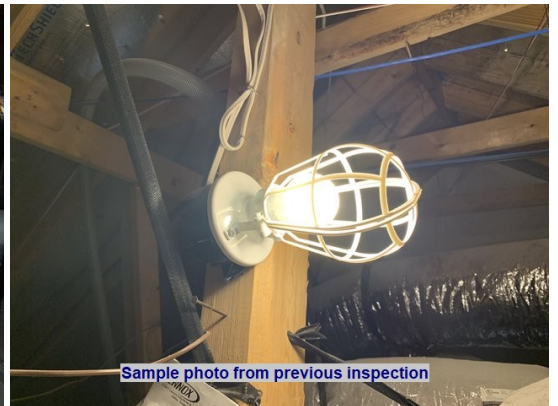
The light fixture in the attic should have a protection for the light bulb or be placed higher so it is less likely to be damaged.

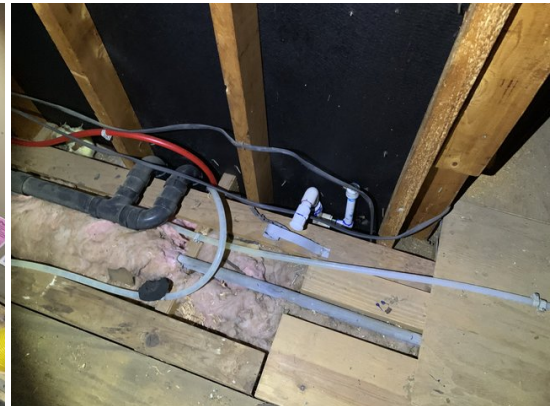
- It appears the original primary condensate drain line was drained into one of the vents in the attic.

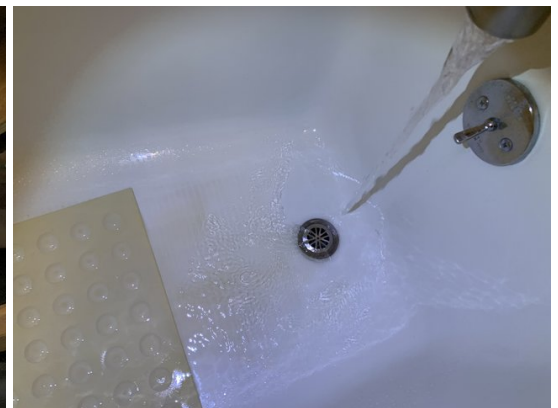
5. It appears the original galvanized steel pipes have been abandoned. Verify the pipes were removed

- Rust in the water of the hall bathroom tub indicates there is some steel pipe present close by it.

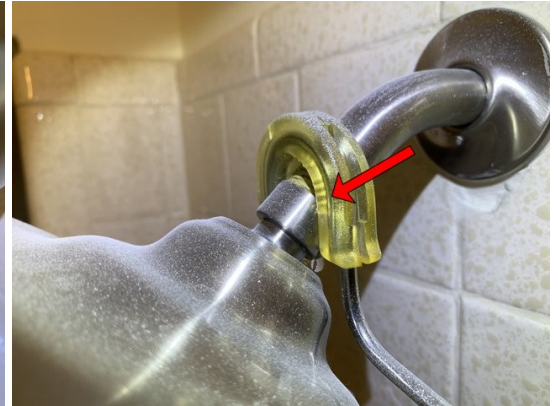
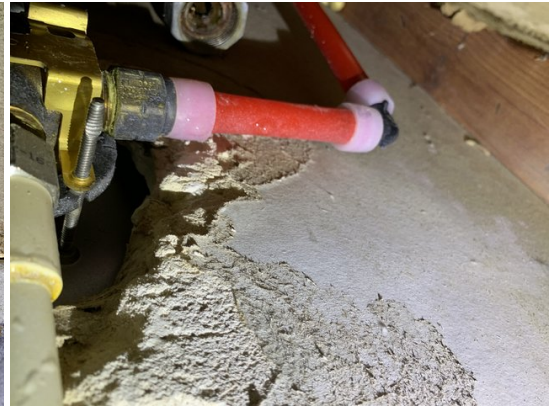
11. Water drops are visible on the hall bathroom tub/shower plumbing lines.

- It is unknown if this is a leak in the shower head or condensation.

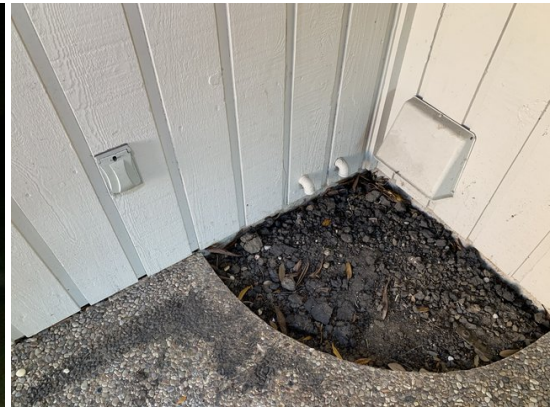
- TPR valve discharge drain line does not terminate within six inches of the final grade on the exterior of the house.
- For future reference, if water is coming out of the exterior drain line, there is an issue with the water heater.
- To see the Mythbusters experiment on water heaters, visit: <https://www.youtube.com/watch?v=jbreKn4PoAc>. Please note their water heater is only a 30 gallon water heater.

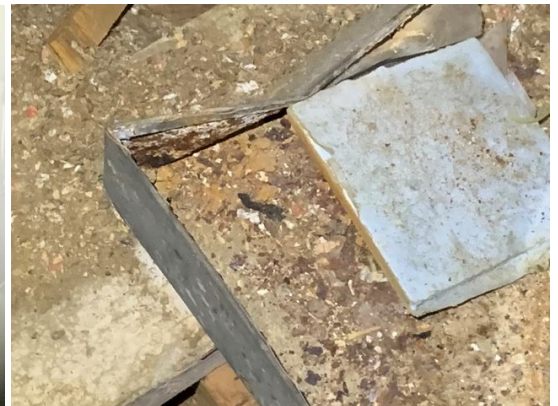
- The pan may be broken.
4. The temperature of the water is too hot. It should be no more than 120 degrees, but this water heater registered at 134 degrees.
 - Because the attic is not a conditioned space, its temperature is affected by the exterior temperature. This temperature fluctuation can affect the water heater temperature. It may need to be adjusted, depending on the season (turned up in the winter and down in the

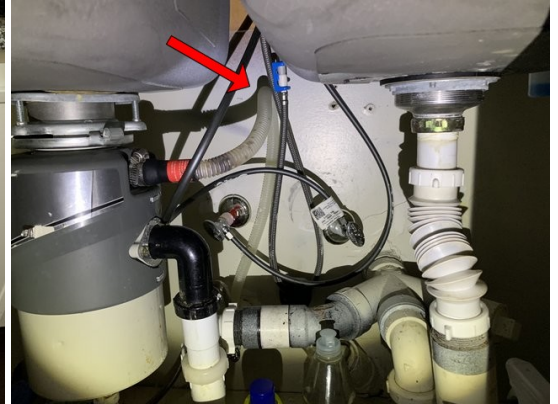
2. The anti-siphon device is missing on the dishwasher. There is an "air-gap" device that is a siphon breaker, or a "high loop" drain line can be installed. This means the drain line needs to be secured to the underside of the countertop.
 - Though there is a loop, it is not in contact with the underside of the countertop.

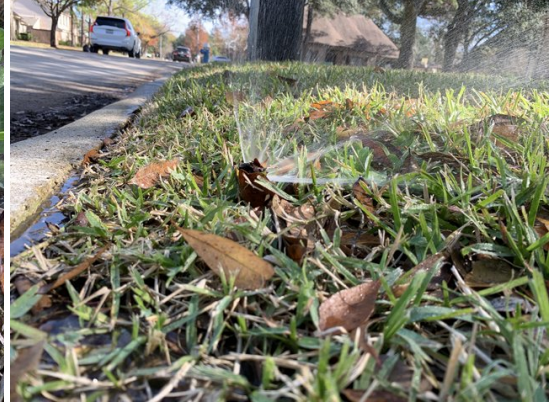
- Some heads need to be adjusted at this time.
