# *Texan Inspection Services LLP*

## **Property Inspection Report**

511 Quintana Roo Place, Seabrook, TX 77586  
Inspection prepared for: Zachary Colander Kristen Colander  
Real Estate Agent: Spencer Mulgrew - Creekview Realty

Date of Inspection: 6/21/2019 Time: 1:00 PM  
Age of Home: 2018 Size: 3567  
Weather: Cloudy/ 92 Degrees  
New Construction

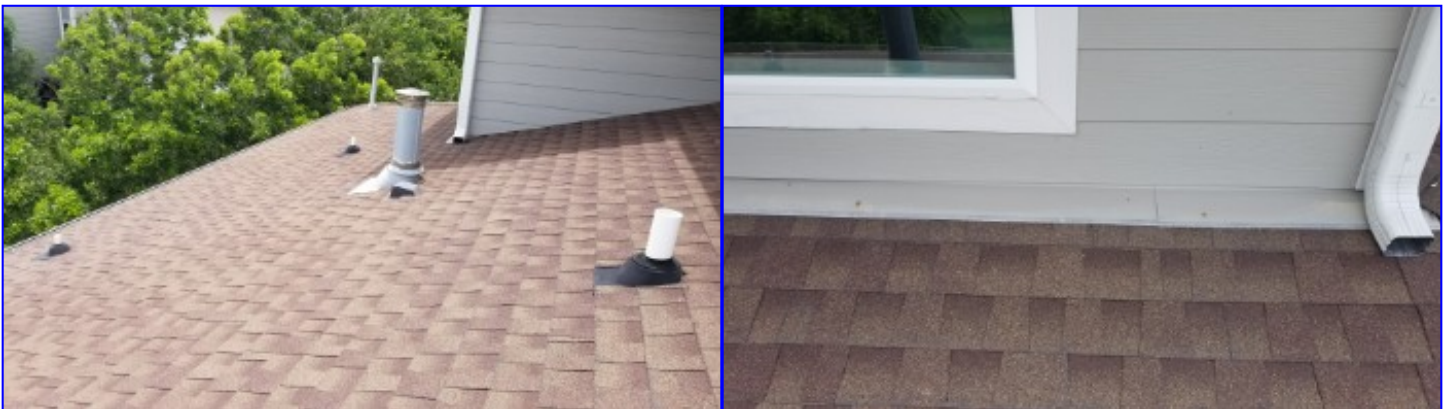
Uncoated/unsealed and or rusty flashing should be improved or repaired to prevent premature deterioration or failure. Maintaining flashing is crucial to prevent water intuition.

Exposed nails are present on the roofing application. Nailheads should be sealed to prevent leaking and rusty nails should be examined and replaced where needed.

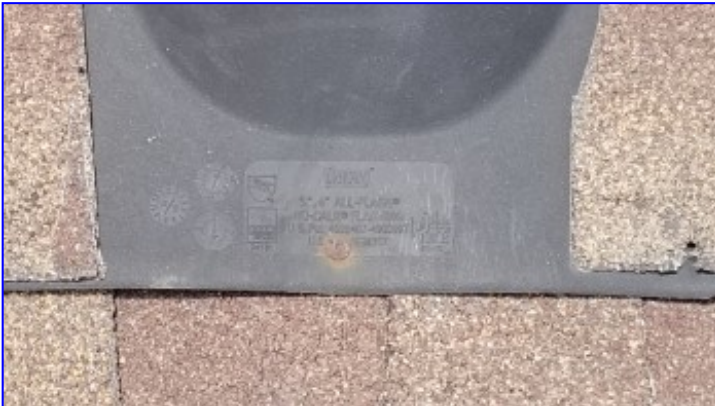
Exposed nails are present on the roofing application. Nailheads should be sealed to prevent leaking and rusty nails should be examined and replaced where needed.

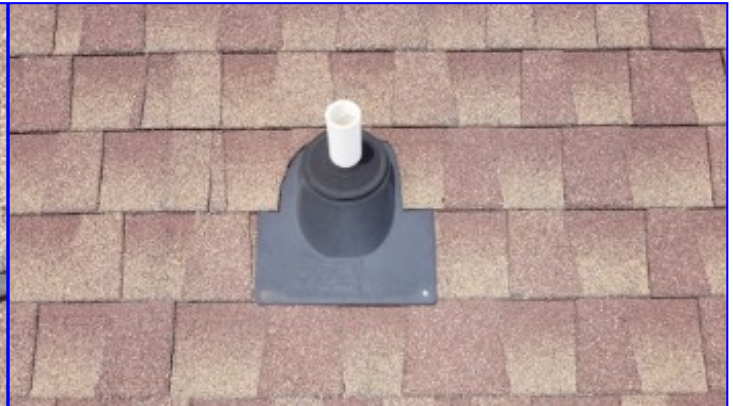
Exposed nails are present on the roofing application. Nailheads should be sealed to prevent leaking and rusty nails should be examined and replaced where needed.

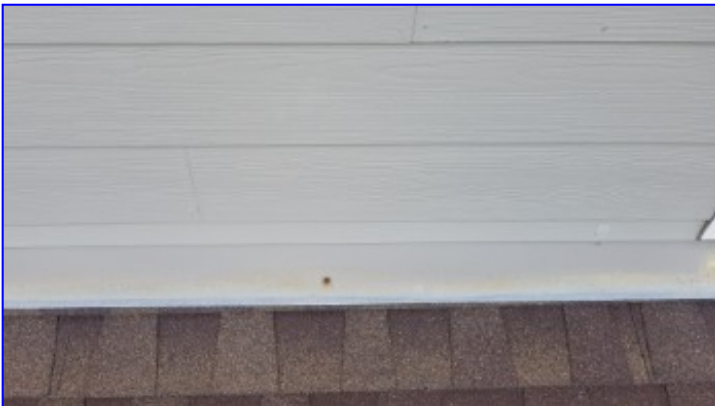
Exposed nails are present on the roofing application. Nailheads should be sealed to prevent leaking and rusty nails should be examined and replaced where needed.

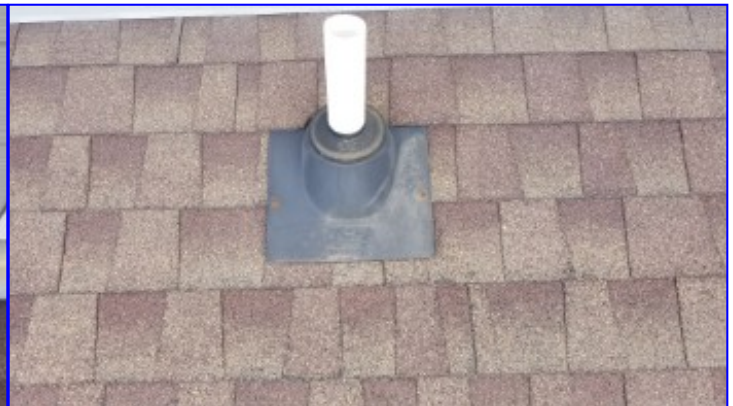
Exposed nails are present on the roofing application. Nailheads should be sealed to prevent leaking and rusty nails should be examined and replaced where needed.

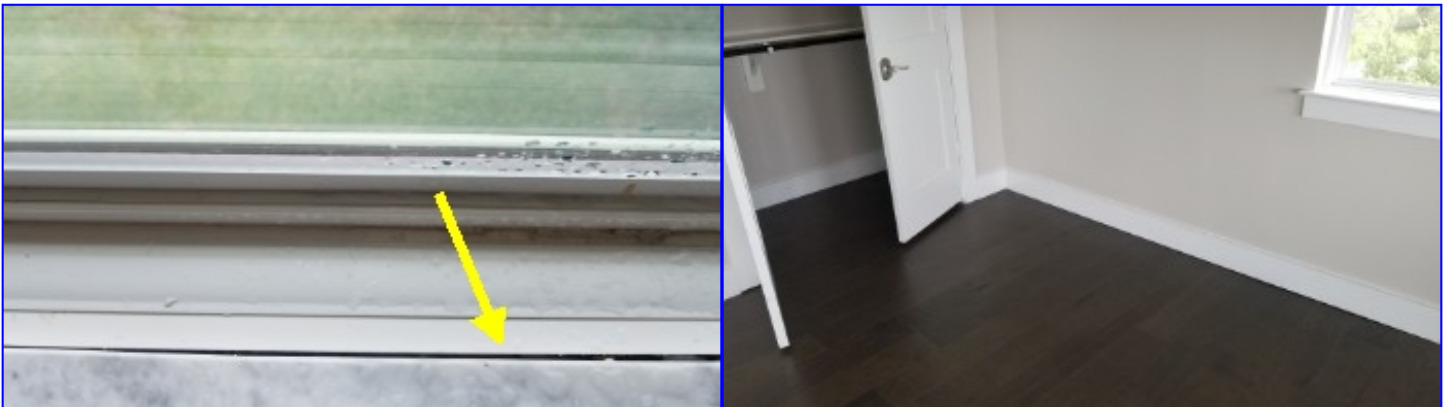
The window frame in the master shower should be sealed.

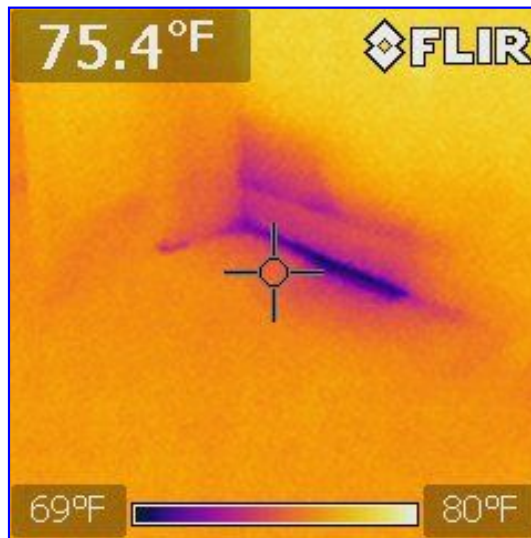
Potential moisture was observed on the left wall of the 3rd floor bonus room. The cause/source should be determined and repairs should be undertaken to prevent further damage. Note: The structure and finish materials adjacent to the area should be examined to determine the extent of damage and repairs made to the materials if needed.

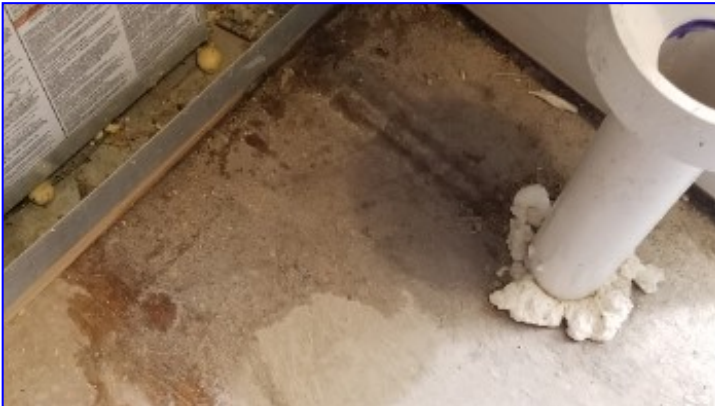
Water staining was observed on the decking in the 3rd floor mechanical room. The cause/source should be determined and repairs undertaken, if necessary, to prevent further damage

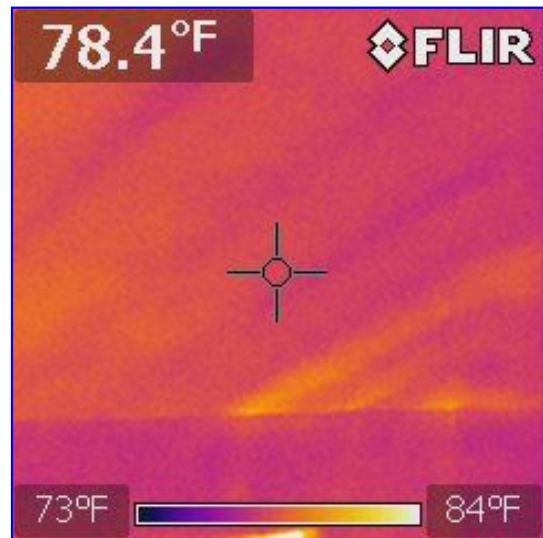
An infrared scan was performed during inspection. No deficiencies were observed at this time.

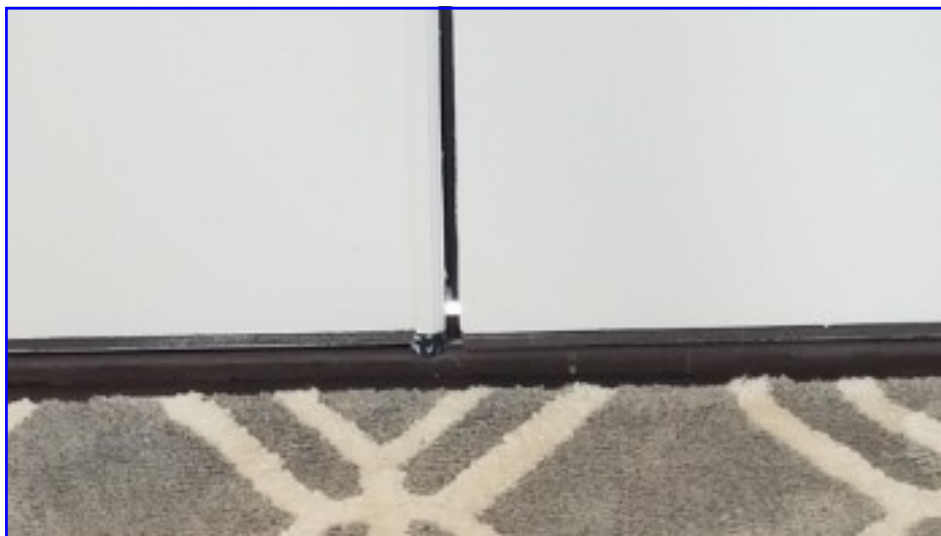
Light can be see st the front door. All exterior and/or attic access doors should be properly weather sealed as necessary to maintain a proper thermal boundary and prevent energy loss and moisture infiltration.

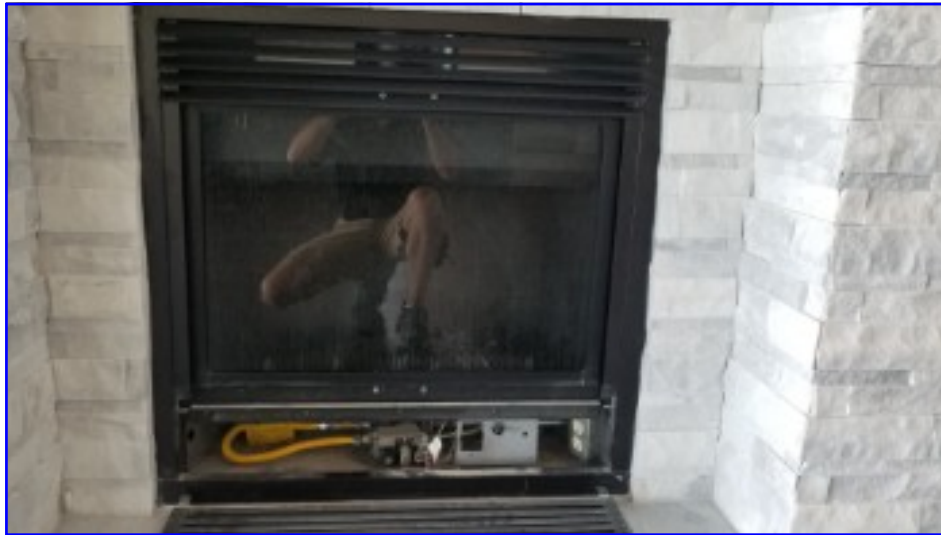
Fireplace was inoperable at time of inspection. Further investigation is recommended and repairs made as necessary.

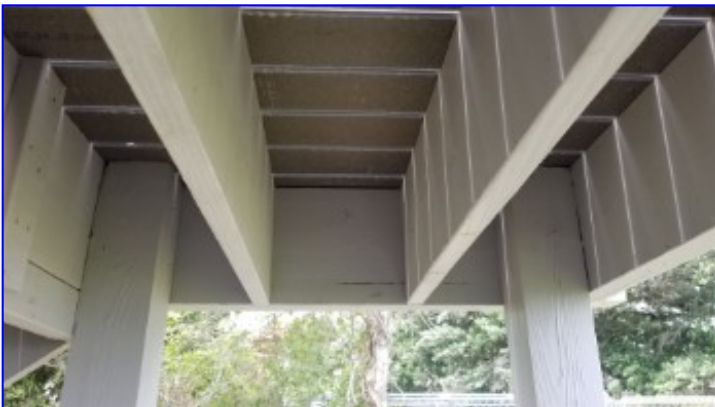
Joist hangers should be installed under the front and rear exterior stair landings to provide proper structural support.

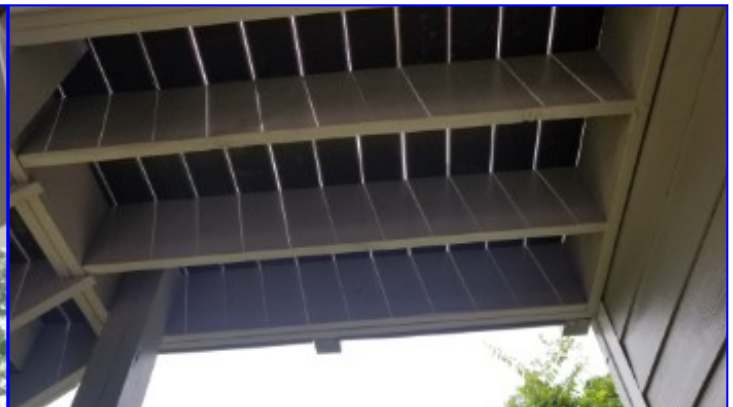
Joist hangers should be installed under the front and rear exterior stair landings to provide proper structural support.

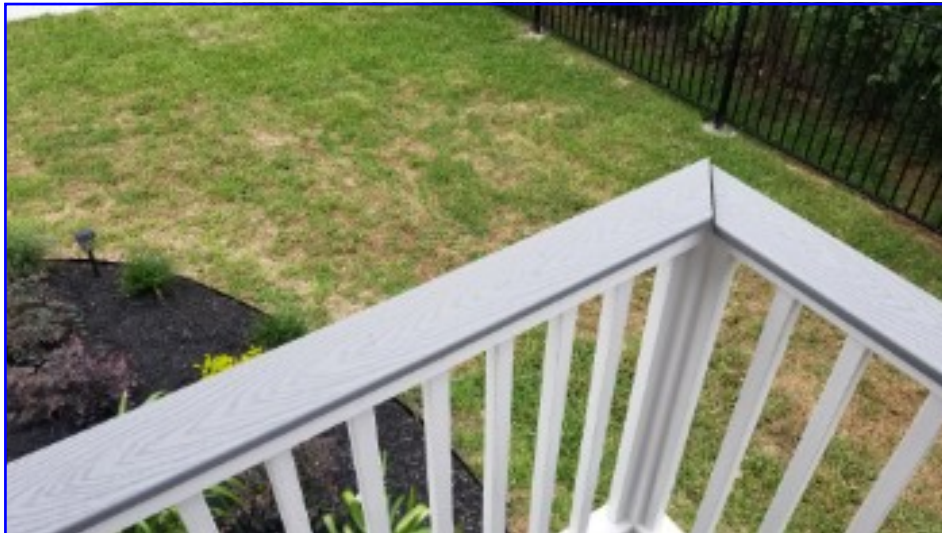
The caps for the balcony and stairs railing are not properly attached. Improvements recommended for improved safety.

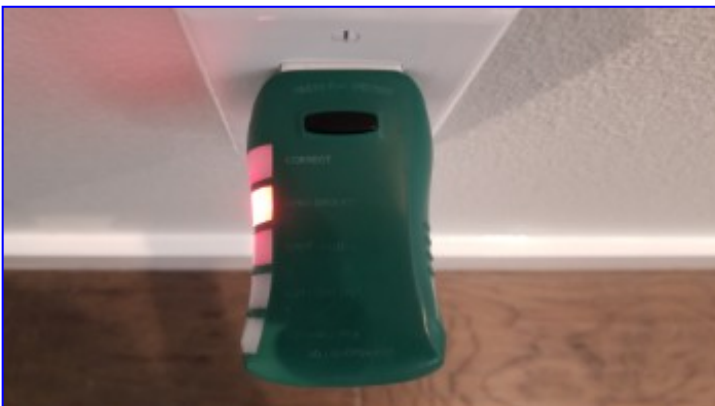
open ground 3rd floor loft

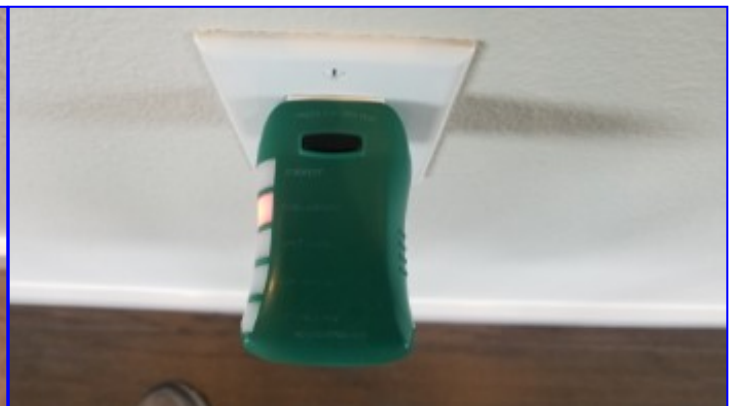
open ground 3rd floor bonus room front wall

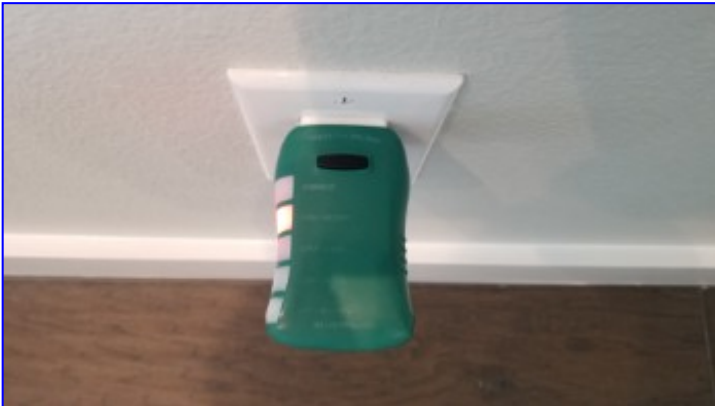
open ground 3rd floor bonus room

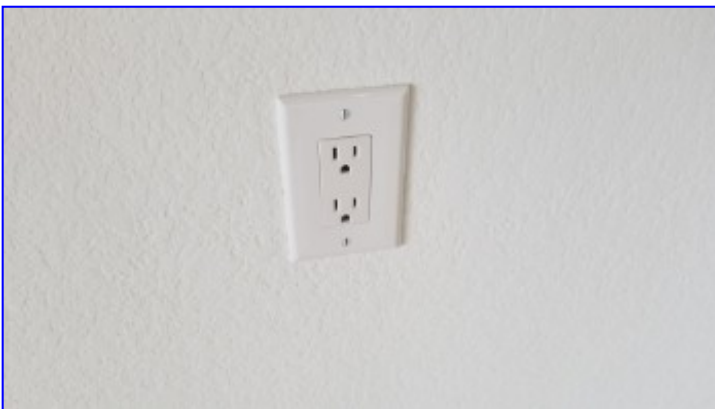
no gfci in garage

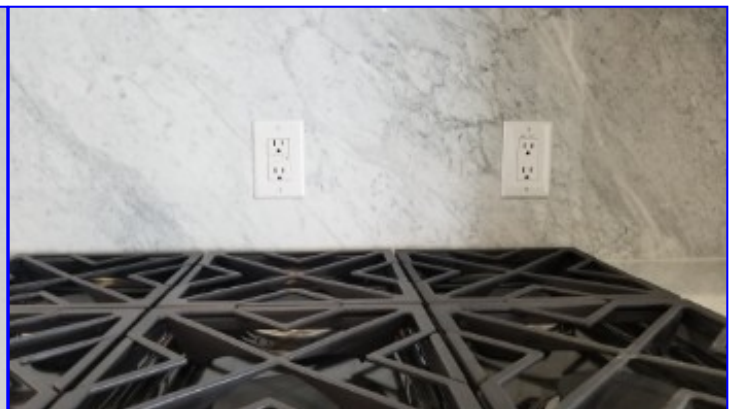
Outlets are installed directly above the cooktop. These should be relocated to prevent damage.

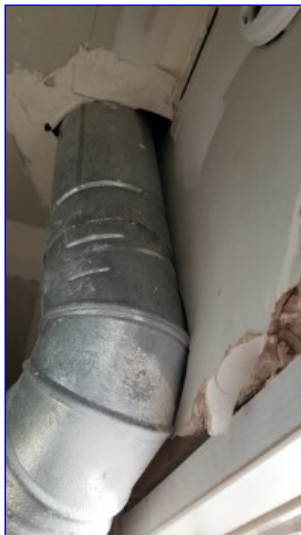
The furnace flue pipe is contacting the roof decking and should be repaired to allow the proper two inch clearance from all combustible materials.

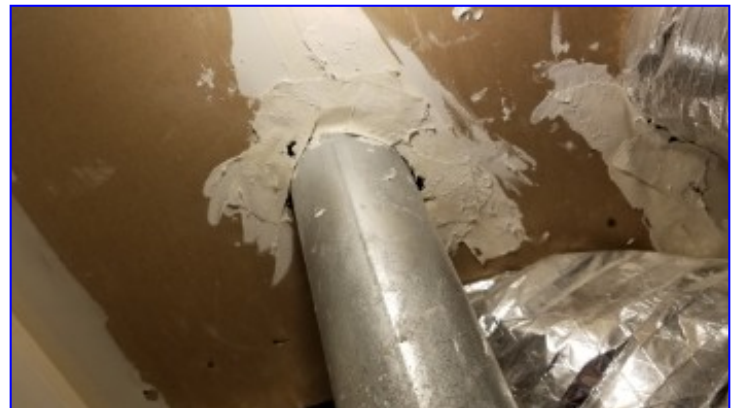
The furnace flue pipe is contacting the roof decking and should be repaired to allow the proper two inch clearance from all combustible materials.

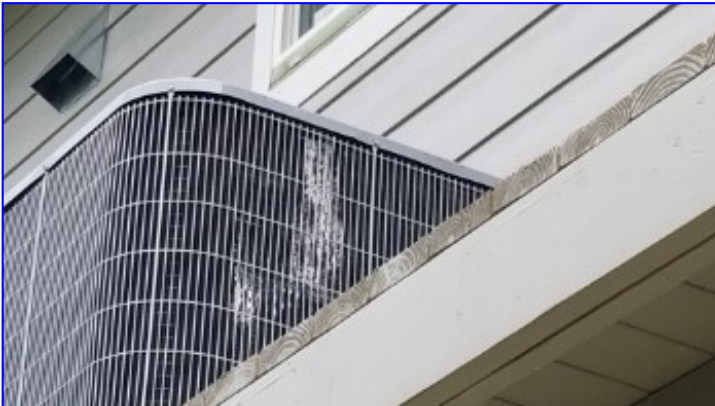
The fins of the outdoor portion of the air conditioning system were observed to be damaged and in need of repair. This condition can reduce the efficiency of the system.

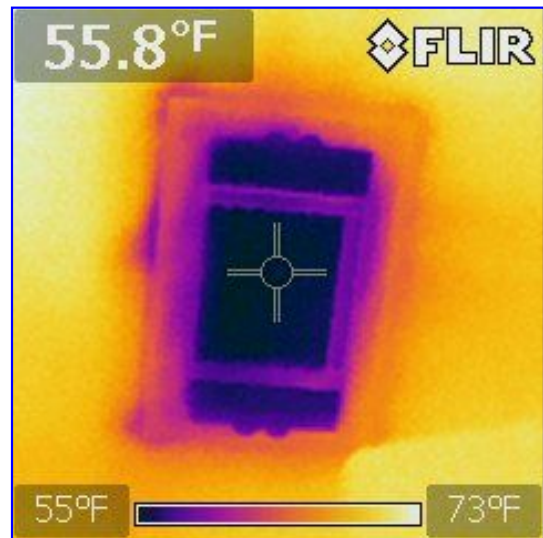
The 2nd floor a/c unit and its components were visually inspected for defects and operated properly at this inspection. The unit produced a temperature differential of 19 degrees. This is within test limits of 15 to 20 degrees.

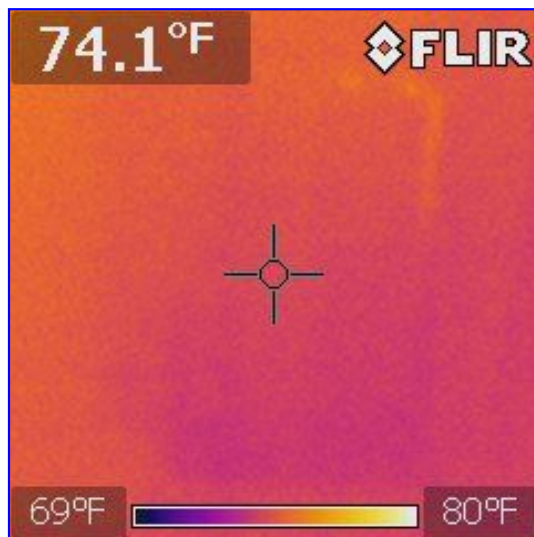
The 2nd floor a/c unit and its components were visually inspected for defects and operated properly at this inspection. The unit produced a temperature differential of 19 degrees. This is within test limits of 15 to 20 degrees.

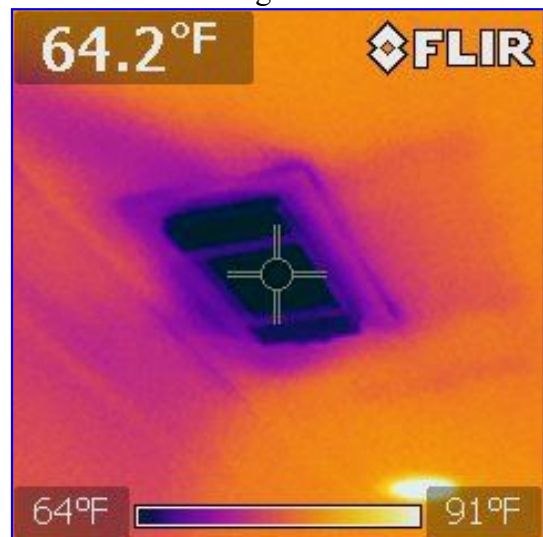
The 3rd floor A/C system did not cool properly. Unit produced a supply of 64 degrees and a return of 77 degrees which is a drop of 13 degrees. This is not within test limits of 15 to 20 degrees. Evaluation by certified HVAC technician is recommended.

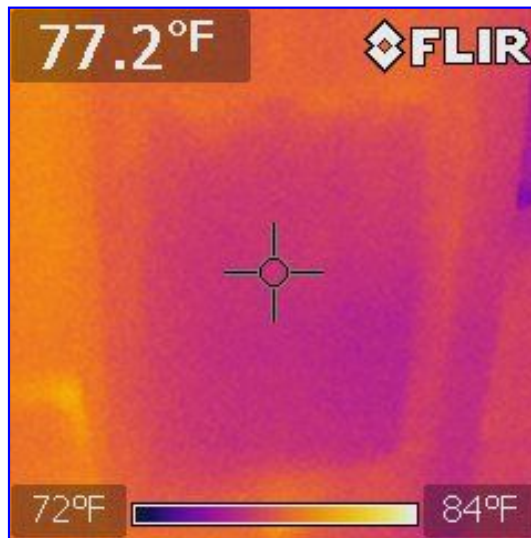
The 3rd floor A/C system did not cool properly. Unit produced a supply of 64 degrees and a return of 77 degrees which is a drop of 13 degrees. This is not within test limits of 15 to 20 degrees. Evaluation by certified HVAC technician is recommended.

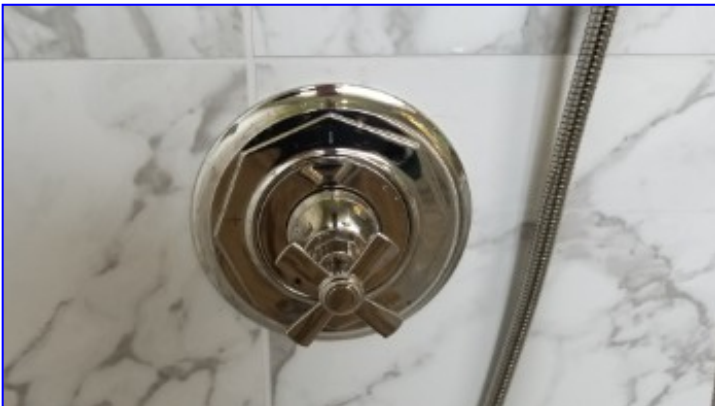
A valve handle in the master shower is inoperative.

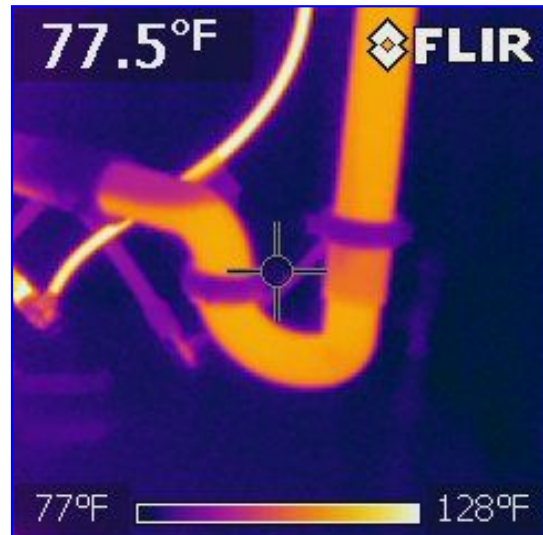
An infrared scan was performed to the materials adjacent to the plumbing fixtures during inspection. No evidence of moisture and or leakage was observed at this time.

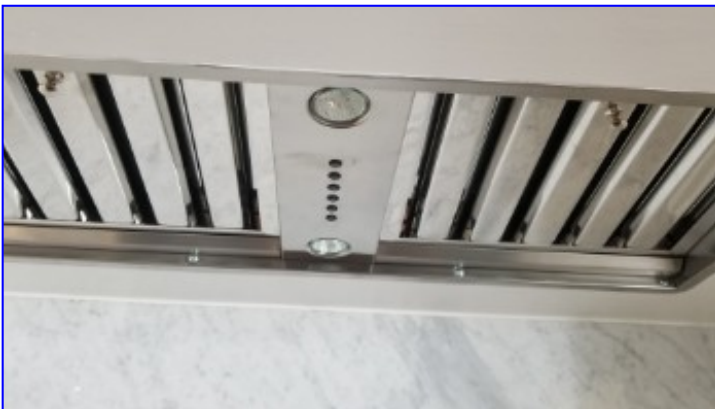
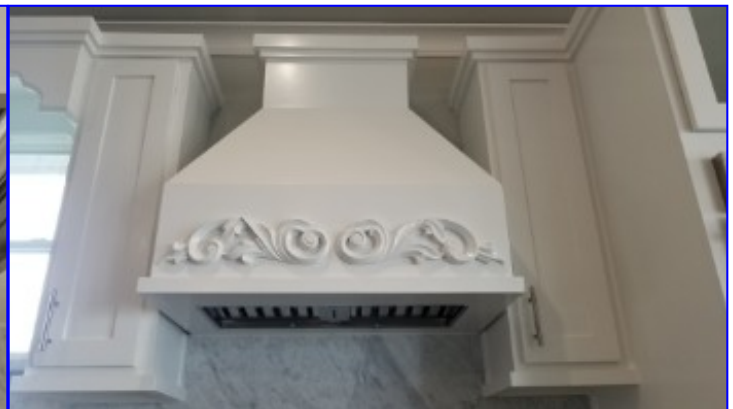
lights inop
