RESIDENTIAL INSPECTION REPORT

9400 Doliver Dr 78
Houston, TX 77063

PROPERTY INSPECTION REPORT FORM

| Susan McDaniel <i>Name of Client</i> | 05/26/2023 9:00 am <i>Date of Inspection</i> |

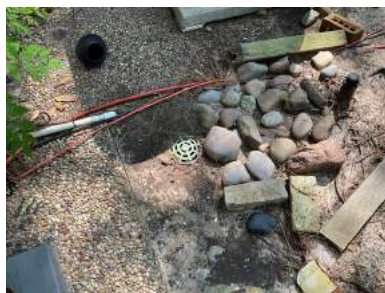
1: Grading & Drainage: Uneven/Cracked Flatwork

Uneven or cracked flatwork can be a trip hazard. Evaluation and remediation recommended.

Recommendation: Contact a qualified concrete contractor.

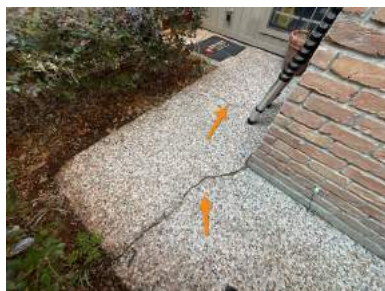
Front Exterior

2: Grading & Drainage: Inadequate

Low spots, ruts, soil erosion, negative grading, standing water and/or damaged sod were present at the time of inspection. Evaluation and remediation by a qualified landscaping contractor or foundation contractor so that water flows away from the home is recommended.

Recommendation: Contact a qualified landscaping contractor

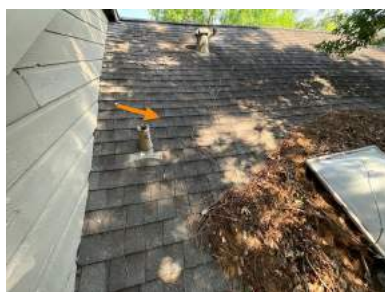
4: Debris on Roof

Debris was present on roof surface. The condition of the roof covering underneath could not be determined. Removal of debris and evaluation of the roofing materials underneath is recommended.

Recommendation: Contact a qualified professional.

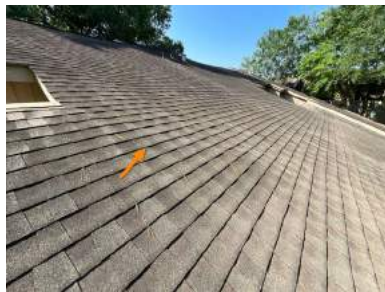
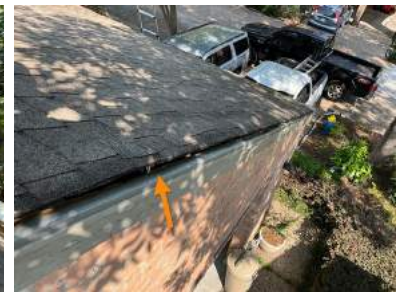
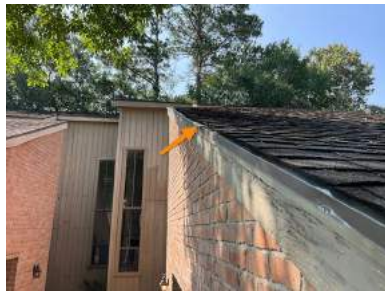
6: Sealant: Deteriorating

Deteriorated roof sealant was observed. The life cycle of this material is generally 5-8 years depending on weather conditions. Evaluation and remediation is recommended.

Recommendation: Contact a qualified roofing professional.

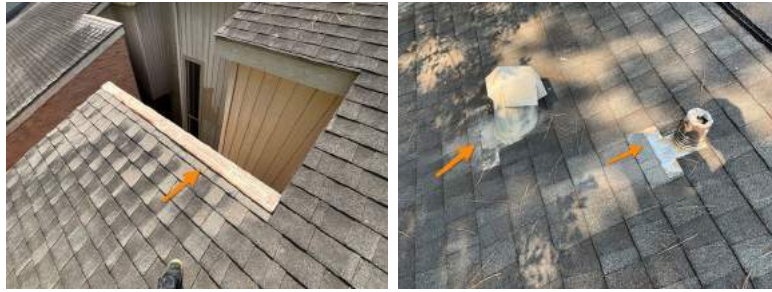
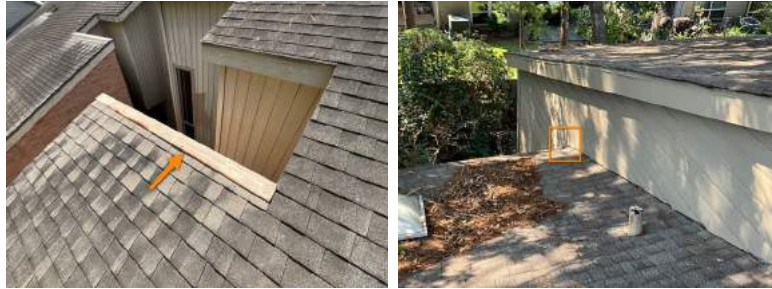
7: Flashing Deficiencies

Corroded, Kickouts Missing -

Deficiencies with the flashings were present at the time of inspection. Evaluation and remediation is recommended.

Corroded Flashings

Kickouts Not Present

Recommendation: Contact a qualified roofing professional.

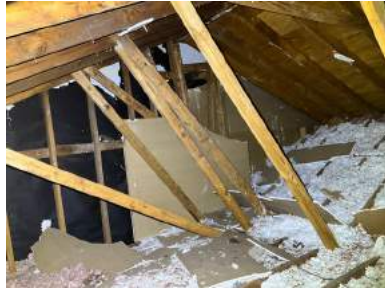
1: Framing: Firestop Missing

A proper firestop/draftstop should be present between the townhome attics or in the breezeway framing between a garage and the house. Evaluation and remediation is recommended.

Recommendation: Contact a qualified professional.

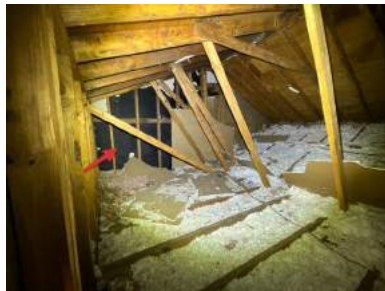
2: Framing: Missing/Inadequate Purlins

Purlins should share the same dimensions as the rafters that they help to support and be braced every 4' on center according to current building standards. Further evaluation and remediation by a qualified roofing contractor is recommended.

Recommendation: Contact a qualified roofing professional.

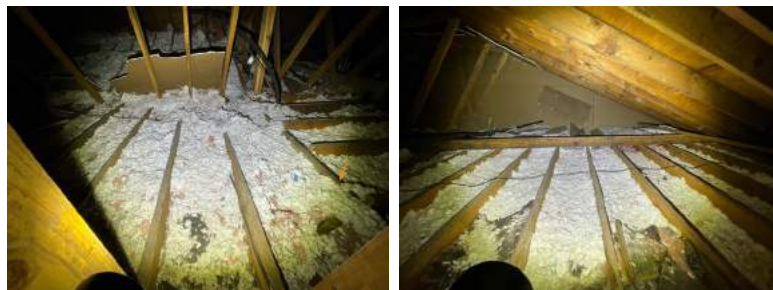
5: Venting: Inadequate

The attic ventilation appeared to be inadequate. Evaluation and remediation is recommended.

Recommendation: Contact a qualified professional.

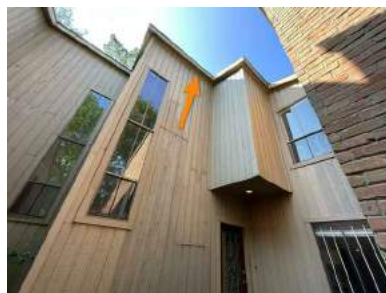
There were no soffit vents present on the exterior. Current building standards recommend having soffit vents installed when ridge vents are used in roof ventilation. Evaluate and remedy as needed.

Soffit Vents Not Present

Recommendation: Contact a qualified professional.

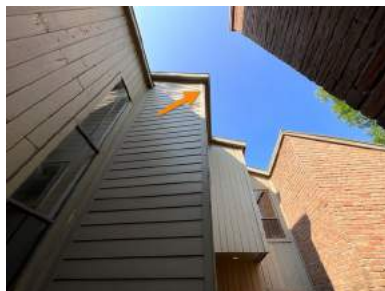
4: Exterior Walls: Surface Defects

The exterior wall coverings, such as siding, trim fascia, soffit or eave had defects. Examples include, but are not limited to:

Damaged - Front Exterior

Recommendation: Contact a qualified professional.

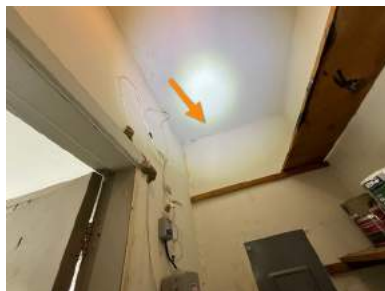
Utility Closet

Wrinkled tape joints can be evidence of current and/or previous structural movement. Evaluation and remediation is recommended.

Recommendation: Contact a qualified professional.

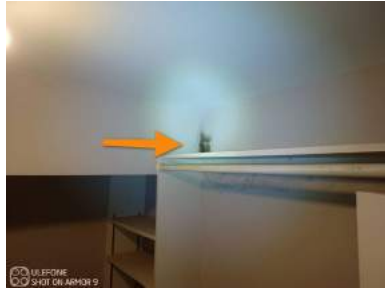
Primary Bathroom Closet 1/2

Wall structure showed signs of water intrusion. Tested positive for moisture at the time of the inspection. Evaluation and remediation is recommended.

Recommendation: Contact a qualified professional.

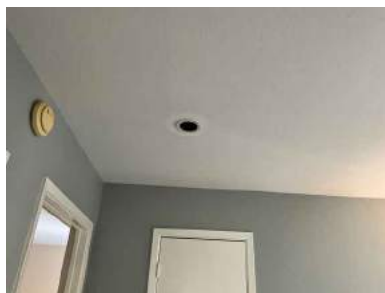
2nd Floor Hall

1: Ceiling: Evidence of Previous Moisture Contact

Ceiling showed signs of previous water intrusion. Tested negative for moisture at the time of the inspection. Evaluation and remediation is recommended.

Recommendation: Contact a qualified professional.

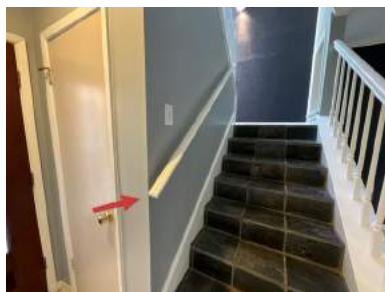
Does Not Turn Into Wall

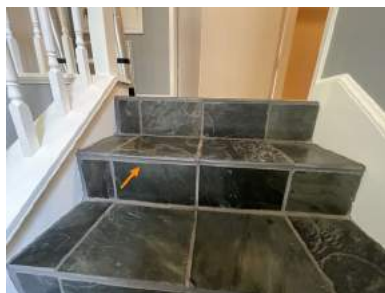
Stair treads exhibited conditions that do not appear to meet current building standards. Evaluation by a qualified contractor is recommended for safety.

Sloped

Recommendation: Contact a qualified professional.

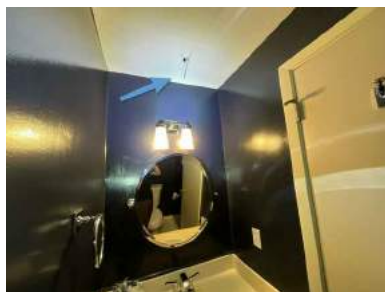
Half Bathroom

1: Note: Secondary Drain Line Termination

Note: The secondary drain line for the air handler emergency drain pan terminated above the half bathroom sink. Although not a deficiency, the termination location is typically located outside of a window that is visible to persons in the home. Remedy as needed.

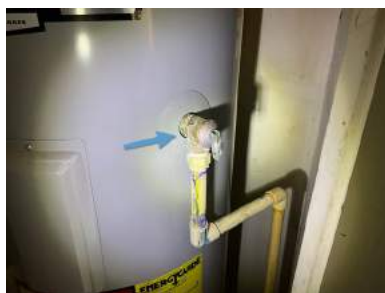
4: TPR Valve Note: Replacement May Be Needed

The manufacturer recommends replacement of the pressure relief valve every three years to ensure proper emergency function. The inspector does not test TPR valves due to safety hazard or possible damage to unit.

Recommendation: Contact a qualified plumbing contractor.

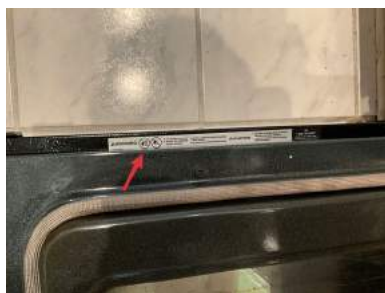
1: Missing Anti-Tip Device

Recommendation: Contact a qualified professional.
