**PROFESSIONAL
DRAIN INSPECTORS**

Invoice # 12717
Susan McDaniel
Inspection at 9400 Doliver Dr. Unit 78
Houston, Tx 77063
05/26/2023

Sewer Inspection Report

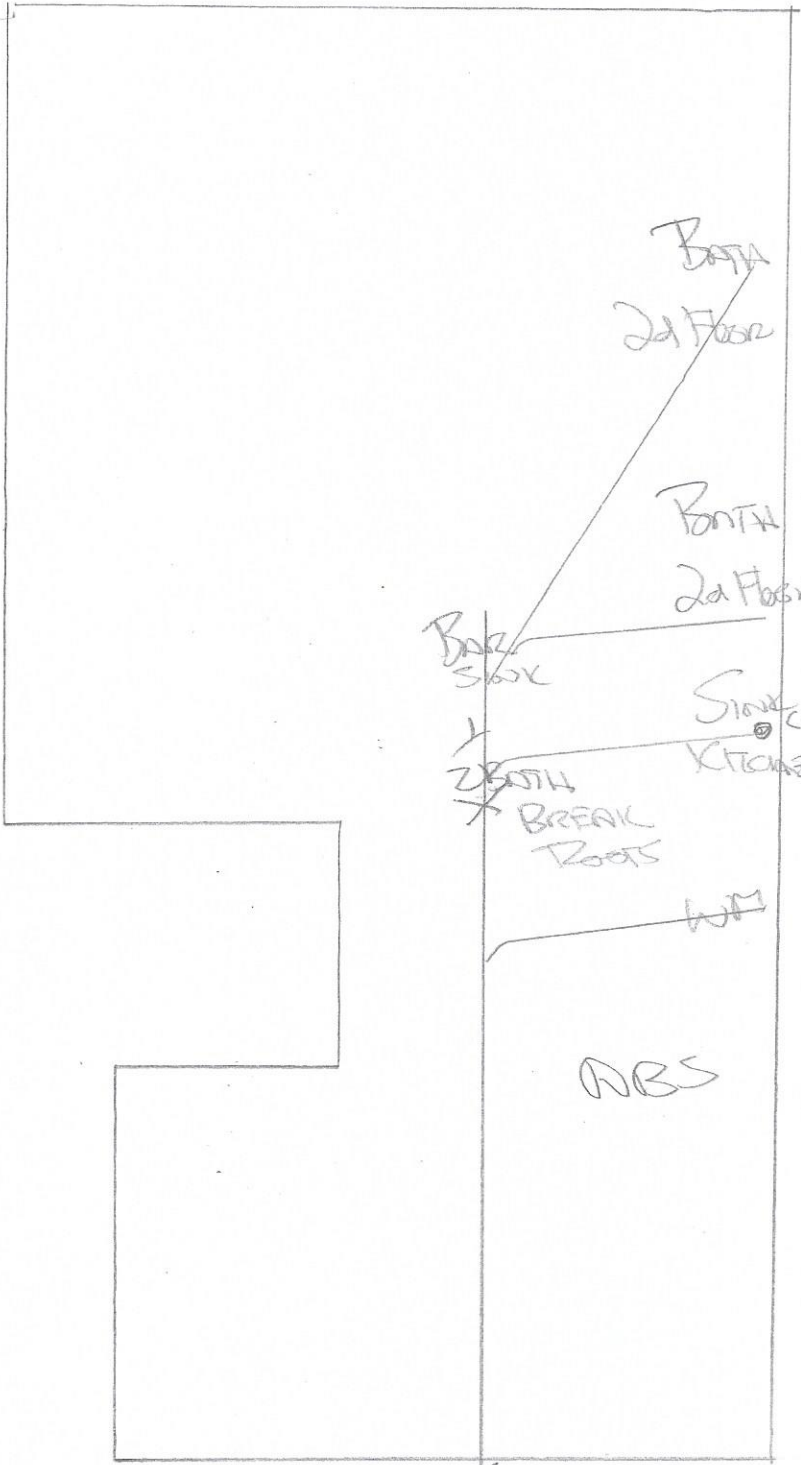
One main and one secondary kitchen clean-out were found (approximate locations both indicated on the diagram).

The system showed two significant breaks, with root intrusion. The first was seen under the half bath toilet and the second was seen at the clean-out location with breaks upstream and downstream from the clean-out.
The roots were too thick to allow the camera downstream to see the city tap.

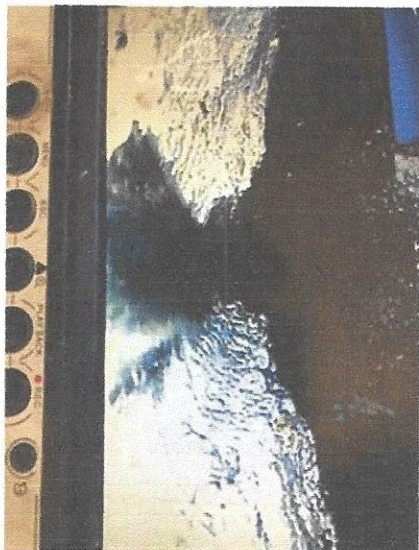
The test showed a 2.5/5 result, indicating and confirming the leaks seen on camera.

BREAK/ROOTS AT
CLEAN-OUT

1. Repair the known leaks only and re-test the system to ensure no further leaks are present or
2. Change out the ABS completely to the more modern PVC pipe (the recommended option).

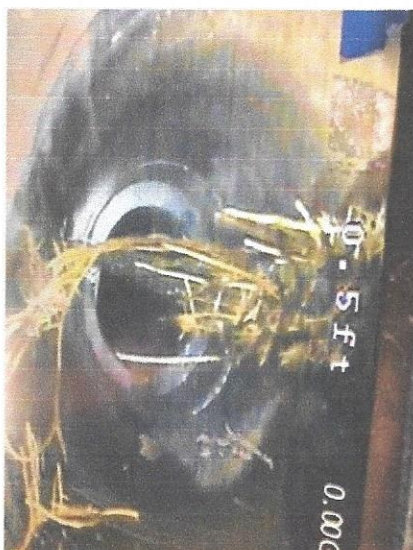
BREAK/ROOTS
UNDER TOILET

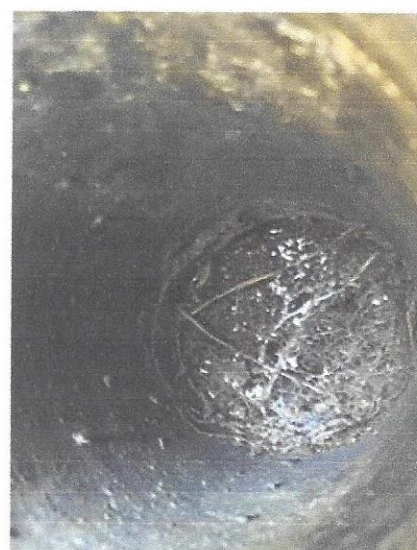
BREAK/ROOTS AT
CLEAN-OUT
