## **GC Home Inspection**

# PROPERTY INSPECTION REPORT FORM

Elijah Adeniyi <i>Name of Client</i>	09/21/2023 <i>Date of Inspection</i>
8102 Rhobell St, Houston, TX 77078 <i>Address of Inspected Property</i>	
Chad Gregory Langston Jr. <i>Name of Inspector</i>	25839 <i>TREC License #</i>
Chad Langston <i>Name of Sponsor (if applicable)</i>	7946 <i>TREC License #</i>

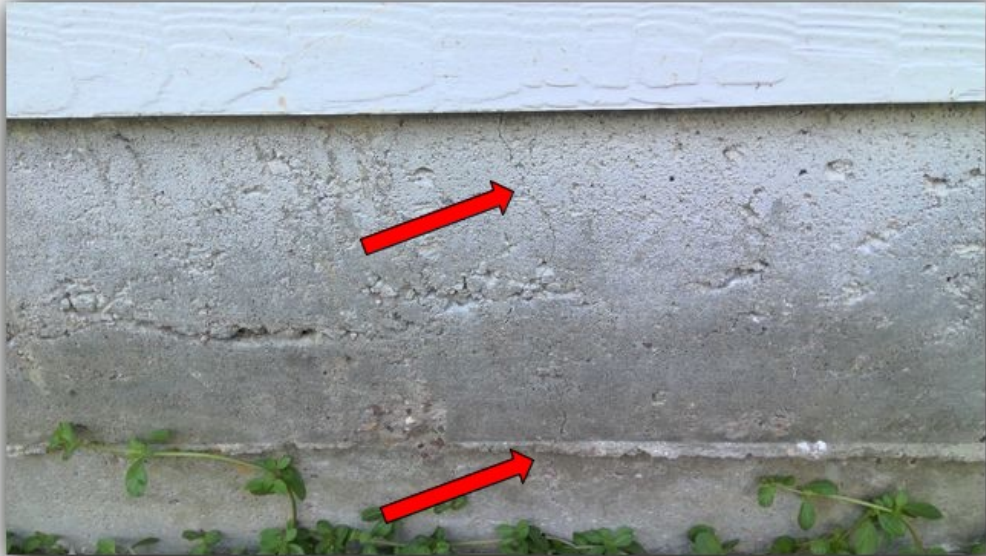
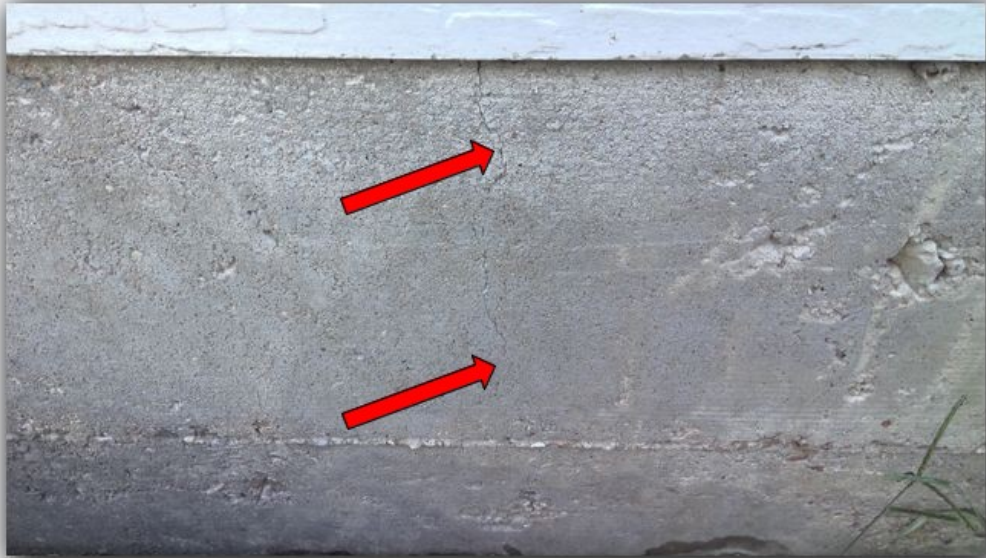
Minor vertical cracking was observed in the foundation. This type of cracking is usually the result of shrinkage of the concrete as it cures. Shrinkage cracks are very common and should not be cause for alarm.

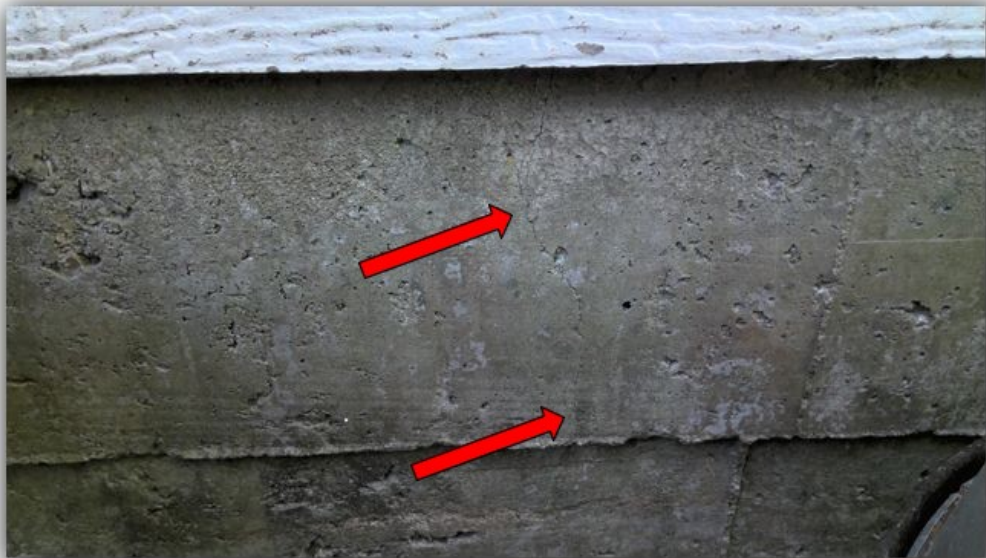
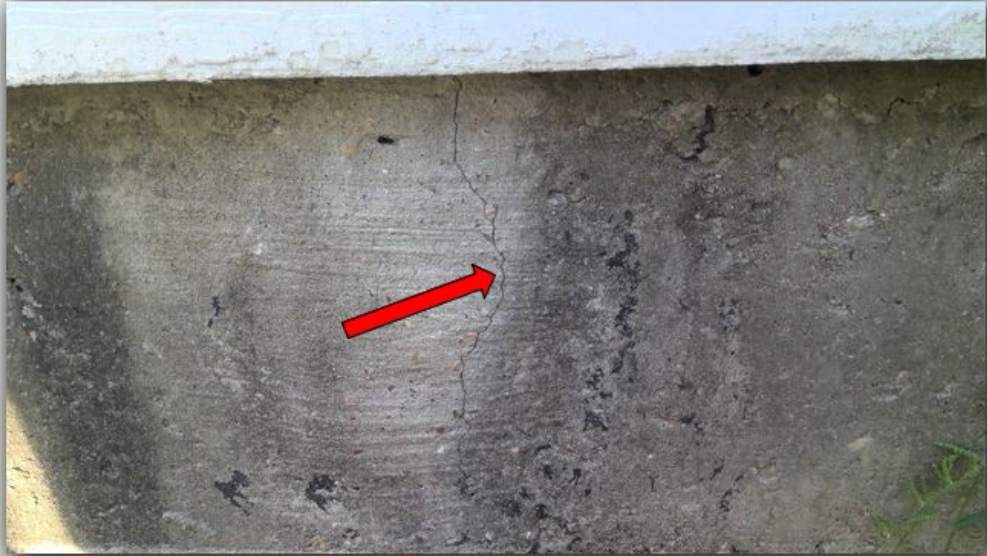
Common minor cracks were observed in the foundation walls of the house. This implies that some structural movement of the building has occurred, as is typical of most houses.

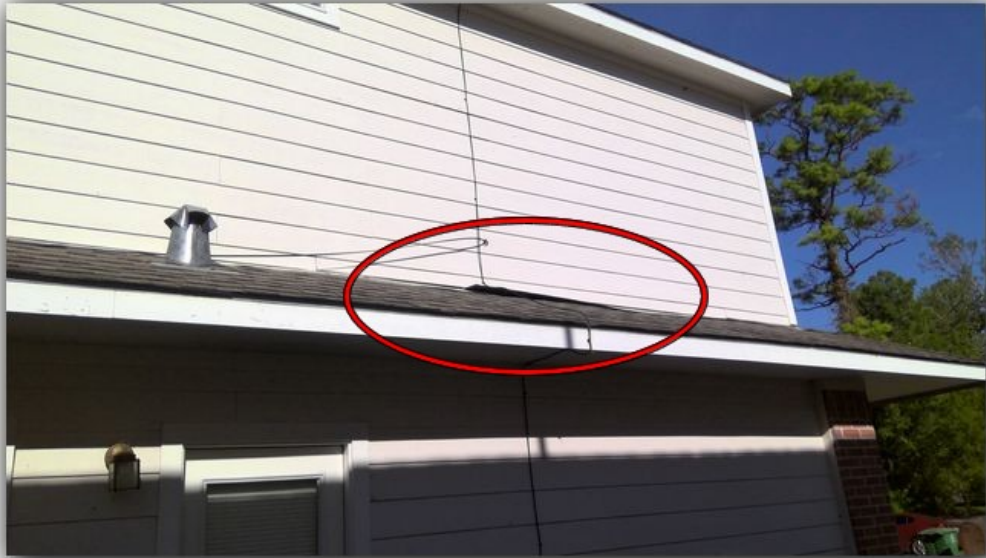
Minor repairs to the roofing are recommended. Damaged or missing roofing material should be repaired. All roof penetrations should be examined and sealed as necessary.

It is recommended that exposed nail heads be caulked or sealed appropriately.

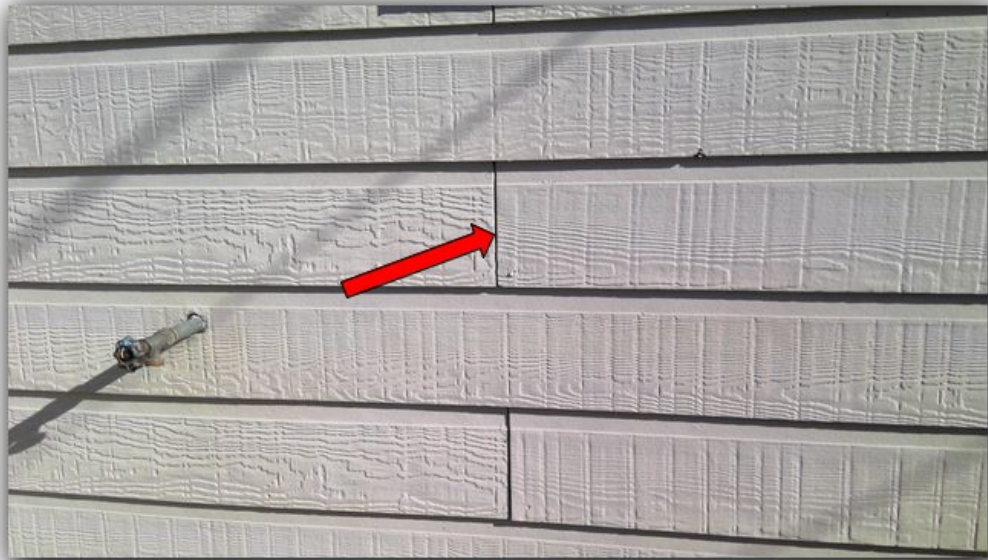
Typical minor cracking was observed on the exterior walls of the house. This implies that some structural movement of the building has occurred, as is typical of most houses.

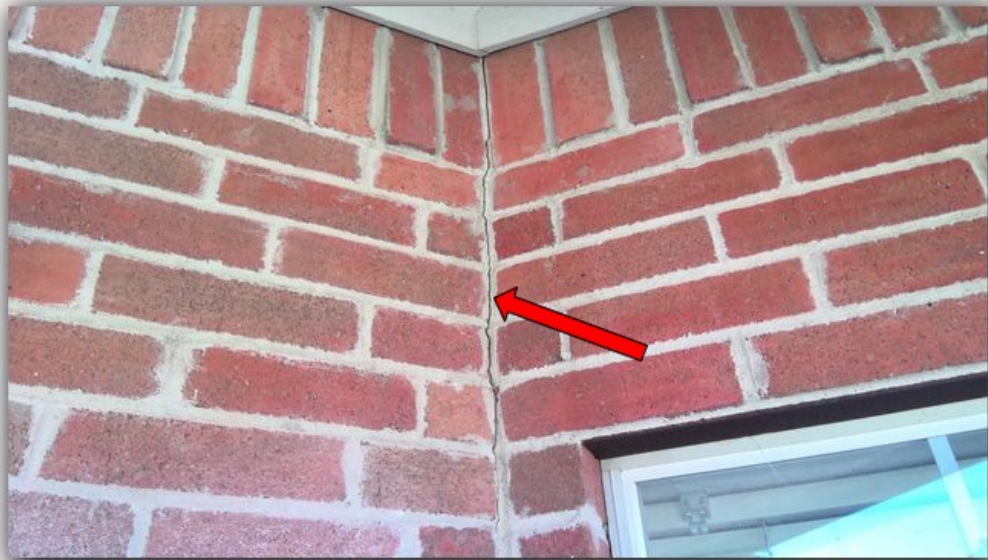
Slightly greater than typical cracking was observed on the exterior wall. The amount of movement does not suggest a serious structural problem. This area should, of course, be monitored. The rate of movement cannot be predicted during a one-time inspection.

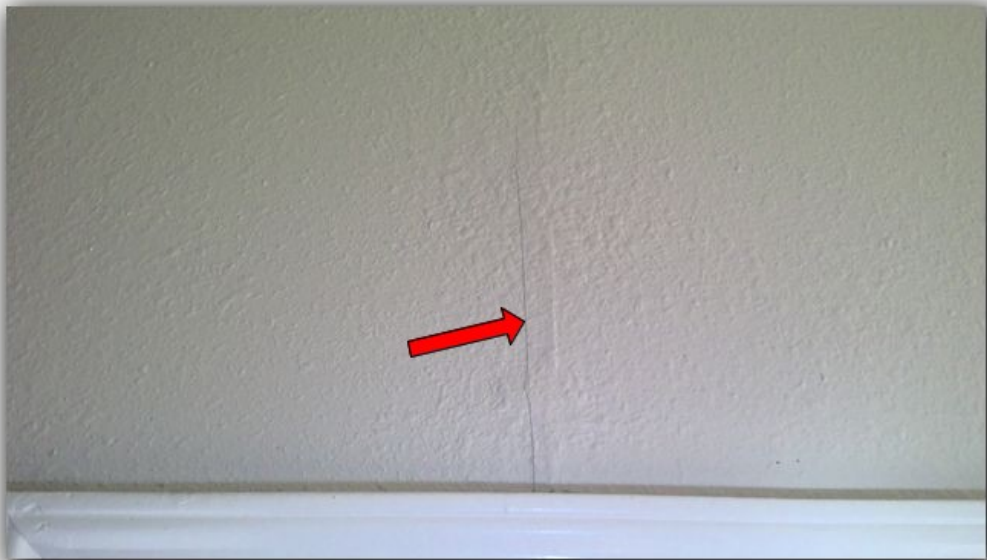
Unit B -

Minor cracks were noted on interior walls in the living room. This condition is mainly cosmetic in nature and should be patched.

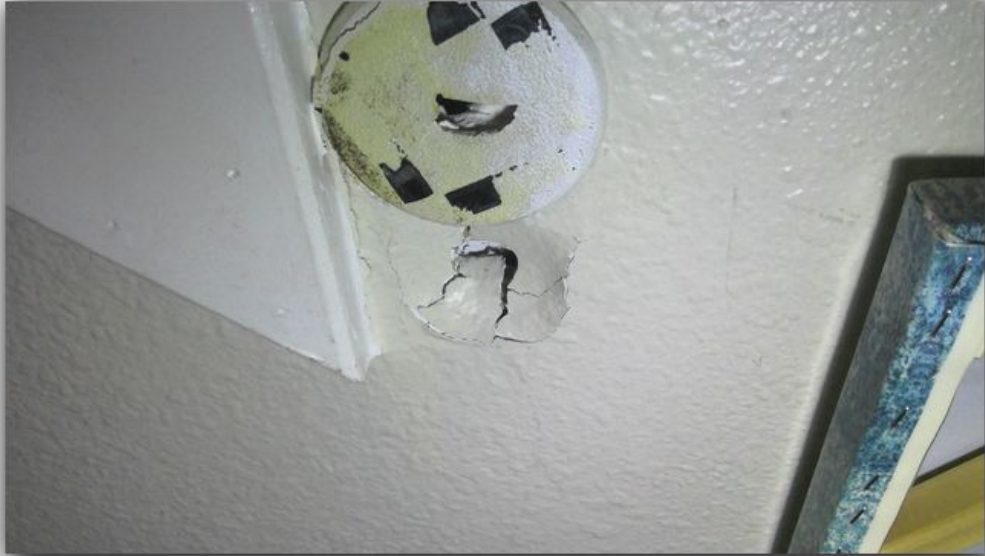
Damage to the interior finish in the front entrance/foyer was observed and should be repaired.

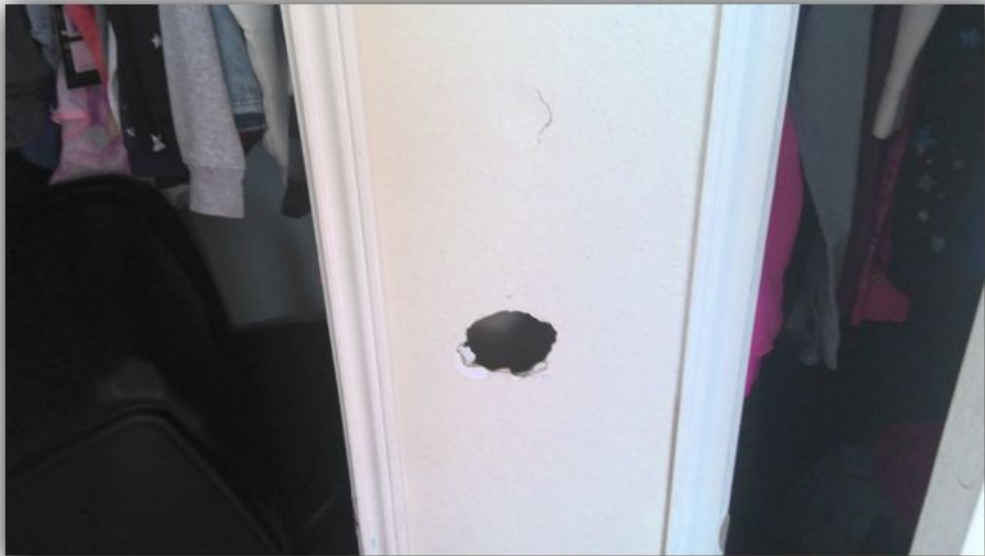
Damage to the interior finish in the east bedroom was observed and should be repaired.

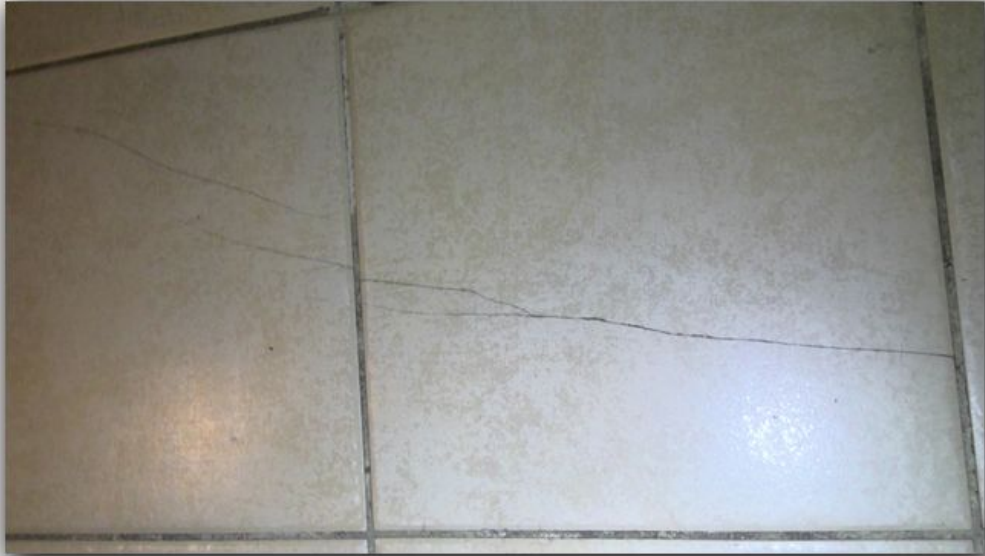
The tile floor in the kitchen is cracked and should be repaired.

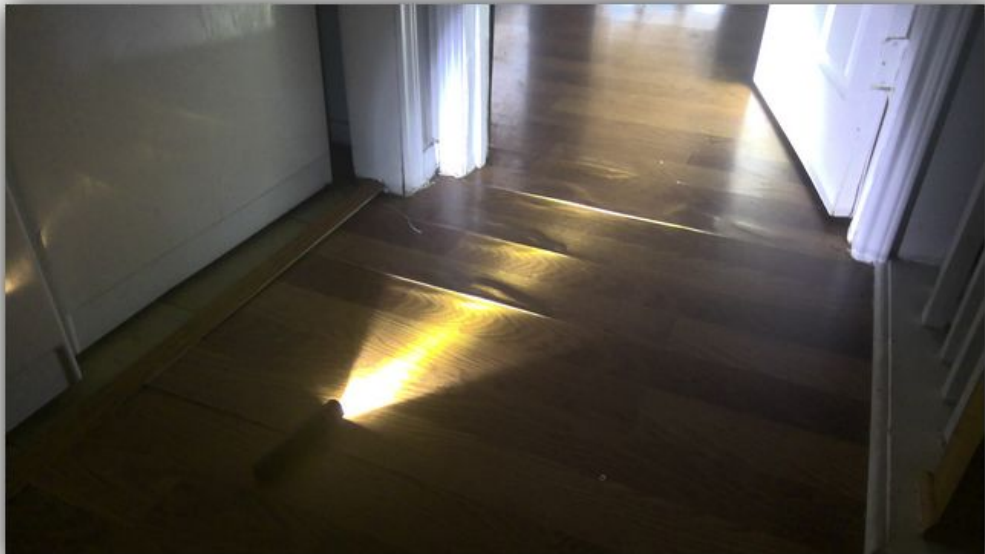
Water damage was noted on the floor adjacent to the laundry area.

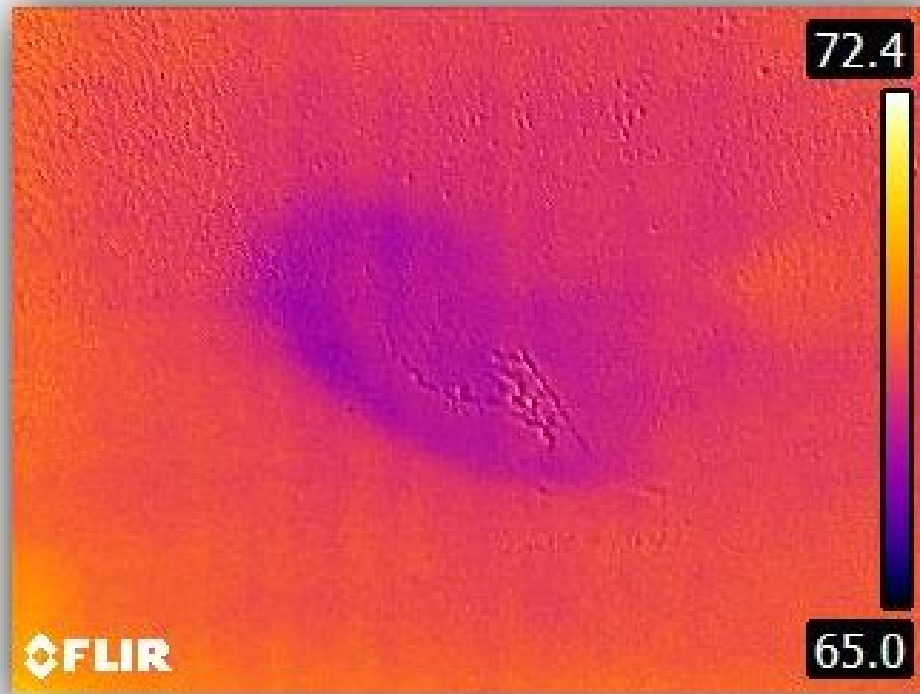
Water damage was noted on the ceiling in the southwest bedroom which is coming from

the condensation dripping off of the plenum. Further investigation and repair should be made as necessary.

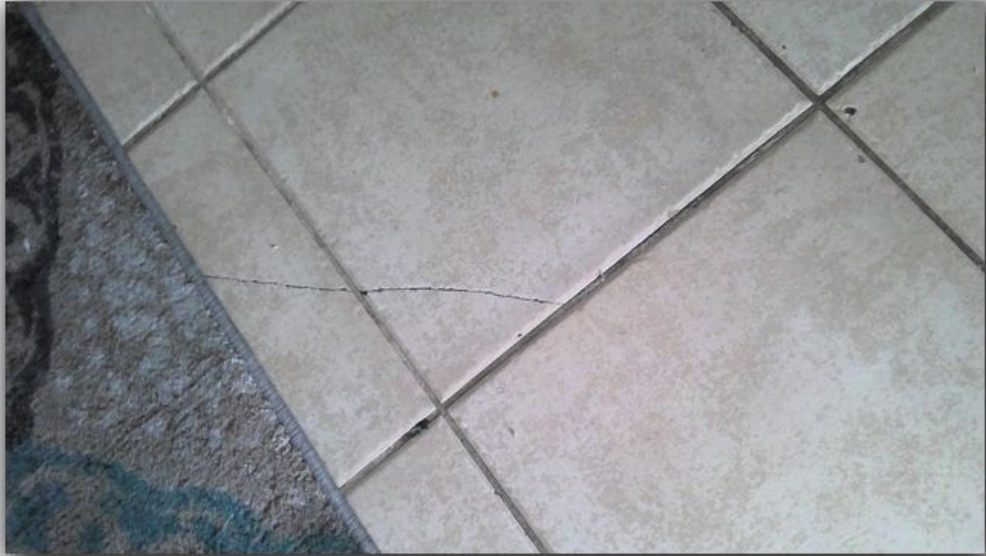
The tile floor in the formal living room is cracked and should be repaired.

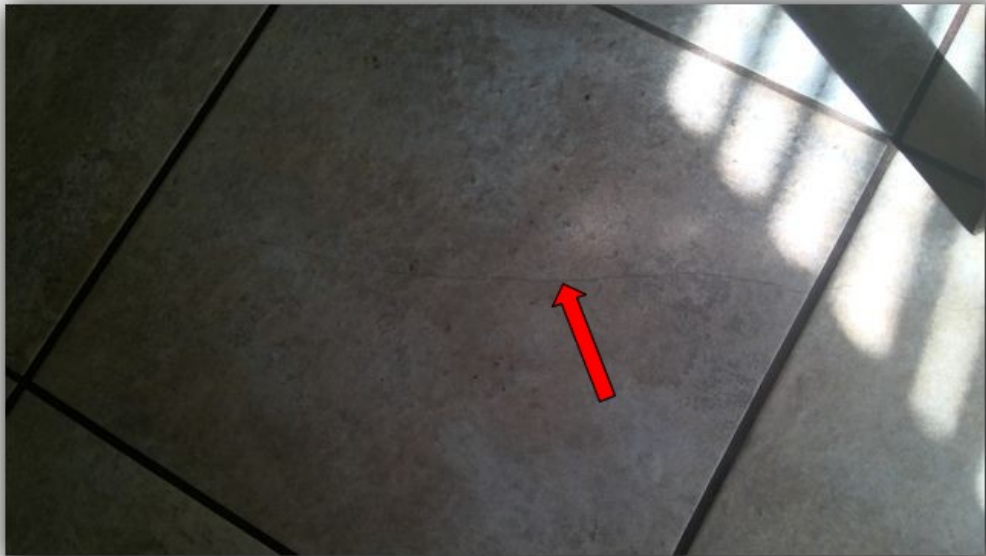
Unit B -

The tile floor in the kitchen and living room is cracked and should be repaired.

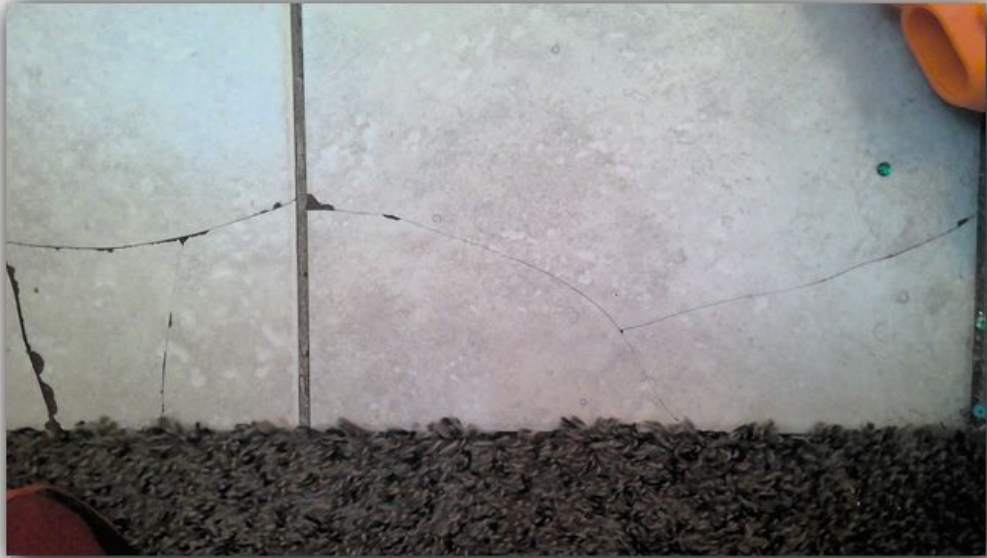
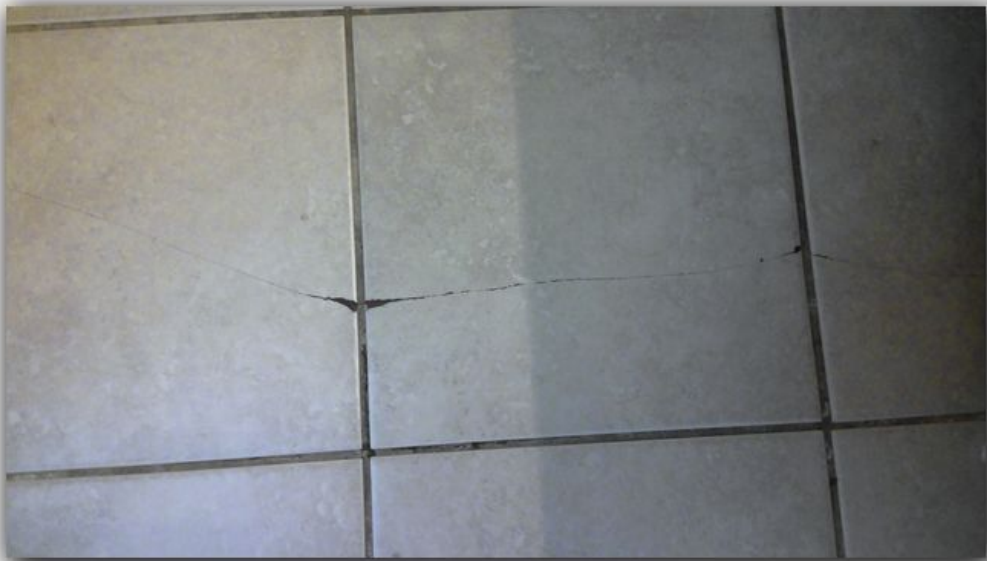
The tile floor in the northeast bedroom's bathroom is cracked and should be repaired.

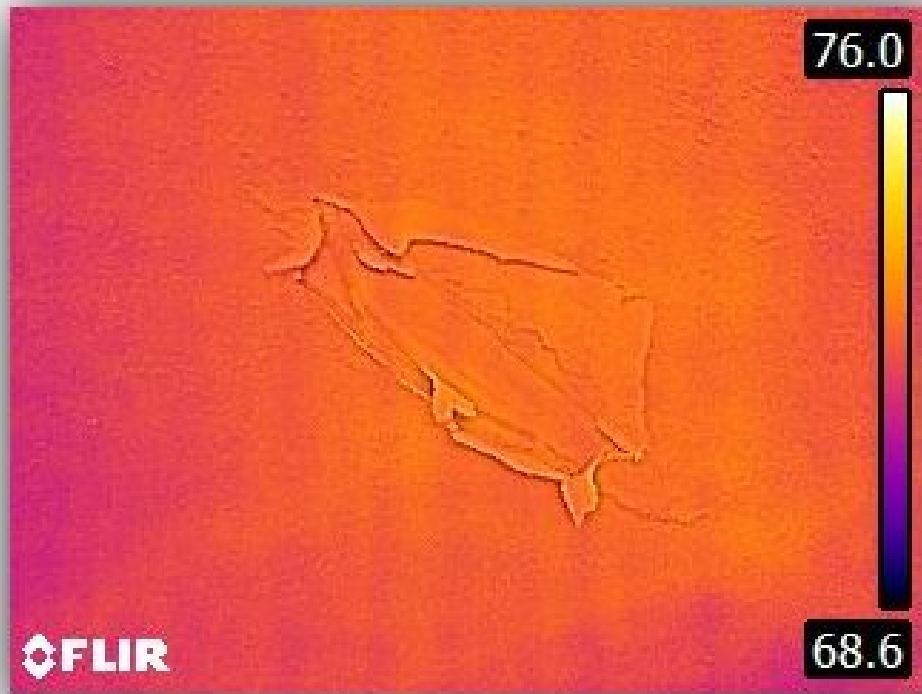
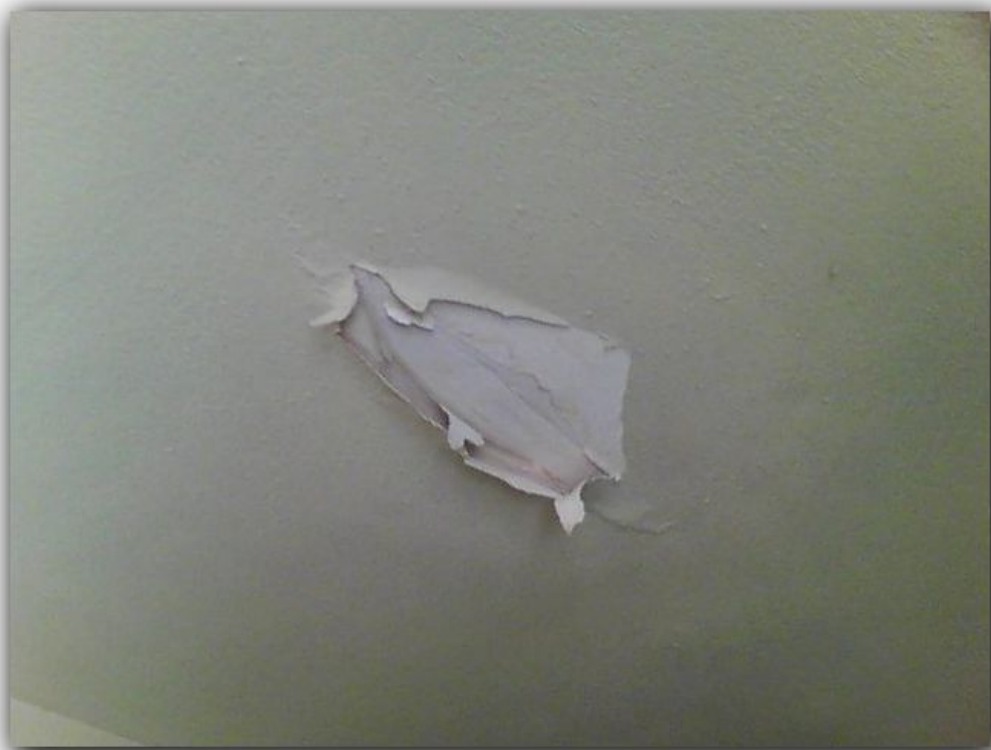
Water damage was noted on the ceiling in the living room. The thermal imaging did not reveal the preservice of moisture in this area.

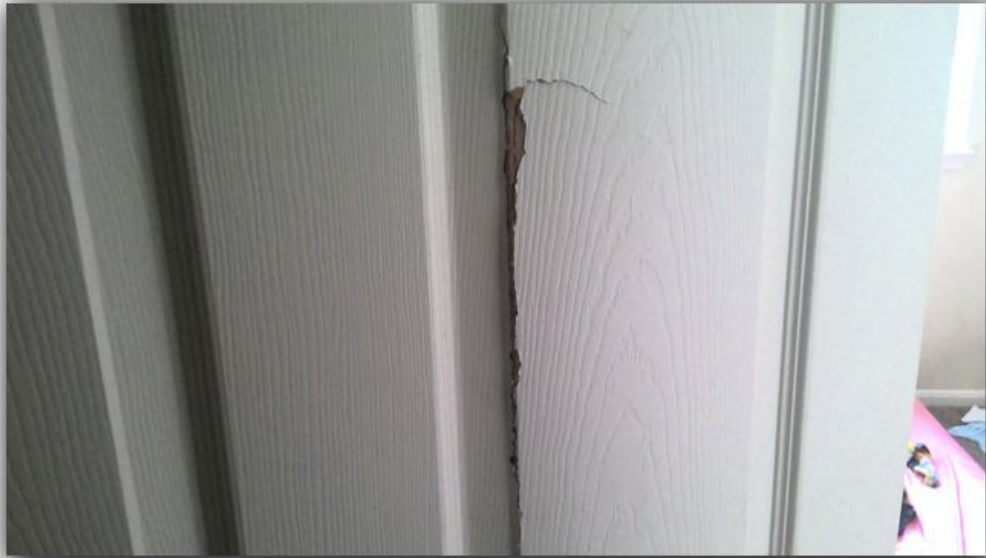
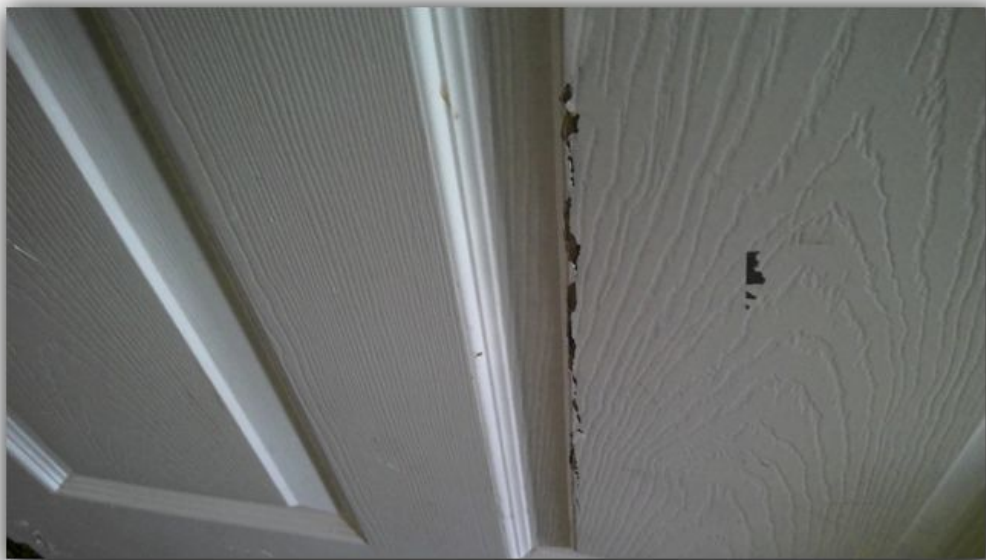
Unit B -

Damaged or non-functional doors in various locations should be repaired.

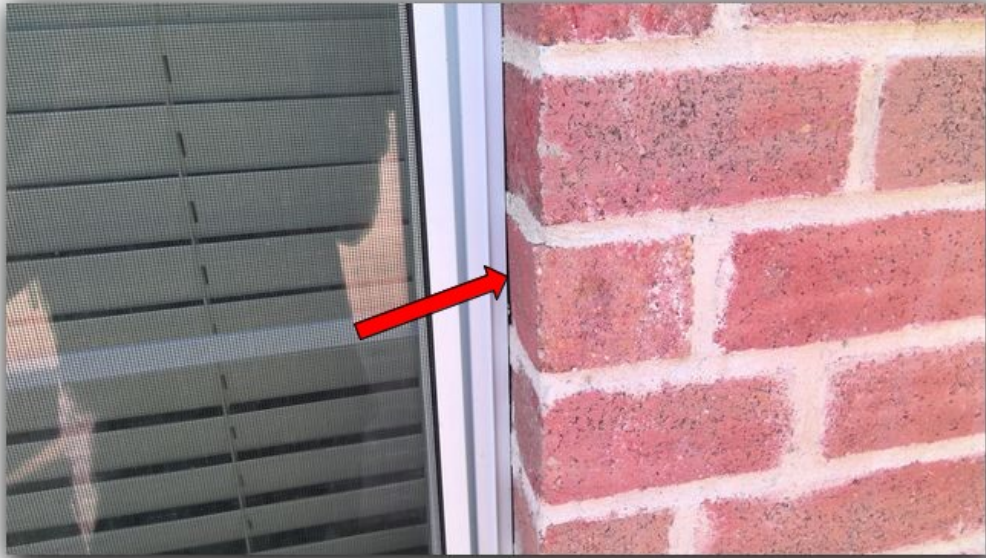
It may be desirable to replace window screens where missing. The owner should be consulted regarding any screens that may be in storage.

The windows should be examined and sealed at the exterior to prevent water infiltration and to improve efficiency.

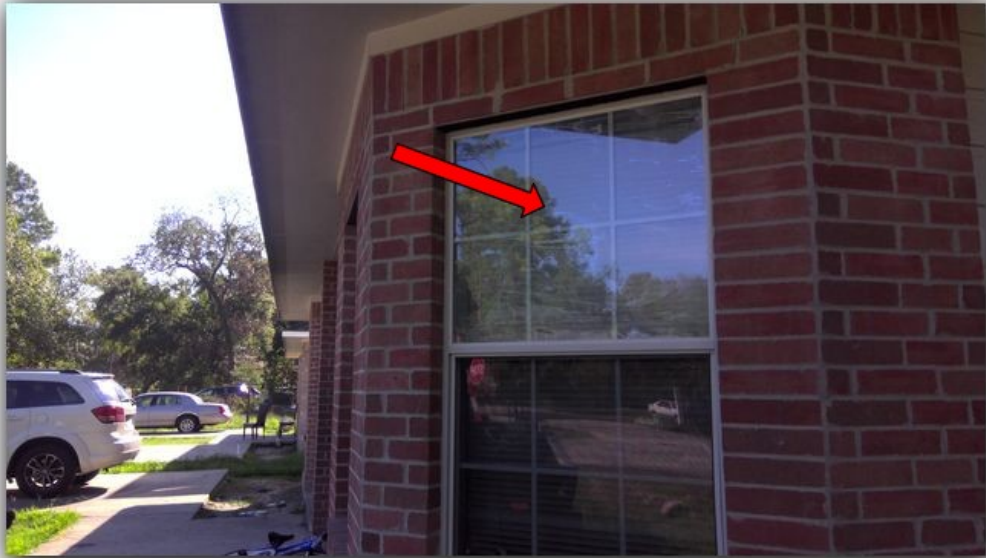
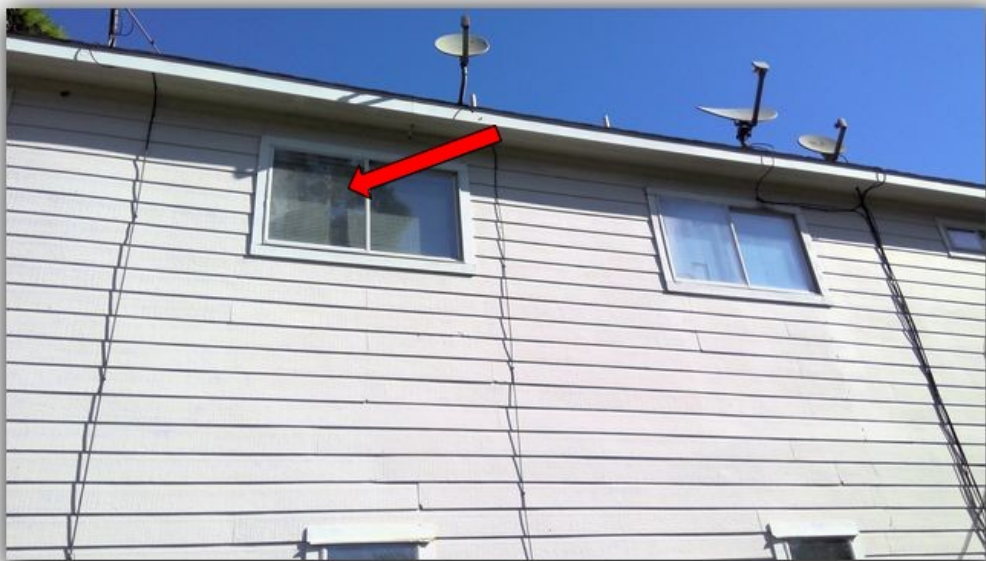
The window(s) have lost their seal in some locations. This has resulted in condensation developing between the panes of glass and can cause the glass to lose its insulating properties. The glass should be repaired or replaced.

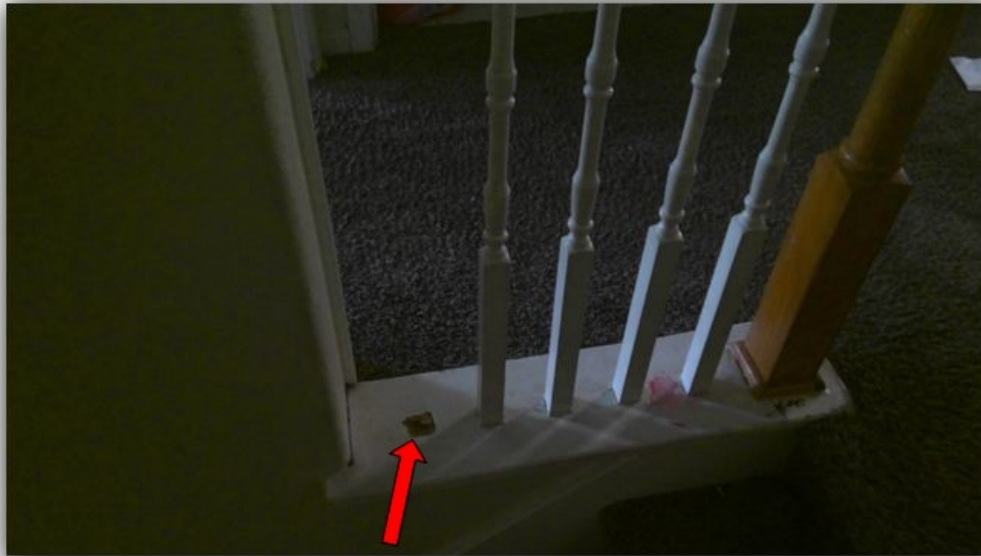
Missing balusters should be replaced.

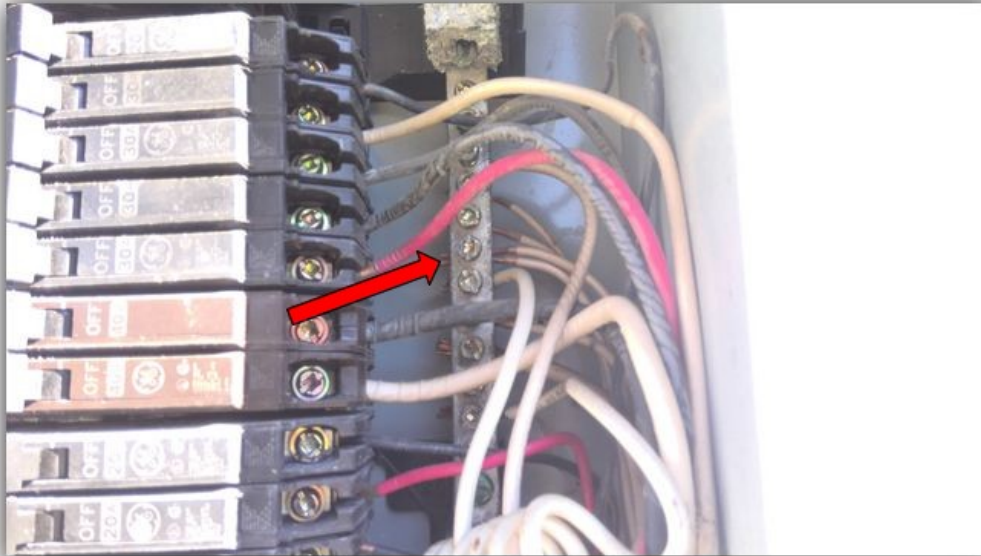
Double lugged neutrals were observed in the breaker box and should be improved as necessary. Neutral wires under the same lug can present problems when attempting to isolate a circuit to perform work or can become loose and cause a fire.

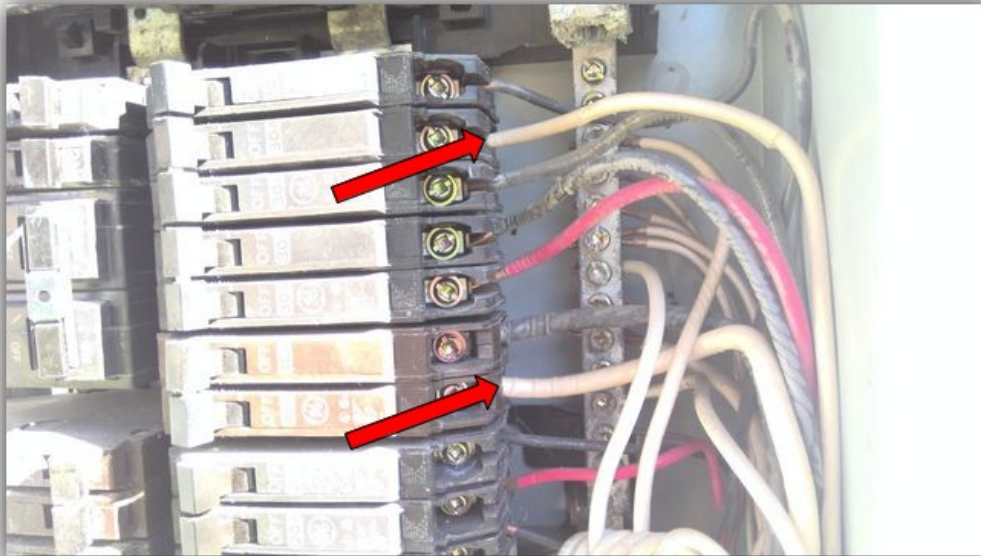
White wires that are "hot" should be properly identified.

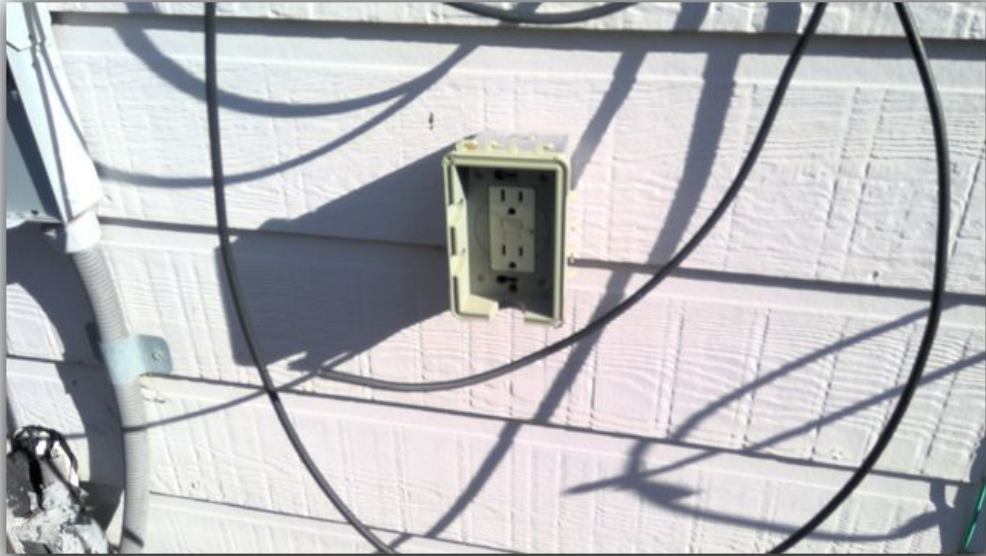
The weather cap on the exterior outlet is missing and should be replaced.

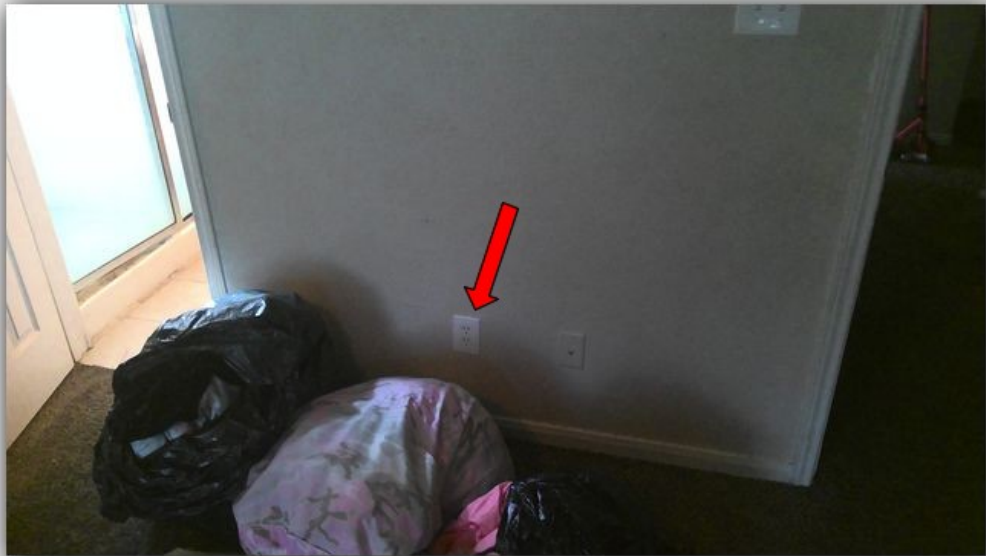
An outlet is loose and should be re-secured.

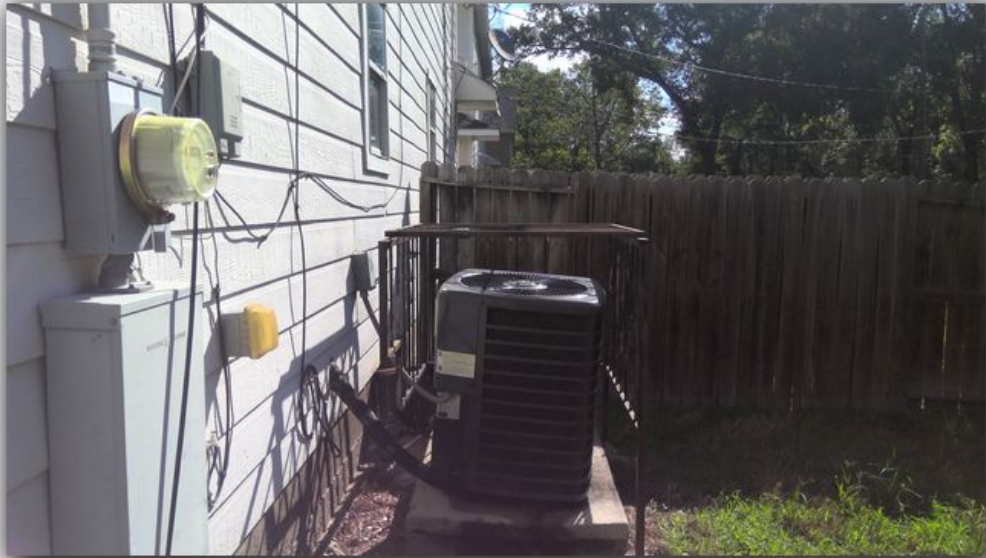
The outdoor unit of the air conditioning system is out of level. This should be improved.

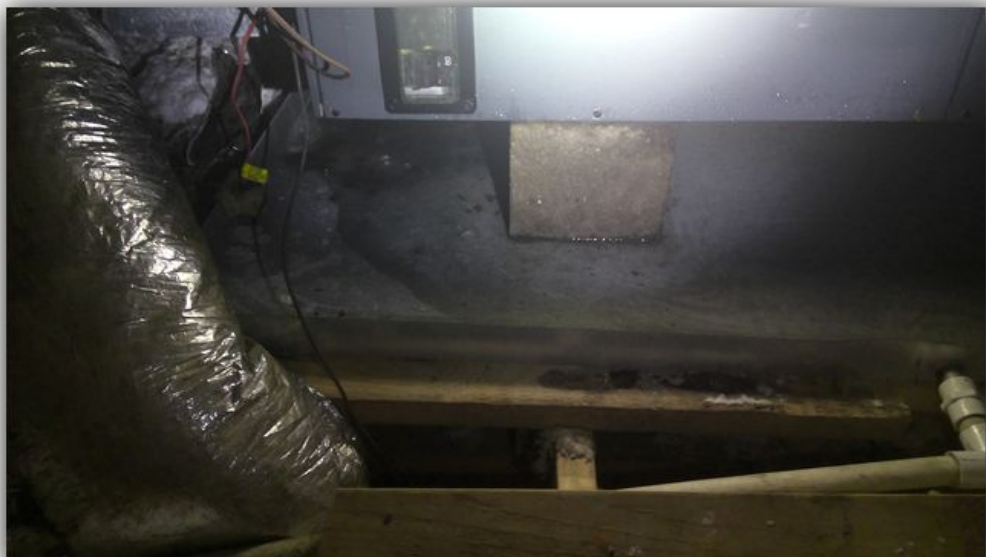
The auxiliary drain pan installed below the evaporator coil of the air conditioning system contains water and debris. This should be emptied and cleaned.

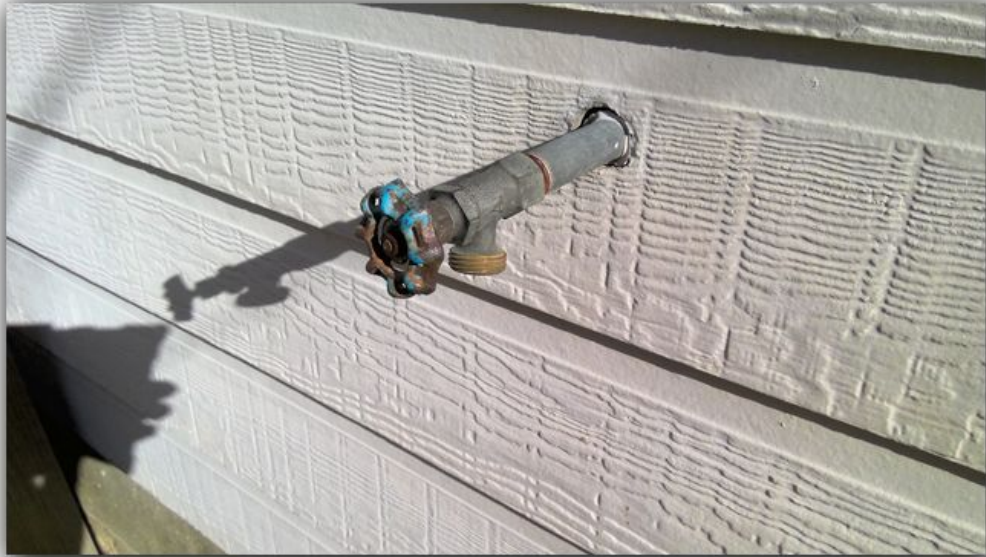
It is recommended that an anti-siphon device be added to the hose bib(s).

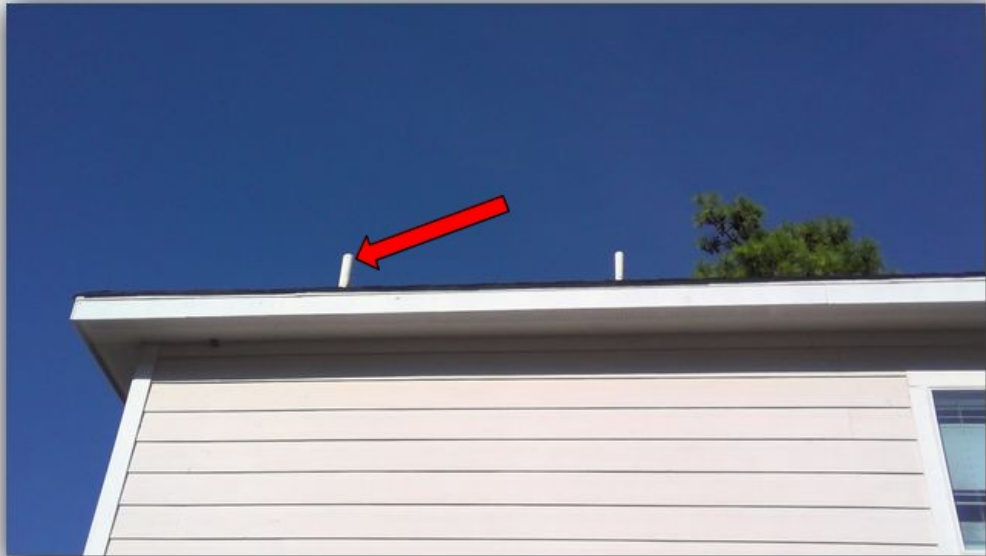
Exposed PVC waste vent pipes should be painted or covered with lead roof jacks to prevent damage from UV light.
