TEXAS RESIDENTIAL INSPECTION

9200 Westheimer Rd 1005 Houston, TX 77063

PROPERTY INSPECTION REPORT FORM

Zainab Tarique Name of Client 9200 Westheimer Rd 1005, Houston, TX 77063	08/15/2023 12:00 pm Date of Inspection
Address of Inspected Property John Lohmann, Marcella Lohmann Name of Inspector	Pro. Inspector #23629, Pro. Inspector #24035 TREC License #
Name of Sponsor (if applicable)	TREC License #

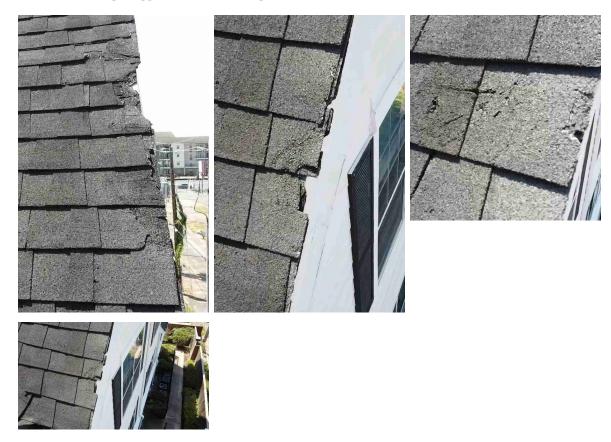
2: Shingles - Damaged/Deteriorated

One or more shingles appeared to have damage/deterioration.

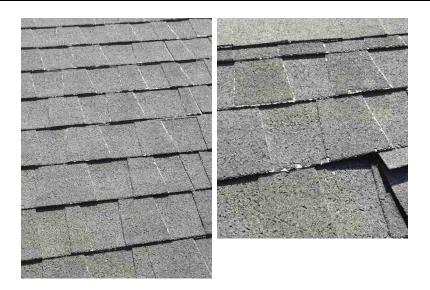
3: Shingles - Worn/Glistened

Shingles had worn/thinning granules, which glistened and showed signs of wear in one or more areas.

Note: The glistening effect was an indicator that the roof covering was missing granules designed to protect the asphalt material underneath.

Recommend buyer obtain a Professional Roofer that is Certified by the Shingle Manufacturer to make a more in depth analysis of the roof and/or make all necessary repairs to bring the roof up to manufacturer's recommended specifications and home warranty standards.

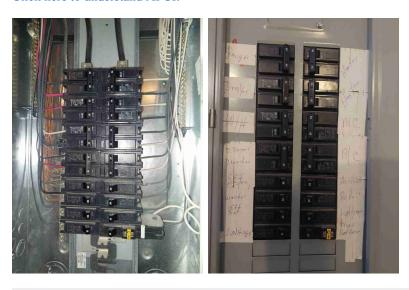
1: AFCI - Not All
Deficiencies

Note: While AFCI may not have been required when this house was built, Inspections of Texas recommends it as a worthwhile safety upgrade.

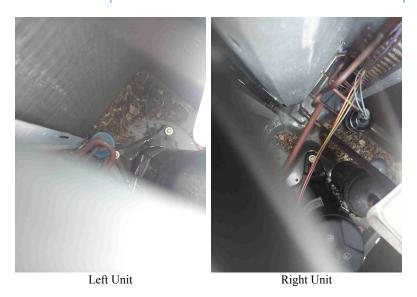
There was debris present in/at the outside condenser unit in one or more places.
