HOUSTON INSPECTIONS

March 12, 2021

PROPERTY INSPECTION REPORT

Concerning: 4713 Lido Ln, Houston, TX 77092
(Address or Other Identification of Inspected Property)

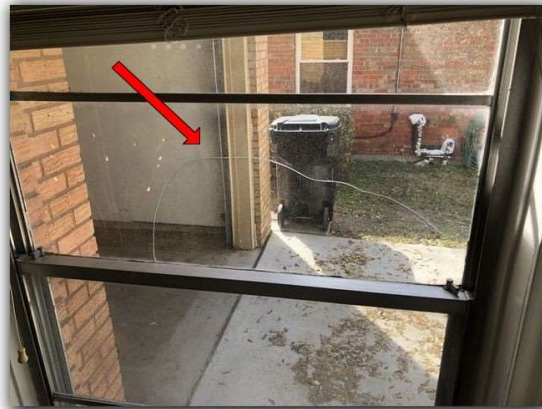
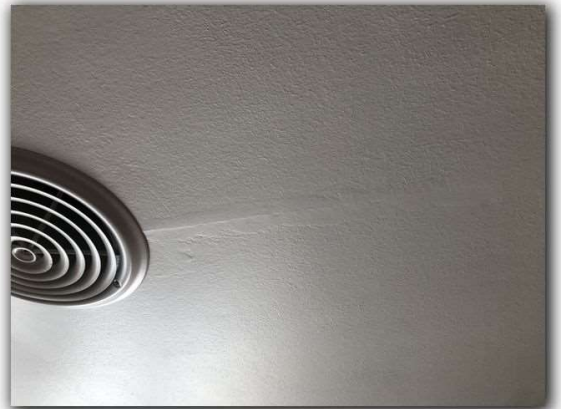
Signs of Structural Movement or Settling:

- Wall, floor, or ceiling cracks
- Doors out of adjustment, i.e. sticking, not latching, etc. as evident of settlement.
- Cracked Window Glass

At the time of the inspection, evidence was found that indicated that the foundation may not be performing its intended function. It is recommended that further inspection be made by a Registered Professional Engineer to determine if there has been a loss of structural integrity and if repairs are needed.

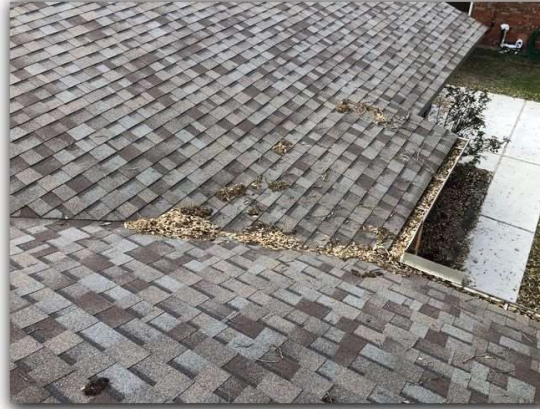
Leaves and other debris were found at sections of the roof covering. Due to the trees around the structure, this will require ongoing maintenance. The buildup of leaves will slow the flow of rainwater from the roof, making the roof vulnerable to water penetrations. Recommend removal of the debris on the roof covering.

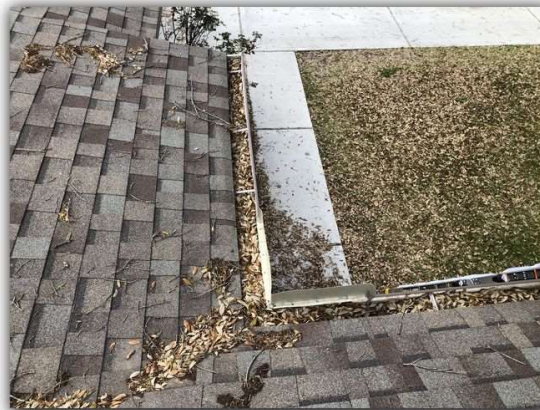
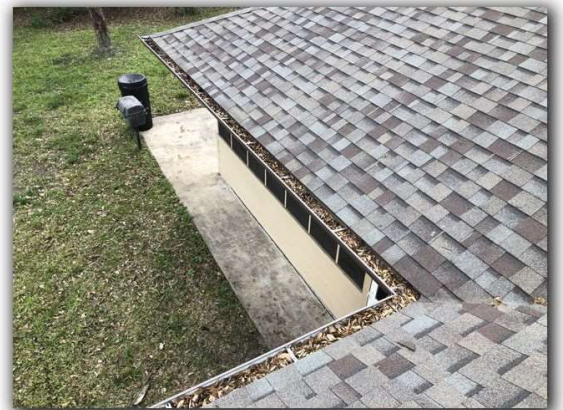
The debris should be cleaned from the gutters to allow proper drainage of rainwater from the roof covering.

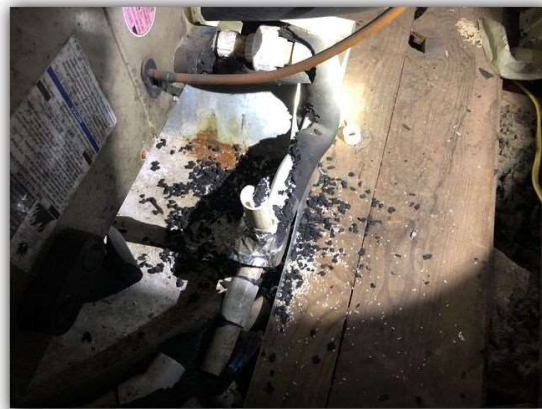
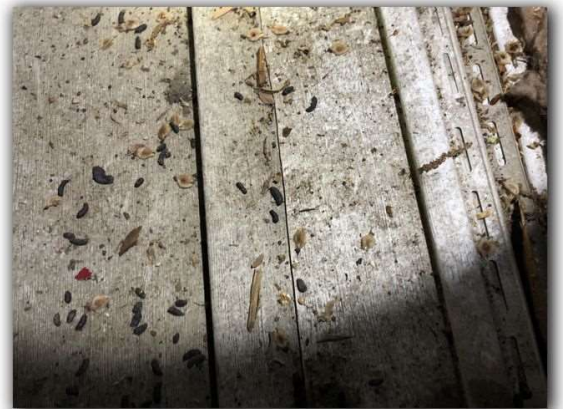
Evidence of rodent activity was noted in the attic as evident by nesting materials, holes, etc.

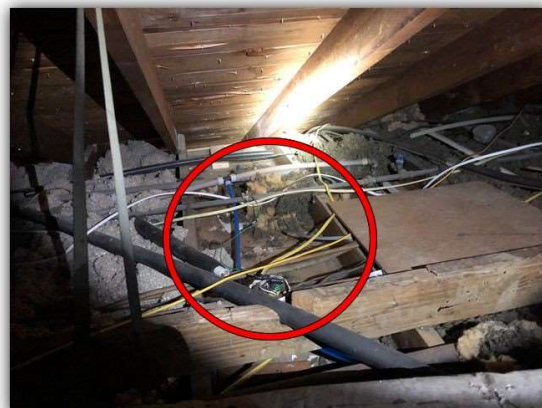
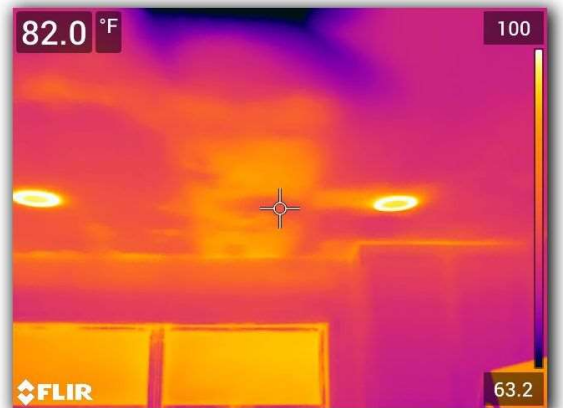
Missing insulation was found at sections of the ceiling / attic while using a infrared camera and while inspecting the attic.

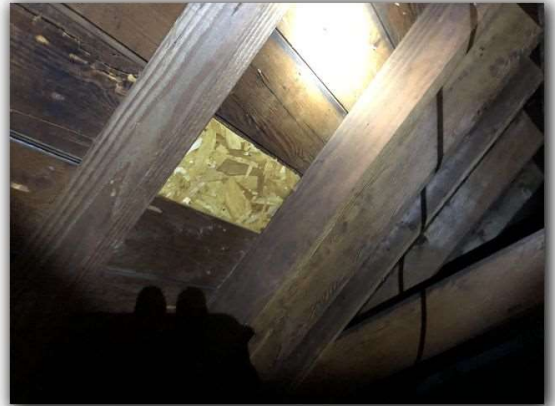
Evidence of previous structural repairs were found in the attic as evident by new lumber at several locations.

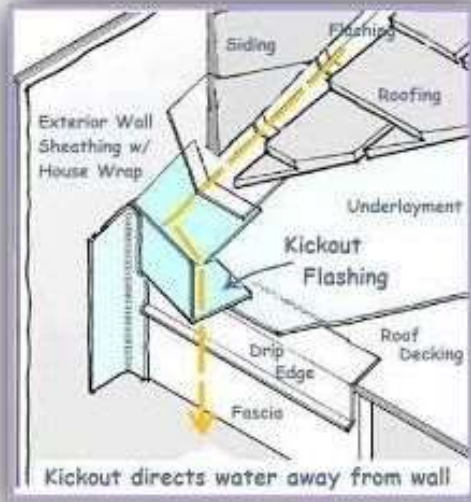
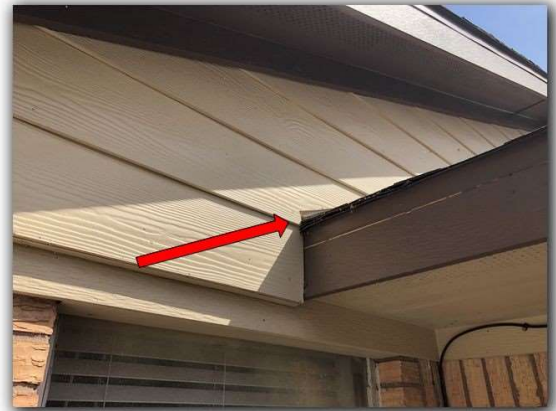
Kickout / diverter flashing is not installed at the wall & roof Intersections. This creates a opening that could allow moisture to enter the wall cavity and create damage.

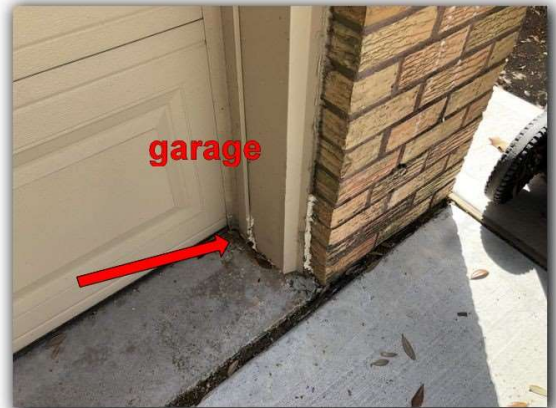
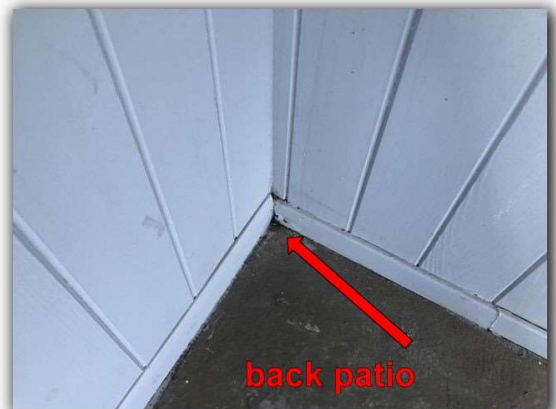
Damaged and / or missing items were found on the exterior of the property. Recommend repairs / replacement of the affected areas. In addition, areas where decay is present should be removed, exposing underlying materials for inspection prior to repair by a qualified tradesman.

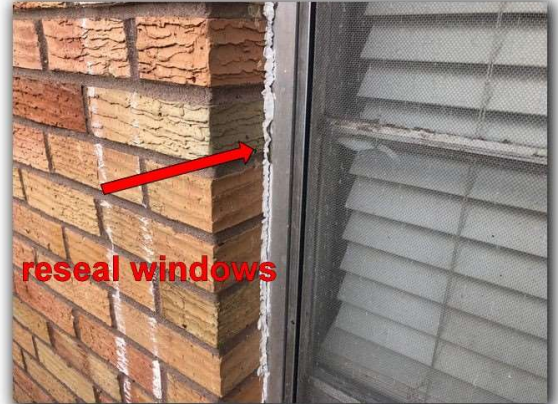
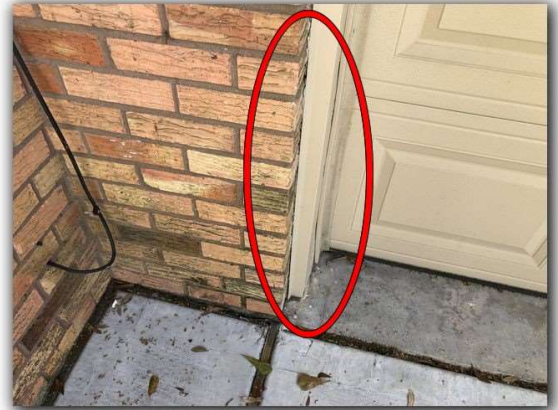
All exterior wall penetrations (electrical panels, electrical disconnects, light fixtures, etc.) and openings (expansion joints, windows, door thresholds, etc.) should be sealed with an approved material to prevent water penetrations into the wall cavities. Properly sealed exterior veneers help provide a barrier against the weather, insects, and enable environmental control of the interior spaces.

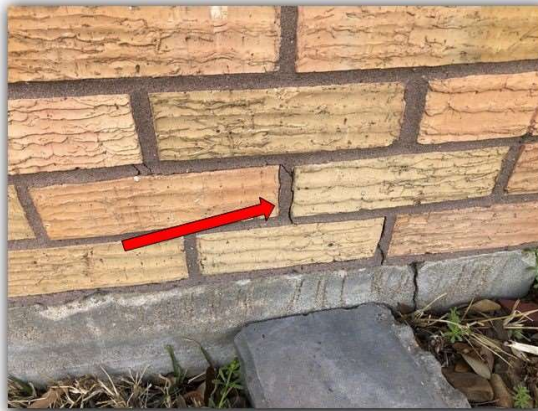
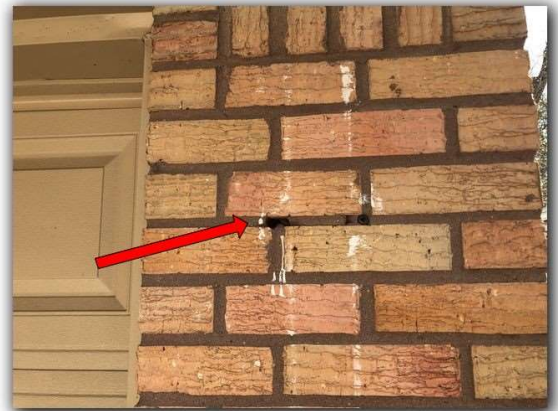
Brick / mortar cracks were found on the exterior of the structure as evidence of settlement of the structure.

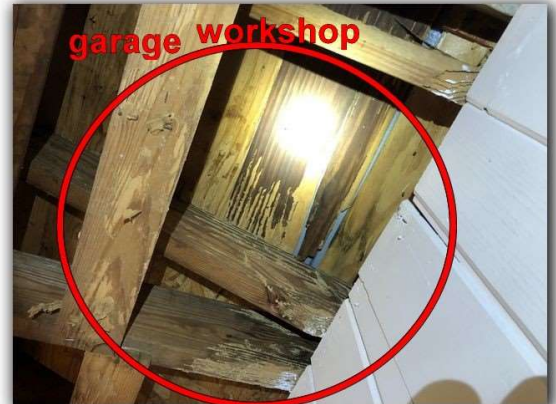
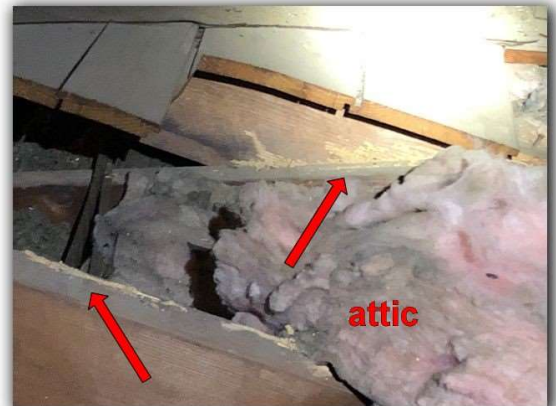
Damage wood and other veneers were found in the garage, bathroom tub access, and attic. The damage appears to have been caused by wood-destroying insects. All visible and underlying damage should be removed and repaired. In addition, the wood-destroying insects, if active, should be treated by a licensed pest control company.

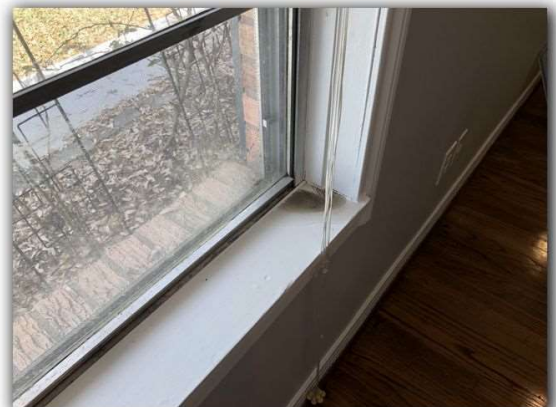
Staining and discoloration was found at the windowsills in several rooms.

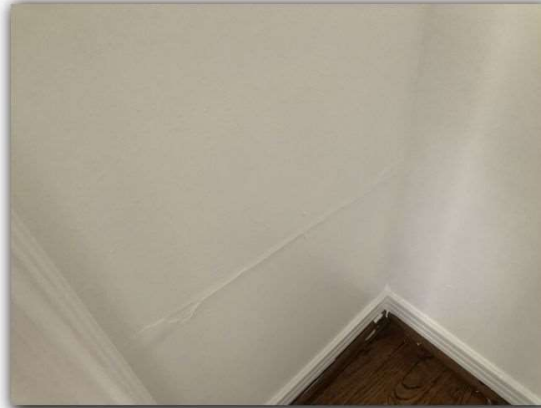
Damaged / discolored drywall was found in the front bedroom closet during the inspection. No abnormalities were found at this area with the infrared camera and no elevated moisture readings were observed when inspected with a pinless (non invasive) moisture meter. Recommend further evaluation to determine the needed repairs.

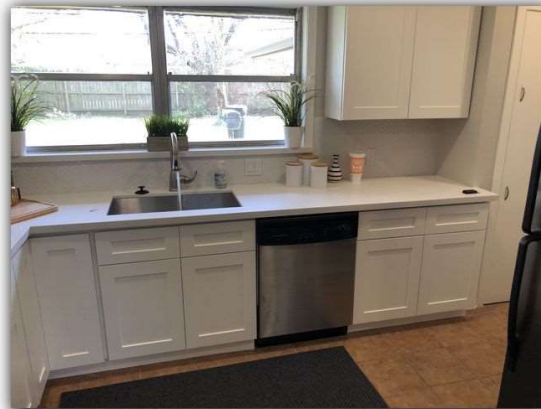
Hardware has not been installed at the kitchen cabinets making them difficult to open.

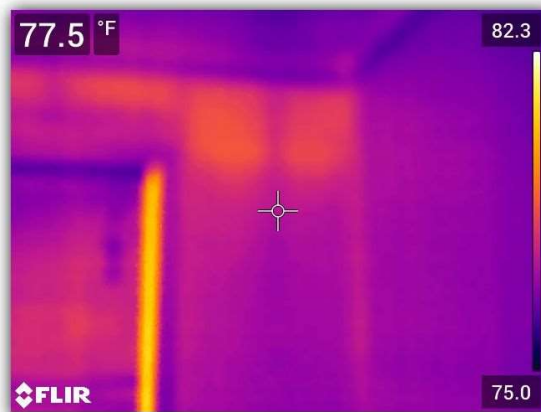
Missing insulation was found at some of the exterior walls in the front bedroom. This problem was found using an infrared camera.

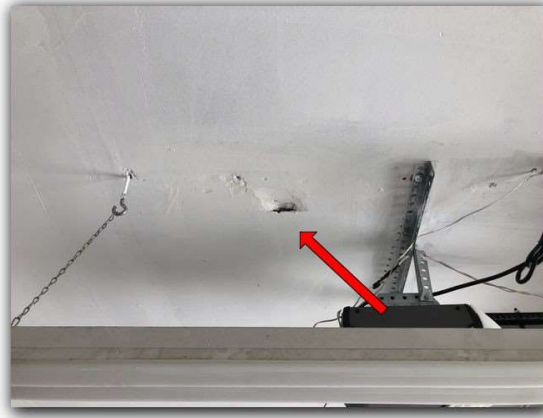
Damaged / discolored drywall was found in the garage during the inspection. No abnormalities were found at this area with the infrared camera and no elevated moisture readings were observed when inspected with a pinless (non invasive) moisture meter. Recommend further evaluation to determine the needed repairs.

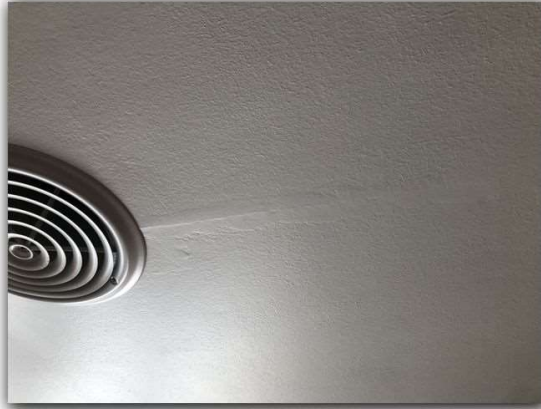
Cracking was noted on the interior ceiling of the property as evidence of settlement.

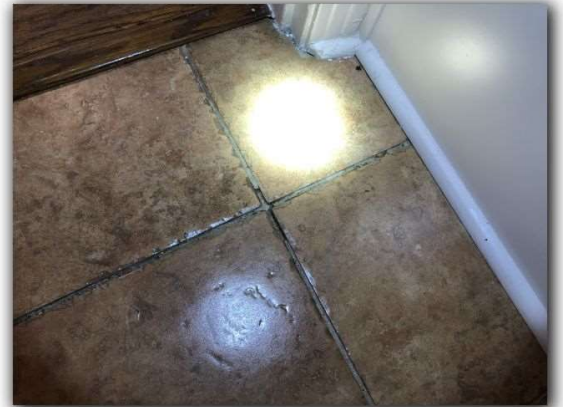
Damaged and missing grout was found at the floor tiles in the kitchen and bathroom.

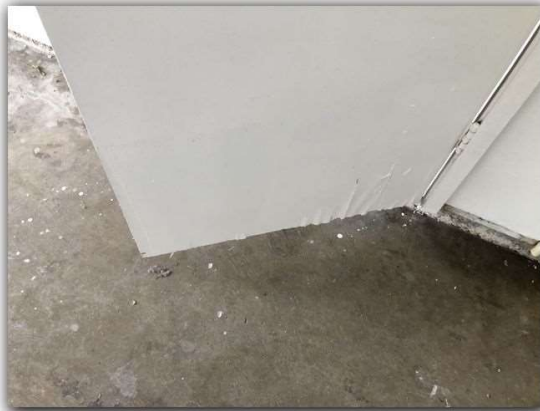
Moisture damage was found at the garage closet door. Recommend replacement of any damage and improvements to correct this problem from reoccurring.

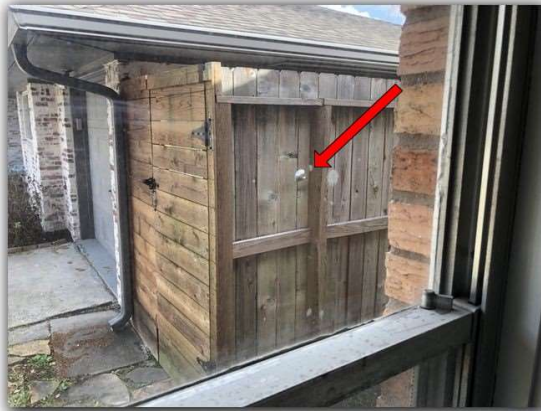
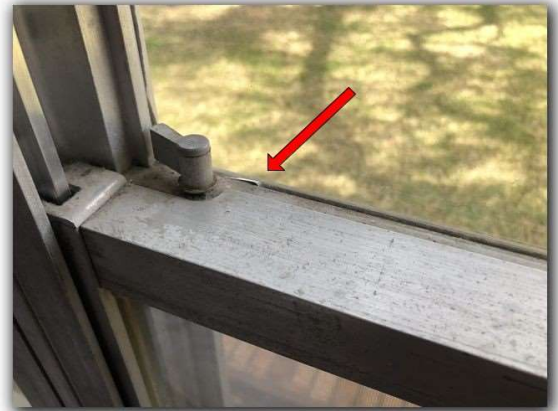
Chipped glass was found in the front bedroom.

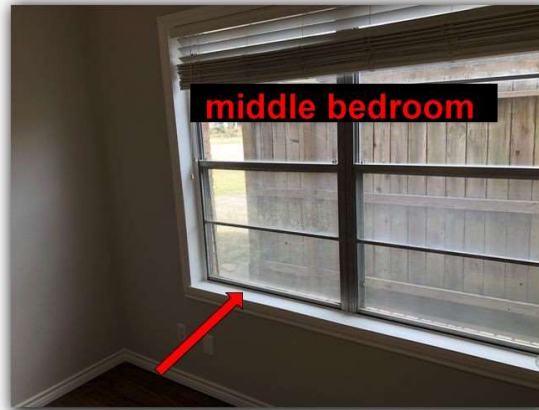
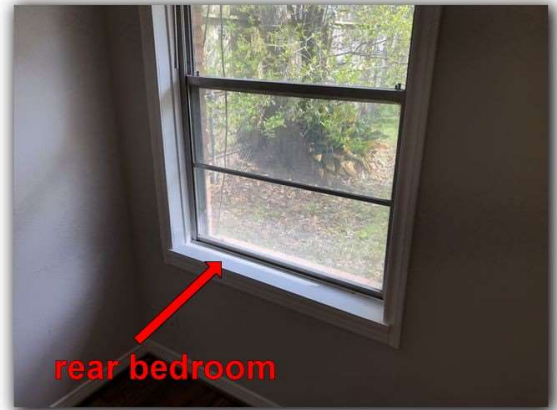
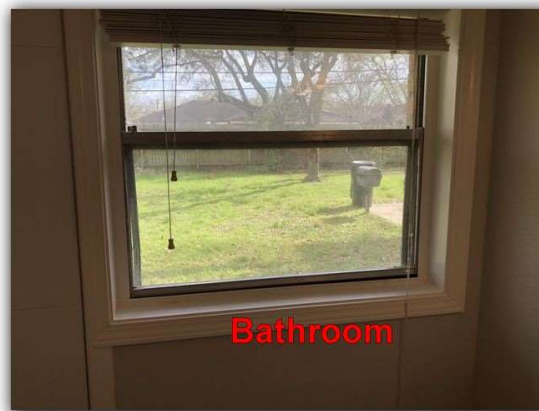
Loose and disconnected springs were found at the windows. This is a common problem found with this style of window. The problem can lead to the windows being difficult to open and not staying open when operated.

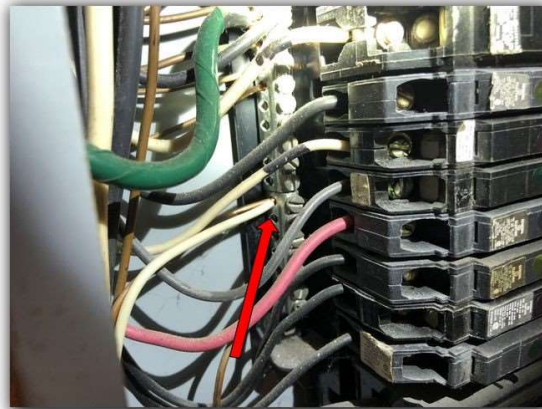
A neutral conductor is connected to the ground bar in the sub panel. Recommend further evaluation by a licensed electrician.

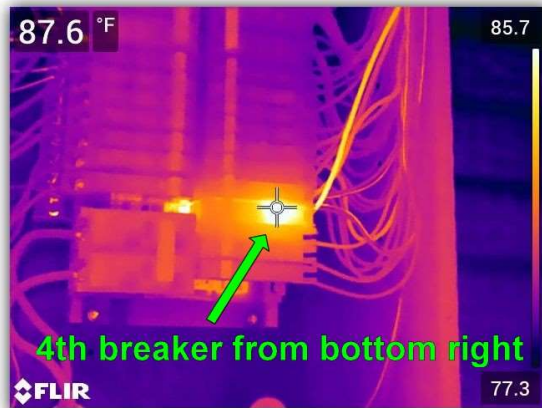
Abnormalities were found during the inspection of the electrical panel with a infrared camera. Recommend further evaluation and repairs by a licensed electrician.

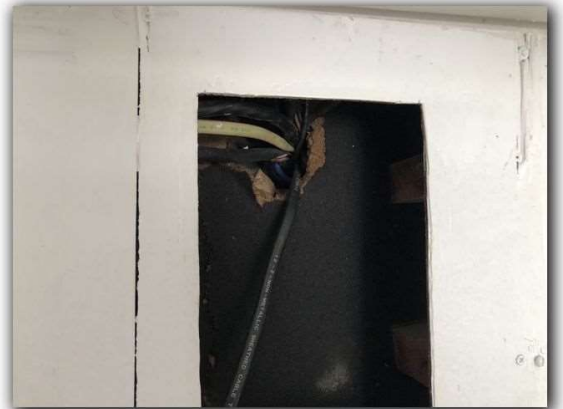
Access was made in the wall behind the sub panel. This is a safety hazard and the access should be sealed to prevent shock hazard.

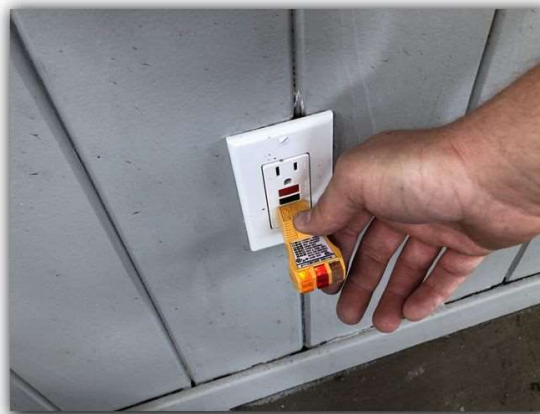
A ground fault circuit interrupter (GFCI) receptacle in the exterior did not respond correctly to testing during the inspection. Recommend repairs.

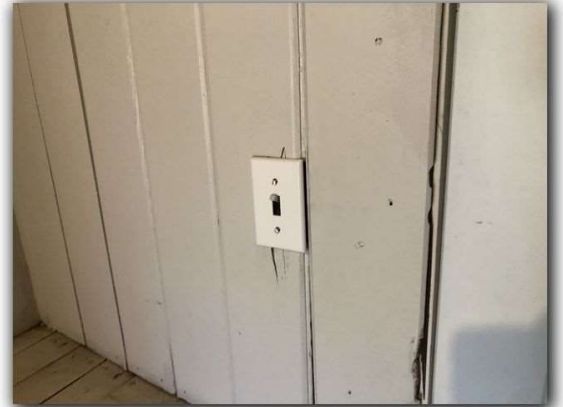
Missing / loose receptacle and switch plates were found at various locations at the property being inspected. All cover plates should be installed.

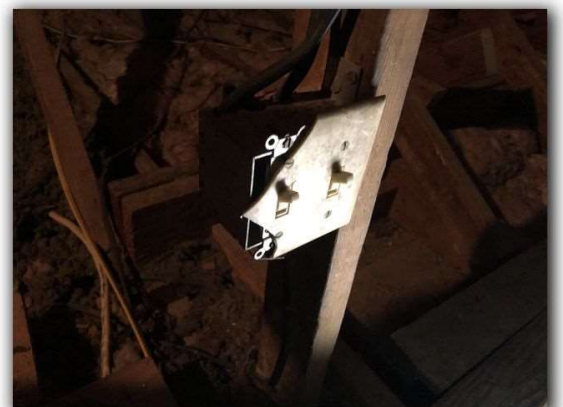
Damaged cover plates were found in the kitchen and attic. Recommend replacement of the plates.

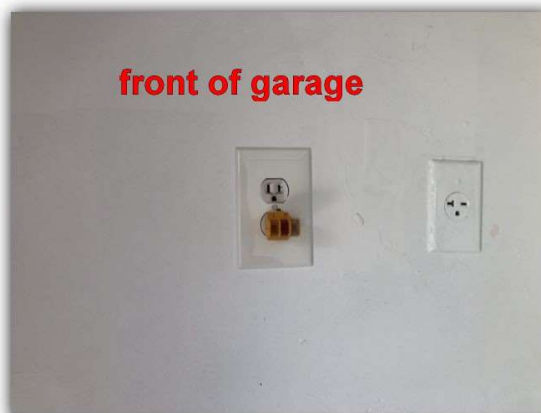
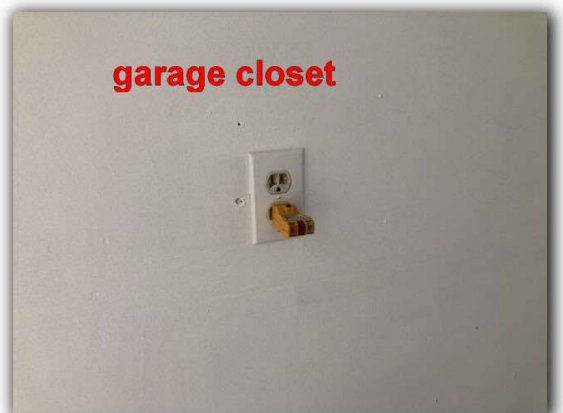
Two receptacles in the garage are not functioning. Recommend further investigation and repairs by a licensed electrician.

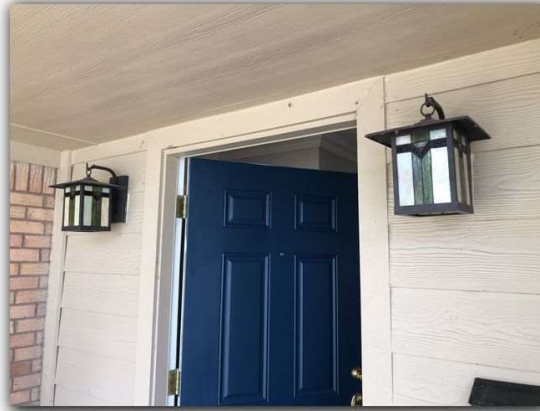
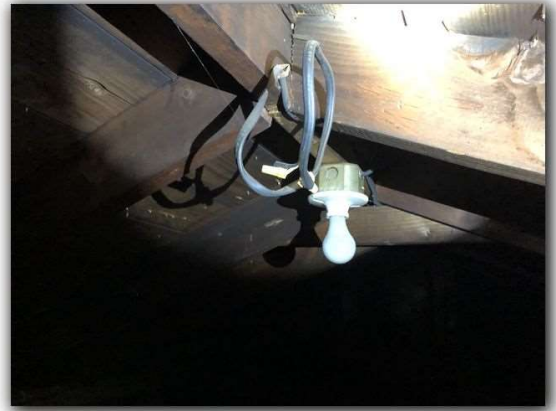
Inoperative lights were found during the inspection of the property in various areas. All lights should be repaired prior to closing to insure it is a bulb problem rather than a circuit or fixture problem.

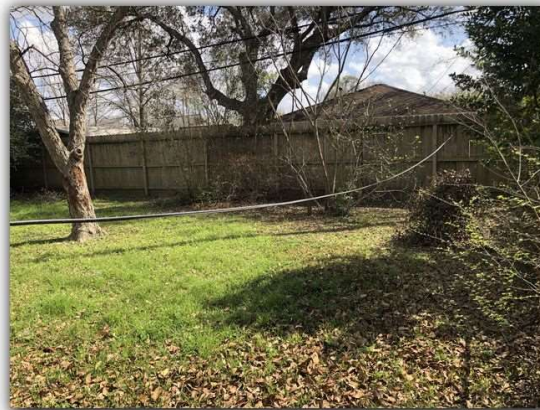
A low hanging wire was noted in the backyard. It is unknown if it is a high voltage or low voltage wire. This is a safety hazard. The wire needs to be properly secured so it is out of the way.

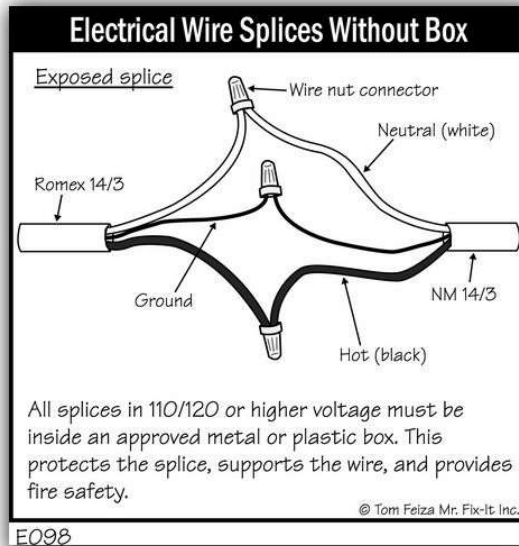
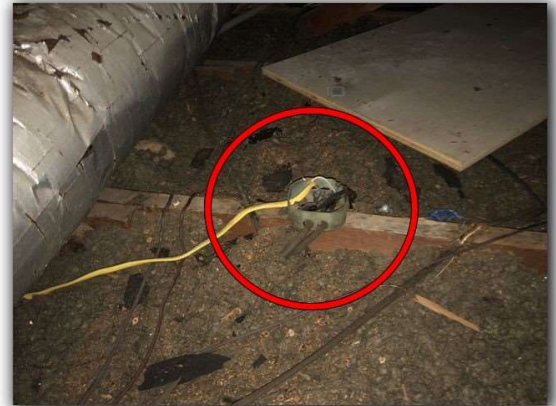
Exposed electrical connections were noted in the attic. Improper electrical connections should be improved. All electrical connections should be made inside junction boxes fitted with cover plates.

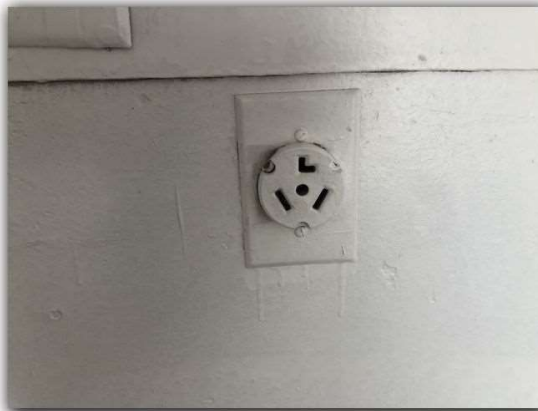
The three-prong receptacle installed in the laundry room is an older style outlet. If a newer electric dryer will be used, this receptacle will have to be replaced by a newer four prong outlet.

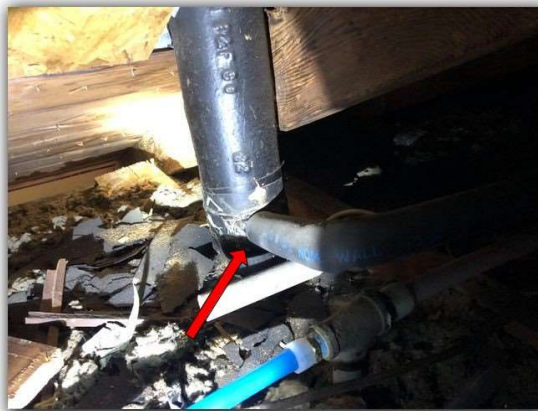
The primary drain line terminates in a plumbing vent in the attic. Recommend improvements.

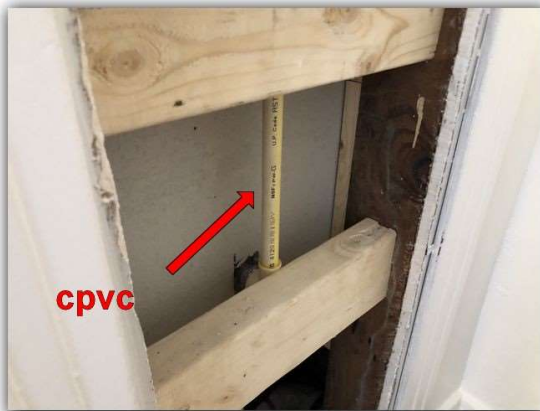
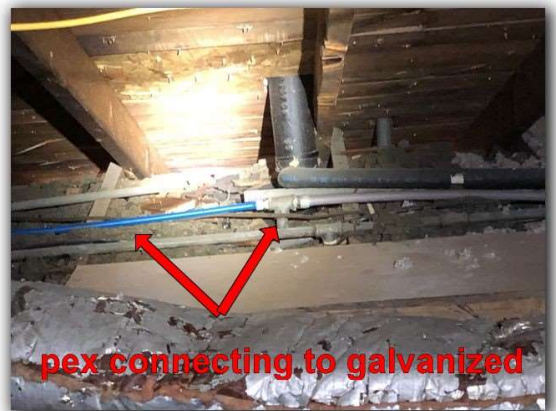
Type of Water Supply Piping: Galvanized / Steel - This property has been plumbed with galvanized/steel piping. The older steel piping is subject to corrosion on the interior of the pipe. This corrosion leads to two different problems. The first problem relates to water pressure. As corrosion builds up, the inside diameter of the pipe becomes constricted, resulting in a loss of water pressure. This piping is typically replaced when the loss of pressure can no longer be tolerated. The second problem can more costly. Depending on the mineral makeup of your water supply, the piping can deteriorate to the point the pin hole leaks develop throughout the supply piping. Both of these problems are difficult to detect during a limited visual inspection. A licensed plumber can further evaluate the piping and make recommendations in regard to repairs and provide estimates. Predicting future performance of the piping is beyond the scope of this inspection.; CPVC; PEX

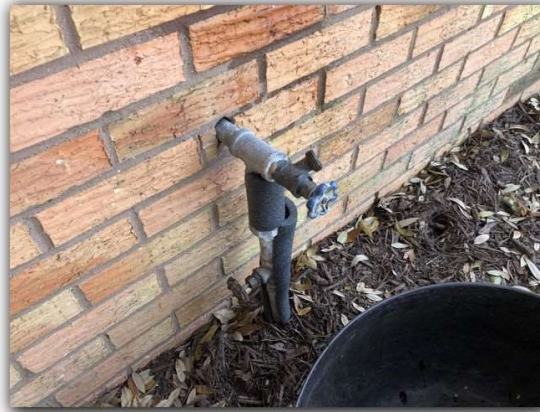
The supply piping on the exterior of the building / structure should be insulated to protect from freezing.

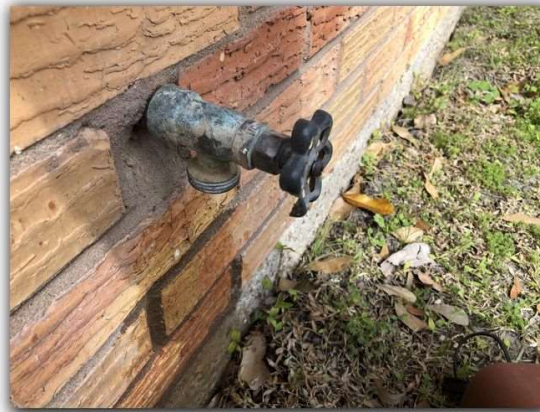
The rear hose bib faucet handle is damaged.

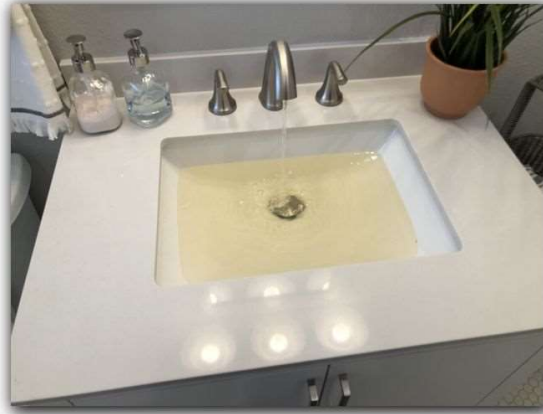
Discolored water was noted while operating the supply plumbing. The source of the this discoloration could not be determined. A licensed plumber should determine the source and make the needed repairs.

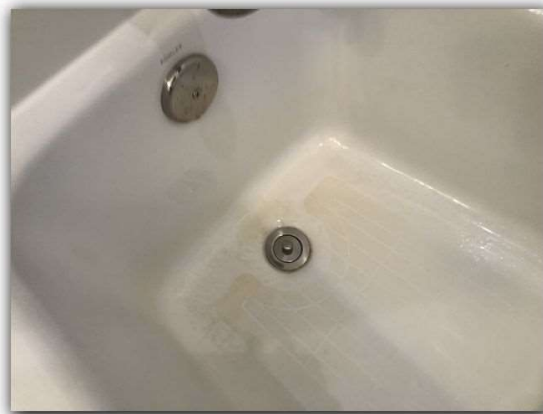
Surface stains/discolorations were found at the tub.

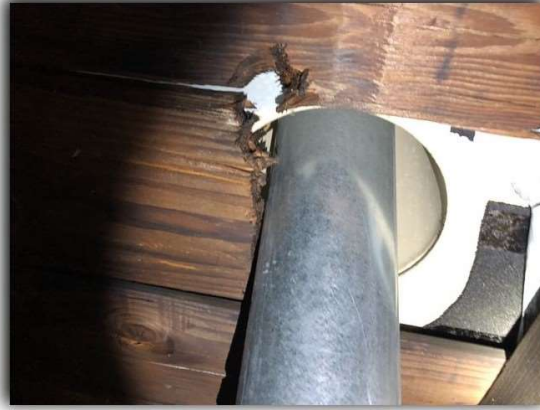
Improper clearance of flue pipe from combustibles

Discoloration was noted at the water heater flue pipe possibly due to the improper clearance at the pipe. Recommend improvements.

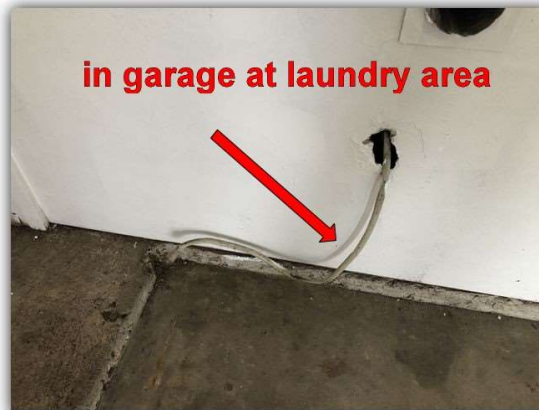
Improper Gas Line Materials - Copper

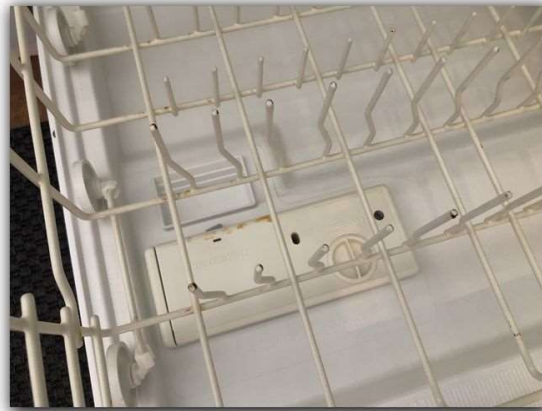
Observed rust on the dishwasher components. Recommend repair with approved materials.

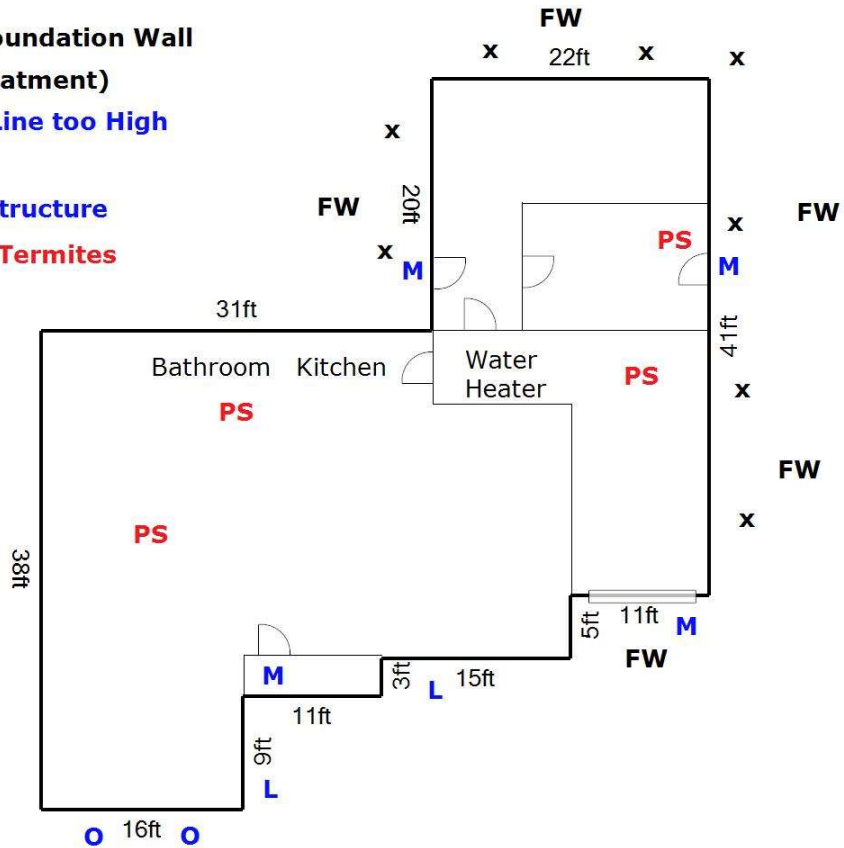
Additional Comments Evidence of previous infestation of wood destroying insects were found during the inspection as reflected on this report / graph. Evidence was found that this property (portions or all) has been treated for wood destroying insects in the past. Final determination of structurally significant damage to wood members (if any) cannot be determined without removal of wall coverings. Recommend client obtain additional information from seller regarding extent and location of previous infestation, chemical and company used, warranty if applicable, etc.. Marathon Pest Control, LLC specifically excludes hidden / latent damage if present (we cannot see thru walls). Conducive conditions were found during the inspection of the property, which could conceal insect activity or promote future insect activity or conceal damage. DUE TO THE CONDUCTIVE CONDITIONS FOUND WE CANNOT GUARANTEE THE ABSENCE OF WOOD DESTROYING INSECTS. The conducive conditions should be corrected. After the conducive conditions have been corrected it is recommended that the property be re-inspected for wood destroying insects. The client should take into consideration the cost of associated with correcting the conducive and / or performing a treatment and plan accordingly. Notice to Client(s): There is always a possibility of the presence of undetectable activity of wood destroying insects. If evidence of active or previous infestation(s) of listed wood destroying insects is reported, it should be assumed that some degree of damage is present, wether visible or non-visible.

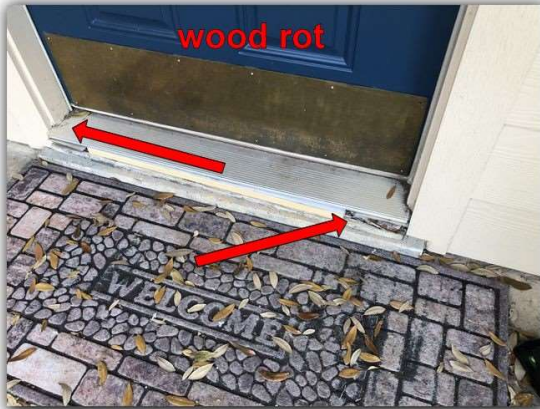
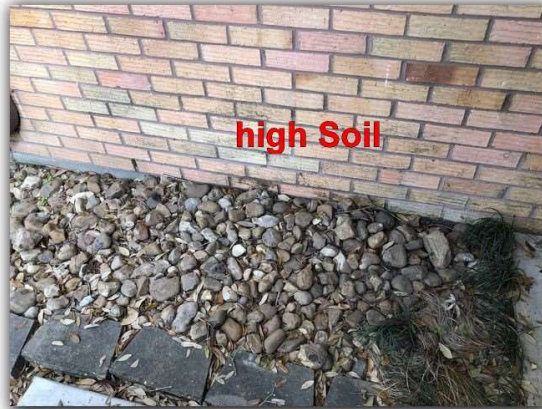
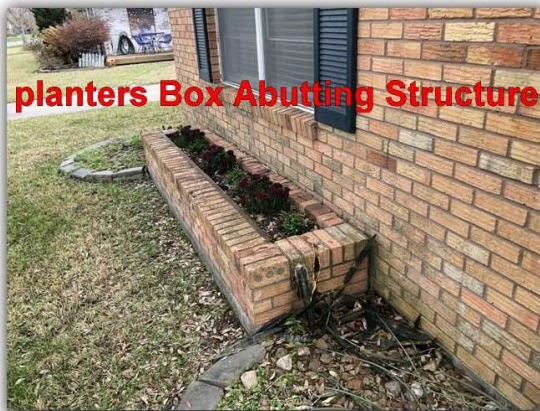
Conducive Conditions Present: Yes (Sample Pictures Below)
