Inspection for Property located at 4921 Oak Landing Drive  
06/04/2020  
Prepared for : Justin Polk Amanda Polk

## PROPERTY INSPECTION REPORT

**Description:** 2 Story, Wood framed single family residence ; Pre-Insulation Inspection

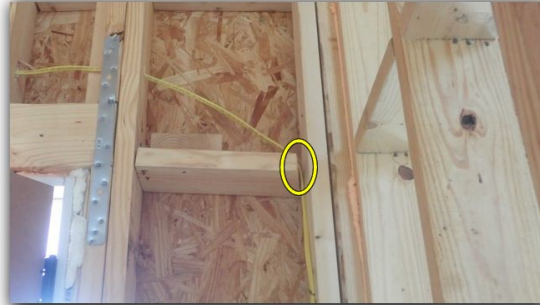
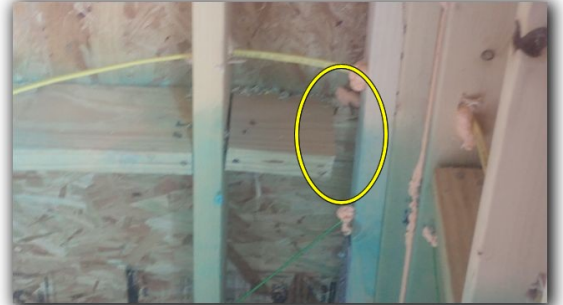
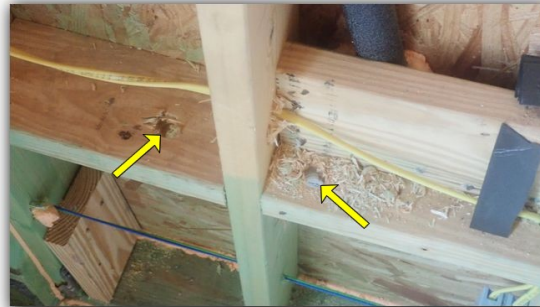
*Comments:* The fireblocking has excessive gaps. This condition defeats the purpose by allowing combustion gasses the ability to easily bypass the block.

**Connections between horizontal and vertical spaces need fireblocking. Fireblocking shall be provided at interconnections between concealed vertical stud wall or partition spaces and concealed horizontal spaces created by an assembly of floor joists or trusses, and between concealed vertical and horizontal spaces such as occur at soffits, drop ceilings, cove ceilings, roofs and similar locations. IRC R302.11**

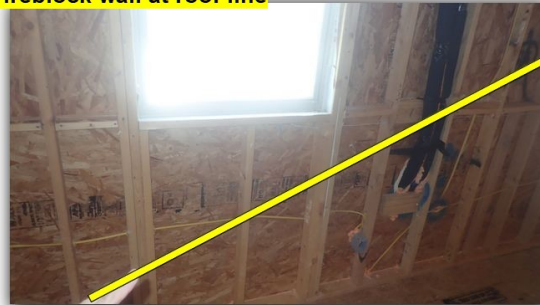
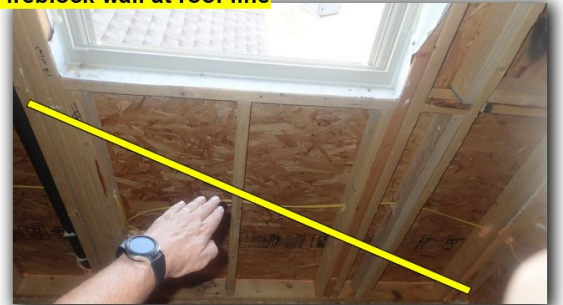
**Fireblock wall at roof line**

**Improper gaps at fire blocking roofline. Blocking should extend to edge of studs.**

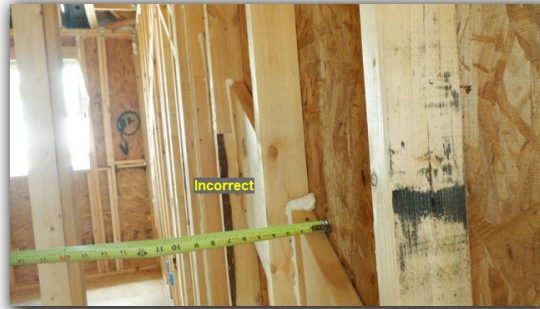
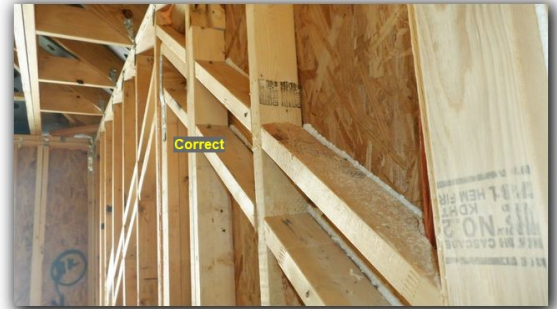
**Additional fire blocking sealant needed in garage wall.**

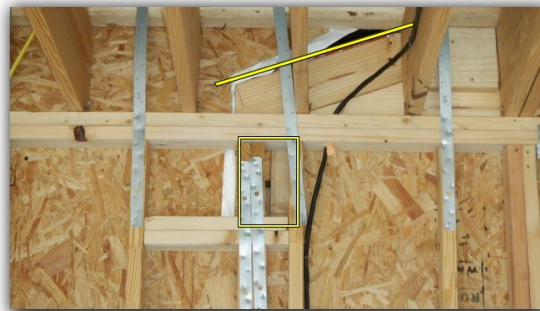
**Front Foyer**

**The structural header support is not in contact with the header.**

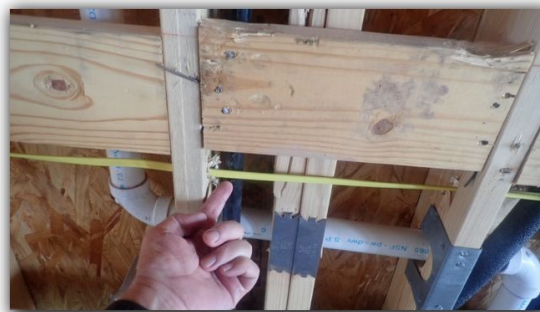
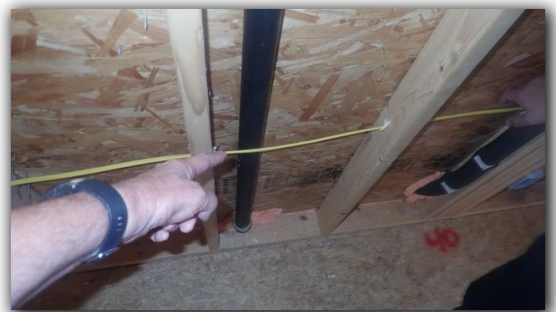
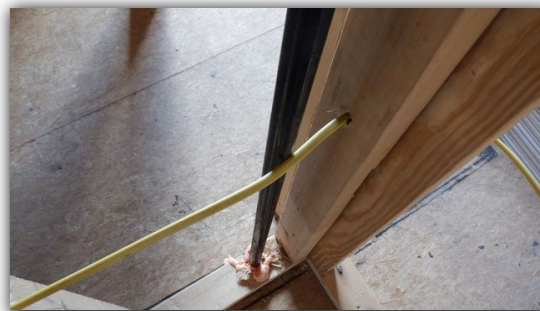
Gas branch pipe should not be in direct contact with electrical wiring.

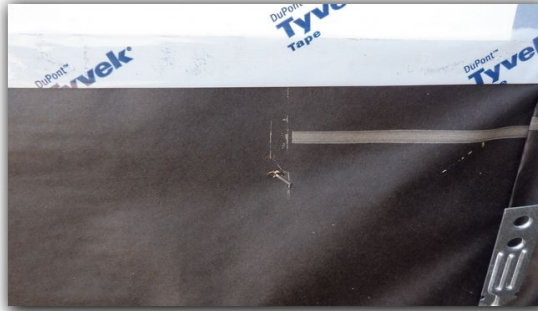
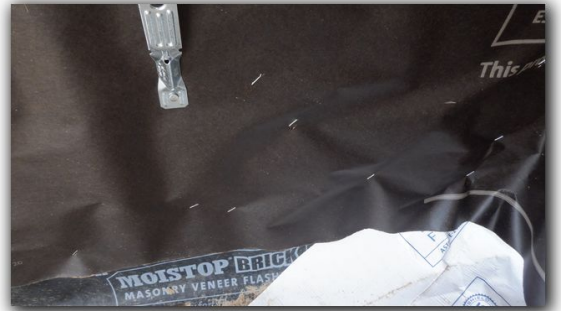
Could not confirm staples used are the proper type at weather barrier.

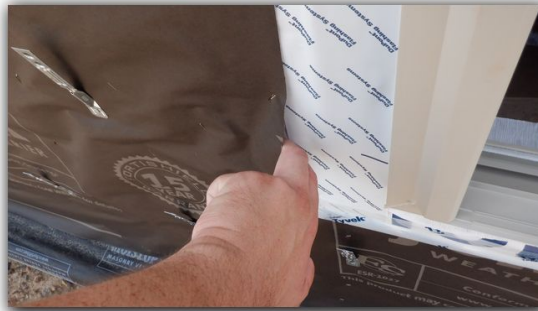
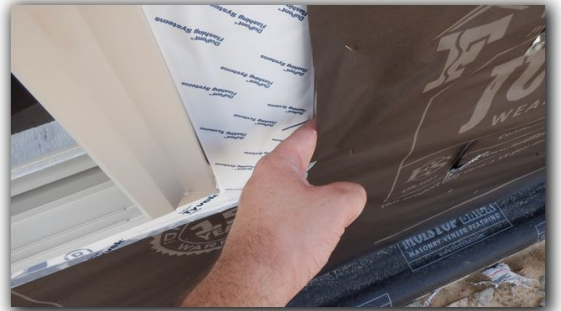
Repair weather barrier to allow for a proper sealing in a shingle-like fashion.

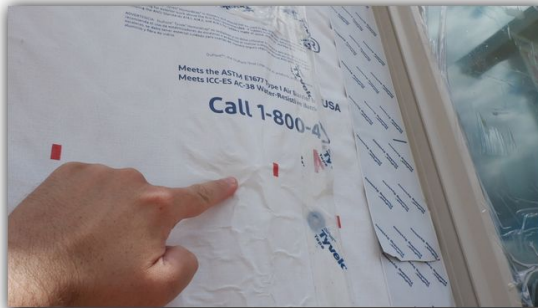
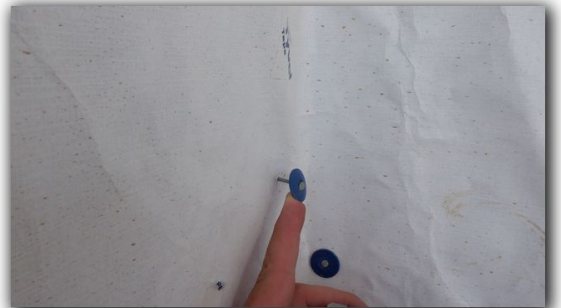
Remove and repair under-driven nails.

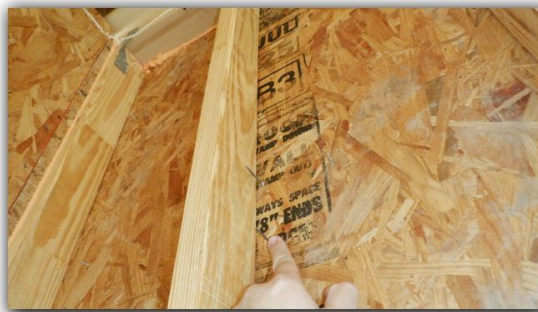
Some fasteners not driven correctly into framing.

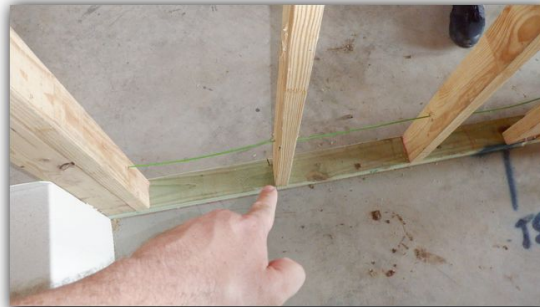
Not every wall stud has a minimum 2 nails in the ends. Some studs as the one pictured below can be easily twisted indicating a single nail.

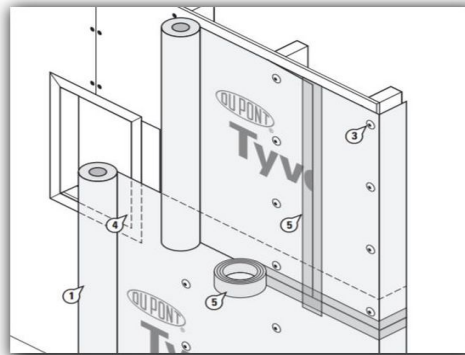
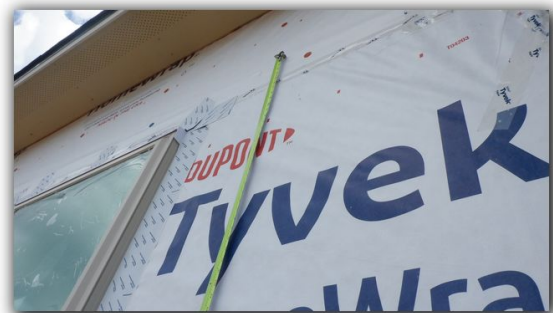
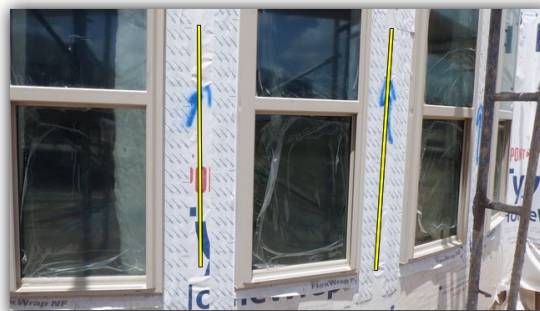
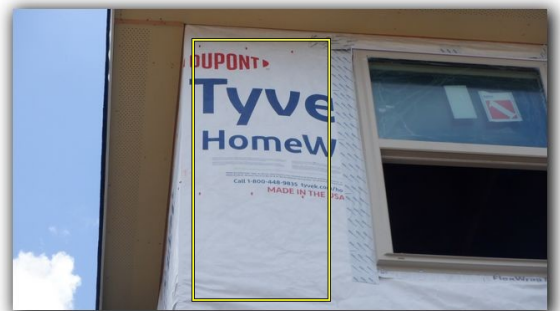
Missing/improper spans on Tyvek without fasteners observed at multiple locations. Housewrap fasteners should be no closer than 6" and no farther than 18" according to the Tyvek installation instructions.

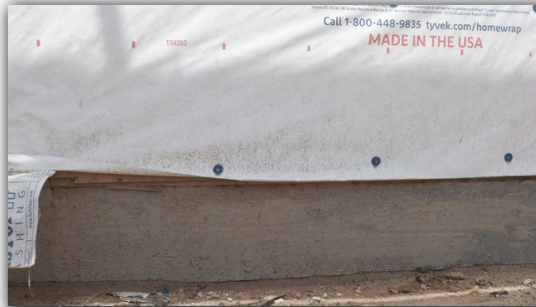
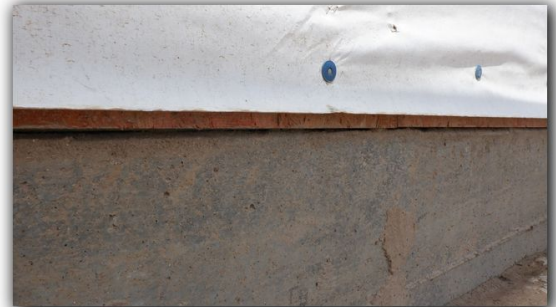
Tyvek not extended past base of OSB, additional Tyvek needed to prevent moisture damage.

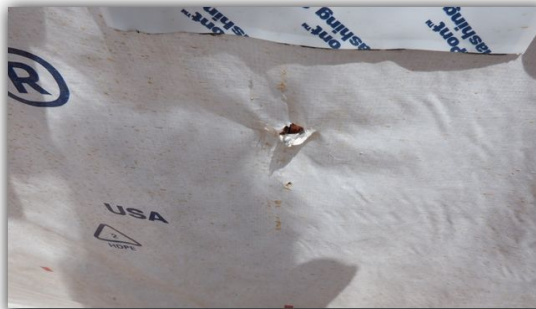
Several holes, rips and tears were observed in the house wrap. According to the manufacturers installation instructions, "- Where housewrap has been torn or punctured, repair with Tape. Where tears or punctures are large, repair with tape and additional vapor barrier. Reference R703.1, R703.2, R703.8

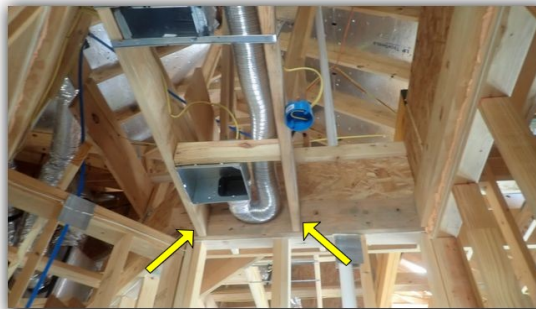
Comments: Ceiling joists are missing required joist hangers where joists over 4 ft are not supported on a bearing surface.

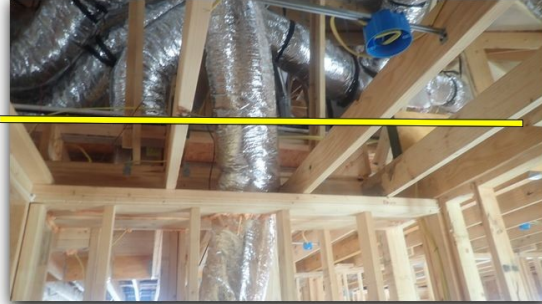
Ceiling joist is not protected from lateral or torsional forces. It should be blocked, attached with a strong-back or have a "Rat-run" added.

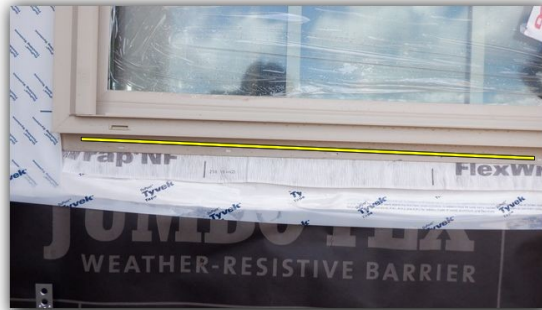
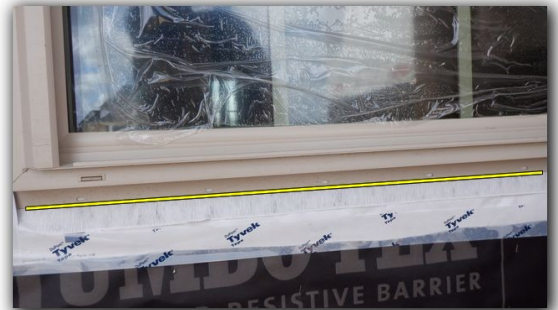
Comments: One or more windows are improperly installed with nailed penetrating the window attachment fin (flange). The window should be attached by placing nails in the nailing fin holes 3" - 7" from the corners and 8" apart all the way around the window. This allows for expansion and contraction of the product over the seasons and years, without compromising the integrity and durability of the window.

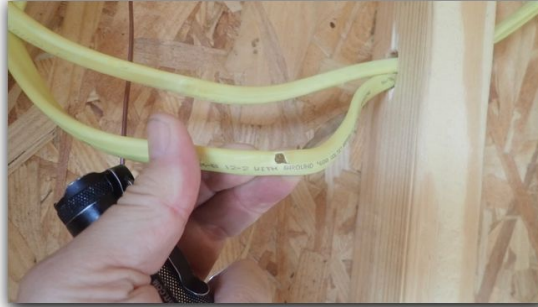
Comments: **The branch wiring has been damaged by an anchor staple. This wire should be replaced.**

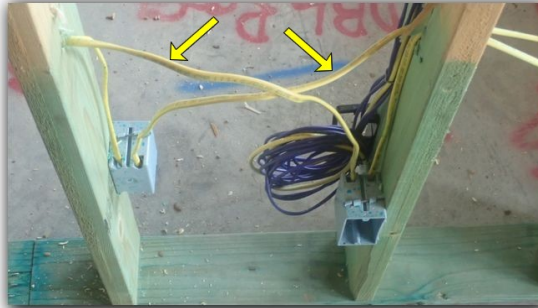
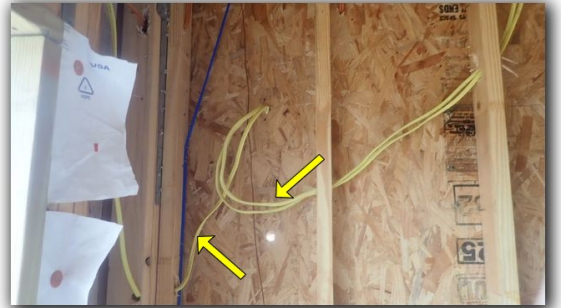
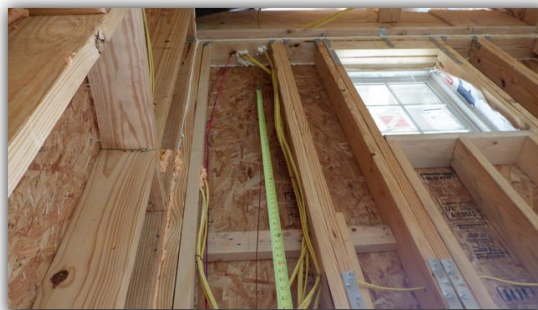
Branch wiring should be secured within 12 in. of box & max 4 1/2 ft. intervals. IRC 3802.1 and NEC 334.30

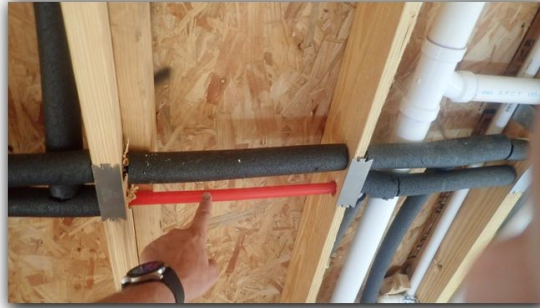
*Comments:* Recommend insulating exterior water line(s) to prevent freeze damage.
