**A-BETTER INSPECTION INC.**

Residence is a one-story wood frame structure.  
For the purpose of this report, residence faces west.  
Residence was vacant at the time of the inspection.

5342 Marisol Cove  
Katy, TX 77493

# PROPERTY INSPECTION REPORT FORM

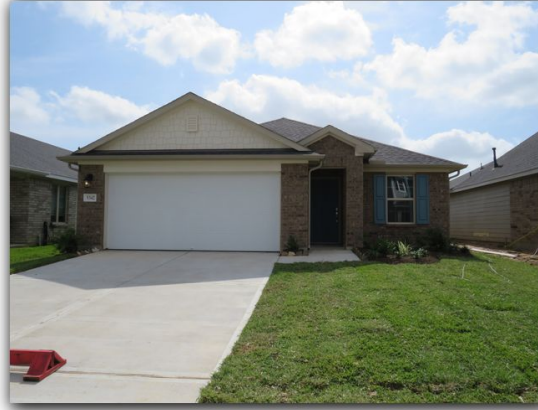
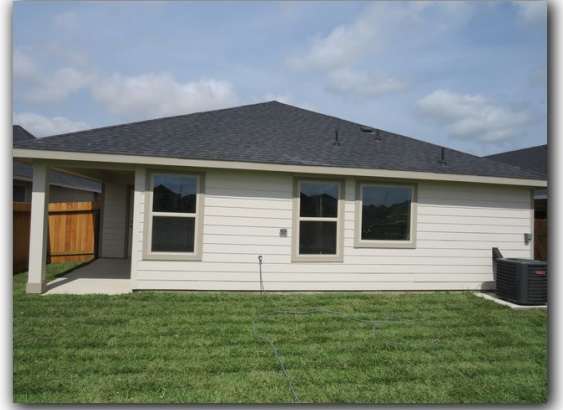
The residence was observed as having a concrete post-tension slab on grade foundation. The foundation appears to be functioning as designed and intended at this time. The structural members and load bearing walls appeared unremarkable at this time. The foundation appears to be reasonably level.

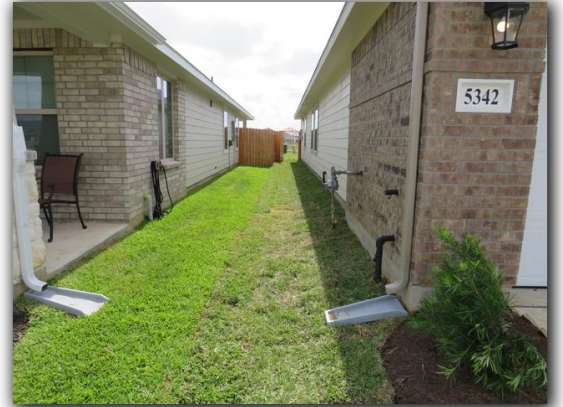
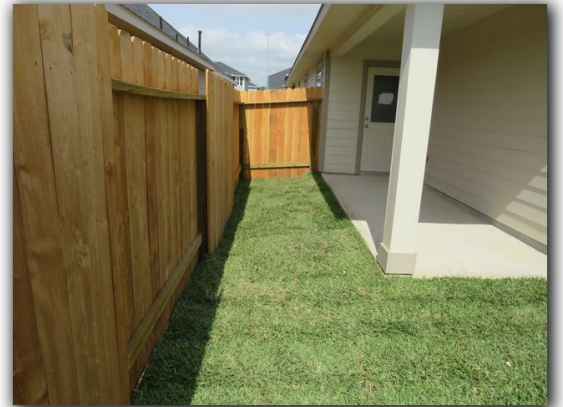
The grading on the property appears satisfactory at this time. The slope and drainage was considered typical and normal. It is recommended that 3-5" of foundation exposure be kept around the perimeter of the foundation and that a consistent moisture content be maintained. Improper grading and moisture control can lead to possible foundation problems.

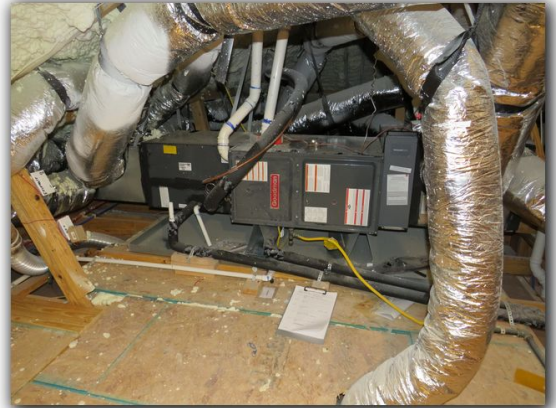
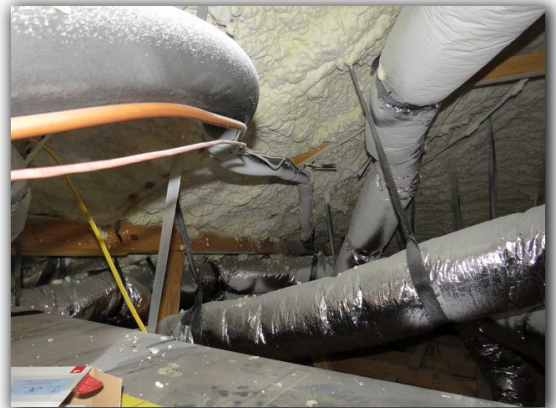
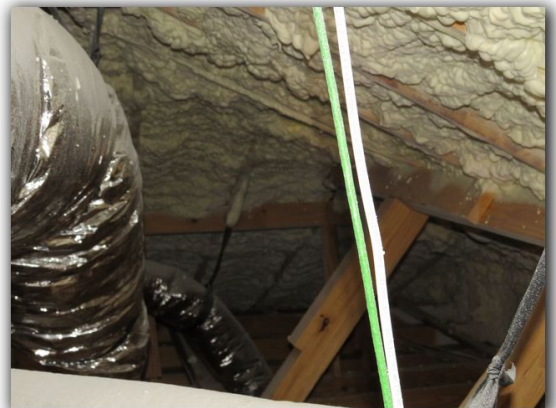
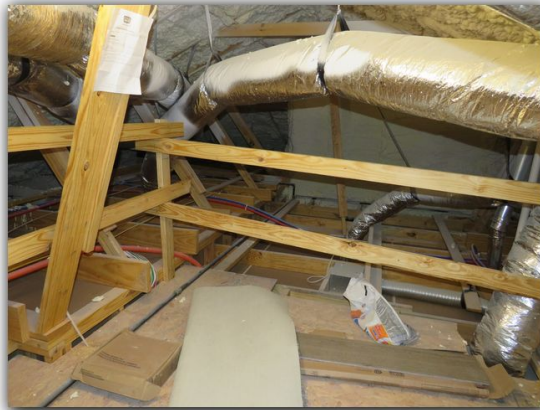
The accessible portions of the attic area of the residence was visually inspected. The overall condition of the visible interior framing and supports appear sound at this time. The rafters and decking were covered by foam insulation and not visible for inspection. Insulation in the attic area appears to be approx. 6-8".

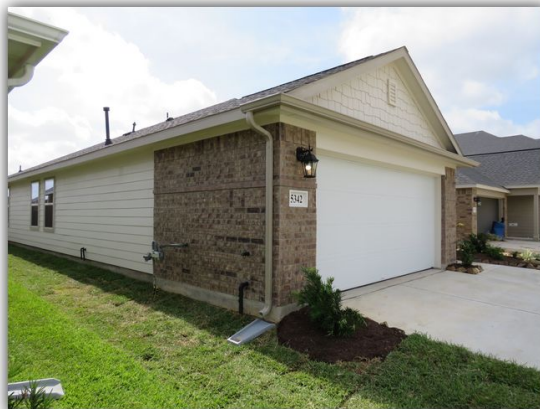
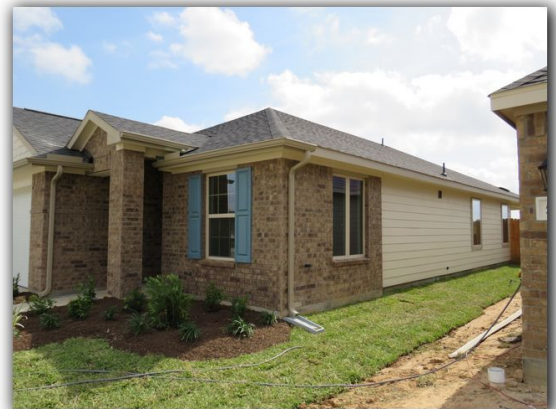
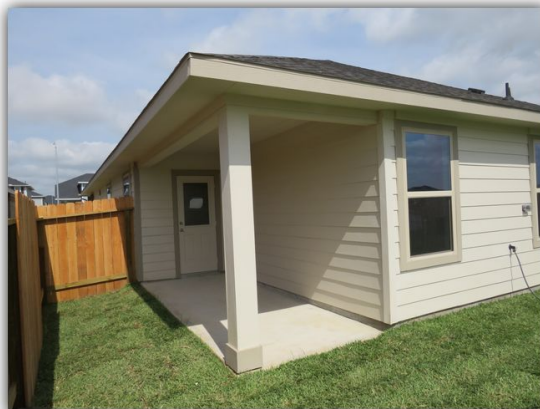
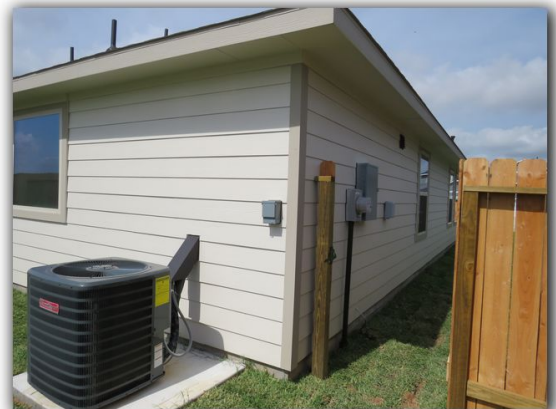
The masonry wall areas and fiber cement sided walls on frame construction were observed to be

in overall good condition at this time.

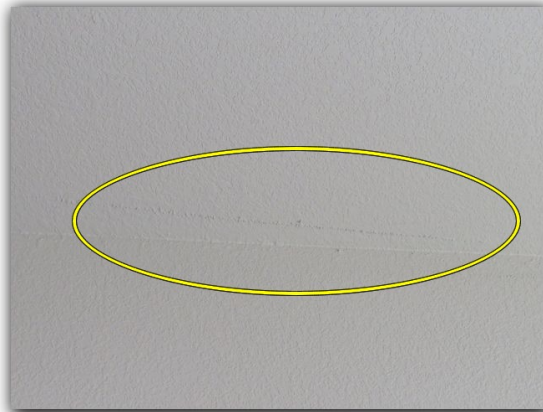
- A drywall blemish was observed at the living room ceiling near the rear entry.

A drywall blemish was observed at the living room ceiling near the rear entry. Blistered/peeled paint observed at the master closet ceiling near the air supply register.

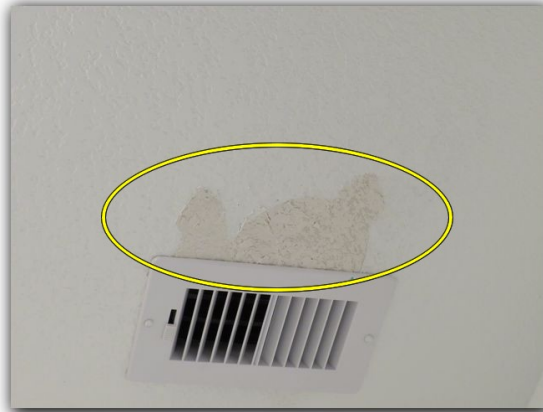
Blistered/peeled paint observed at the master closet ceiling near the air supply register.

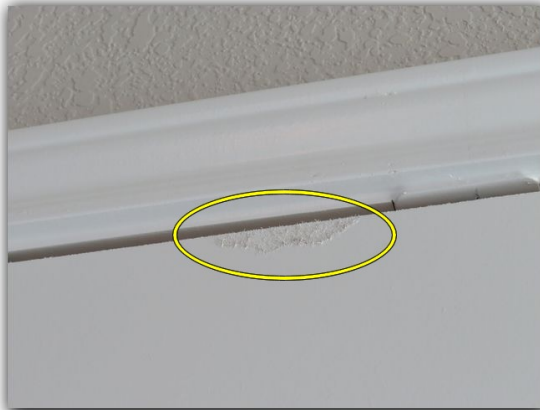
Blemish observed at the master bath entry doors.

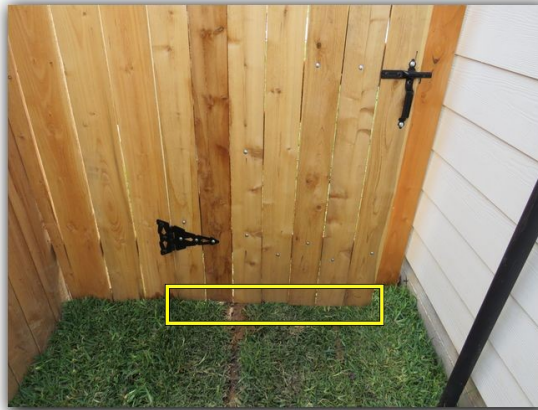
The yard gate observed to drag on the exterior grading. Recommend trimming the bottom of the yard gate to allow unrestricted open/close operation of the gate.

The yard gate observed to drag on the exterior grading. Recommend trimming the bottom of the yard gate to allow unrestricted open/close operation of the gate.

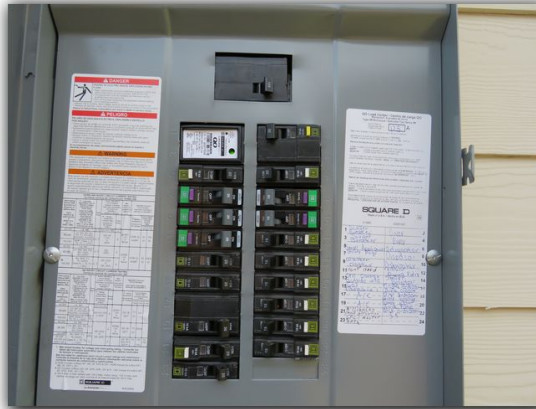
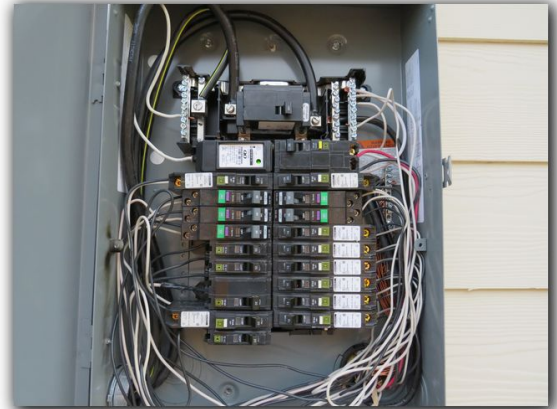
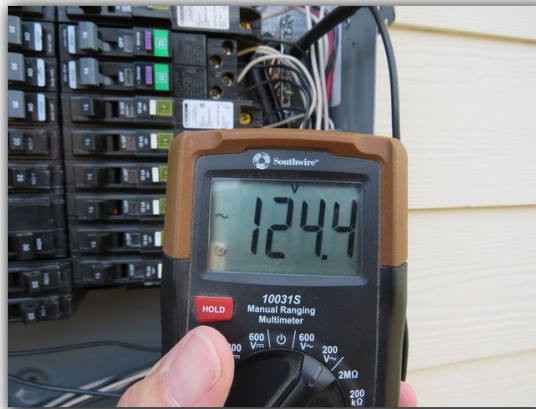
125amp service panel-125amp main- 120/240v copper wired breaker service. Breaker wiring, bus bar shields and breakers showed no indications of over heating or arcing and were observed to be in good condition at this time.

The service panel cabinet does not appear to be bonded. Repairs are needed to bond the service panel cabinet to the neutral bus bar. Metal components that can become energized from a lightning strike should be bonded/grounded.

The service panel cabinet does not appear to be bonded. Repairs are needed to bond the service panel cabinet to the neutral bus bar. Metal components that can become energized from a lightning strike should be bonded/grounded. GFCI protection appears to be needed for the 240v A/C condenser circuit.

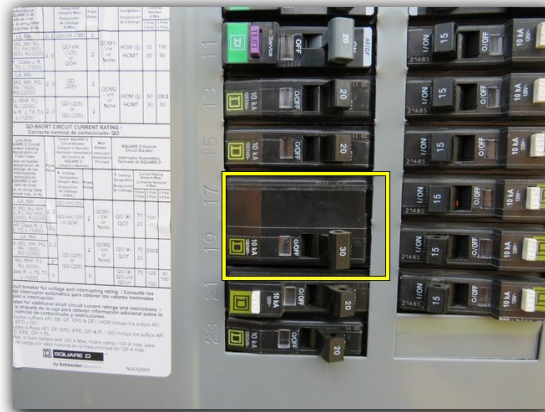
GFCI protection appears to be needed for the 240v A/C condenser circuit.

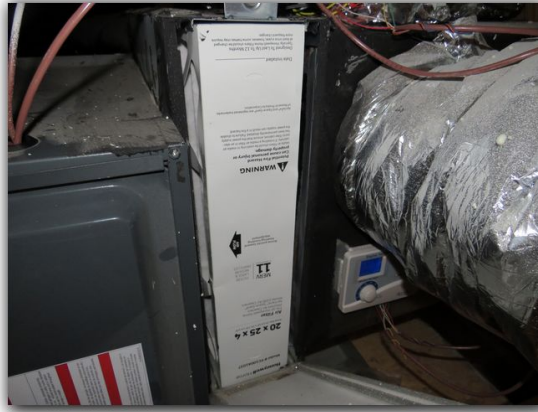
2021 GOODMAN gas fired forced air 40,000 BTU furnace MOD. #GMVC960403BN.

Air handler was equipped with a media filter. Recommend replacing the filter every 6-8 months. Additional filters may be used on air returns if desired. Recommend using the economy filters so as not to impede air flow.

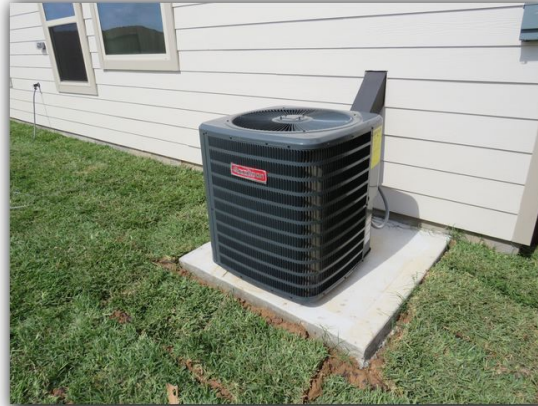
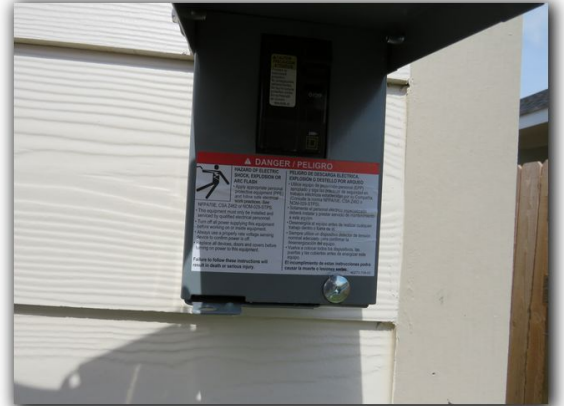
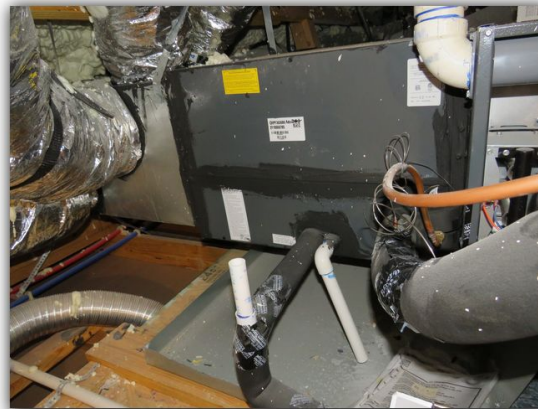
2021 GOODMAN 2 ton 30 amp condensing unit MOD. #GSX160241FJ.

The cooling system was operated using the standard manual controls in the residence, the equipment is visually checked for damage and component operations. The interior room temperature and supplied air temperature are measured as a tool in determining the present operating condition of the system. Normal temperature differential for a cooling system considered in satisfactory operating condition is between **14-22 degrees**. Measured room temp. **75 degrees**. Supplied air temp. **59 degrees**. Temperature differential **16 degrees**. The cooling system was considered in satisfactory operating condition at this time.

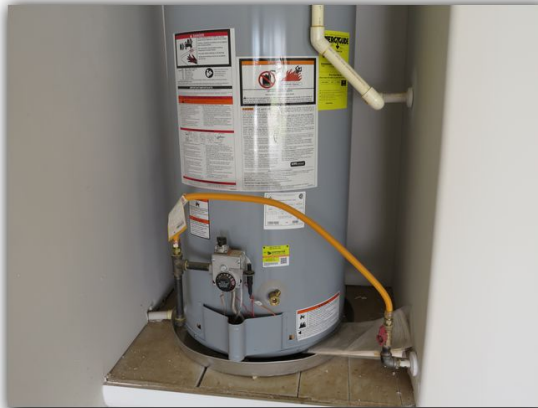
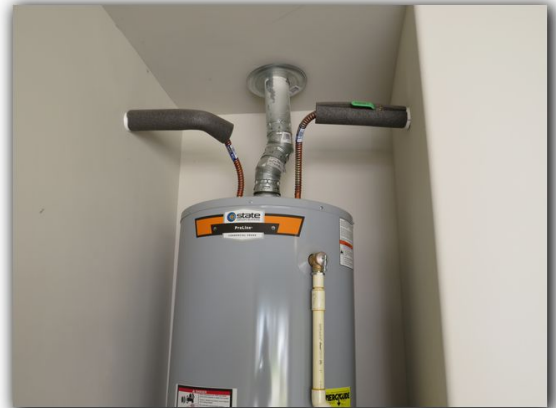
2022 STATE 50 gallon gas fired water heater MOD. #GS6-50-BCT 250, unit was observed to be functional and properly installed at this time. Water temperature was measured at 113 degrees, temperature controls on the water heater can be adjusted for comfort levels.
