# PROPERTY INSPECTION REPORT

**Concerning:** 8299 Cambridge St 601, Houston TX 77054  
(Address or Other Identification of Inspected Property)

**By:** Derek Carl - TREC #22170 01/10/2020 9:00 am  
(Name and License Number of Inspector) (Date)

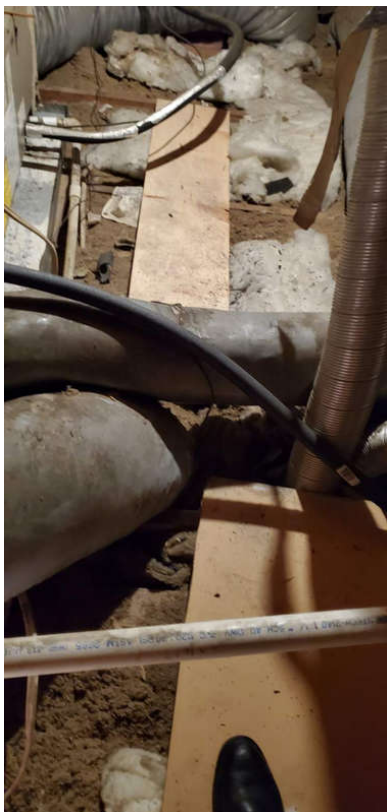
Attic

**1: No platform**

No walkway was provided in the attic. Persons entering the attic must walk on ceiling or roof framing members which are often hidden from view beneath the insulation. This activity can be difficult and/or hazardous. The ceiling-covering material (drywall or plaster) will usually not support the weight of a person.

Recommendation: Contact a qualified professional.

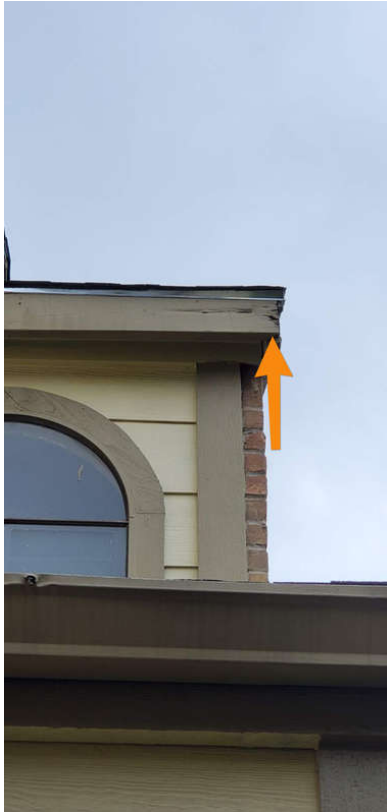
Front of the home

**1: Damaged Trim**

There were damaged trim pieces around the exterior of the home. The Inspector recommends having any damaged trim pieces replaced. All work should be done by a qualified professional.

Recommendation: Contact a qualified professional.

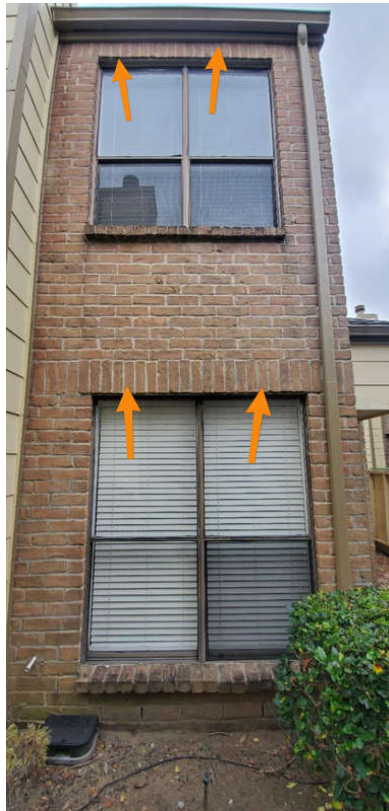
Front of the home

**2: Weepholes**

There were no weep holes installed above the windows. Weep holes act as a ventilation system for the internal wall cavity and allow water to drain from within the cavity. Recommend having weep holes added.

Recommendation: Contact a qualified professional.

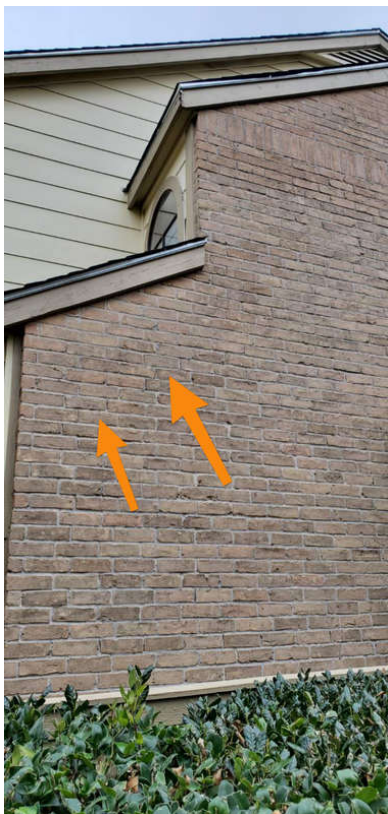
Right Side

### 3: Minor crack(s)

There were several areas that had minor cracks in the exterior walls. This is caused by the soil settling over time. This is not of concern as of now, but you should continue monitoring. Recommend consulting with a structural engineer should the cracks worsen.

Recommendation: Recommend monitoring.

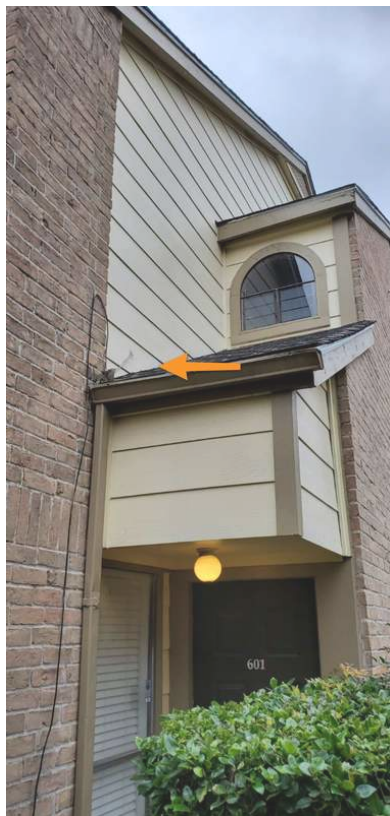
Front of the home

**4: 1 1/2" gap missing in between shingles and siding**

The siding on the exterior wall located above the entryway was in direct contact with the shingles on the roof. The siding also shows signs of deterioration. There should be a 1 1/2" gap between the exterior wall covering/siding and the shingles to prevent moisture wicking, decay, and other damage.

Recommendation: Contact a qualified professional.

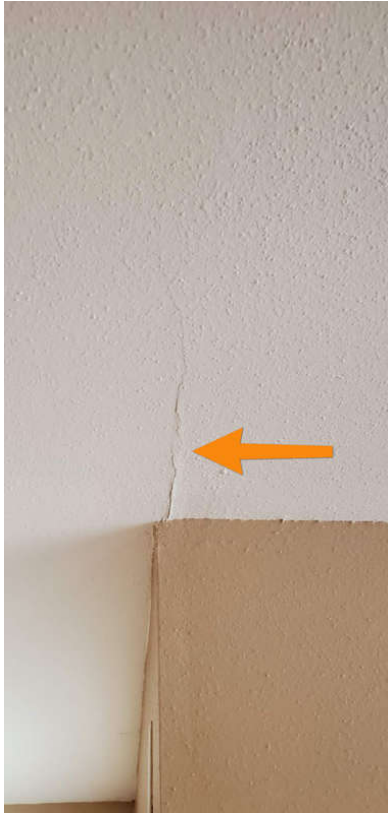
2nd Floor Bedroom

**1: Ceiling - Minor Damage**

Minor damage or deterioration of the ceiling was visible at the time of the inspection.

Recommendation: Contact a qualified drywall contractor.

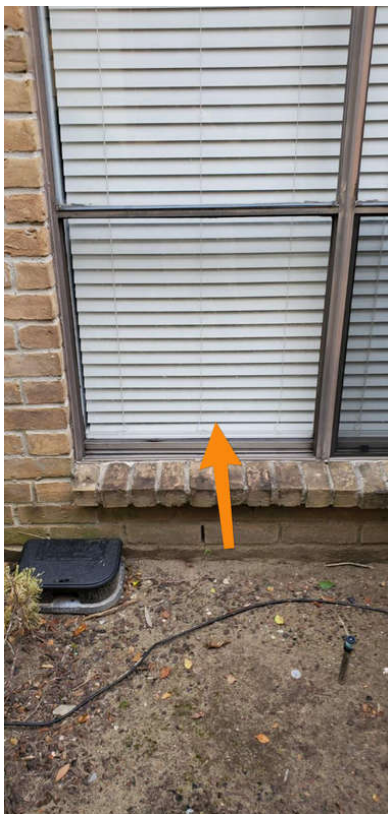
Right Side Front of the home

**1: Damaged/Missing Screen(s)**

One or more windows screens were damaged and/or missing. Recommend replacement by a window repair contractor.

Recommendation: Contact a qualified window repair/installation contractor.

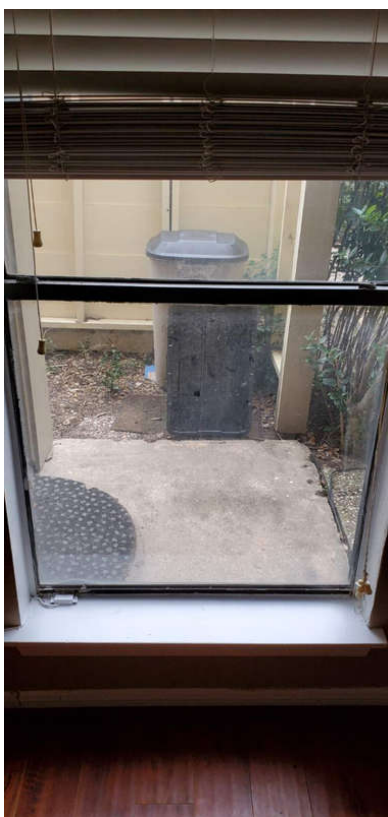
Throughout the home

## 2: Windows difficult to operate

Windows in the home were generally difficult to operate.

Recommendation: Contact a qualified window repair/installation contractor.

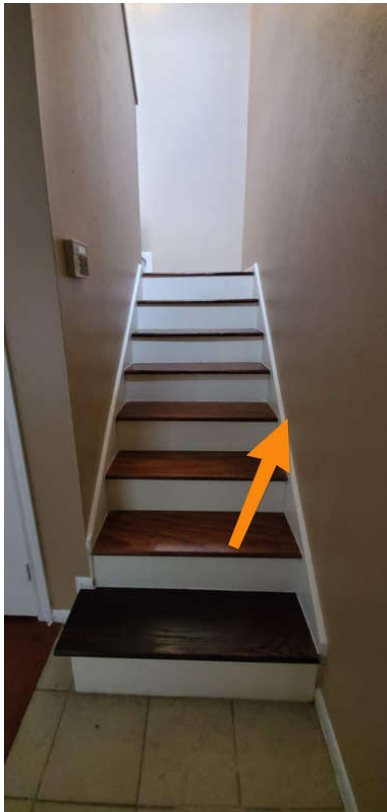
**1: Handrail not installed**

The staircase did not have handrail(s) installed. This is a safety hazard. Recommend a qualified professional install a handrail.

Recommendation: Contact a qualified professional.

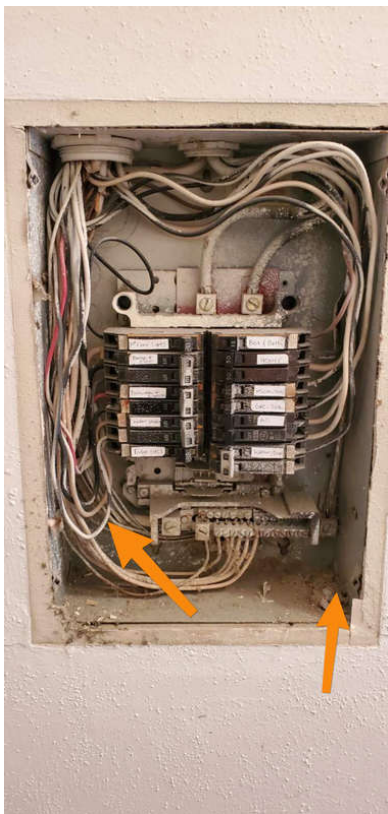
**1: Dirty interior**

The interior of the electrical service panel cabinet was dirty and needed cleaning. This condition may affect the ability of electrical components within the service panel to function as they were designed. The Inspector recommends that the service panel be cleaned by a qualified electrical contractor.

Recommendation: Contact a qualified electrical contractor.

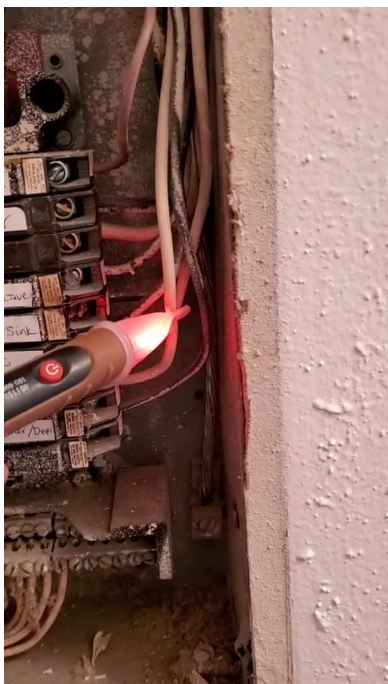
**2: conductors incorrectly colored/marked**

In the service panel, conductors with white insulation were being used as ungrounded conductors but were not marked as such. This is a potential electric shock/electrocution hazard and should be corrected by a qualified electrical contractor.

Recommendation: Contact a qualified electrical contractor.

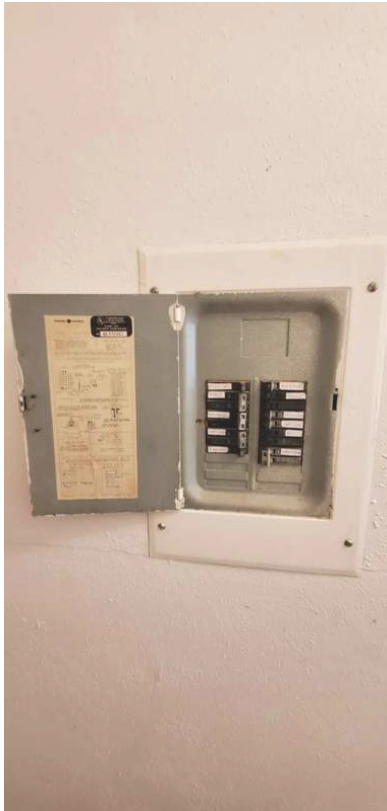
Master Closet

**3: Service panel installed in closet**

The service panel was located inside of a closet. Due to the combustible nature of clothing and inadequate clearances, service panels are no longer allowed to be installed in closets. The Inspector recommends consulting with a qualified electrical contractor to discuss options and costs for moving the service panel to a proper location.

Recommendation: Contact a qualified electrical contractor.

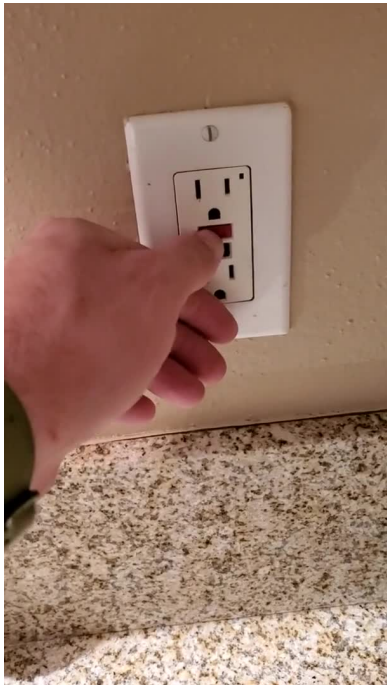
Kitchen

**2: GFCI Failure**

A ground fault circuit interrupter (GFCI) electrical receptacle in the interior feature location did not respond to testing and did not reset. The inspector recommends receptacle repair or replacement as suggested by a qualified electrical contractor.

Recommendation: Contact a qualified electrical contractor.

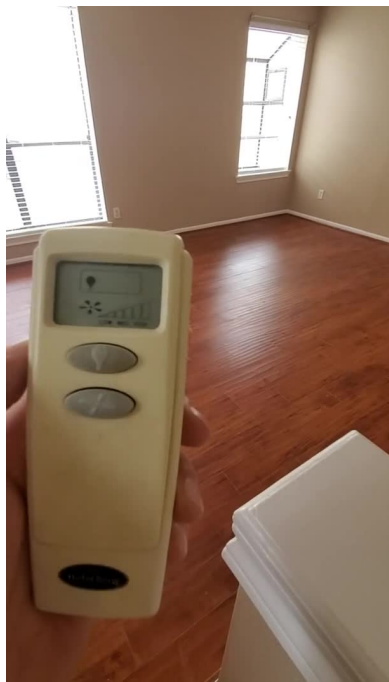
Master Bedroom

**3: Ceiling light did not respond**

A ceiling light fixture in the interior feature location did not respond to the switch. The bulb may need to be replaced or there may be a problem with the switch, wiring or light fixture. If after the bulb is replaced this light still fails to respond to the switch, this condition may represent a potential fire hazard and the Inspector recommends that an evaluation and any necessary repairs be performed by a qualified electrical contractor.

Recommendation: Contact a qualified electrical contractor.

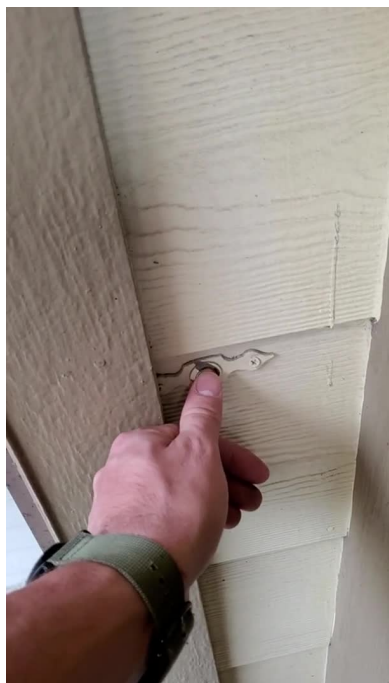
Front of the home

**4: Doorbell did not operate**

Doorbell did not operate as intended. No sound came through when activated.

Recommendation: Contact a qualified electrical contractor.

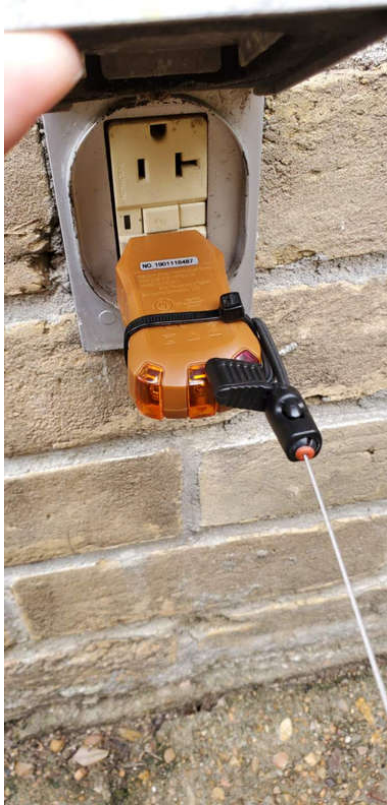
Right Side

**5: No power to exterior receptacle**

The exterior receptacle did not have power at the time of the inspection. Recommend a licensed electrician inspect further to determine the cause.

Recommendation: Contact a qualified electrical contractor.

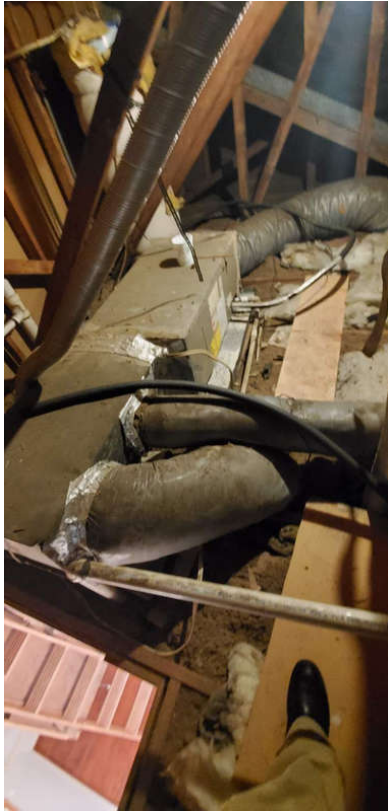
Attic

**1: Needs Servicing and Cleaning**

The furnace should be cleaned and serviced annually. Recommend a licensed HVAC contractor clean, service and certify furnace.

Recommendation: Contact a qualified HVAC professional.

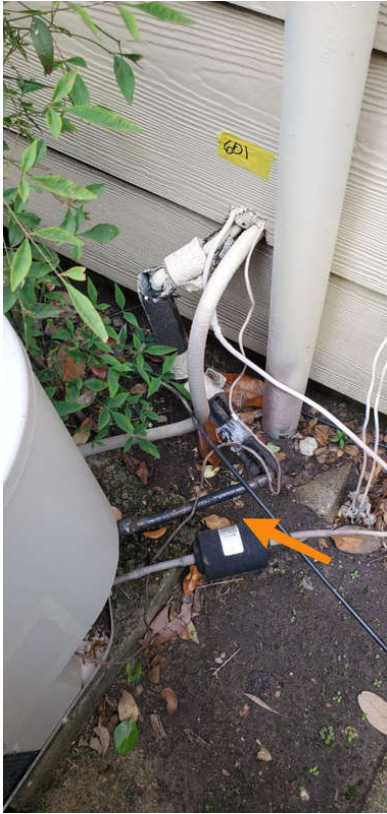
Right Side

**1: Insulation Missing and/or Damaged**

The insulation on the refrigerant line was missing and/or damaged which can cause energy loss and condensation buildup. Recommend having a licensed HVAC professional make necessary repairs.

Recommendation: Contact a qualified HVAC professional.

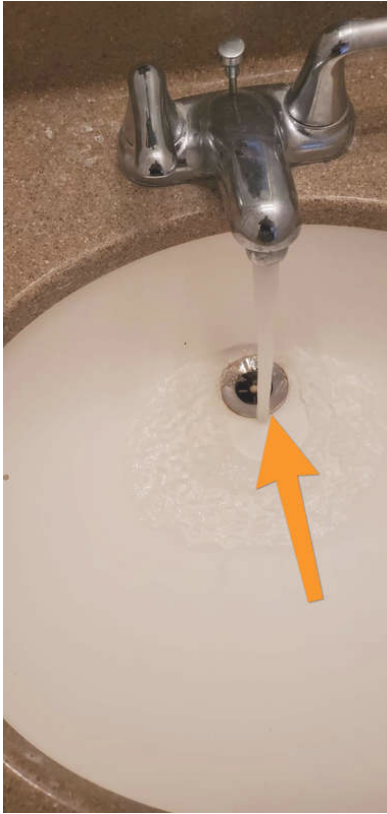
**1: Drain stopper malfunction**

The drain stopper did not function properly.

Recommendation: Contact a qualified professional.

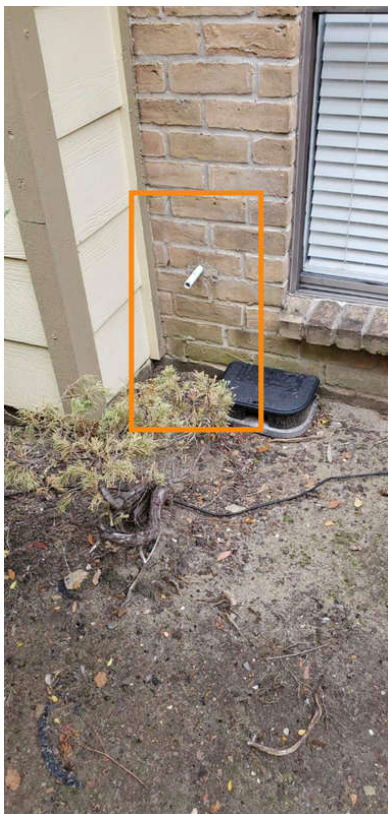
Front of the home

**1: TPR pipes terminates too high**

The discharge pipe of the water heater temperature/pressure relief (TPR) valve was terminated more than 6 inches above the floor. The TPR does not discharge towards the ground. These conditions could result in scalding if the pressure relief valve were activated while a person was nearby. The Inspector recommends correction by a licensed plumbing contractor.

Recommendation: Contact a qualified plumbing contractor.

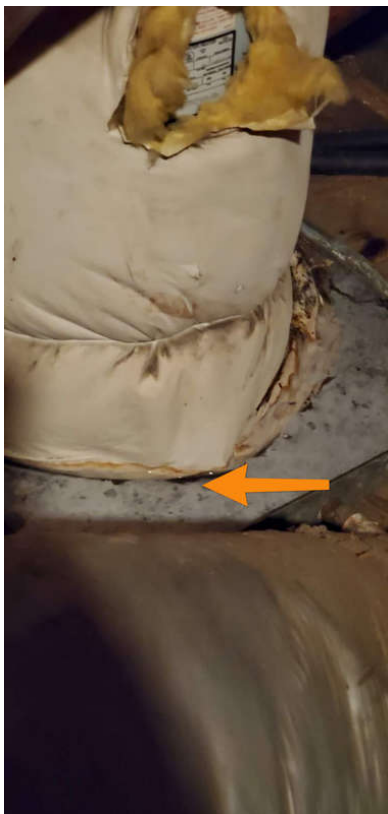
Attic

## 2: Water in pan

This water heater was actively leaking at the time of the inspection. This should be shut off, drained immediately and evaluated by a qualified HVAC professional or plumbing contractor. There was no access platform to the hot water heater, so a visual inspection was performed and the source of the water in the pan was not determined.

Recommendation: Contact a qualified plumbing contractor.

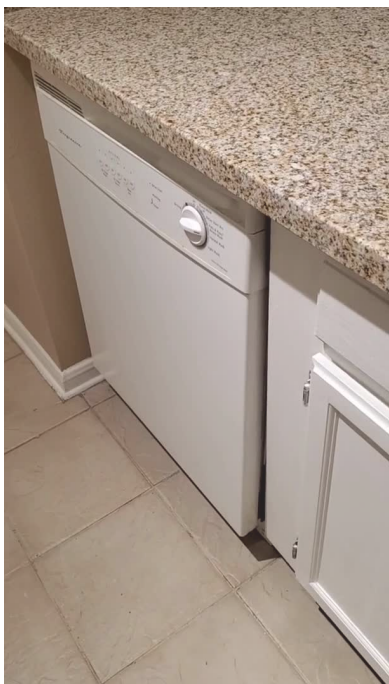
Kitchen

**1: dishwasher makes a loud noise during cycle**

The dishwasher was making a loud noise when it started on a normal cycle. The dishwasher operated as intended. Inspector recommends monitoring. Should the problem worsen, contact a qualified professional to determine the cause and make necessary repairs.

Recommendation: Recommend monitoring.
