PROPERTY INSPECTION REPORT

Prepared For: Richard Whitaker
(Name of Client)

Concerning: 2001 Bayleaf Manor Dr., Manvel, TX 77578
(Address or Other Identification of Inspected Property)

By: Chad Langston, Lic #7946 07/16/2021
(Name and License Number of Inspector) (Date)

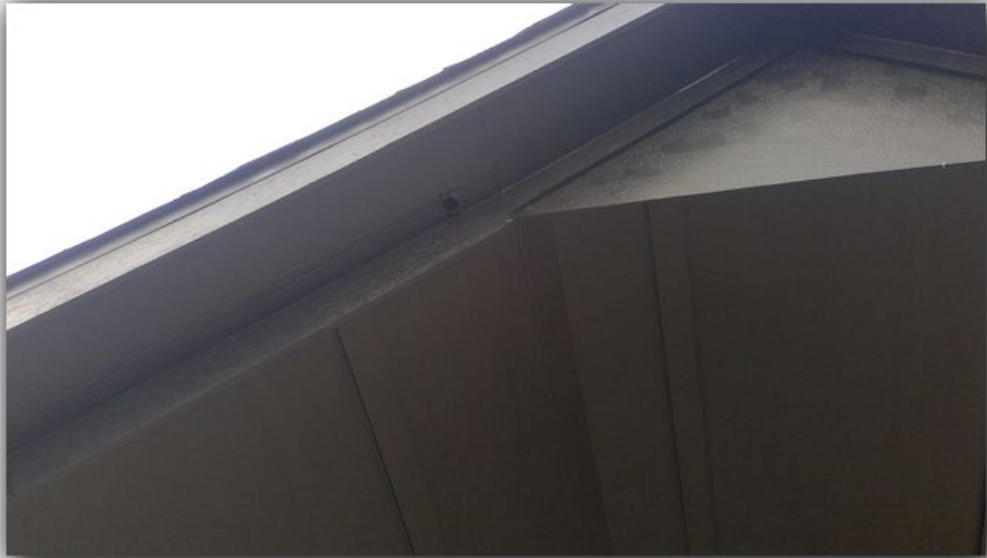
Damage was noted to the soffit at the rear of the home. Repairs should be made as necessary.

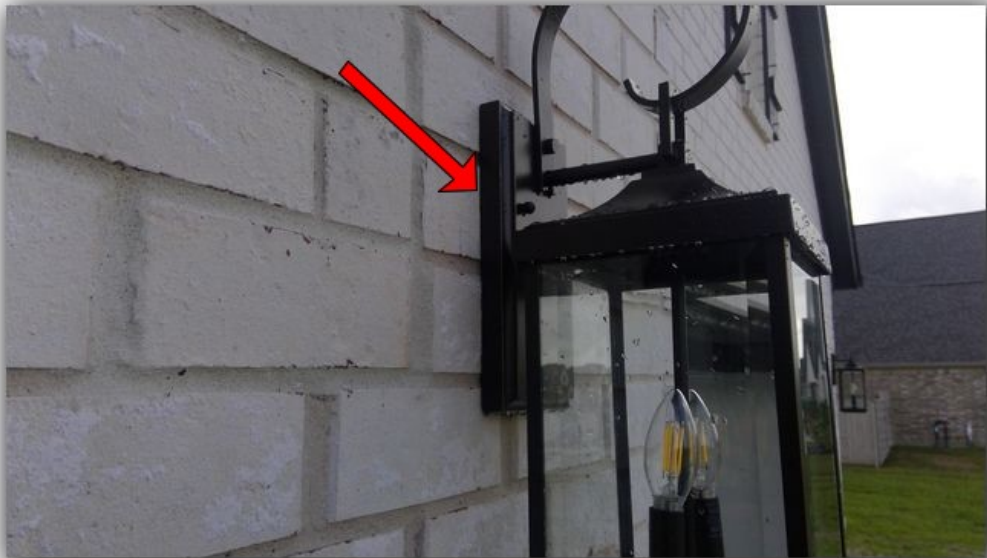
Exterior wall penetrations should be examined and sealed as necessary.

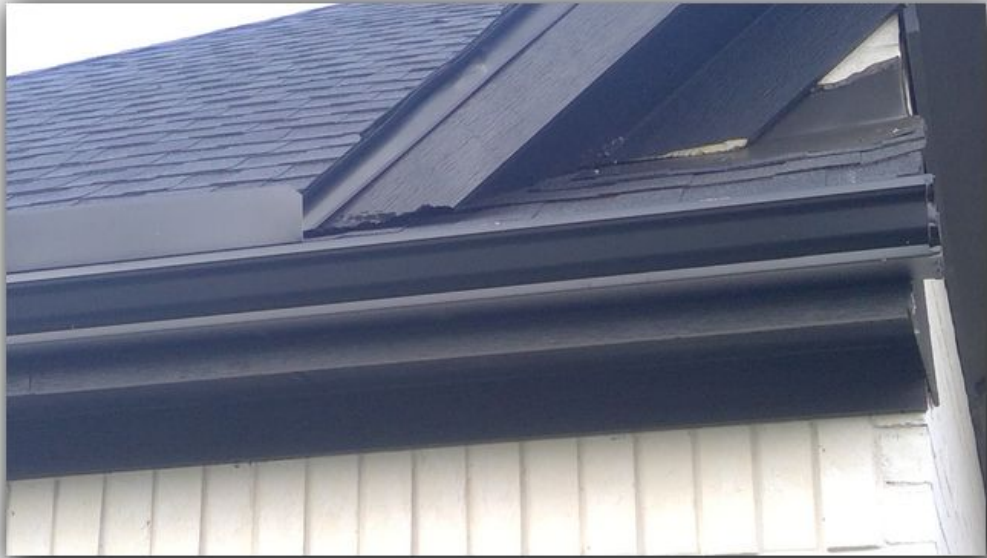
Damage was noted on the fascia trim at the rear of the home. Repairs should be made to prevent further damage.

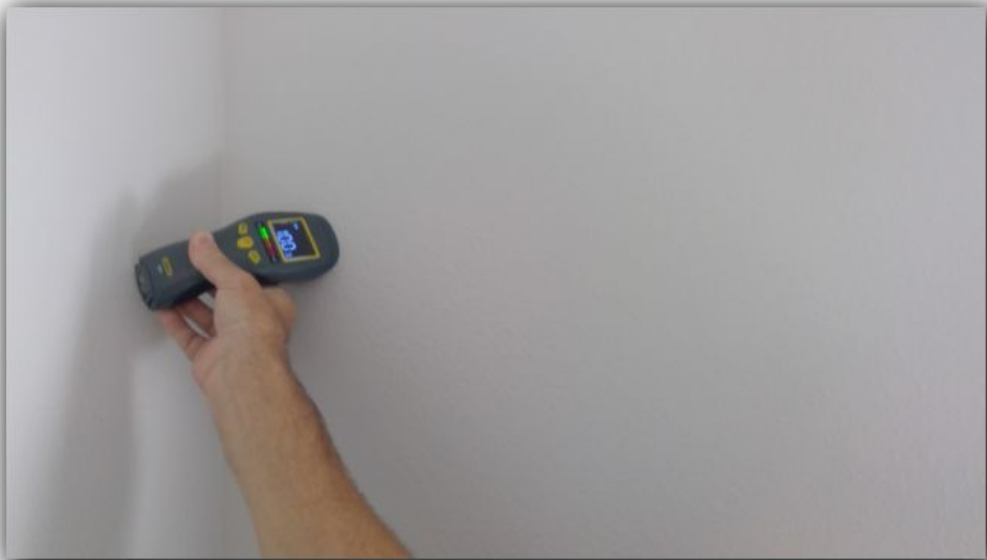
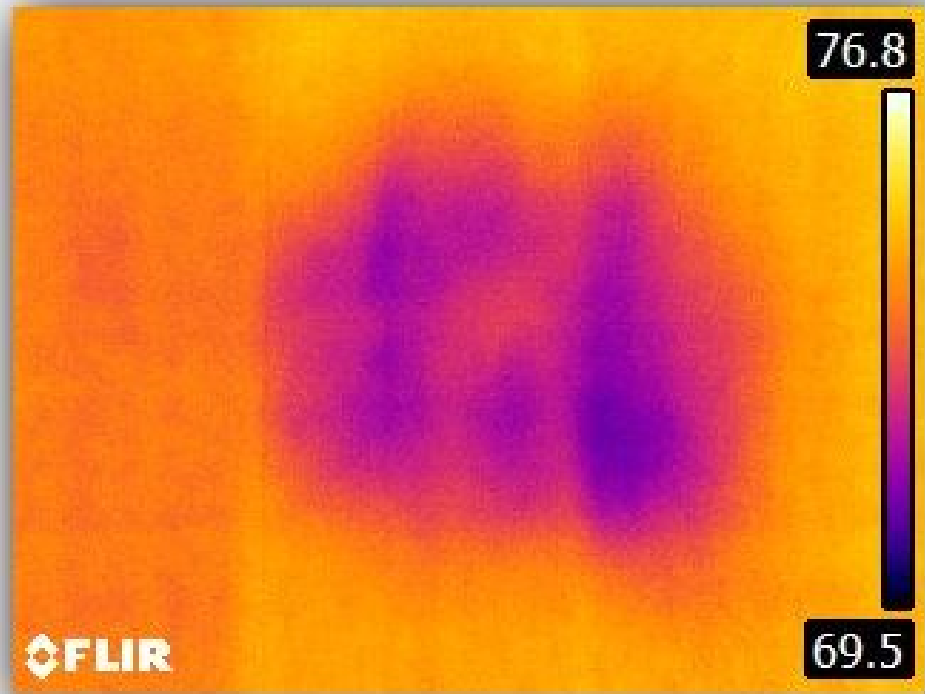
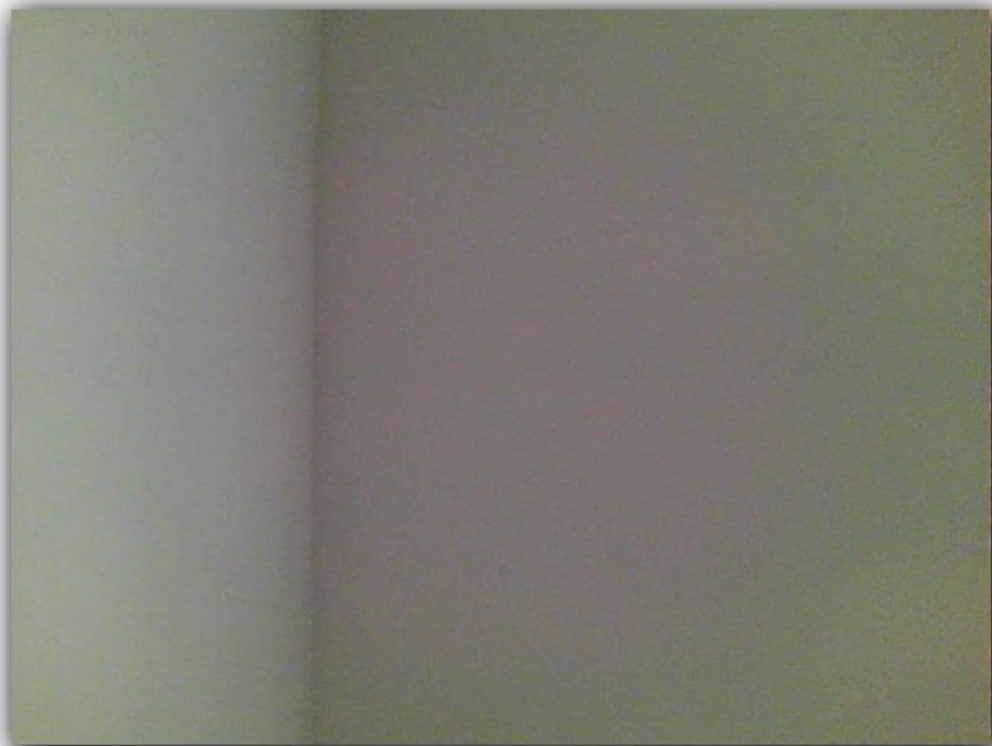
A thermal anomaly was detected in the main bathroom at the back of the house. Further investigation and repairs should be made as necessary.

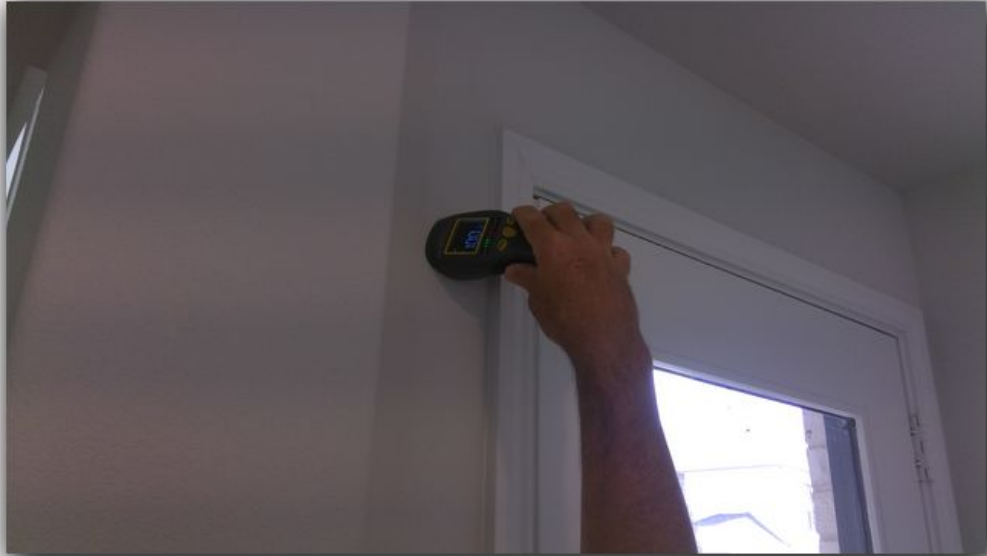
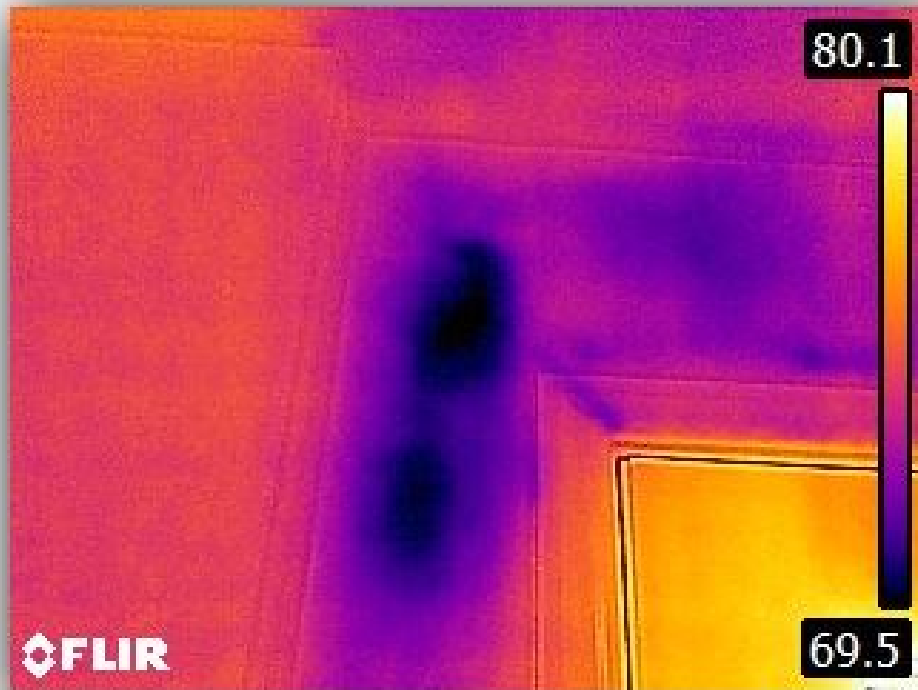
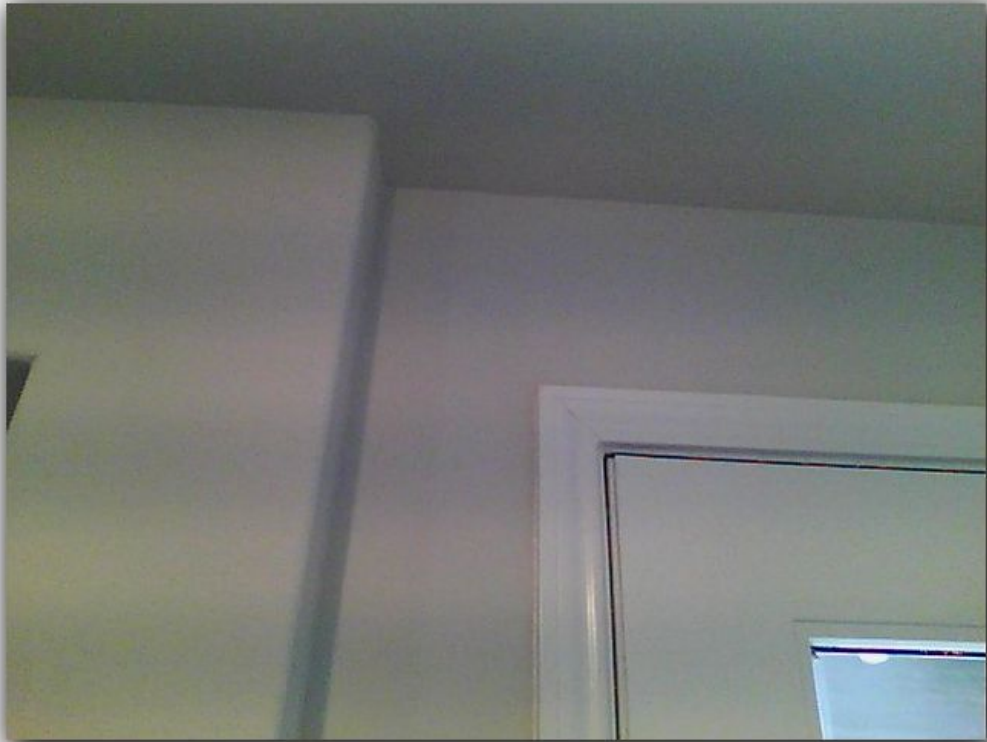
A thermal anomaly was detected over the back door. Further investigation and repairs should be made as necessary.

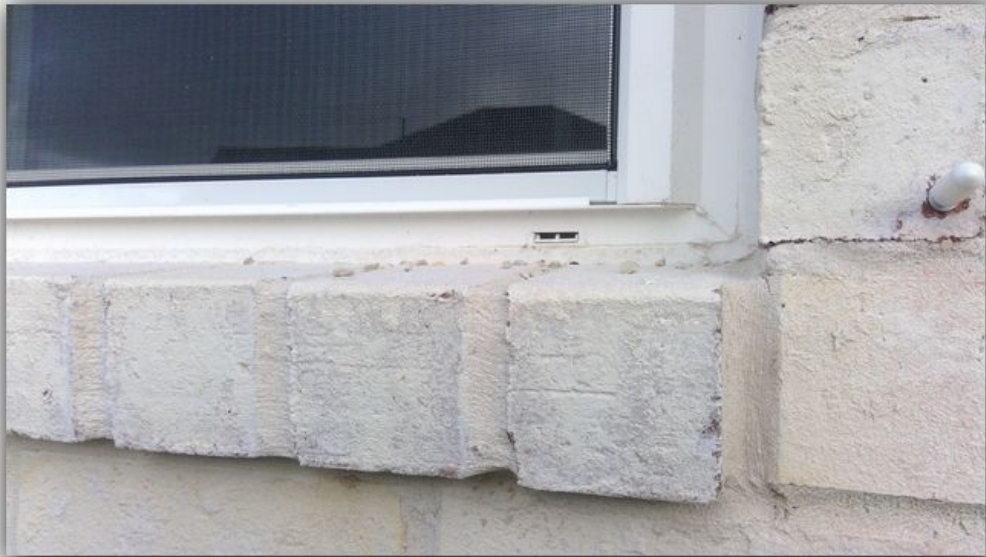
The weep hole covers were installed incorrectly and should be repaired.

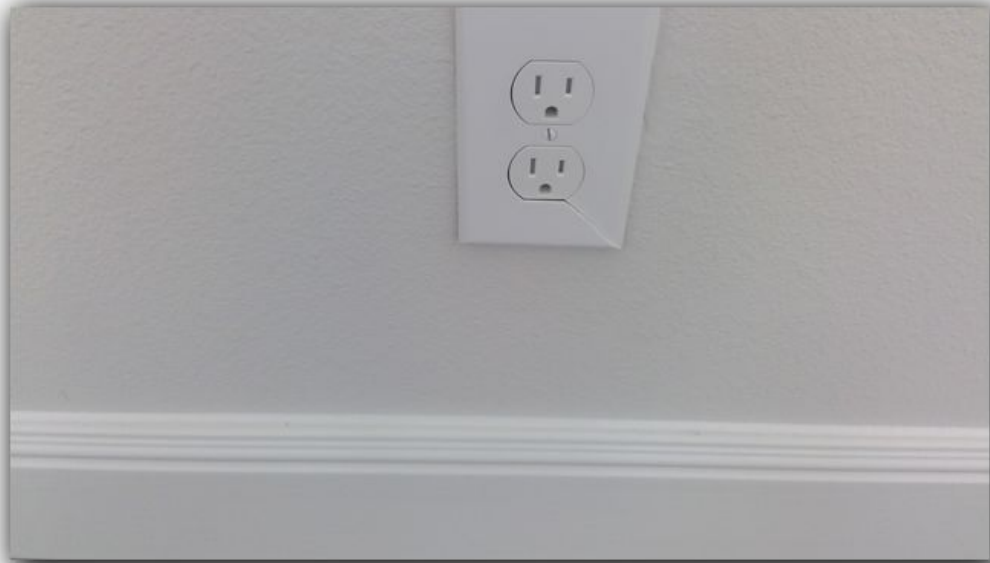
Damaged cover plates in the study should be replaced.
