Thorough-Fair Inspections, PLLC  
3706 Indian Mound Ct.  
Crosby, TX 77532  
713-504-2768

## PROPERTY INSPECTION REPORT

Prepared For: Taylor and Kelly Magorien

Concerning: 15807 Sunlit Falls Dr., Humble, TX 77396

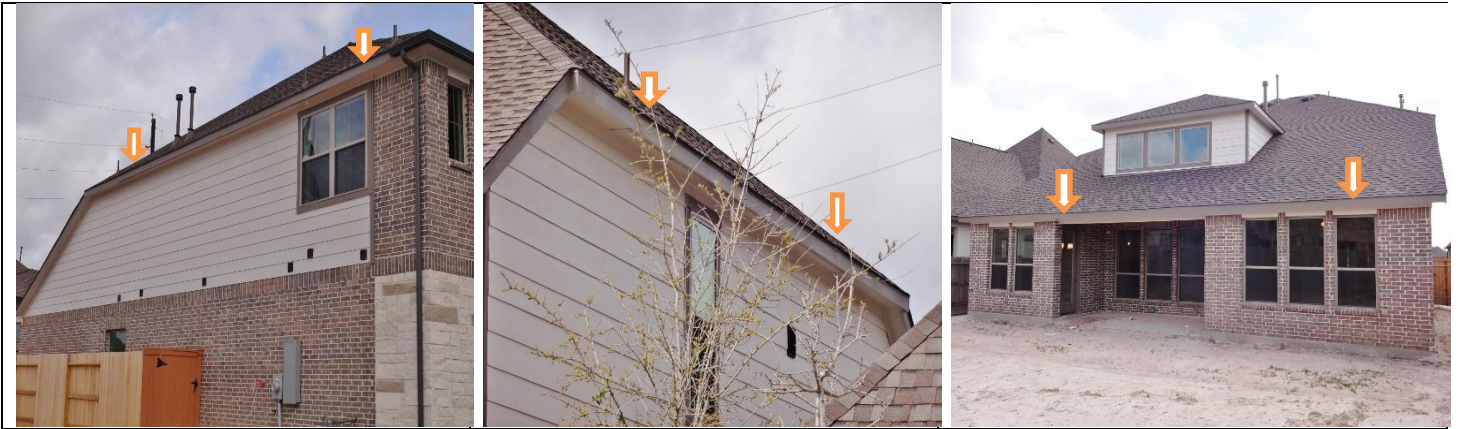
- Observed the absence of gutters and downspouts to control roof drainage at all sides of the house and garage. Under current building standards, in areas where expansive or collapsible soils are known to exist (P.I. > 20), all dwellings shall have a controlled method of water disposal from roofs that will collect and discharge all roof drainage to the ground surface at least five feet from the foundation walls or to an approved drainage system. The currently installed roof drainage system does not meet or exceed this standard if in deed the soil conditions (expansive and / or collapsible) warrant such a roof drainage system. I recommend further investigation with the builder to determine if soil samples and analysis performed on this site or in the area nearby demonstrate the presence of expansive or collapsible soils and warrant improvement of the current roof drainage system.

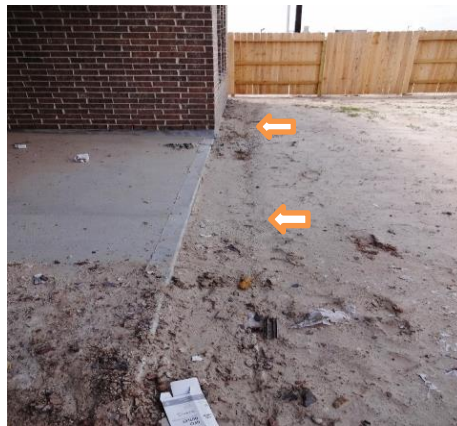
- Observed soil trenching and / or erosion at the base of the foundation at the right, left and rear sides of the house / garage apparently from roof run-off water. Accordingly, I recommend adding continuous gutters to collect and control roof run-off water for disposal away from the base of the foundation. Disposal of water away from post-tension foundations (via grading or other measures) is one of the requirements for this type of foundation per guidelines developed by the Post Tension Institute for the life of the structure. [ref: Post Tension Institute, Chapter 12 - Property Owner Maintenance]

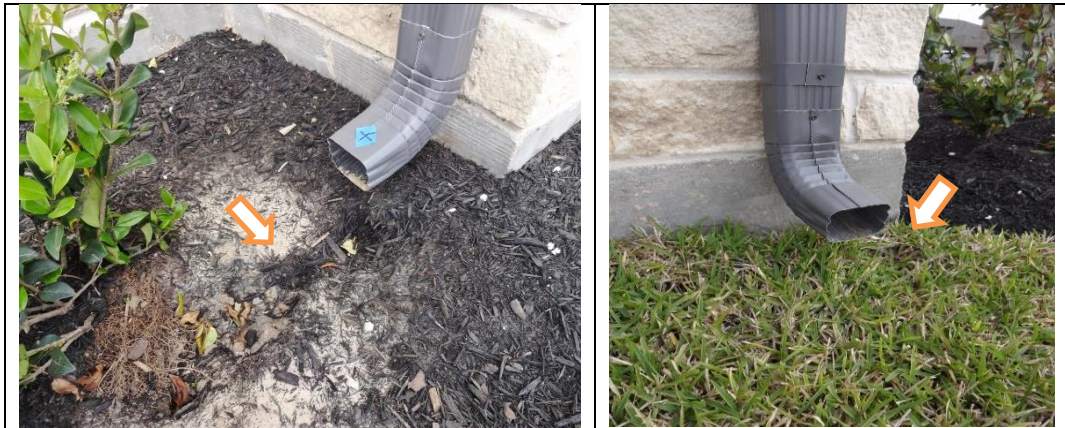
- Observed down spouts serving the gutter system at the front of the house are terminating too close to the foundation causing soil. I recommend installing a splash block under the down spout or a down spout extension that will deposit water at least five feet away from the foundation. Some affected areas have been identified with blue tape and an "X".

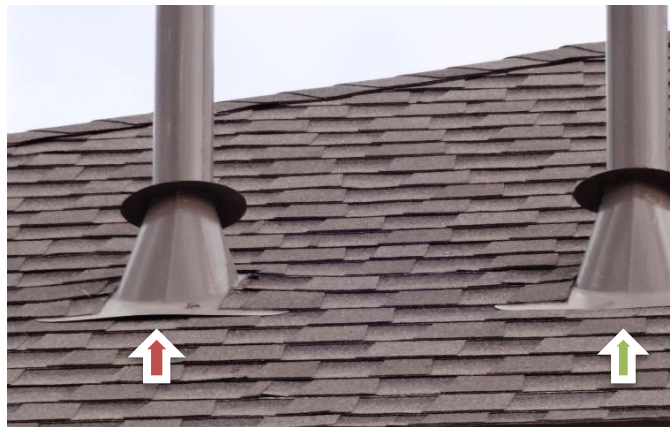
- Observed raised metal flashing at base of the roof jack serving the water heater flue at the left side roof cover above the 2<sup>nd</sup> floor. In need of improvement to prevent further / future wind uplift and moisture penetration.

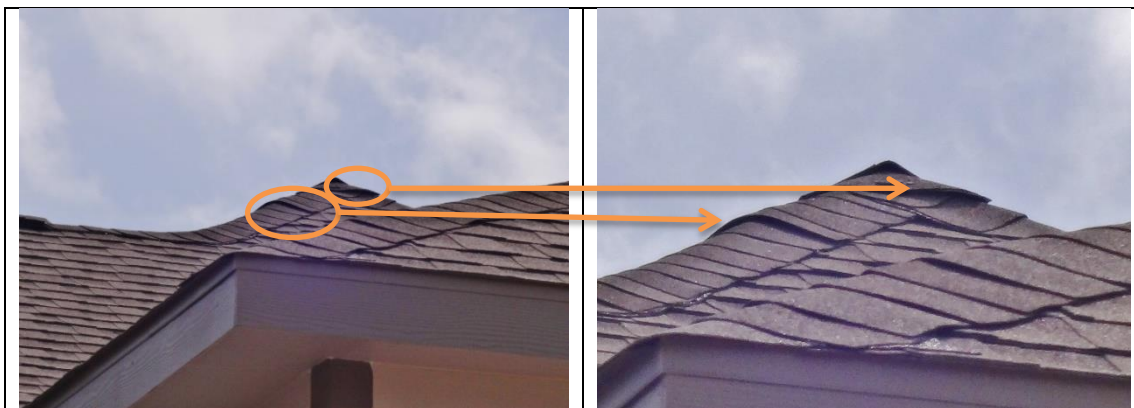
- Observed raised singles at the hips at the rear of the center ridge above the 2<sup>nd</sup> floor. In need of improvement to prevent further / future wind uplift and moisture penetration.

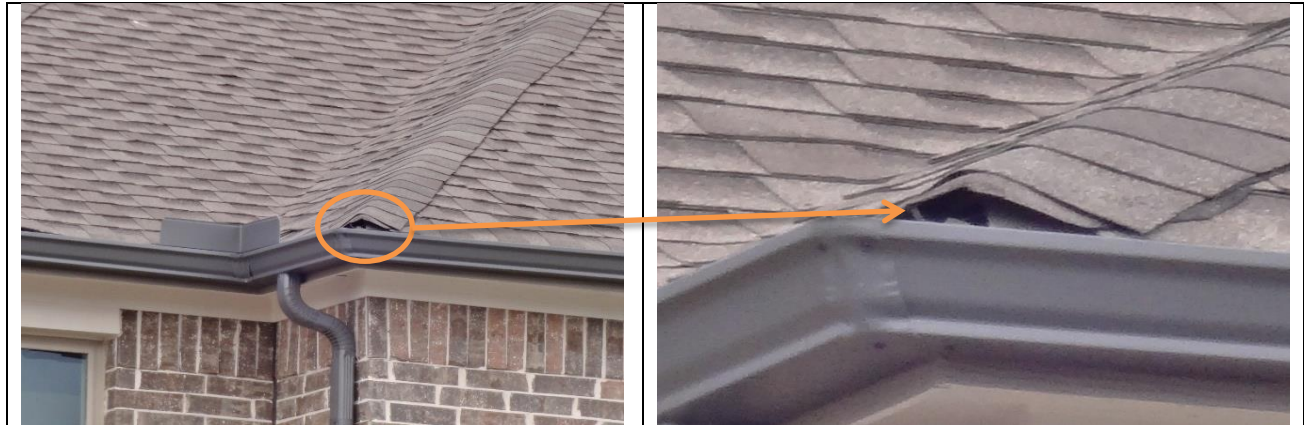
- Observed a void at the base of the hip roof above the left front corner at the upstairs game room. In need of further investigation and improvement to prevent further / future moisture penetration.

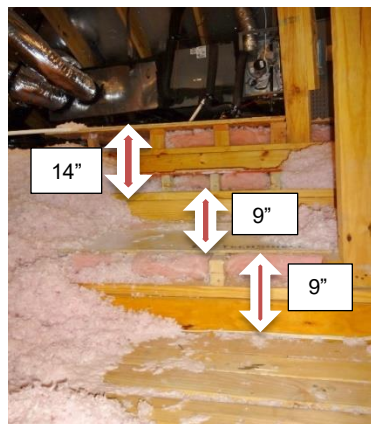
- Observed the absence of proper stairs leading to the downstairs HVAC unit in the attic above the 2<sup>nd</sup> floor. Under current building standards, the catwalk leading to appliances installed in attic space shall be level with no changes in elevation unless constructed like a normal stair, maximum 7<sup>3</sup>/<sub>4</sub>" high with a tread 11" deep if square nosing is used. The riser heights at the bottom two stairs is 9" vertical rise and the top stair is 14" vertical rise. The discrepancy in riser heights is a recognized safety hazard and is in need of improvement.

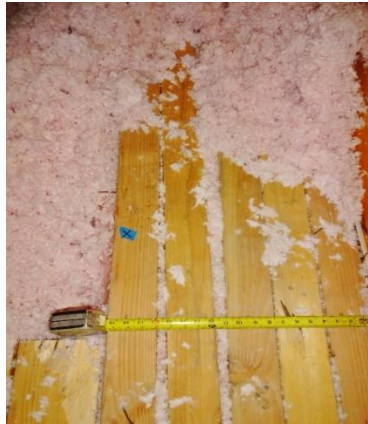
- Observed the catwalk near the stairs leading to the downstairs HVAC unit is too narrow, only 19 inches wide. Under current building standards, a continuous, unobstructed catwalk constructed as normal flooring, minimum 24" wide, leading to the HVAC units from the folding stair opening, shall be installed. This deficiency is a recognized safety hazard and, in my opinion, is in need of improvement.

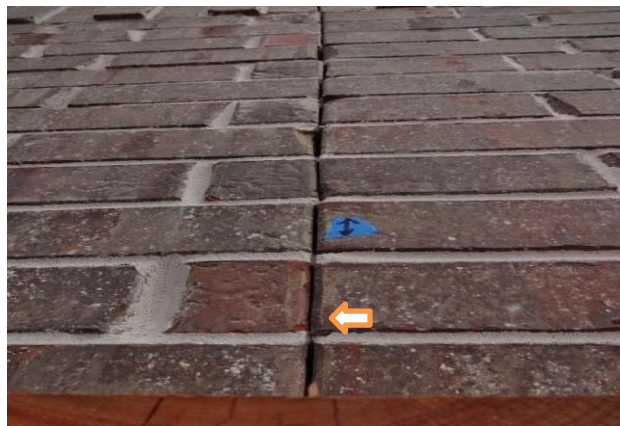
- Observed fresh paint throughout the exterior of the house.
- Observed the absence of caulking / sealant at the separation joint at the brick veneer at the left side of the house near the wooden gate. In need of improvement to prevent further / future moisture intrusion. Affected area has been identified with blue tape and an arrow.

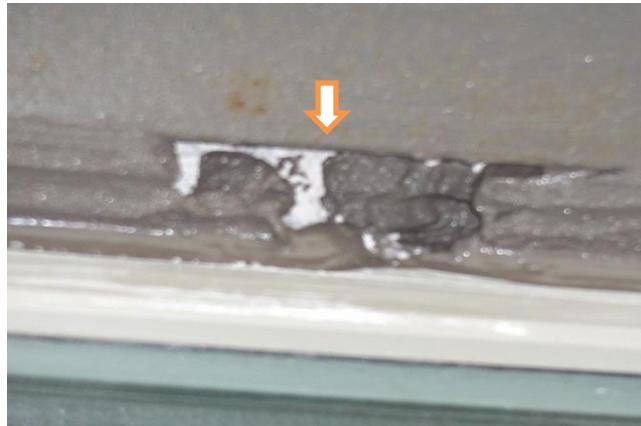
- Observed open cavities in the mortar at the lintel and wall area above the left side windows at the study. In need of improvement to prevent further / future insect, rodent and moisture intrusion.

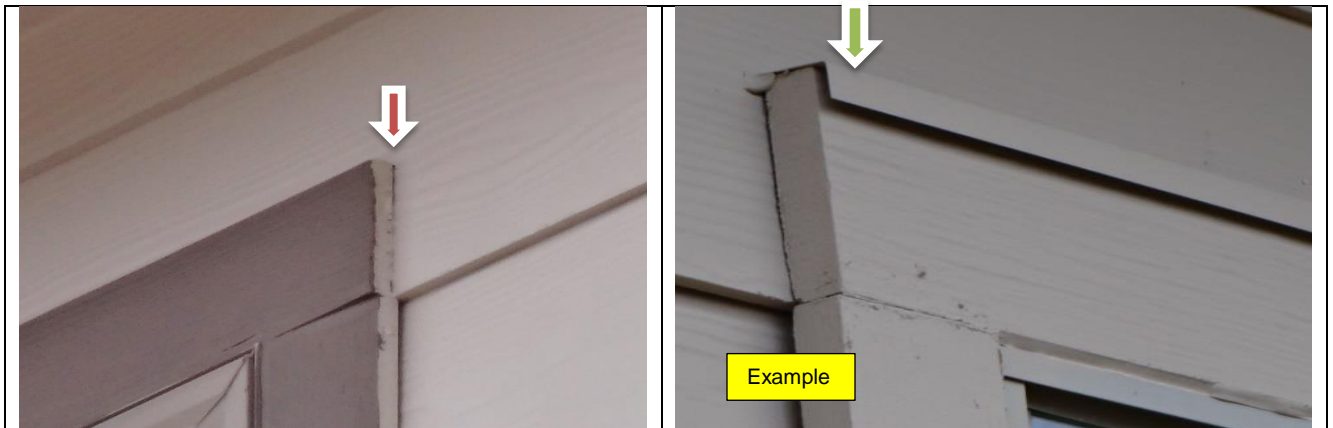
- Observed the absence of approved corrosion-resistant flashing above the projecting trim above the window at the center gable at the front of the house. Under current building standards, approved corrosion-resistant flashing shall extend continuously above all projecting trim. In need of improvement to prevent wood decay and further / future moisture penetration.

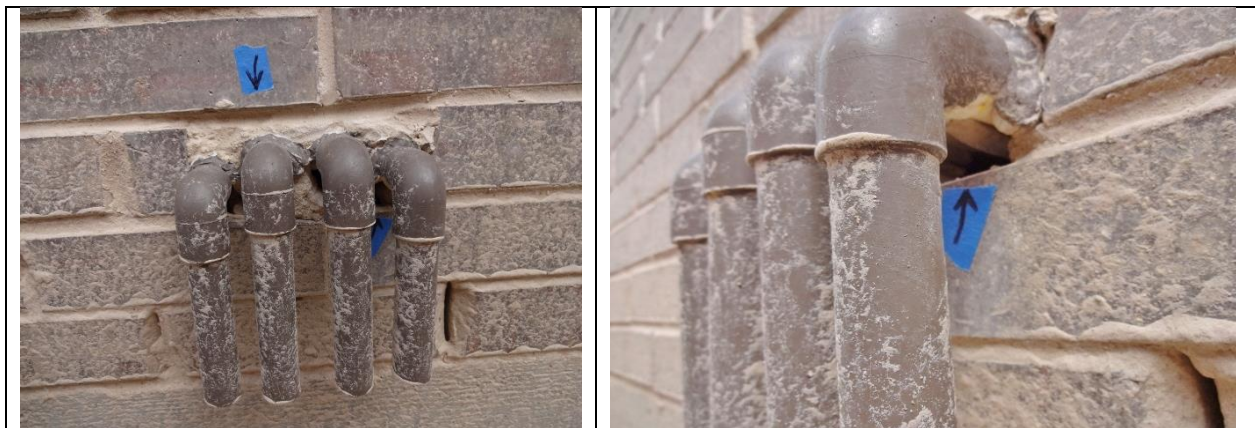
- Observed large unsealed voids in the left side brick veneer wall where the water heater T&P valve and auxiliary pan piping passes through the wall – in need of sealing to prevent further / future intrusion by insects, rodents and moisture. Affected area has been identified with a piece of blue tape and an arrow.

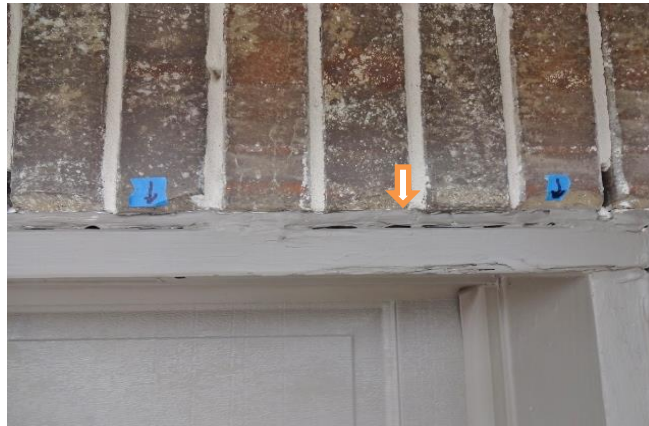
- Observed voids at the caulk joint at the brick and wood interface at the right end of the horizontal wood frame above the overhead door opening at the garage. In need of improvement (caulking) to prevent further / future moisture penetration. Affected areas have been identified with blue tape and an arrow.

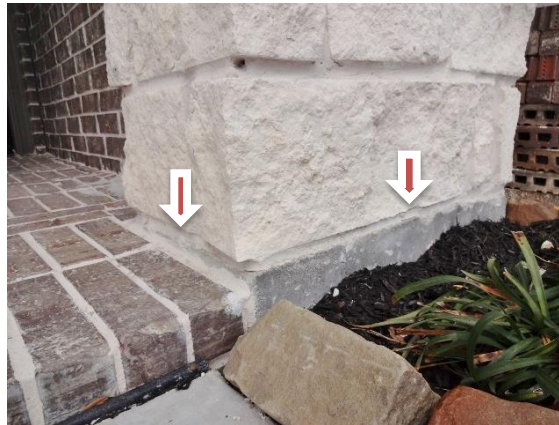
- Observed the absence of weep holes in the stone veneer wall at the right side of the front porch. Under current building standards, weep holes shall be installed in the lower course of the brick veneer, at 33 inch intervals, to help vent and drain moisture from within the wall cavity. In need of improvement.

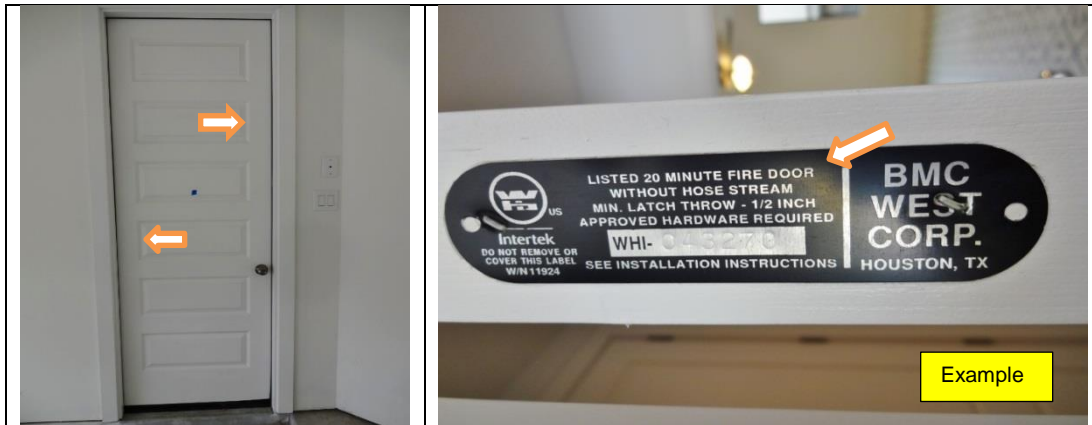
- Observed the six panel door installed at the garage entry to the house may not be appropriately fire rated for this application because the center panel areas are not of the proper thickness. Under current building standards, the door that enters the house from an attached garage is considered a fire separation door and should be 1 3/8 inch minimum thickness of solid wood, solid core or fire rated (20 minute) for that location. The large interior wood panels in the center of this door are only 3/4" thick and thus do not meet the minimum thickness requirement of 1 3/8 inch to qualify as an approved fire separation door. This does not preclude the door from being a listed fire-rated

door; it simply was not labeled and did not meet the criteria stipulated in the TREC Standards of Practice. In need of further investigation and improvement.

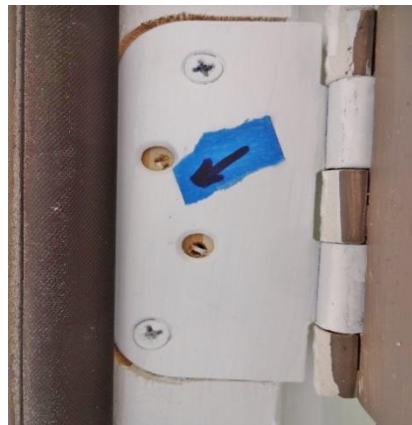
- Observed the absence of six (6) screws at three (3) hinges at the rear entry door. Affected areas have been identified with blue tape and an arrow. In need of improvement.

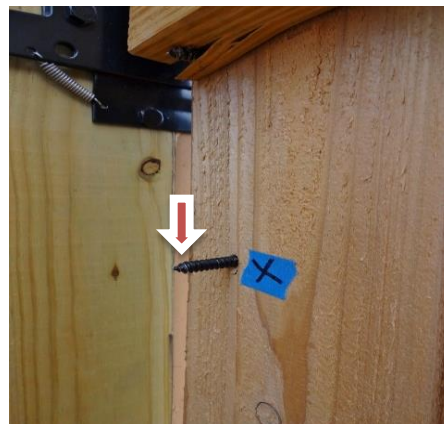
- Observed the bullet type catches at the top of the double doors at the media room at the 2<sup>nd</sup> floor do not engage the strike plates and will not latch properly. In need of improvement. Affected doors have been identified with blue tape and an arrow.
- Observed cabinet drawers in the kitchen and upstairs right side bathroom are hard to open and close. In need of improvement. Affected drawers have been identified with blue tape and an "X".
- Observed a sharp metal screw protruding through the wood gate at the left side of the house. In need of improvement for safety reasons. Affected area has been identified with blue tape and an "X".

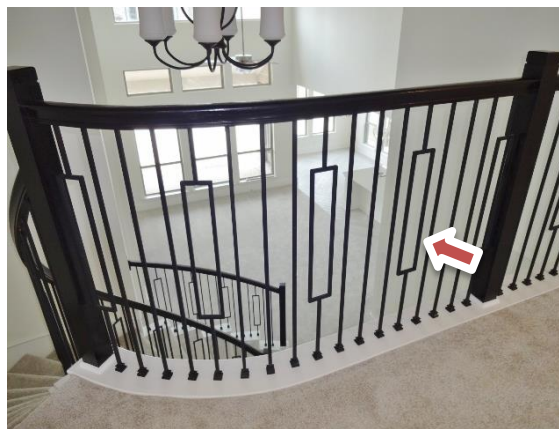
- Observed the decorative wrought iron guard rails at the upstairs walkways are structured in such a way as to provide a ladder effect which may create potential child safety hazards - in need of improvement.

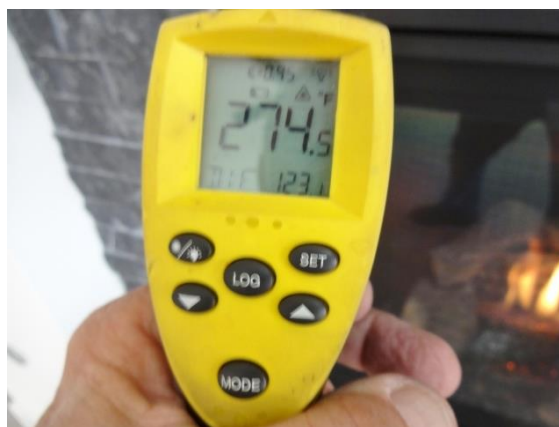
**NOTE:** Observed surface temperature in excess of 274F degrees at the metal louver at the top of the fireplace after operating the burner unit for a period of 20 minutes. This presents a potential burn hazard to anyone coming into contact with the screen / glass at front of the firebox.

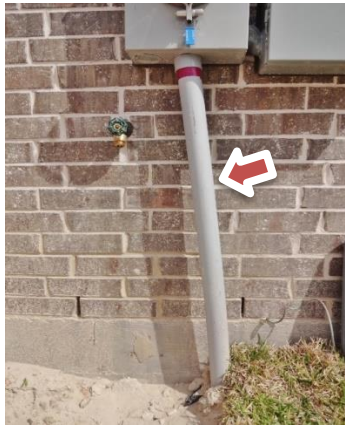
- Observed the absence of a slip joint at the vertical service conductor conduit serving the meter can. Additionally this conduit enters the fitting at the base of the meter can at an obtuse angle. Over time and with intense sunshine at that side of the house, the conduit will likely separate from the fitting and expose the service conductors to adverse weather conditions. Under current electrical standards, a slip joint shall be incorporated into the vertical, above grade, conduit to provide for adequate expansion and contraction of the conduit. In need of improvement.

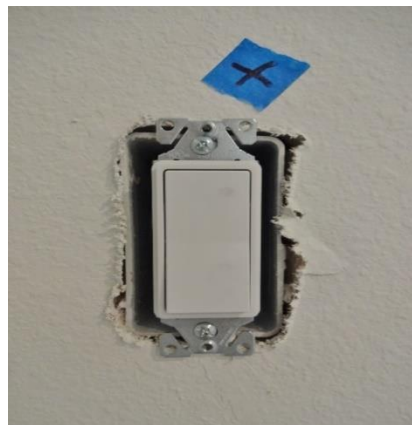
- Observed exposed wiring connections and the absence of a proper cover at the wall switch at the upstairs media room. For safety reasons, all wiring connections shall be made within enclosed junction boxes. Affected switch has been identified with blue tape and an "X". Also observed this switched outlet has been placed directly behind the right hand double door at the entry to this room. The placement of this switch requires that a person entering this room close the door in order to turn on the lights. For safety and convenience reasons, I recommend further review and relocation of this switch.

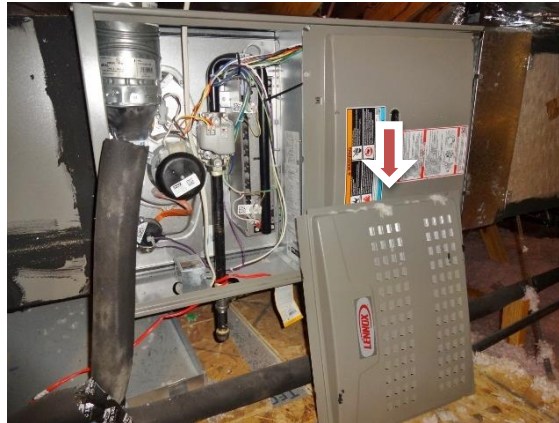
- Observed the furnace cover has been removed and was laying loose adjacent to the unit. In need of improvement to properly shield electrical wiring and moving parts from inadvertent homeowner contact.

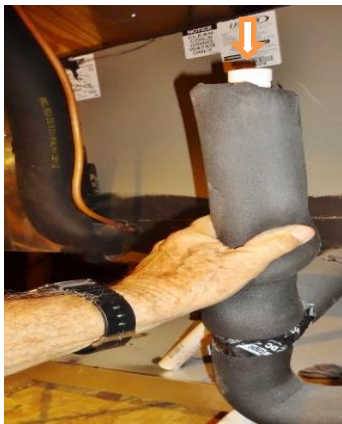
- Observed only a -11F degree temperature differential between measurements taken at the return air vent and various supply air registers after operating the system for over one hour. Acceptable temperature differential range for this type A/C system is -15F to -20F degrees
- The A/C system is not performing at maximum efficiency. In need of improvement. I recommend further inspection, service, and repair by a qualified A/C - Heat technician.
- Observed significant air loss occurring at the riser at the condensate piping near the evaporator coil housing. I recommend installing a removable cap on top of the riser to prevent further air loss.

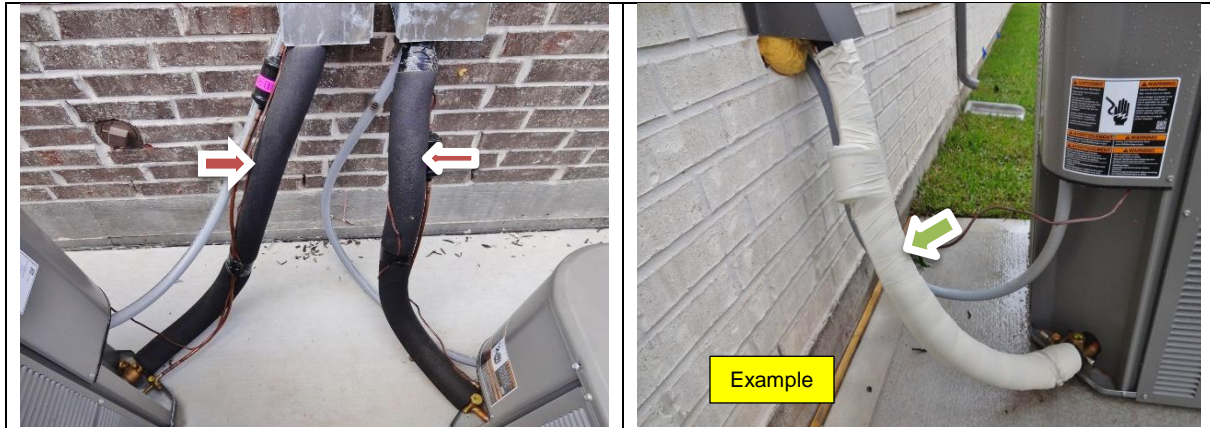
- Observed the exterior refrigerant line insulation at both condenser units was not protected from UV decay. Under current HVAC standards, piping insulation exposed to weather shall be protected from damage, including damage from sunlight, moisture, equipment maintenance and wind shall include shielding from solar radiation that can cause degradation of the material. Adhesive tape shall not be permitted. In need of improvement.

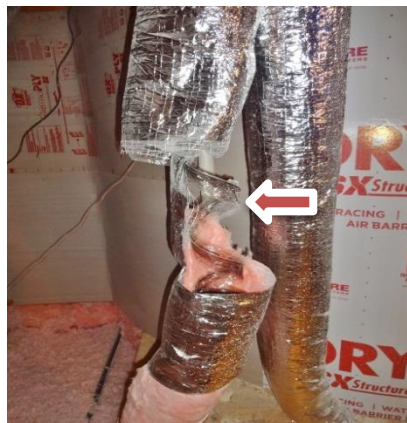
- Observed a severely damaged duct at the walk-in attic at the 2<sup>nd</sup> floor adjacent to the media room. In need of repair or replacement.

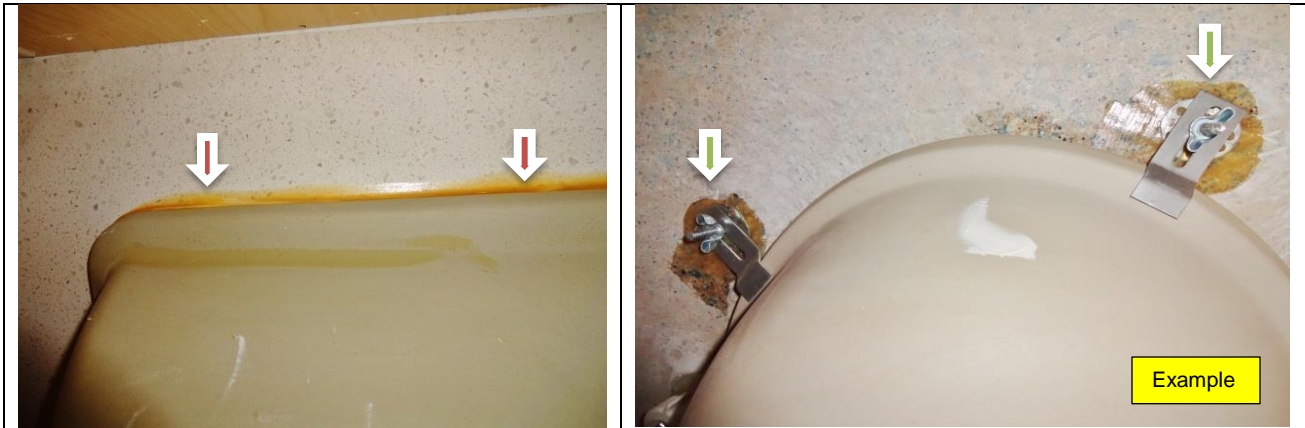
- Observed the absence of proper fastening of undermount sinks to granite / quartz countertops at all of the full bathrooms. The flanges at these sinks appear to simply be glued to the underside of the granite / quartz and lack additional horizontal or vertical support at the flange. I recommend further investigation and improvement to insure that the sink will remain firmly in place under water loading of the bowl(s).

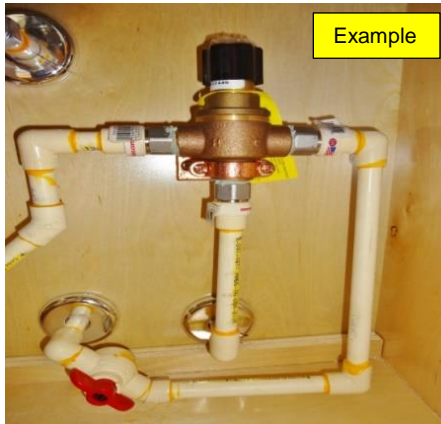
- Observed the absence of a thermostatic mixing valve at the bathtub. Under current plumbing standards, (in effect since 2006) the hot water supplied to a bathtub, utilizing separate hot and cold water faucets, shall be limited to a maximum temperature of 120F degrees by a water temperature –limiting device that conforms to ASSE 1070. In need of further investigation and improvement to prevent possible scalding.

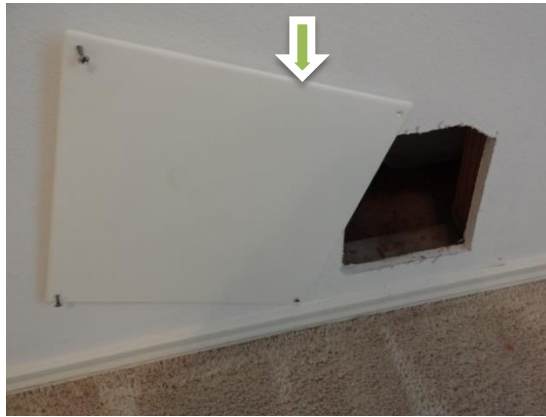
- Observed all bathtub drain piping in this dwelling was inaccessible and was not inspected. Under current plumbing standards, tub drain piping utilizing threaded and / or slip joint connections shall be accessible. I could not determine if threaded connections have been utilized at the tub drain piping in this dwelling. Therefore, in my opinion, a readily usable drain access (see example below) shall be provided for each tub in this dwelling to allow for periodic observation and detection of leaks at the drain. Providing tub drain access can help in the early detection of water leaking from tub drains before it can cause significant structural / foundation damage and / or attract wood destroying insects. In need of improvement.

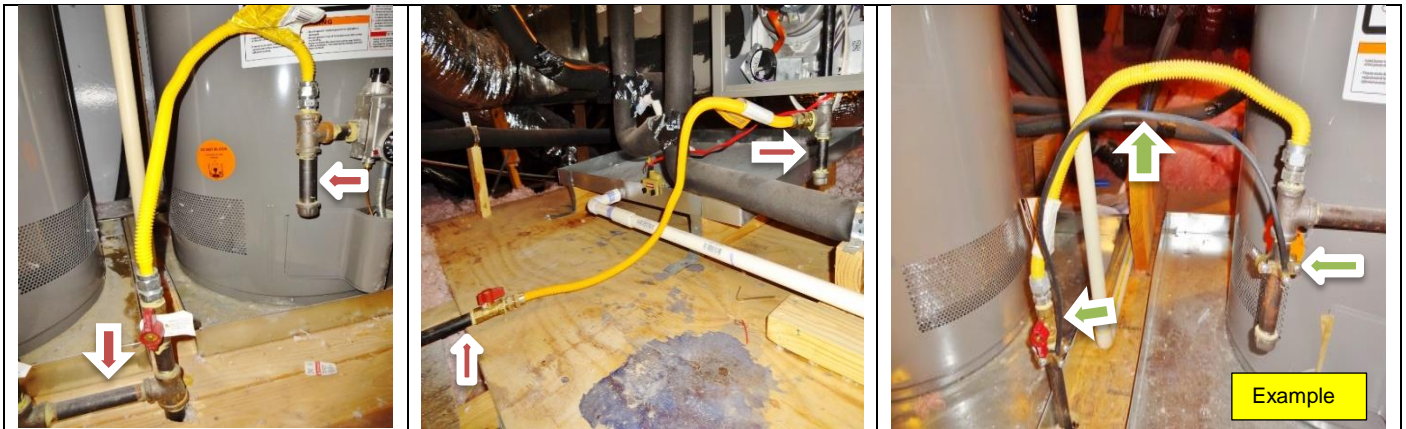
- No gas line general inspection was conducted. Service connections and shutoff valves were checked for leaks, with a TIF 8800 combustible gas detector, only at the appliances using gas. Unexposed gas lines were not inspected.
- Observed the absence of electrical bonding at the ends of the flexible branch line gas connectors at the water heaters, furnaces and cooktop all of which appear to be the Corrugated Stainless Steel Tubing (CSST) type. Under

current Fuel Gas standards established by the National Fire Protection Association (NFPA) [see Nat. Fuel Gas Code NFPA 54, 2015 Edition, ANSI Z 233.1, 7.13.2] bonding is required because gas leakage from small holes in CSST is believed to be caused by lightning strikes near buildings in which the CSST is installed. Bonding the flexible branch line gas connector to the solid gas piping system with an appropriately sized conductor would reduce the number of such failures. See example below.

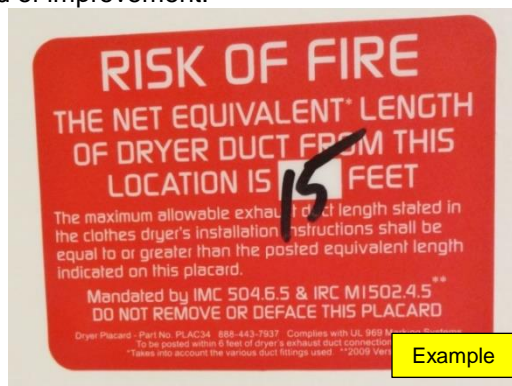
- Observed the absence of a permanent label advising the equivalent length of the exhaust duct. Under current building standards, where the exhaust duct is concealed within the building construction, the equivalent length of the exhaust duct shall be identified on a permanent label or tag. The label or tag shall be located within 6 feet of the exhaust duct connection. In need of improvement.
