Property Inspection Report

**Jay Bertrand 23607
Noble Inspection LLC**

2202 Hilshire Trails Drive

Date of Inspection: 8/7/2023

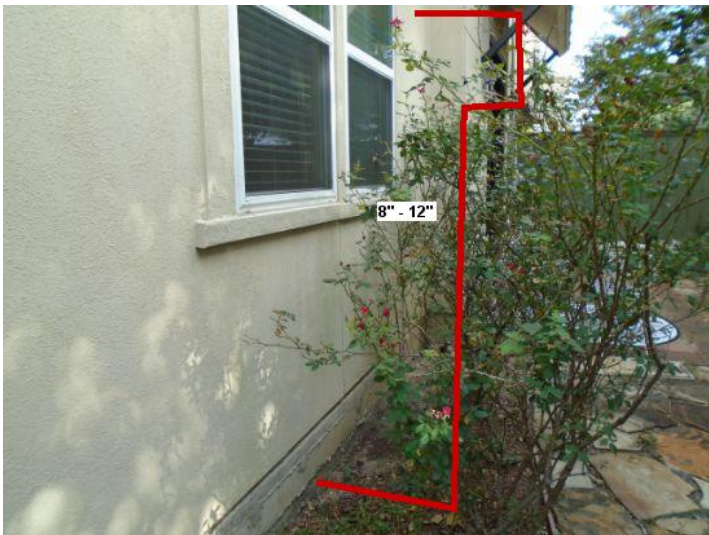
Cut all bushes away from the brick wall 8"-12" for best drying results.

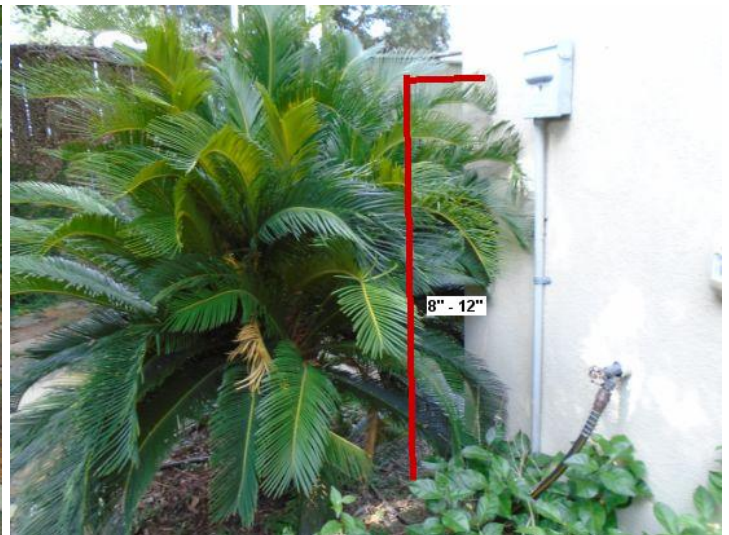
Cut all bushes away from the brick wall 8"-12" for best drying results.

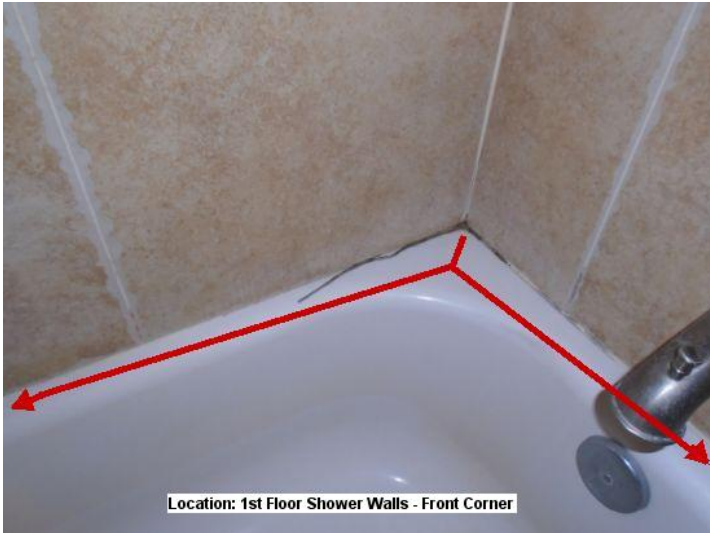
Evidence of cracked grout in one or more locations in the bathrooms of today's inspection.

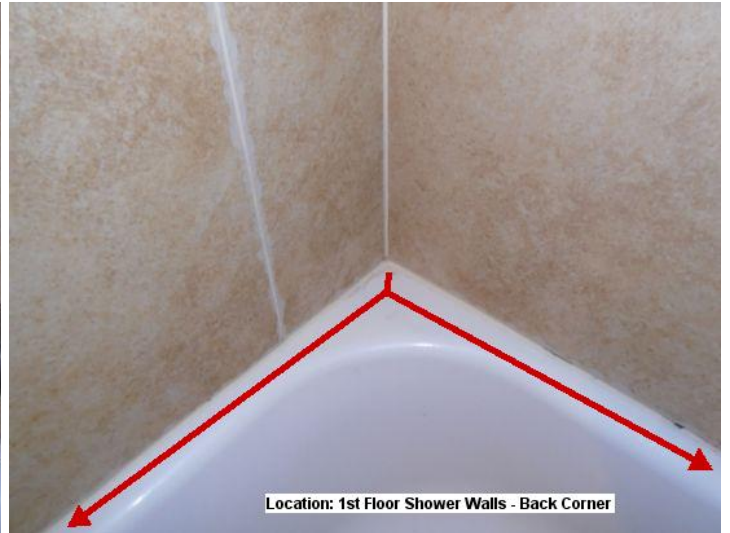
Evidence of cracked grout in one or more locations in the bathrooms of today's inspection.

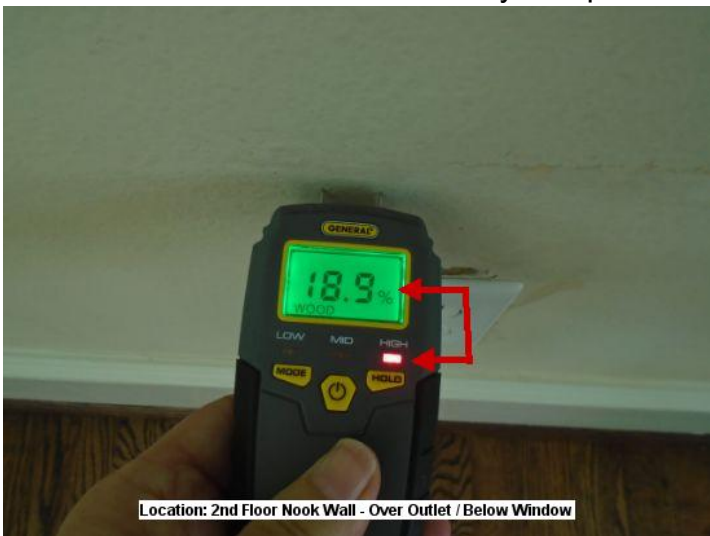
Moisture readings in two or more locations of the South facing walls were abnormal and further investigation may be necessary.

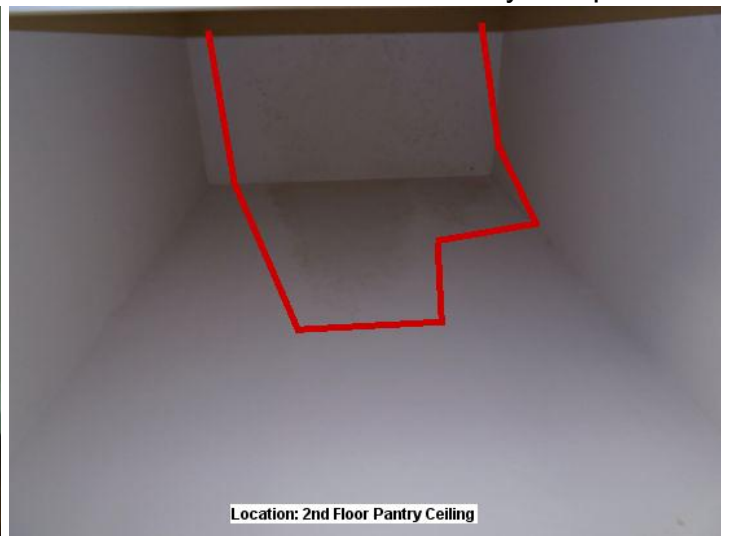
In two or more locations - evidence of moisture and smells like mold. May need an inspector that specializes in mold discovery and remediation to offer an opinion and repair analysis.

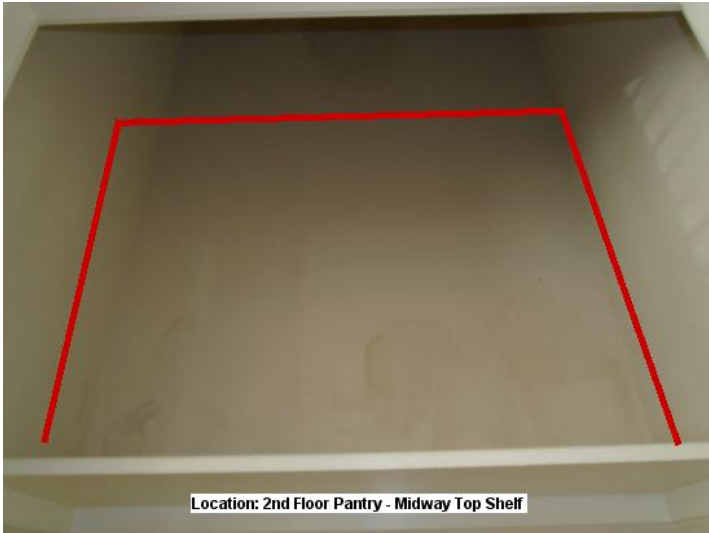
In two or more locations - evidence of moisture and smells like mold. May need an inspector that specializes in mold discovery and remediation to offer an opinion and repair analysis.

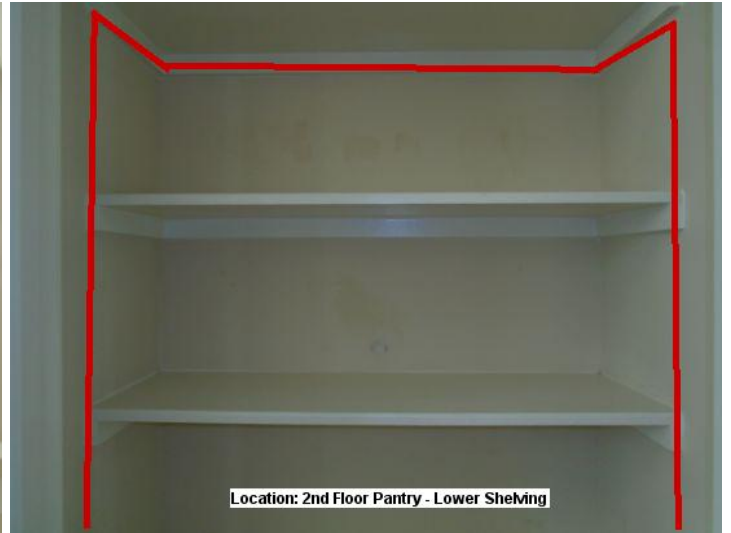
In two or more locations - evidence of moisture and smells like mold. May need an inspector that specializes in mold discovery and remediation to offer an opinion and repair analysis.

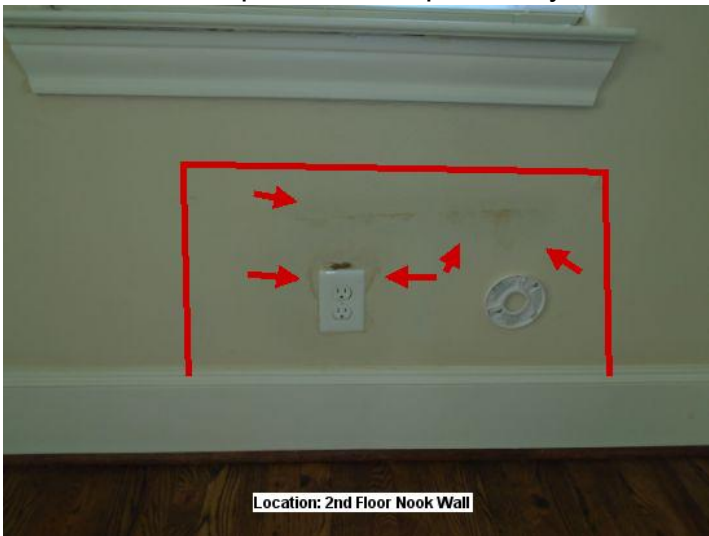
Moisture readings in two or more locations of the South facing walls were abnormal and further investigation may be necessary.

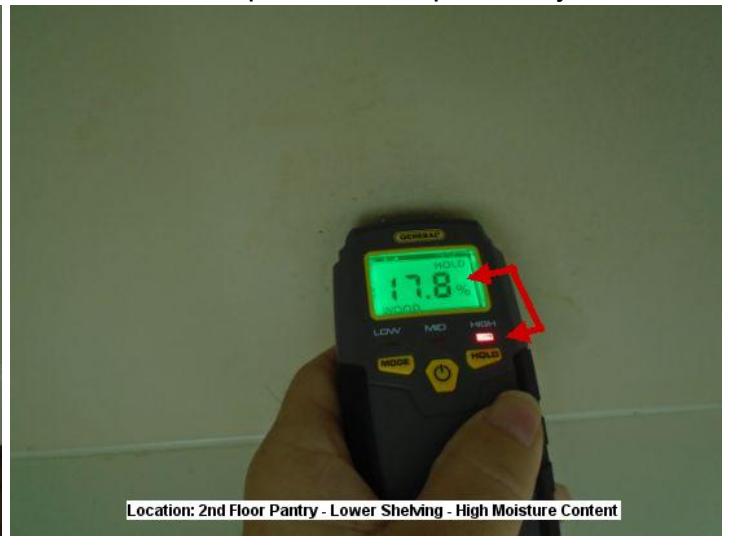
Moisture readings in two or more locations of the South facing walls were abnormal and further investigation may be necessary.

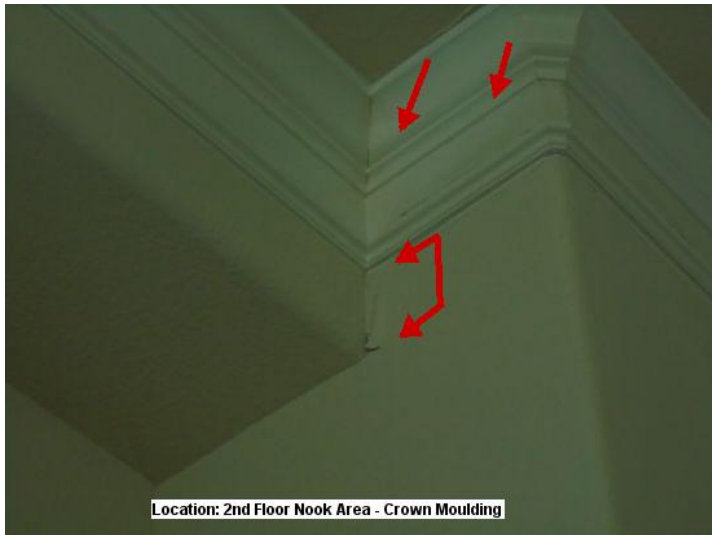
Location: 2nd Floor Nook Area - Crown Moulding

Moisture readings in two or more locations of the South facing walls were abnormal and further investigation may be necessary.

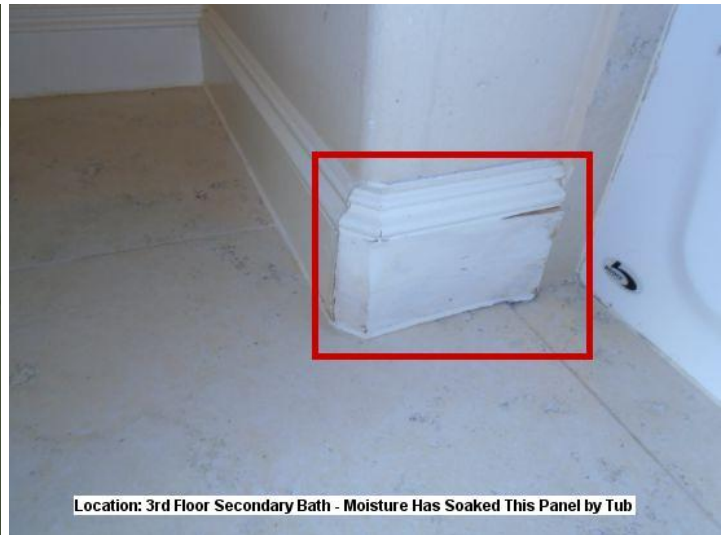
Location: 3rd Floor Secondary Bath - Moisture Has Soaked This Panel by Tub

In two or more locations - evidence of moisture and smells like mold. May need an inspector that specializes in mold discovery and remediation to offer an opinion and repair analysis.

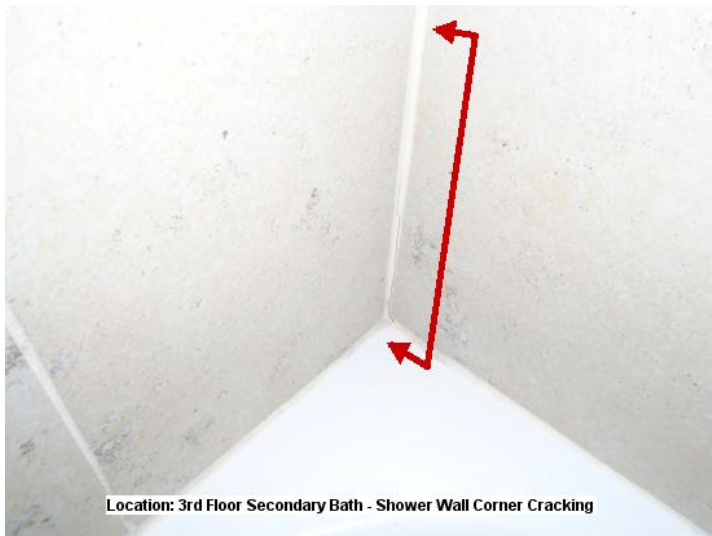
Location: 3rd Floor Secondary Bath - Shower Wall Corner Cracking

Evidence of cracked grout in one or more locations in the bathrooms of today's inspection.

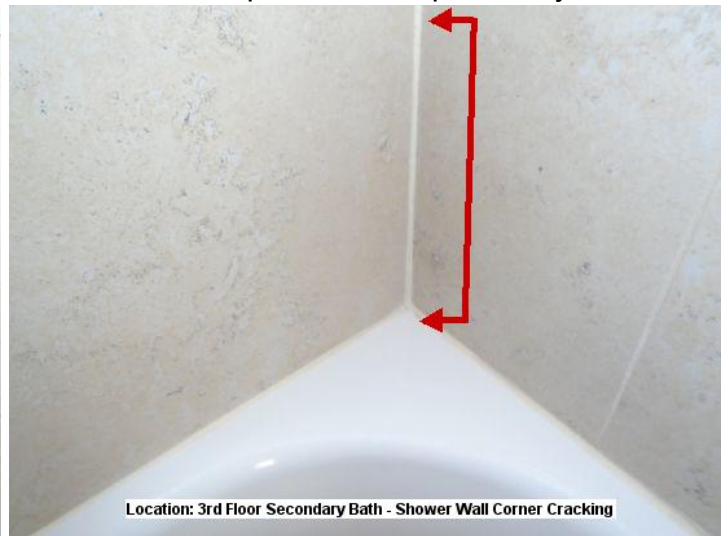
Location: 3rd Floor Secondary Bath - Shower Wall Corner Cracking

Evidence of cracked grout in one or more locations in the bathrooms of today's inspection.

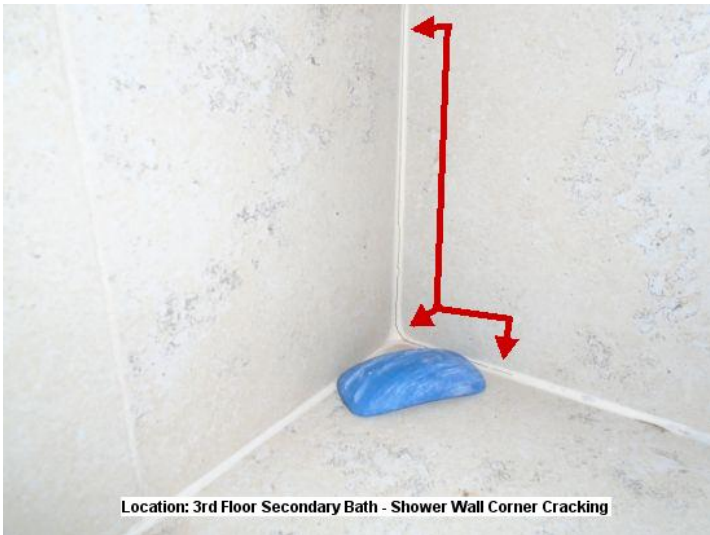
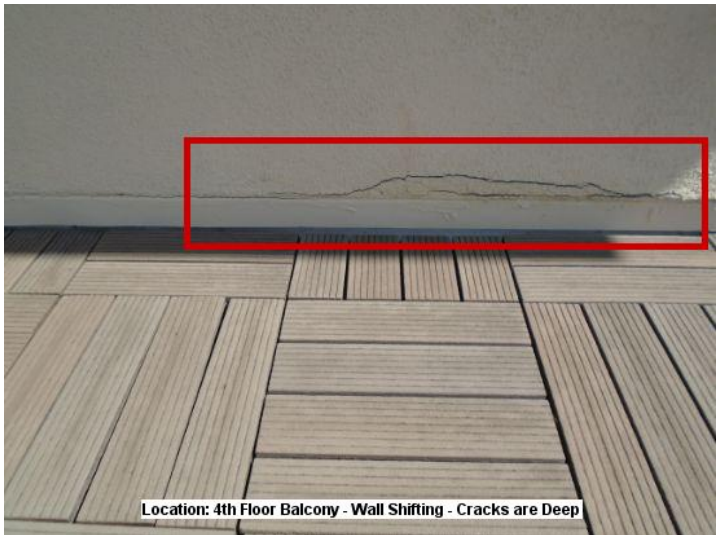
Evidence of cracked grout in one or more locations in the bathrooms of today's inspection.

Evidence of cracked stucco panel were shifting may have occurred.

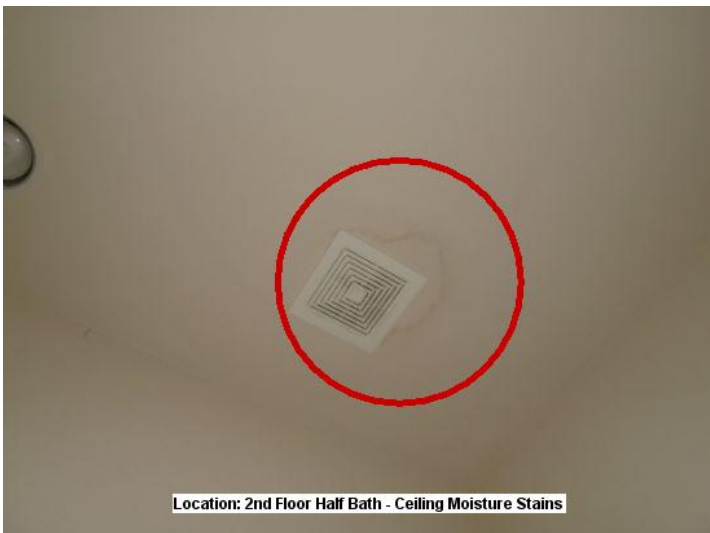
Large stains

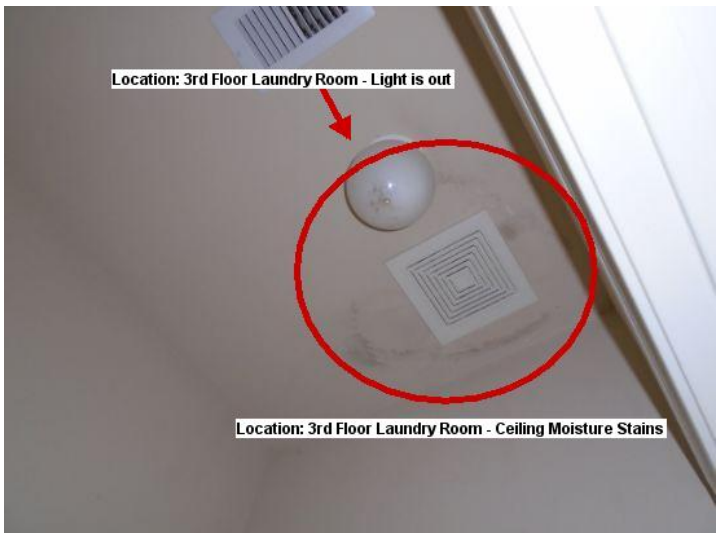
Large stains

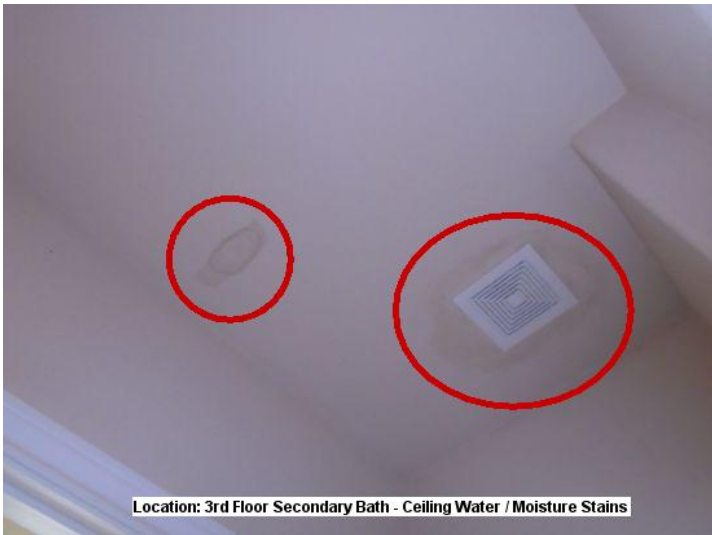
Location: 3rd Floor Secondary Bath - Ceiling Water / Moisture Stains

Large stains

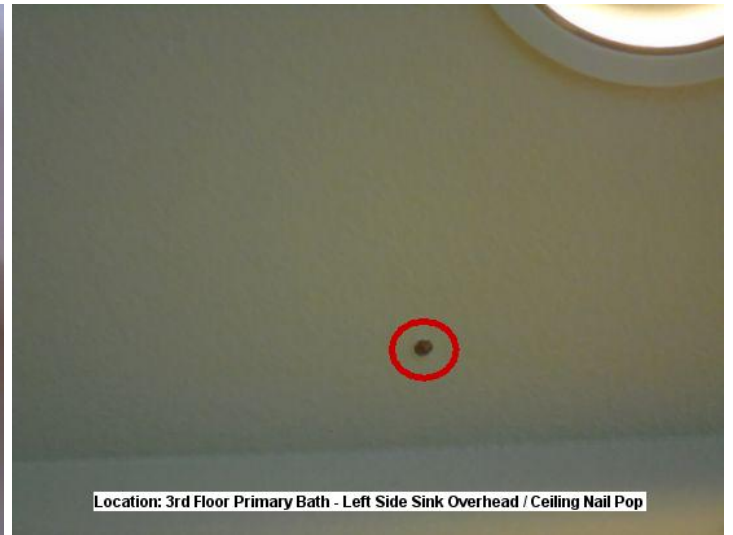
Location: 3rd Floor Primary Bath - Left Side Sink Overhead / Ceiling Nail Pop

Nail pops in ceiling and in walls in one or more places throughout this home. Mostly these are cosmetic and not serious to be reported. Repair at your leisure.

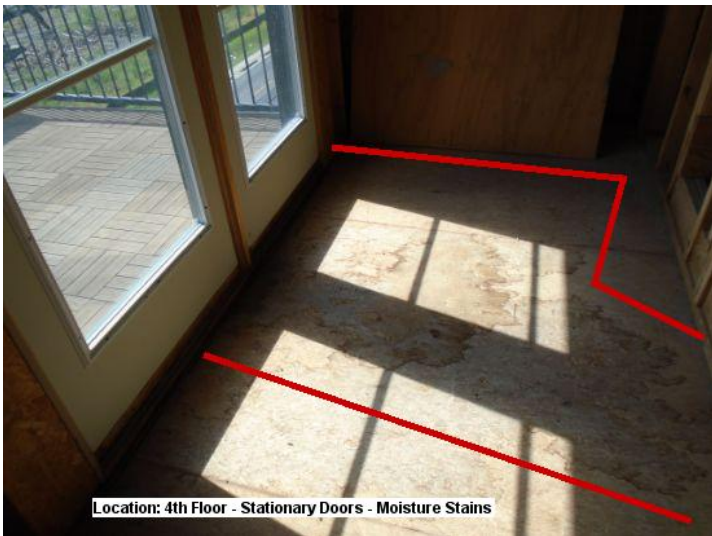
Location: 4th Floor - Stationary Doors - Moisture Stains

Large stains

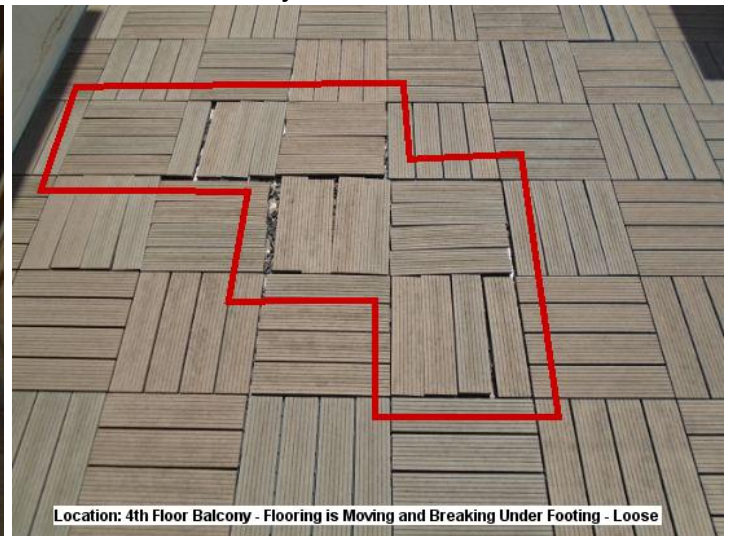
Location: 4th Floor Balcony - Flooring is Moving and Breaking Under Footing - Loose

Balcony flooring on the fourth floor has evidence of loose panels and deteriorating going on underneath the floor panels.

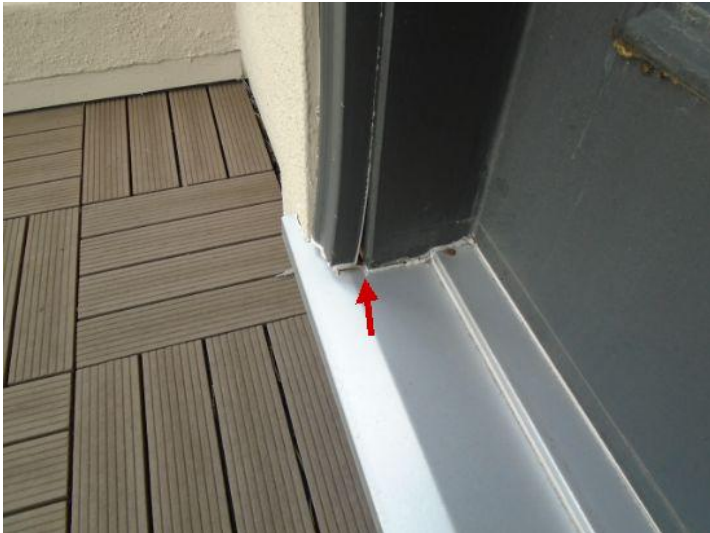
Balcony exterior siding has evidence of damages that may create an issue if not closely monitored.

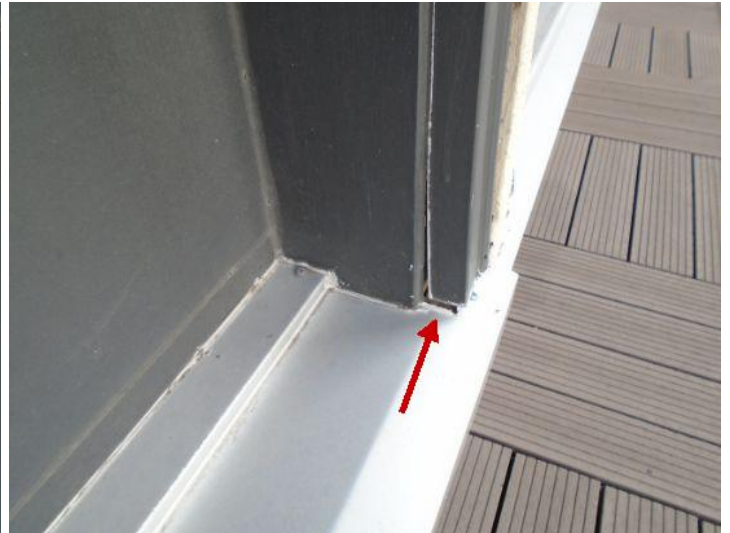
Balcony exterior siding has evidence of damages that may create an issue if not closely monitored.

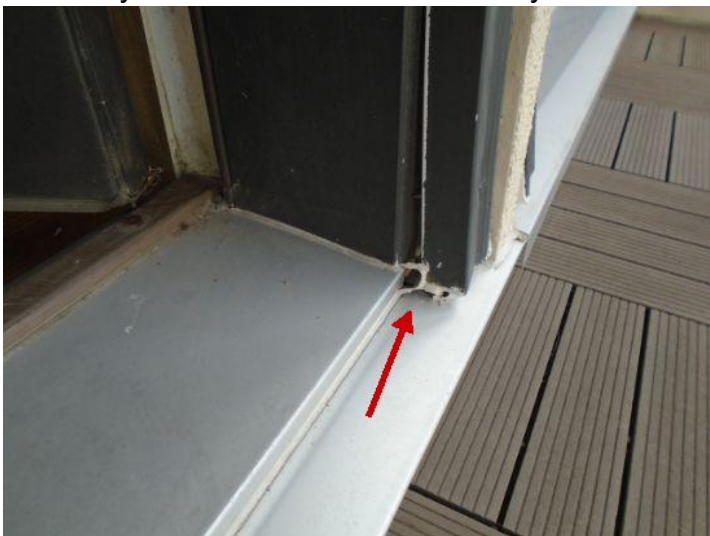
Balcony exterior siding has evidence of damages that may create an issue if not closely monitored.

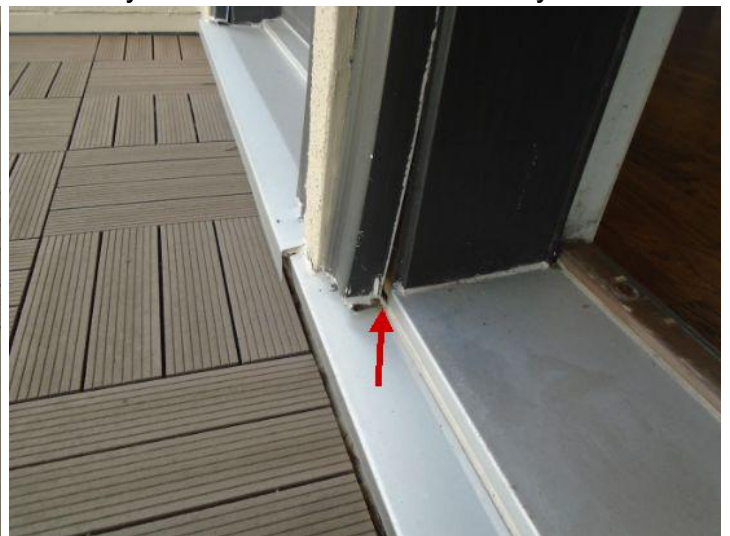
Balcony exterior siding has evidence of damages that may create an issue if not closely monitored.

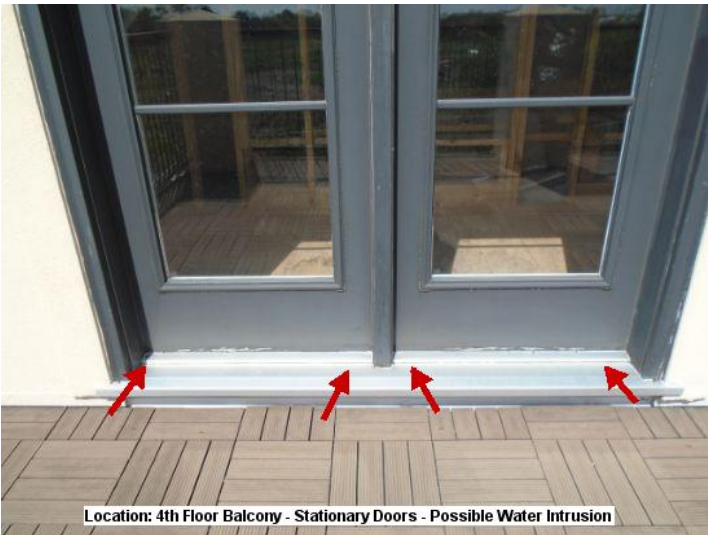
Location: 4th Floor Balcony - Stationary Doors - Possible Water Intrusion

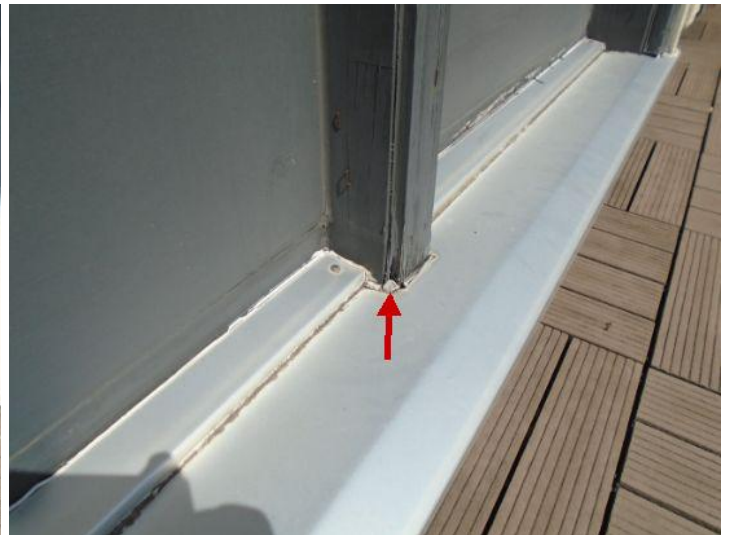
Balcony exterior siding has evidence of damages that may create an issue if not closely monitored.

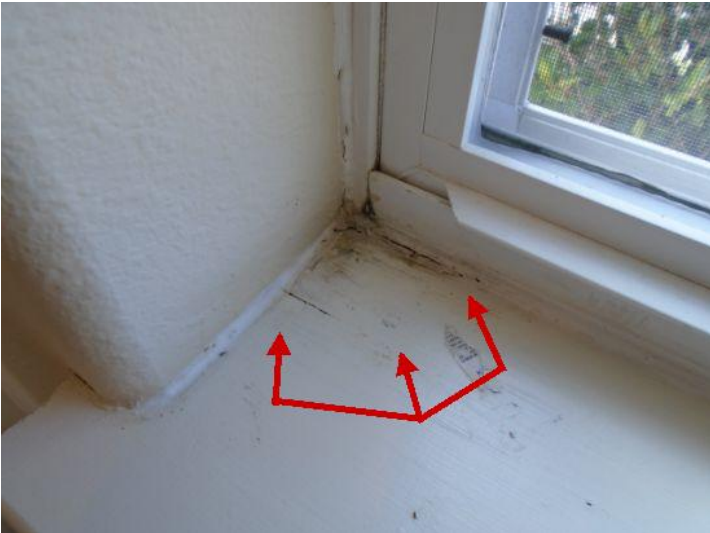
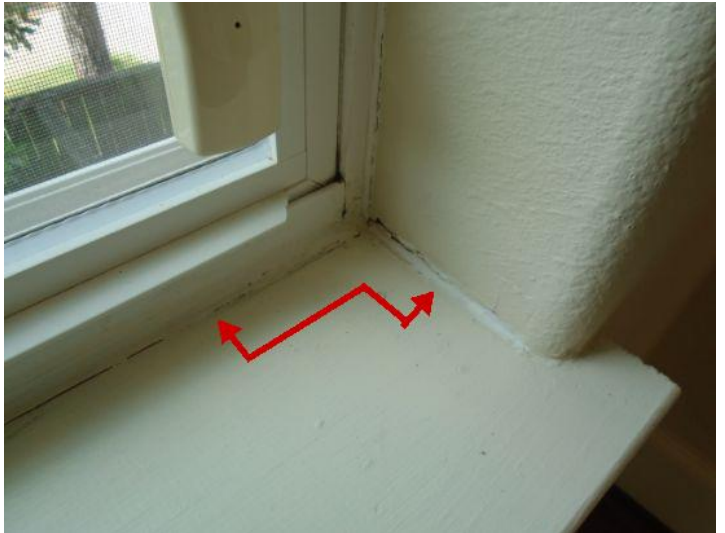
On one or more window sills, evidence of cracking and or paint peeling.

Recommend interior water proofing on two or more windows.

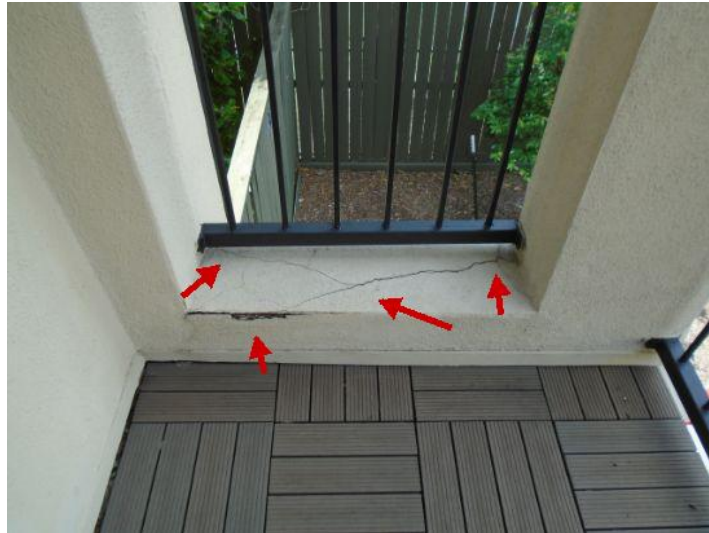
Front support beam mortar is cracked and or cracking.

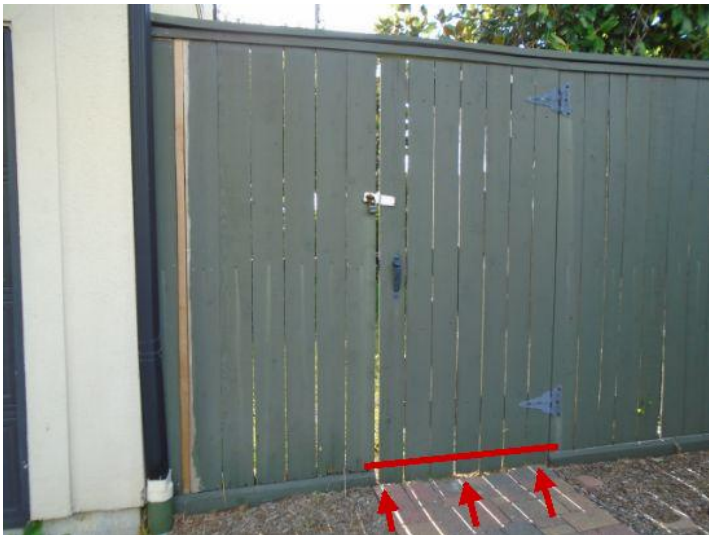
Fence gate is jamming up at the bottom and will not allow the gate to open or close properly.

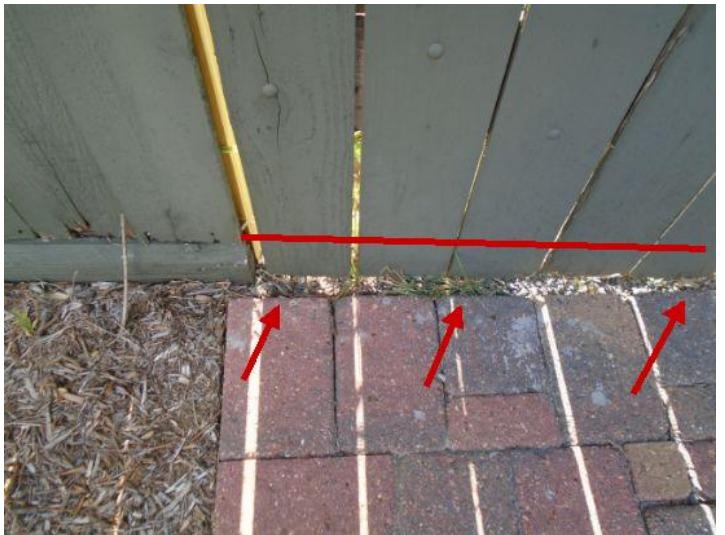
Fence gate is jamming up at the bottom and will not allow the gate to open or close properly.

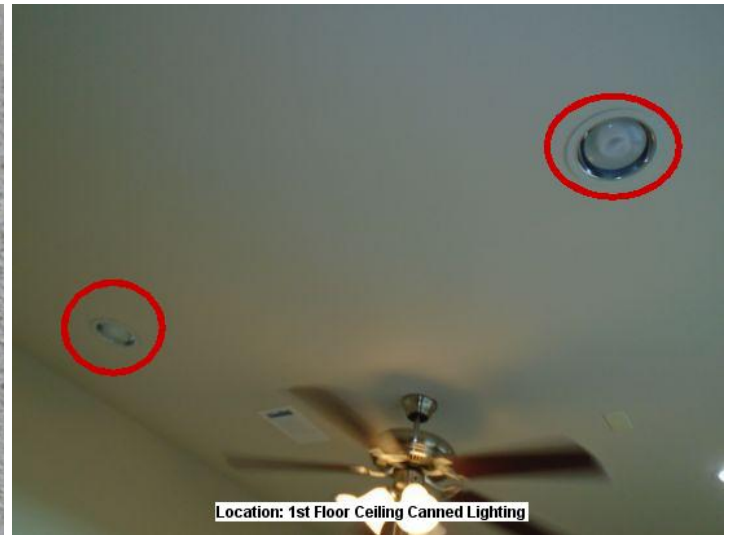
One or more overhead lights were unresponsive during today's inspection.

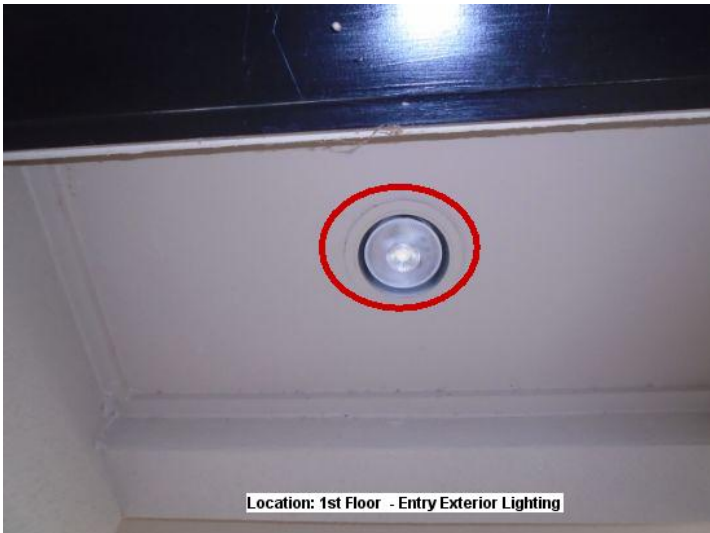
Location: 1st Floor - Entry Exterior Lighting

One or more overhead lights were unresponsive during today's inspection.

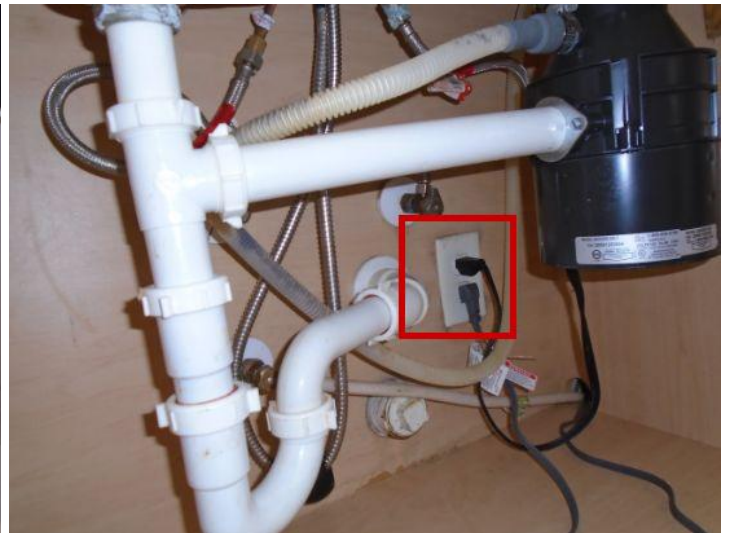
Outlet under sink for the dishwasher is not GFCI Protected.

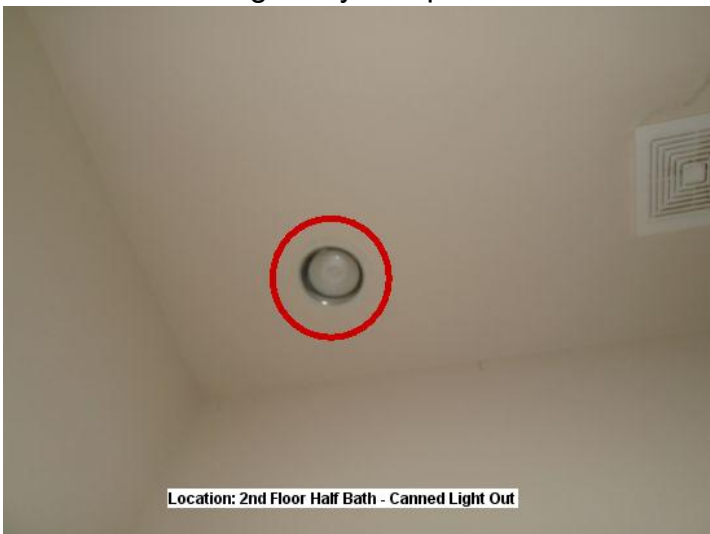
Location: 2nd Floor Half Bath - Canned Light Out

One or more overhead lights were unresponsive during today's inspection.

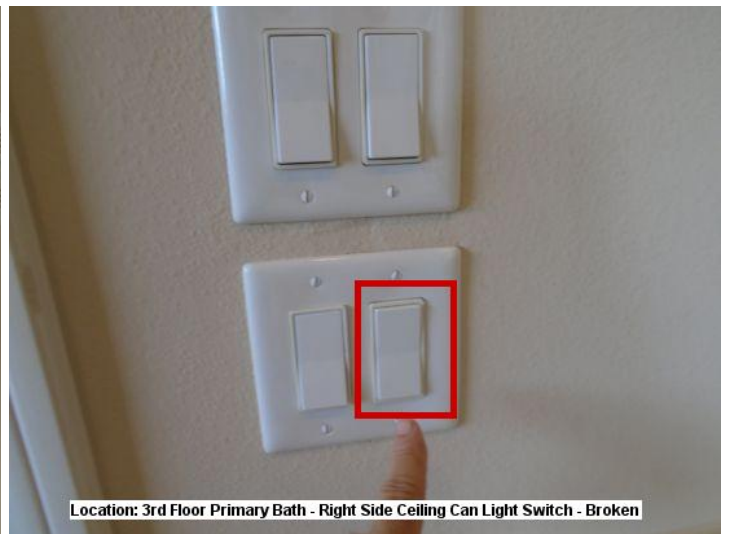
Location: 3rd Floor Primary Bath - Right Side Ceiling Can Light Switch - Broken

One or more switches are NOT working as intended.

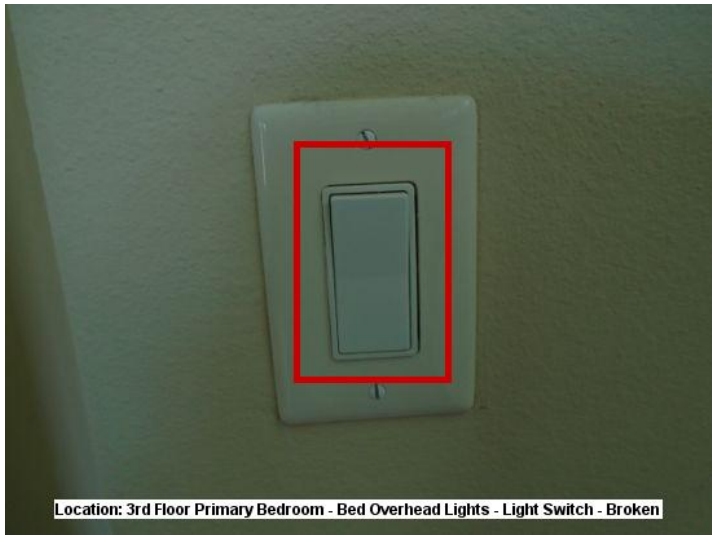
Location: 3rd Floor Primary Bedroom - Bed Overhead Lights - Light Switch - Broken

One or more switches are NOT working as intended.

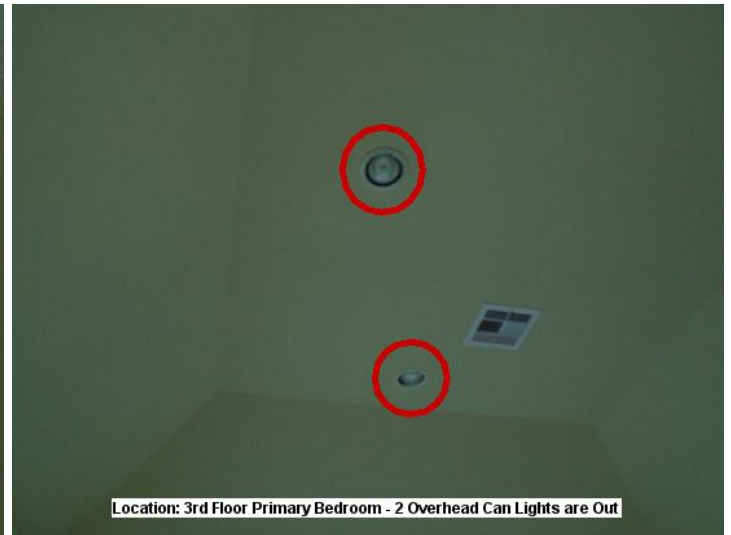
Location: 3rd Floor Primary Bedroom - 2 Overhead Can Lights are Out

One or more overhead lights were unresponsive during today's inspection.

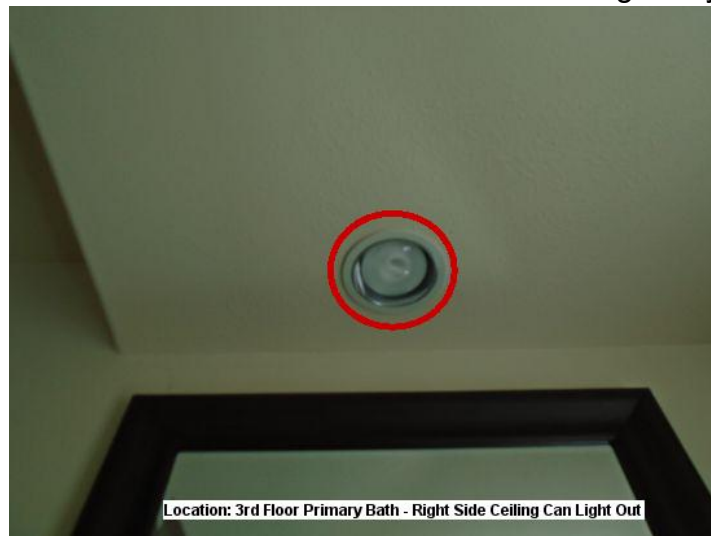
Location: 3rd Floor Primary Bath - Right Side Ceiling Can Light Out

One or more overhead lights were unresponsive during today's inspection.

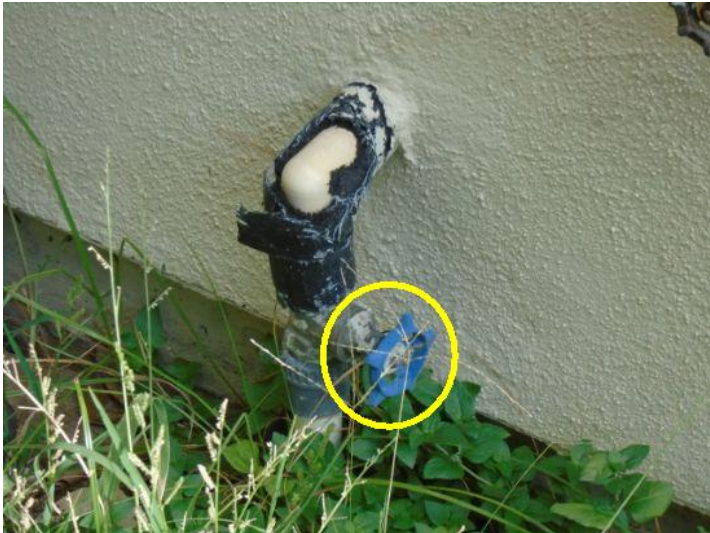
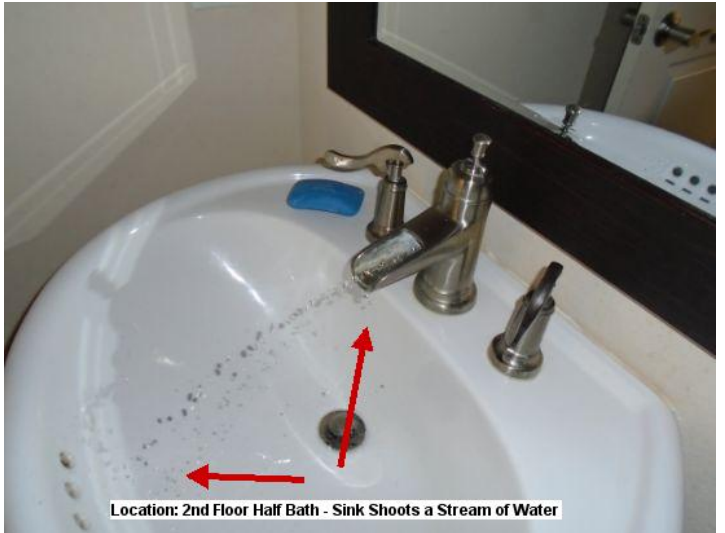
In one or more bathroom sinks, the pressure and angle of water flow exceeds the limits of the sink size.

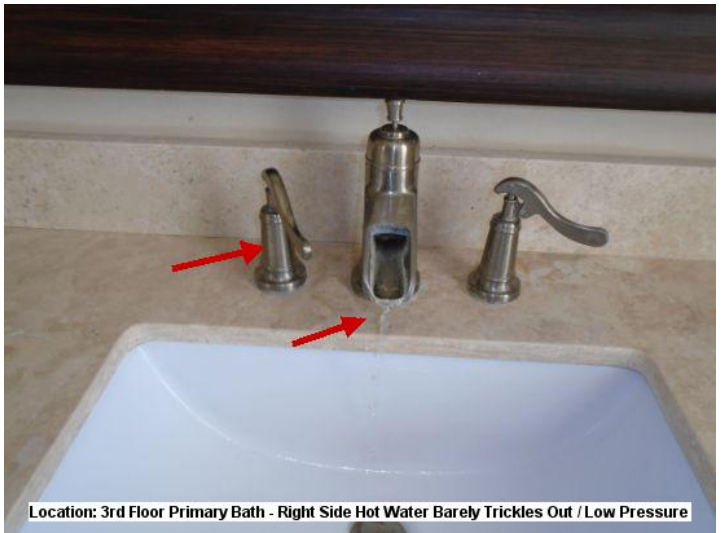
In one or more bathroom sinks, the pressure and angle of water flow exceeds the limits of the sink size.

In one or more sinks the flow of water is a trickle even with water turned on all the way.

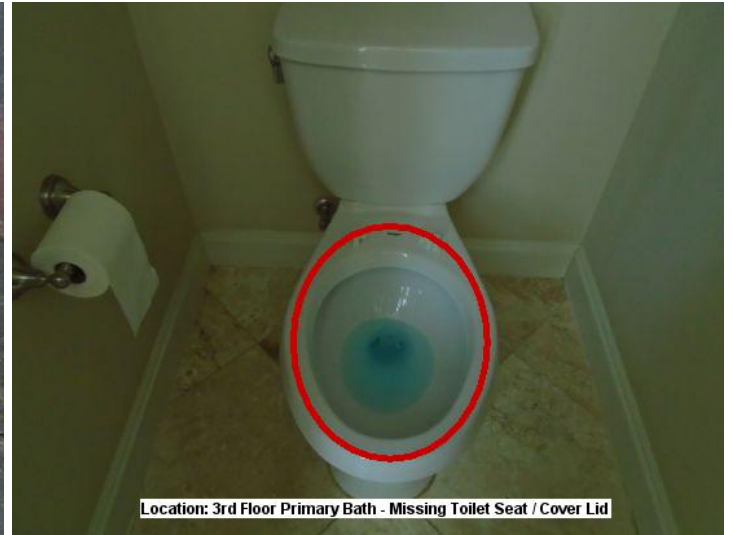
Primary Bathroom toilet seat and lid were missing during today's inspection.

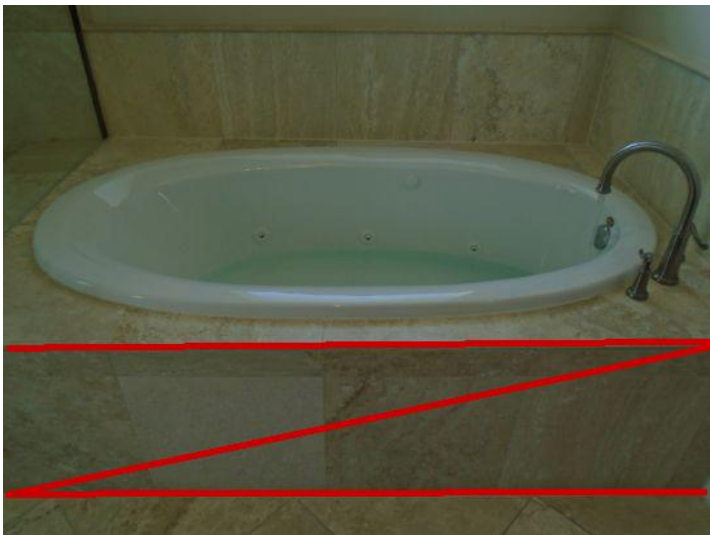
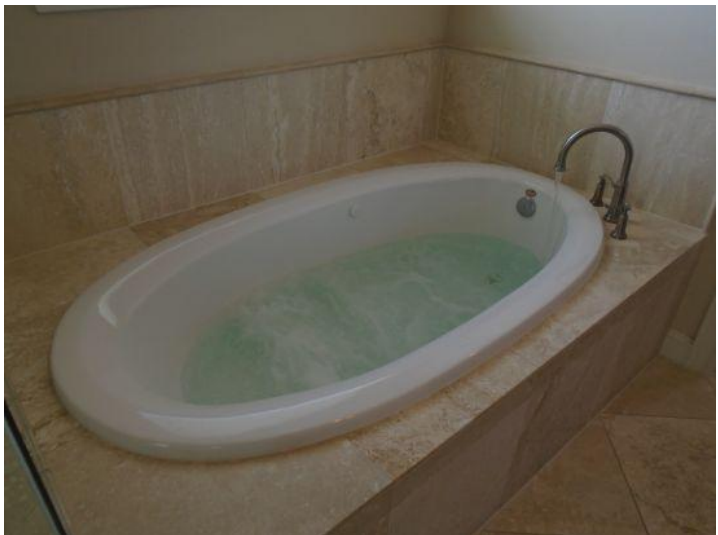
Access panels were available but painted shut - No visual inspection was done under the tubs surface.

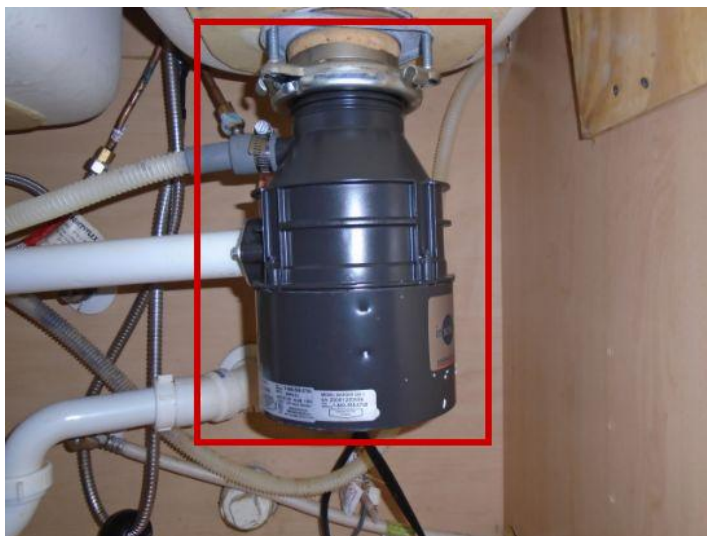
Disposal was inoperable at time of inspection.
