# Property Inspection Report

LOCATED AT:  
12 Quintana Dr  
Galveston, Texas 77554

INSPECTED ON:  
Tuesday, June 20, 2023

Inspector, Terry May TREC#23696  
May Home Inspection

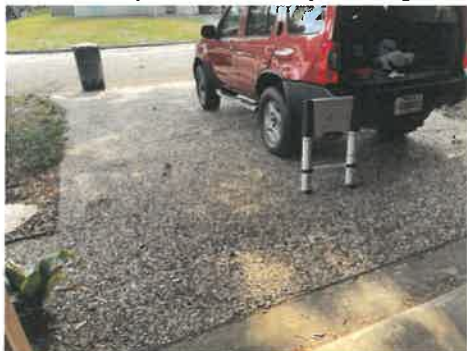
Driveway OK

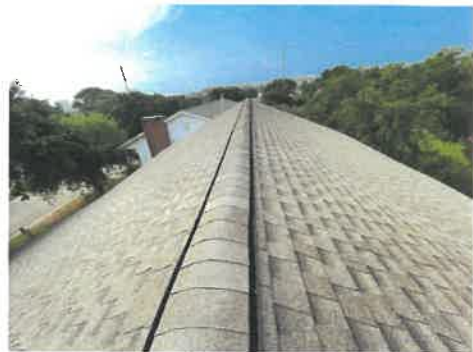
Portions of the surface granulation are deteriorated and there are minor surface cracks developing.

Minor granular deterioration

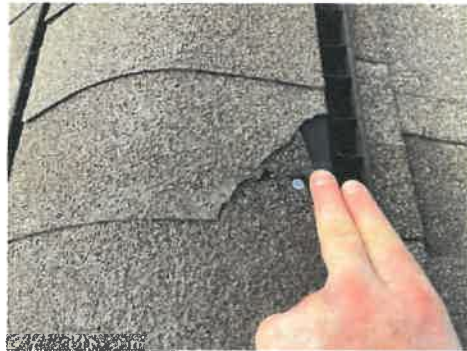
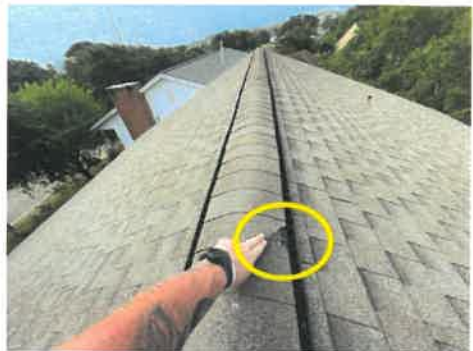
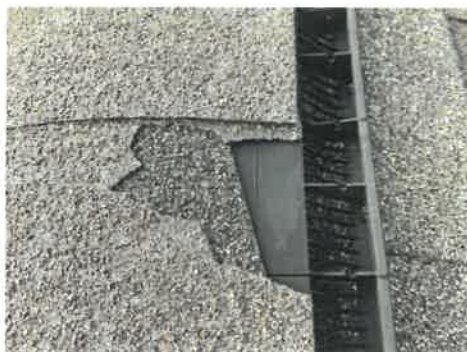
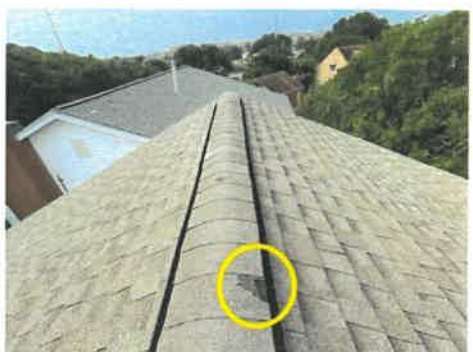
Some of the shingles are damaged and/or deteriorated.

Damaged ridge cap shingle

*Repaired*

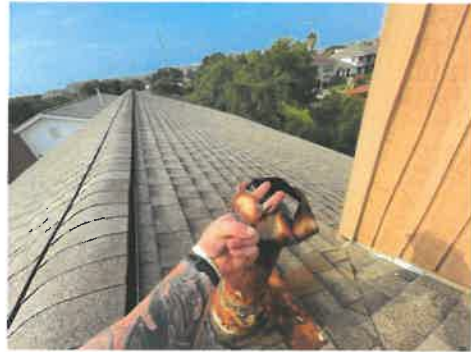
Some of the flashings, roof jacks and/or vents are damaged and/or corroded. We recommend they be repaired or replaced to prevent leakage.

Rusted/damaged rain cap on exhaust flue

*repaired*

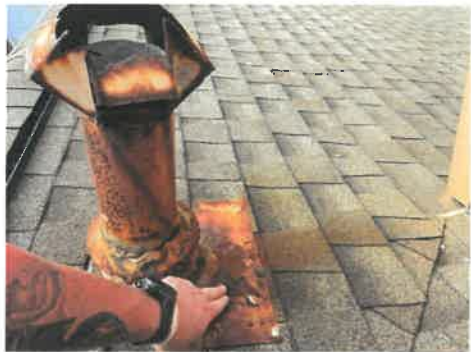
Rusted flashing

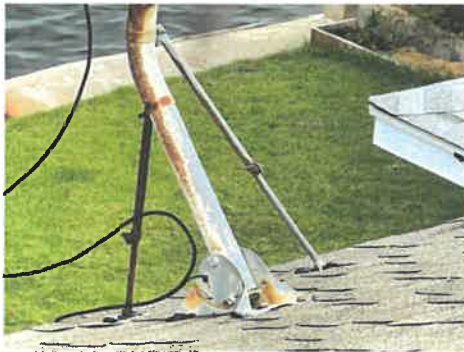
The satellite dish mount is on top of the roofing surface. While not necessarily improper, it is a poor location. Monitor the mounting bolt sealant and replace sealant as needed to maintain watertightness. If the satellite dish is not going to be used in the future, **DO NOT REMOVE THE MOUNT PLATE**. Seal around it and monitor the sealant. The roof is much more prone to leak if the existing plate is removed.

Satellite dish on roof

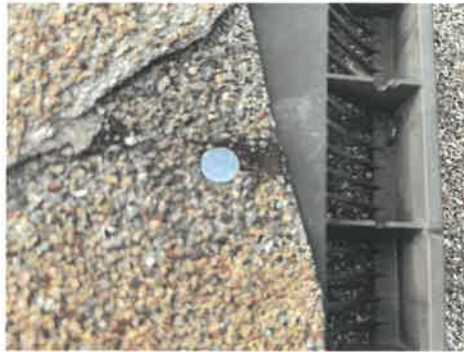
Exposed nail heads: exposed nail heads on top of the roof structure should be caulked and sealed to help alleviate water intrusion.

Exposed nailhead

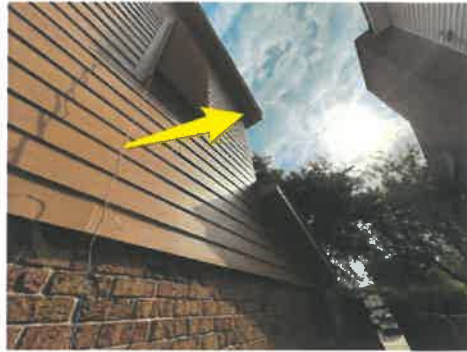
Damaged soffit material was observed on the left side of the structure. Recommend replacing all soft, rotten, and/or damaged wood.

Left front: damaged soffit

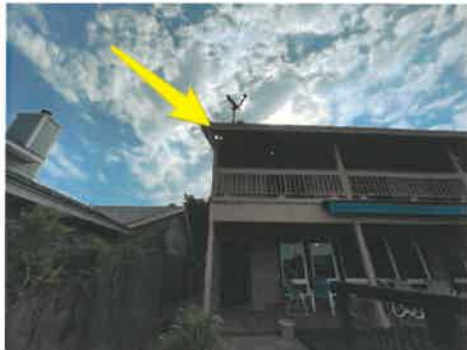
Damaged fascia: a fascia board/trim board on the rear side of the structure was observed to be missing. Recommend replacing all soft, rotten, and/or damaged or missing wood.

Right rear: missing trim board/fascia

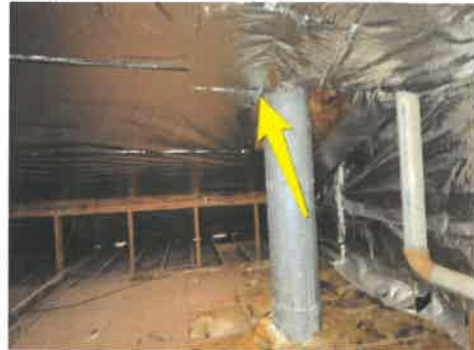
There is evidence of past leaks. We cannot determine if active leaks still exist. We recommend monitoring this condition and/or inquiries of the owner.

Moisture stain around chimney

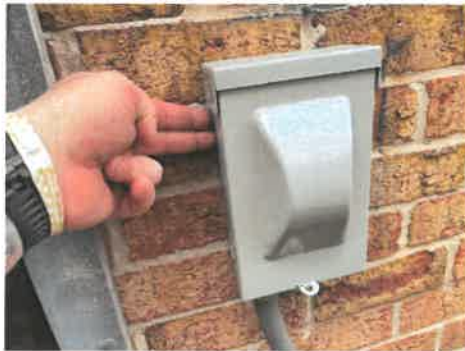
Any and all openings in the exterior wall should be caulked and sealed to alleviate water and unwanted pest intrusion into the structure.

Caulk/seal all exterior wall protrusions

*repaired*

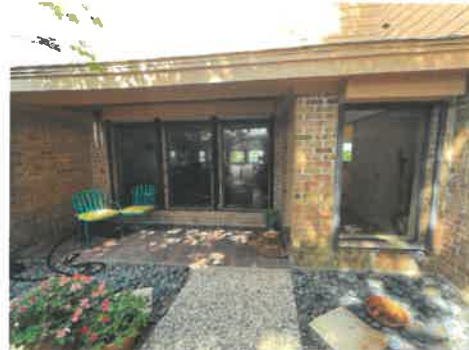
Caulking improvements needed around window frames on exterior side of the structure.

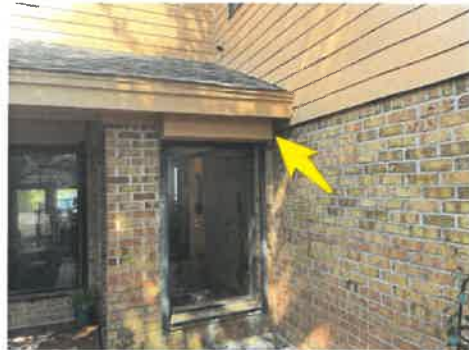
the veneer has pulled away from the building and/or has become unbonded from the wood frame in areas. We recommend removal and/or repair of the masonry because of the potential for damage or injury should the veneer completely collapse.

Front: loose brick veneer needs repaired

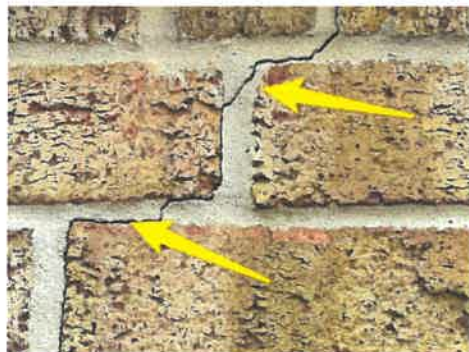
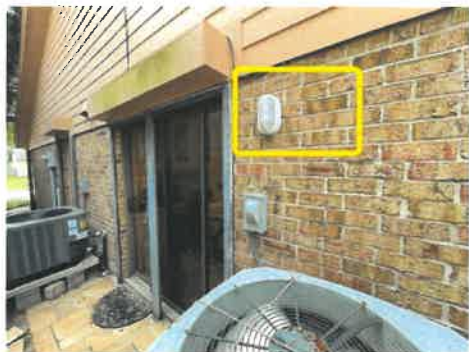
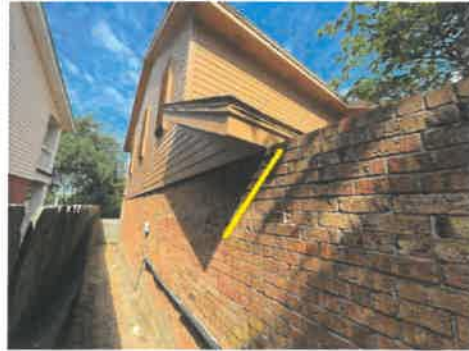
Crack; repair and monitor: some cracking was observed on the left and right side of the structure. This suggest that typical movement has occurred. This does not suggest a serious structural concern, but should be repaired and monitored for ongoing movement. If ongoing movement is observed, recommend having it further evaluated and repaired by a licensed contractor.

Crack in grout: typical movement, repair and monitor

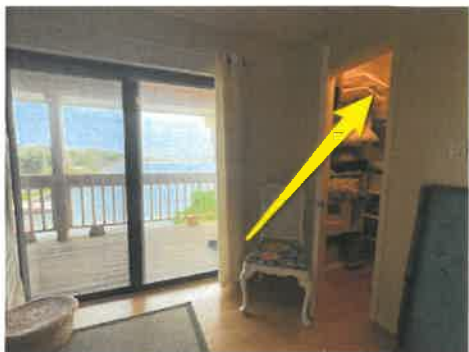
Moisture staining present in the ceiling.

Right rear corner bedroom closet: moisture stain

*repaired*

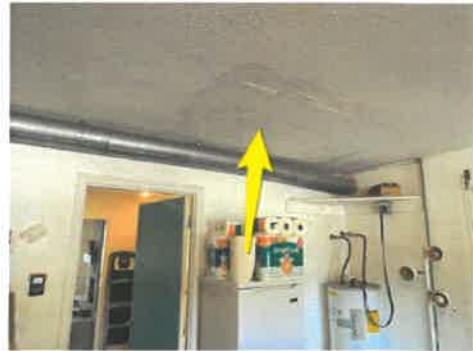
Patching observed: some patching was observed in locations throughout the structure which is indicative of previous issues. This does not mean that the problem is ongoing, but it is suggested that frequent monitoring of the area should be taken.

Garage: patching observed

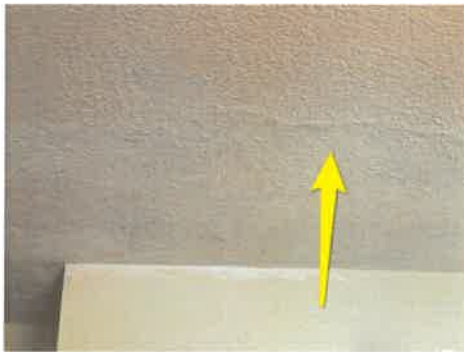
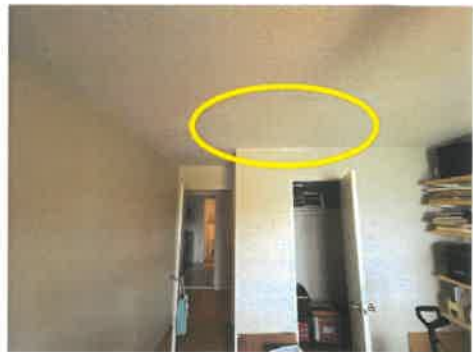
2nd floor rear middle bedroom: patching observed

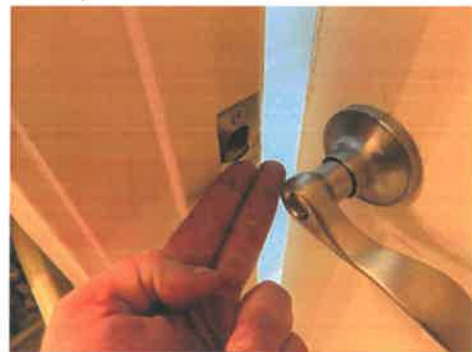
Several doors throughout the structure would not properly latch. Recommend adjusting the strike plate so that the doors latch as intended.

Master bathroom: won't latch

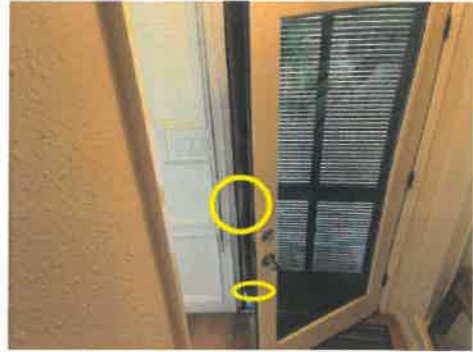
Back exterior door: won't latch

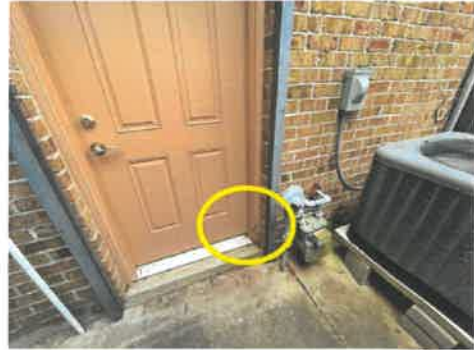
Wood decay at door jam: Wood decay was observed to the door jam on the right side of the structure. Recommend replacing all soft, rotten and or damaged wood.

Right: wood decay

*repaired*

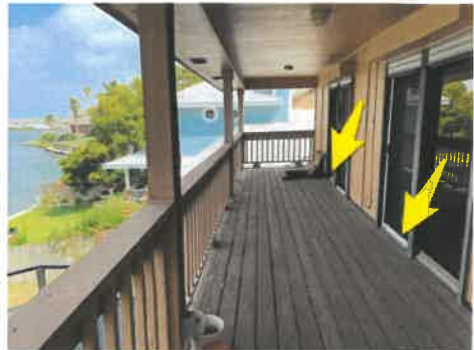
Screen door: damage/corrosion : the screen doors to the upstairs bedrooms that lead out to the rear balcony were observed to have minor damage and corrosion to the frame of the door screen. Although the doors operated as intended, Recommend repair/replacement.

Upstairs bedrooms: screen door corrosion/damage

*repaired*

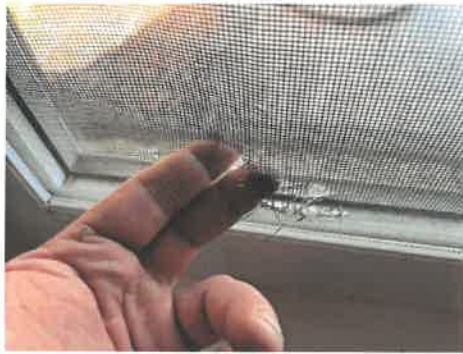
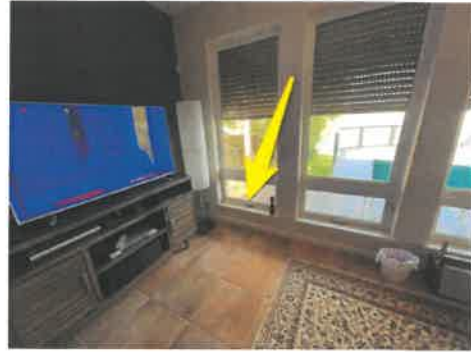
Some damaged or poor fitting window screens.

Living room: Window screen damage

*repaired*

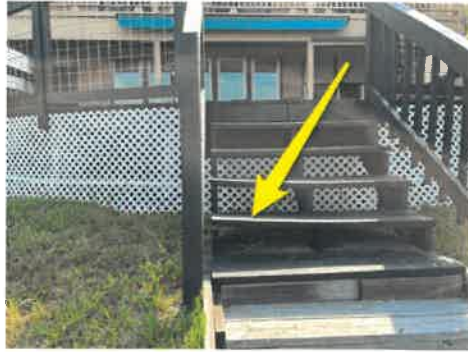
The stairs at the pictured areas are damaged.

Damaged steps/raised nails

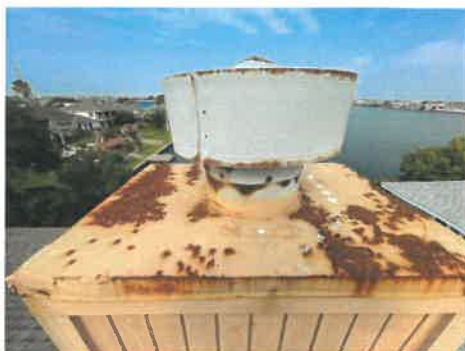
Chimney cap flashing rusted. The chimney cap had excessive corrosion at the time of inspection. Recommend corrosion control or replacement to alleviate the potential for water intrusion.

Chimney cap is rusted

*replaced*

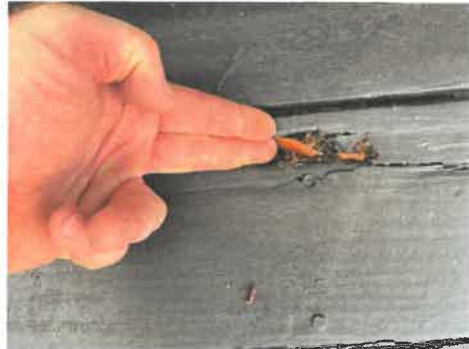
There are deteriorated deck boards at the pictured area(s). We recommend replacement of all damaged material.

Deck has some deterioration: recommend replacement

*all repaired*

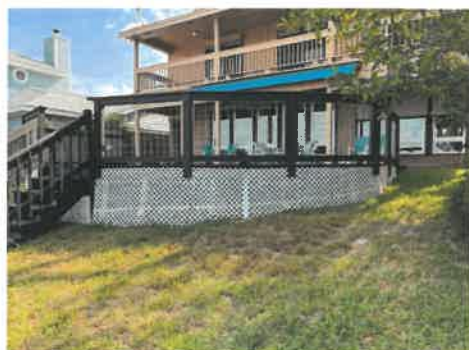
Wood to ground contact/obstructs view: wood to ground contact was observed on the rear deck where it joints to the main structure. Wood to ground contact is a conducive condition for wood destroying insects and should be eliminated. Recommend removing the conducive condition or getting a treatment performed by a licensed pest company for wood destroying insects for preventative measures. Note that the rear deck obstructs most of the foundation slab face on the rear side of the structure, which hinders the view of the inspector. Deficiencies may have been present that could not be viewed because of this obstruction.

Wood to ground contact/ deck obstructs view of foundation face

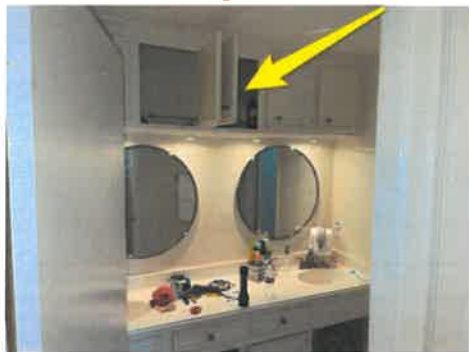
Master bathroom: open splice

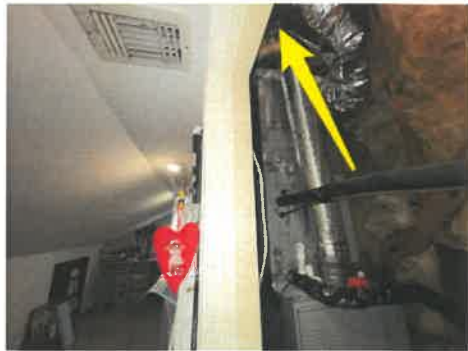
Fire stop missing: no fire stopping was observed where the HVAC duct protrudes through the attic area. The fire stop is recommended so that in case of fire, it will not penetrate through the attic to the rest of the house. Recommend installation by qualified professional.

Fire stop missing

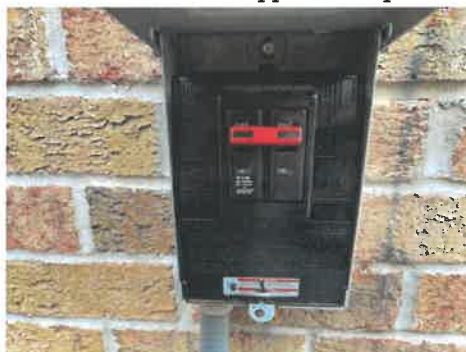
Service disconnects OK

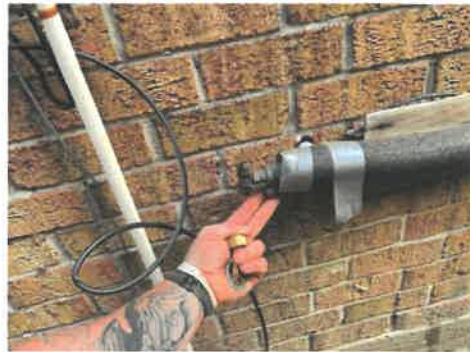
A back flow preventer is recommended to help alleviate the potential for siphoning of dirty water into the clean potable water.

A backflow preventer is recommended

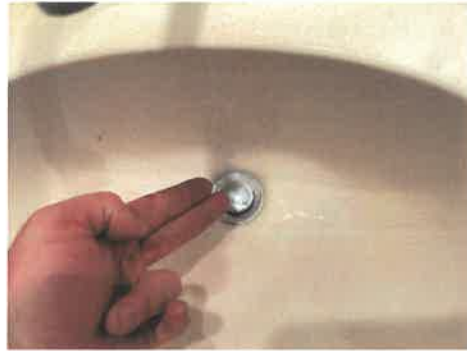
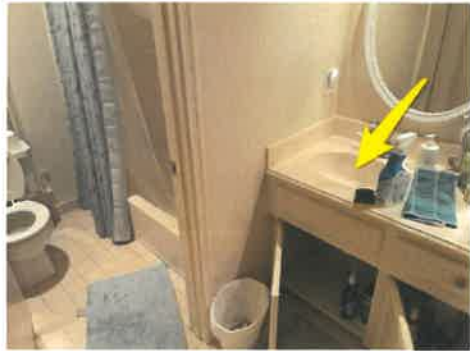
Hall bathroom sink drain stopper inoperative.

Hall bathroom: inoperable stopper

*Repaired & replaced*

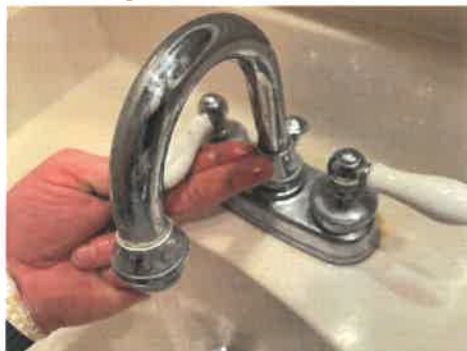
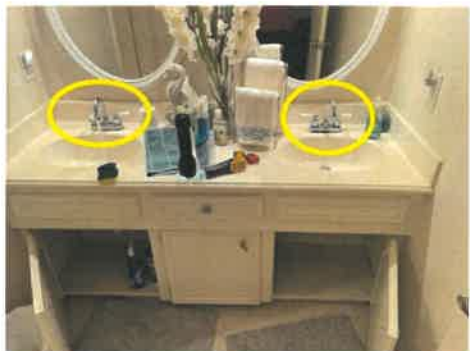
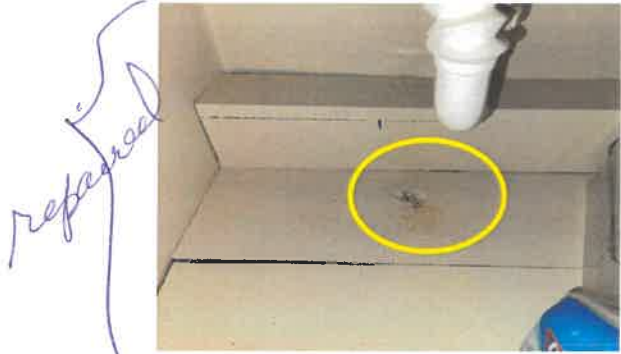
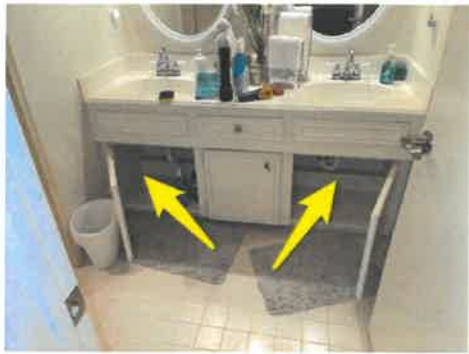
Hall bathroom: leaks at faucet/control handles: repairs or replacement should be carried out by a licensed plumber.

Hall bathroom: leaks at faucet on both sinks

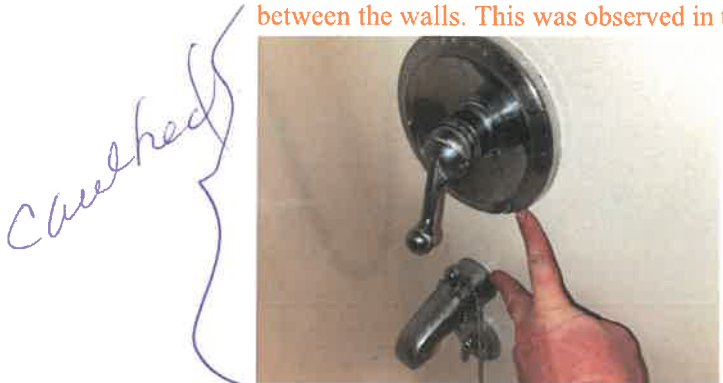
Shower and tub wall protrusions should be caulked and sealed to alleviate water intrusion in between the walls. This was observed in the master and Jack and Jill bathrooms.

Caulk/seal all shower and tub wall protrusions

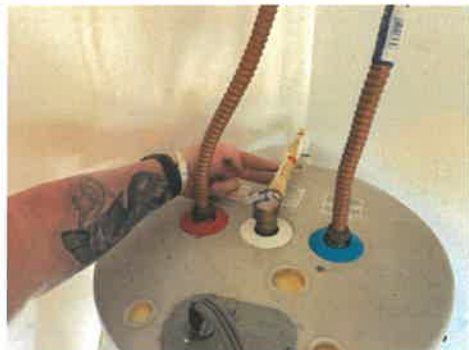
DISCHARGE PIPING: The discharge pipe is smaller than the discharge fitting on the temperature and pressure relief valve. This is potentially hazardous. We recommend it be replaced with an approved and properly sized pipe as well as having the discharge pipe terminated to outside of the structure.

TPR discharge not proper

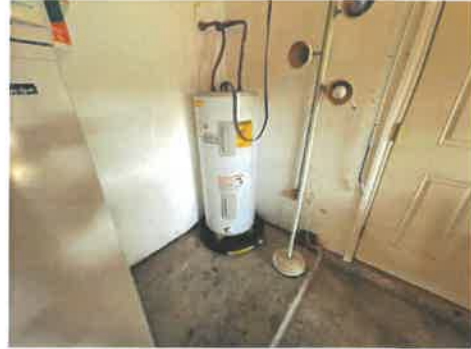
Improper elevation

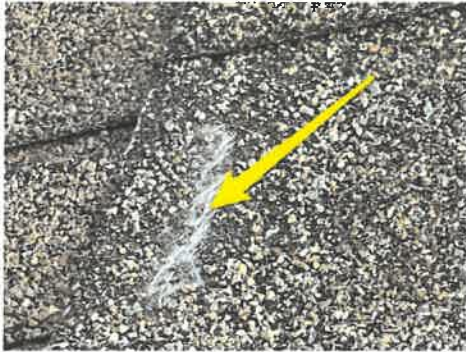
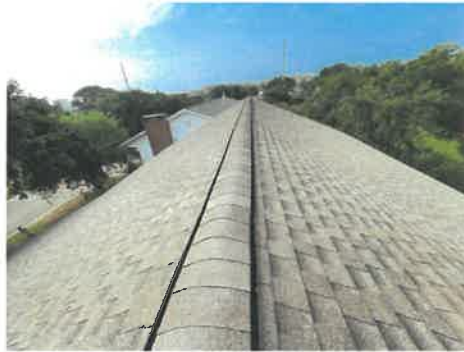
3: Portions of the surface granulation are deteriorated and there are minor surface cracks developing.

Minor granular deterioration

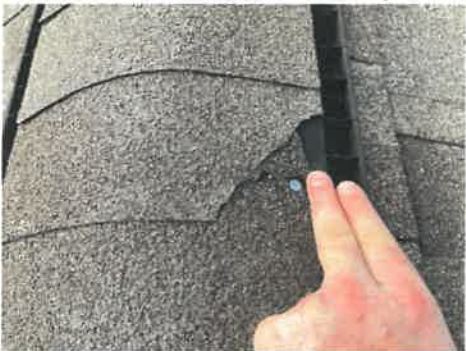
4: Some of the shingles are damaged and/or deteriorated.

Damaged ridge cap shingle

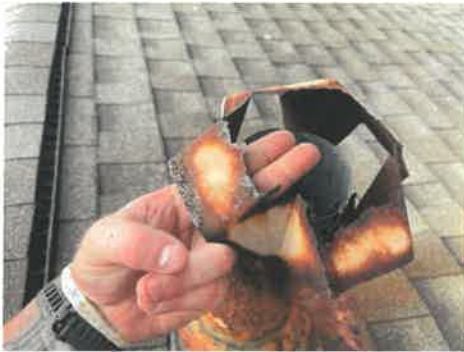
**5:** Some of the flashings, roof jacks and/or vents are damaged and/or corroded. We recommend they be repaired or replaced to prevent leakage.

Rusted/damaged rain cap on exhaust flue

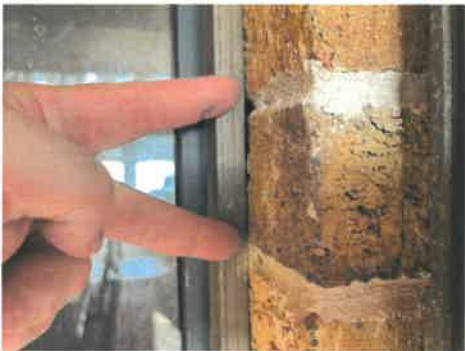
11: Caulking improvements are needed around the window frames on the exterior side of the structure to help alleviate water intrusion.

Caulking improvements needed around window frames on exterior side of the structure.

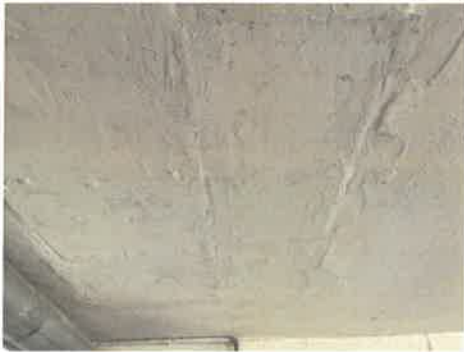
**15: Patching observed:** some patching was observed in locations throughout the structure which is indicative of previous issues. This does not mean that the problem is ongoing, but it is suggested that frequent monitoring of the area should be taken.

Garage: patching observed

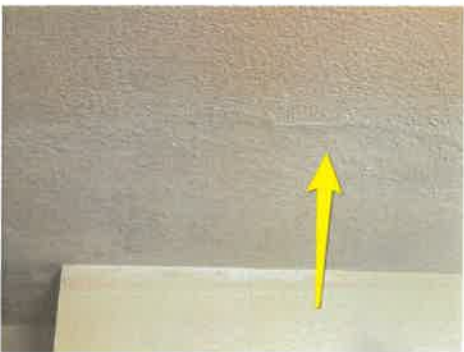
2nd floor rear middle bedroom: patching observed

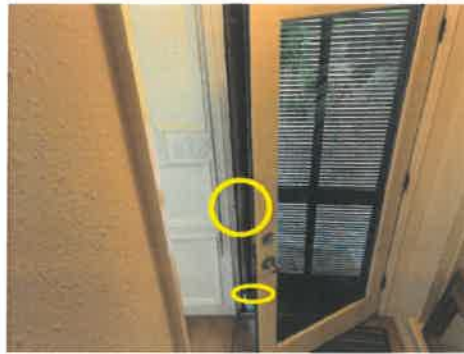
Back exterior door: won't latch

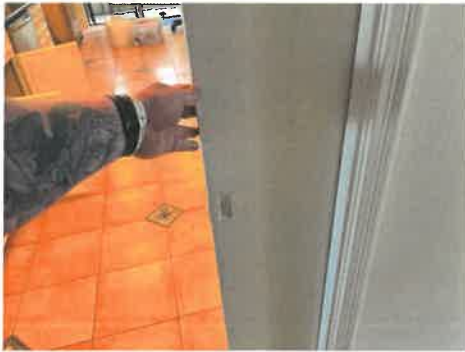
**17: Sliding door won't open/close:** the sliding door that leads from the kitchen to front entry would not close fully at the time of inspection. Recommend repairs by a licensed contractor so that the door opens and closes as intended.

Kitchen: door doesn't close all the way

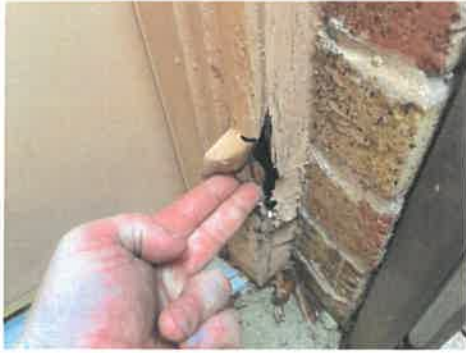
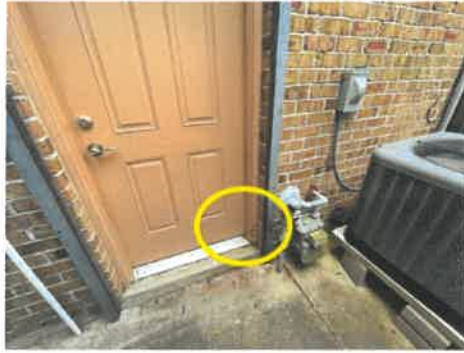
**19: Wood decay at door jam:** Wood decay was observed to the door jam on the right side of the structure. Recommend replacing all soft, rotten and or damaged wood.

Right: wood decay

*repaired*

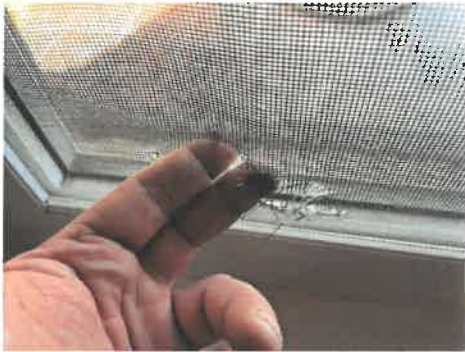
22: Some damaged or poor fitting window screens.

Living room: Window screen damage

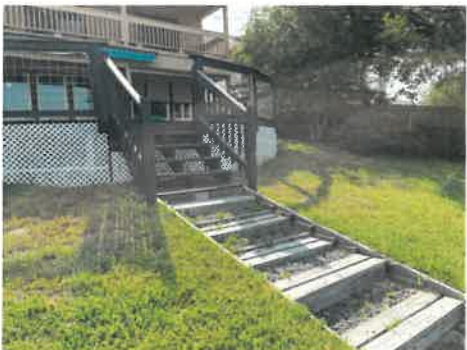
Wood to ground contact/ deck obstructs view of foundation face

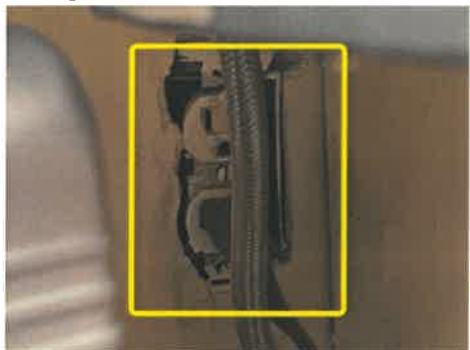
31: Some cover plates missing in the interior. Recommend cover plates to be installed over all electrical receptacles to help alleviate accidental shock.

Kitchen: missing cover plate

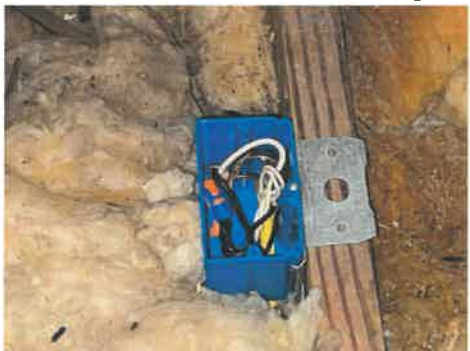
32: Junction boxes within the attic space need to cover plates installed for safety purposes.

Attic: open junction box

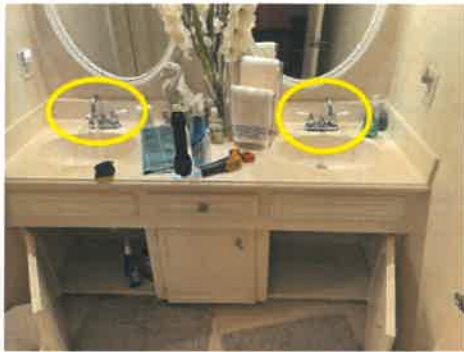
Hall bathroom: leaks at faucet on both sinks

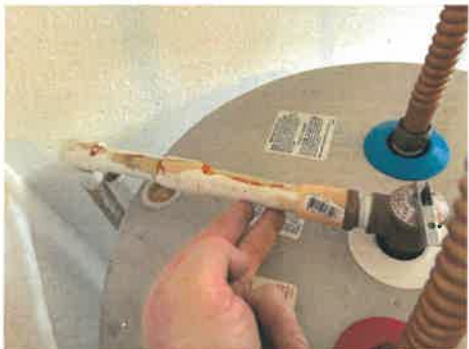
39: DISCHARGE PIPING: The discharge pipe is smaller than the discharge fitting on the temperature and pressure relief valve. This is potentially hazardous. We recommend it be replaced with an approved and properly sized pipe as well as having the discharge pipe terminated to outside of the structure.

TPR discharge not proper
