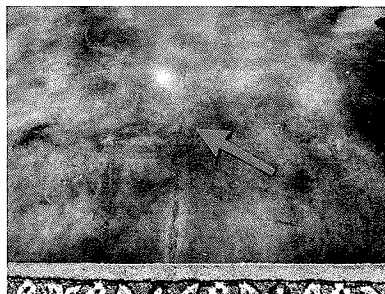
**1: Shrinkage Cracks**

Common cracks were observed in the exposed areas of the slab. This commonly occurs as the result of settling and/or surface checking. Surface checking occurs when concrete is poured in a dry state, which increases tensile strength. The dry state results in differential curing causing the surface areas to fracture. This is normal with concrete slabs. Cracks should be monitored for disjointing and/or separations and evaluated if adverse conditions are observed.

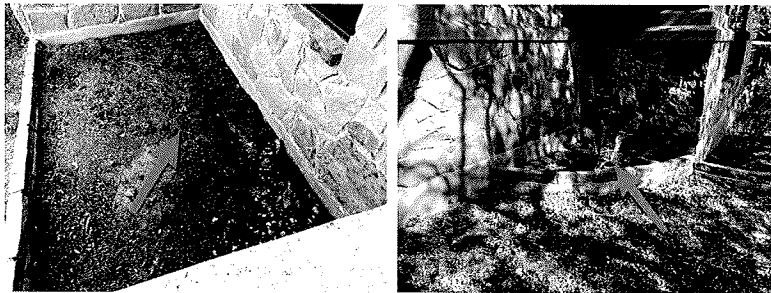
There are areas of pooling or possible pooling water near the foundation at one or more locations. The grading may need to be improved to ensure proper moisture runoff in those areas.

Frank Garcia  
leveled  
flower bed

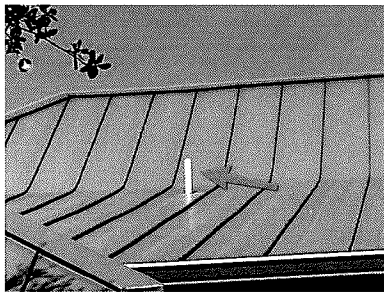
**2: Paint sewer vent pipes**

One or more unpainted sewer vent pipes were observed on the roof. PVC and neoprene will deteriorate where exposed to ultraviolet rays. Painting the vent pipe and neoprene auto caulk can help prevent deterioration caused by exposure to ultraviolet rays.

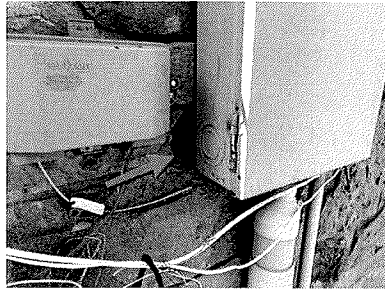
**2: Wall penetrations not sealed**

There are one or more exterior wall penetrations that are not sealed. The penetrations should be sealed to help prevent moisture and/or pest intrusion in those areas.

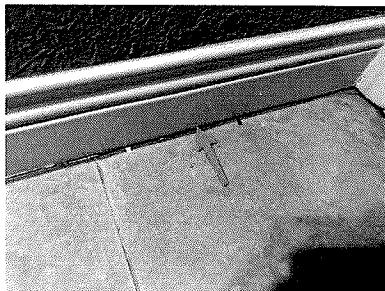
**3: Separations at baseboards**

There are separations at the baseboards at one or more locations about the house. This normally occurs with seasonal temperature and humidity changes that cause the wood to expand and contract. Repair as necessary.

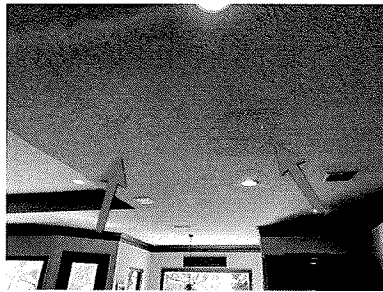
Previous repairs were observed on the ceiling. The cause or reason for repairs are unknown and the quality of the repairs are beyond the scope of this inspection. Contact sellers for more information.

From HVAC Previous Owner repaired

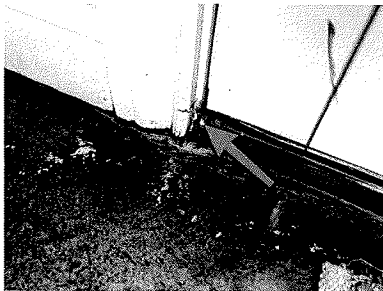
Moisture damage was observed on one or more door casings. Repair or replace as necessary.

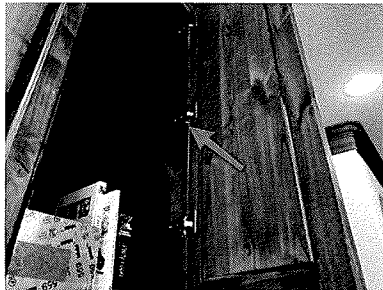
**3: Loose or missing door hardware**

One or more doors have loose or missing hardware. Repair or replace as required.

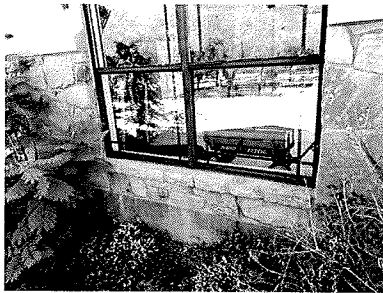
One or more windows are missing a screen. Recommend replacement.

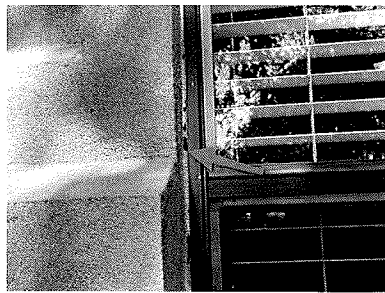
**3: Exterior window deteriorated caulk joint**

There are separated caulk joints around the exterior window frames at one or more locations. This may indicate settling and/or seasonal movement in those areas. The caulk should be touched up or replaced to exclude pests and moisture from those areas. Where deteriorating caulk is noted it should be assumed that some moisture penetration has occurred and that some hidden damage may be present.

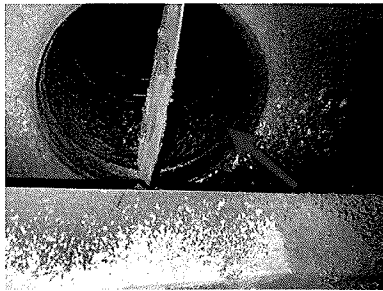
**1: Buildup of soot and creosote**

There was a buildup of soot and creosote in the firebox and chimney at the time of the inspection. It is recommended that they be professionally cleaned prior to the next use.

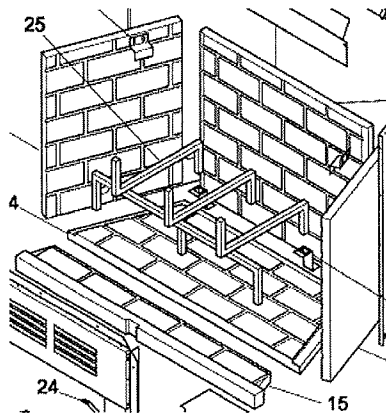
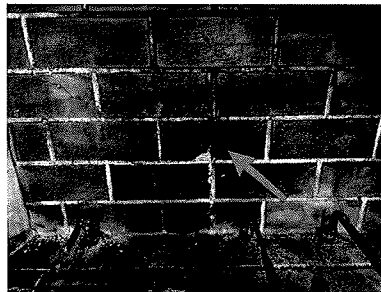
**2: Deteriorated/Cracked refractory panels**

The refractory panel at the back of the firebox is deteriorated and/or cracked. The panel should be replaced to ensure heat is properly deflected out of the firebox. Further evaluation and/or repair is advised.

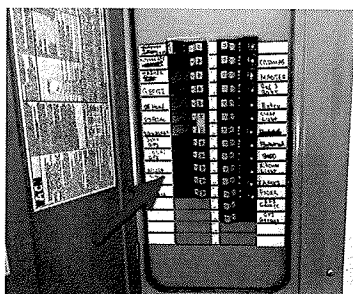
There are missing arc-fault protection devices in the electrical panel. These may not be required in every jurisdiction but are recommended to prevent shock and fire hazards. The installation of arc-fault breakers is reflected in the 2015 International Residential Code: E3902.16 Arc-fault circuit-interrupter protection. Branch circuits that supply 120-volt, single-phase, 15- and 20-ampere outlets installed in kitchens, family rooms, dining rooms, living rooms, parlors, libraries, dens, bedrooms, sun-rooms, recreations rooms, closets, hallways, laundry areas and similar rooms or areas shall be protected.

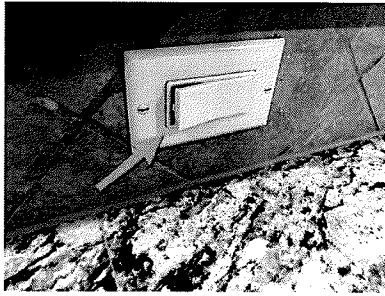
**2: Damaged faceplate**

One or more receptacles have damaged faceplates. Replacement of the outlet by a licensed electrician is advised.

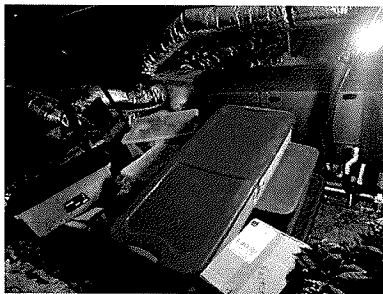
The furnace was not accessible at the time of the inspection. Once the unit is accessible the unit should be evaluated for visual signs of deficiencies.

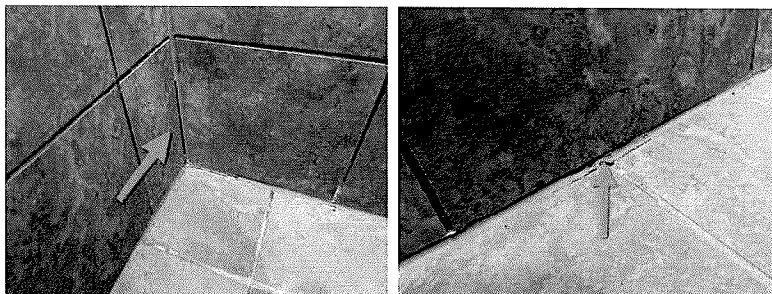
There are fractured and/or separated caulk and/or grout joints in the shower enclosure(s). It is beyond the scope of this inspection to determine if moisture penetration has occurred and/or is present in non visible areas, such as behind wall coverings. For a more detailed analysis, a professional tile contractor should be consulted. The joints should be sealed to help prevent moisture penetration in those areas.

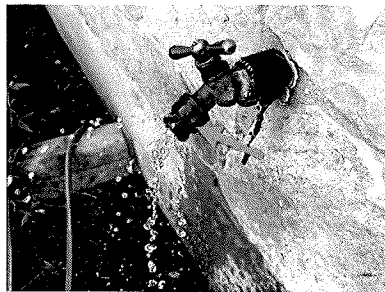
**3: Anti-Siphon Leak**

One or more exterior faucets leaked from the anti-siphon device when the valve was opened. Repair or replacement is recommended.

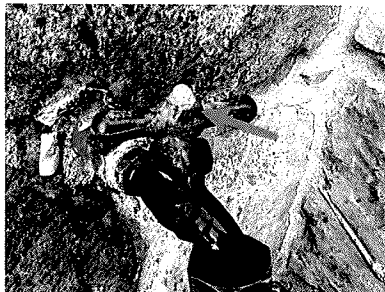
**4: Exterior faucet leaks at stem**

There are one or more exterior faucets that leaked from the valve stem when tested. This may indicate a worn washer and/or fitting. Further evaluation and/or repair by a licensed plumber is advised.

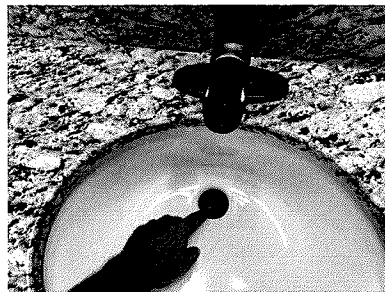
**2: Stopper did not function**

One or more drain stoppers did not function properly. Repair or adjustment as needed for proper operation of the stopper.

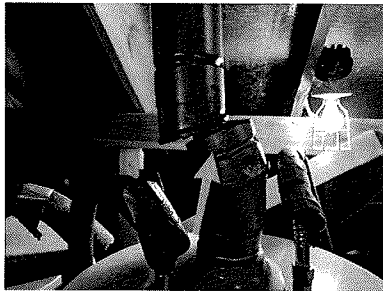
The water heater flue vent pipe is disconnected. This will allow exhaust gas from the water heater to be vented into this space. This could become a safety hazard due to the exhaust gases have no odor. Further evaluation and or repair by a licensed plumber is advised.

*Repaired*

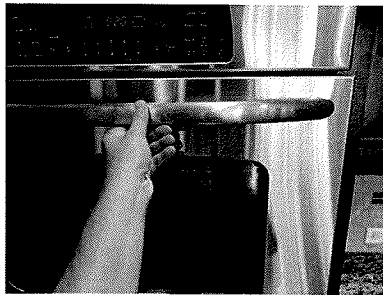
The oven door handle is loose. Repair as required.

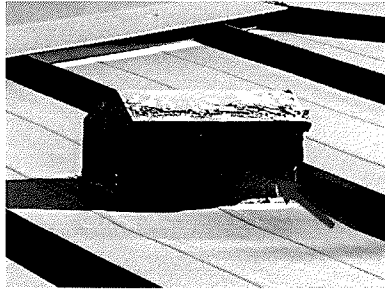
Lint accumulation was observed in the dryer vent cover. This may indicate the vent and/or cover need to be cleaned. Lint accumulations can obstruct air flow and reduce dryer performance. Additionally, dryer vent obstructions are a fire hazard. It is recommend the vent be cleaned to ensure proper performance.

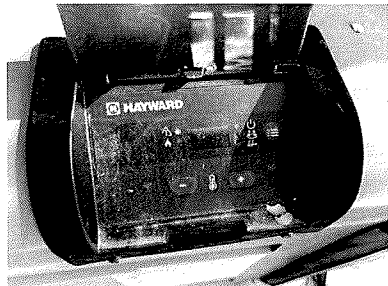
The pool heater did not activate when tested and the Service indicator light activated when operating the equipment. This commonly occurs when there is air in the gas lines and can be corrected by bleeding the lines. This can also indicate the equipment is malfunctioning. Further evaluation and or repair by a pool specialist is advised.

Repaired

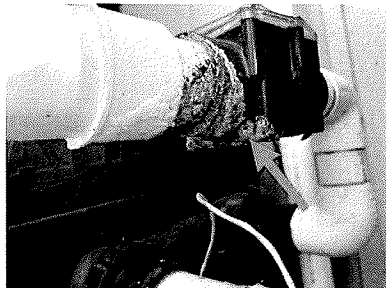
Water was observed on the equipment pad. This may indicate a leak in that area. Further evaluation and/or repair is advised.

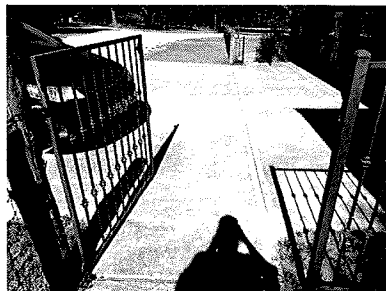
**3: No fence**

There is no fence installed between the house and the pool. A fence, at least 60" tall, should be installed with a self-closing gate that opens away from the pool. The latch should be installed no less than 54" from the ground. There should be a barrier between the house and the pool or an alarm on the exterior doors leading to the pool so the owner is notified of the doors opening. The improvements are recommended, especially if small children are present, for safety.
