May 26, 2023

RE: Foundation Inspection
Job #21185

5602 Pine Street

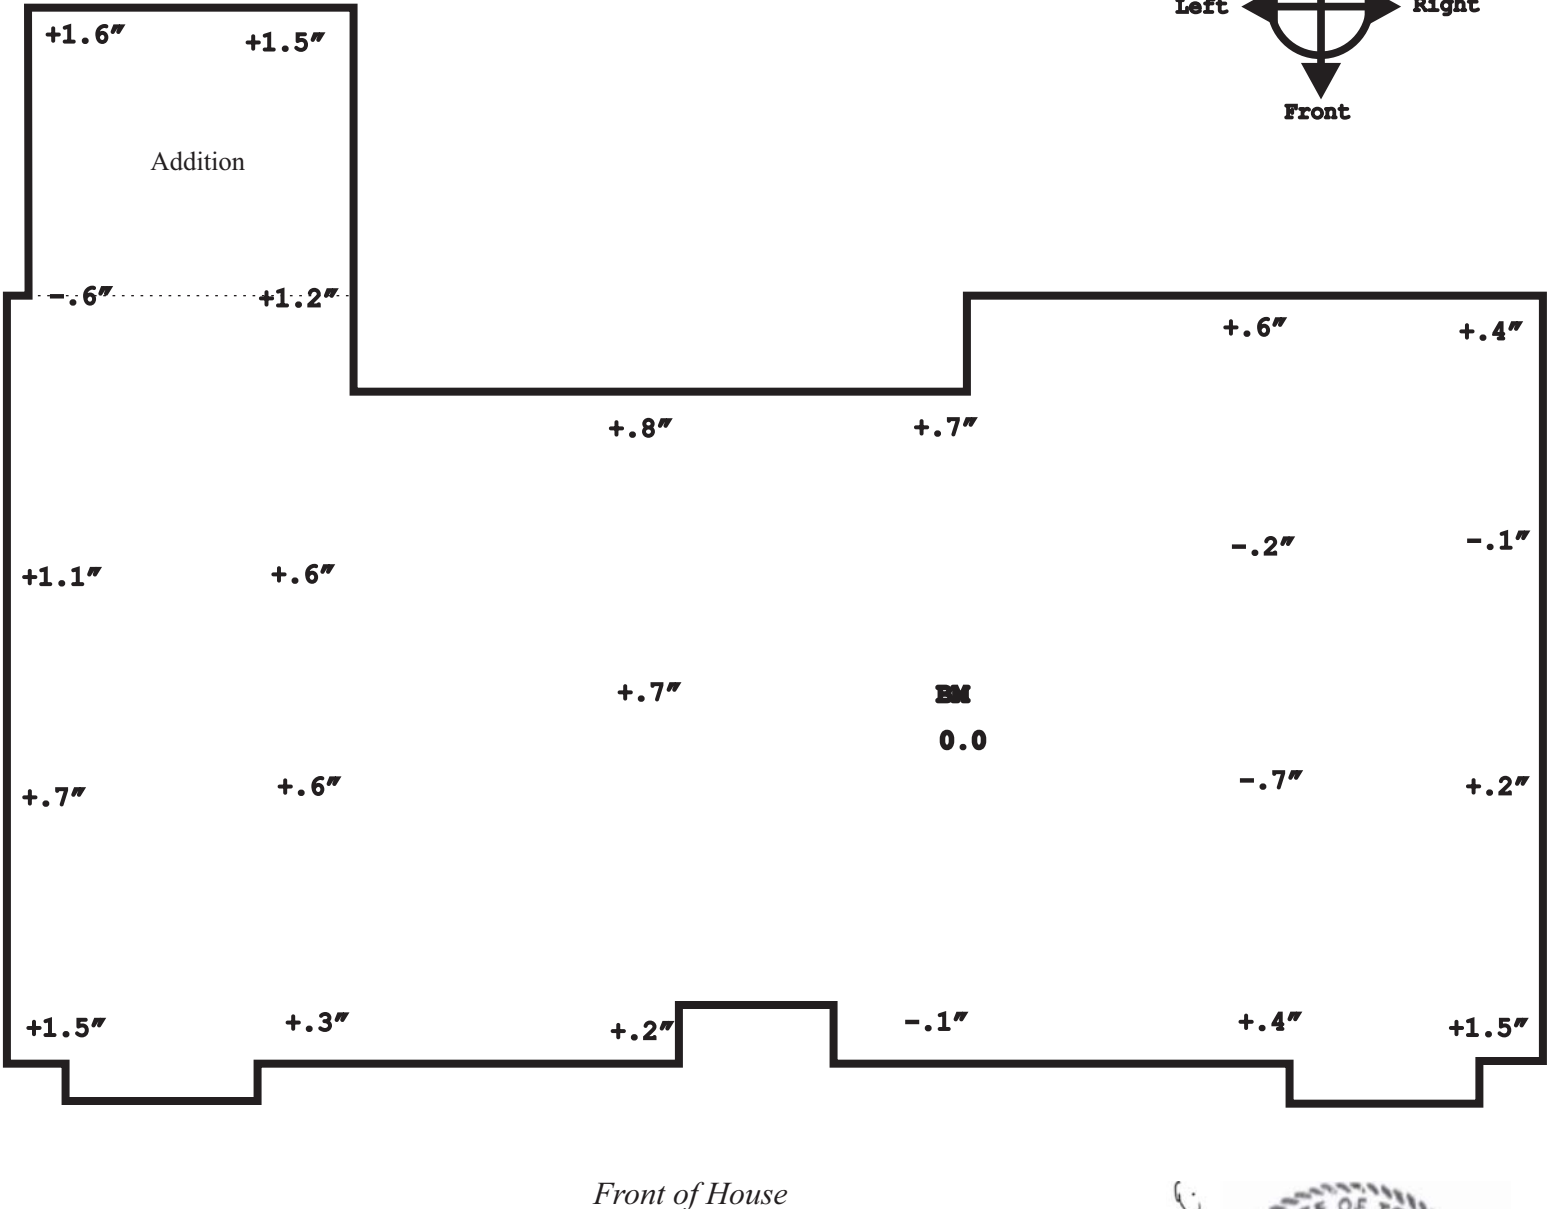
Minor movement was observed on the *left side* of the house as evidenced by elevation differentials, and sheetrock cracks on this side of the house.

The slab elevations were measured using an electronic manometer level measuring the surface of the floor coverings. Minor deviations were observed, but they were not consistent to indicate a significant problem. The locations of the measurements are noted on floor plan attached.

FYI: The elevation differential 2.3" is not a functionality issue, but an aesthetic issue. During this era, residential construction standards for slab flatness were not established.

Elevation Differential 2.3"

Instrument Repeatability Error 0.2"
