PROPERTY INSPECTION REPORT FORM

<i>Name of Client</i> 23219 Sawleaf Cir, Katy, TX 77494 <i>Address of Inspected Property</i> Tyler Adams <i>Name of Inspector</i> <i>Name of Sponsor (if applicable)</i>	8/21/2023 <i>Date of Inspection</i> 24087 <i>TREC License #</i> <i>TREC License #</i>
--	---

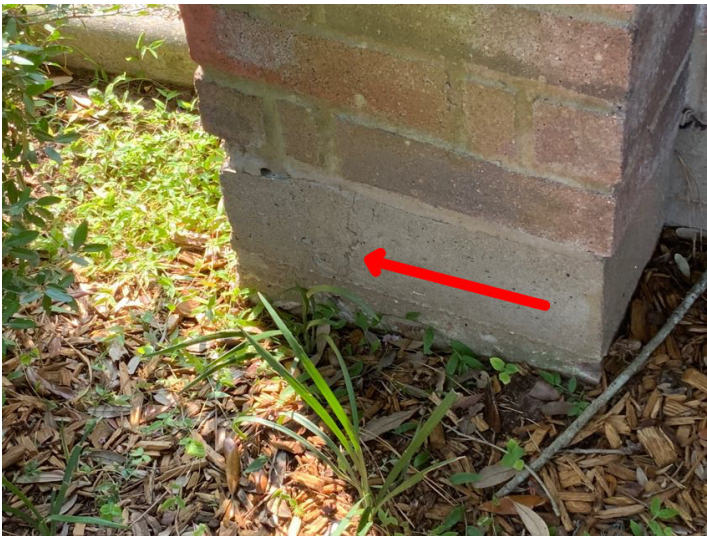
- Corners of the foundation were found to be broken. This is a common deficiency. Patching of the corners is recommended to reduce the risk of water penetration, further damage exposing tension cables/rebar, and/or damage to masonry exterior walls (as the corners provide a brick ledge).

Broken front left corner.

Foundation: Repair all broken corners.

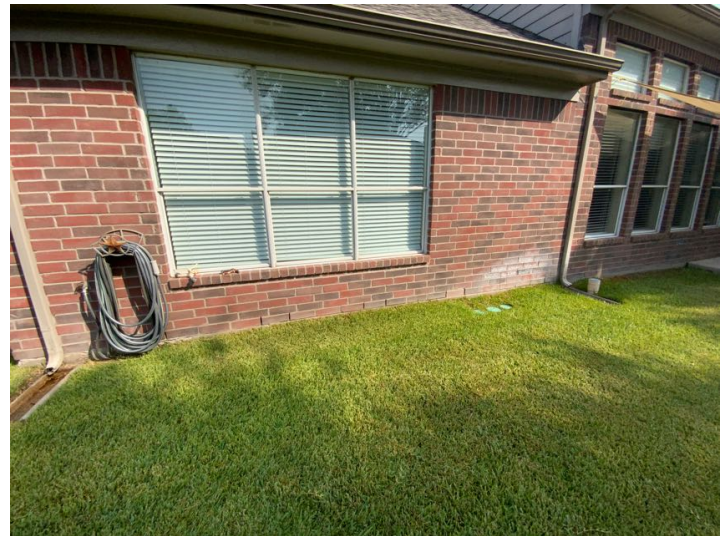
High soil blocking visual inspection of foundation at Back of home.

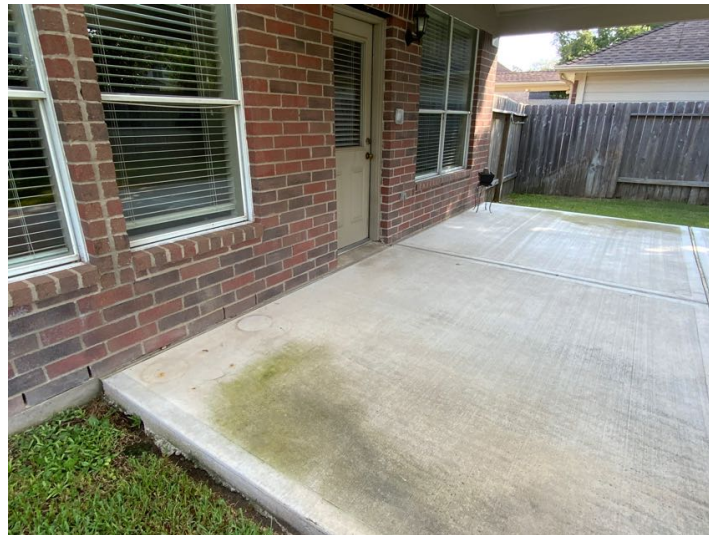
Patio blocking visual inspection of foundation at Back of home.

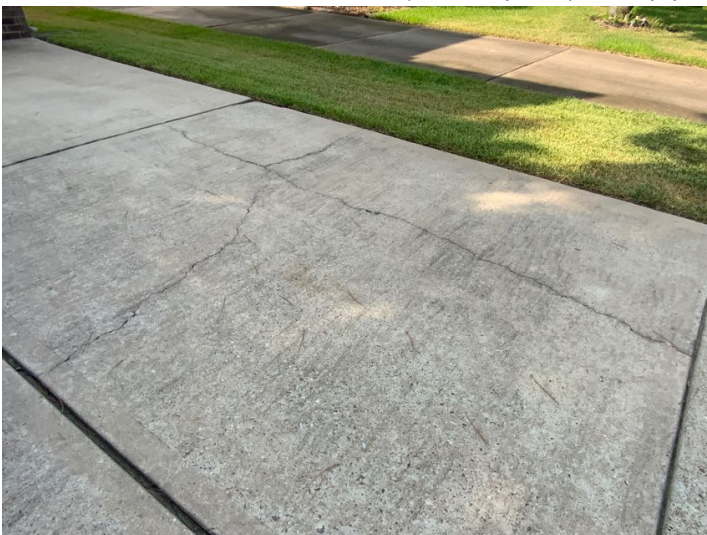
Driveway cracks.

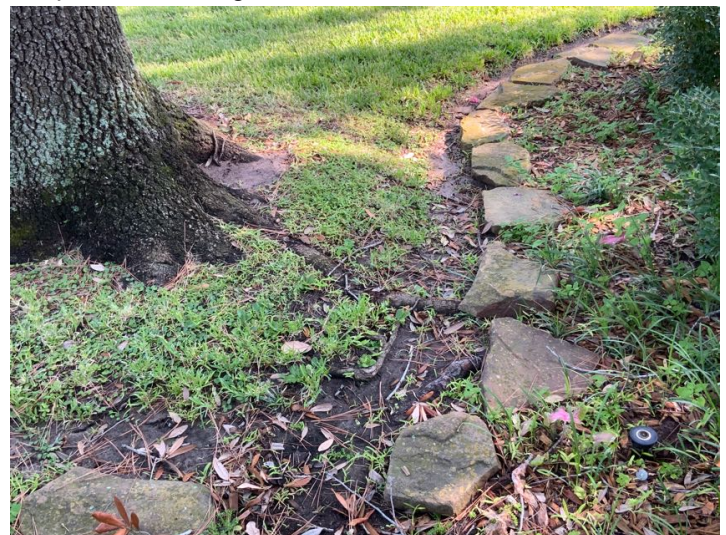
Root encroachment.

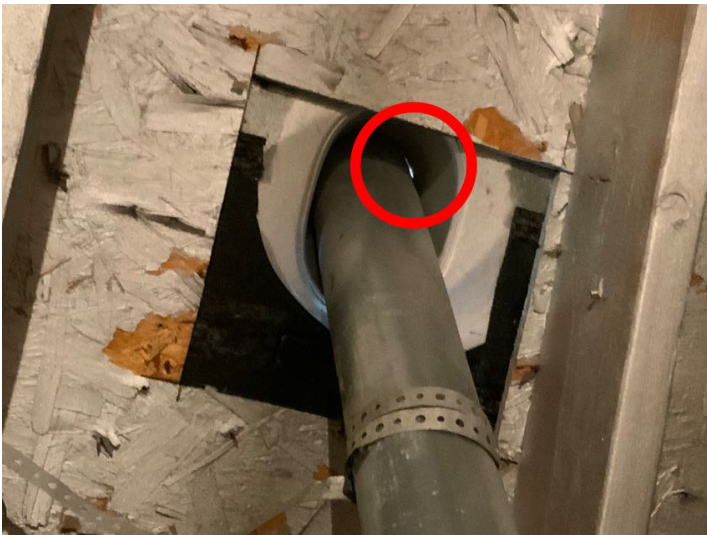
- Flue pipes in the attic space need seal improvements where they terminate through the roof covering to prevent water and/or pest entry to the home.
- Prior repairs to the roof structure are evident. It may be wise to consult the current owner regarding their knowledge of the roof structure and/or any repairs that became necessary.

Daylight at water Heater flue pipe.

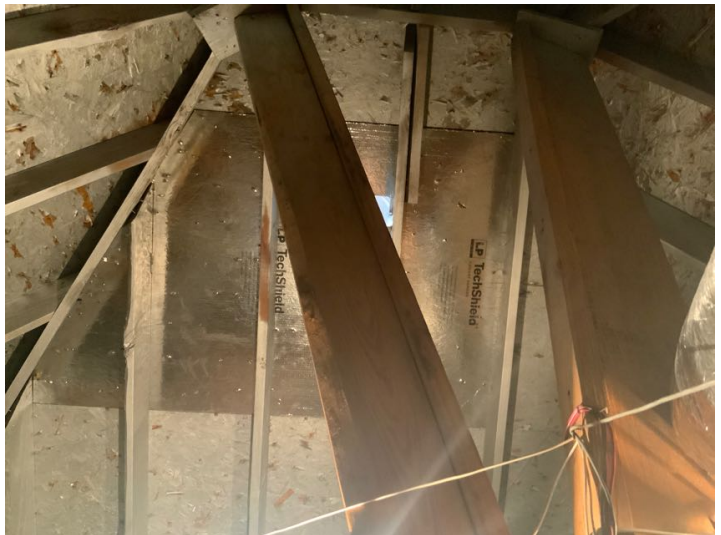
Evidence of prior repairs.

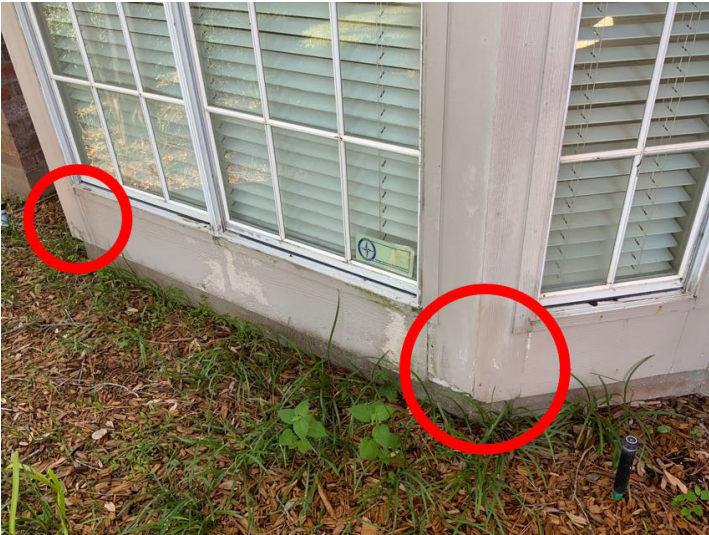
- Siding damage was observed at the time of inspection. Repairs/replacement of damaged siding is needed.
- Trim board seal improvements are needed to prevent water and/or pest entry to the home.

Damaged siding at ground of home.

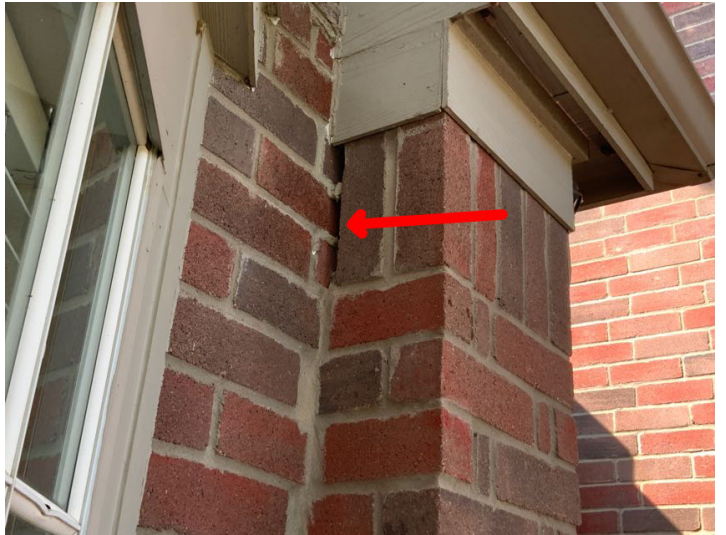
Brick seam seal improvements needed at front of home.

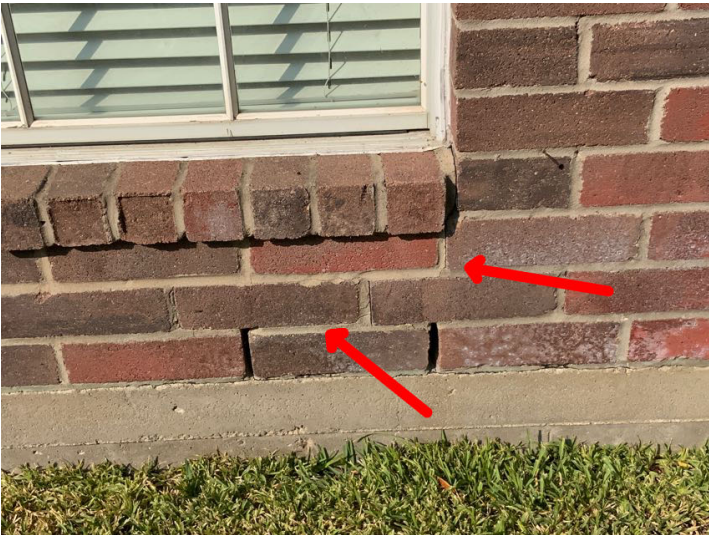
- Cracks observed on exterior walls suggest settlement of the home. These cracks don't suggest greater than typical settlement, however patching and monitoring is recommended as the rate of movement can not be predicted at a one time inspection.

Minor settlement crack at left of home.

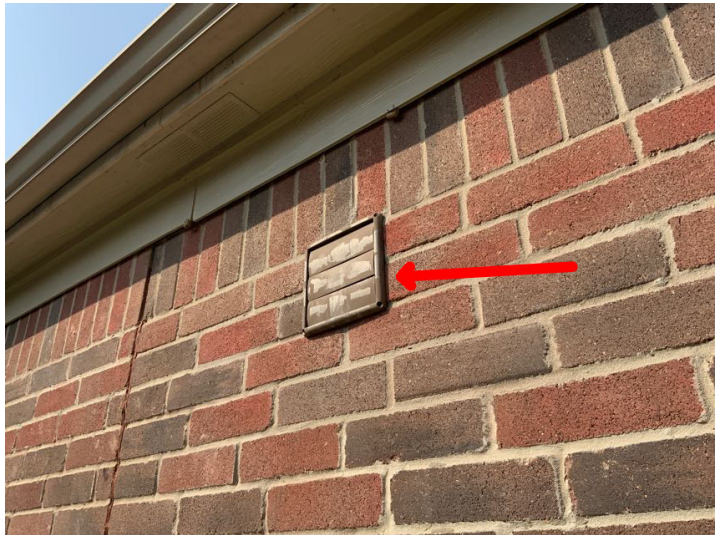
Vent perimeter seal improvements needed at left of home.

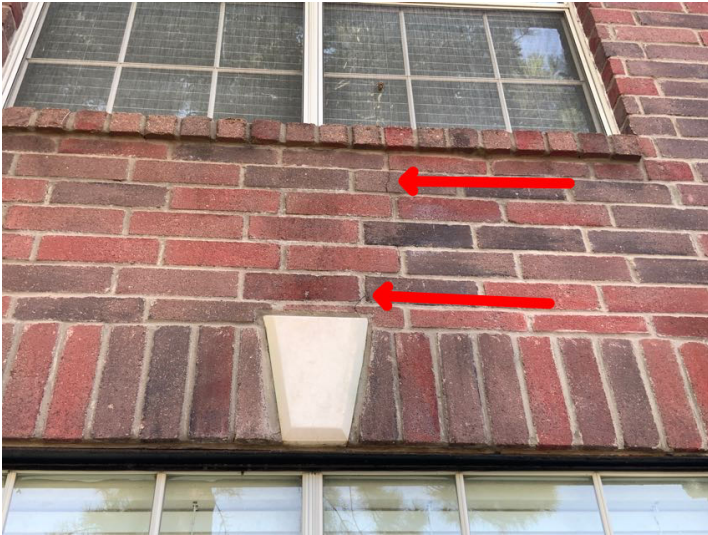
Minor settlement crack at front of home.

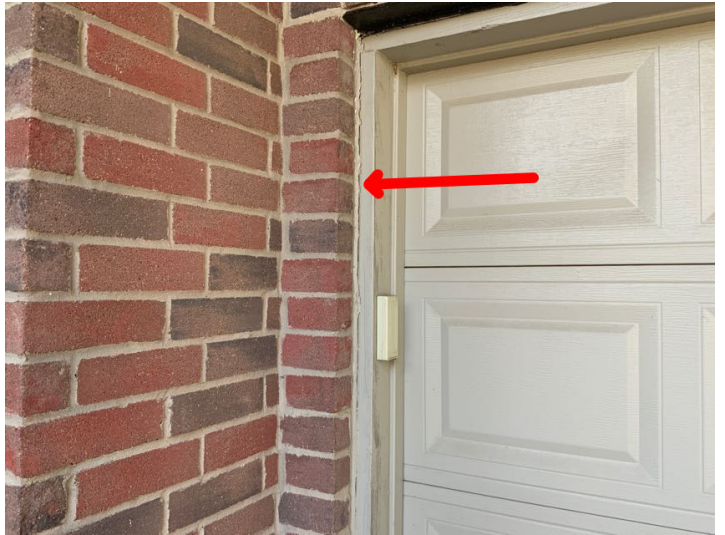
Trim board seal improvements needed at garage.

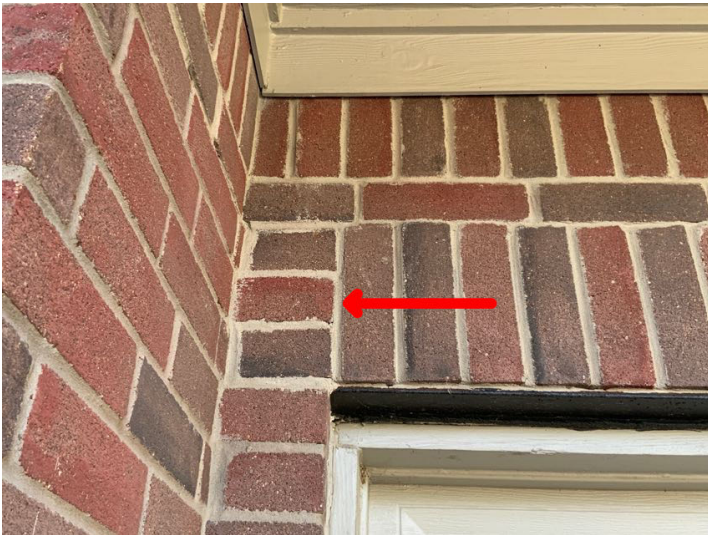
- Exterior wall cracks above a lintel (in effect, a beam supporting the brickwork above an opening in the wall) suggests that the lintel may be marginally adequate. This condition is not uncommon. Repairs by a qualified masonry contractor may be necessary,

Lintel movement crack at garage.

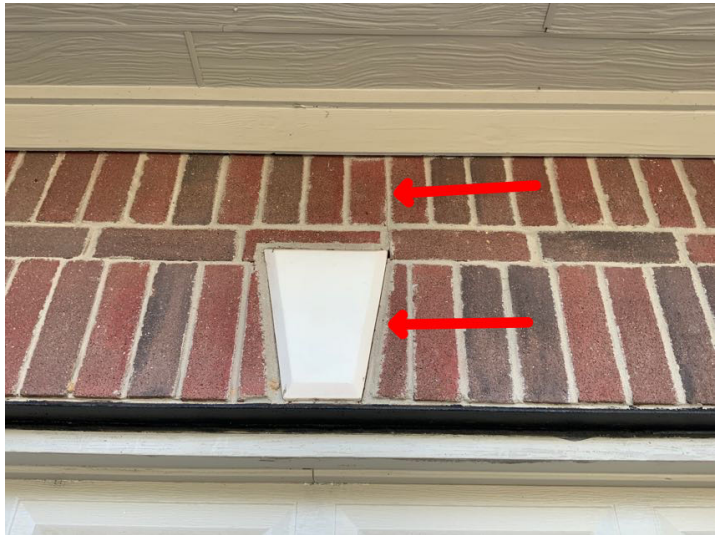
Minor settlement crack at front of home.

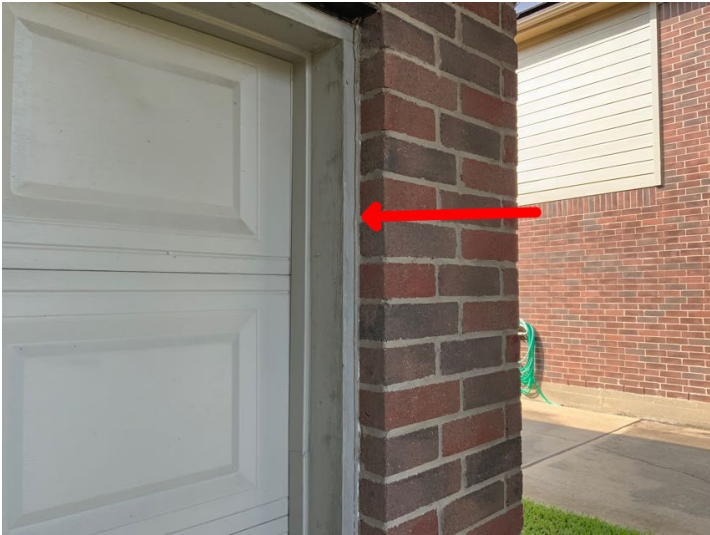
Trim board seal improvements needed at garage.

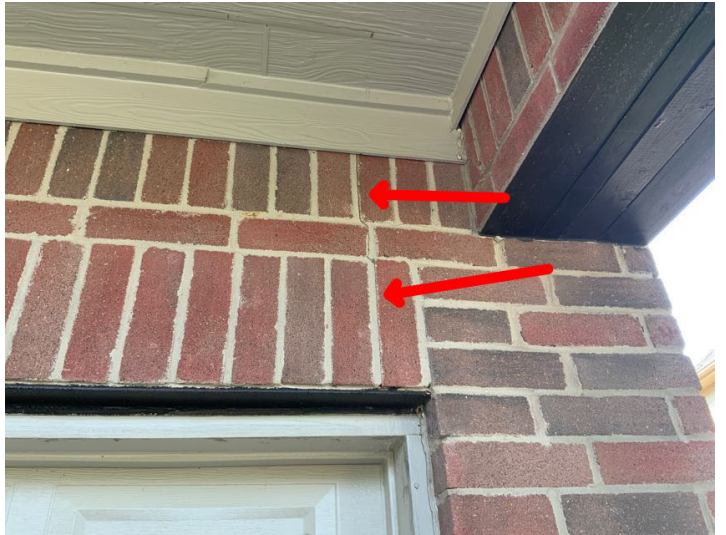
Lintel movement crack at garage.

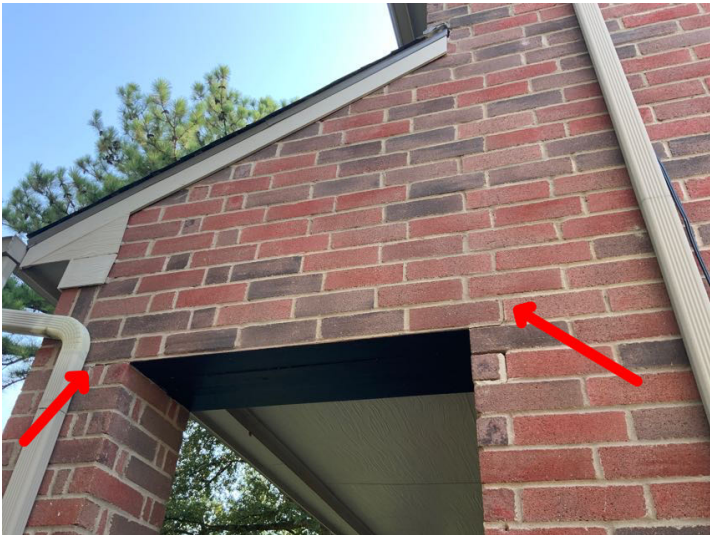
Lintel movement cracks at right of home.

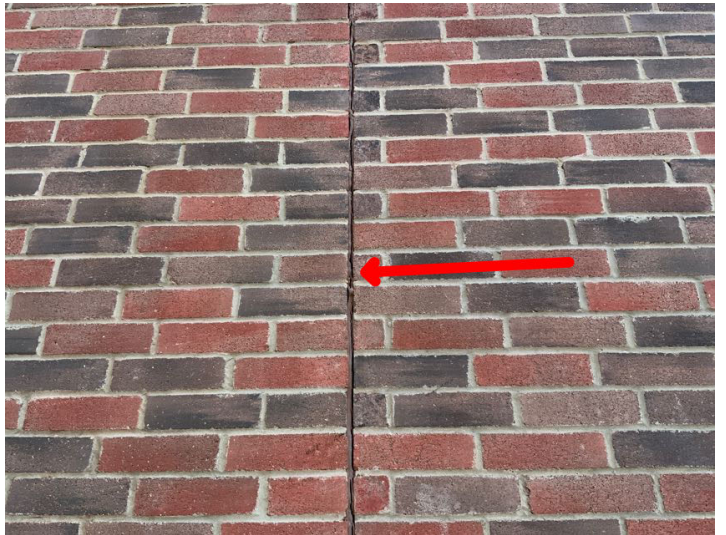
Brick seam seal improvements needed at right of home.

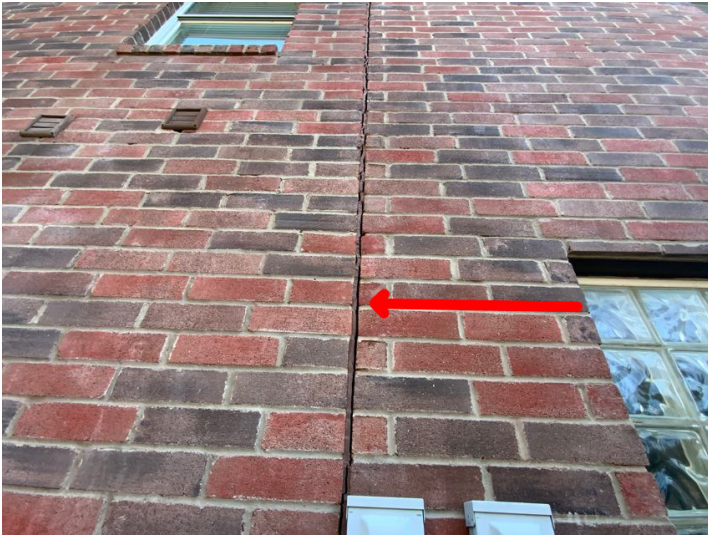
Brick seam seal improvements needed at right of home.

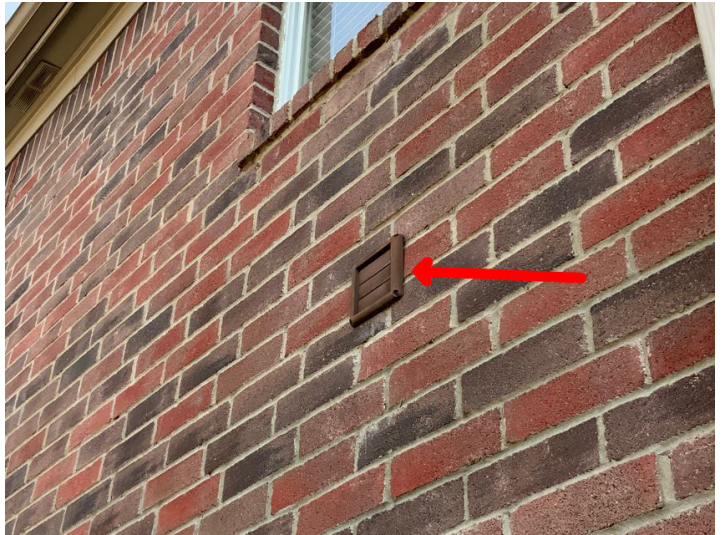
Vent perimeter seal improvements needed at right of home.

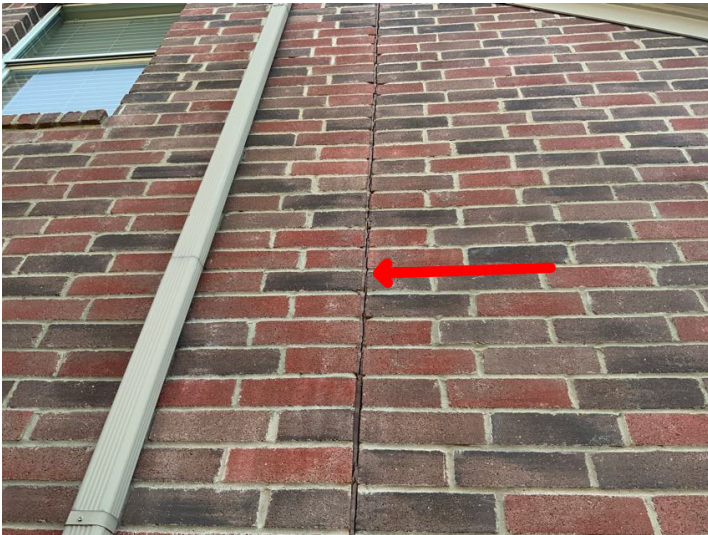
Brick seam seal improvements needed at right of home.

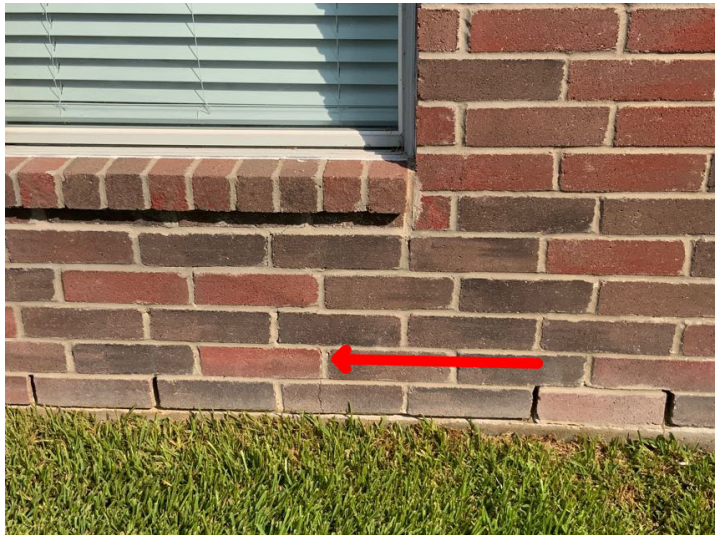
Minor settlement crack at Back of home.

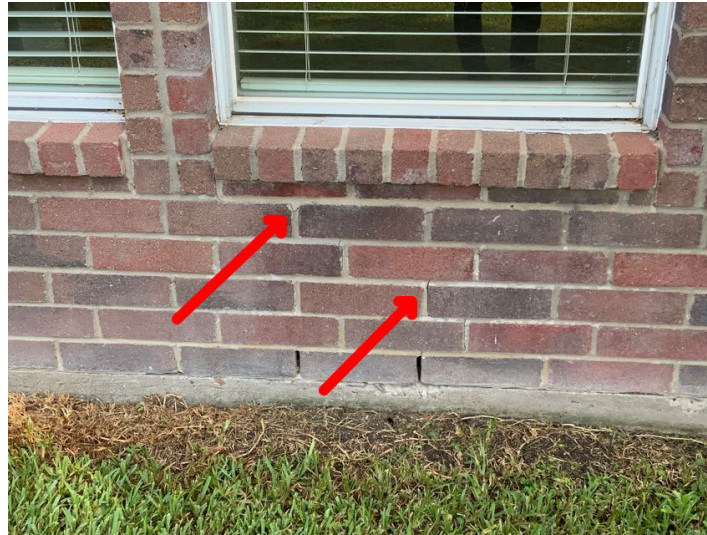
Minor settlement crack at Back of home.

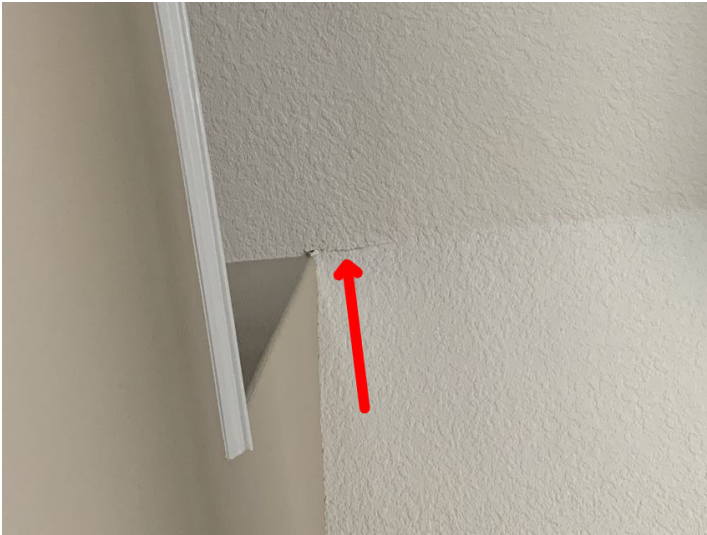
Seam failure at entryway.

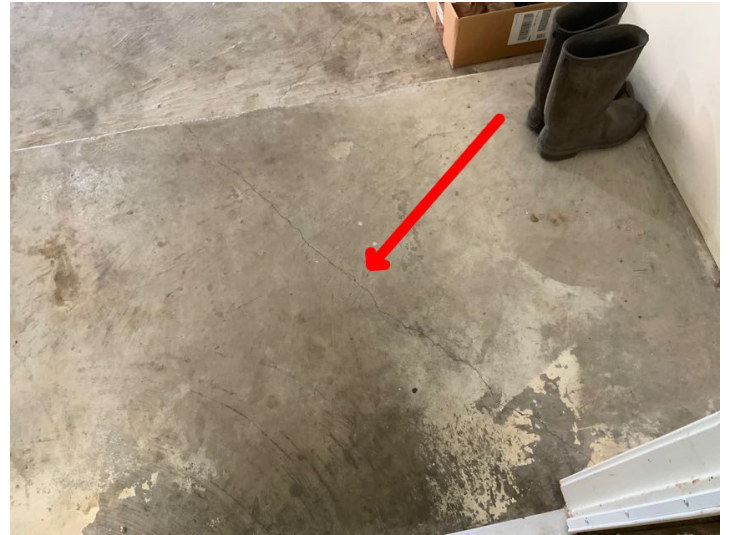
Minor cracks in garage floor.

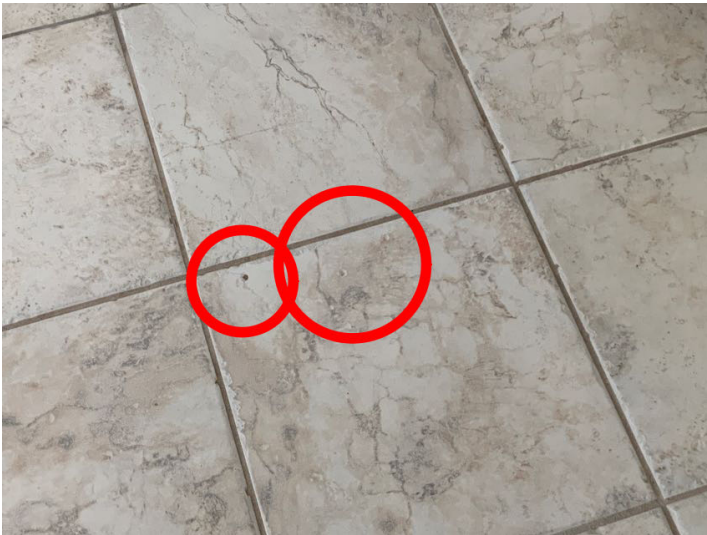
Chipped tile in primary bedroom.

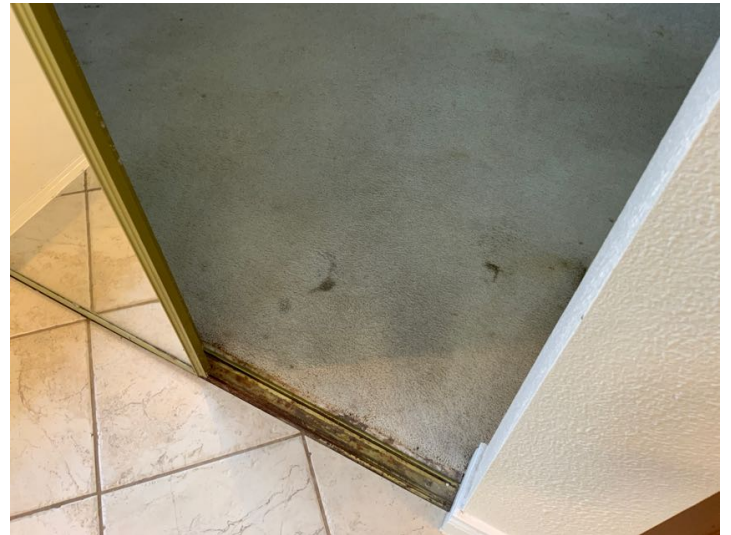
Damaged and stained carpets at primary bedroom closet.

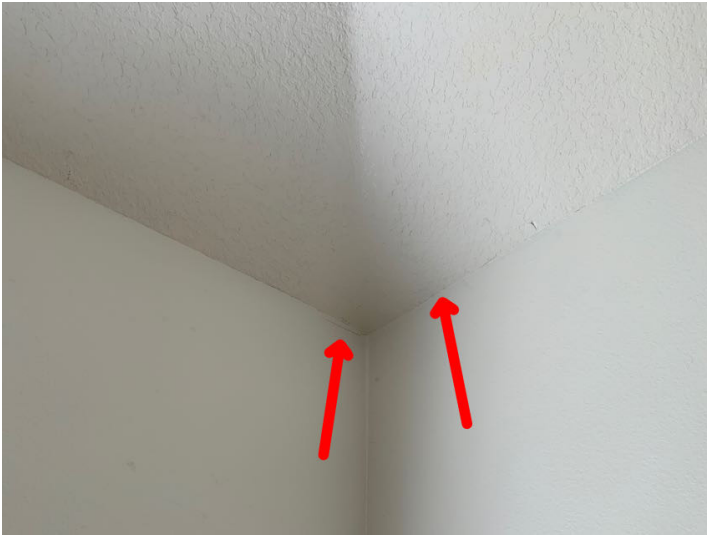
Seam failure in primary bedroom.

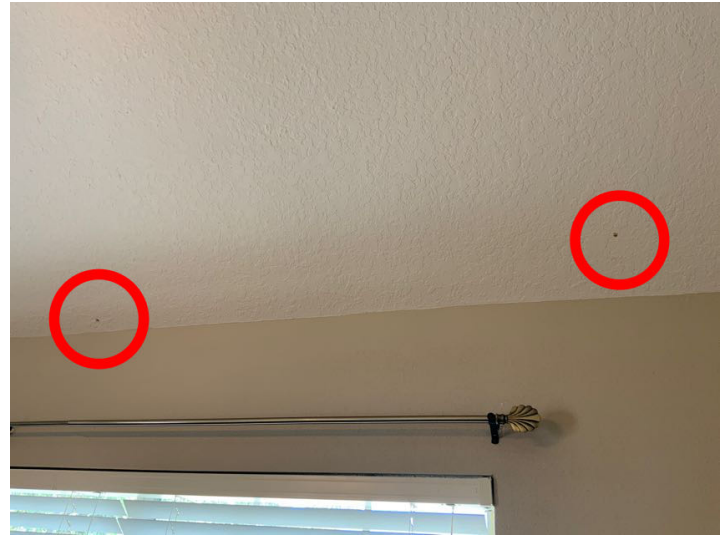
Nail pops throughout home.

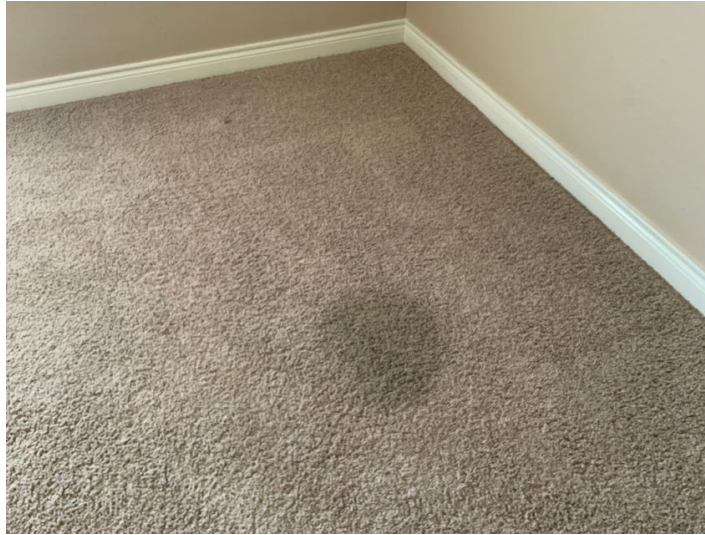
Carpet screen at upstairs Back left bedroom.

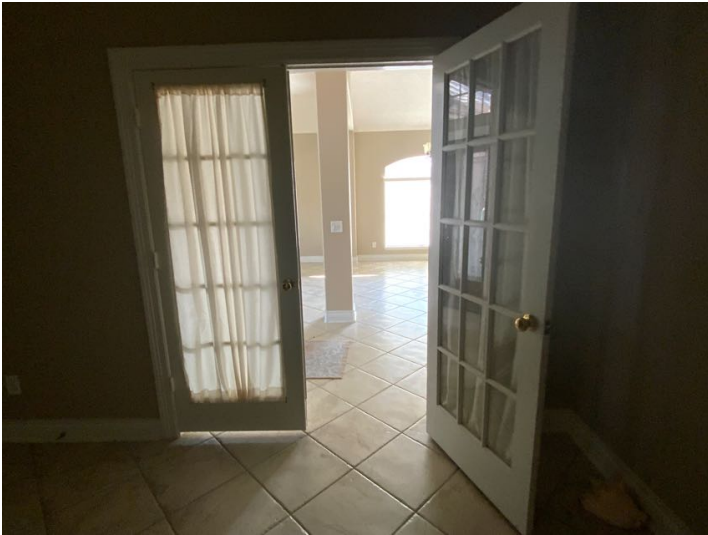
Ghost door at office.

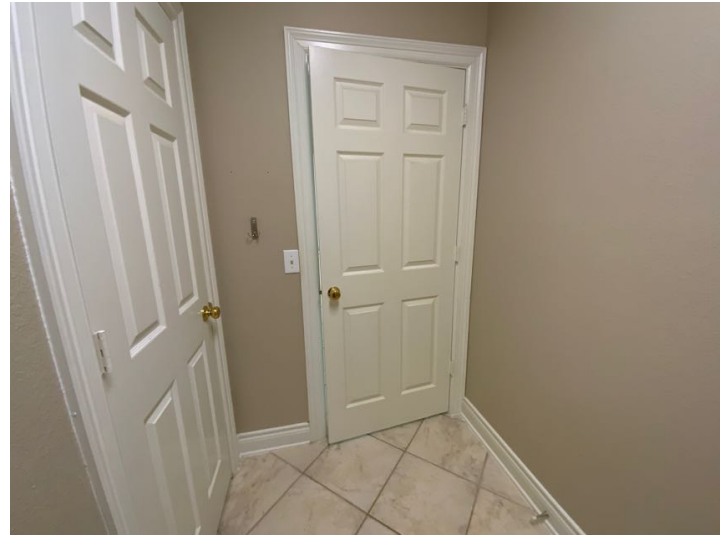
Trim adjustments needed at laundry room.

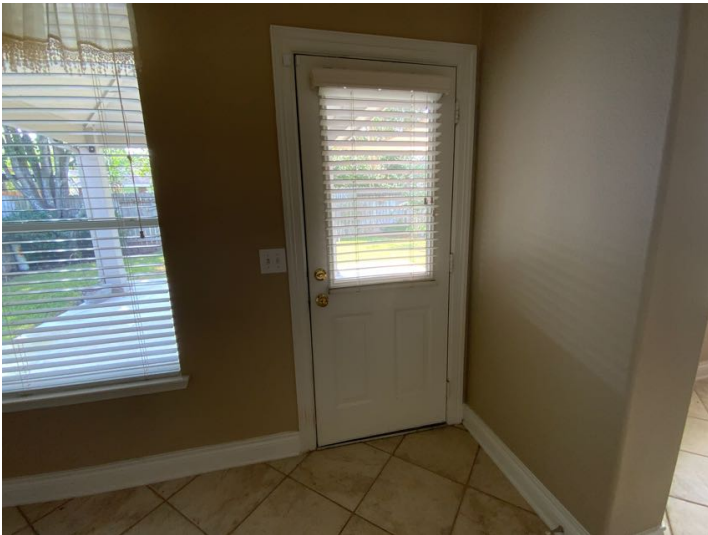
Trim adjustments needed at Back door.

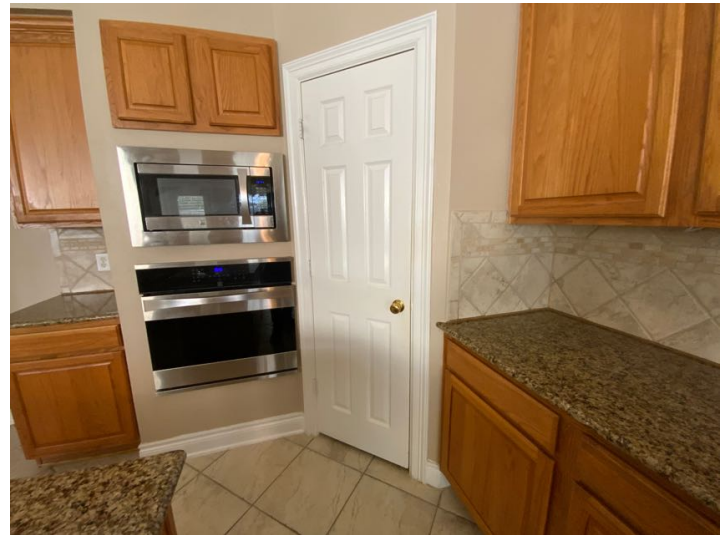
Trim adjustments needed at pantry door.

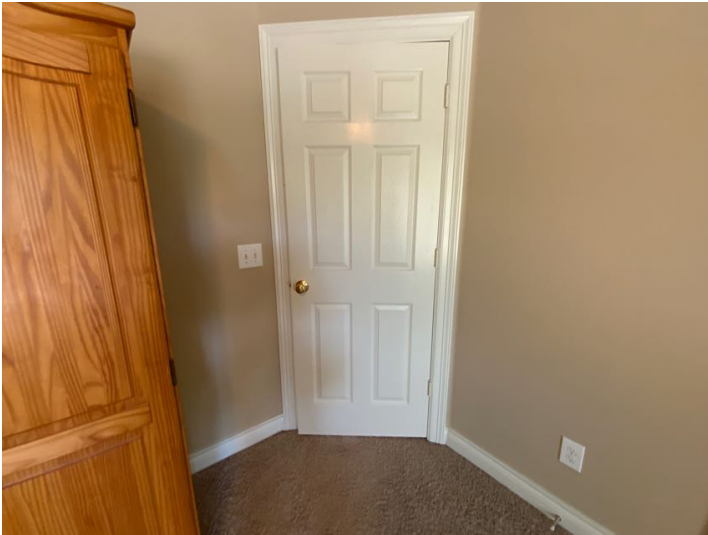
Upstairs front left bedroom door does not latch.

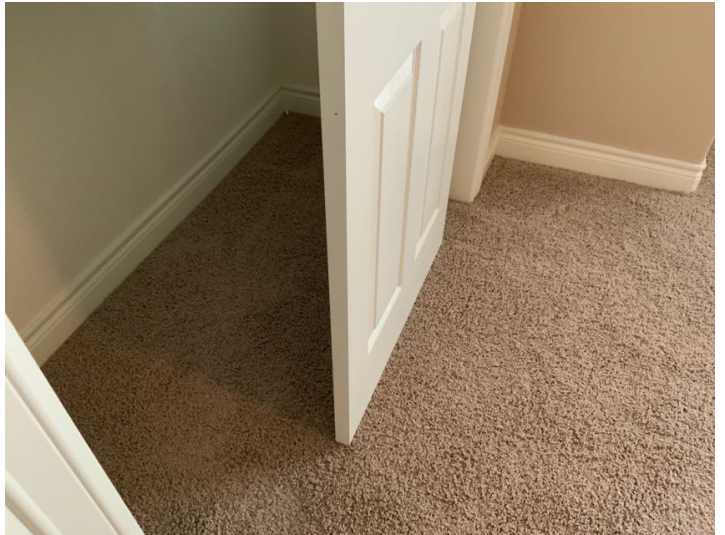
Missing hardware at upstairs front left bedroom closet.

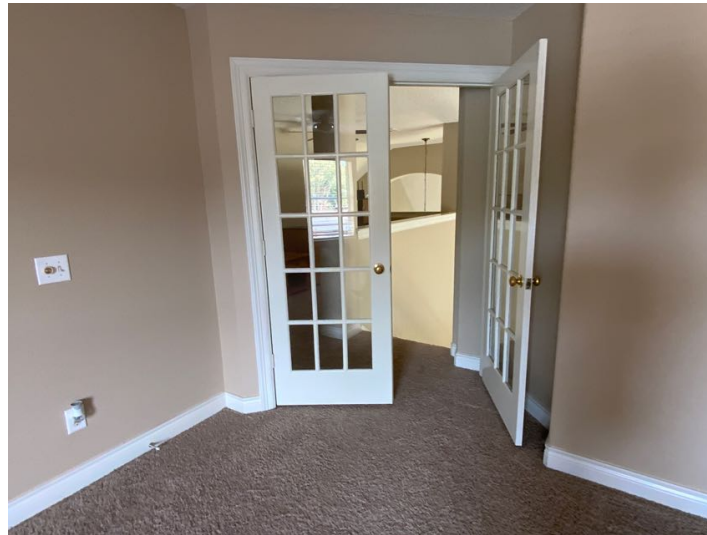
Trim adjustments needed at upstairs media room.

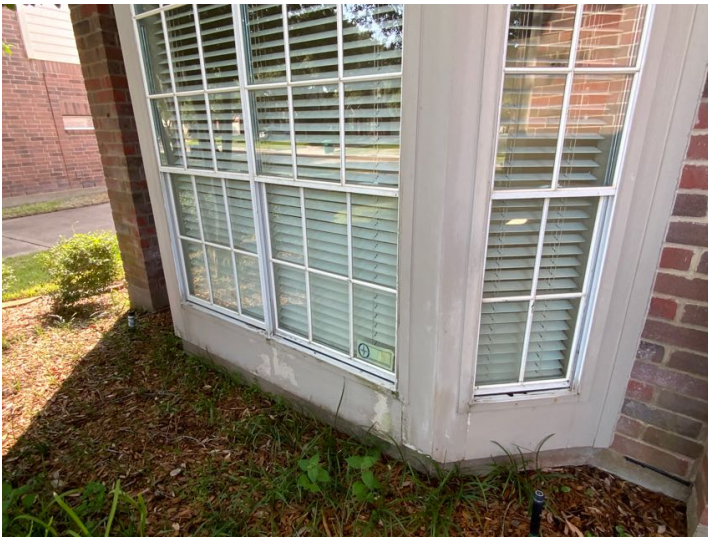
Missing screens throughout home.

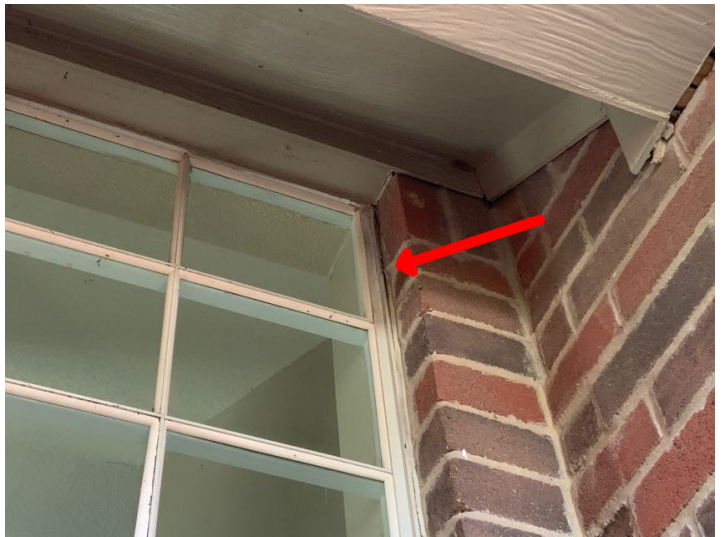
Exterior caulking improvements needed at front of home.

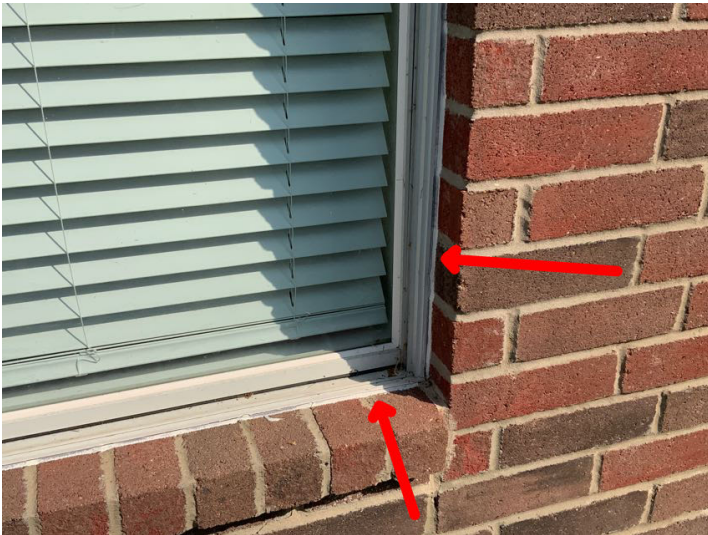
Exterior caulking improvements needed at Back of home.

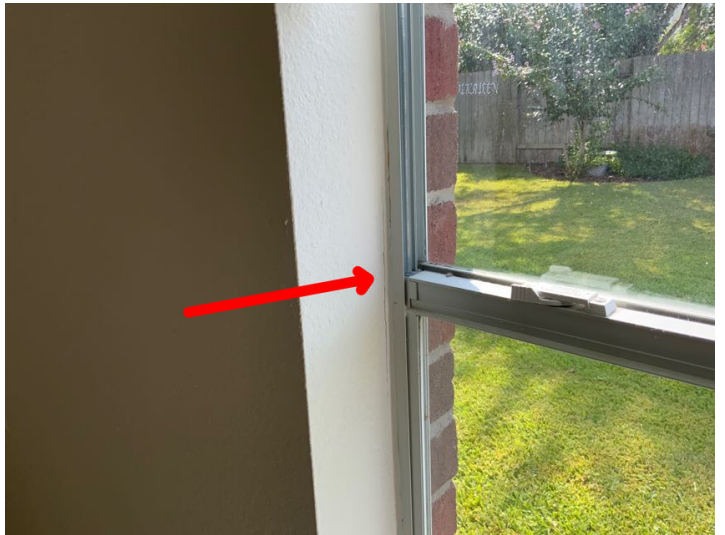
Interior caulking improvements needed throughout home.

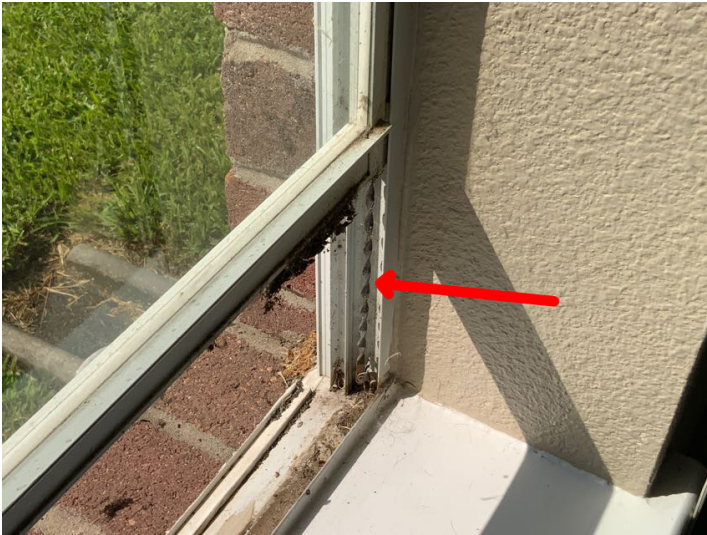
- Balance springs are in need of repair and/or replacement. These allow the window to safely remain in an open position. Sprung units can be a potential hazard.

Sprung balance springs throughout home.

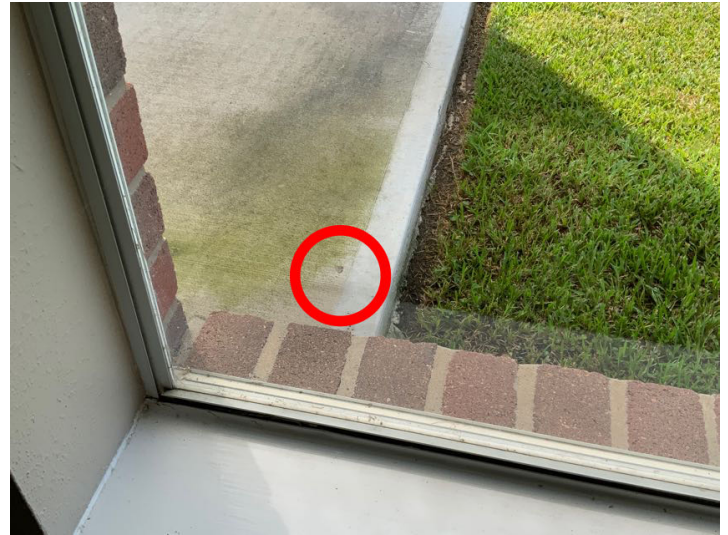
Cracked windows in living room.

Windows: Repair cracked window.

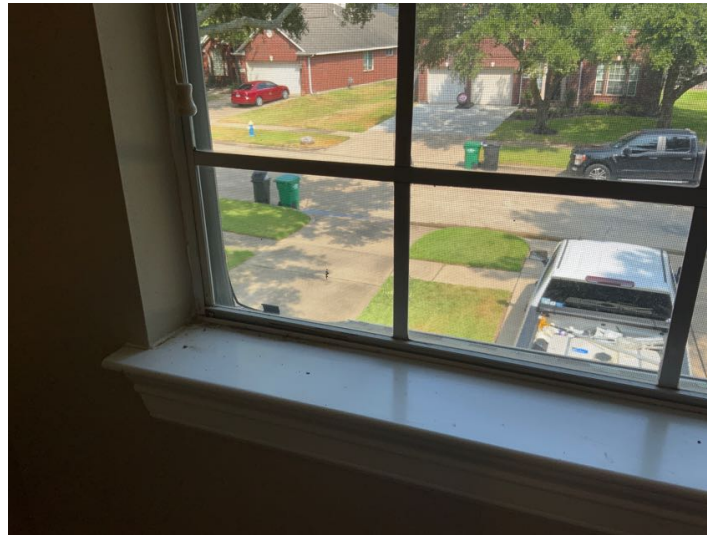
Damaged screen at upstairs front right bedroom.

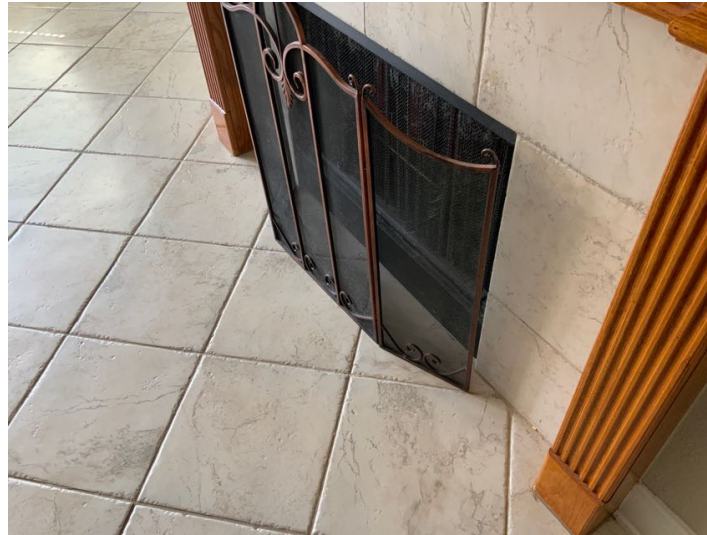
Undefined hearth.

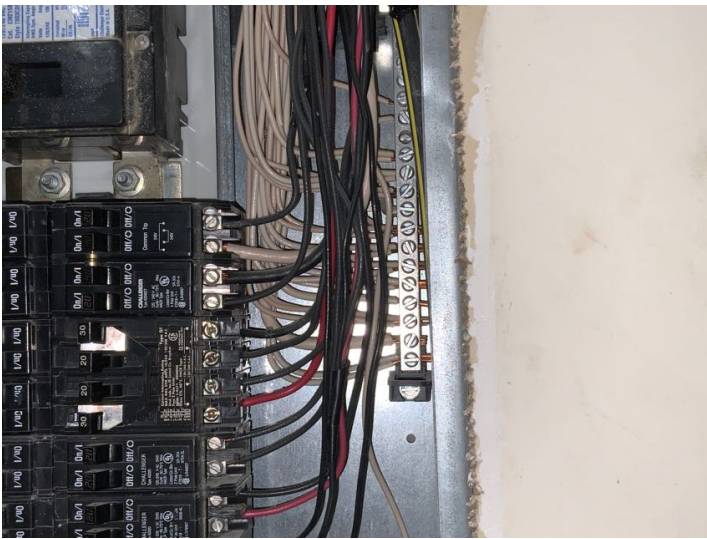
Double tapping on the neutral bar.

Electrical: Licensed electrician needed to:
- Replace oversized A/C breaker.
- Correct all double tapping on the neutral bar.

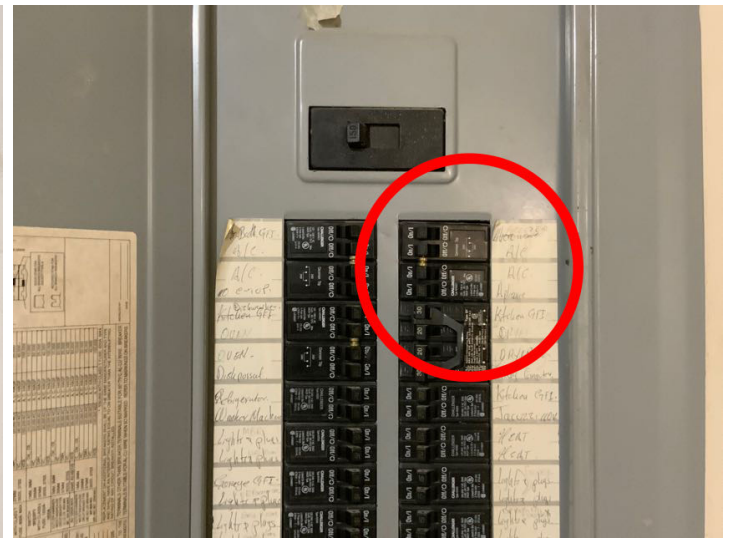
- Further evaluation by a licensed electrician is recommended.
- Fasteners used to secure the panel cover are required to have blunt ends in order to reduce the risk of wire damage or injury. Replacement of improper fasteners is needed.
- Double tapping was observed at the neutral bar. Each neutral wire should connect to the neutral bar on it's own lug. Repairs are needed by a licensed electrician for safety purposes.
- Oversized breakers within the main distribution panel should be replaced by a licensed electrician for safety purposes. Oversized breakers can serve as a fire hazard.

Oversized **A/C** breaker.

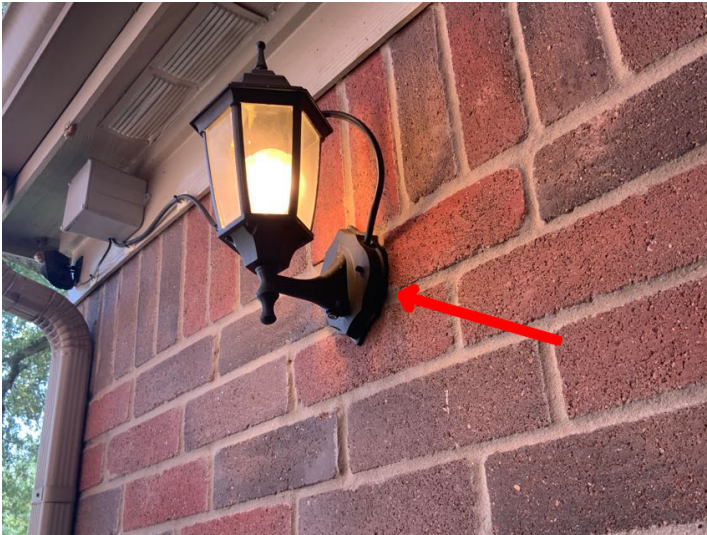
Outdoor light seals needed.

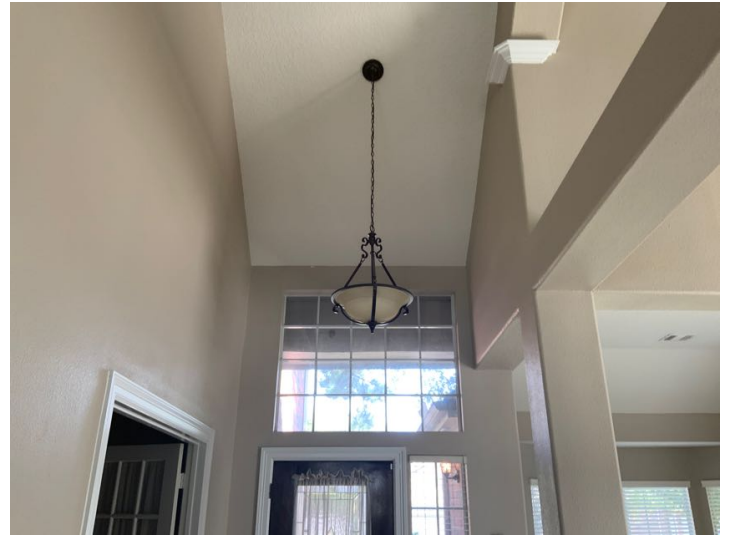
Inoperative light at entryway.

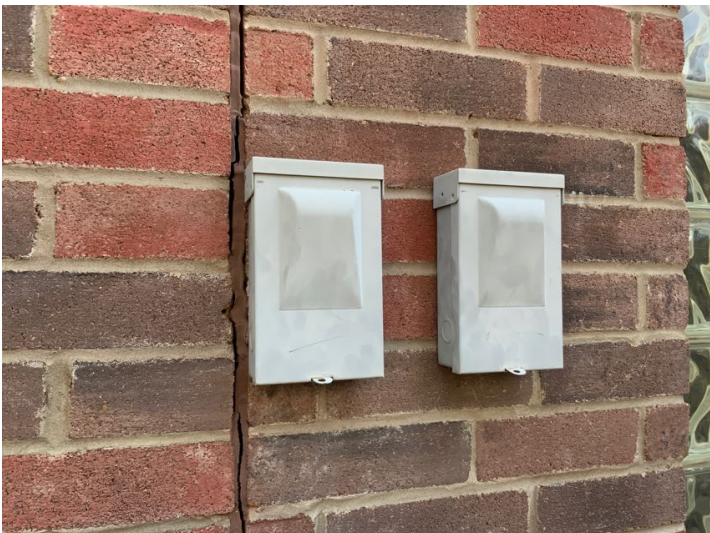
Seals needed.

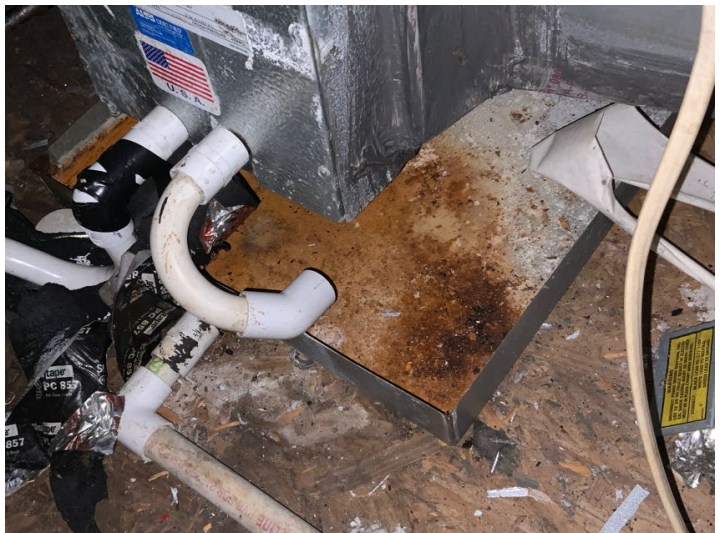
Rust in drip pan under unit 1.

HVAC: Qualified HVAC technician needed to:
- Clear rust in drip pan at unit 1.

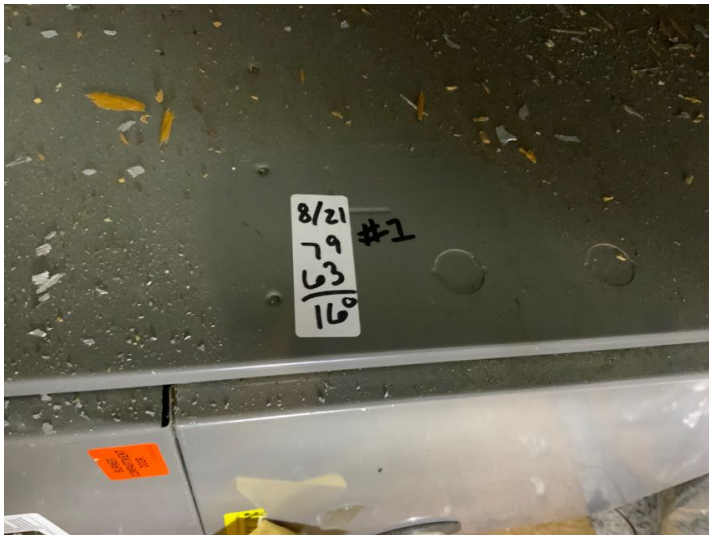
Ref photo. Unit 1. 16° differential.

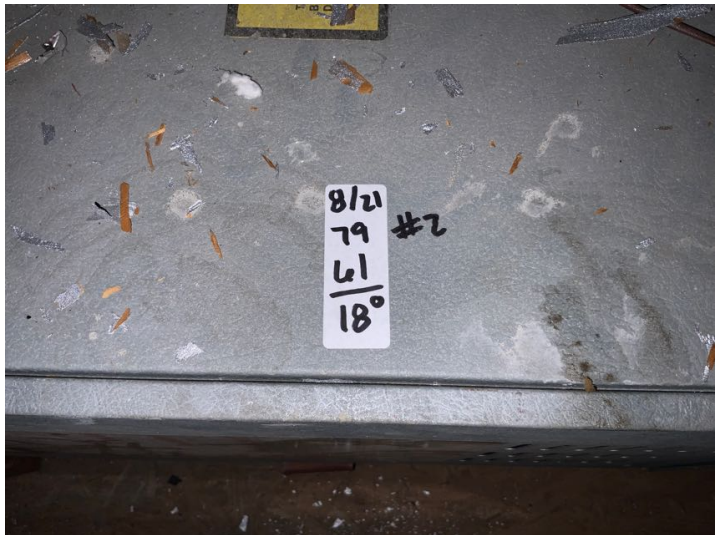
Ref photo. Unit 2. 18° differential.

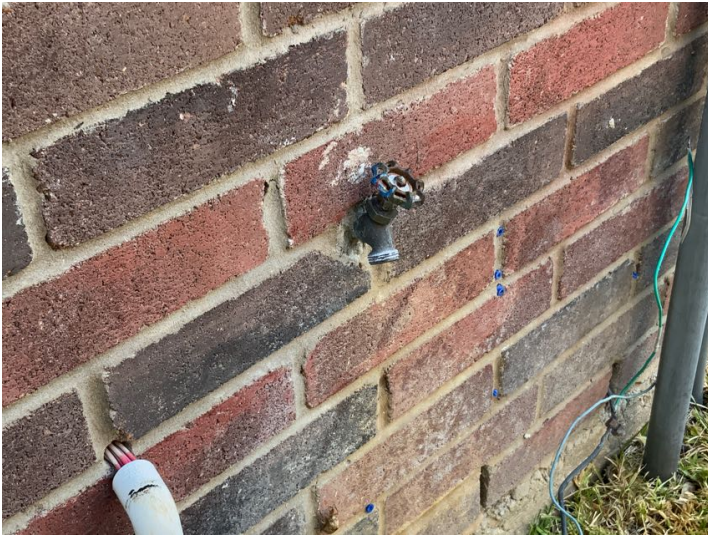
Anti siphon valves are required.

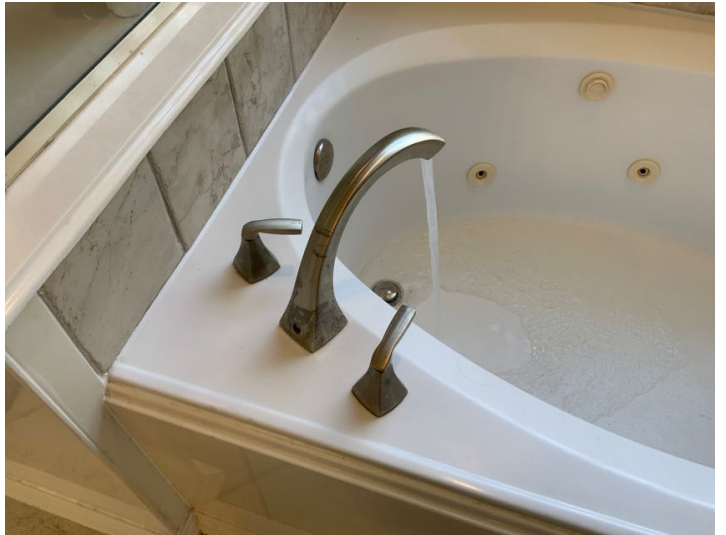
- The faucet is loose and should be tightened to reduce the risk of supply lines coming loose, potentially leaking to a leak.
- Fixtures in tubs, showers, and/or sinks need to be sealed to prevent water from getting behind or below units, causing damage.

Loose faucet at primary bathroom bathtub.

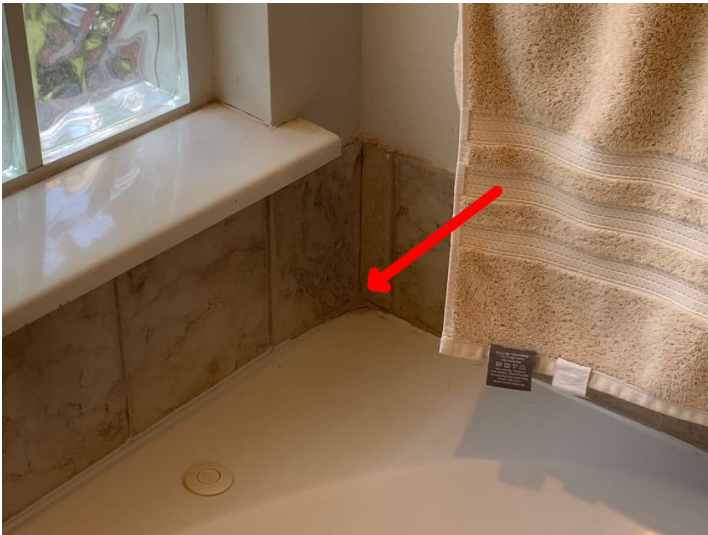
Bathtub enclosure caulking improvements needed at primary bathroom.
