PROPERTY INSPECTION REPORT FORM

<i>Name of Client</i> 23219 Sawleaf Cir, Katy, TX 77494 <i>Address of Inspected Property</i> Tyler Adams <i>Name of Inspector</i> <i>Name of Sponsor (if applicable)</i>	8/21/2023 <i>Date of Inspection</i> 24087 <i>TREC License #</i> <i>TREC License #</i>
--	---

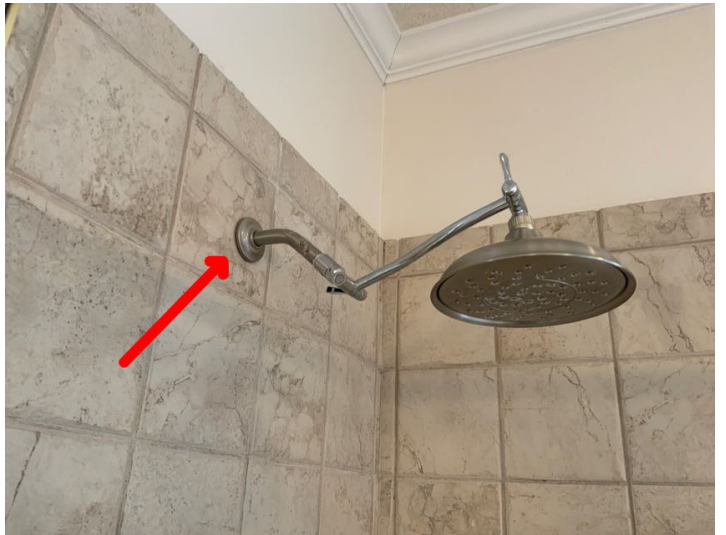
Faucet seal improvements needed at primary bathroom shower.

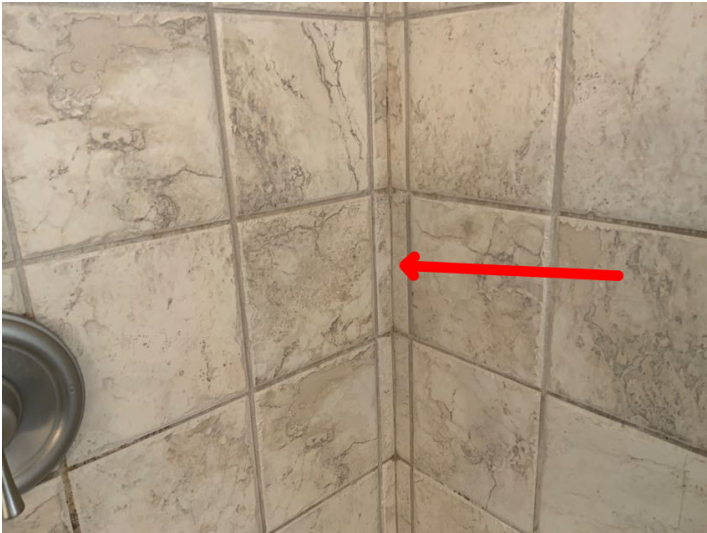
Shower enclosure caulking improvements needed at primary bathroom.

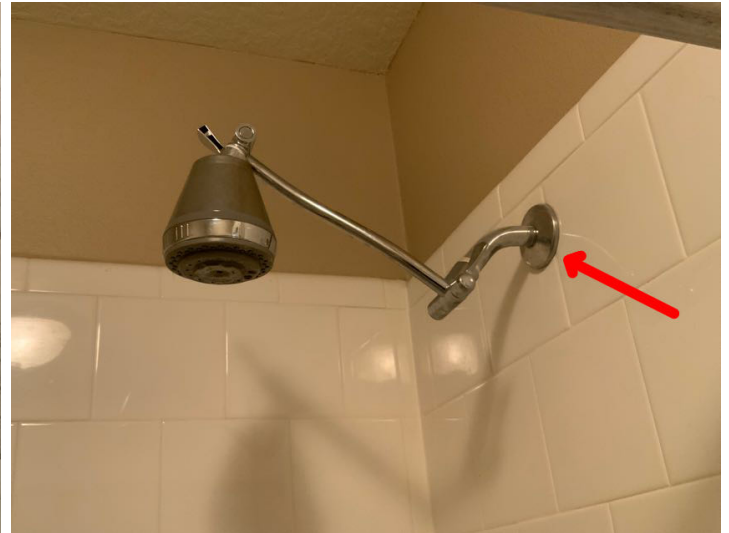
Faucet seal improvements needed at upstairs bathroom bathtub.

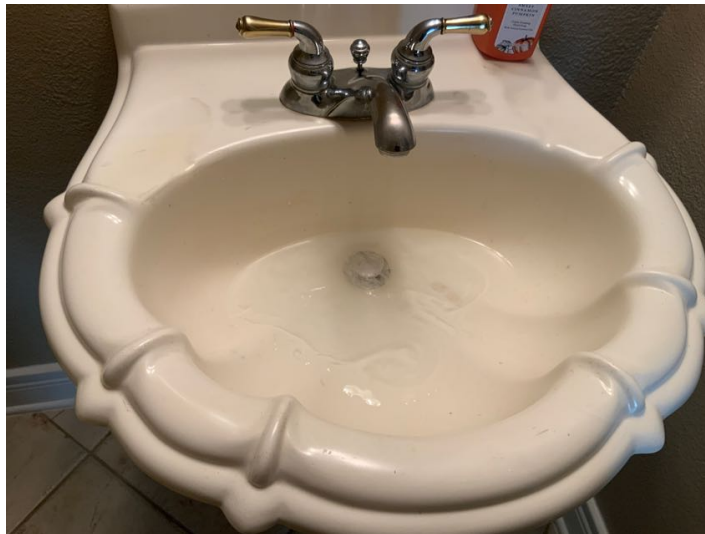
Slow drain at main bathroom sink.

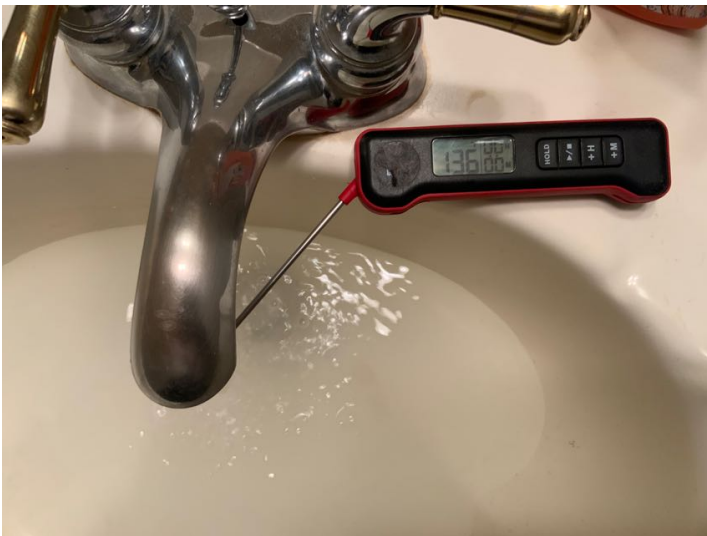
- Further evaluation by a licensed plumber is recommended.
- The water was found to be higher than what is considered safe. The water should not exceed 120 degrees for safety purposes. Adjustments should be made to lower the water temperature to reduce the risk of injury.
- The Temperature and Pressure Relief Valve (TPRV) serving the water heater is inoperative. This condition should be repaired by a licensed plumber for safety purposes.
- Flue pipe seal improvements are needed to prevent water and/or pest entry to the home.

Recommend adjusting to a safe water temperature of 120°.

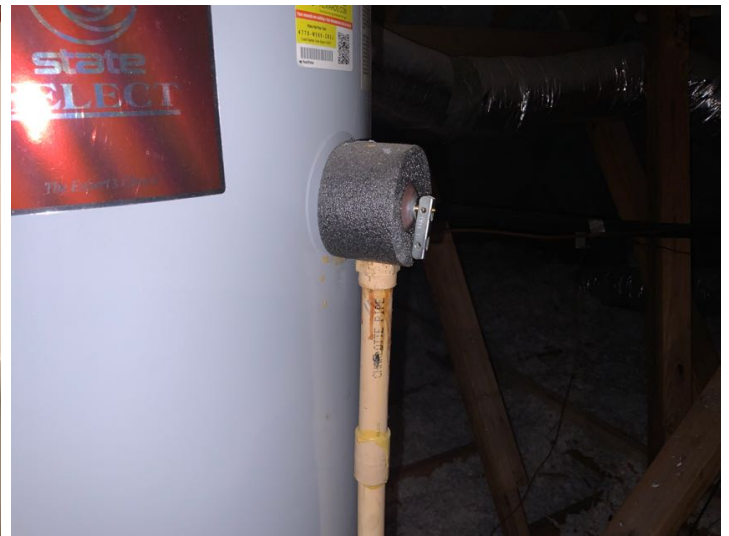
Inoperative **TPR valve**.

Plumbing: Licensed plumber needed to:
- Replace inoperative TPR valve.

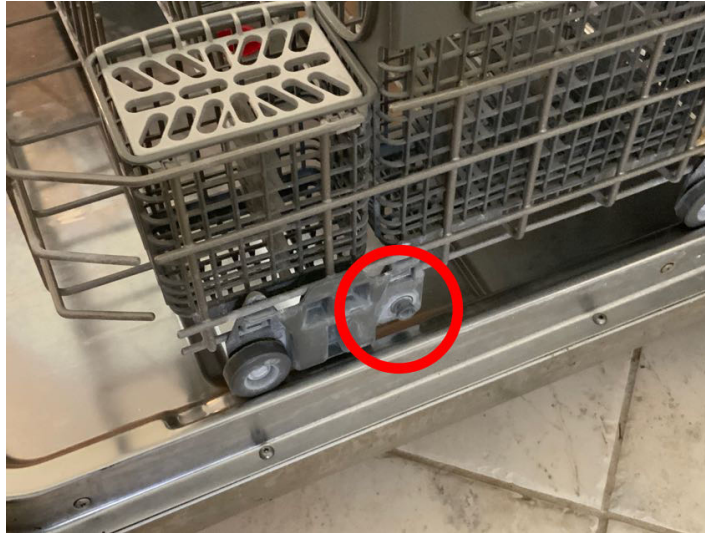
- The dish trays for the dishwasher were found to be in poor condition and should be repaired.

Damaged tray.

Appliances: Replace damaged dishwasher tray.

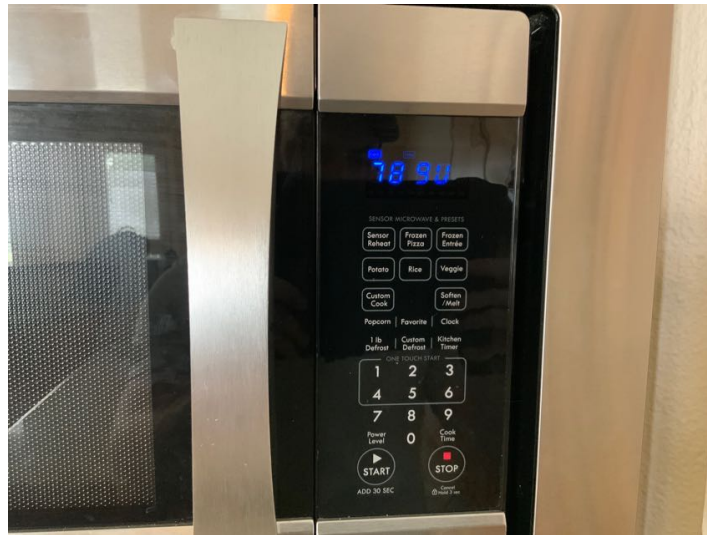
- The microwave display was damaged at the time of the inspection. Repairs may be desirable.

Damaged display.
