GC Home Inspection

8106 Rhobell St
Houston, TX 77078

PROPERTY INSPECTION REPORT FORM

Elijah Adeniyi <i>Name of Client</i>	09/06/2023 <i>Date of Inspection</i>
8106 Rhobell St, Houston, TX 77078 <i>Address of Inspected Property</i>	
Chad Gregory Langston Jr. <i>Name of Inspector</i>	25839 <i>TREC License #</i>
Chad Langston <i>Name of Sponsor (if applicable)</i>	7946 <i>TREC License #</i>

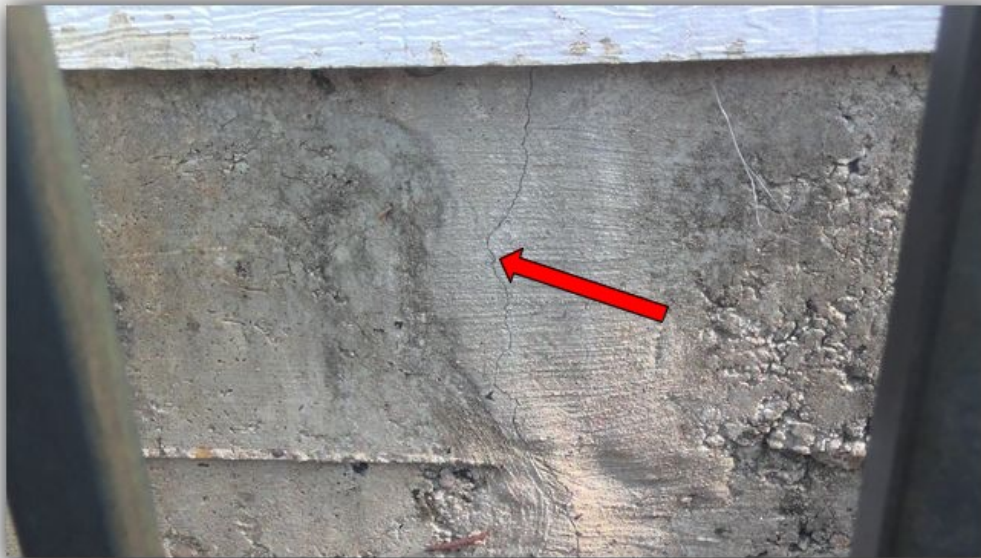
Slightly greater than typical foundation cracking was observed. The amount of movement does not suggest a serious structural problem. This area should, of course, be monitored. The rate of movement cannot be predicted during a one-time inspection.

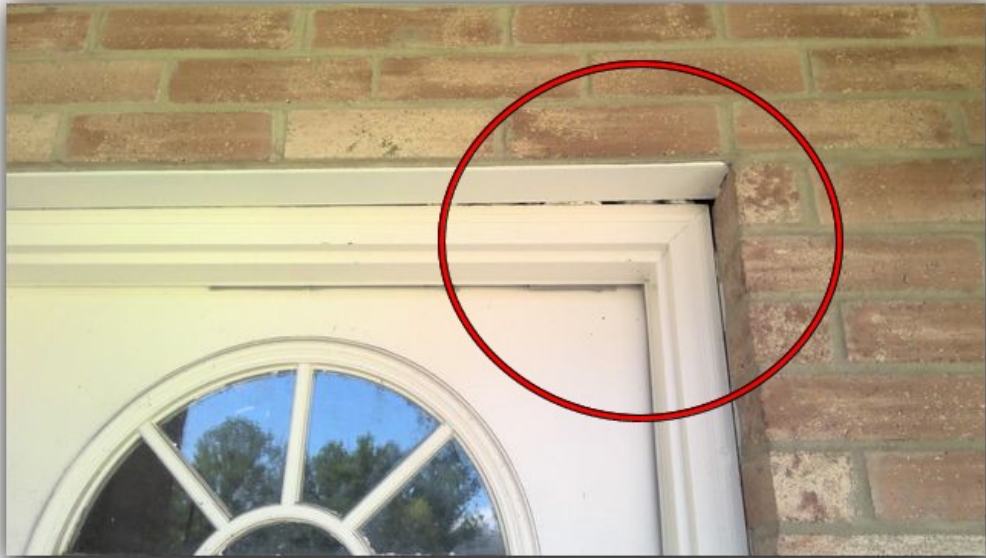
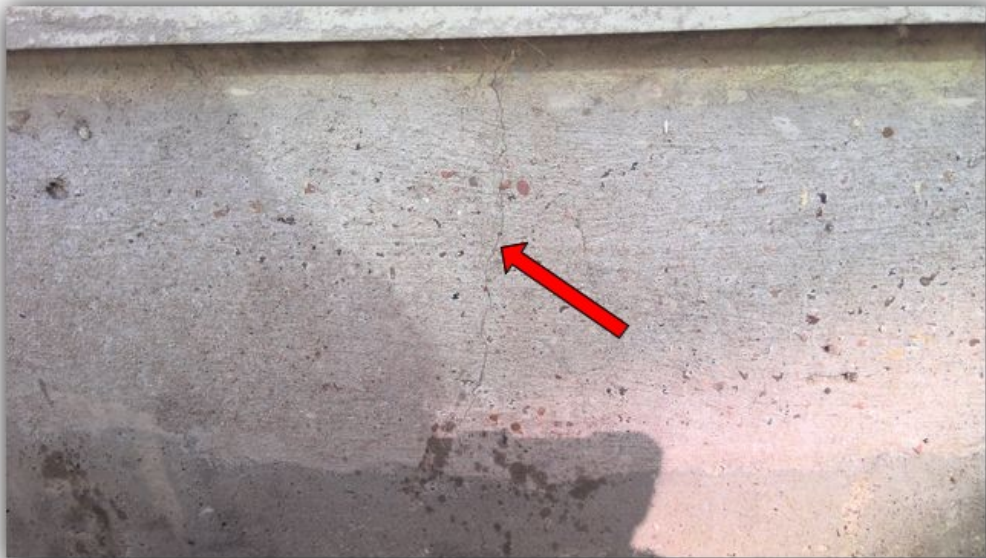
Common minor cracks were observed in the foundation walls of the house. This implies that some structural movement of the building has occurred, as is typical of most houses.

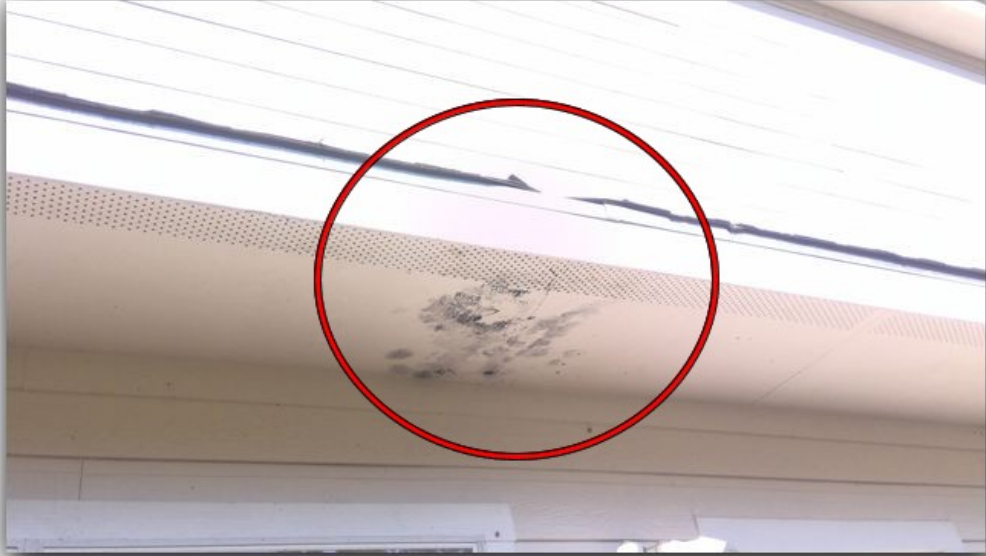
Minor repairs to the roofing are recommended. Damaged or missing roofing material should be repaired. All roof penetrations should be examined and sealed as necessary.

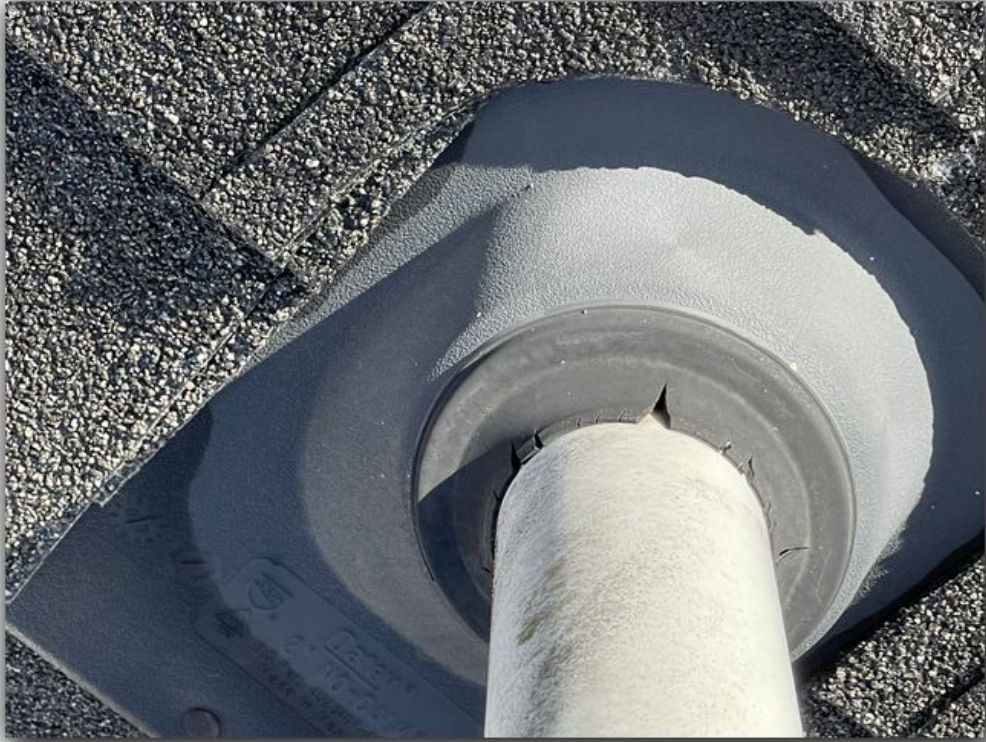
Lifted flashing should be re-secured.

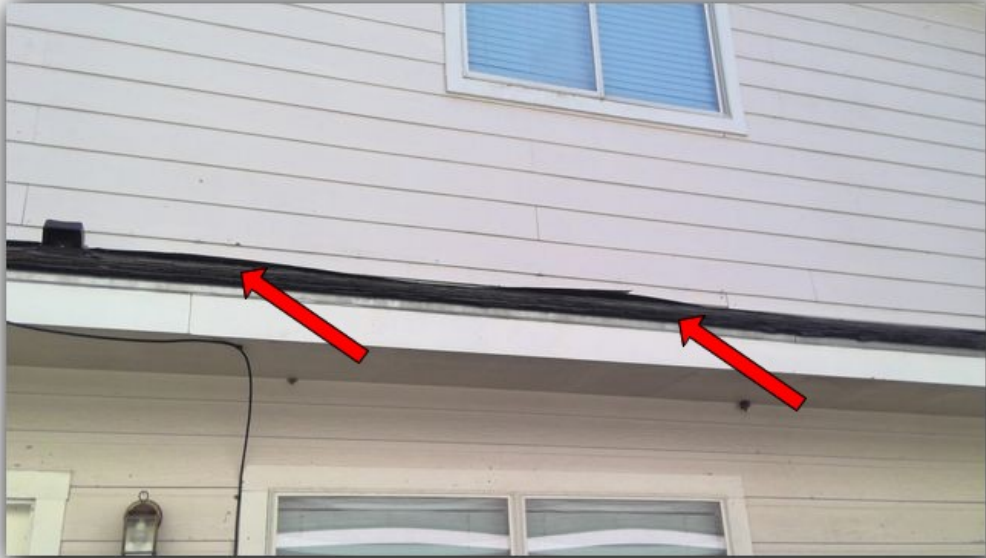
Older roof, approximately 1/2 of serviceable life expectancy. Observed one or more of the following conditions: brittle, cracked, curled ends, and/or excessive granular loss of shingles.

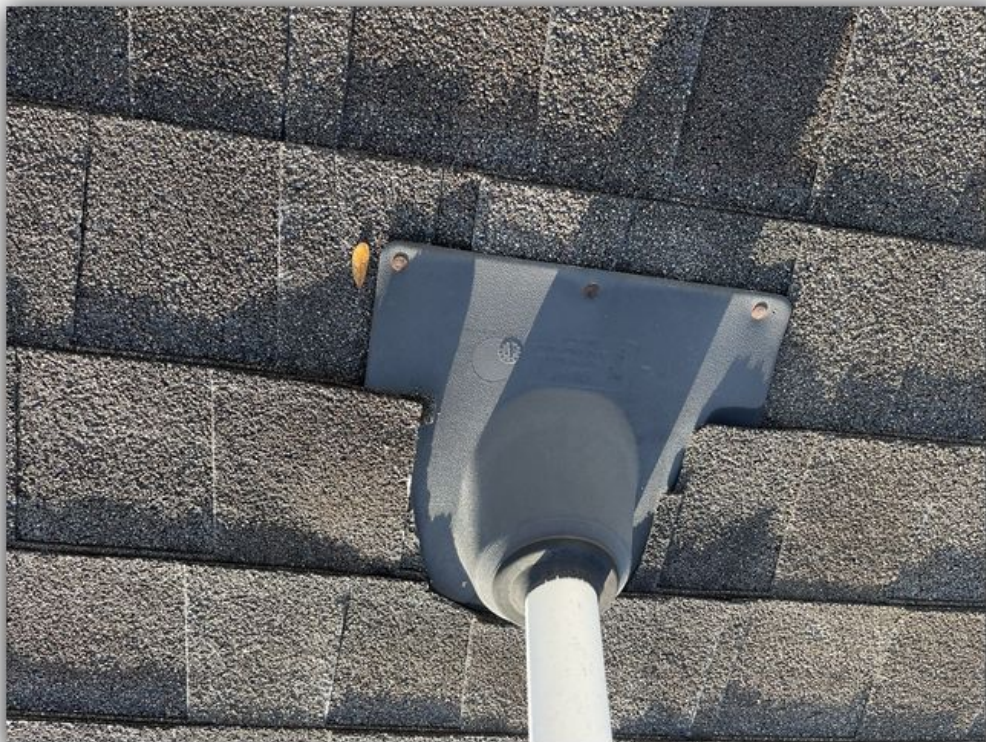
It is recommended that exposed nail heads be caulked or sealed appropriately.

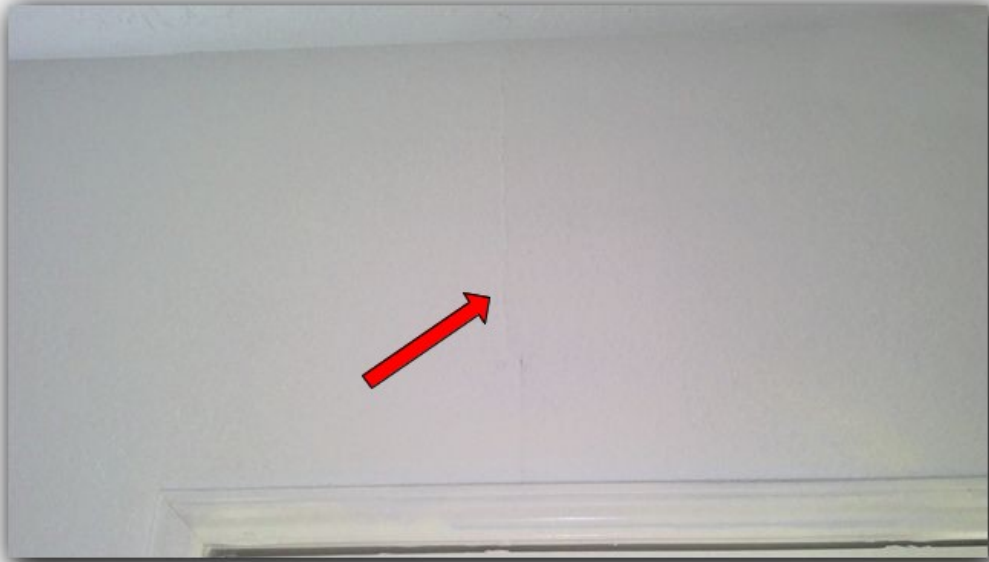
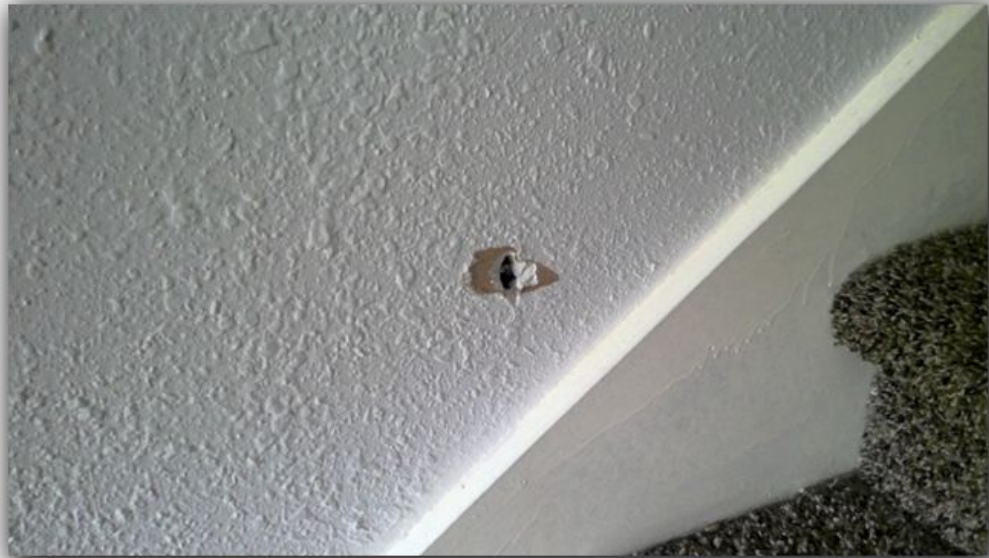
Damage to the interior finish in various locations was observed and should be repaired.

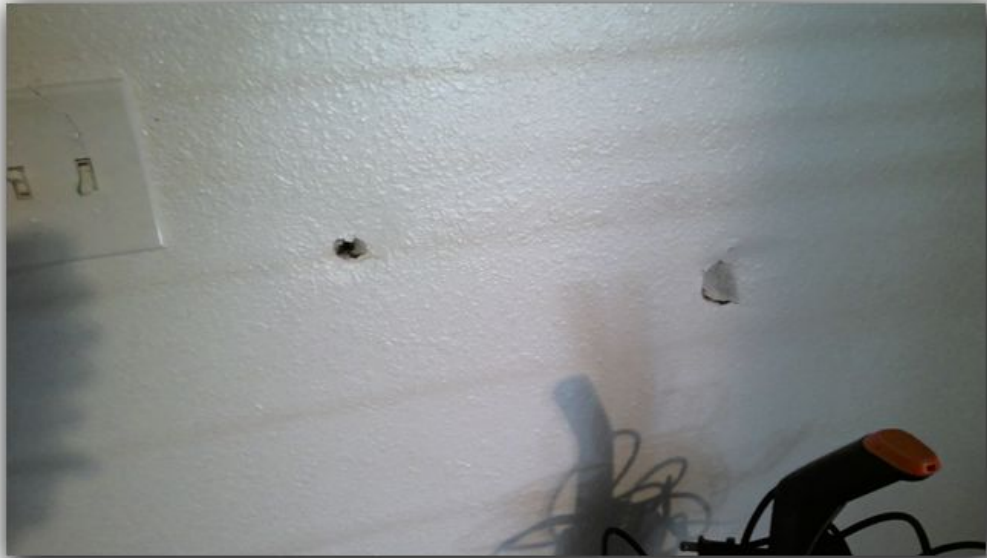
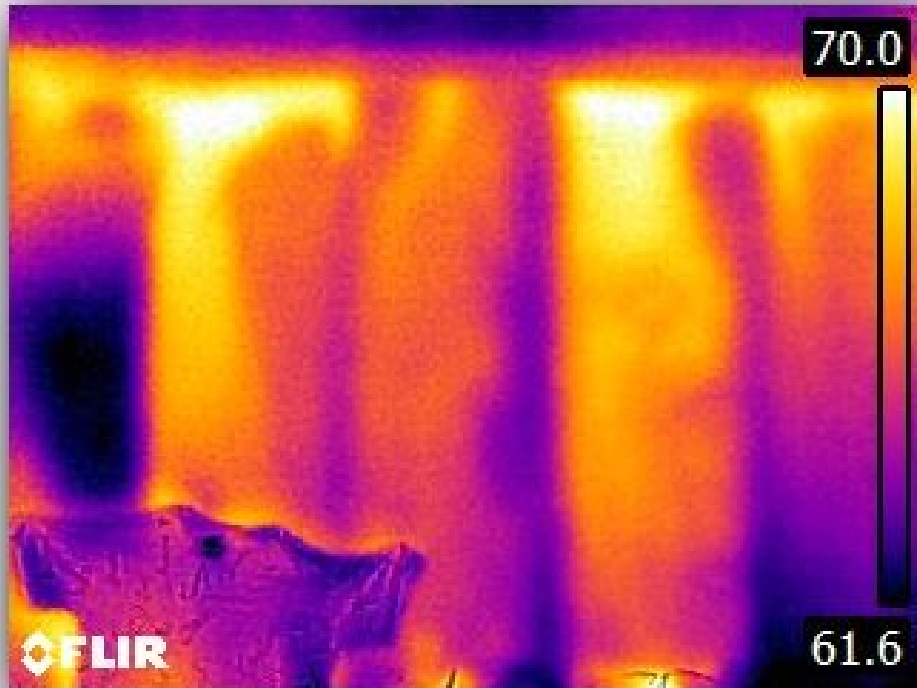
A thermal anomaly was observed in the wall of the north bedroom indicating missing insulation. Improvements may be desirable.

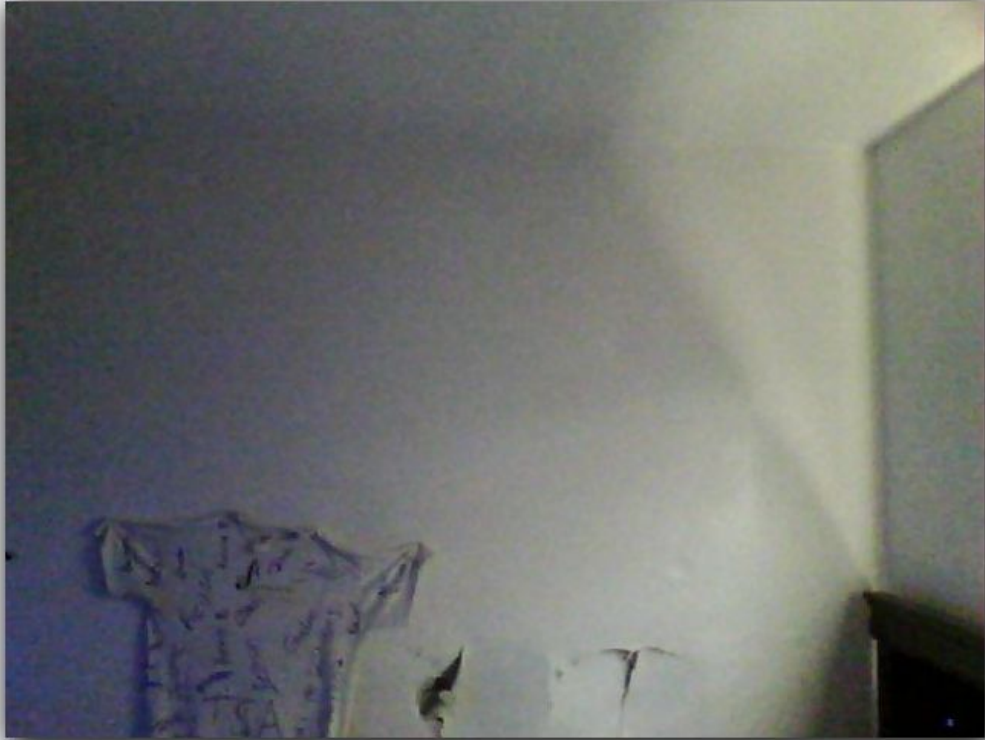
A thermal anomaly was observed in the south bedroom wall adjacent to the tub indicating moisture likely from spillage at the tub/shower. Improvements should be made as necessary.

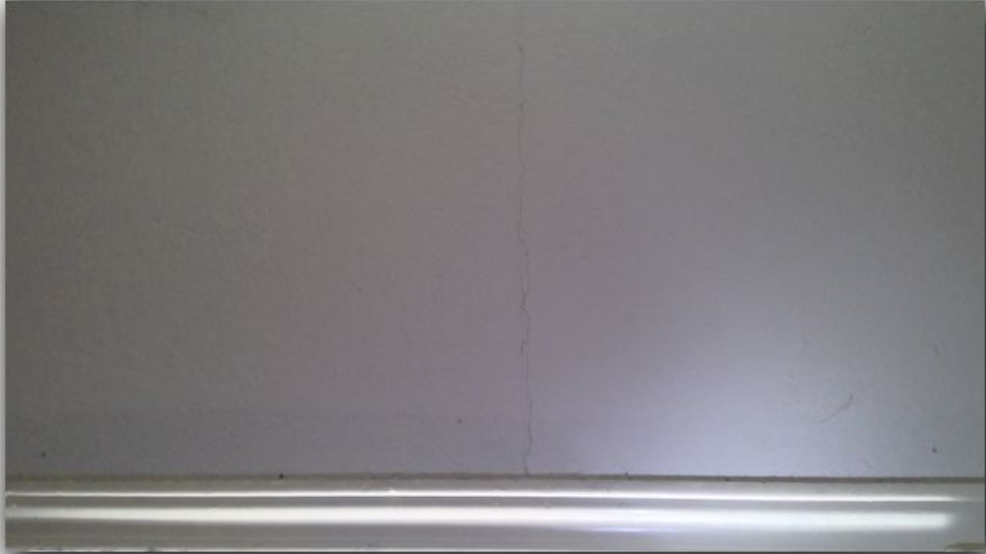
Minor cracks were noted on interior walls in the living room. This condition is mainly cosmetic in nature and should be patched.

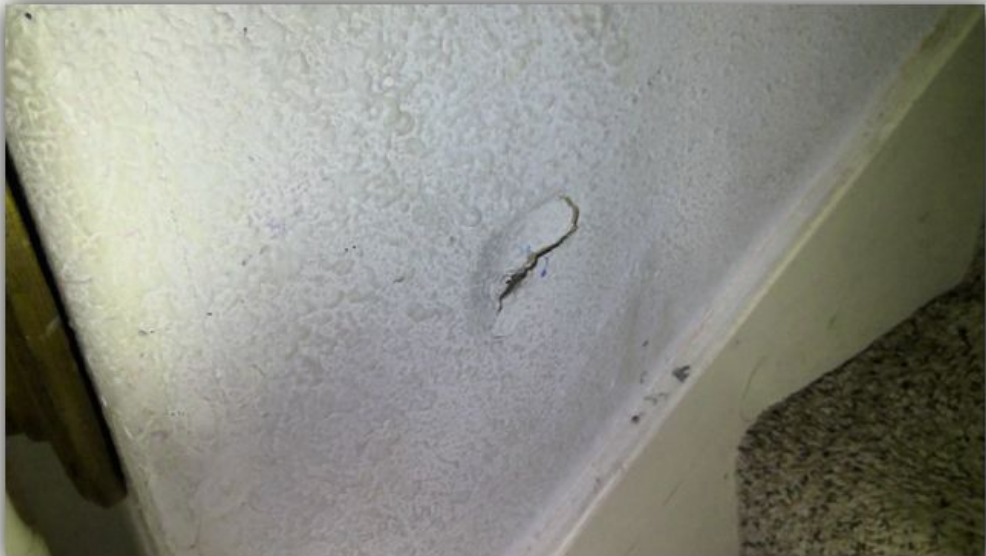
Damage to the interior finish at the stairway was observed and should be repaired.

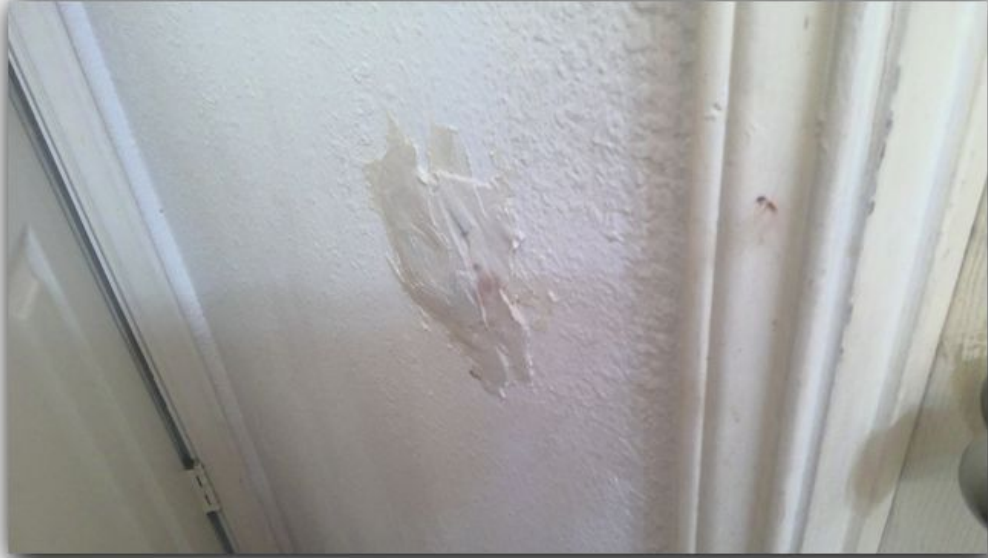
Evidence of patching was detected on interior walls in the second floor bathroom on the southside.

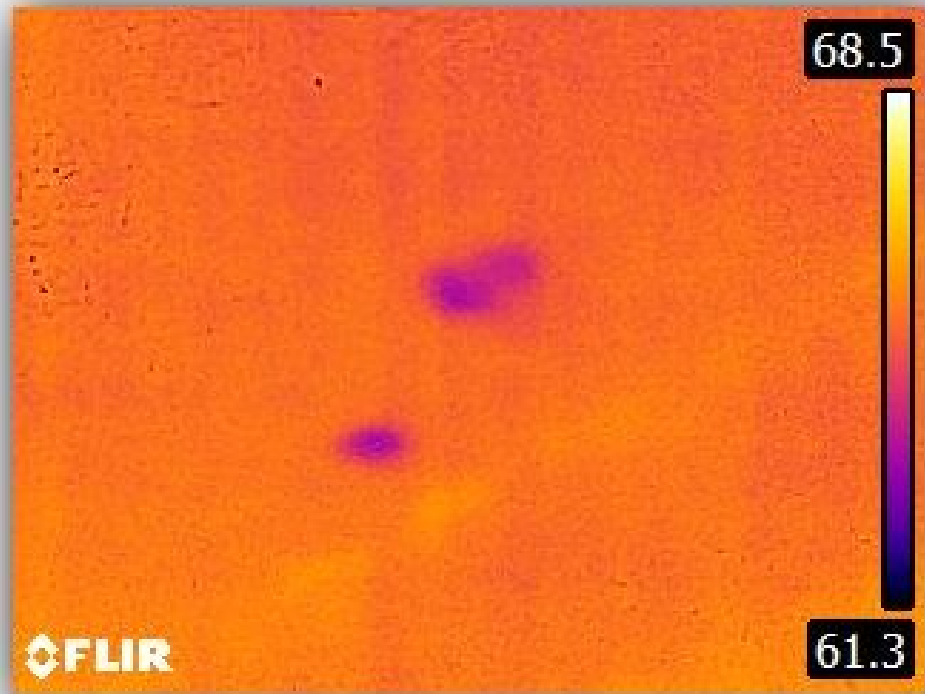
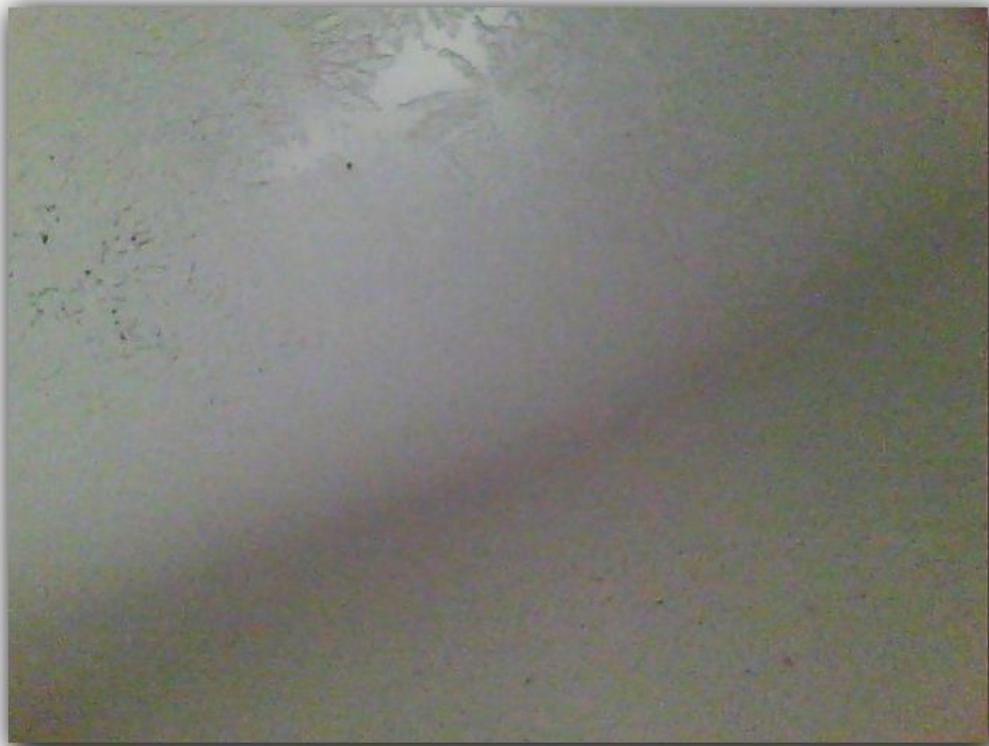
Thermal anomalies were observed in the ceiling of the master bedroom and kitchen/breakfast room indicating moisture. Improvements should be made as necessary.

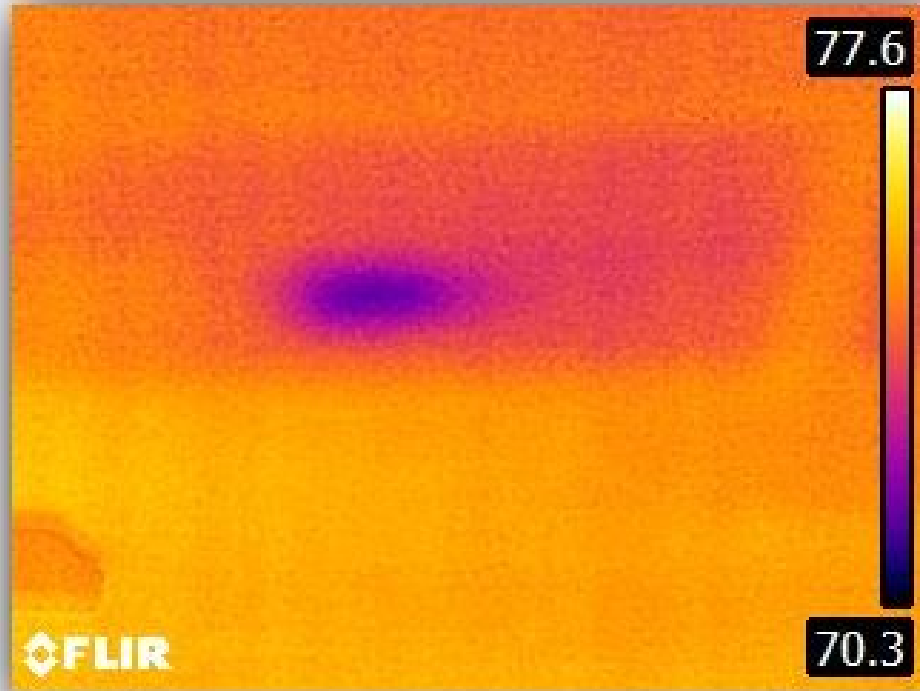
Thermal anomalies were observed in the ceiling of the master bedroom and adjacent to the return air register on the second floor indicating moisture. Further investigation and repair should be made as necessary.

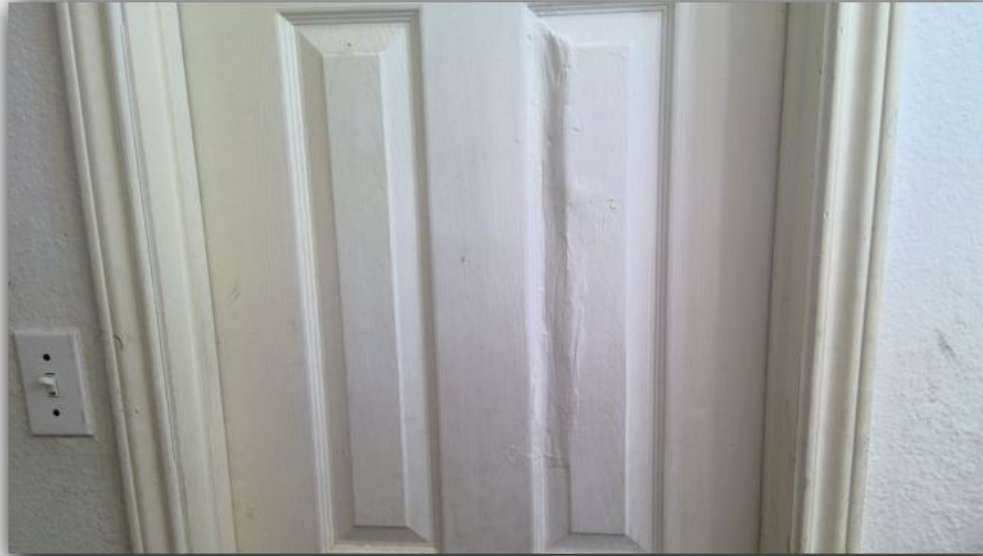
Damaged or non-functional doors in the south second floor bathroom should be repaired.

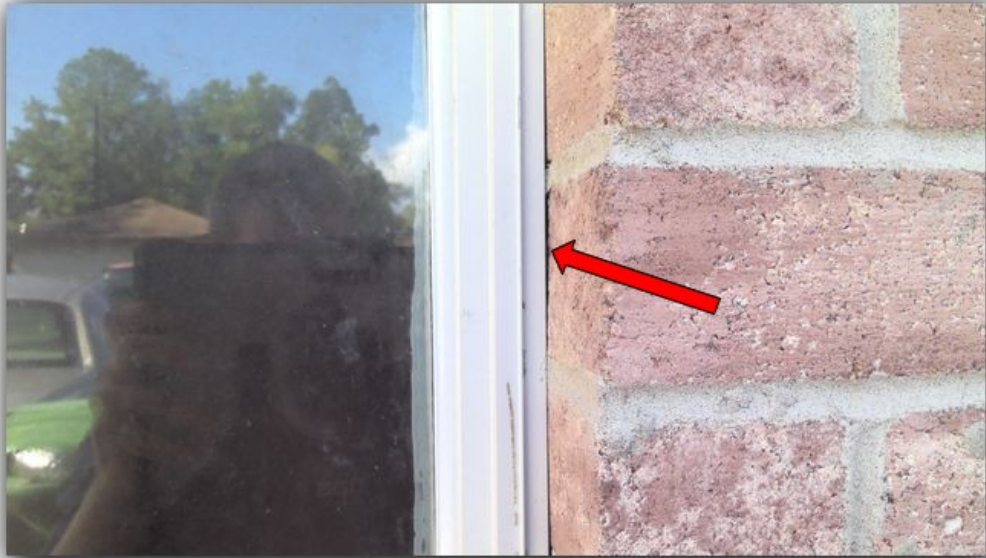
The windows should be examined and sealed at the exterior to prevent water infiltration and to improve efficiency.

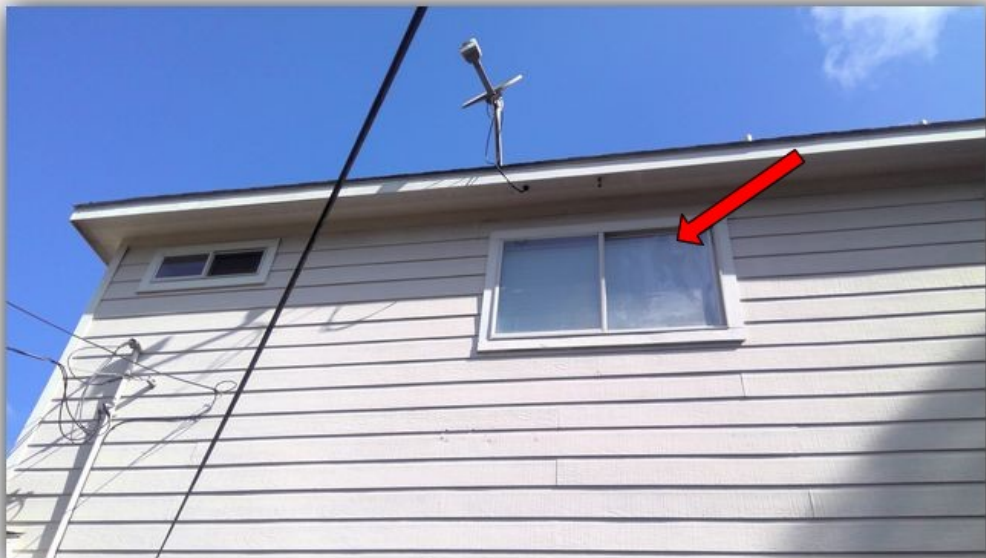
The window(s) have lost their seal in various locations. This has resulted in condensation developing between the panes of glass and can cause the glass to lose its insulating properties. The glass should be repaired or replaced.

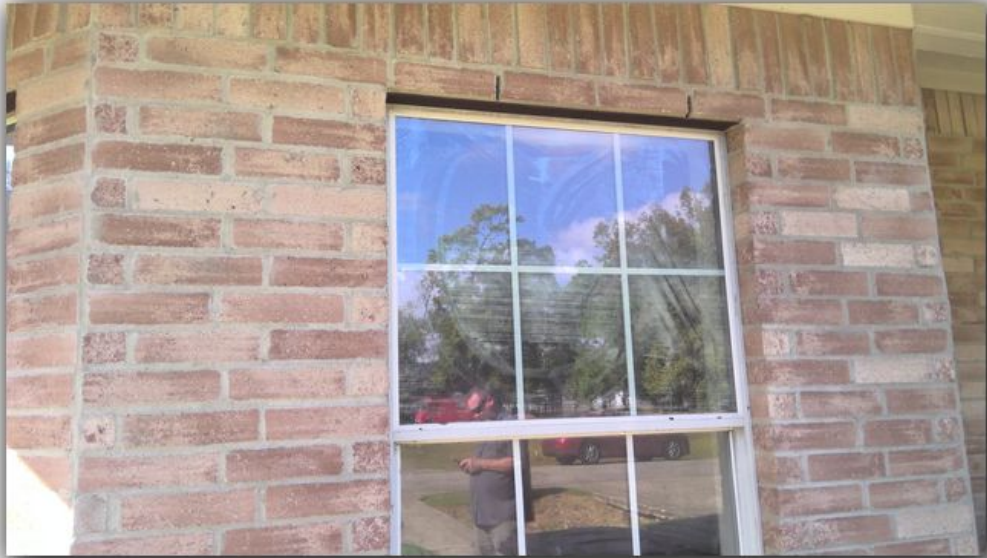
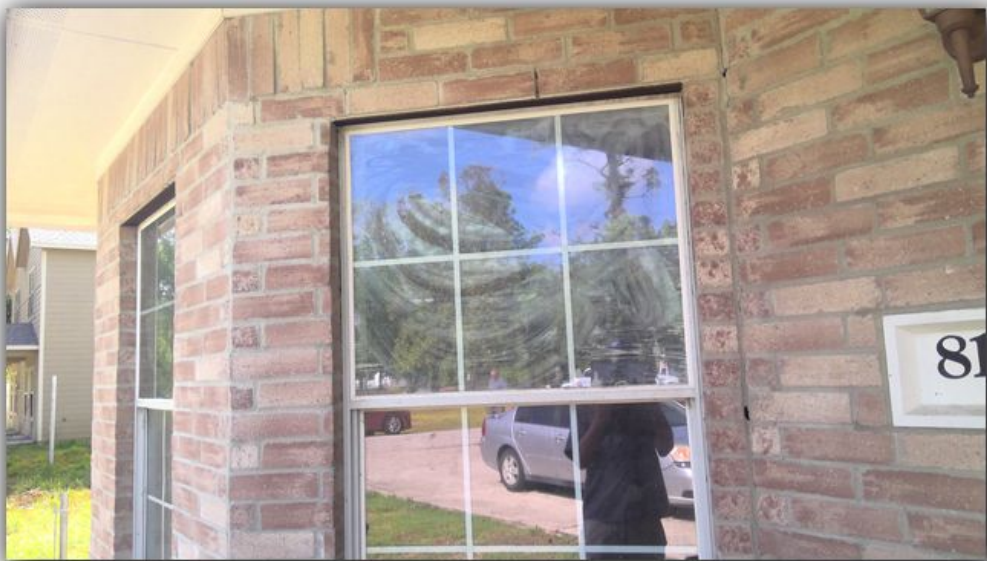
The window(s) have lost their seal in various locations. This has resulted in condensation developing between the panes of glass and can cause the glass to lose its insulating properties. The glass should be repaired or replaced.

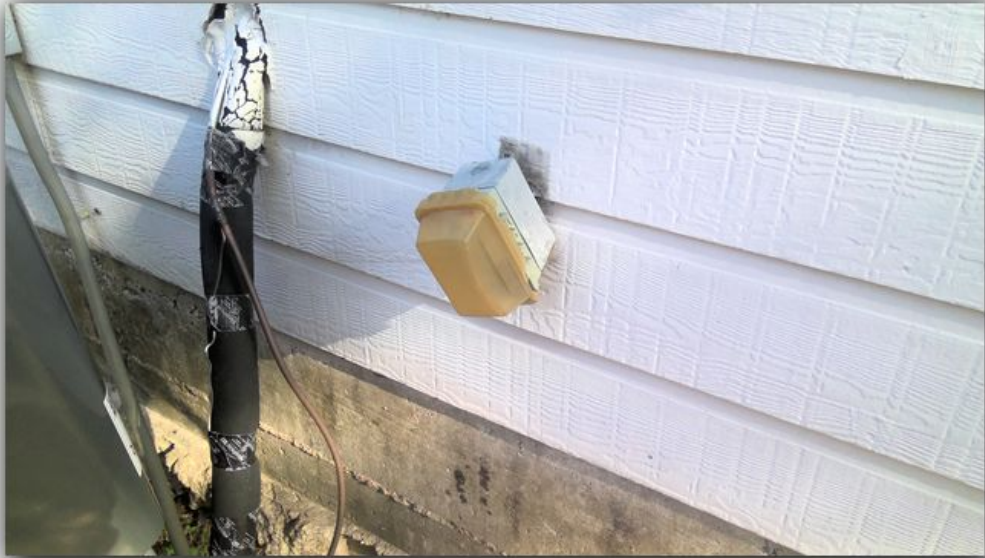
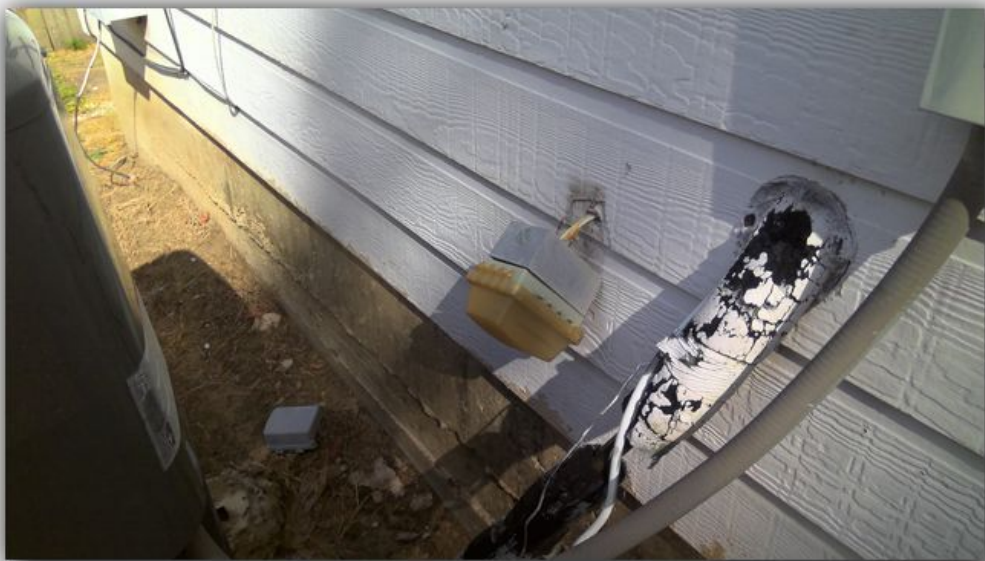
An outlet is loose at the rear exterior of unit A and Unit B and should be re-secured.

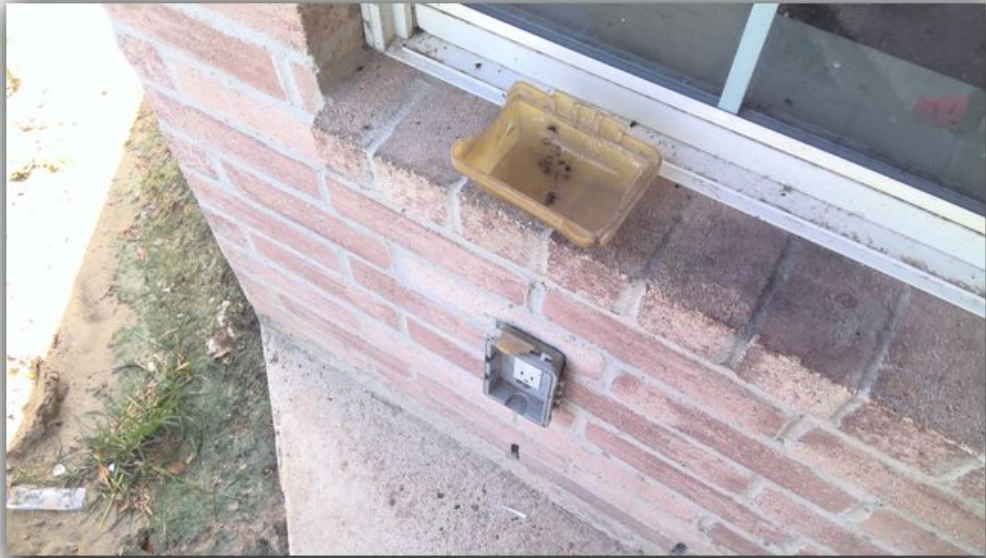
The weather cap on the exterior outlet is damaged and should be replaced.

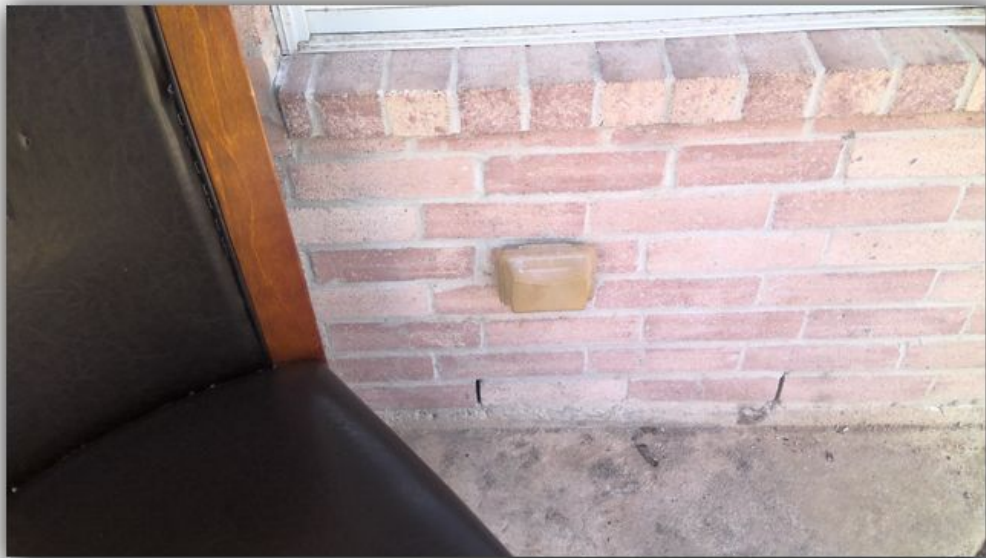
A ground fault circuit interrupter (GFCI) outlet at the exterior of the home did not respond correctly to testing during the inspection. This receptacle should be replaced.

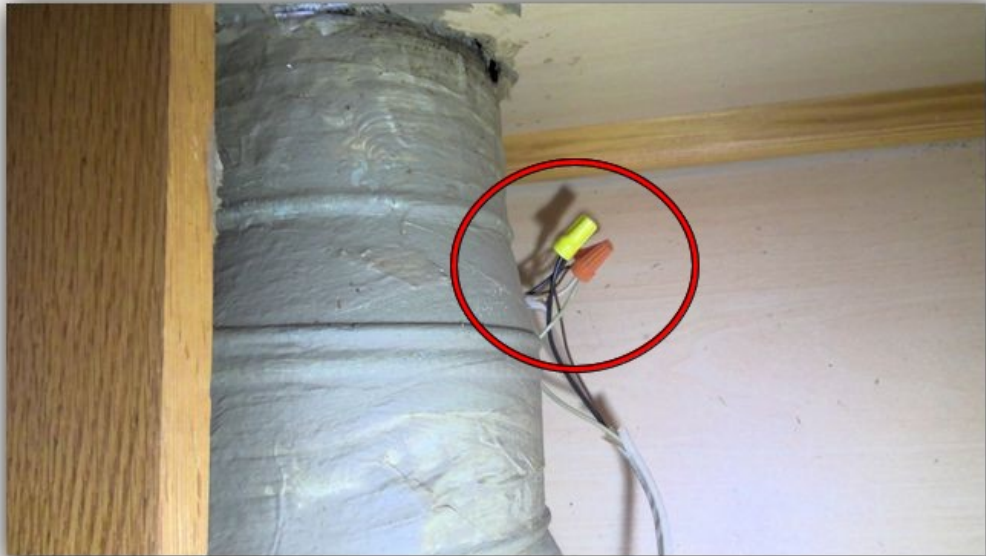
Improper electrical connections should be improved. All electrical connections should be made inside junction boxes fitted with cover plates.

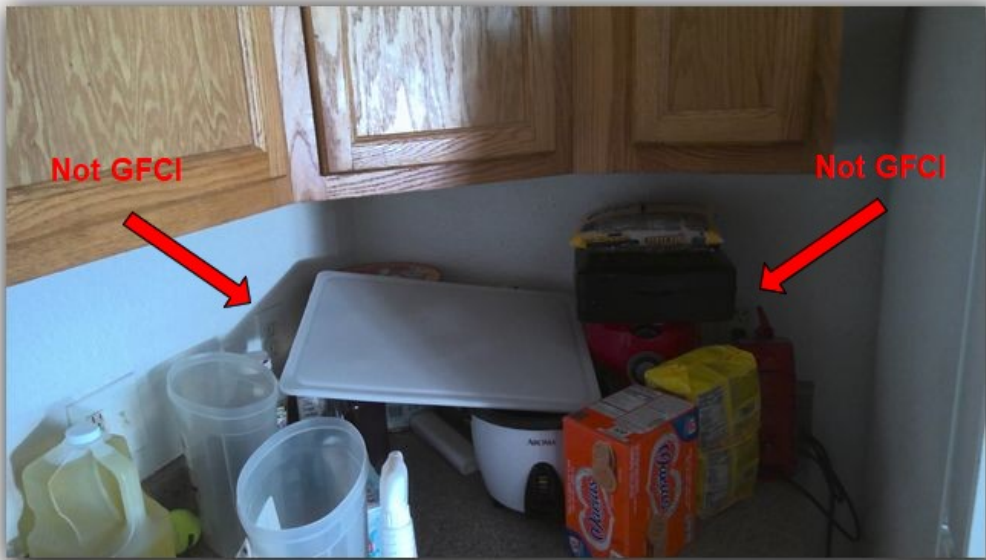
The installation of a ground fault circuit interrupter (GFCI) is recommended in the kitchen at all counter top level outlets. A ground fault circuit interrupter (GFCI) offers protection from shock or electrocution.

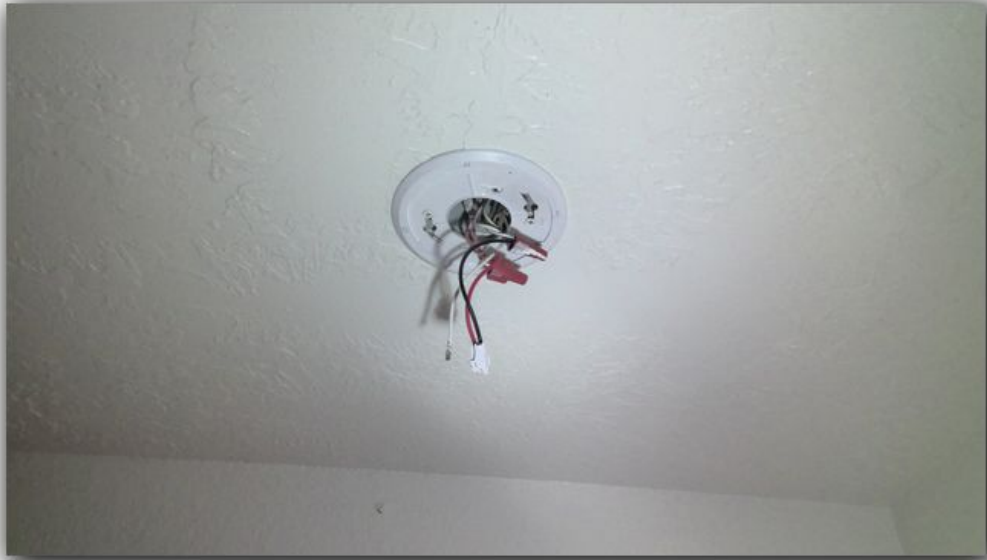
Missing smoke detectors should be replaced.

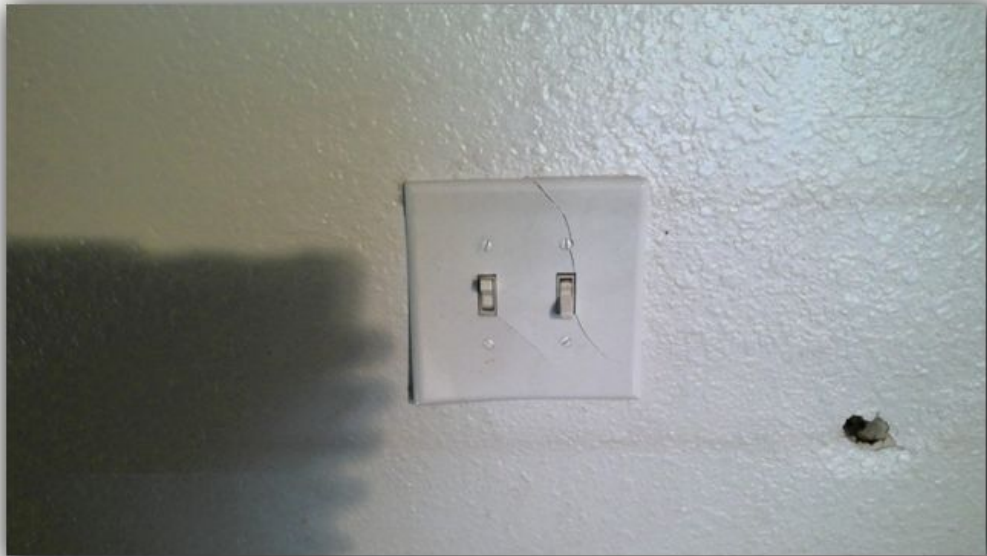
The damaged light switch in the second floor hallway should be repaired.

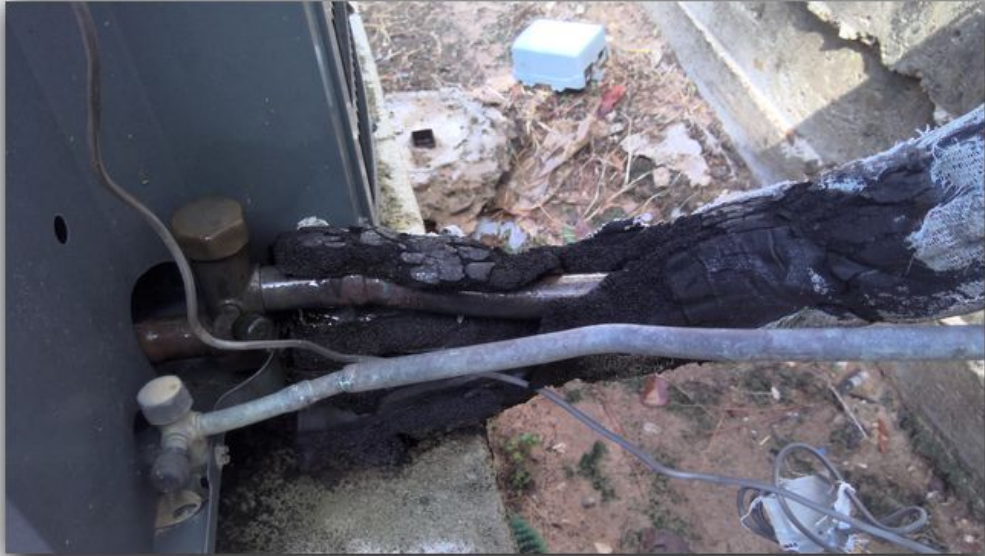
Damaged insulation on refrigerant lines should be repaired.

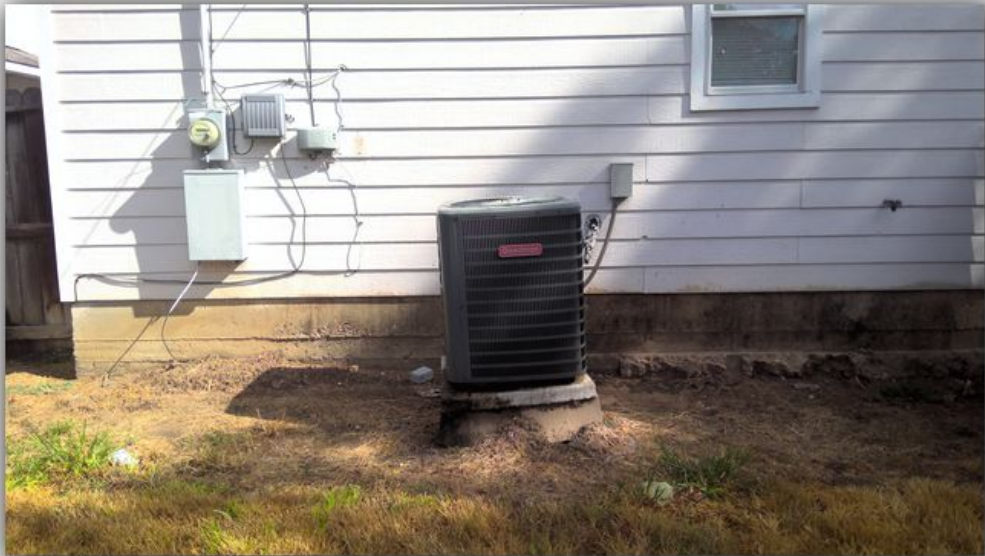
The outdoor unit of the air conditioning system is out of level. This should be improved.

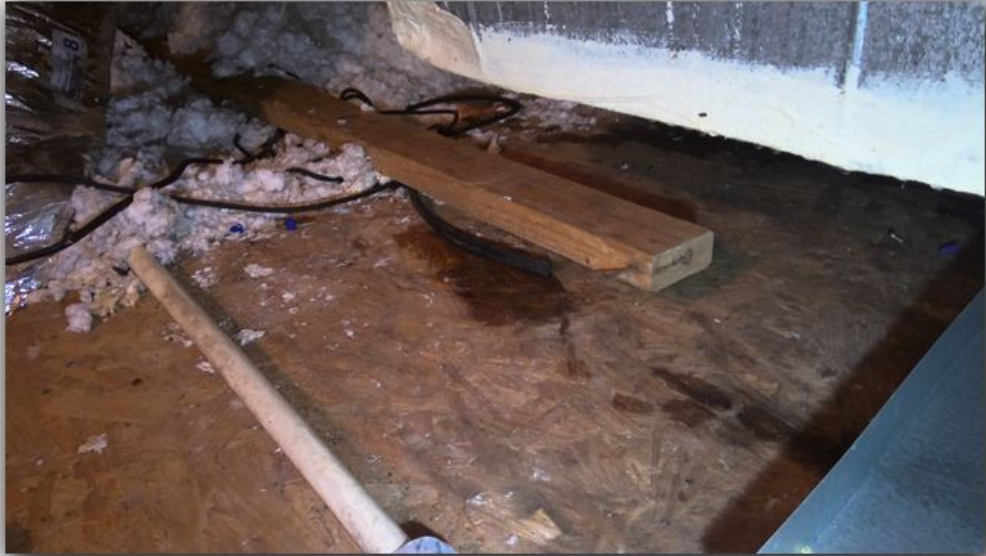
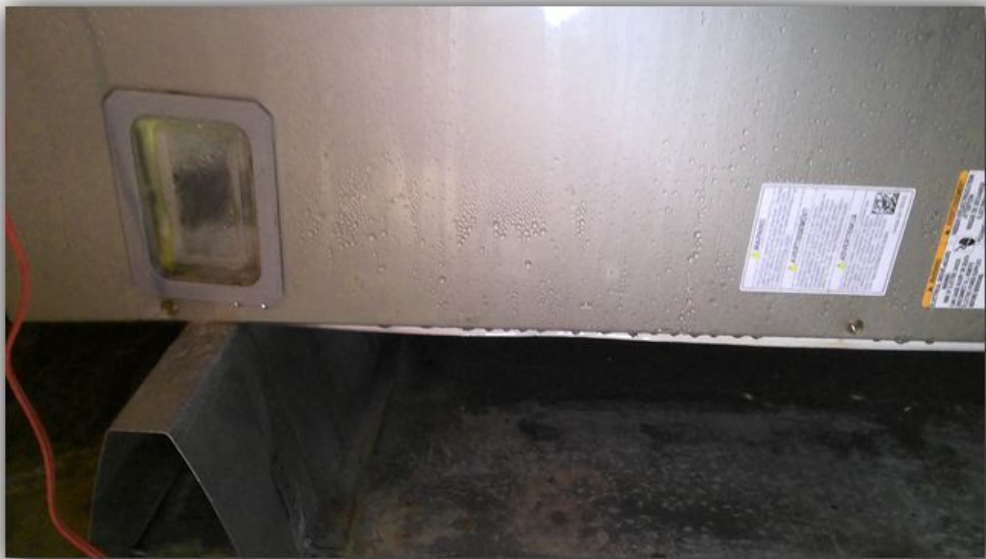
The coil cabinet/furnace/plenum should be better sealed. Condensation is forming on the outside of the unit and dripping into the pan and decking below. Further investigation and repairs should be made as necessary.

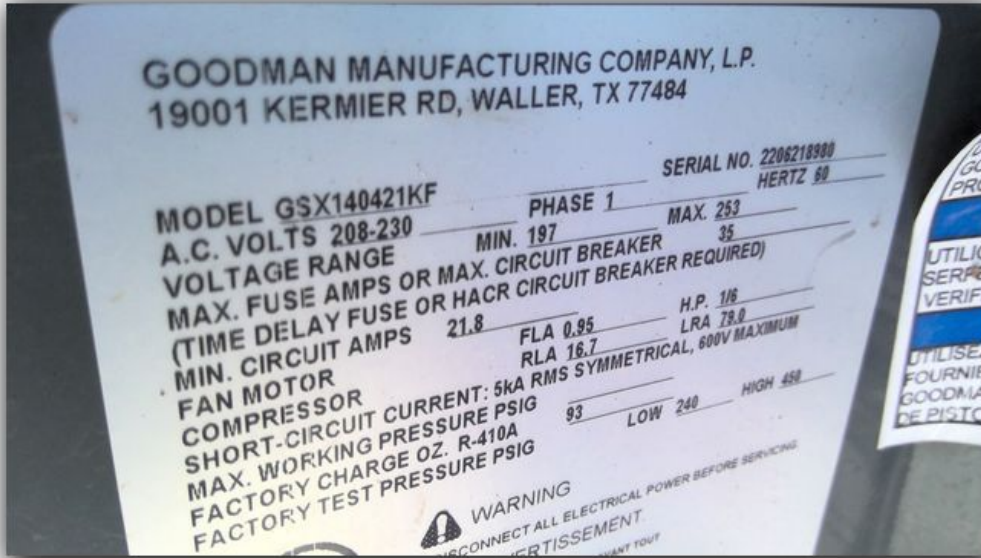
Unit B -
2022 3.5 ton

The outdoor unit of the air conditioning system is out of level. This should be improved.

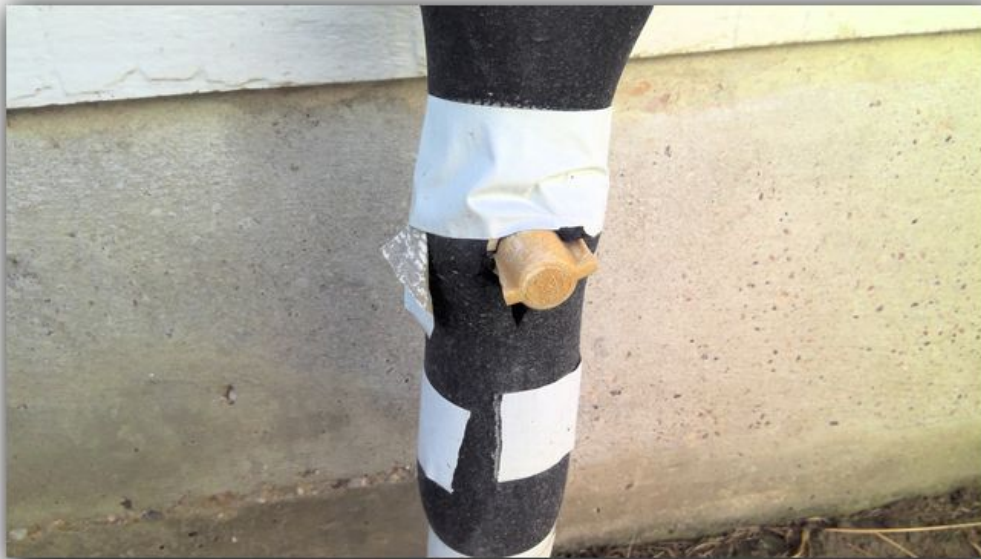
The handle for the water supply valve for unit A is damaged and in need of repair.

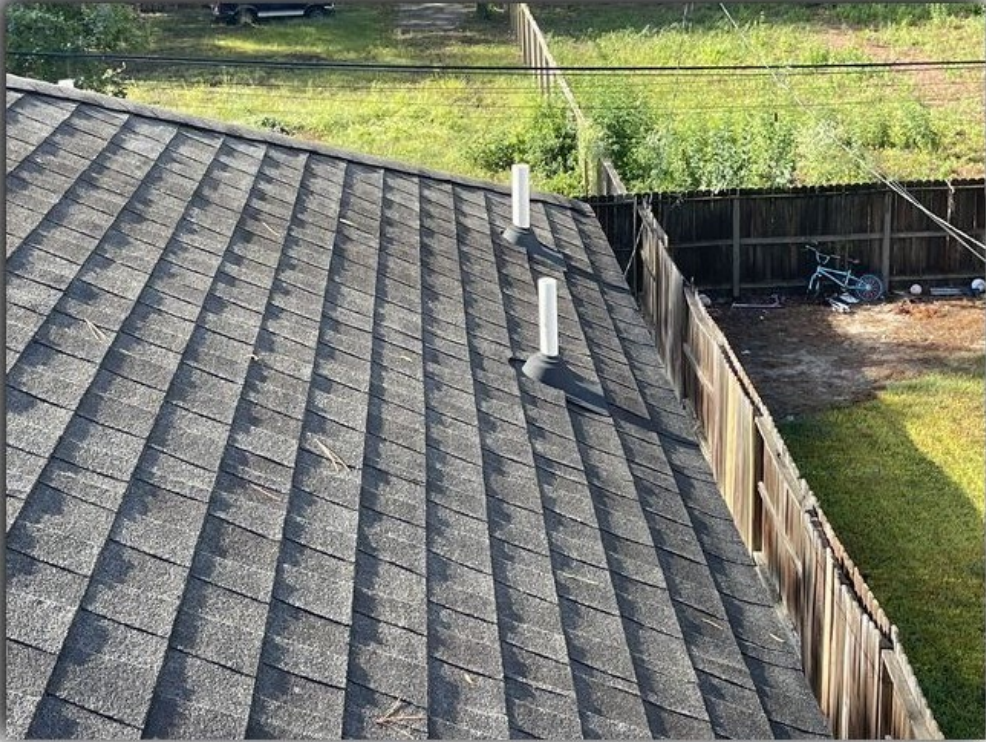
Exposed PVC waste vent pipes should be painted or covered with lead roof jacks to prevent damage from UV light.
