GC Home Inspection

8106 Rhobell St
Houston, TX 77078

PROPERTY INSPECTION REPORT FORM

Elijah Adeniyi <i>Name of Client</i>	09/06/2023 <i>Date of Inspection</i>
8106 Rhobell St, Houston, TX 77078 <i>Address of Inspected Property</i>	
Chad Gregory Langston Jr. <i>Name of Inspector</i>	25839 <i>TREC License #</i>
Chad Langston <i>Name of Sponsor (if applicable)</i>	7946 <i>TREC License #</i>

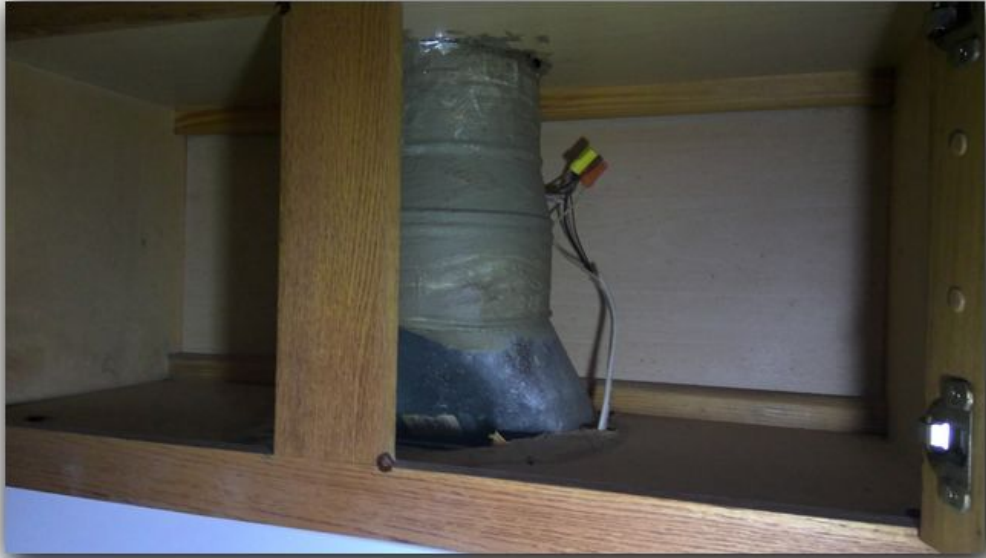
The range hood fan should be repaired so as to discharge to the building exterior.

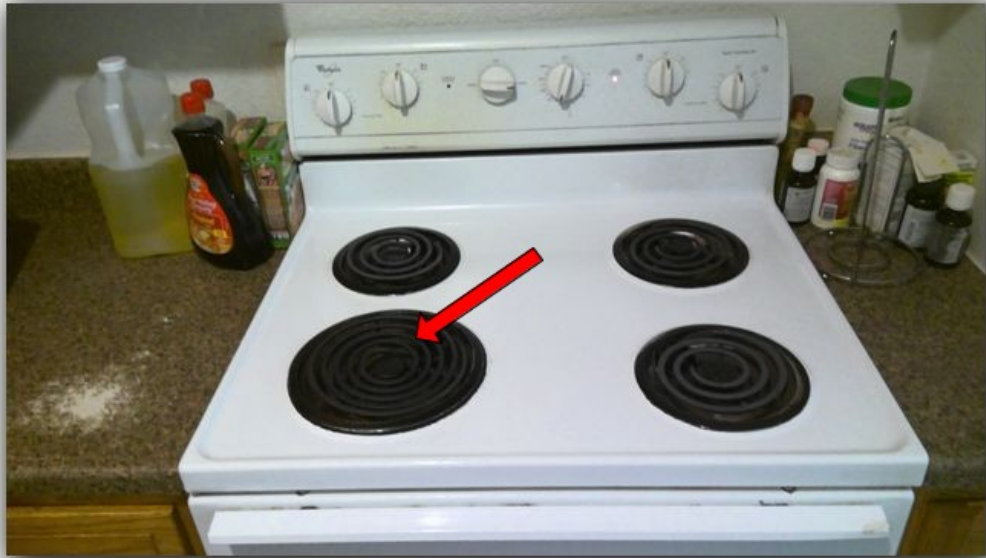
A burner on the electric range is inoperative and should be repaired.
