Your Professional Inspection Report Has Been Prepared Exclusively For You.

Danny & Tamra Duarte
5816 Maco St
Galveston, TX 77551
August 22, 2022

Inspected By: Tom Langley TREC #20644
(903)-480-8210

PROPERTY INSPECTION REPORT FORM

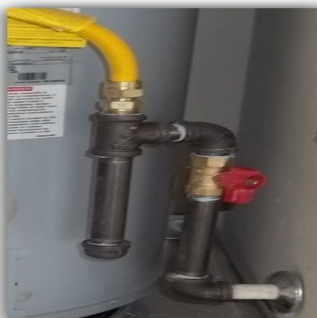
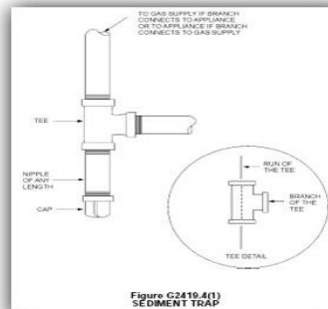
D - The heater gas supply line is not equipped with a sediment trap just before the gas appliance connector. This condition does not meet current installation requirements and should be corrected.

Samples of correct sediment trap installations
