PRELIMINARY FOUNDATION INSPECTION REPORT: JOB NO. 22-Galv235

LOCATION: 5816 Maco
Galveston, TX

DATE OF INSPECTION: August 25, 2022

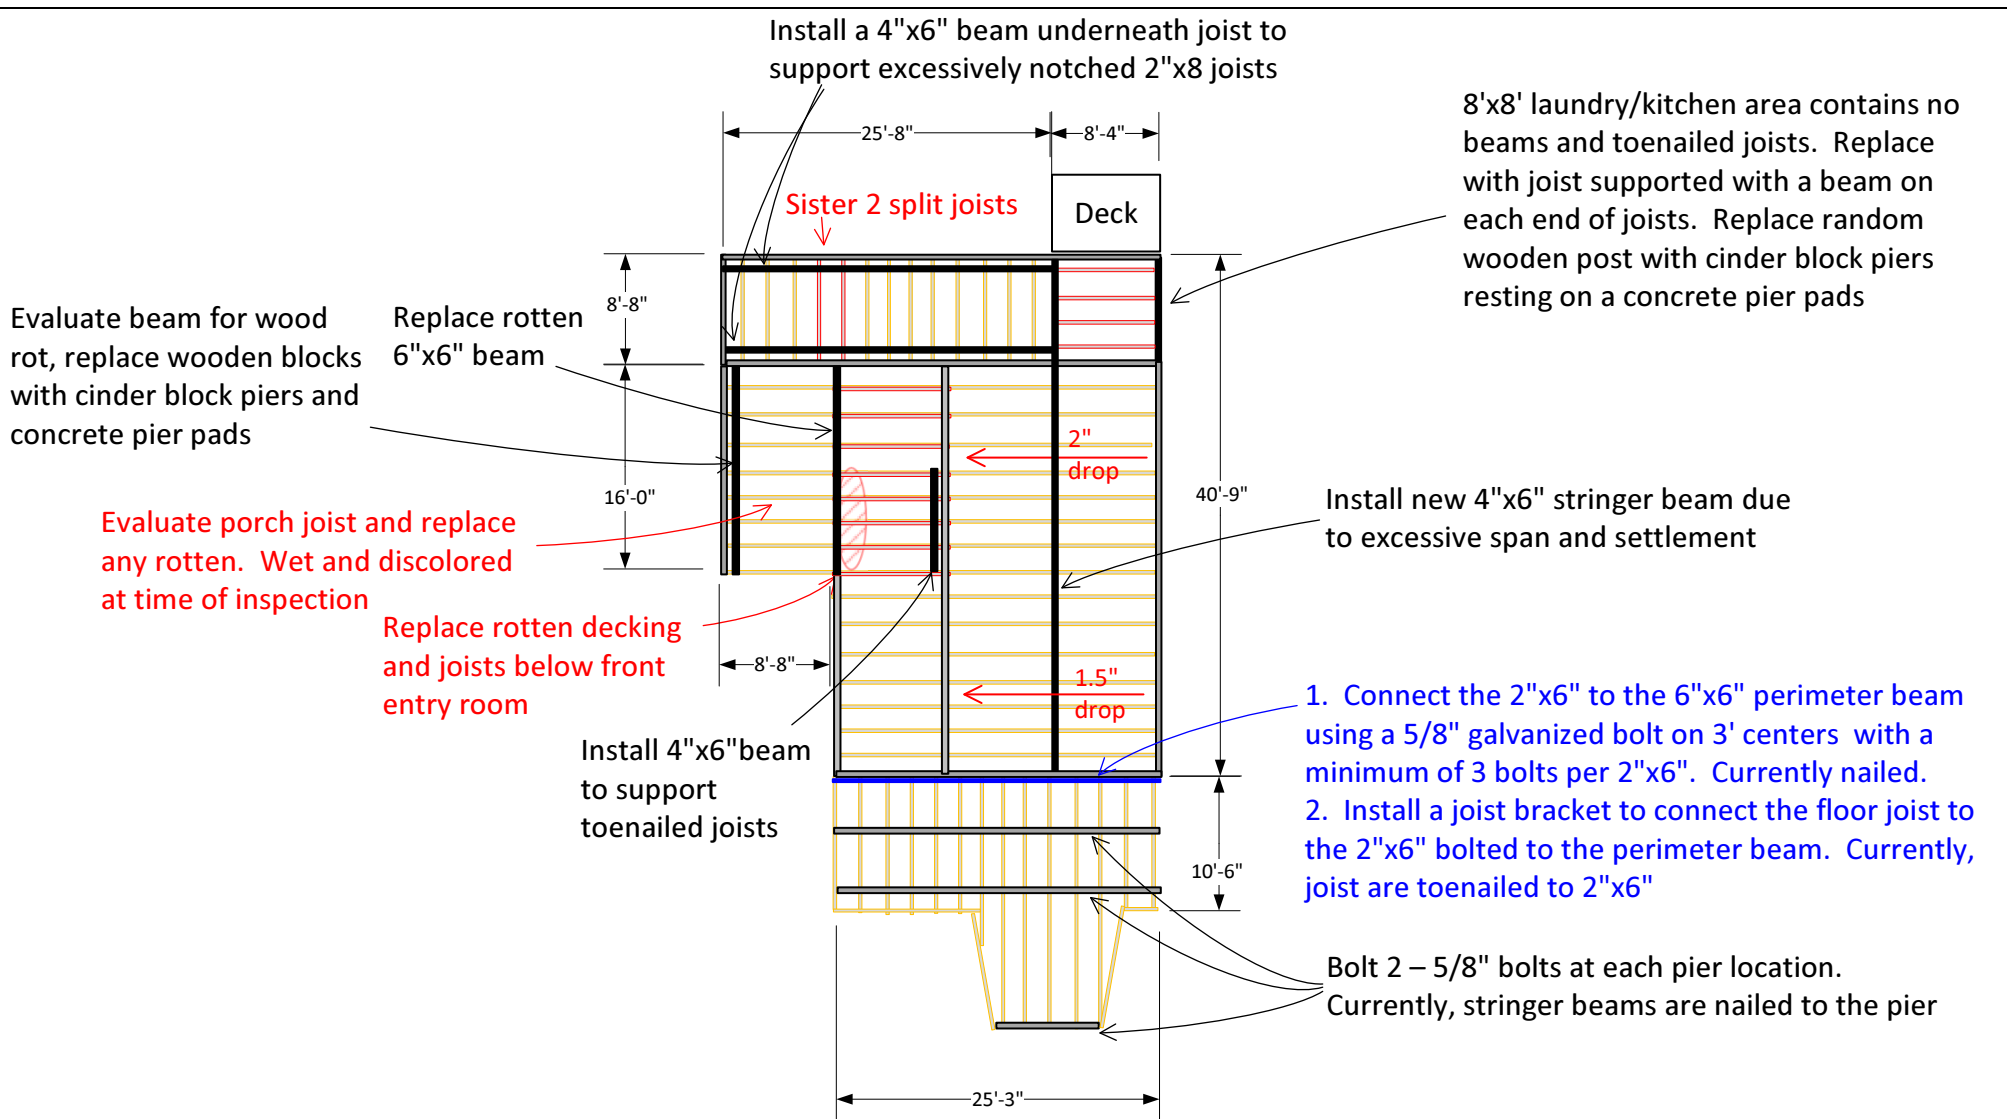
- Existing 2"x6" floor joist on 24" centers
- Existing 4"x6" support beams
- New 4"x6" beam to be installed
- Concrete perimeter beam

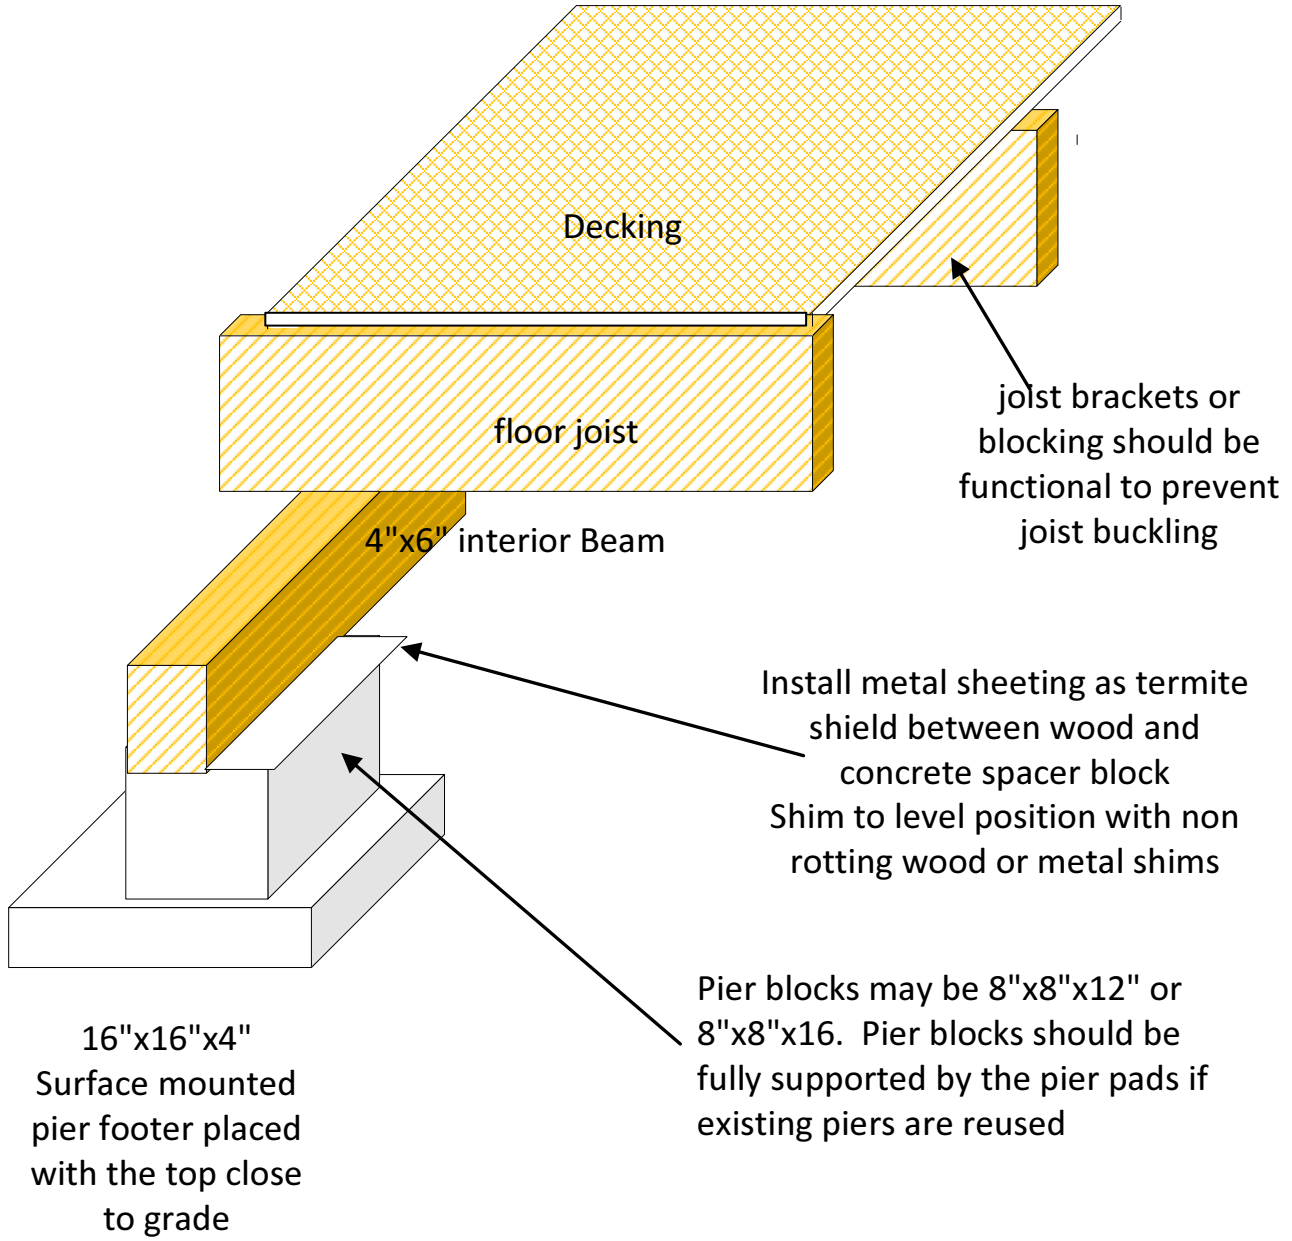
Pier Detail

16"x16"x4"
Surface mounted
pier footer placed
with the top close
to grade

Install metal sheeting as termite
shield between wood and
concrete spacer block
Shim to level position with non
rotting wood or metal shims

Pier blocks may be 8"x8"x12" or
8"x8"x16. Pier blocks should be
fully supported by the pier pads if
existing piers are reused

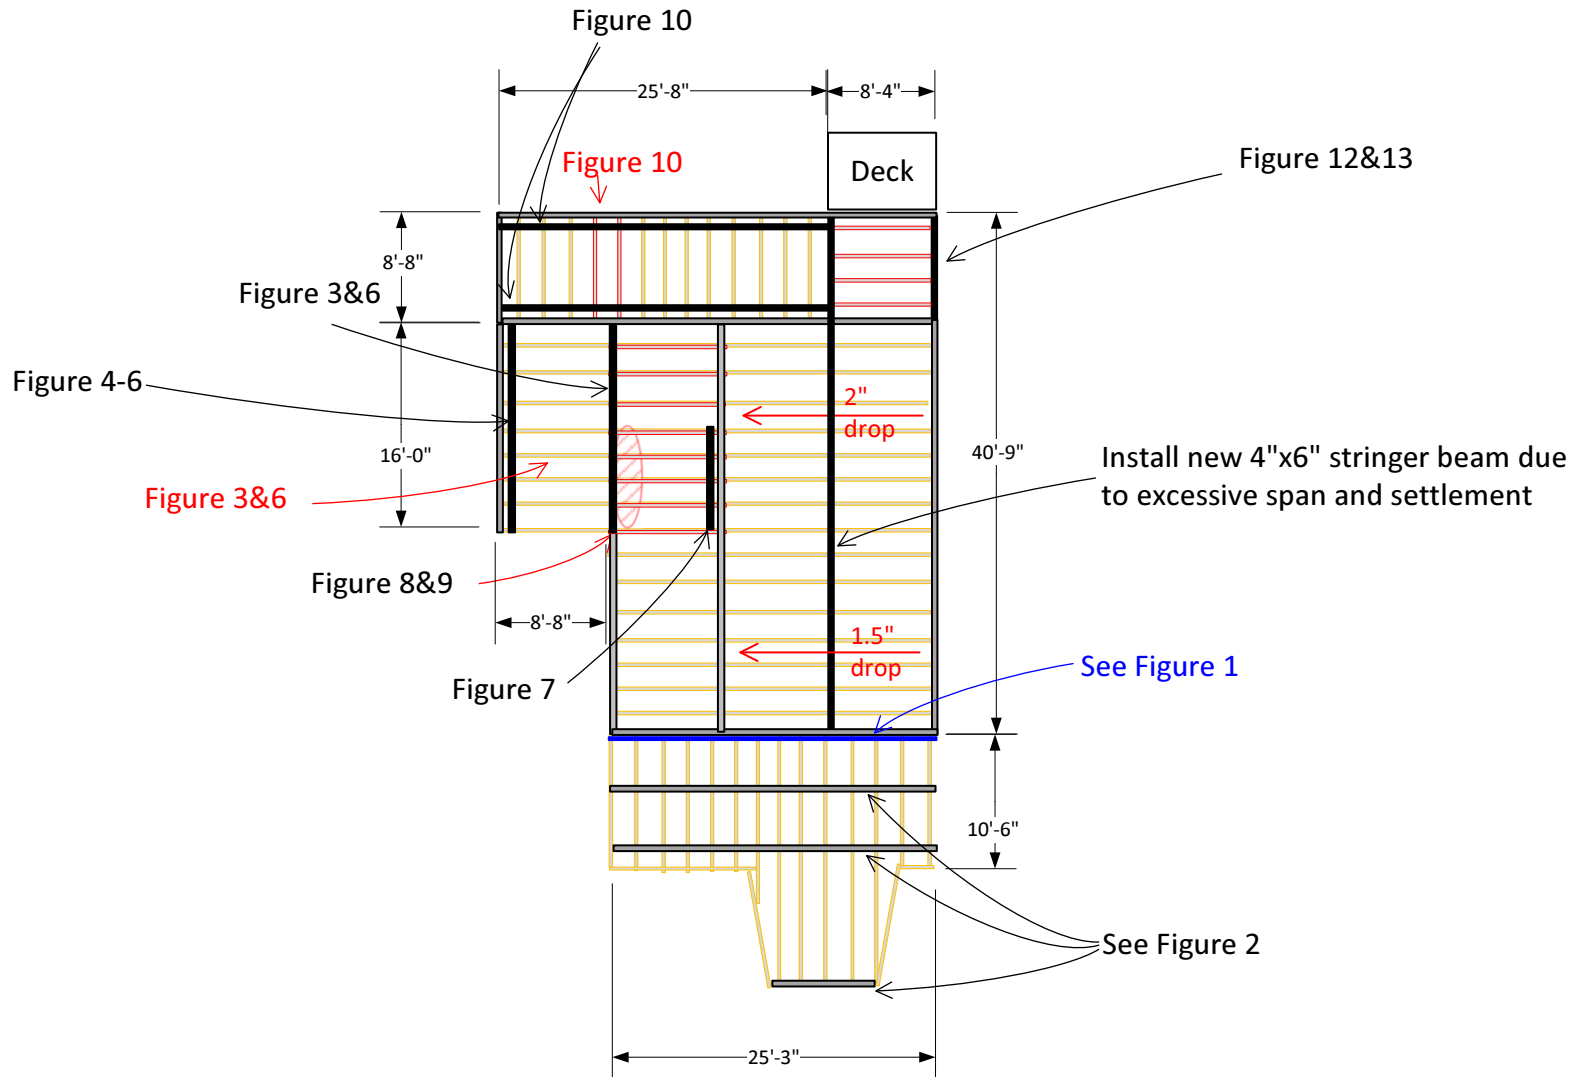
- Existing 2"x6" floor joist on 24" centers
- Existing 4"x6" support beams
- New 4"x6" beam to be installed
- Concrete perimeter beam

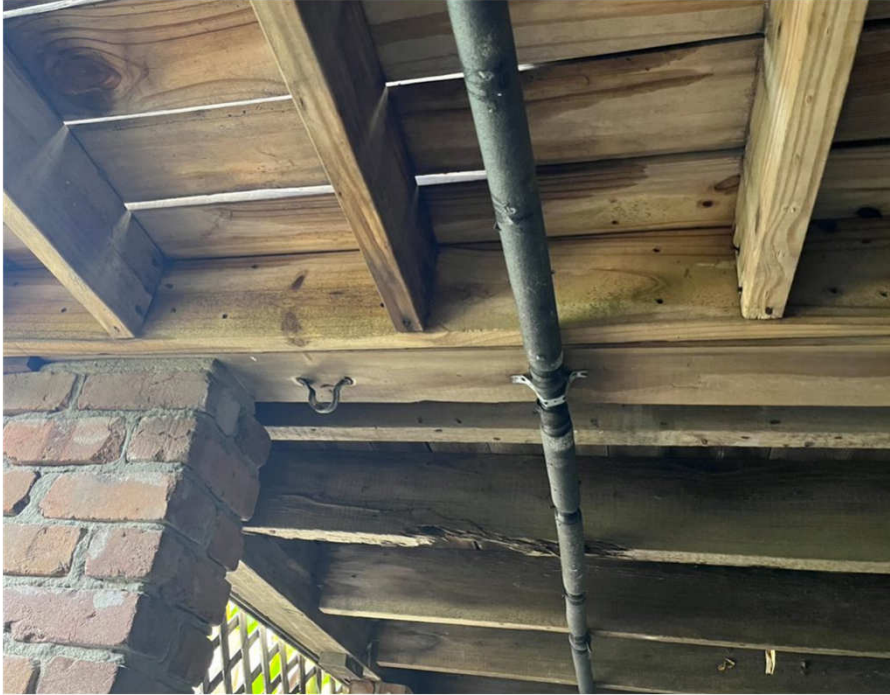
Figure 1:

1. Connect the 2"x6" to the 6"x6" perimeter beam using a 5/8" galvanized bolt on 3' centers with a minimum of 3 bolts per 2"x6". Currently nailed.
2. Install a joist bracket to connect the floor joist to the 2"x6" bolted to the perimeter beam. Currently, joist are toenailed to 2"x6"

1. The floor joists on the front deck next to the front perimeter beam have been toenailed to the nailed end beam. Connect the 2"x6" end beam to the 6"x6" perimeter beam using a 5/8" galvanized bolt on 3' centers with a minimum of 3 bolts per 2"x6". Install a joist bracket to connect each floor joist to the 2"x6" bolted to the perimeter beam.

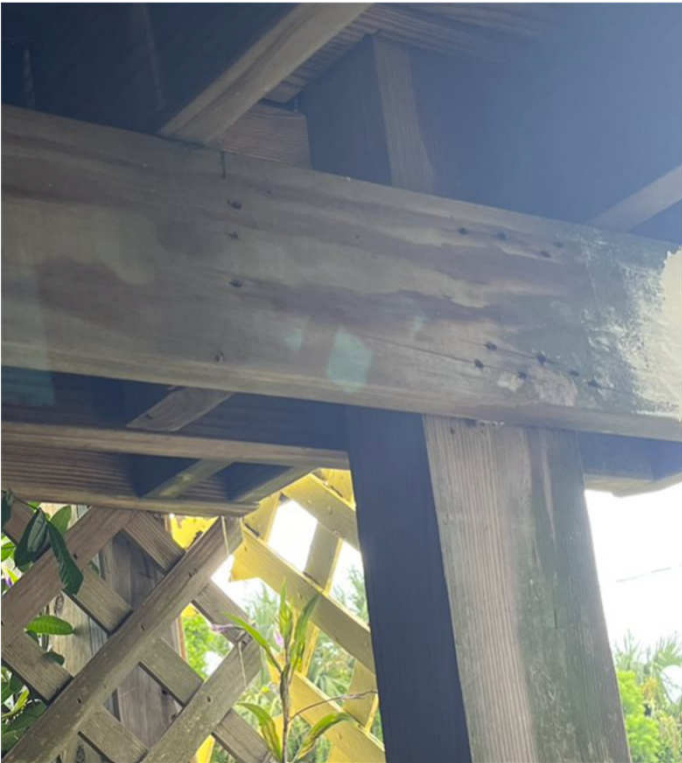
Figure 2:

Bolt 2 – 5/8" bolts at each pier location.
Currently, stringer beams are nailed to the pier

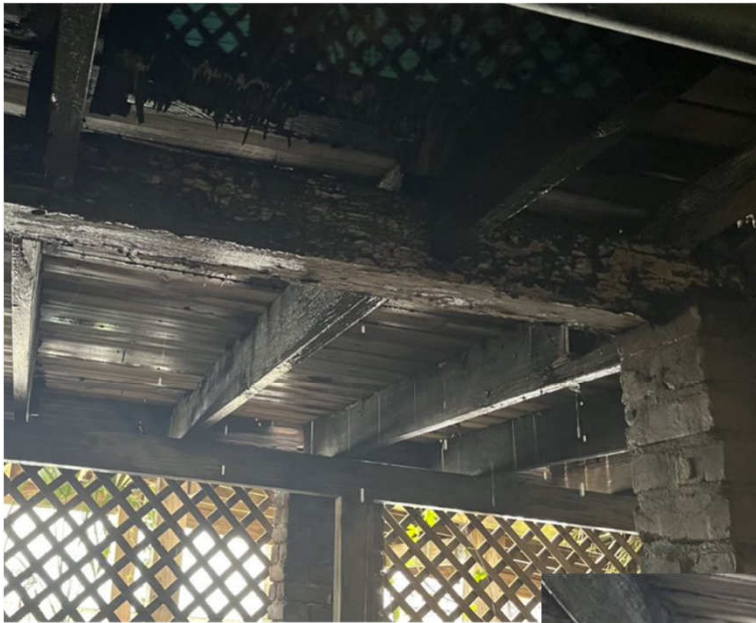
Figure 3:

- Replace rotten 6"x6" interior beam.
- Evaluate porch joist and replace any rotten. Joists were Wet and discolored at time of inspection

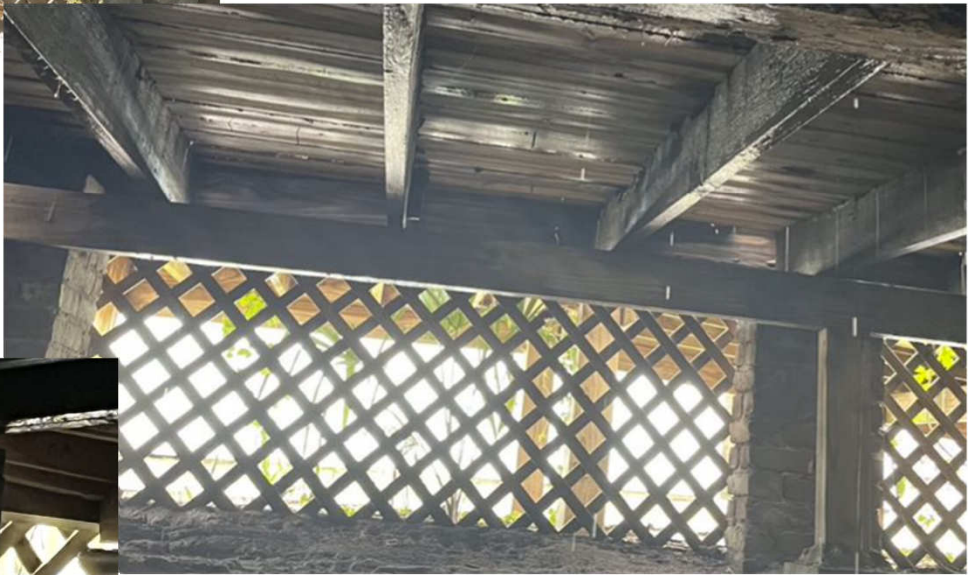
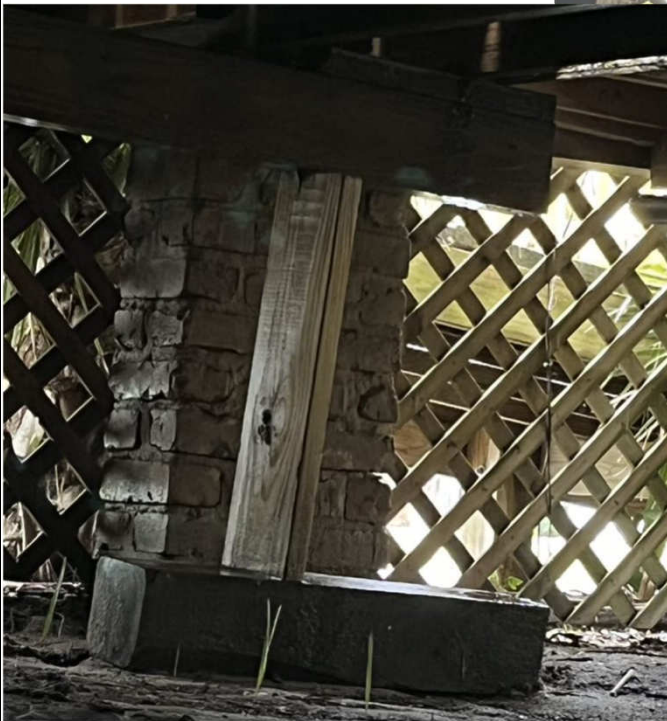
Figure 4&5:

- Evaluate beam for wood rot, replace wooden blocks with cinder block piers and concrete pier pads

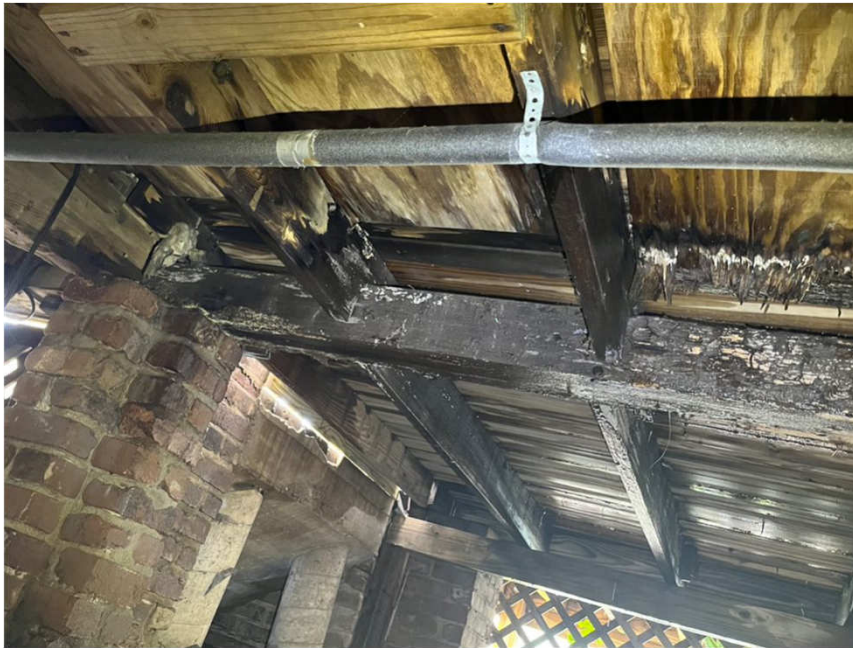
Figure 6:

- Replace rotten 6"x6" interior beam.
- Evaluate porch joist and replace any rotten. Joists were Wet and discolored at time of inspection

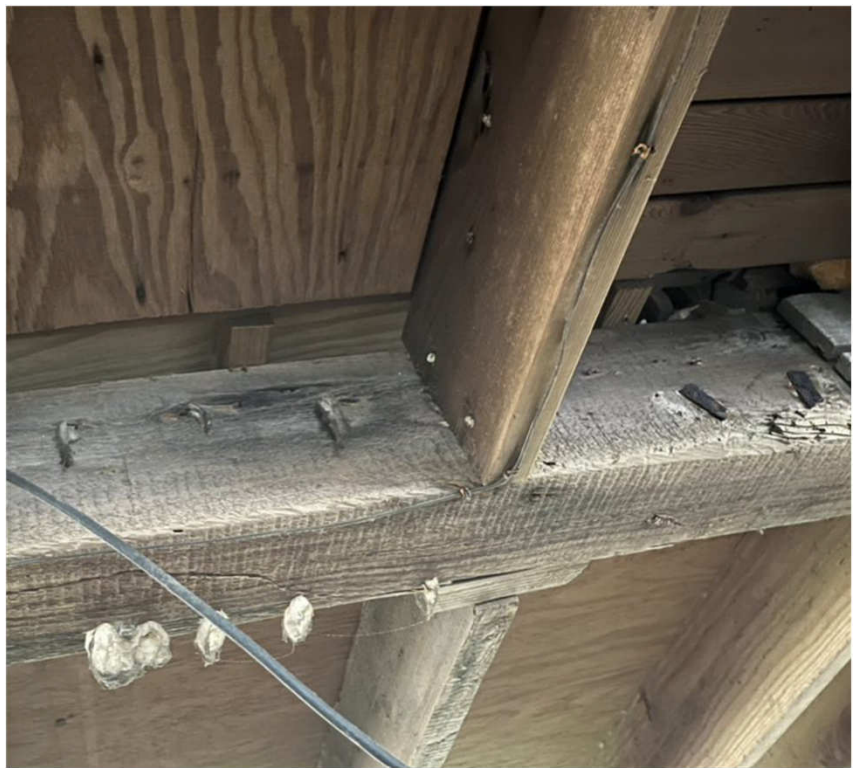
Figure 7:

- Install 4"x6" beam to support toenailed joists

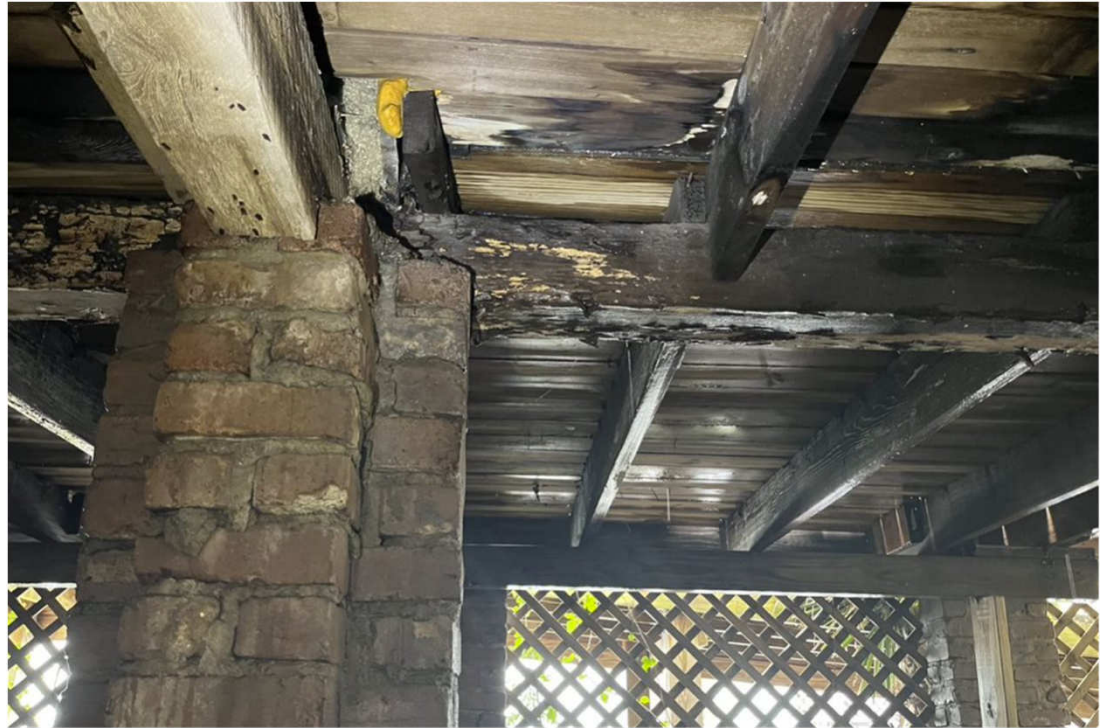
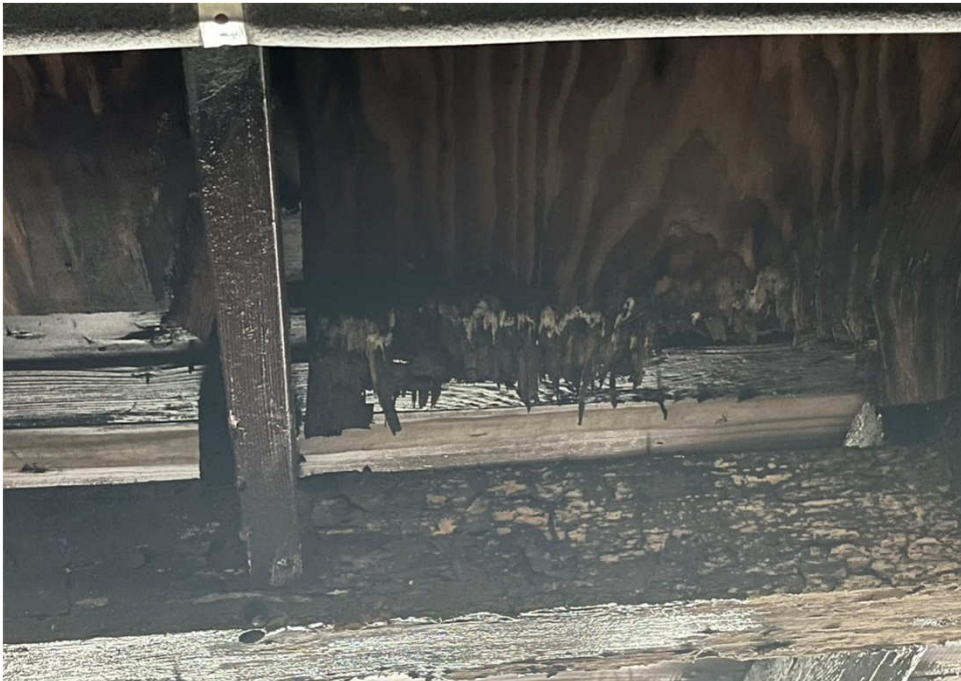
Figure 8&9:
Replace rotten decking and joists below front entry room

Decking - Replace rotten decking and joists below front entry. Decking is soft from top and black on bottom.

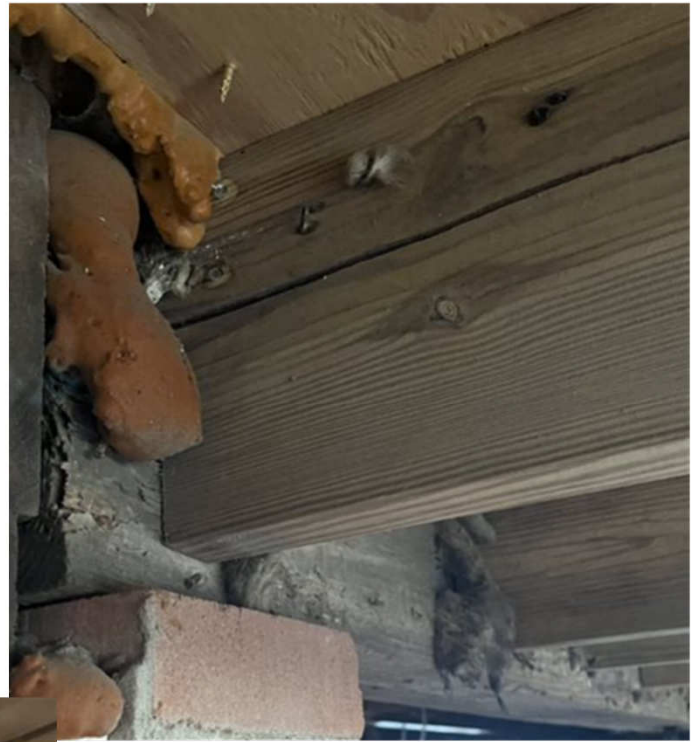
Figure 10:
Install a 4"x6" beam underneath joist to support excessively notched 2"x8 joists. Sister notched joists that have split as shown in Figure 10.

3. The joists supporting the back bathroom/kitchen addition have been excessively notched and are splitting. Sister the split joists and install a 4"x6" beam under each joists without notching.

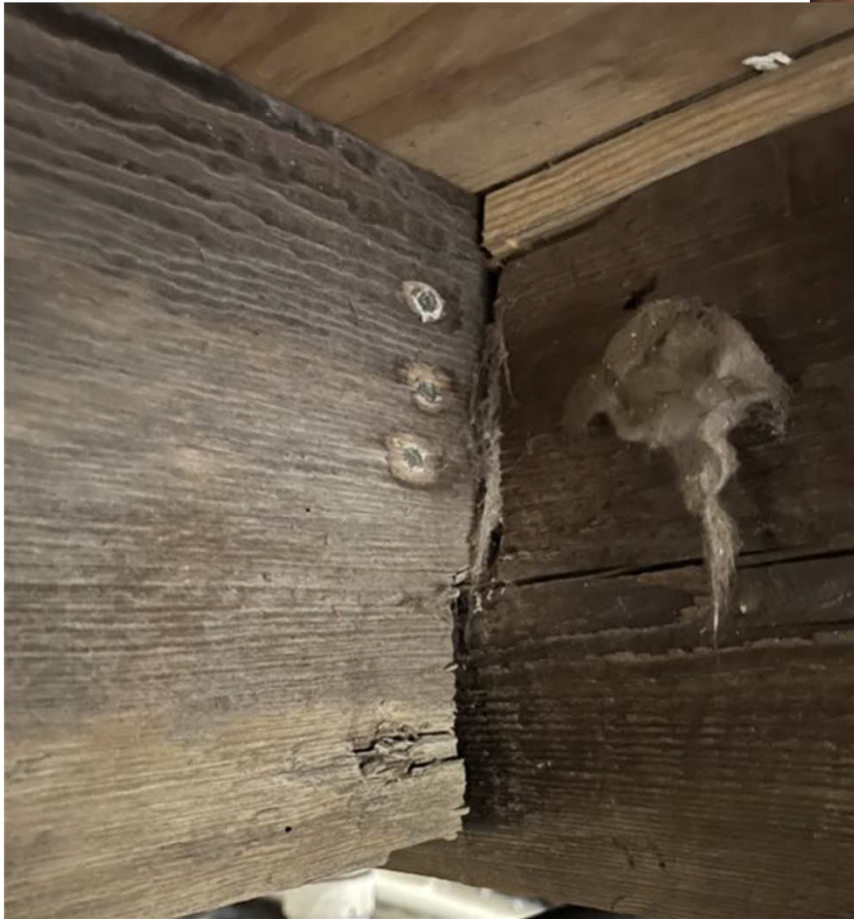
Figure 11:
The original joists re notched, however since the joists are true 2"x8" construction, they appear to hold up to the stress without splitting.

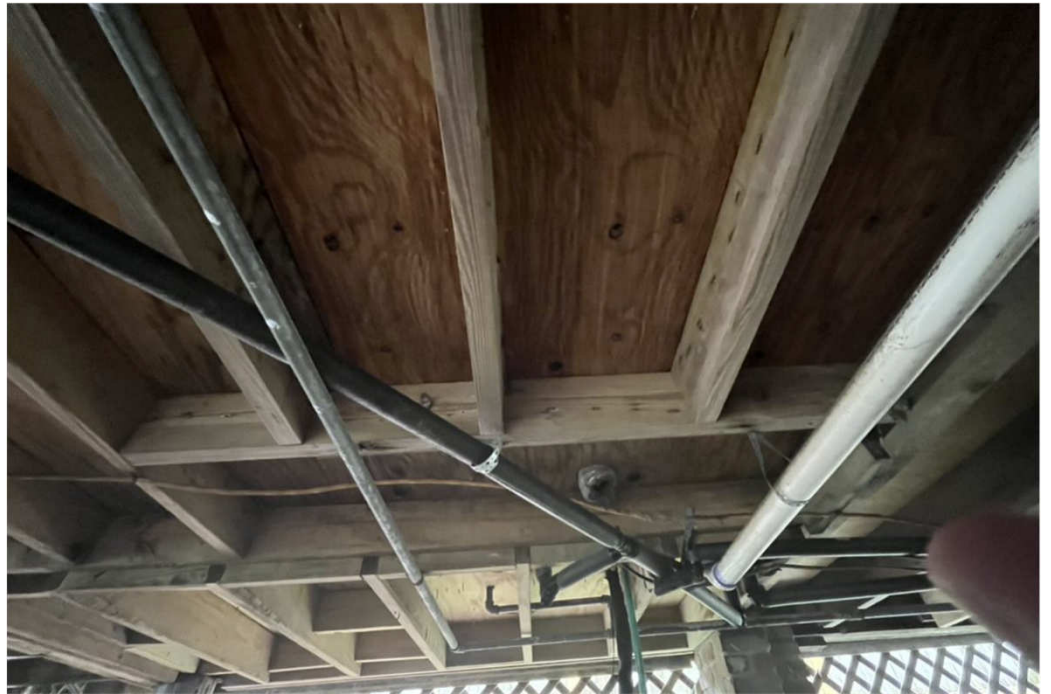
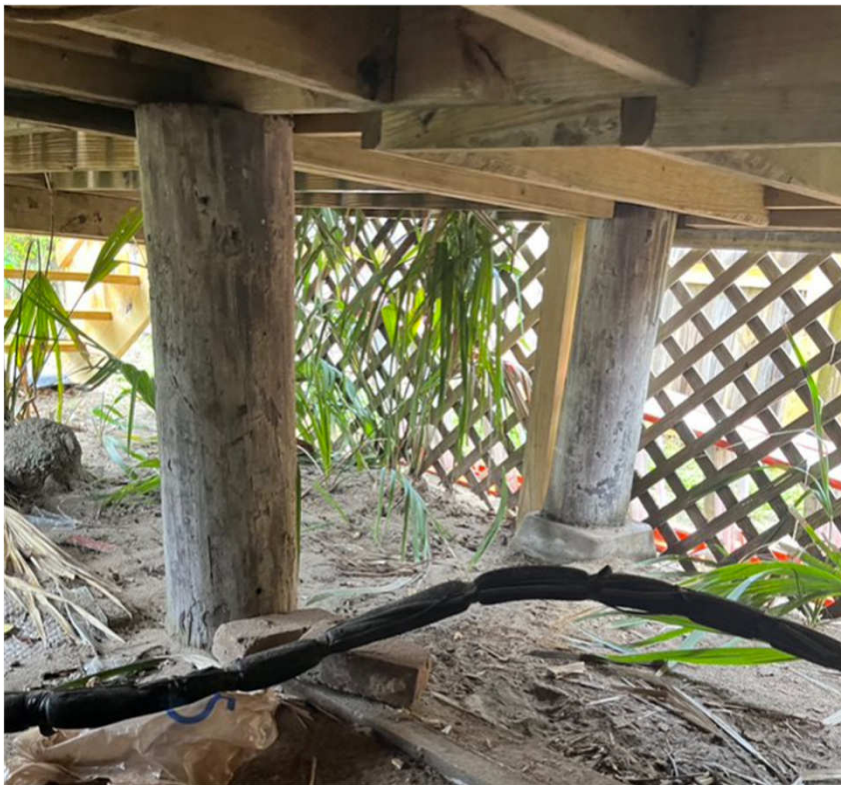
Figure 12&13:
 8'x8' laundry/kitchen area contains no beams and toenailed joists. Replace with joist supported with a beam on each end of joists. Replace random wooden post with cinder block piers resting on a concrete pier pads
