PROPERTY INSPECTION REPORT

8635 Spring Green Dr., Houston , Texas 77095
Inspection prepared for: Matt Messer
Real Estate Agent: Open House - Open House

Date of Inspection: 9/5/2023
Age of Home: 1984 Size: 2,201
Structure Type: Structure is a wood framed structure
on a concrete slab foundation.

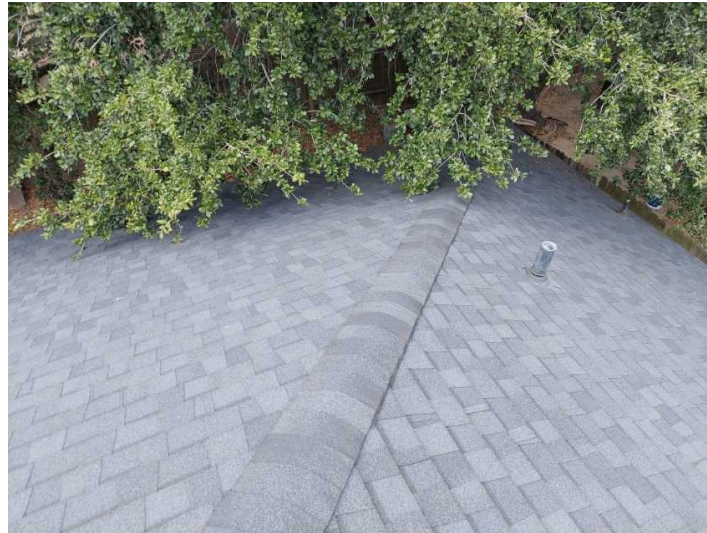
Tree limbs/branches should be trimmed away from roof covering

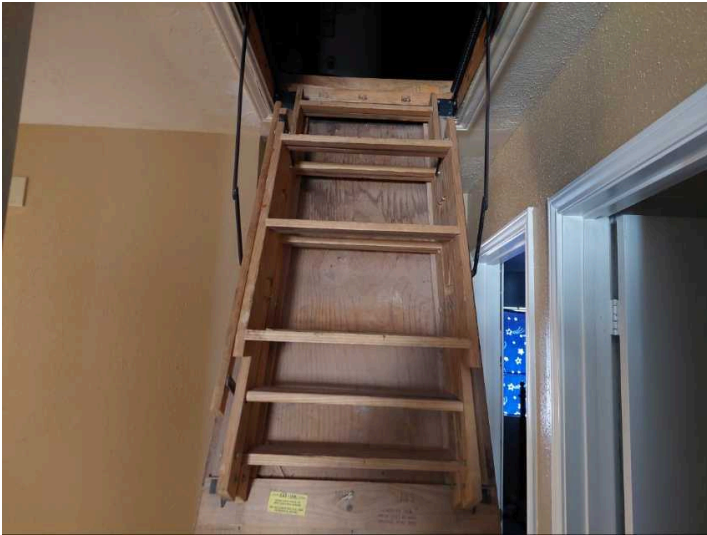
- The attic structure was observed to be conventionally framed with rafters, purlins and collar ties
- There is no insulation installed on the attic access cover as required by current standards.
- One or more of the attic ladder components were observed to be damaged and should be corrected for safety concerns.

Attic access missing insulation.

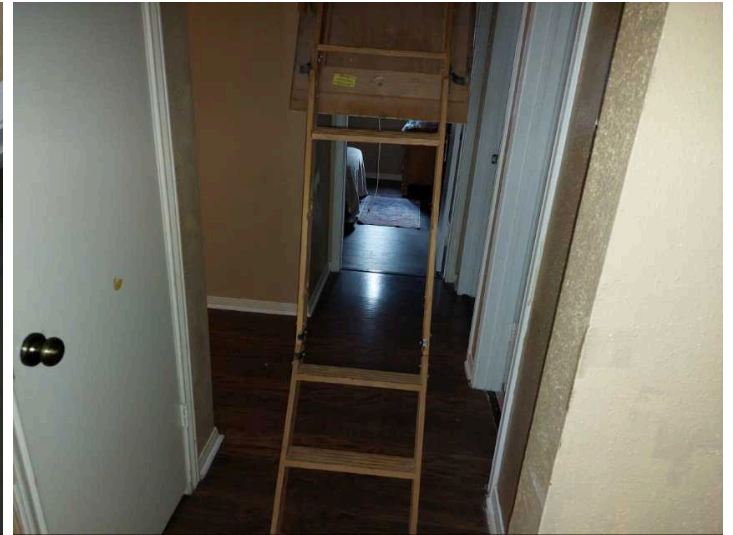
Damaged attic access ladder.

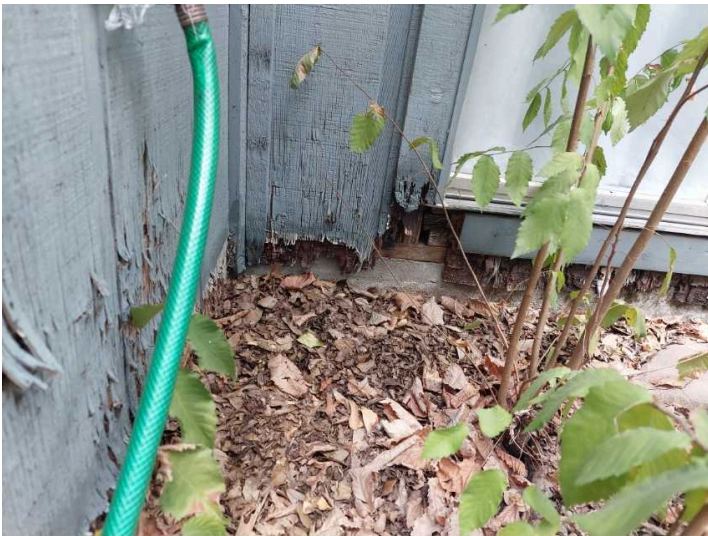
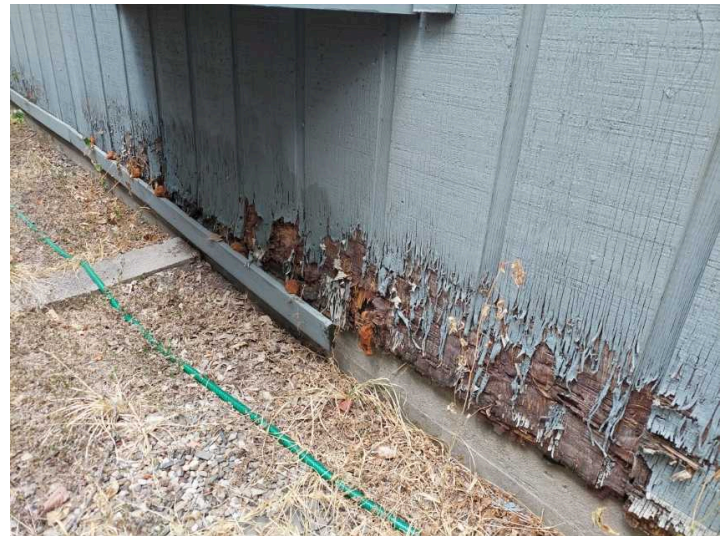
Damaged siding left side of house.

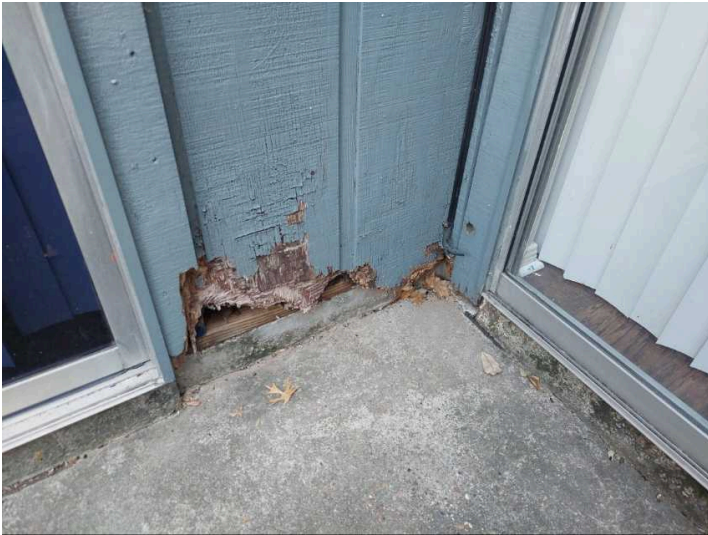
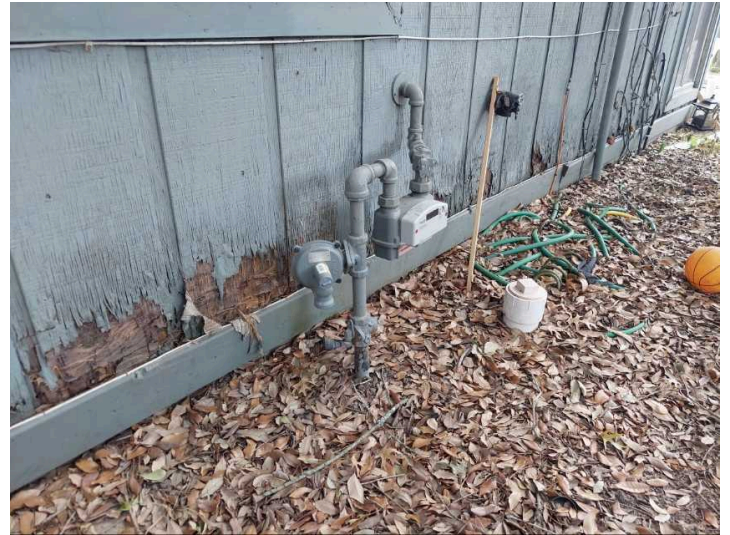
Damaged siding back side of house.

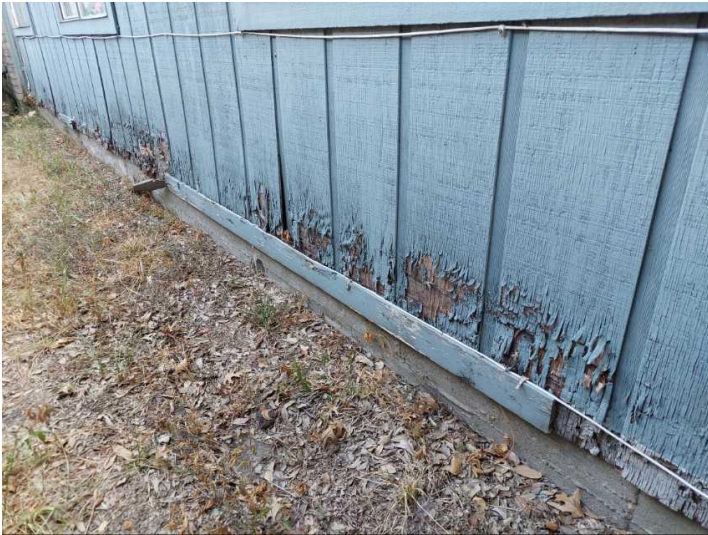
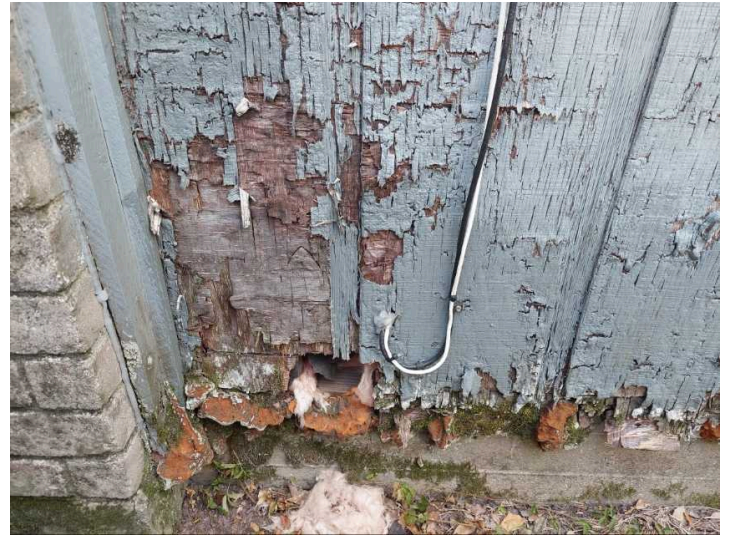
Damaged siding right side of house.

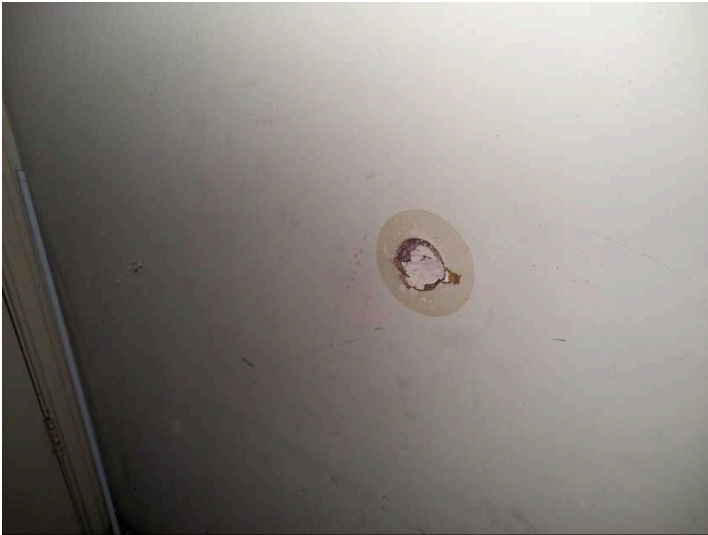
- Utility room/laundry room has connections for a gas dryer and an electric dryer.
- Interior - Home was partially / and or completely occupied at the time of the inspection. Stored personal belongings can affect the inspectors view of the entire wall system. Only areas free and clear of furniture and other obstructions are inspected. Observation of these areas related to structural performance and water penetration only. The inspection does not include obvious damage. It is recommended that all surfaces be kept well sealed. This inspection does not cover any issues that are considered to be environmental. Such as, but not limited to, lead based paint, asbestos, radon, mold, mildew or fungus.
- The siding was noted with damage in one or more locations.
- One or more interior and/or garage walls was noted with damaged drywall.

Interior wall damage in garage

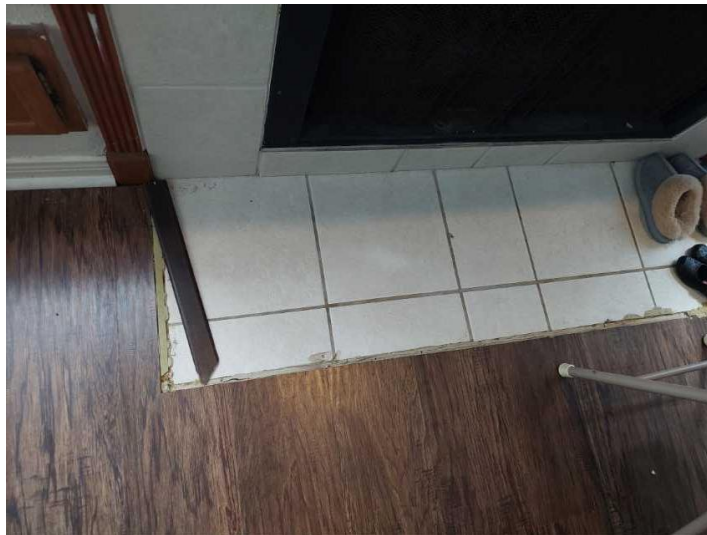
- **Wood floors noted with damage in one or more locations.**

Damaged wood floor

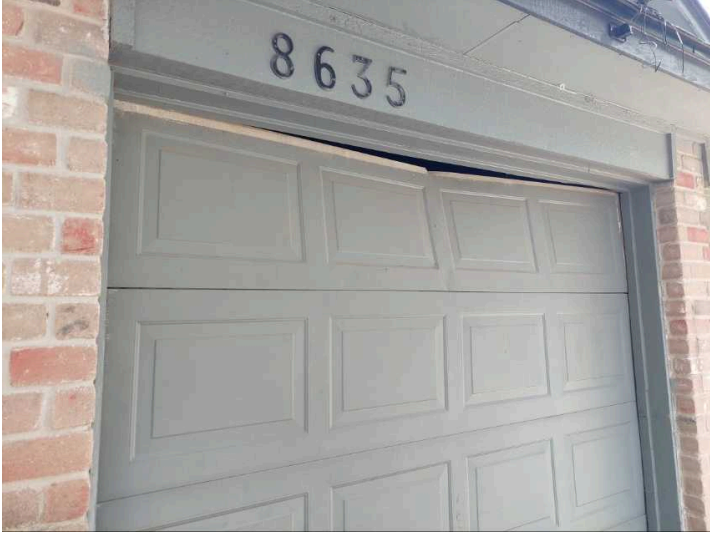
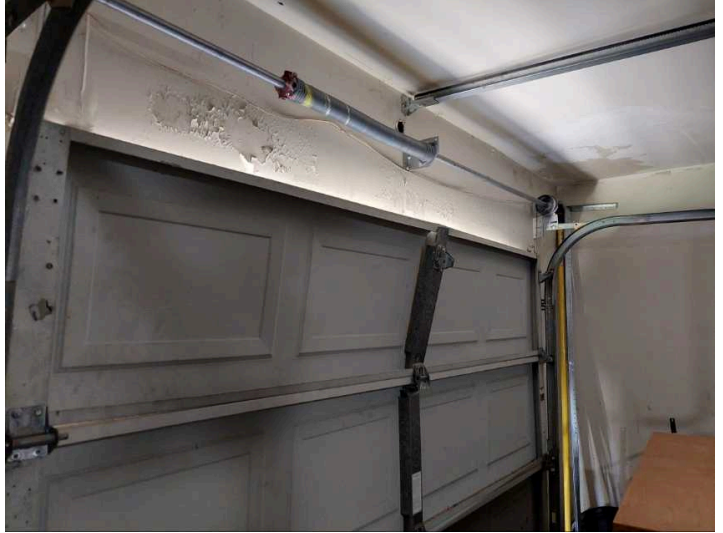
One or more of the garage door panels were observed to be damaged, weathered, warped and/or dented at the time of the inspection.

Garage door is damaged.

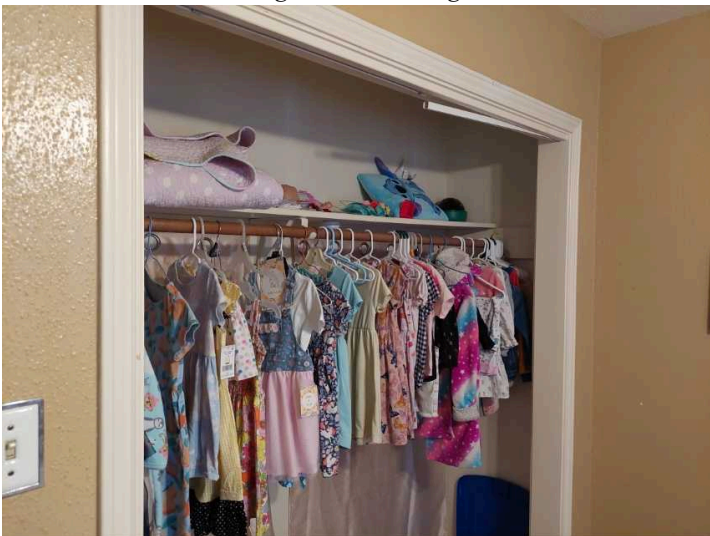
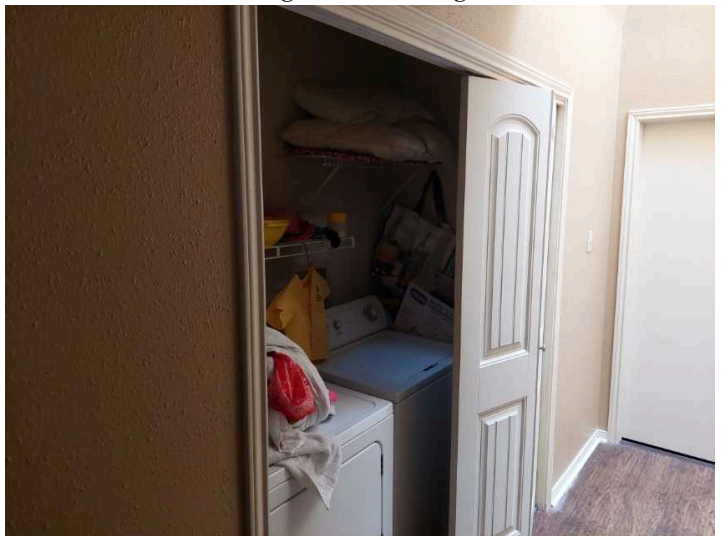
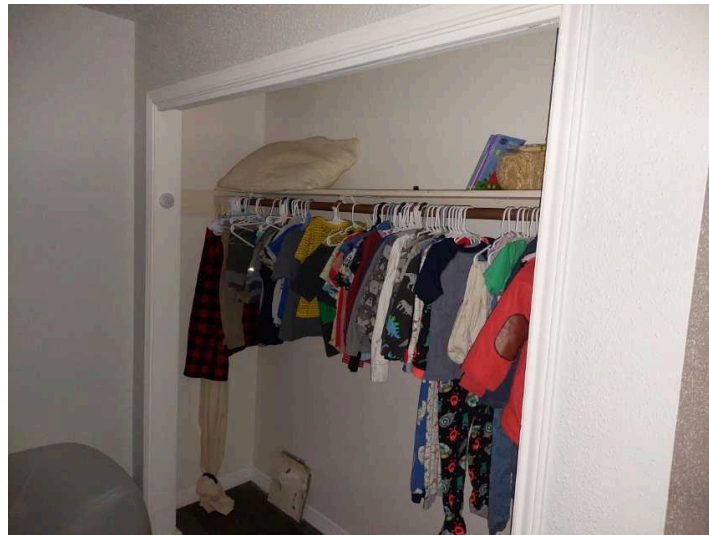
One or more interior doors were missing.

Missing door

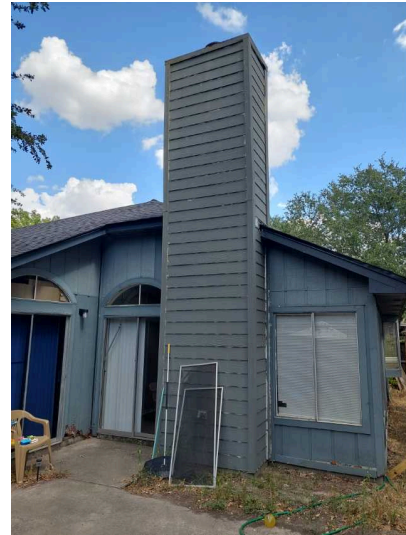
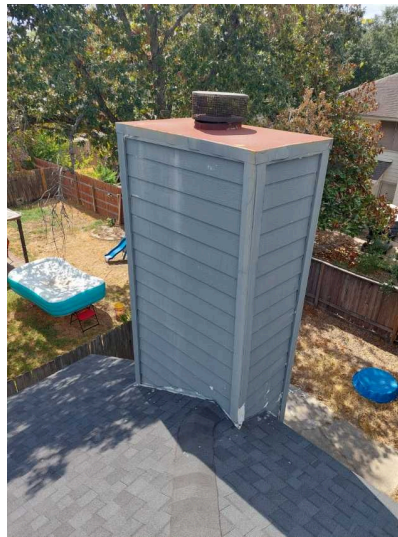
• **The metal fireplace chimney cap was noted with corrosion. Damaged chimney cap can create a moisture intrusion problem.**

Fireplace chimney

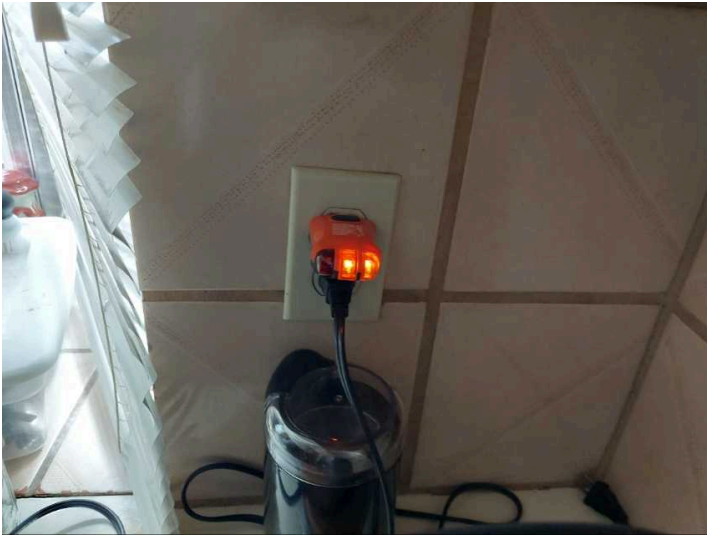
- One or more kitchen electrical receptacles noted without **GFCI** protection.
- Missing and/or non-functional exterior light fixture at front door
- The doorbell was noted as missing and or components were missing at the time of the inspection

Kitchen electrical receptacle not GFCI protected

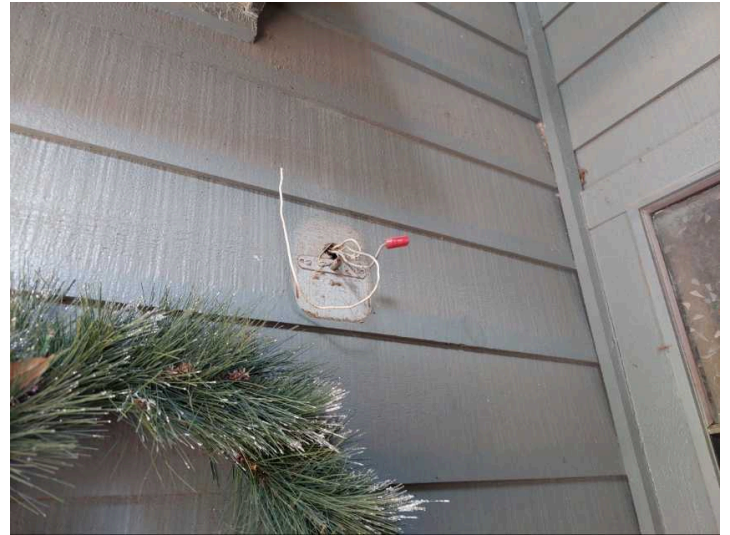
Missing front porch light

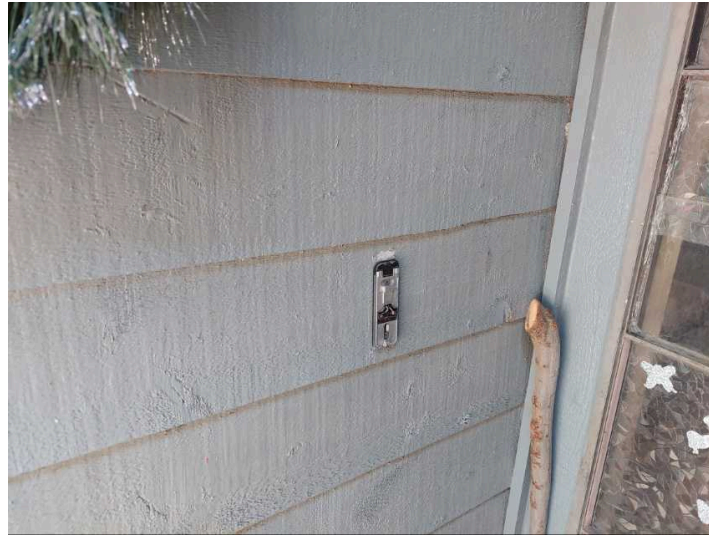
Missing door bell

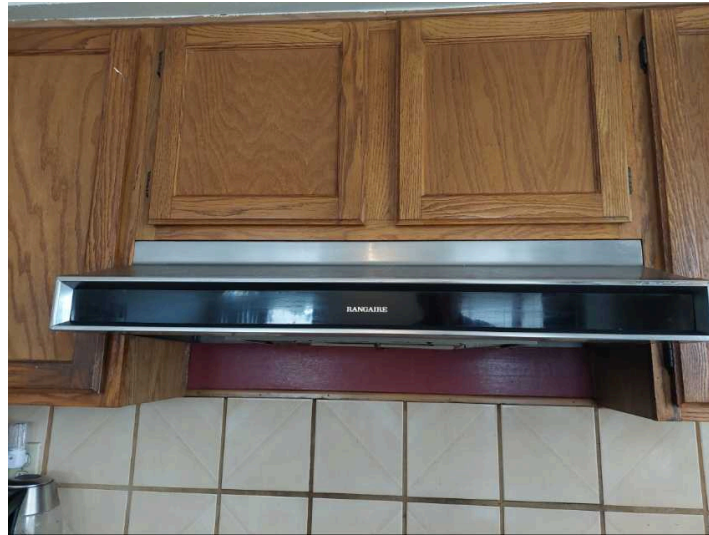
- The range hood fan operated properly, but the light did not come on.

Range hood

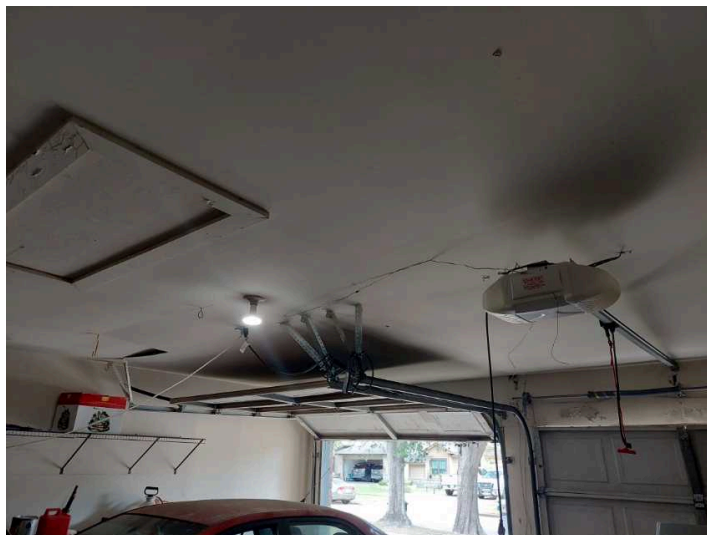
- One or more garage door operator(s) was not working at time of inspection.

Garage door operator

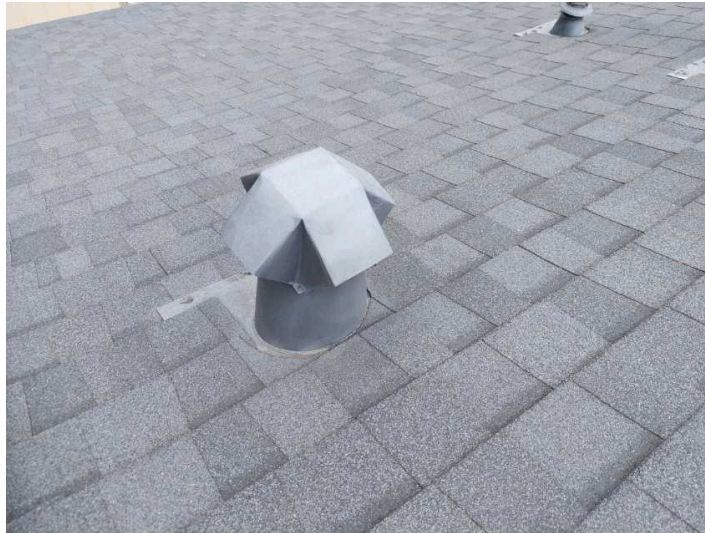
- The dryer vent pipe has been terminated through roof with an unapproved roof jack. Dryers terminated at roof requires a roof jack that is designed for this purpose. It is required to have a back draft damper to keep birds and rodents from building nests in the dryer exhaust pipe.

Unapproved roofjack used for dryer vent pipe
