"STRUCTURAL & MECHANICAL INSPECTION REPORT"

2705 Meadow Lane, La Marque, TX 77568

Concerning: 38 Willow Lane

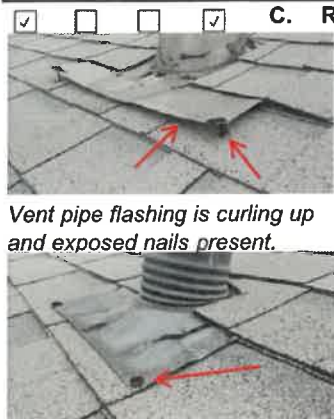
Vent pipe flashing is curling up and exposed nails present.
Exposed nails present on vent pipe.
