**20942 Punkin Street
New Caney TX 77357**

Client(s): Ortiz
Inspection Date: 6/24/2023
Inspector: JB Atterberry , 24834 (TX)

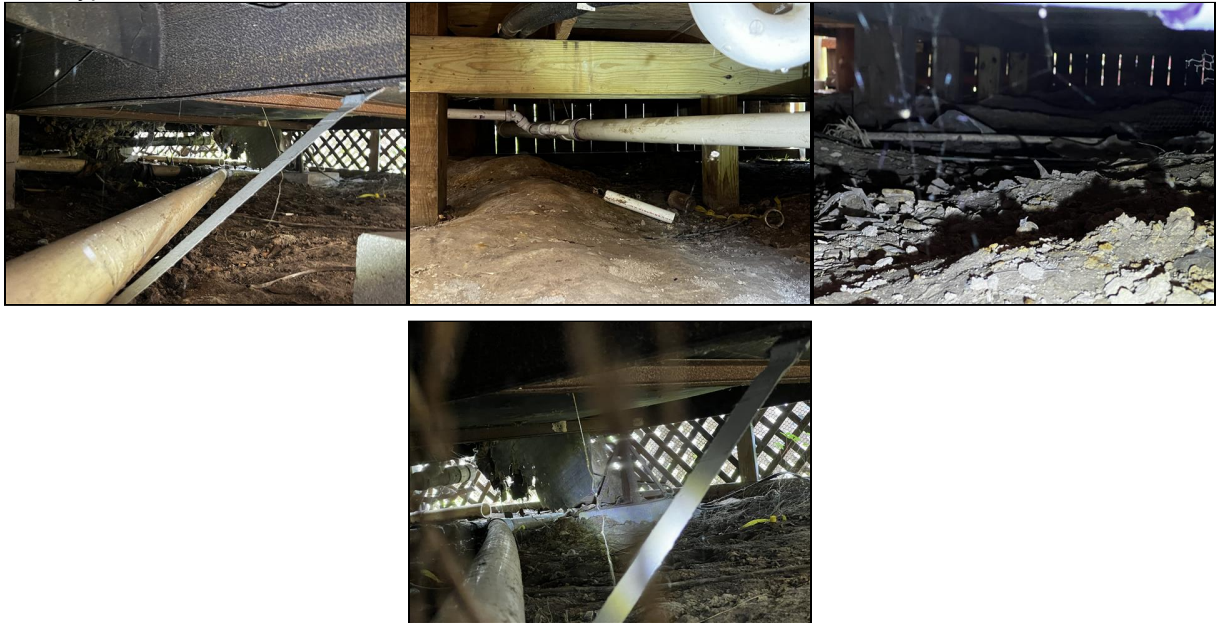
The pier & beam foundation structure exhibits signs of differential settling (un-level floors, doors out of square, cracks in wall and ceiling sheetrock etc.). Pier and beam foundations do require maintenance, levelling or repair every few years (the intervals are dependent upon the materials and quality of construction). I recommend further evaluation of the foundation structure by a licensed foundation repair company familiar with this type of structure.

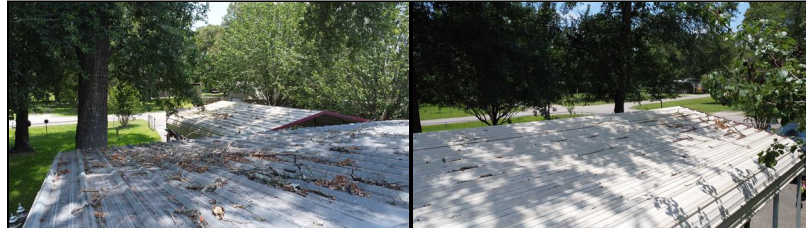
Remove all debris from roof slopes and valleys. Leaf debris may hide possible defects and damage to roofing materials. Debris may also cause water to dam up on roofing material.

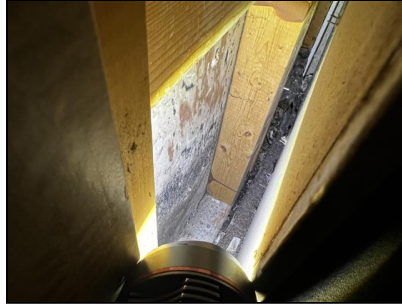
Signs of fungi growth are present on ceiling in areas of the middle bedroom closet. We did not inspect, test or determine if this growth is or is not a health hazard. The underlying cause is moisture or dampness. Recommend you contact a mold inspector or expert for investigation or correction if needed.

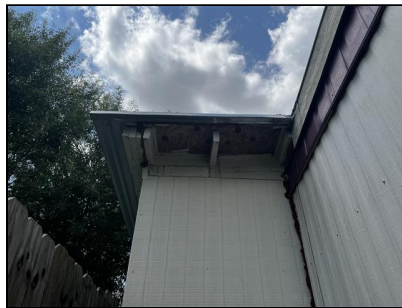
Seal (paint) all exposed wood surfaces around the exterior of the home to include any bare wood, joints in siding and trim, etc.

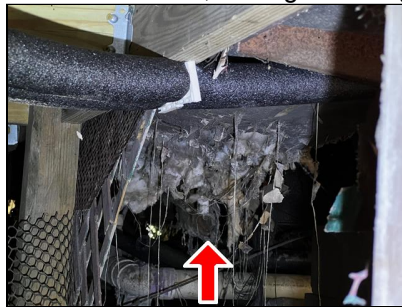
Subfloor insulation is falling from the floor structure, netting is damaged. Recommend repair.

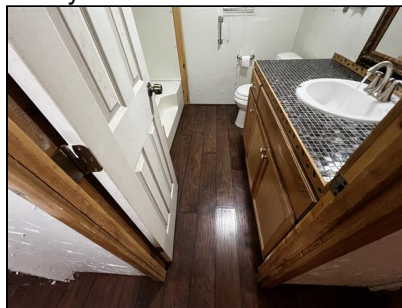
Noted areas, in the hall bathroom, where the structural integrity of the floor appears compromised, indicating a potential weakness or instability. Recommend further evaluation by a qualified professional.

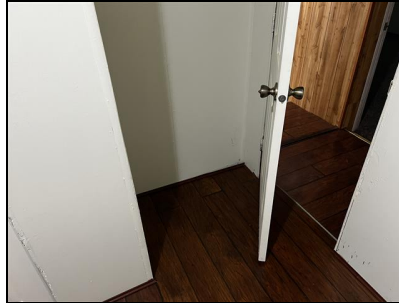
Recommend replacing all missing door stops.

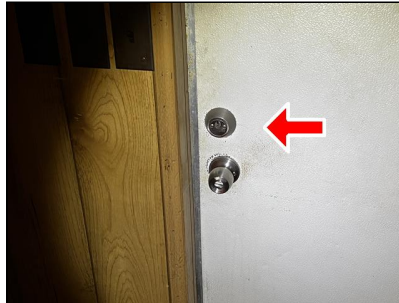
Double keyed dead bolt locks are installed on the front entry door. Today's standards recommends single keyed locks for emergency egress concerns.

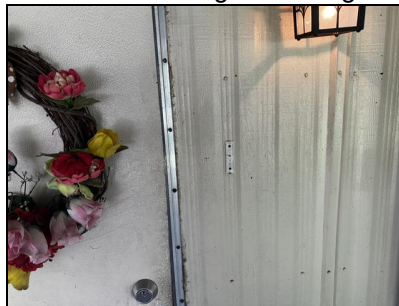
The door bell button is loose from the wall and/or damaged/missing. Repair is advised.

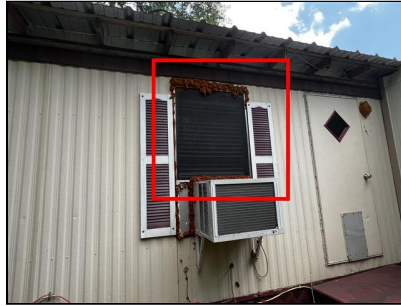
Noted a rear window, has been insulated with foam, which is not normal construction. Recommend further evaluation by qualified window professionals.

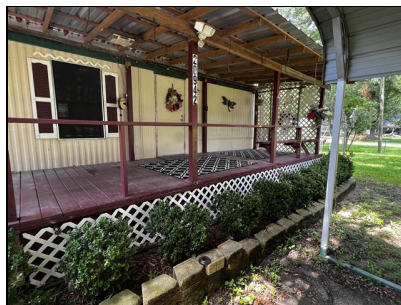
Deck balusters are improperly spaced greater than 4 inches apart as called for by today's child safety standards

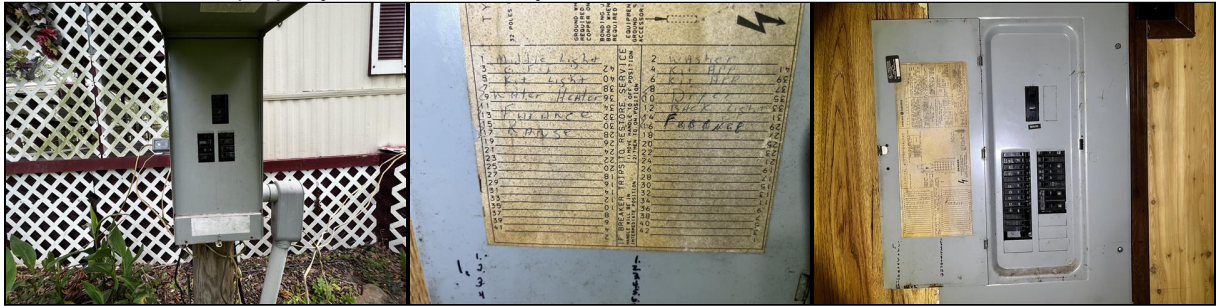
All breakers should be properly labeled to identify branch circuits controlled

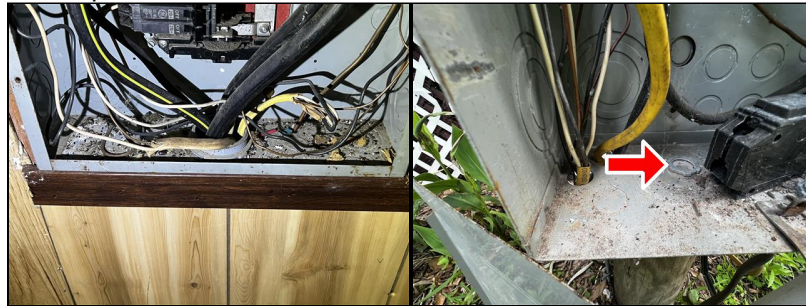
Remove debris from inside panel.

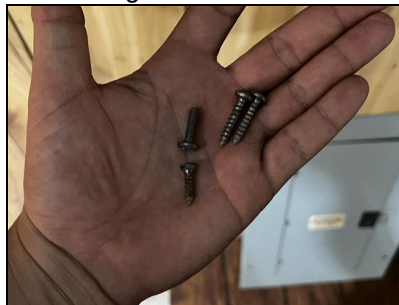
Panel dead front(s) was not secured with a blunt ended screw. Sheet metal fasteners can penetrate interior conductor sheathing and cause an arcing hazard.

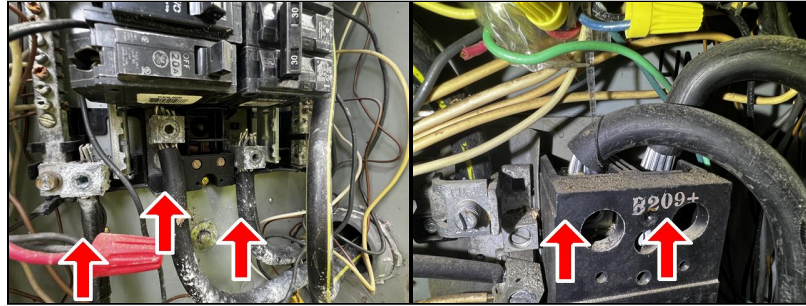
Ground bond could not be determined for the main panel panel. Typical bonding screw is designated with green color. It may be that this has faded, or that an improper screw was used. What ever the case, a I

recommend a licensed electrician review this to ensure proper ground bonding.

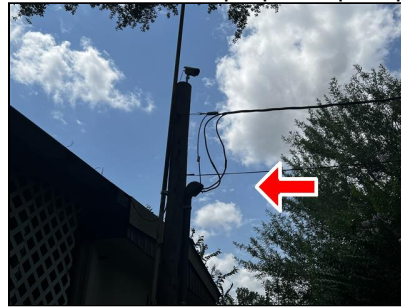
Main service wires at the weather head do not have proper drip loop.

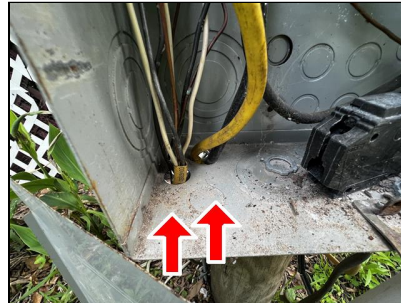
Conductors should enter panels through conduit bushings, and not make contact with panel sheet metal. These are easily installed plastic clip inserts.

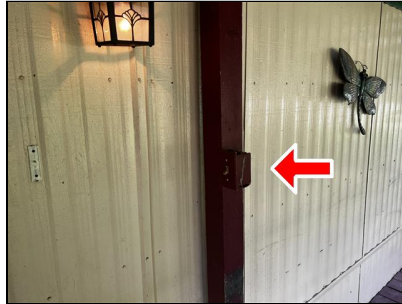
While operating switches, one without an obvious function was found in the main entry. Ask the Seller to explain the function of any such switch. If this does not solve the "mystery," consult with a qualified electrician.

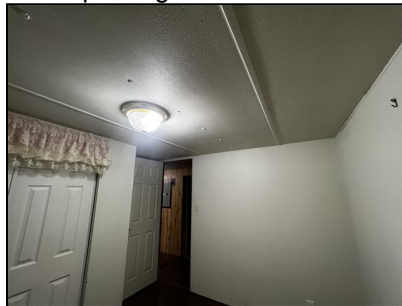
Smoke alarms are not in all required locations (sleeping and adjoining common areas, interconnected, hard wired, battery back up). Recommend updating to current standards.

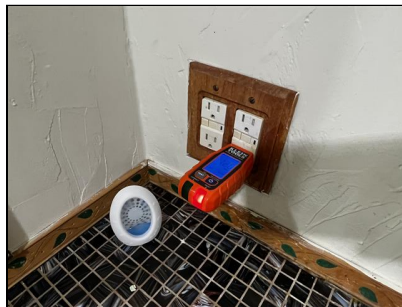
A GFCI is not functioning in the hall bath. I recommend an electrician to evaluate and repair or replace as needed.

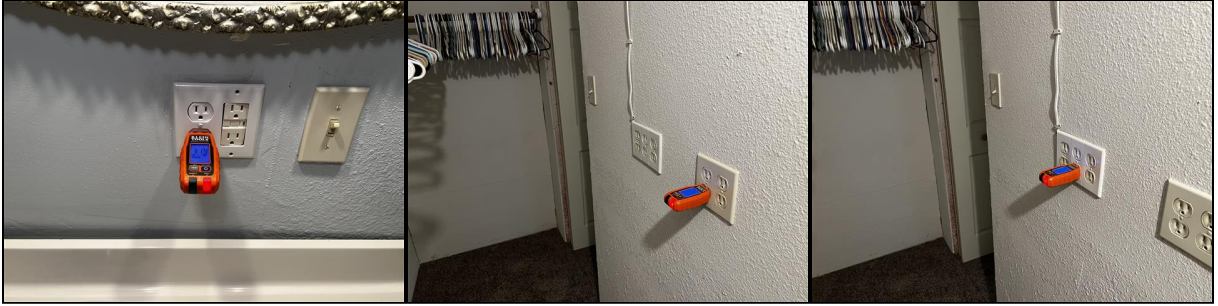
❌ There was an ungrounded circuit observed in most if not all rooms. The cause should be diagnosed and repaired by a licensed electrician.

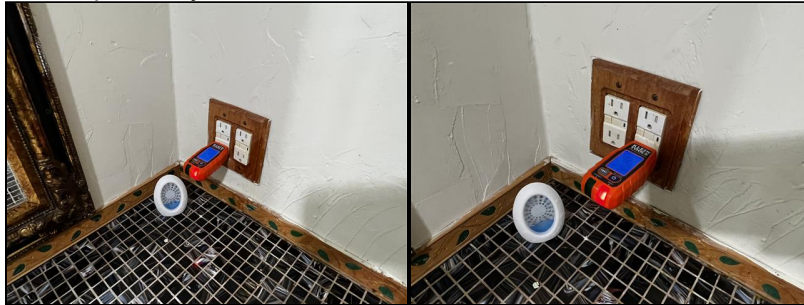
❌ There was a circuit with reversed polarity (hot/neutral reversed) observed in the hall bath. The cause should be diagnosed and repaired by a licensed electrician.

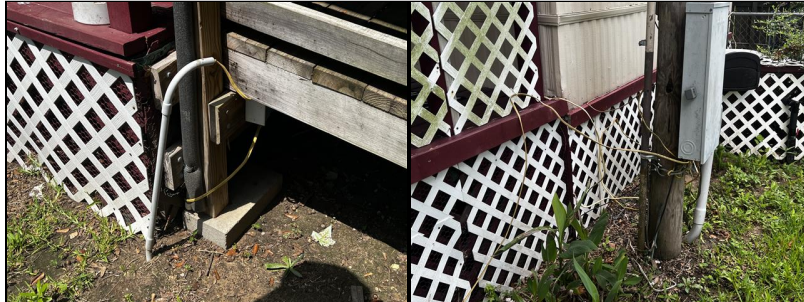
❌ Some conductors were observed to be improperly exposed to elements, foot traffic or mechanical movement. All exposed conductors should be encased in conduit to prevent injury, and damage to the circuit(s).

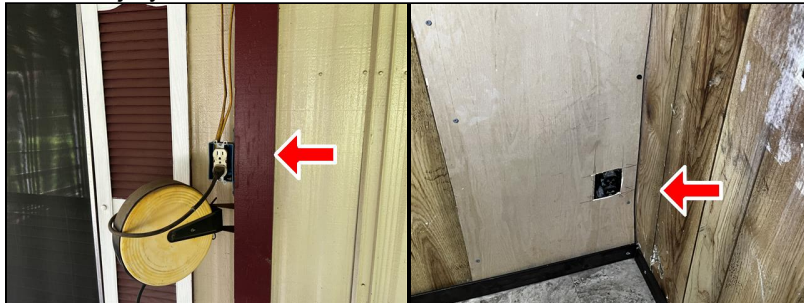
❌ Replace missing/damaged cover plates on various outlets and switches. Prevent access to live components that can cause injury or electrocution.

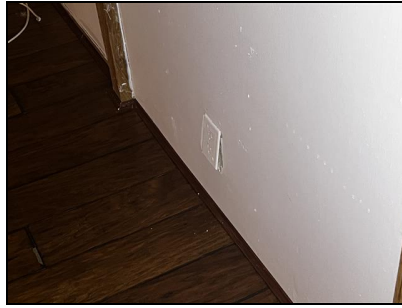
Noted several receptacles throughout the home that are loose at wall connection. Over time this can cause the electrical connections to become loose. A loose connection then can heat up and fail. Recommend having licensed electrician evaluate concern and properly secure receptacles affected.

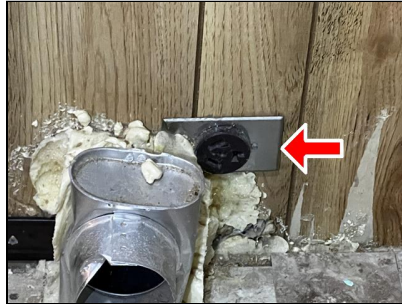
The utility 220 electric dryer outlet is a 3 prong type. Electric dryers today are now sold with a 4-prong plug. It may be necessary to swap out the 4-prong plug on newer units

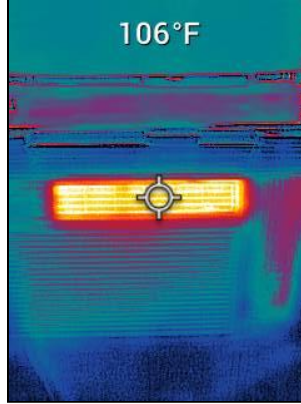
Noted the home furnace was not functional at time of inspection. Furnace does not appear to be connected at all.

The home's heat is supplied by window units. Noted the living room unit is the only unit supplying heat to the home. Recommend further evaluation by a qualified professional.

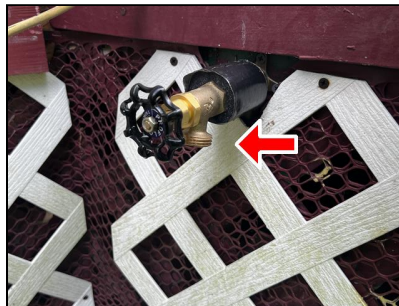
One or more exterior hose bibs (faucets) are missing back-flow check valves as called for by today's standards.

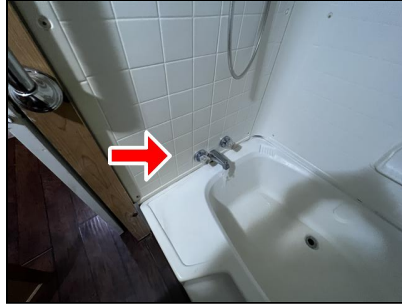
☒ The bathtub fill spouts and/or controls need to be reseated and sealed (caulked) to prevent moisture seepage into tub surround. (Hall bath tub)

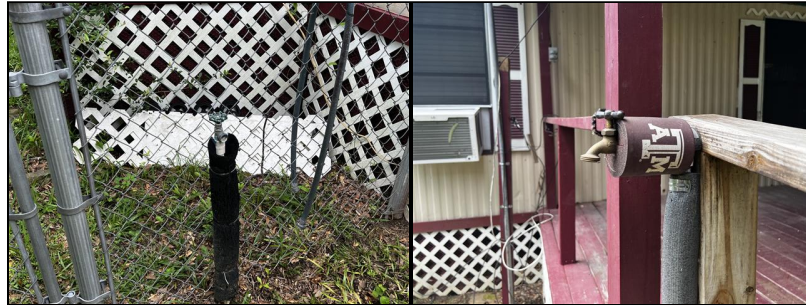
☒ Noted two exterior hose bibbs were not functional at time of inspection. Recommend further evaluation by a licensed plumber.

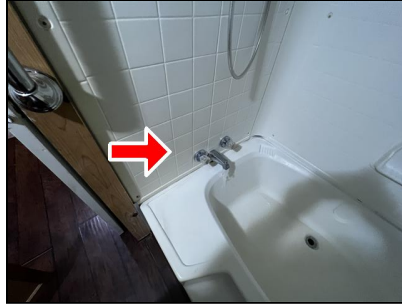
☒ Noted the water control valves, located in the hall bathroom, for the bath tub, are not secured in the wall. Recommend further evaluation by a licensed plumber.

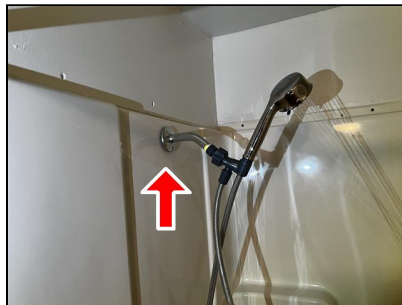
☒ Noted in the master bathroom, the shower head supply, is not secured in the wall. Recommend further evaluation by a licensed plumber.

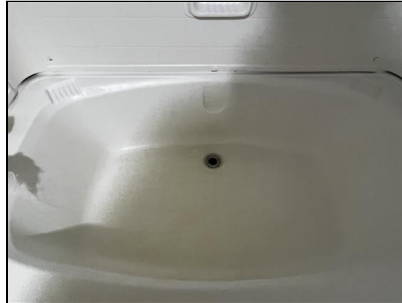
Have all missing/non-functional drain stops repaired/replaced.

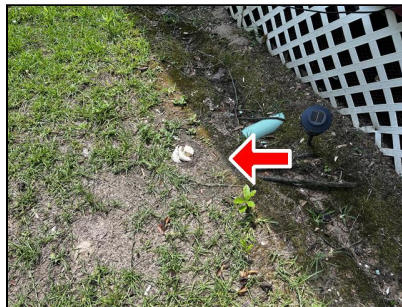
Recommend replacing damaged drain cleanout covers in front yard (commonly damaged from lawn equipment).

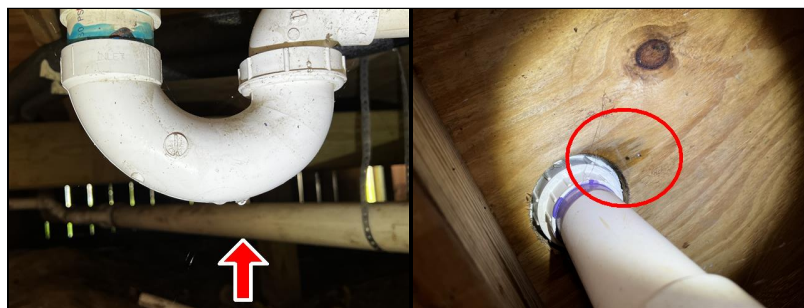
Noted a small leaking in the master bathroom toilet drain. Recommend further evaluation by a licensed plumber.

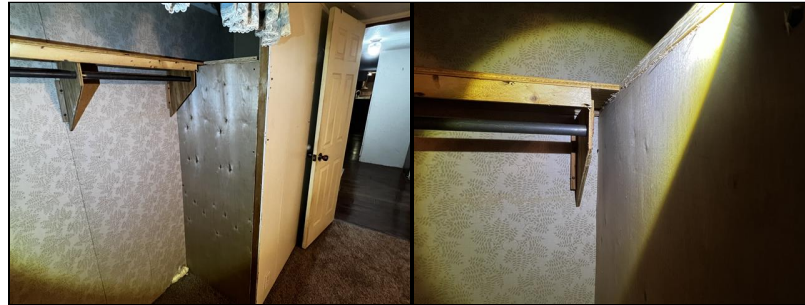
Noted the water heater was not accessible at time of inspection. Water heater was closed off, and has no access door.

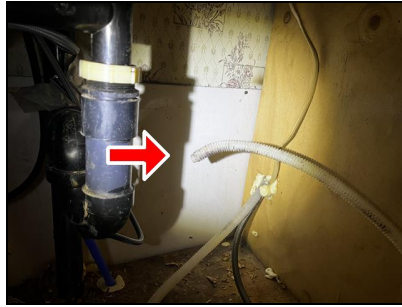
Dishwasher could not be inspected due to drain line was not connected.

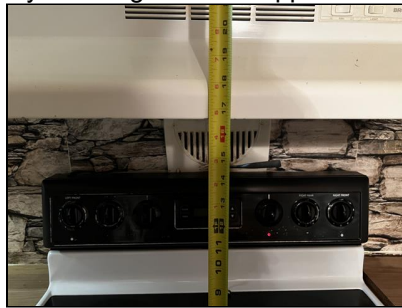
The range hood has been installed too close to the range. The range hood should be installed between 24-30 inches above the range. Currently the range hood is approx 16 1/2 inches above the range.

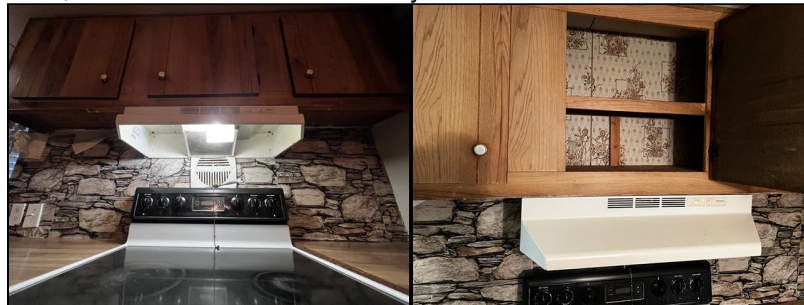
The vent fan is functional, but does not ventilate directly to exterior.

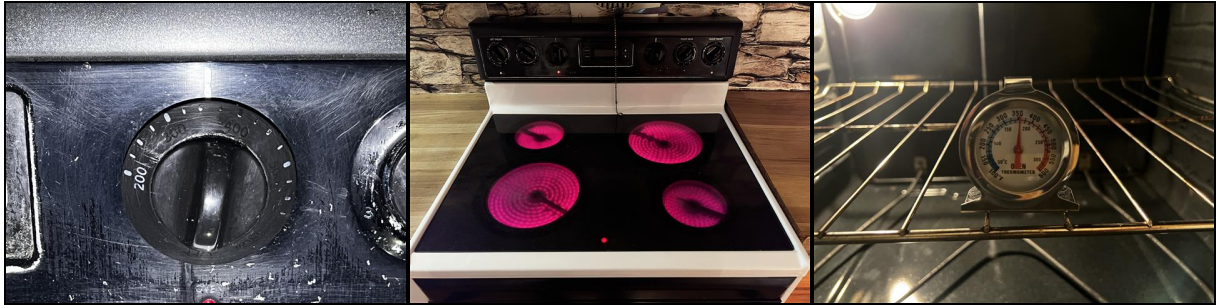
There is no child protection anti-tip device installed. Anti-tip brackets prevent the stove from accidentally tipping over if weight is placed on the oven door
