TREC-7-6

24607 Emerald Pool Falls Dr
Tomball, TX 77375

PROPERTY INSPECTION REPORT FORM

Offer Pad	06/29/2023 12:00 pm
<i>Name of Client</i>	<i>Date of Inspection</i>
24607 Emerald Pool Falls Dr, Tomball, TX 77375	
<i>Address of Inspected Property</i>	
Cullen Fleetwood	TREC # 20717
<i>Name of Inspector</i>	<i>TREC License #</i>
<i>Name of Sponsor (if applicable)</i>	<i>TREC License #</i>

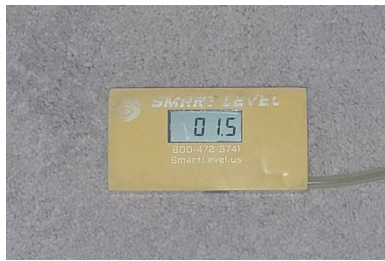
1: OUT OF TOLERANCE -ZIP LEVEL READING ONLY

ZIP LEVEL READING OUT OF TOLERANCE - Foundation observed appeared to be out of tolerance per the ZIP LEVEL READING ONLY. Zip level showed an elevation difference of 1.5".

There were no other visual signs of settling noted at the time of inspection. Prior to closing, the foundation should be inspected by a qualified foundation specialist, familiar with the soils and construction methods of the region, in order to determine if permanent repairs are required.

Recommendation: Contact a qualified professional.

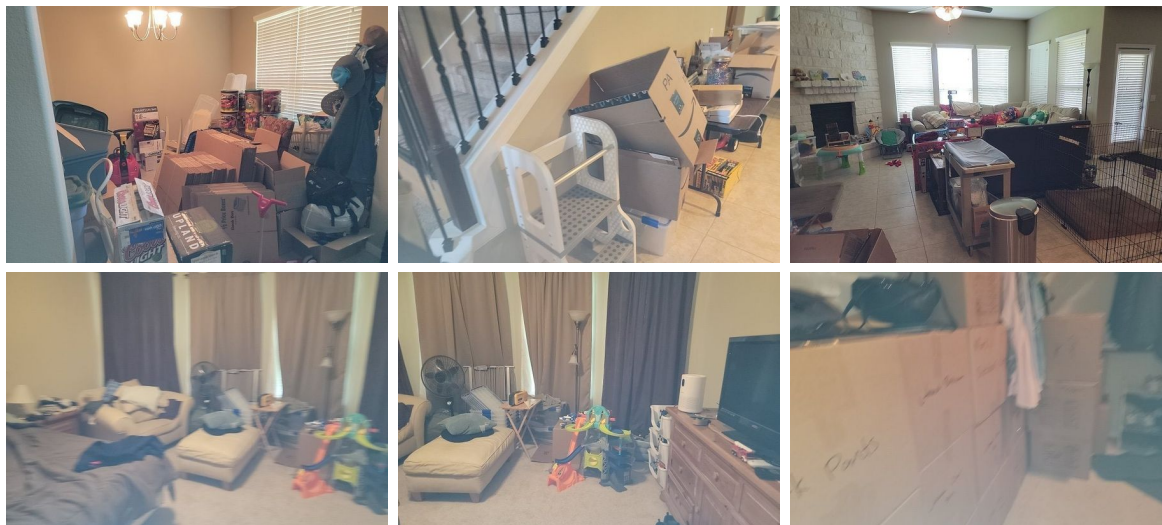
Throughout

Inspection/assessment was limited due to sellers belongings. Recommend fully observing the area prior to closing if needed.

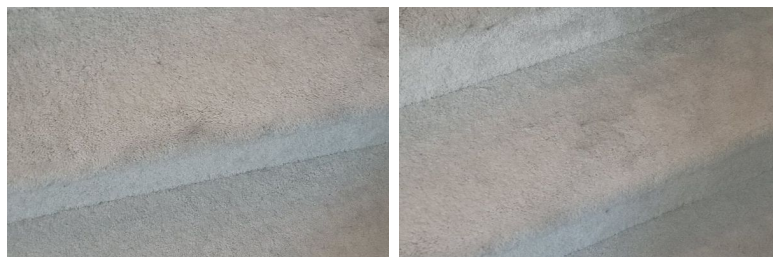
Stairway

Minor to moderate carpet staining noted. Recommend assessment/service as needed by a qualified carpet/flooring professional.

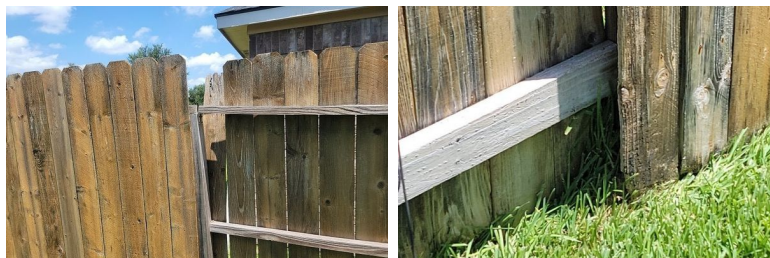
1: Wood fence

Loose, weathered and/or damaged wood planks observed at the wood fence. Recommend replacement as/where needed by a qualified professional.

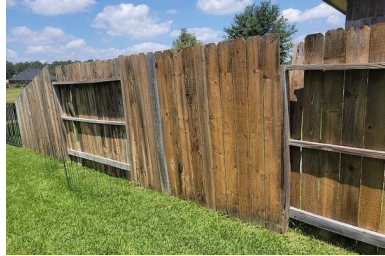
2: Fence not Stained

The perimeter wood fence is not stained/sealed. Recommend staining or painting by a qualified professional to maintain material integrity.

Recommendation: Contact a qualified professional.

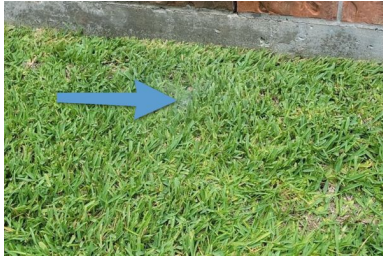
1: Obstruction

One obstructed sprinkler head present at zone 3.

Recommendation: Contact a qualified professional.
