# **INSPECTION GROUP**

**NOTICE CONCERNING HAZARDOUS CONDITIONS, DEFICIENCIES, AND CONTRACTUAL AGREEMENTS**

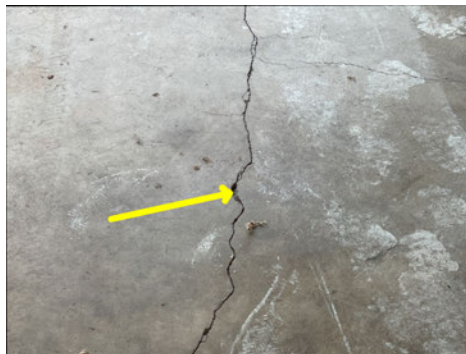
Observed one or more cracks in the foundation; garage.

Multiple large foundation cracks observed in the garage.

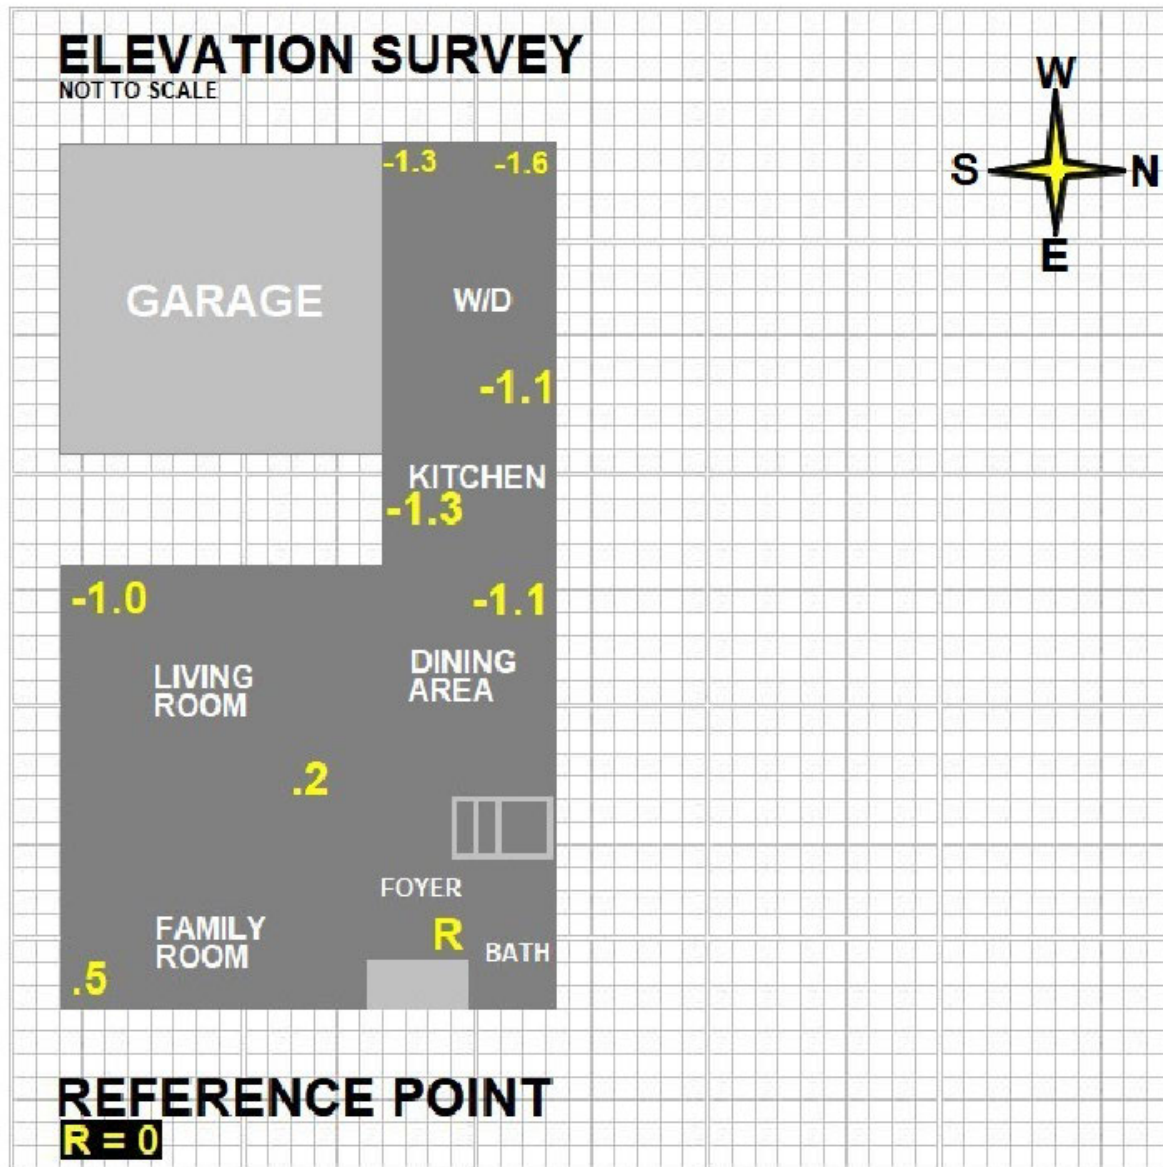
A foundation elevation survey was conducted during the inspection. The floor plan drawing (not to scale) below represents data gathered using a Zip Level and adjusting for floor covering height differences. i.e. differences between tile, carpet and wood flooring (except step down to the garage). Measurements are listed to the nearest 1/10th of an inch. The greatest variance was -1.6" to .5"

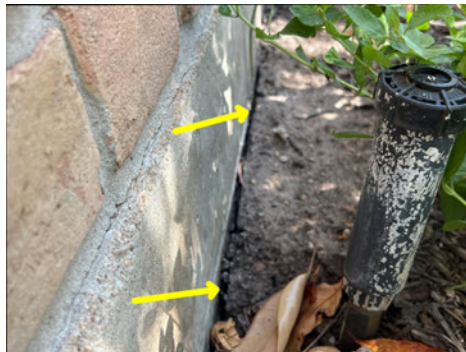
The soil has pulled away/separated from the foundation; indicates inadequate moisture level of soil supporting the foundation system, this situation should be addressed to prevent damage to the foundation.

The soil has pulled away from the foundation wall at multiple locations.

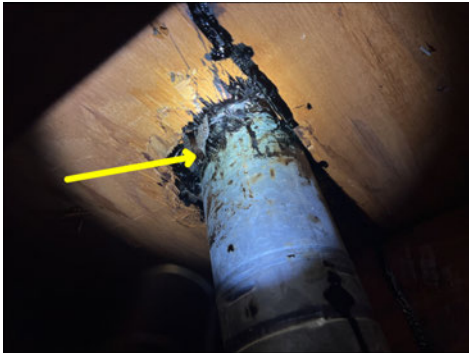
Observed improper use of roof tar as a sealant around the house / water heater vent piping. Roof tar is not an approved sealant around hot vent piping.

Improper tar repairs observed around hot vents.

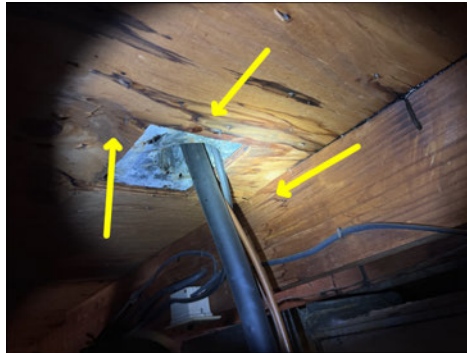
Areas of water stained/ rotted roof decking observed in attic. All accessible stains were checked with moisture meter, no active moisture detected at time of inspection.

Multiple water stains observed on roof decking/attic framing. Dry at the time of inspection.

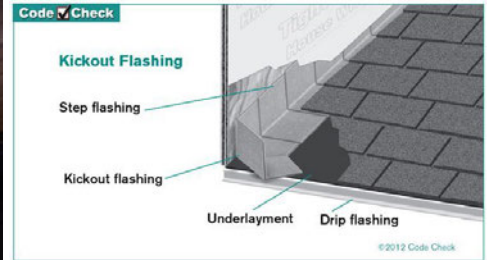
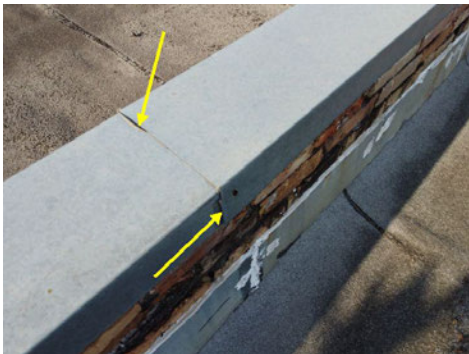
Roof flashing/cap flashing not sealed at seams and joints.

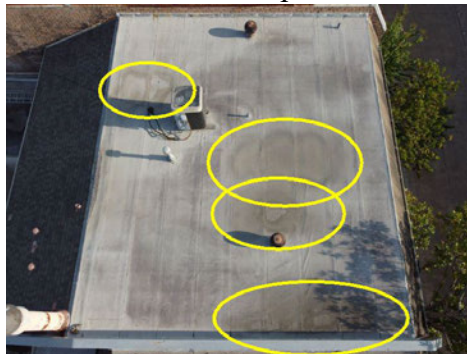
Standing water and/or stains from previous standing water observed on the flat roof. This condition is conducive to water penetration. Recommend roofer be consulted regarding the ability to correct drainage on the roof to prevent/reduce standing water.

Observed multiple areas of water stains/evidence of ponding water on both flat roofs.

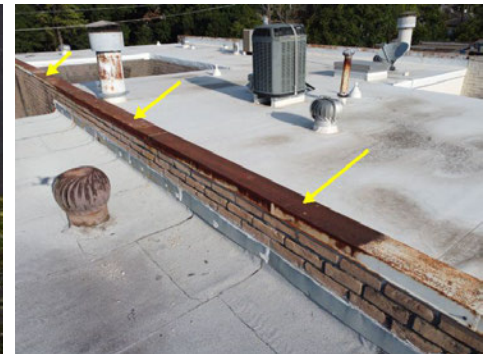
Observed rusted flashing on the roof.

Multiple areas of rusted flashing observed on the roof surface.

Recommend painting all exposed metal above roof line to prevent rusting and extend service life.

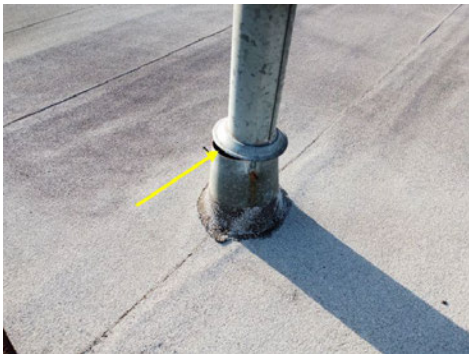
Misaligned storm collar observed on one or more hot vents.

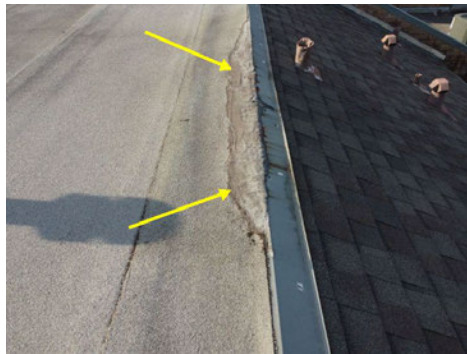
Observed spot repairs to the roof surface; possible water penetration area.

Flat roof damage/repair observed on the roof.

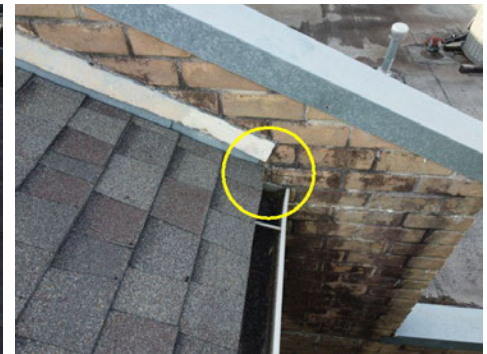
Kick-out flashing missing at multiple areas on the roof.

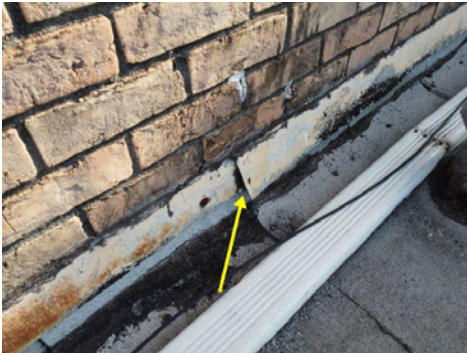
Observed masonry counter flashing damaged, missing or improperly installed. May allow water penetration to occur between the masonry and flashing.

Counter flashing damaged at multiple locations on the roof.

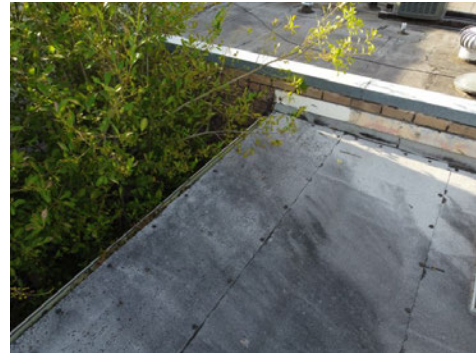
Tree limbs in contact with the roof can/ will damage the roof.

Trees/foliage touching roof.

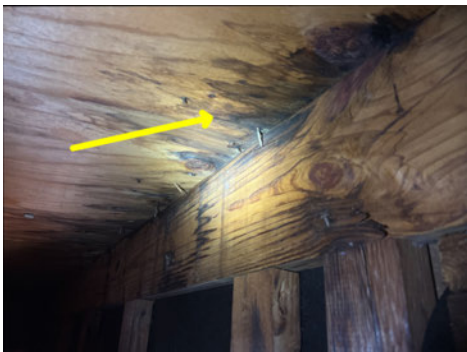
Observed multiple areas of water stains/wood rot in the attic.

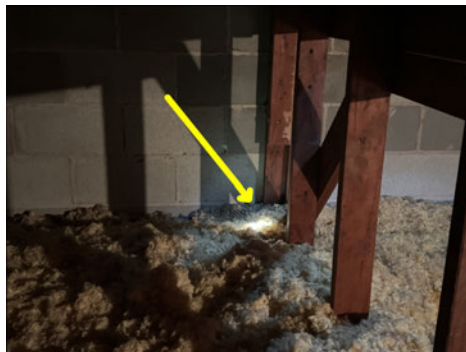
Daylight is visible from interior of attic at one or more locations. Recommend sealing these areas to prevent potential pest / rodent / water entry.

Daylight observed in the attic at multiple unintended locations.

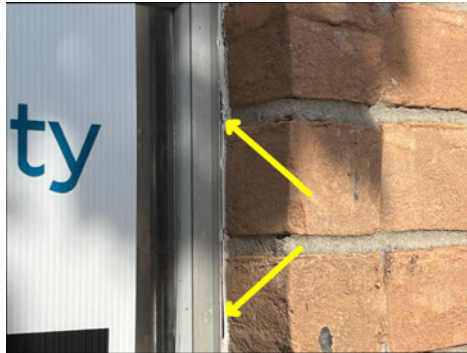
Caulking missing and/or deficient around windows/doors/vertical trim/joints in siding. May allow wind driven rain entry.

Seal all exterior windows/vertical trim/joints in siding.

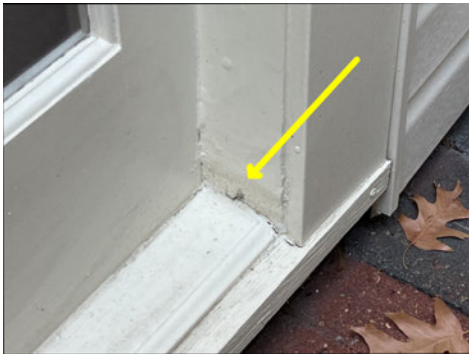
Wood rot observed on areas of house/garage.

Exterior wood rot observed at multiple locations.

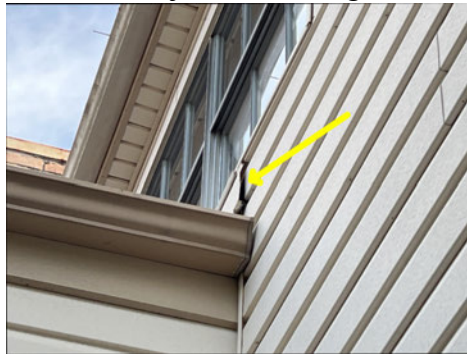
Damaged/loose siding observed.

Damaged/cracked siding should be repaired to prevent water penetration.

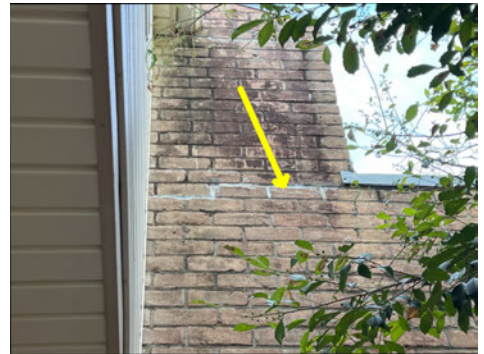
Cracks in brick/stone veneer and/or repairs, at one or more locations. Recommend buyer take photographs of cracks, their location, and width [ruler across the crack] with a high-resolution camera that has a date stamp for future reference.

Brick cracks/repared cracks observed.

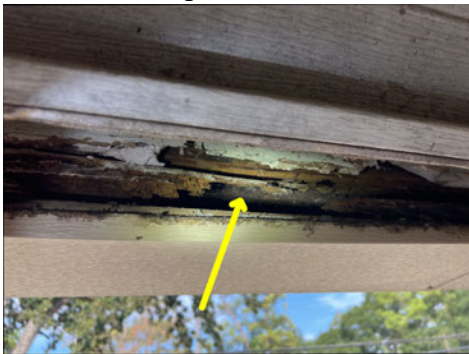
Observed wood rot above the garage door/garage door header.

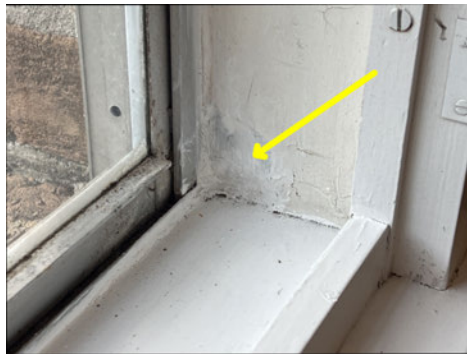
Water stains/damage to the interior of one or more window jambs. Moisture meter indicated that the stains were not active (wet) at the time of inspection.

Water stain/damage at multiple window jambs. Dry.

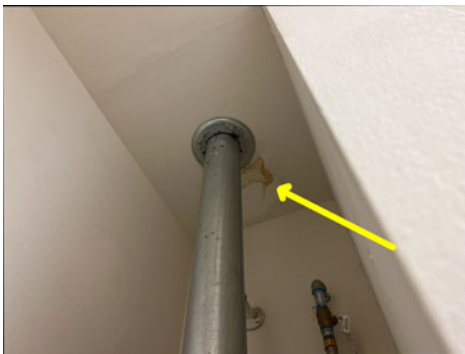
Water stains, damage or repairs observed, moisture meter indicated that stains are not active (wet) at the time of inspection; ceiling above the water heater.

Water stain at ceiling above the water heater. Dry at the time of inspection.

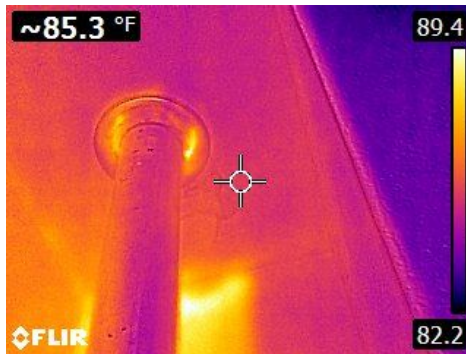
The water stain in the ceiling above the water heater was dry at the time of inspection.

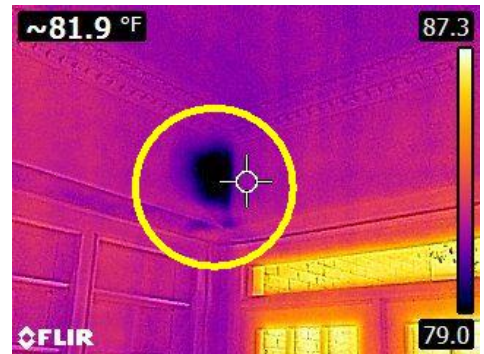
**Active(visible) water leak observed in the living room ceiling/wall after running the master shower.**

Active water leak observed in the living room ceiling/wall below the master shower.

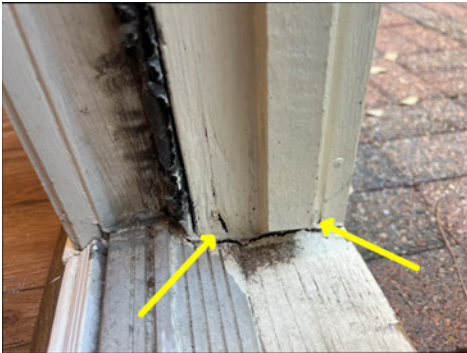
Wood rot observed at courtyard door/frame/trim.

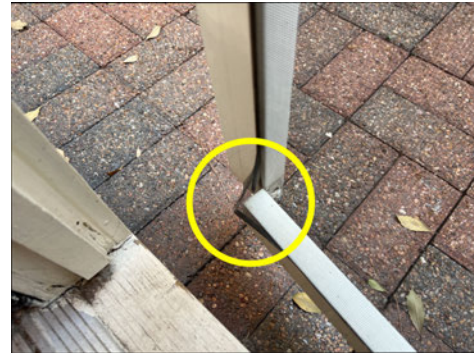
The courtyard screen door is damaged.

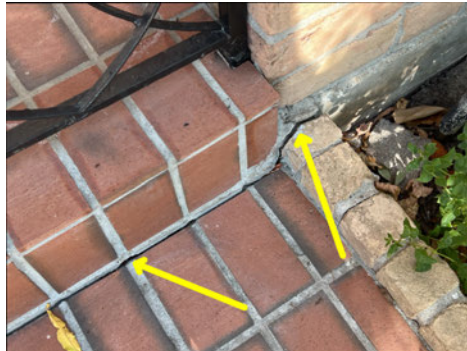
The front patio steps have settled and has multiple cracks.

The front patio steps have settled/cracked.

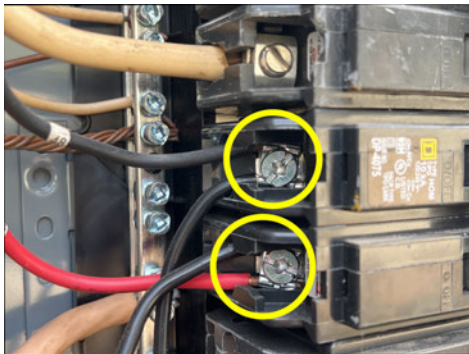
Double lugged breaker(s), [two wires improperly on 1 breaker] observed.

Two wires under one breaker lug observed at multiple locations in the electrical panel.

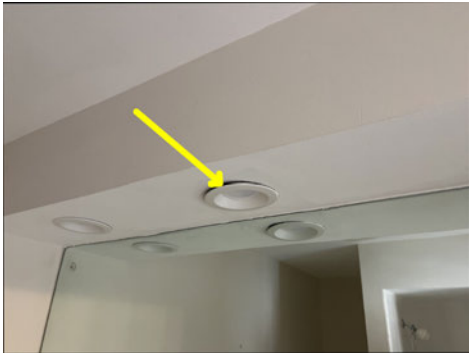
Observed one or more light fixtures not properly secured to the ceiling.

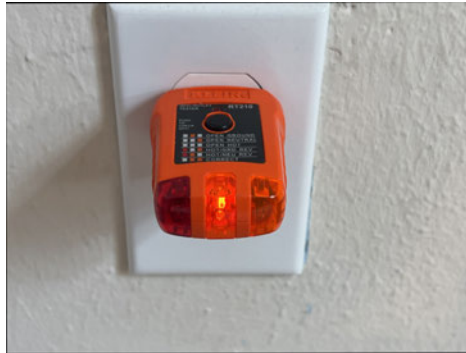
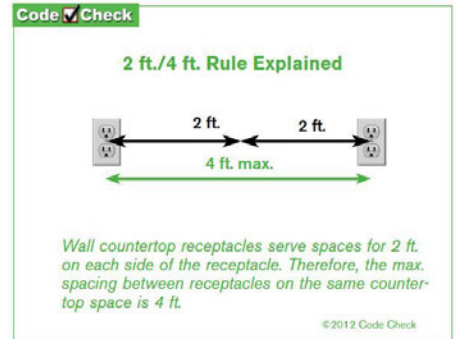
Improperly wired, 3 prong outlet not grounded or polarity reversed, including but not limited to; multiple locations throughout the home.

Multiple improperly wired three prong outlets observed in the home.

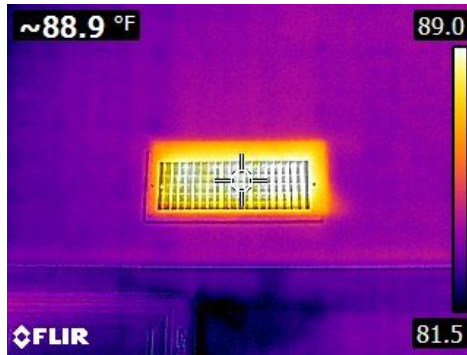
**Furnace unit does not cycle/heat properly. Recommend qualified/licensed HVAC technician service and repair as needed; first floor unit.**

The west furnace did not heat as intended at the time of inspection.

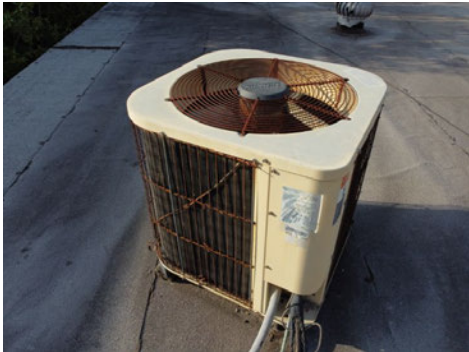
The west condenser unit data plate is damaged. Information no longer visible.

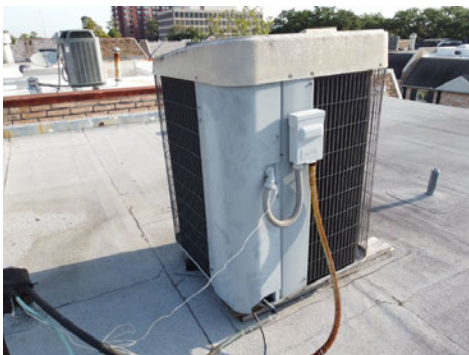
The east condenser unit data plate is missing.

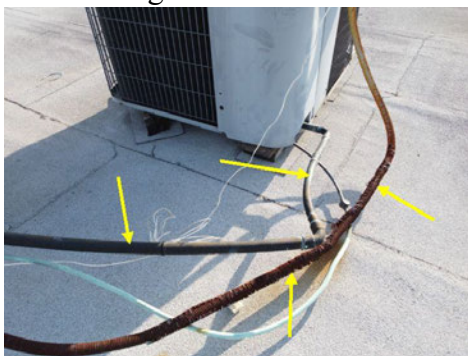
Conduit rusted through exposing electrical wiring; roof AC units.

The condenser unit suction line insulation is missing on the roof. Electrical conduit rusted through.

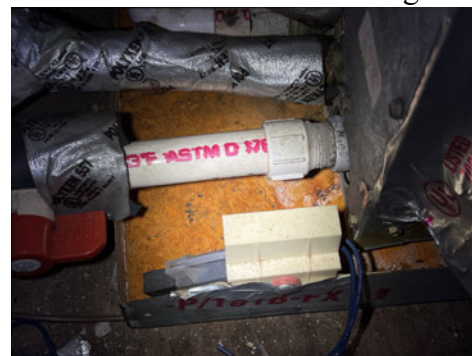
East AC drain pan is very rusted.

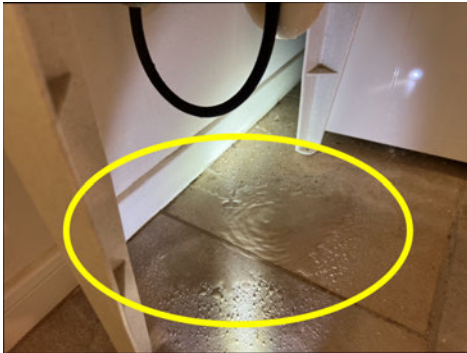
Water leak observed below the laundry room sink.

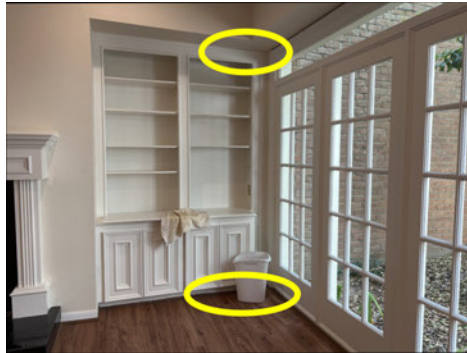
The master shower leaked through the ceiling onto the floor in the living room during operation.

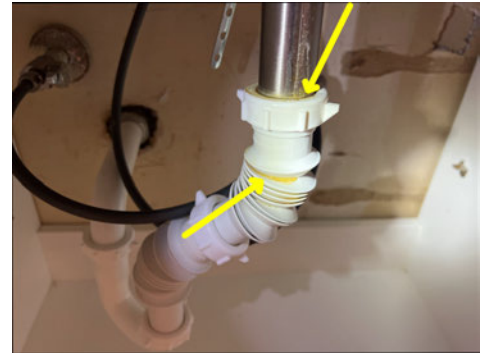
Small leak observed below the left master bath sink.

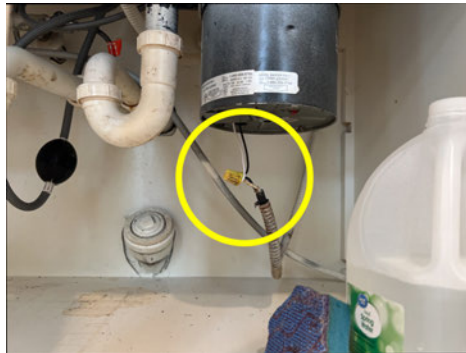
Electrical conduit is not secured to the base of the disposal unit.

Wiring and electrical conduit not secured below the disposal.
