ENGINEER'S REPORT

11 Windermere Lane
Houston, TX 77063

Inspection No. 20130143

Date of Inspection: January 22, 2013

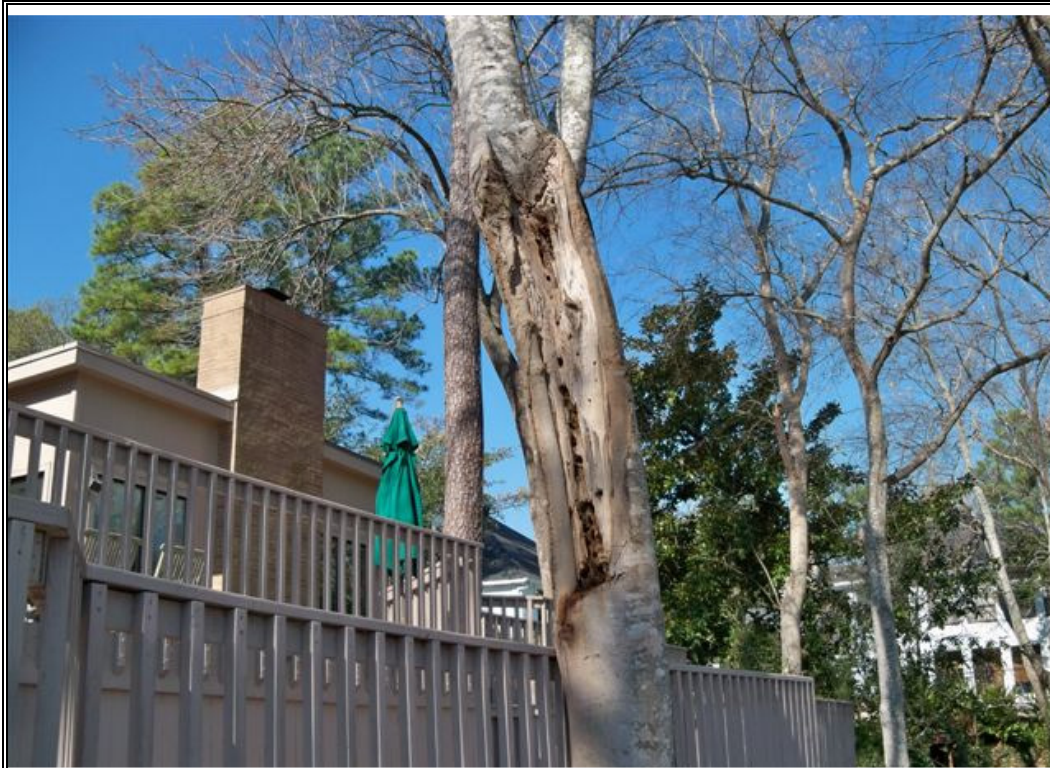
Photo Number
5

Description:
Damaged tree at rear. Recommend an arborist evaluate

- We noted an insect damaged tree at the rear which overhangs the deck. For safety we recommend an arborist evaluate the health of the tree.

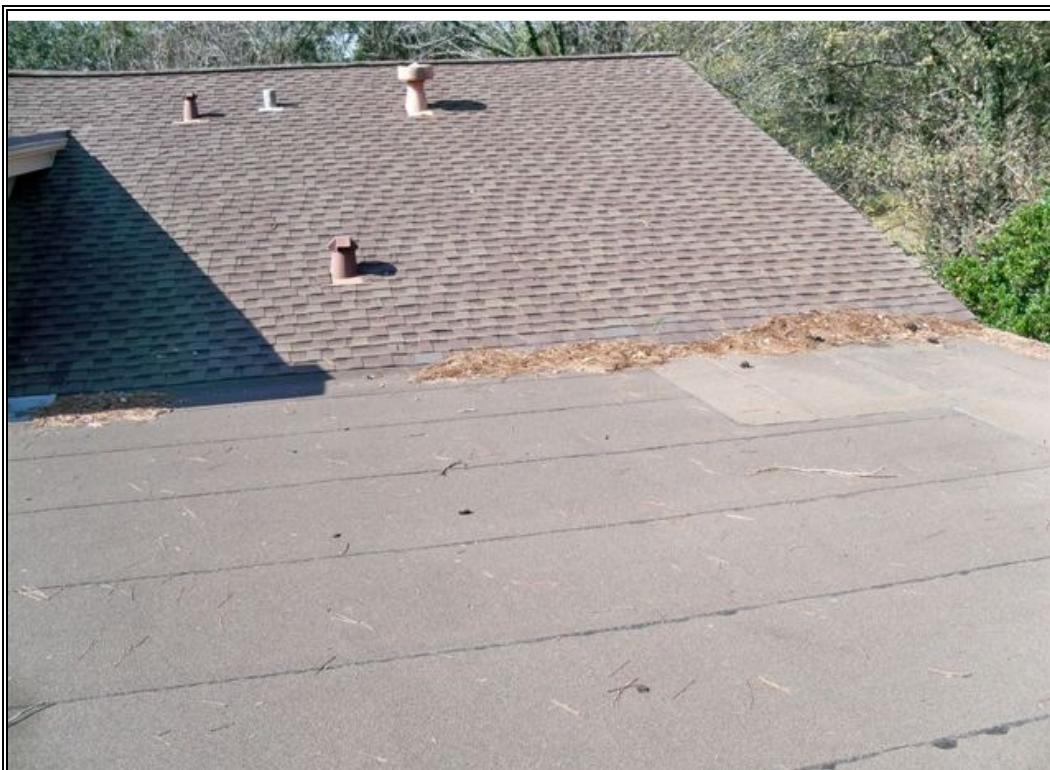
Photo Number
6

Description:
View of flat roof surfacing over living room

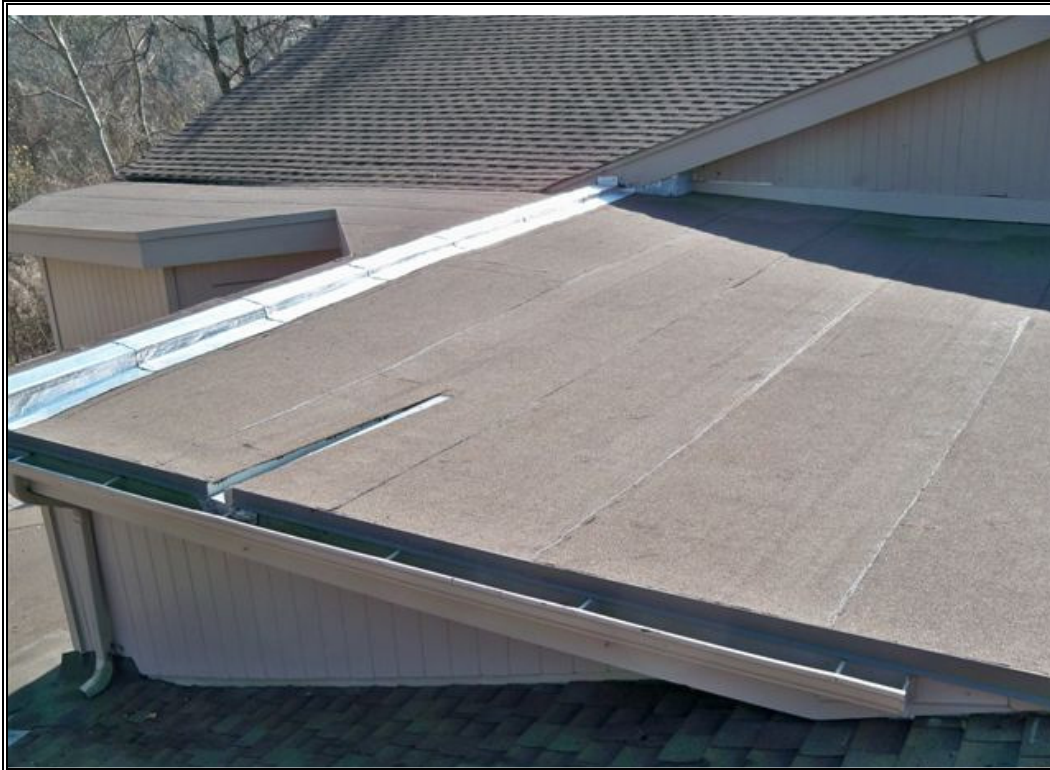
Photo Number
7

Description:
View of flat roof
surfacing over
foyer and dining
room

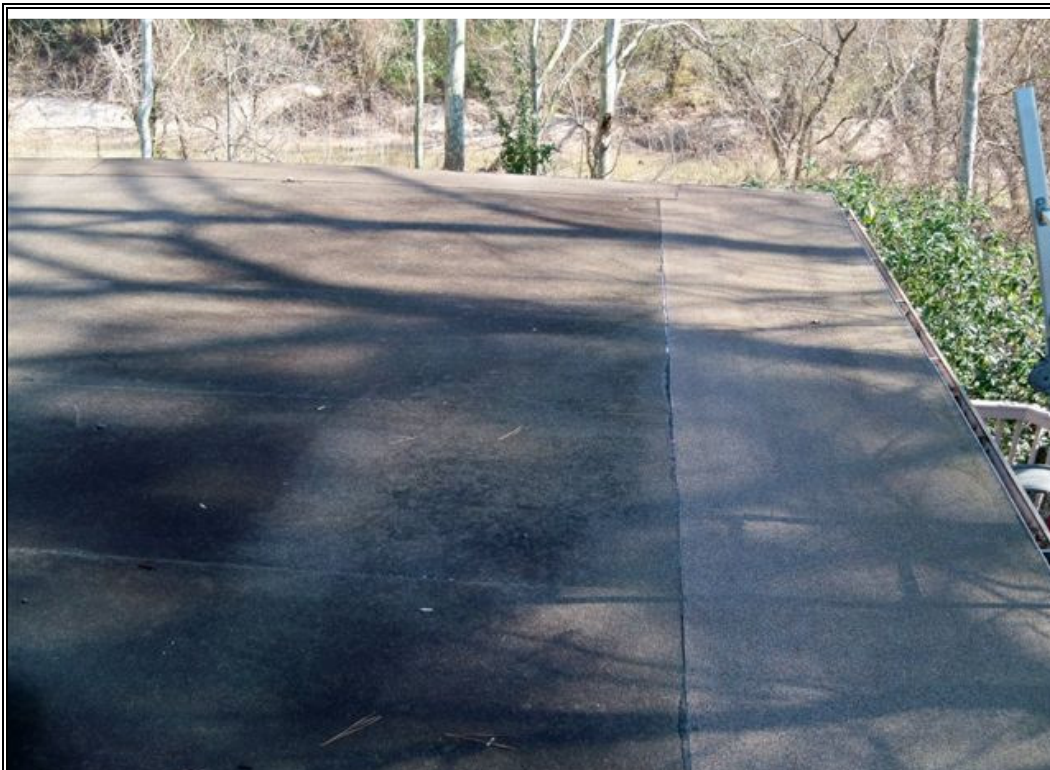
Photo Number
8

Description:
View of flat roof
surfacing above
gameroom

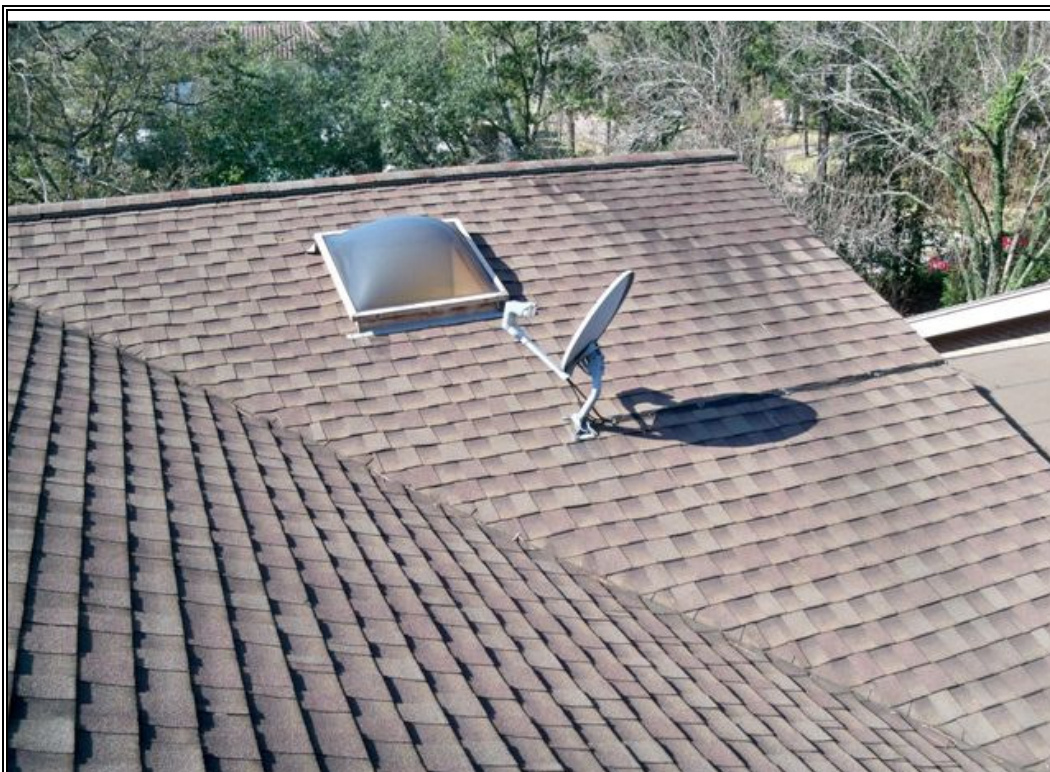
Photo Number
10

A satellite dish is mounted on the roof. Over time this type of mounting could loosen, creating a leak in the roof. This area should be kept under observation.

Description:
View of satellite
dish on roof

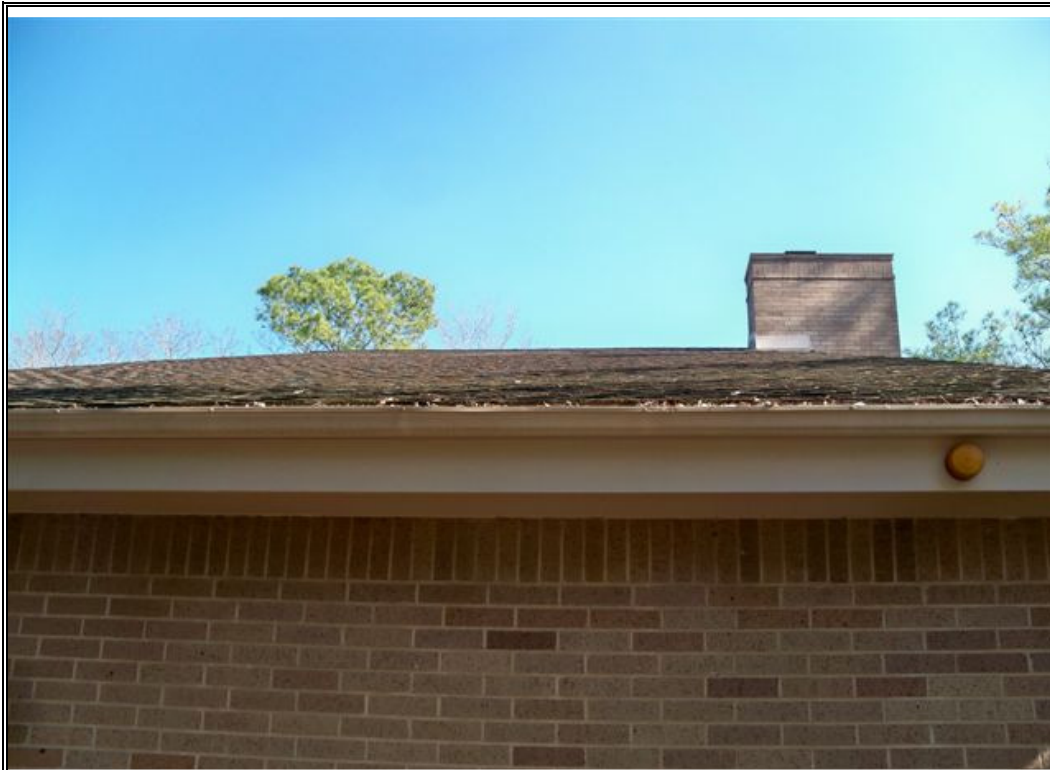
Photo Number
11

- Roof sag (roof rafter deflection) was noted at the right front roof slope. The rafter sag is visible in the interior sloped ceiling of the room above the garage. In our opinion, the degree of sag is not considered a significant structural deficiency.
- We measured significant deflection in the floor of the room above the garage. The mid-span deflection exceeds allowable limits. While the floor deflection is noticeable (a serviceability issue), in our opinion it is not considered a significant structural deficiency. However, we do recommend limiting the amount of furniture etc. placed in the center and

Description:
Roof sag noted in
front right roof
slope

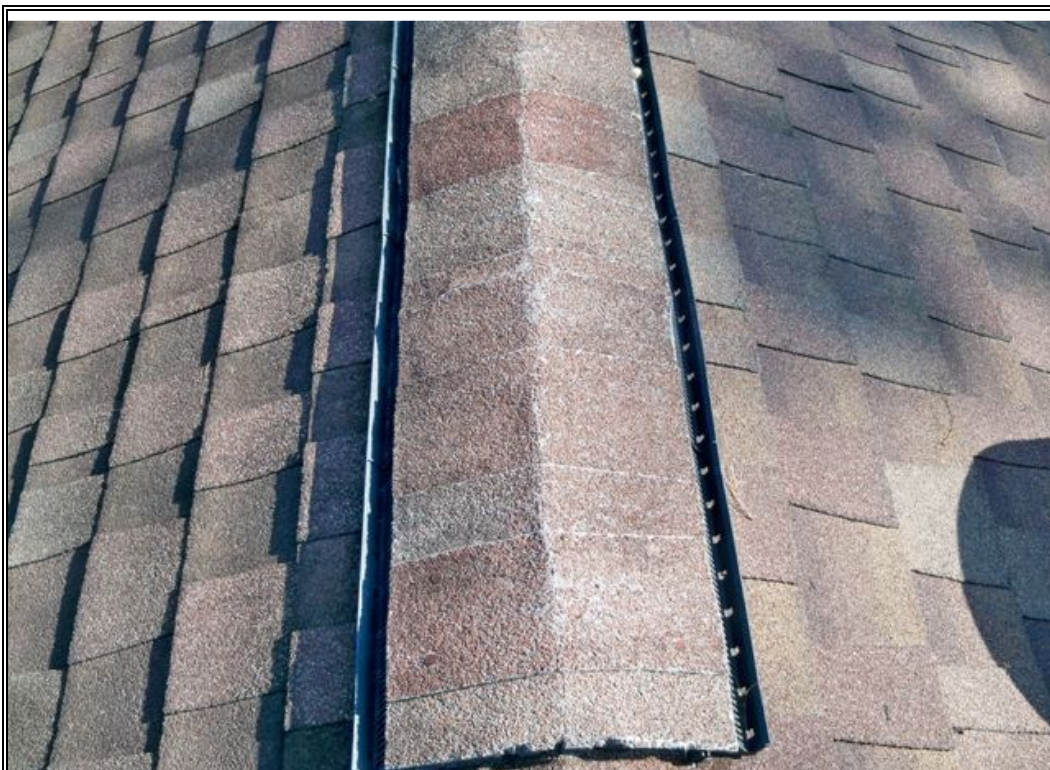
Photo Number
12

Description:
Deteriorated ridge
row shingles
(typical)

- We observed ridge row shingles which are deteriorated along the roof ridges. We recommend these shingles be replaced.
- We noted one roof vent on the right side with corroded flashing.

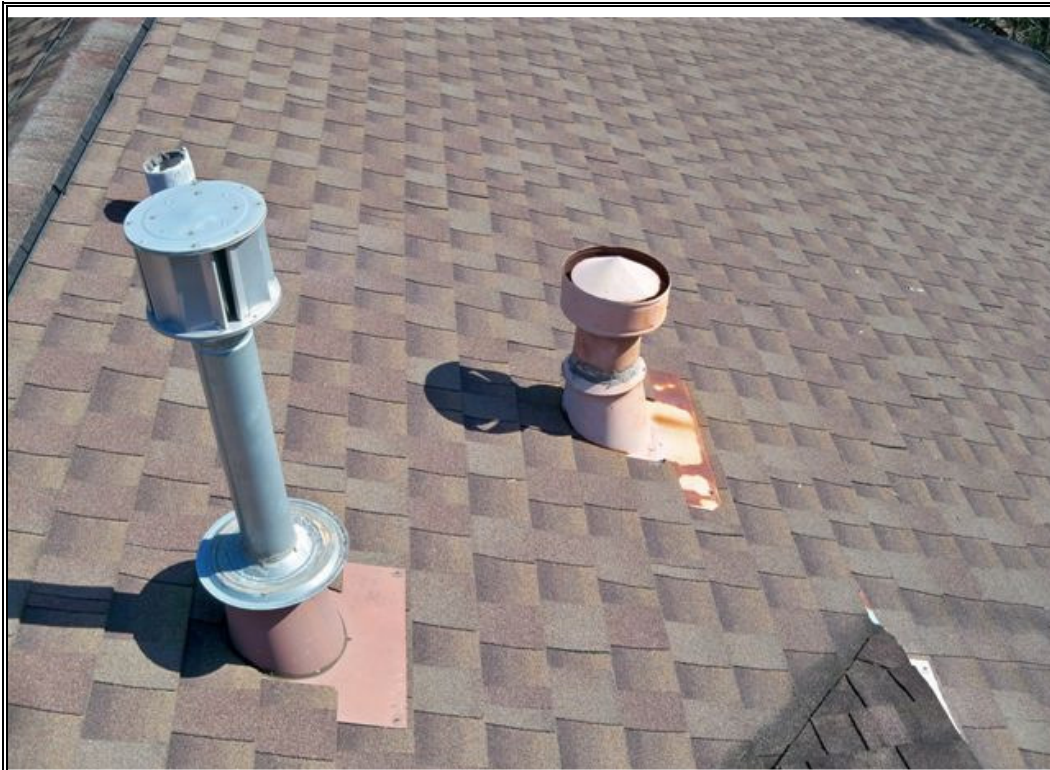
Photo Number
13

Description:
Roof vent flashing
corroded at right
side

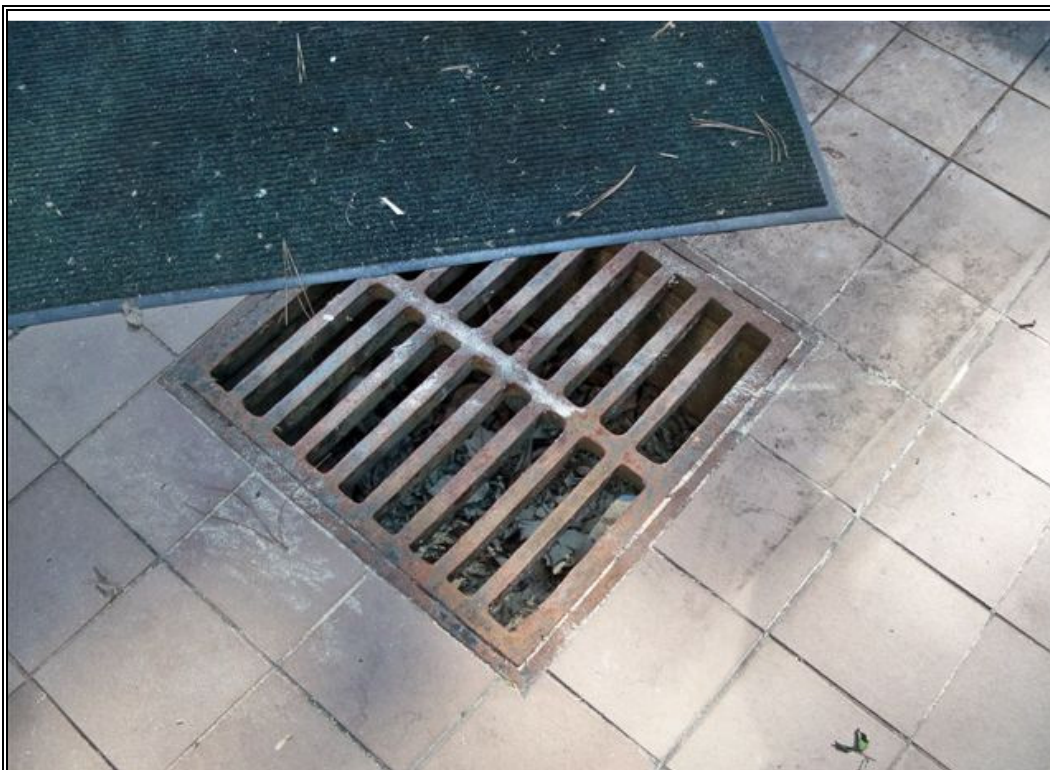
Photo Number
14

Description:
Debris
accumulation in
rear catch basin

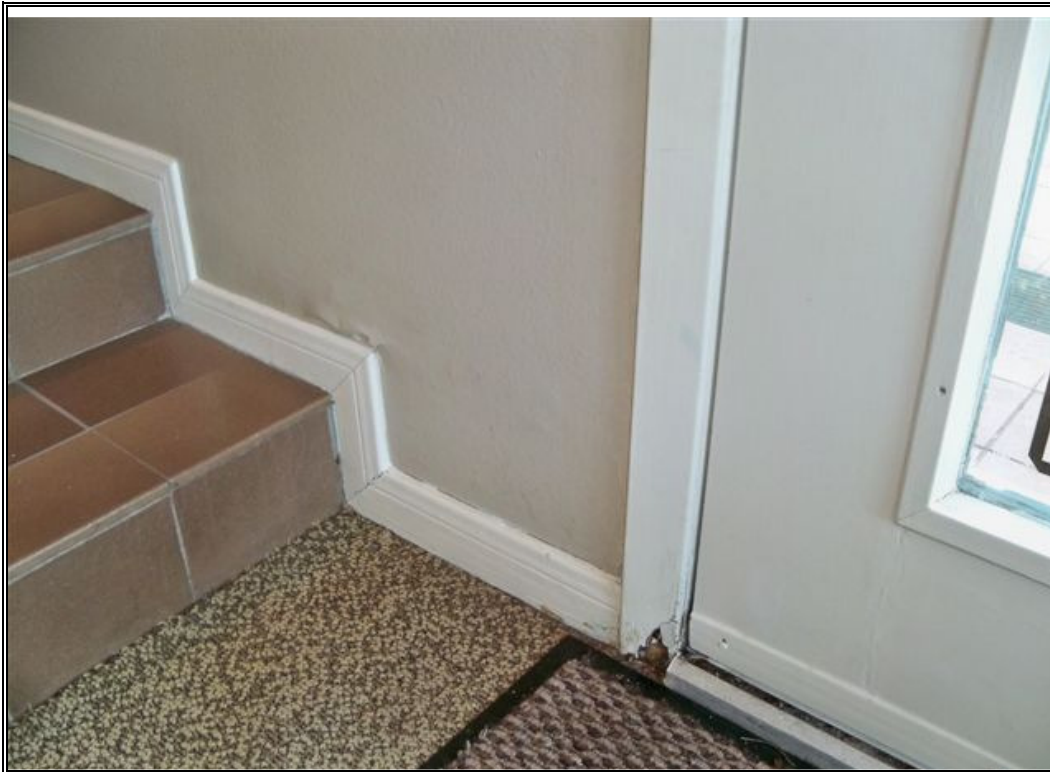
Photo Number
15

Wood rot was observed at, but not limited to, the bottom of the gameroom back door frame and wall, the deck support post at the left rear stair to the backyard, and the deck stair at the left rear stair to the backyard. Bulkhead timbers are rotted under rear deck. Rot is caused by decay fungi that grows and develops under moist wood conditions (moisture content > 20%) and moderate to warm temperatures. If the moist conditions are removed, the fungi cannot grow and further decay will be arrested.

Description:
Wood rot and
water damage in
gameroom wall
and door frame

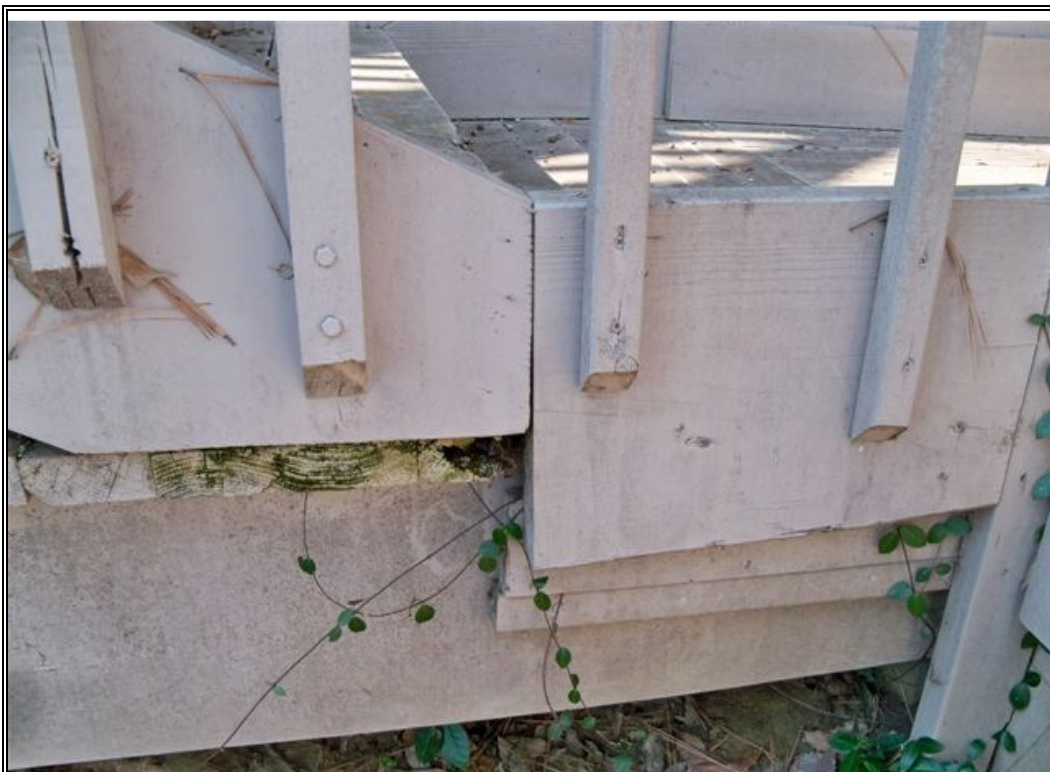
Photo Number
16

Description:
Localized wood rot
in deck stair at left
rear stair to
backyard

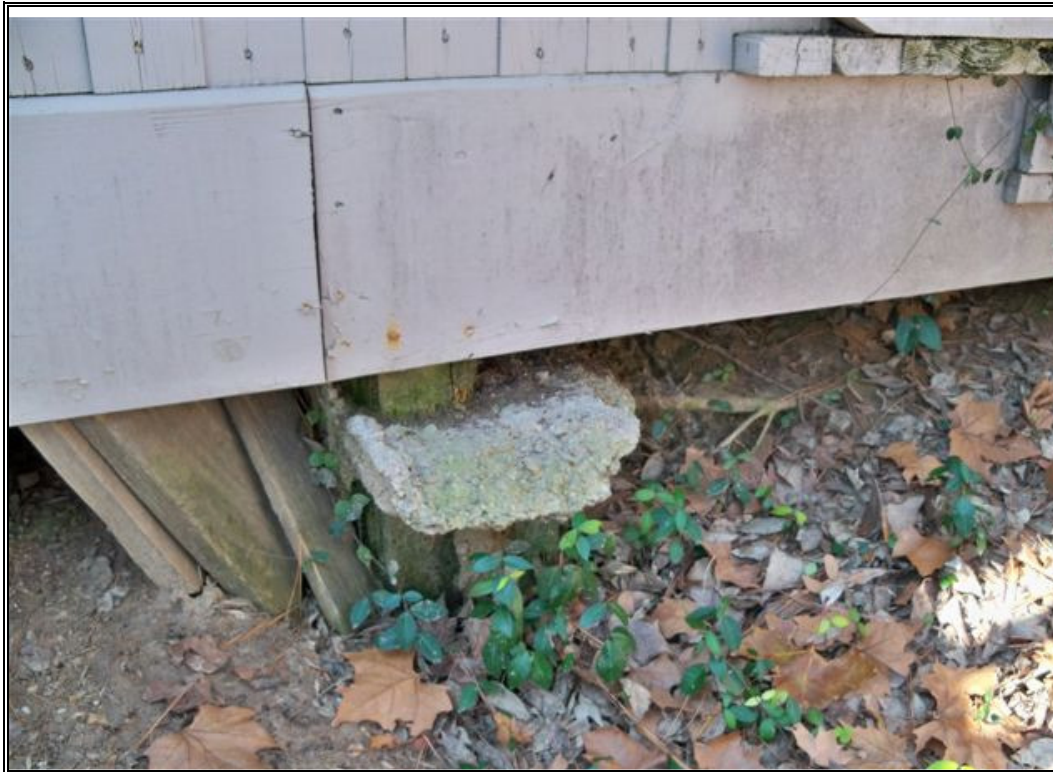
Photo Number
17

Description:
Localized wood rot
in deck support
post at left rear
stair to backyard

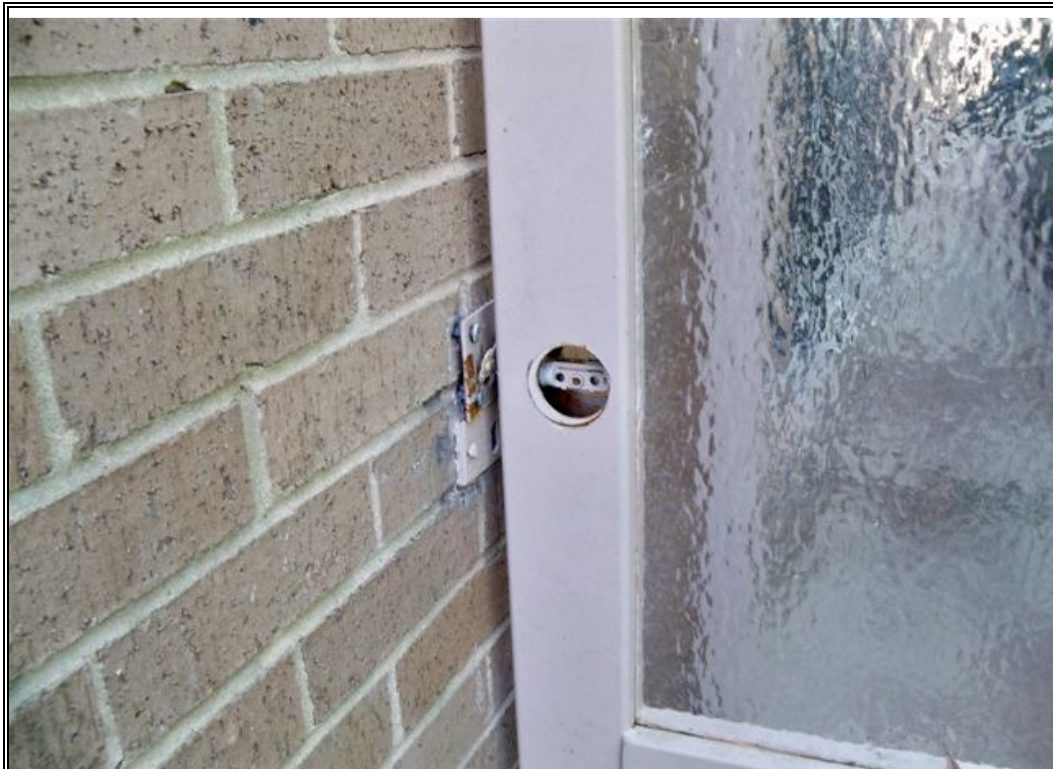
Photo Number
18

Description:
Left rear gate latch
inoperable

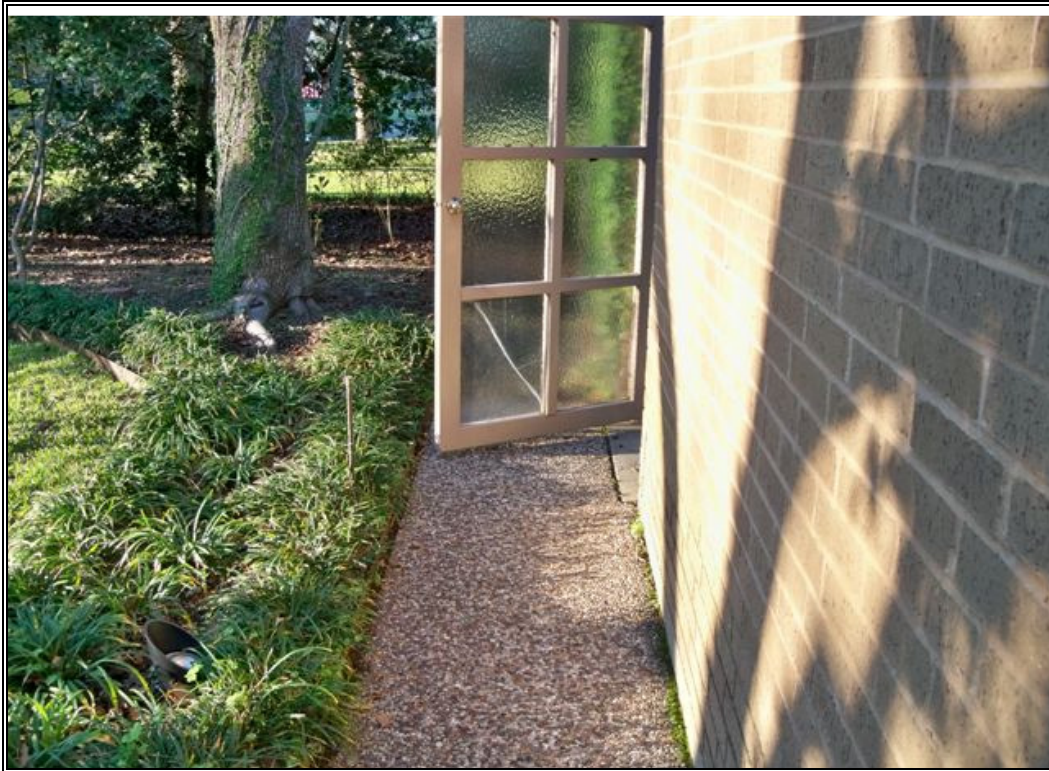
Photo Number
19

Description:
Front left gate
glass cracked

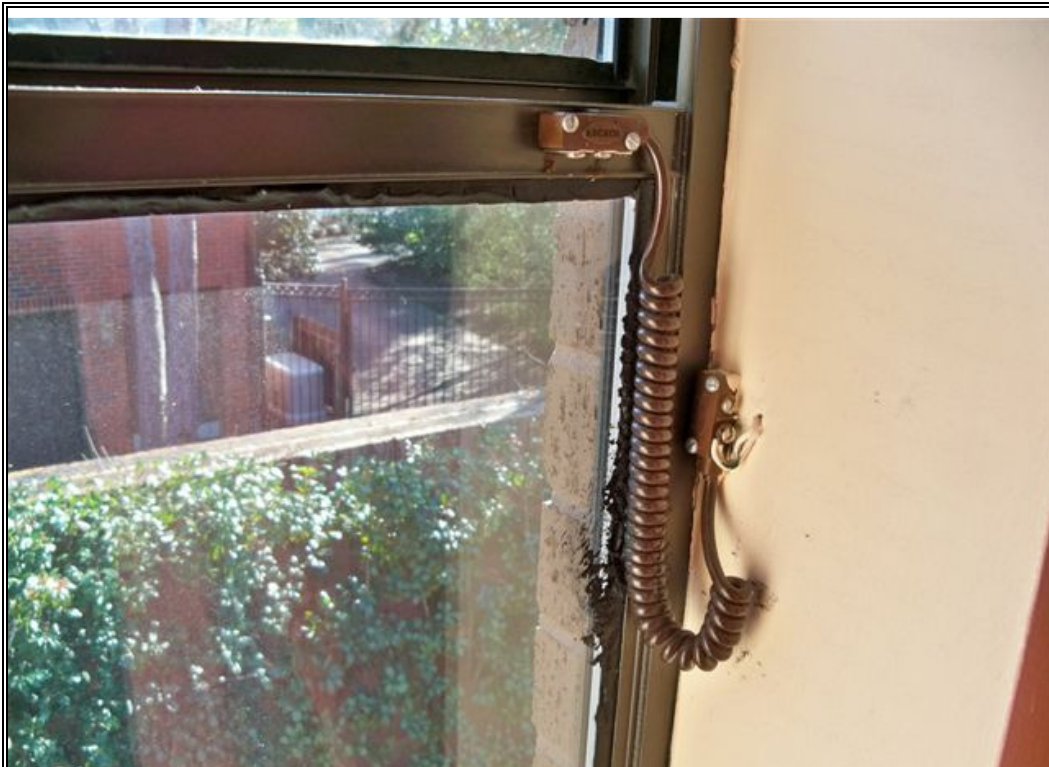
Photo Number
20

Description:
Excessive window
caulking in 2nd
story front right
bedroom

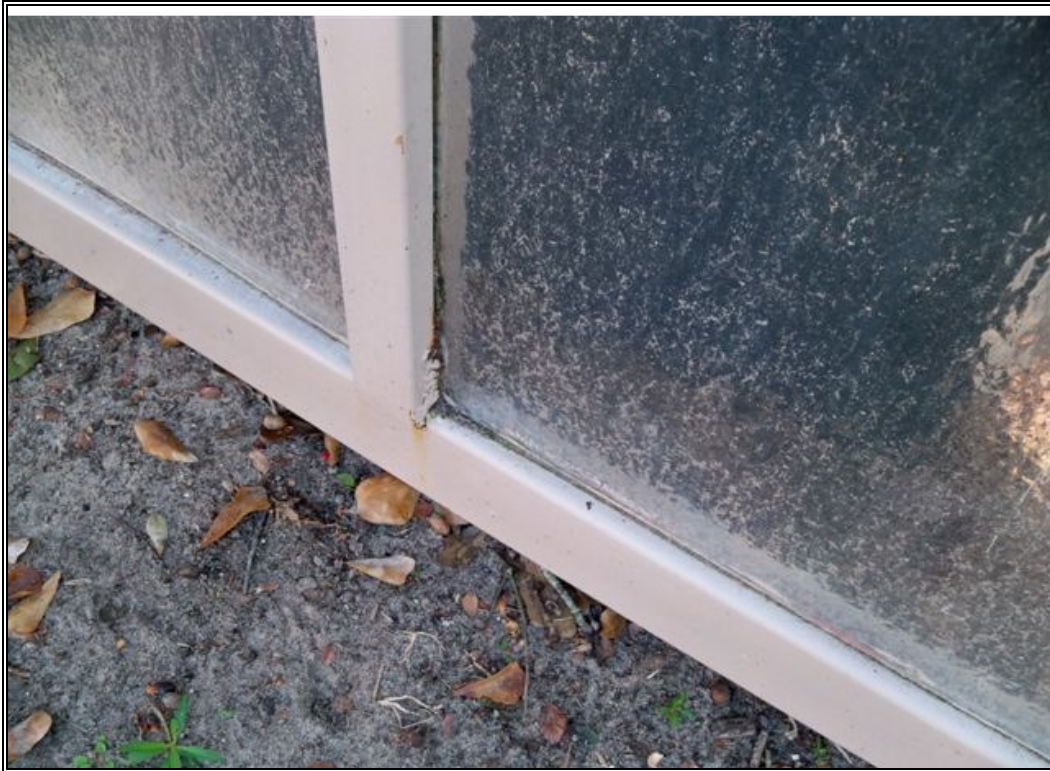
Photo Number
21

Early stage corrosion noted on driveway gate frame

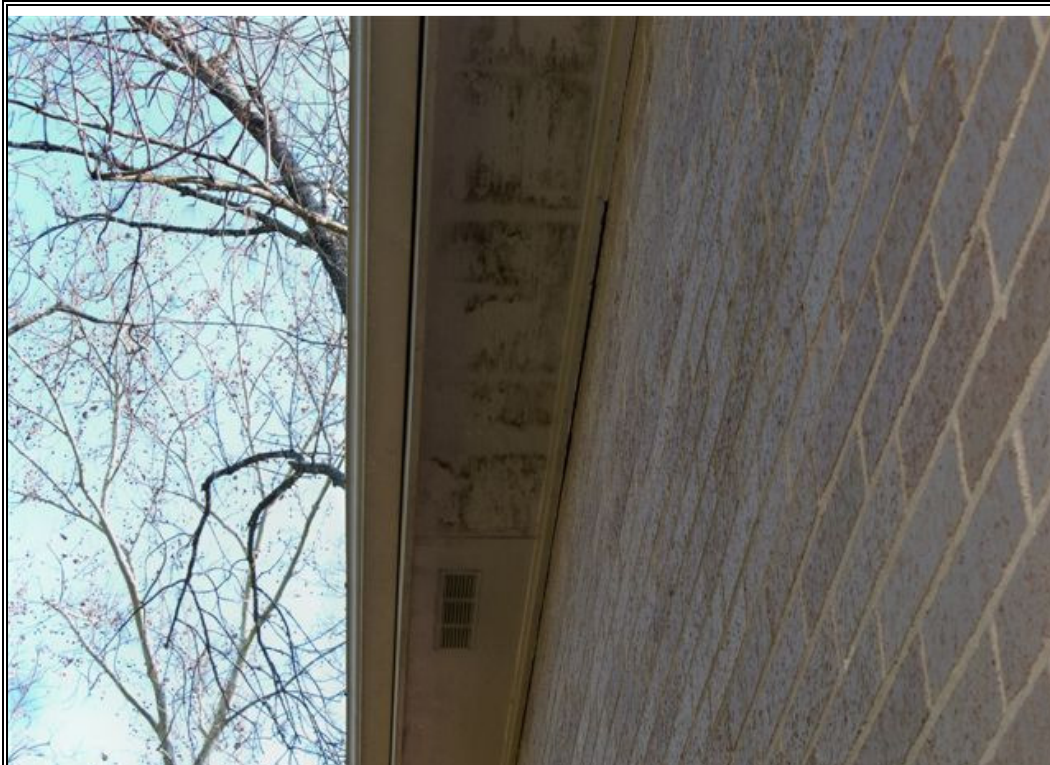
Surface mildew noted under soffits

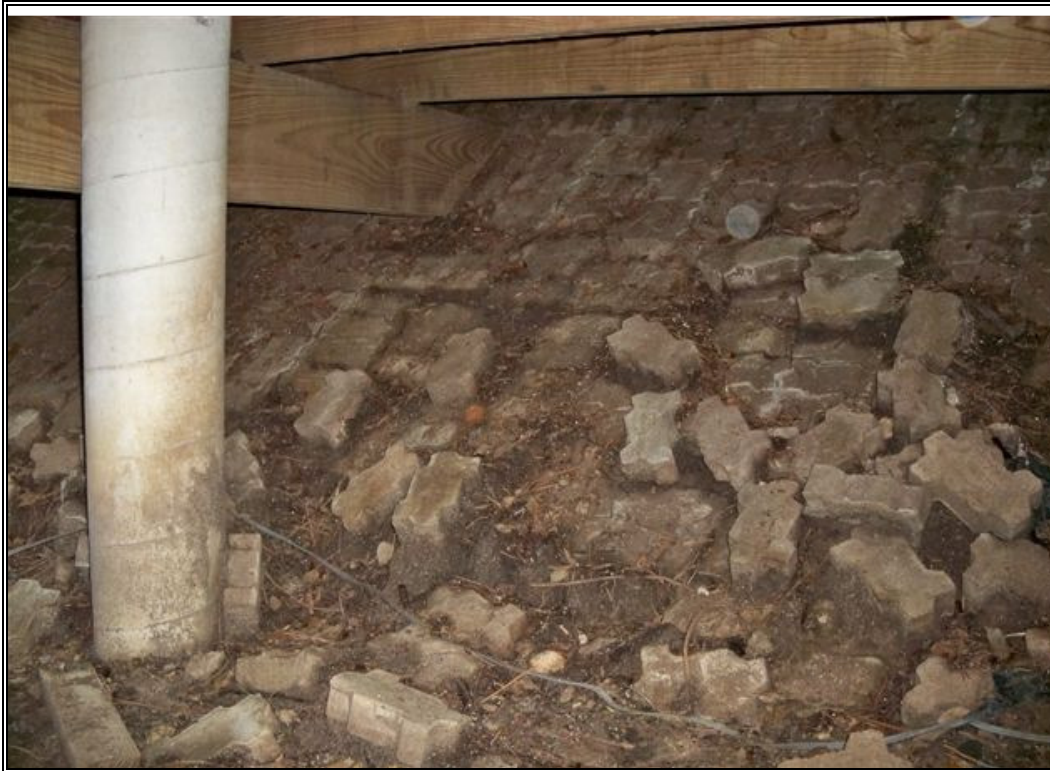
Photo Number
23

Description:
Slope rip rap paving dislodged in locations beneath rear deck (typical)

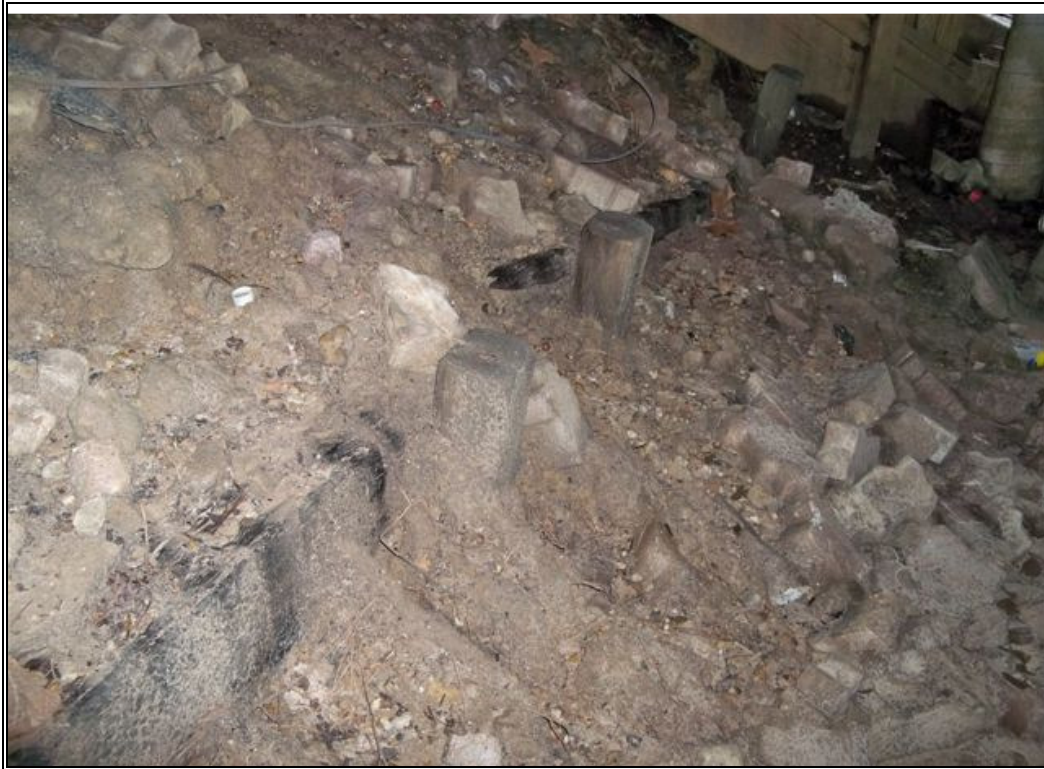
Photo Number
25

Description:
Bulkhead timbers
rotted under rear
deck

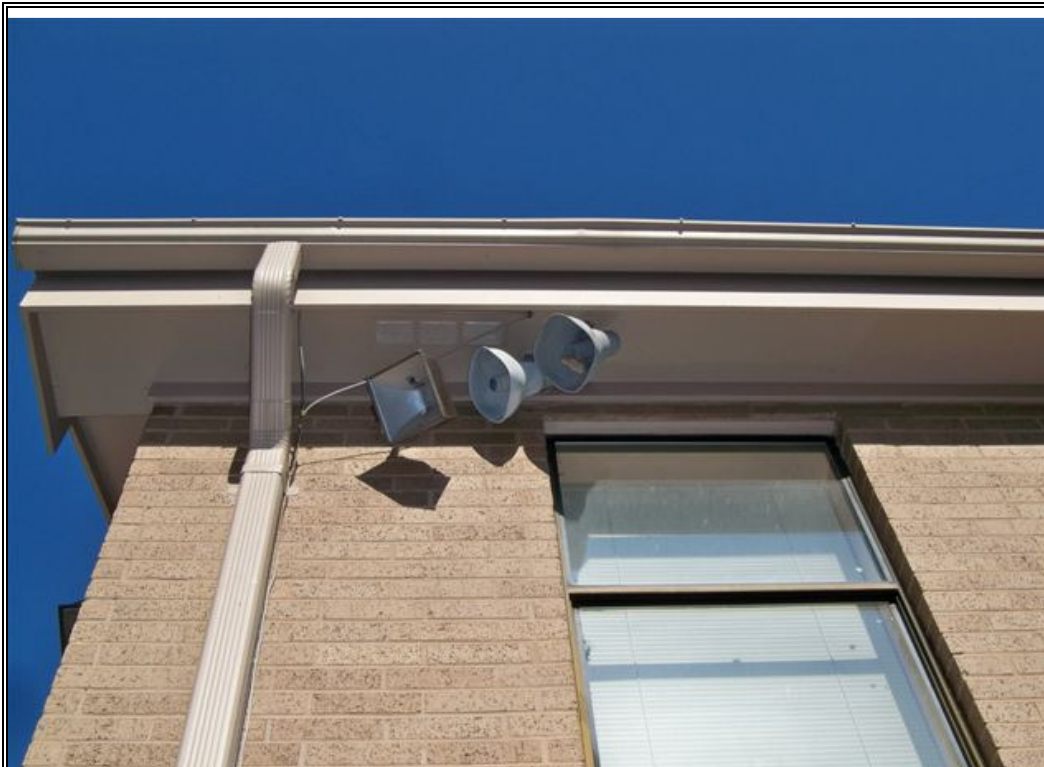
Photo Number
26

Description:
Exterior flood light
missing bulb at
right side

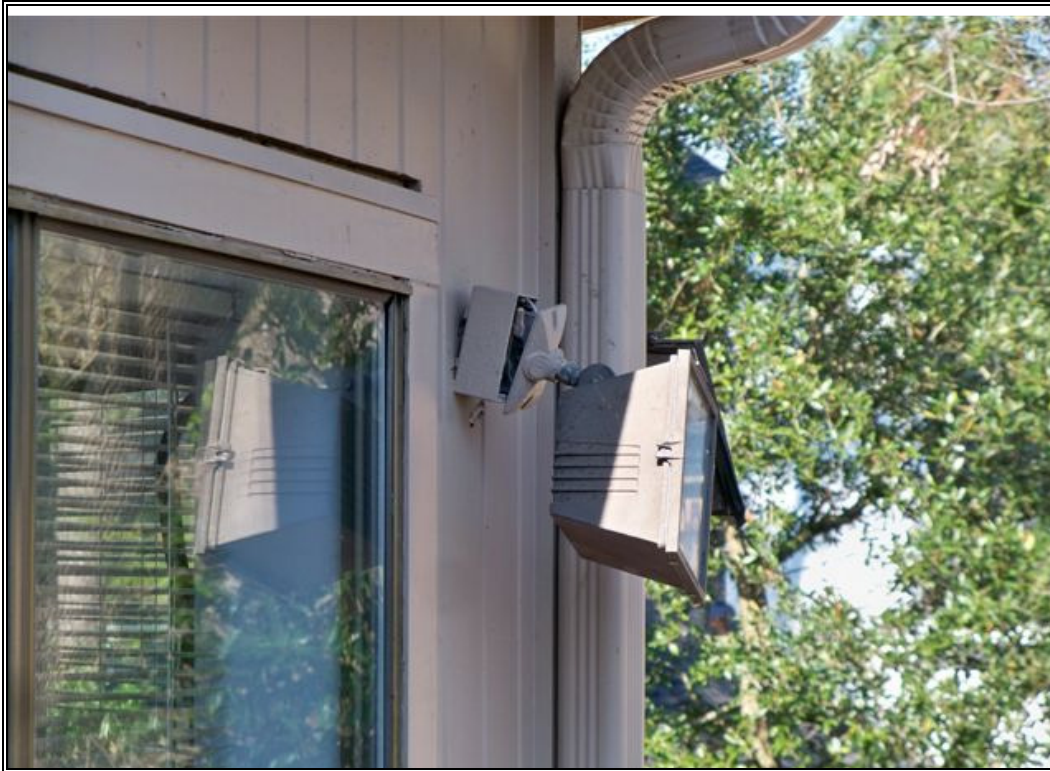
Photo Number
27

Description:
Exterior flood light
detached at rear

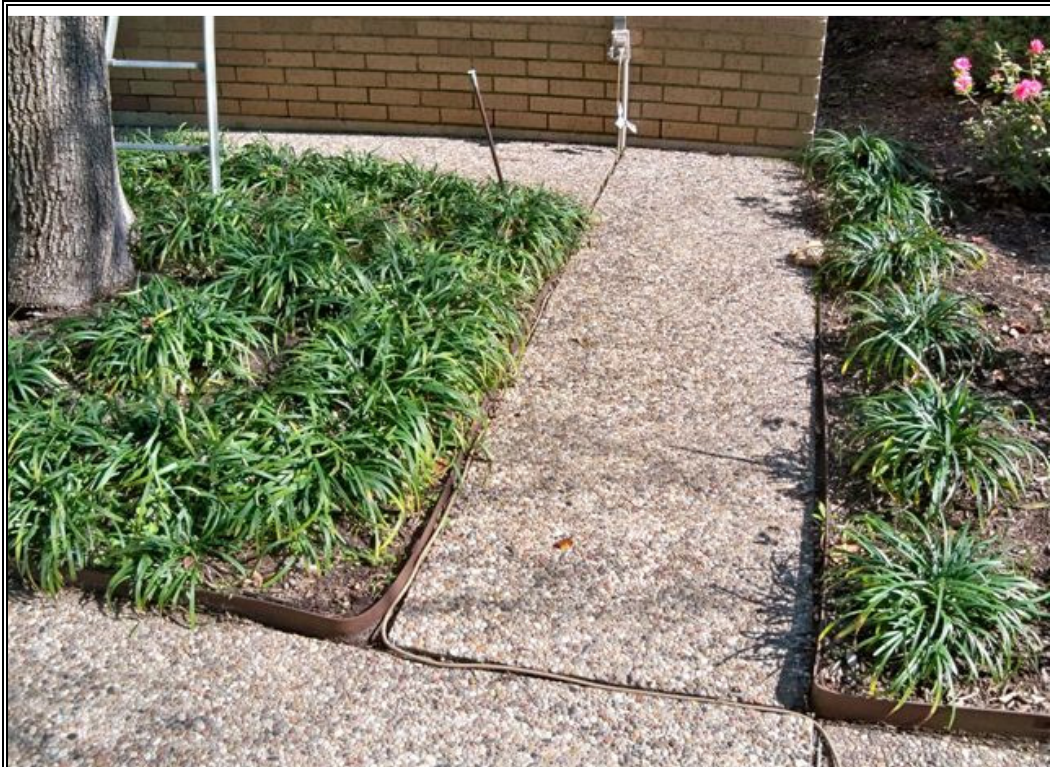
Photo Number
28

Description:
Exposed extension
cord to fountain
pump at front

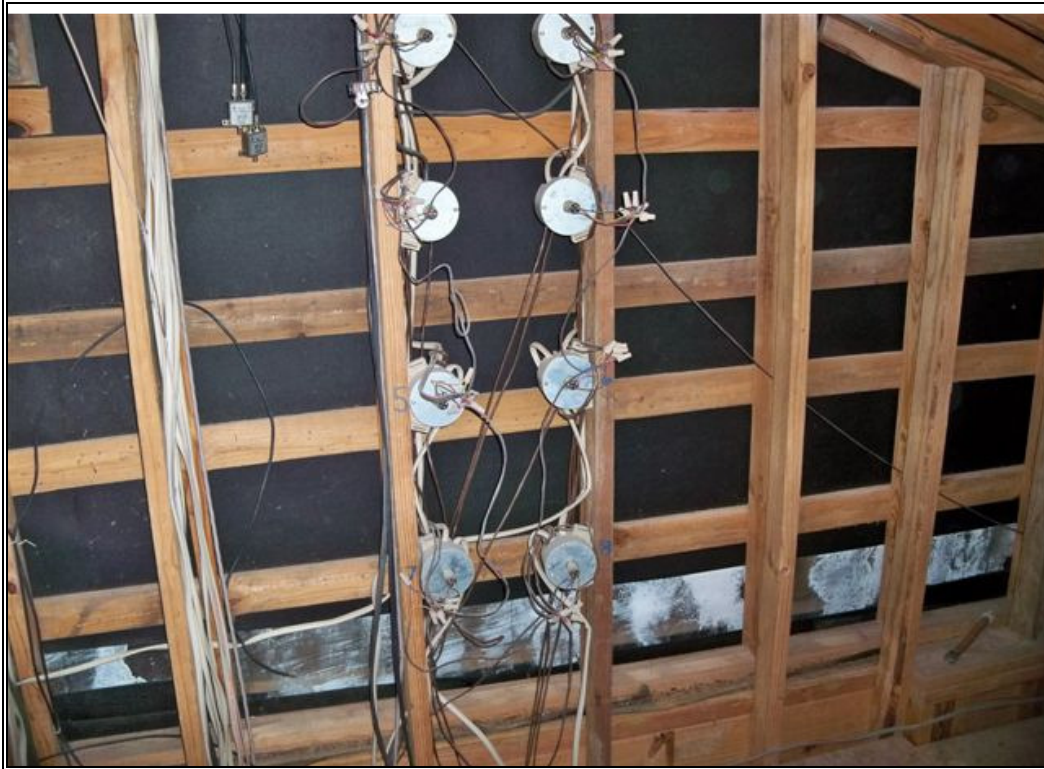
Photo Number
29

Description:
Unidentified electrical components in right side attic with exposed wiring connections

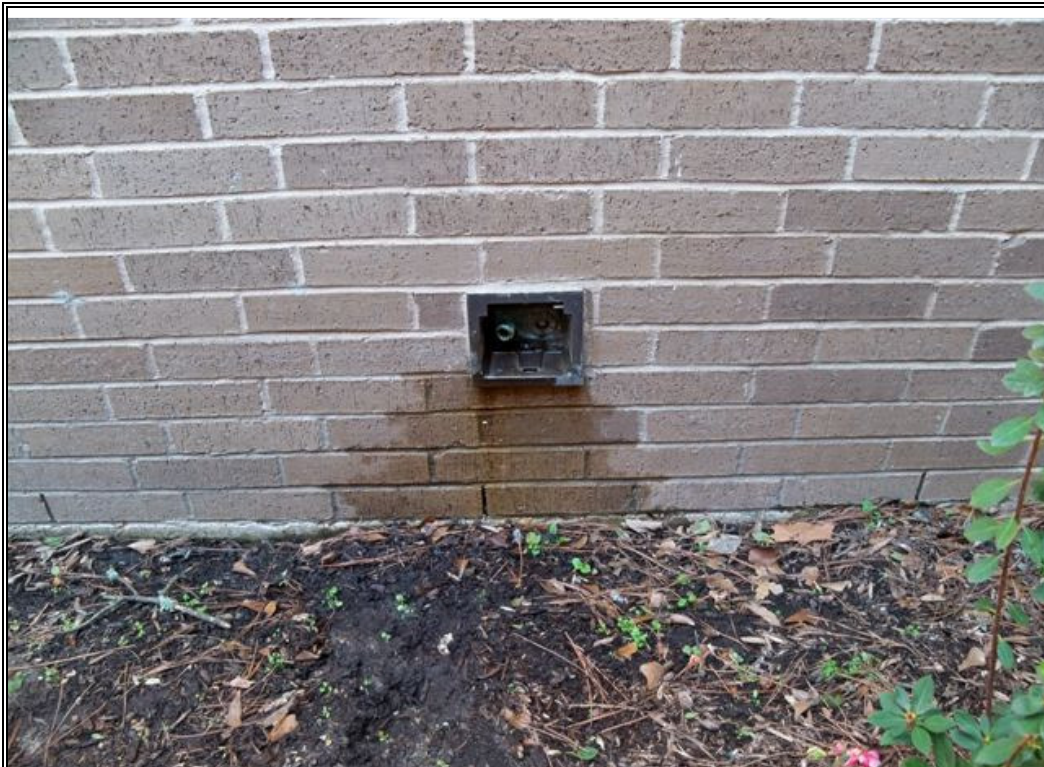
Photo Number
30

Description:
Leaking hose bib at front entry. Valve missing handle

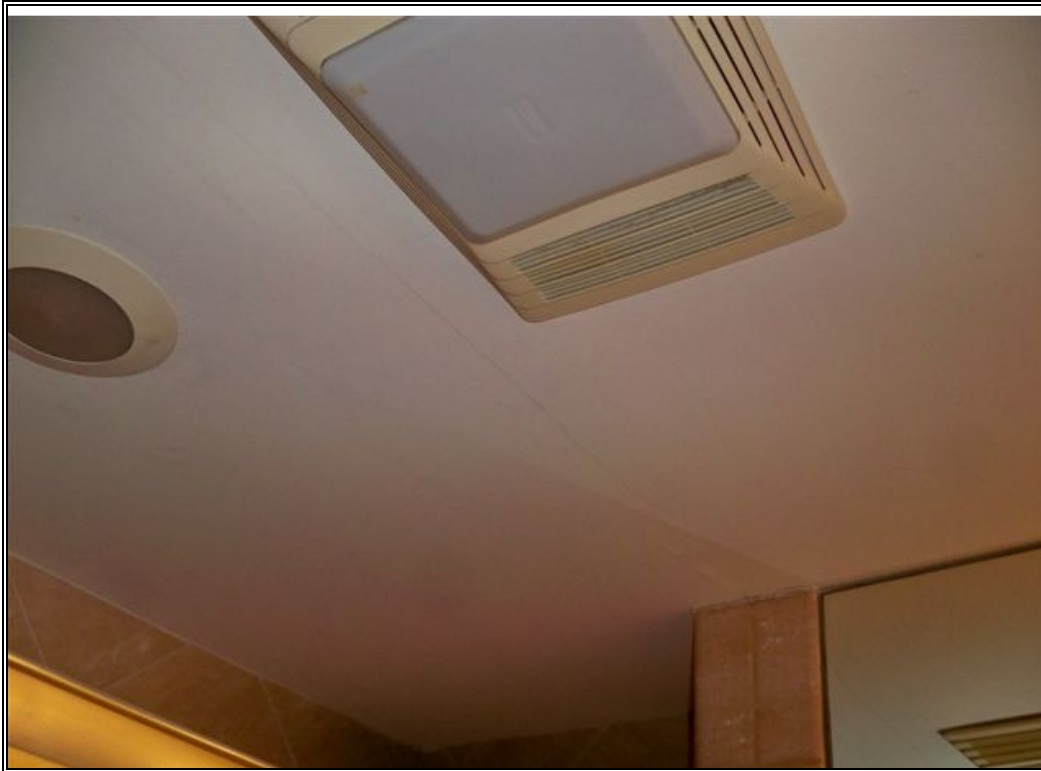
Photo Number
31

Description:
Ceiling drywall
crack in bathroom
above garage

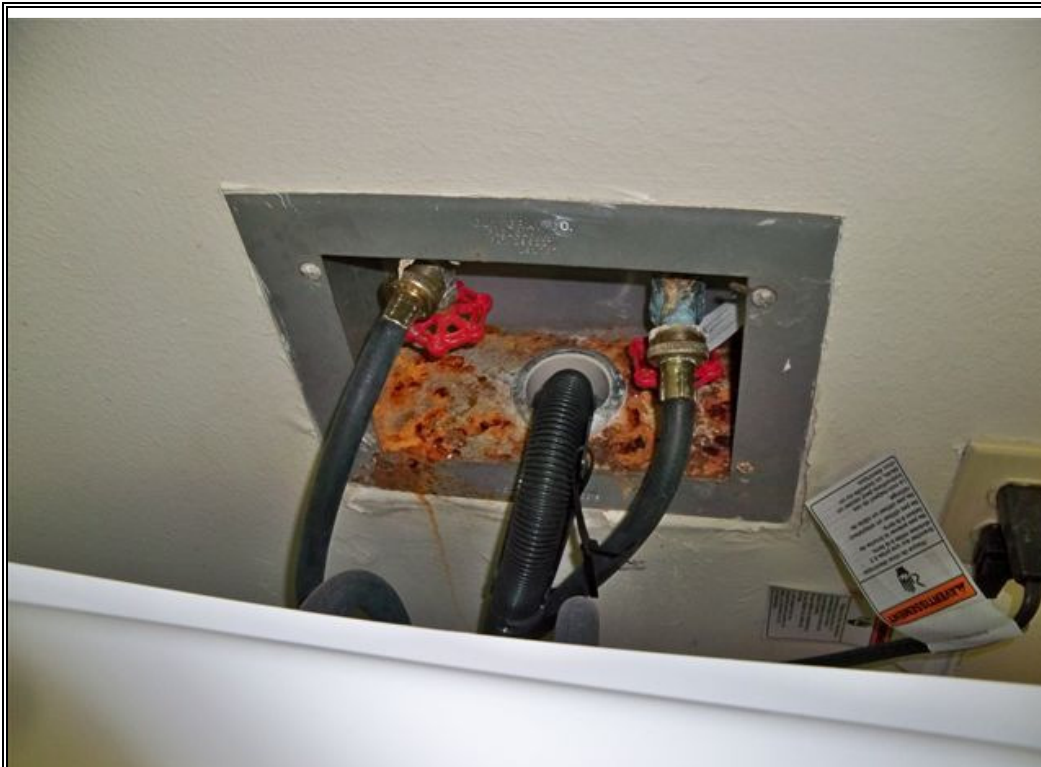
Photo Number
32

Description:
Corroded drain
box in laundry
room

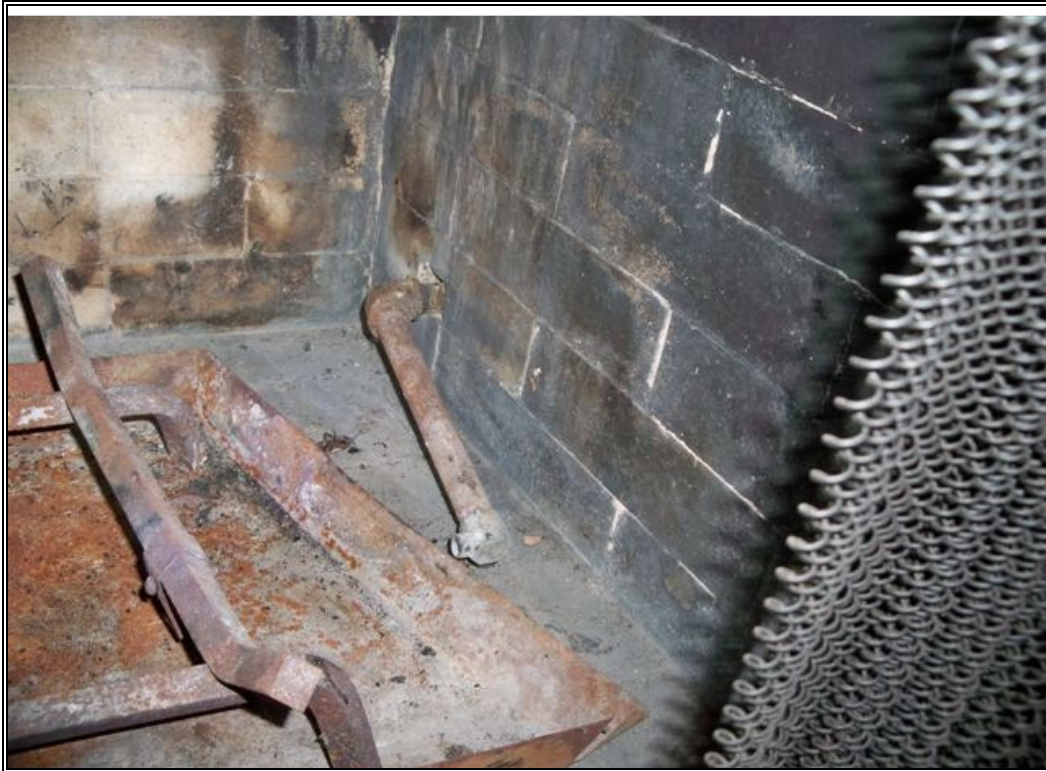
Photo Number
33

Description:
Fireplace gas
burners
deteriorated typical
both fireplaces
