ENGINEER'S REPORT

11 Windermere Lane
Houston, TX 77063

Inspection No. 20130143

Date of Inspection: January 22, 2013

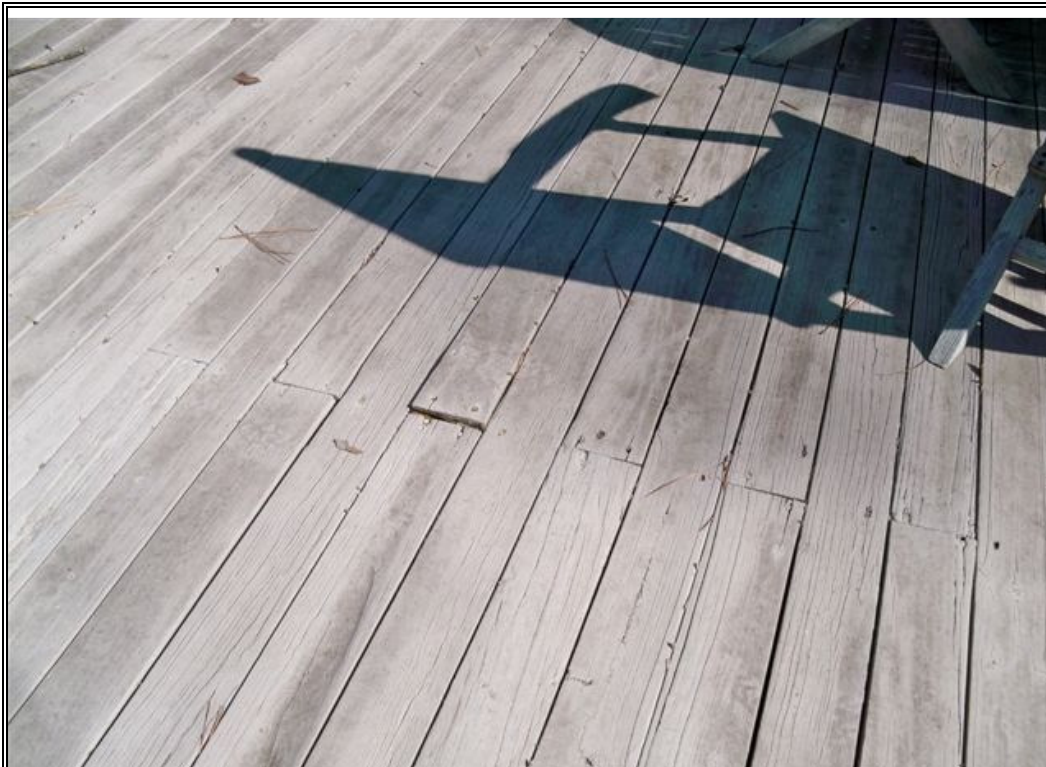
Photo Number
34

Description:
Deck boards loose
in locations
